Region 03, 94 - Williamson County

THOMPSON STATION RD. E. Crossing NFA 1928 / I65

INSPECTION TEAM'S SUMMARY  
BRIDGE NUMBER 94-1928-0.97  
NON-FA ROUTE 1928 OVER I-65

FEBUARY 03, 2025

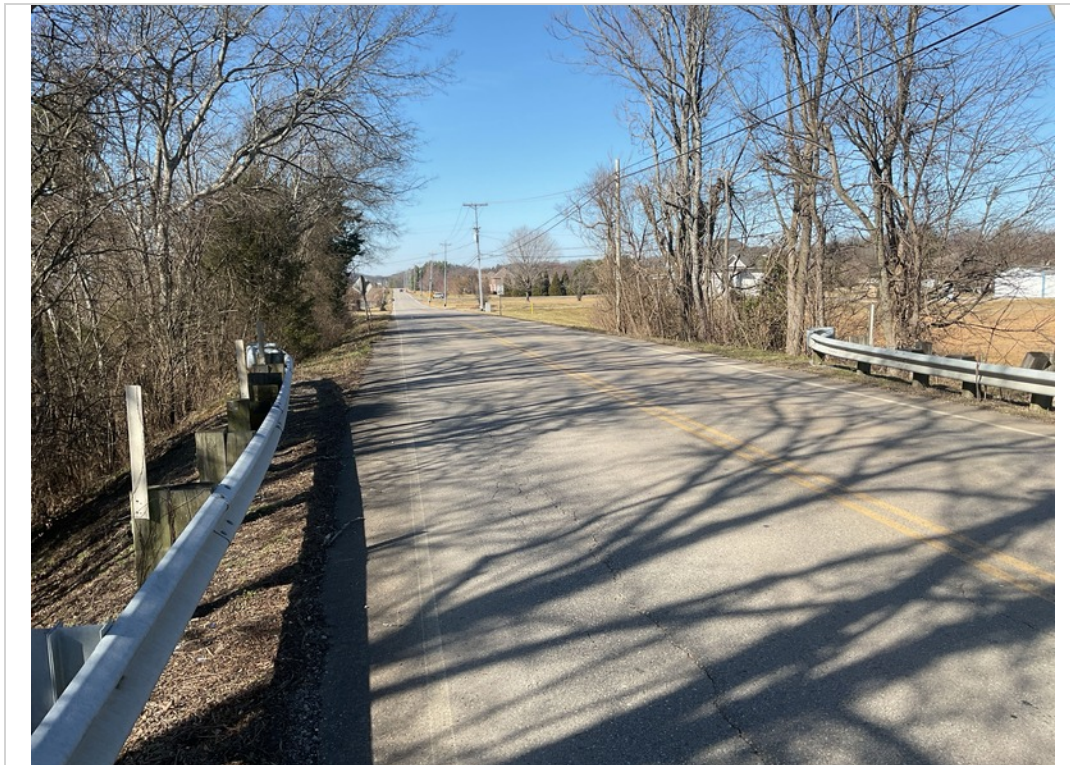
APPROACH #1

Alignment (Good) \_\_\_\_\_  
 Pavement (Fair) CRACKS IN ASPHALT IN APPROACH NO.1, CRACKS AND SPALL IN ASPHALT AT APPROACH NO. 2  
 Embankment (Good) \_\_\_\_\_

| Date Added | Recommendation | Priority |
|---|---|---|
| 02/03/2025 | REPAIR ASPHALT IN BOTH APPROACHES | |

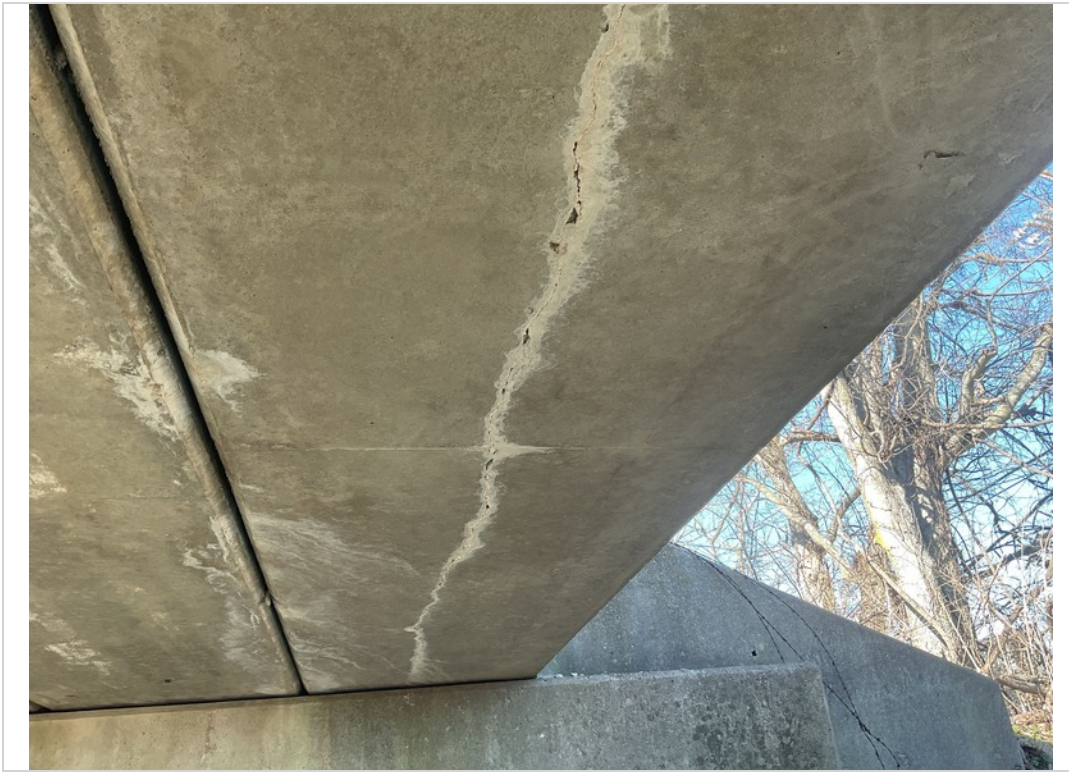
CRACK IN BOTTOM OF BOX BEAM "A", SPAN #1

| BEAMS | A | FAIR | 1/32" CRACK W/EFF |

| Date Added | Recommendation | Priority |
|---|---|---|
| 02/02/2017 | REPAIR BOX BEAM "A" IN SPANS NO. 1 AND 4 | 3 |

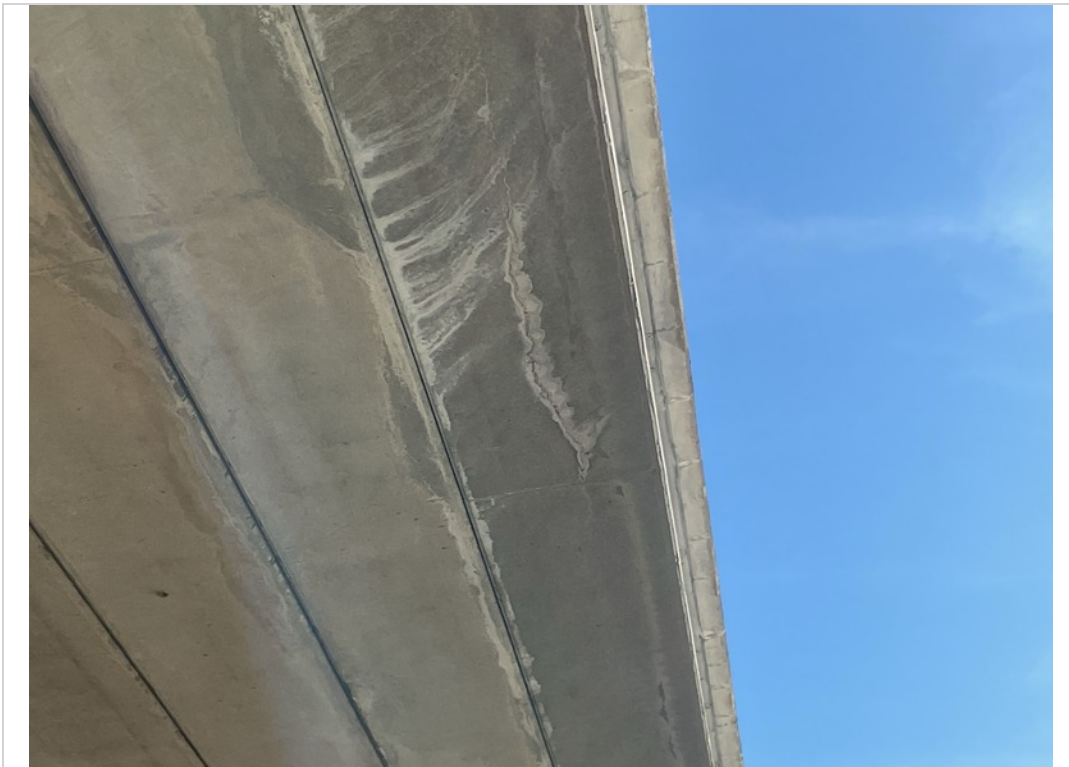
CRACK IN BOTTOM OF BOX BEAM "I", SPAN #2

| | I | FAIR | CRACKS UP TO 1/16" OPEN, EFF, RUST STAINS |

| Date Added | Recommendation | Priority |
|---|---|---|
| 02/04/2015 | REPAIR BOX BEAM "I" IN BOTTOM SPANS NO. 2, 3, AND 4 | 3 |

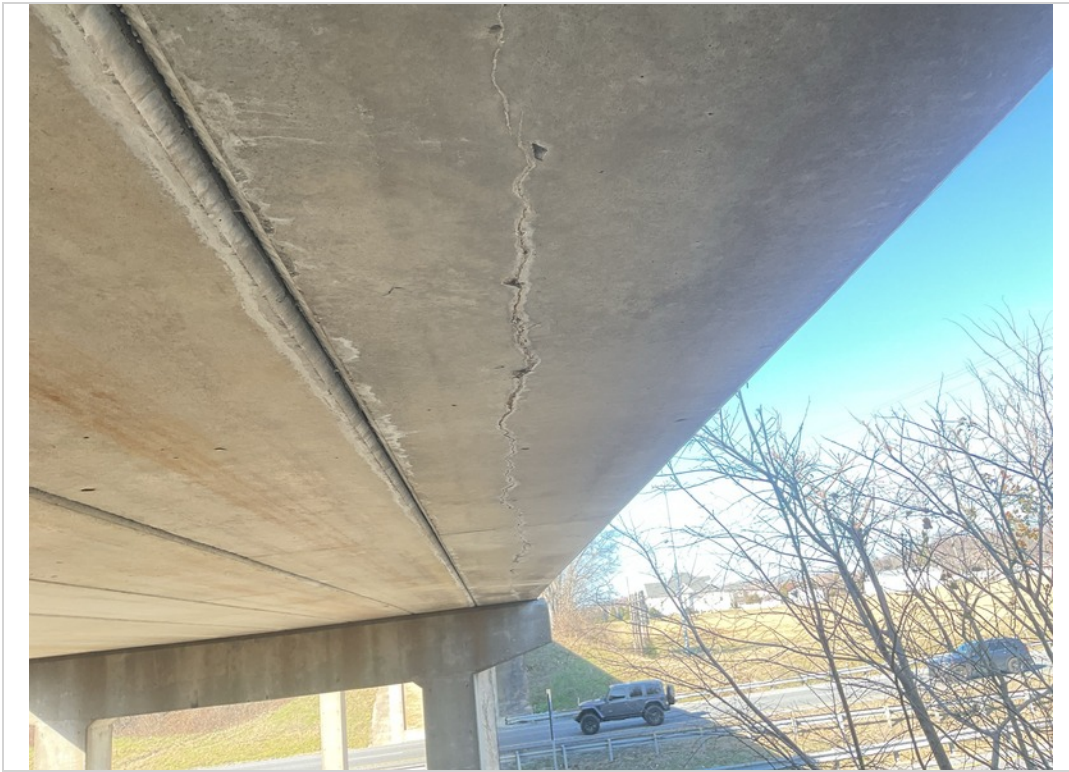
CRACK IN BOTTOM OF BOX BEAM "A", SPAN #4

| BEAMS | A | FAIR | 1/32" CRACKS, EFF, RUST STAINS |

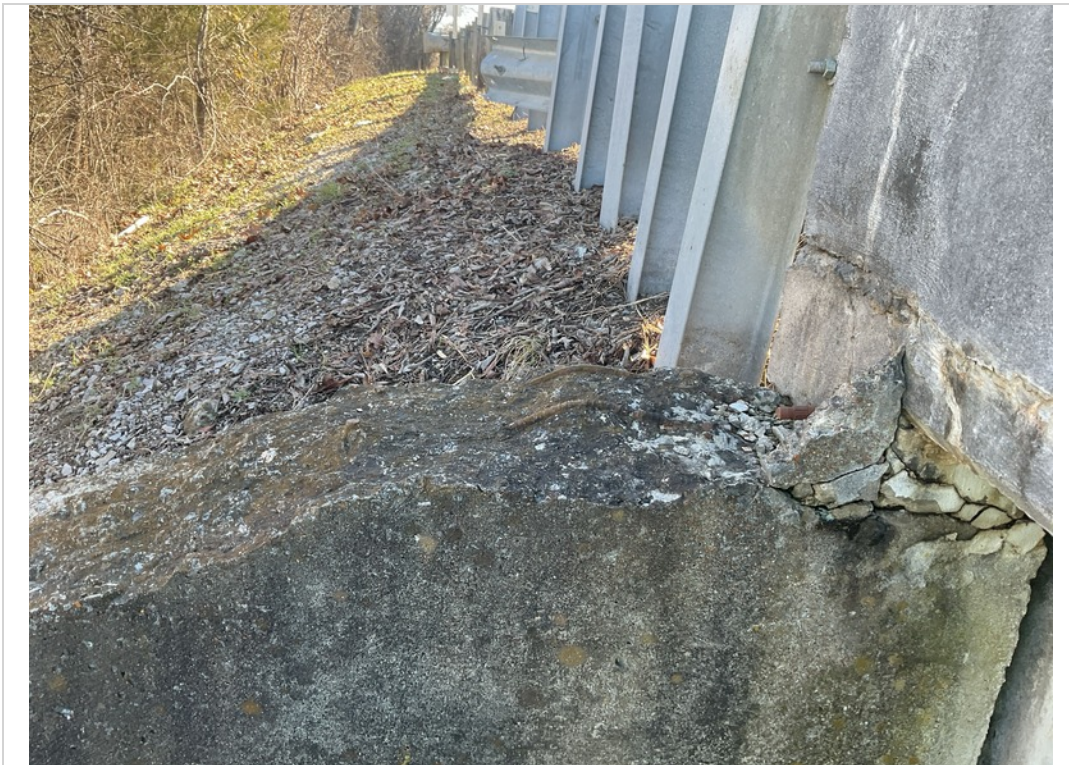
| <b>Abutment Wings</b> | (Fair) | LARGE CHIP IN LEFT WING AT ABUTMENT 2 |

SPALL W/ REBAR IN TOP OF ABUT. #2 LEFT WING

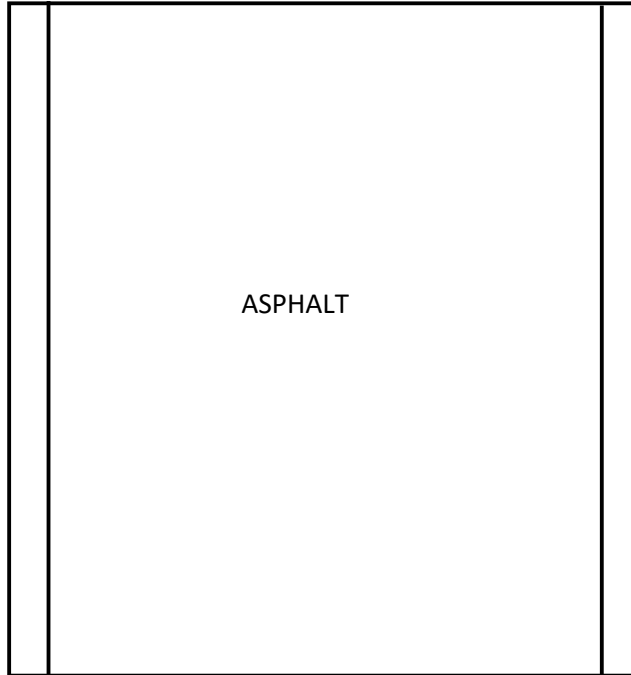
# Top Span No. 2

| W. SURFAC | GOOD | HAIRLINE CRACKS IN ASPHALT |
| PARAPET | GOOD | HAIRLINE CRACKS |

| Date Added | Recommendation | Priority |
|---|---|---|
| 02/03/2025 | SEAL CRACKS IN ASPHALT WEARING SURFACE | |

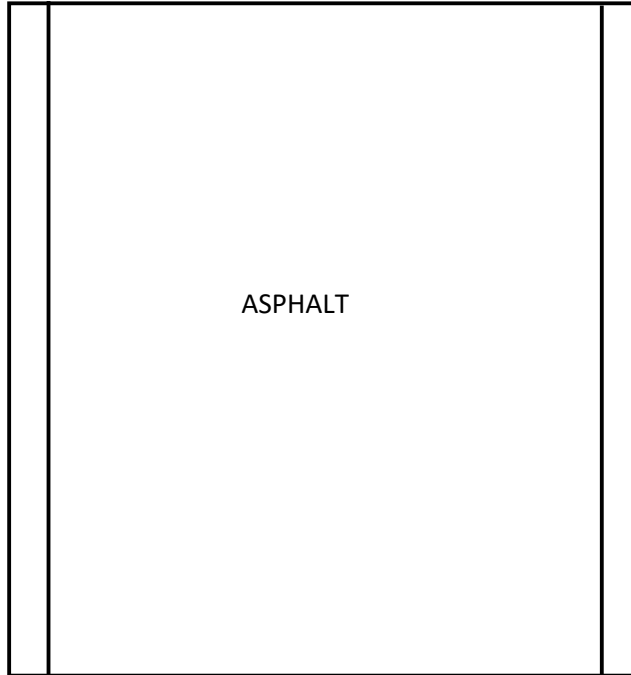
# Top Span No. 3

| W. SURFAC | GOOD | HAIRLINE CRACKS IN ASPHALT |
| PARAPET | GOOD | HAIRLINE CRACKS |

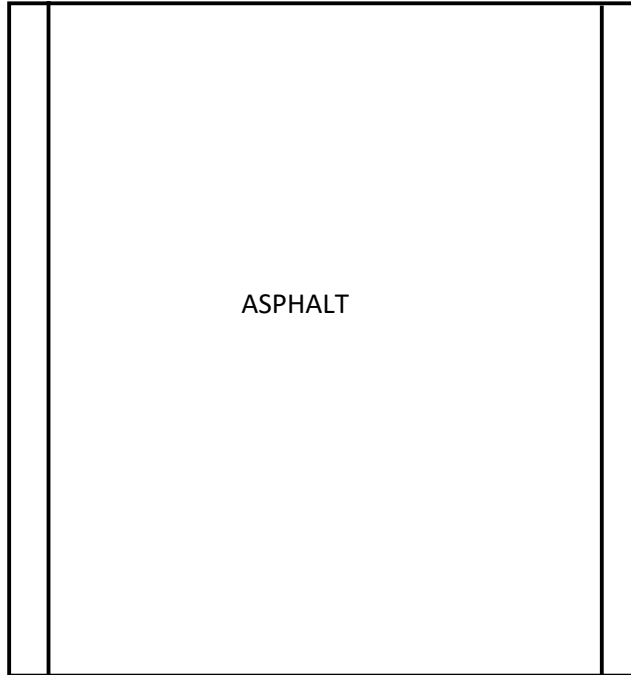
# Top Span No. 4

| W. SURFAC | GOOD | HAIRLINE CRACKS IN ASPHALT |
| PARAPET | GOOD | HAIRLINE CRACKS |

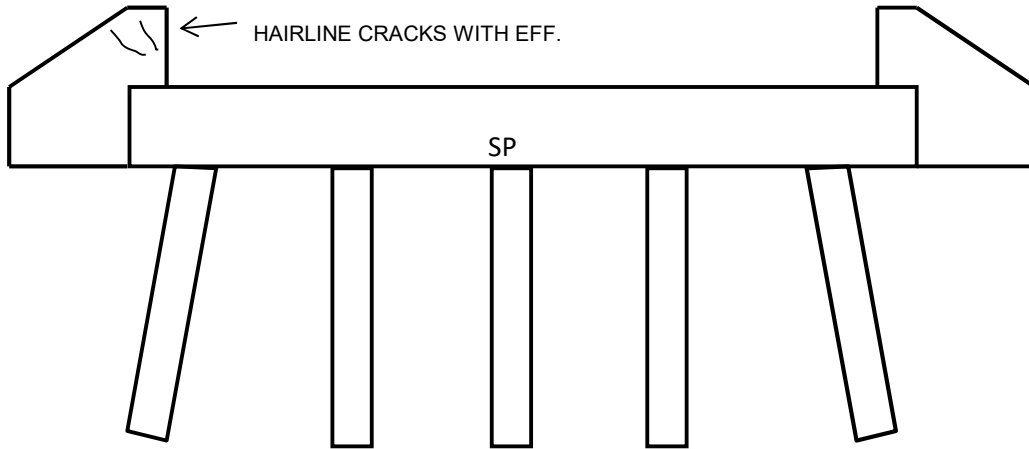
# Abutment No. 1

| RIGHT WING | GOOD | HAIRLINE CRACKS WITH EFF. |

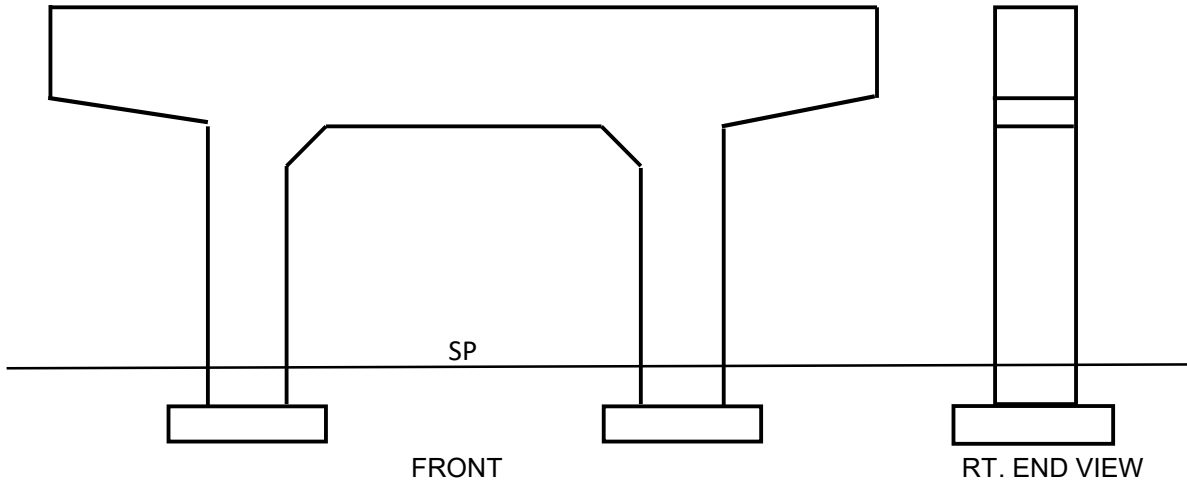
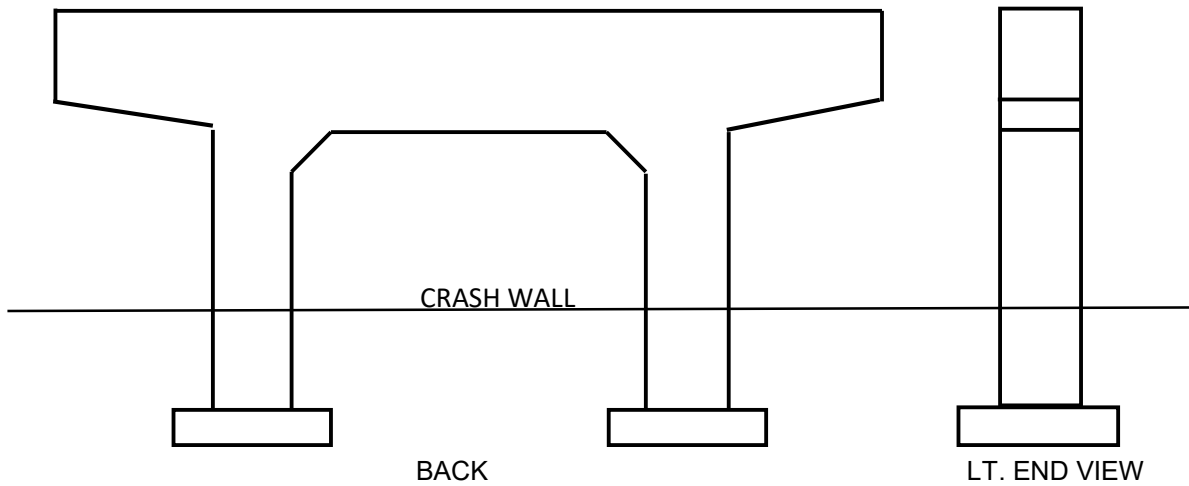
# BENT NO. 1

| CAP | GOOD | SOUND PATCHES IN BOTTOM OF CAP (9 LF) |

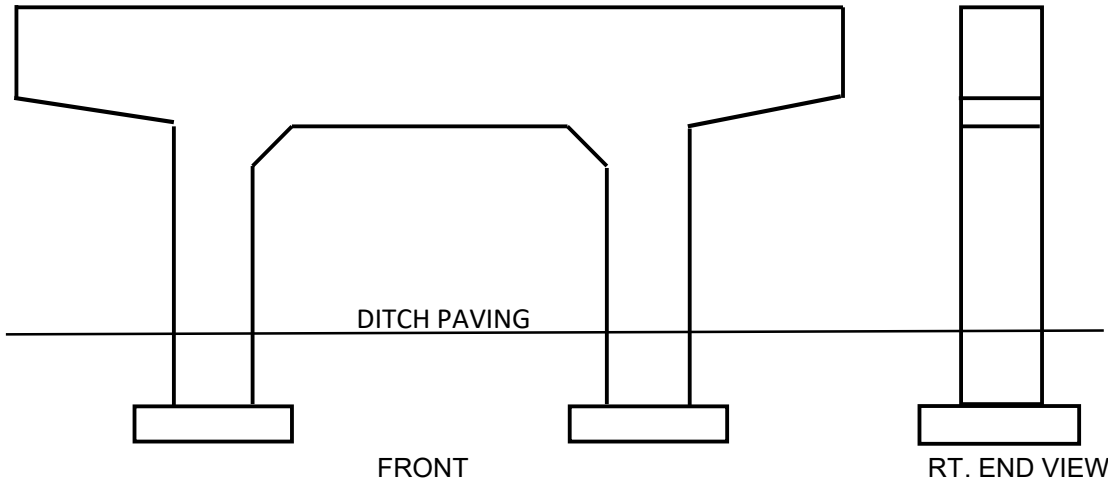
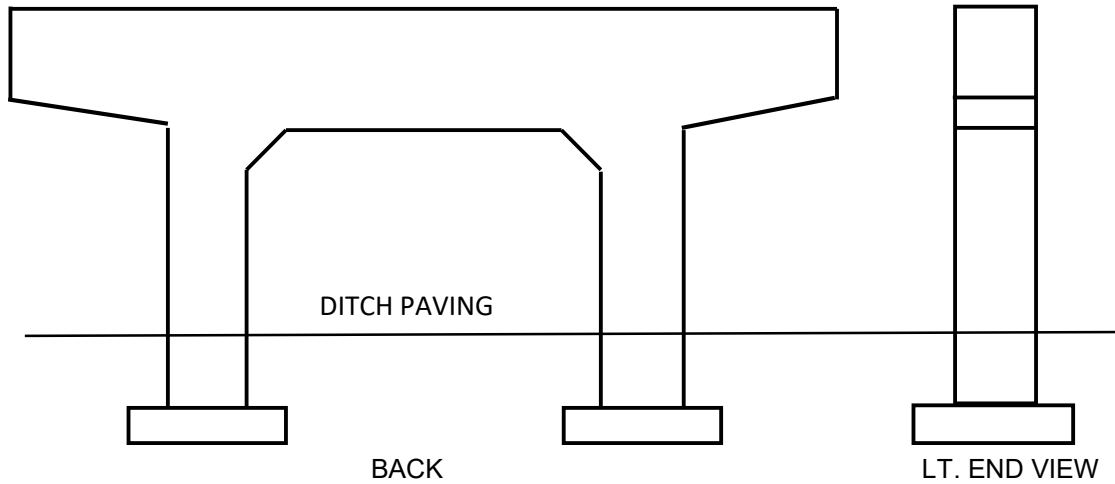
# BENT NO. 2

| CAP | GOOD | SOUND PATCHES IN BOTTOM OF CAP (4 LF) |

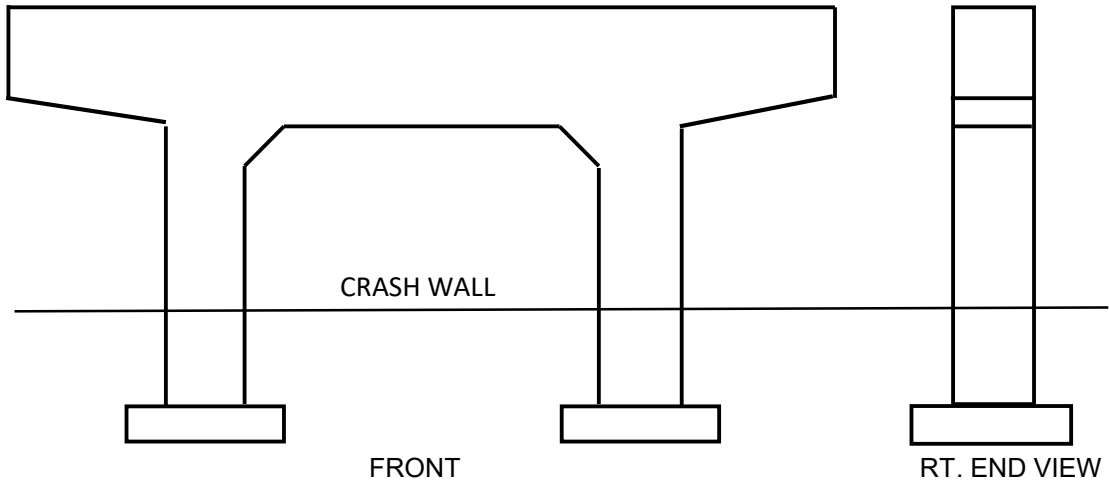
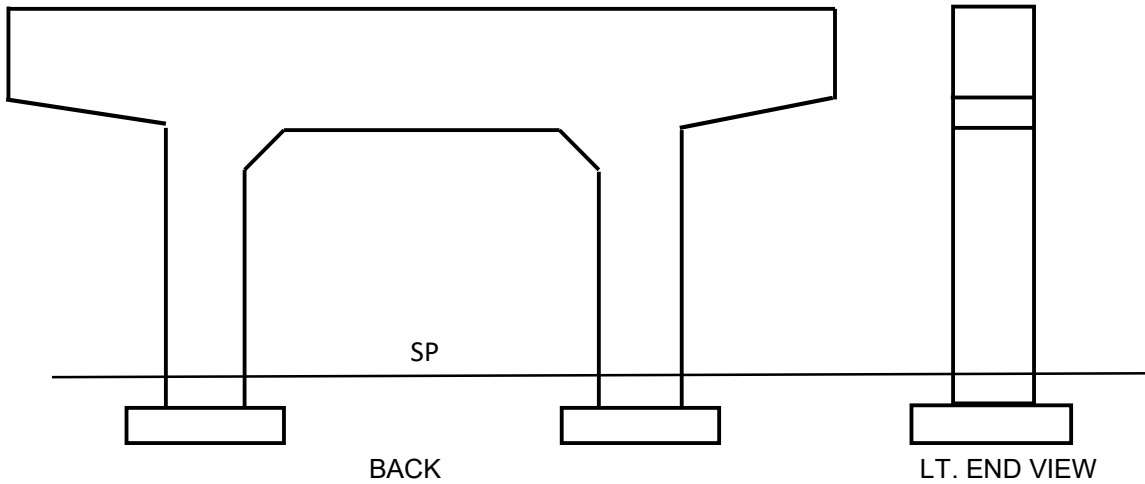
# BENT NO. 3

| CAP | GOOD | SOUND PATCHES IN BOTTOM OF CAP (4 LF) |

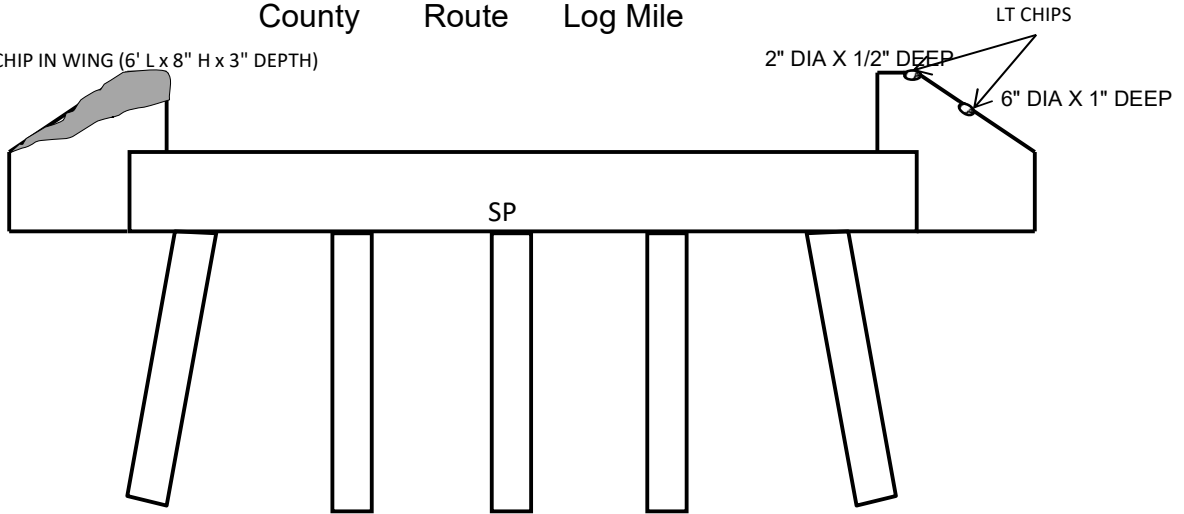
# Abutment No. 2

LARGE CHIP IN WING (6' L x 8" H x 3" DEPTH)

| LEFT WING | FAIR | LARGE CHIP IN WING |
| | | 6' L x 8" H x 3" DEPTH |
| RIGHT WING | GOOD | LT CHIPS |
