I-65 Crossing I65 / SR106 & HARPETH RV

90 - LAST INSPECTION DATE 02/14/2025

| IDENTIFICATION | |
|---|---|
| (8) Structure Number | 94I00650005 |

Bridge 94I00650005 is a 4-span bridge on a 70 degree skew composed of a cast-in-place concrete deck supported by prestressed AASHTO Type II beams. The bridge has a total length of 193'-10.25", an out-to-out width of 44'-0", a roadway width of 40'-5", and carries 2 lanes of traffic. The maximum span length is 52'-10.125". On February 14, 2025 a Michael Baker inspection team performed a 1-day Routine Inspection on the bridge. Korbin Hinson and Sean Bonner inspected the top of deck, superstructure, and substructure from the ground. The weather conditions were sunny and 28 degrees.

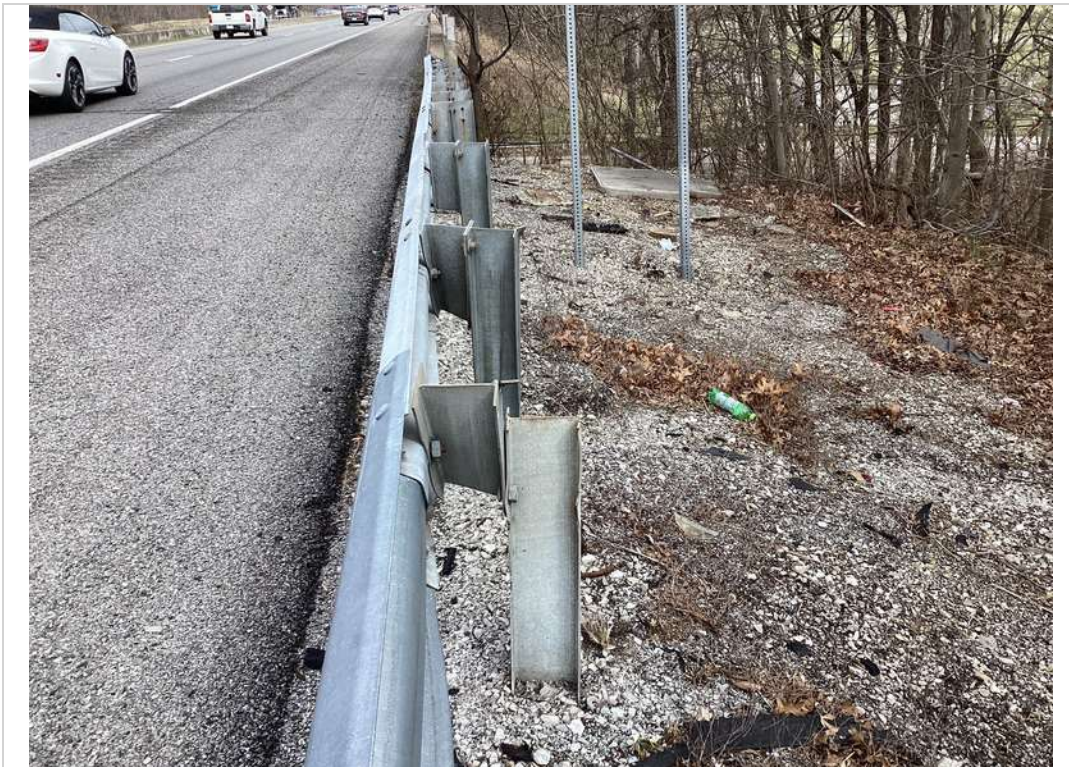
Approach 1 right damaged guardrail posts

| Date Added | Recommendation | Priority |
|---|---|---|
| 02/14/2025 | REPAIR GUARDRAIL POSTS ON THE RIGHT SIDE OF APPROACH NO. 1 | 3 |

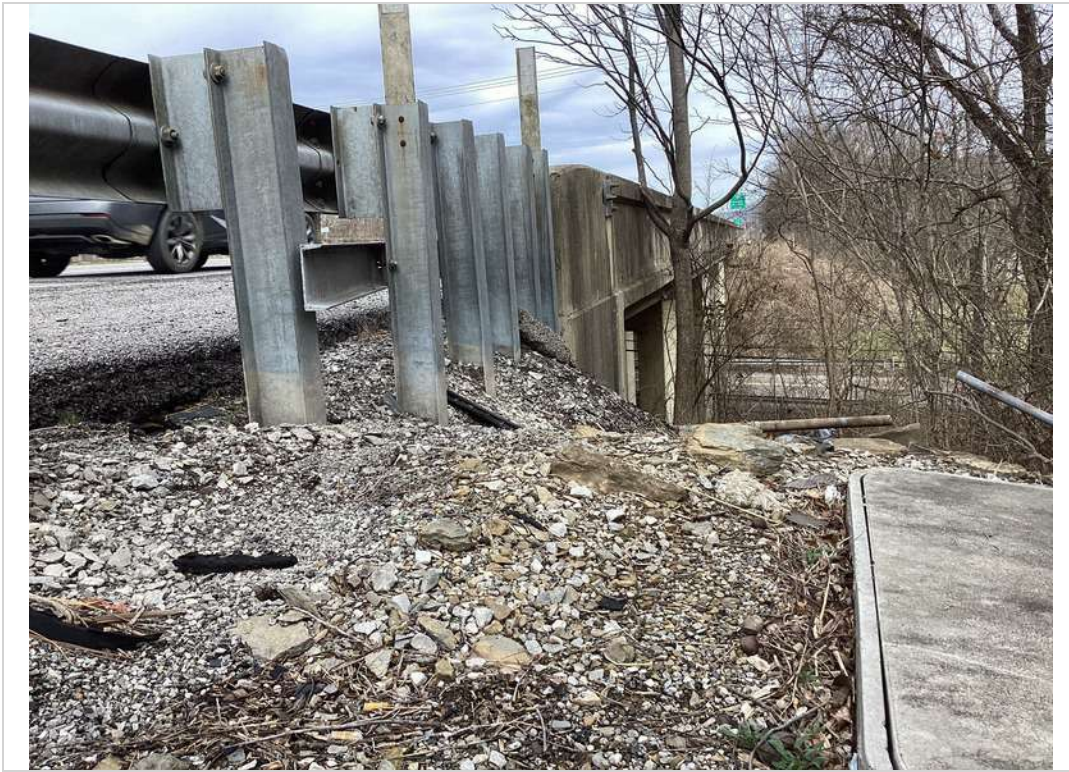
Approach 1 right embankment erosion

| Date Added | Recommendation | Priority |
|---|---|---|
| 02/14/2025 | REPAIR EMBANKMENT EROSION ON THE RIGHT SIDE OF APPROACH NO. 1 | 3 |

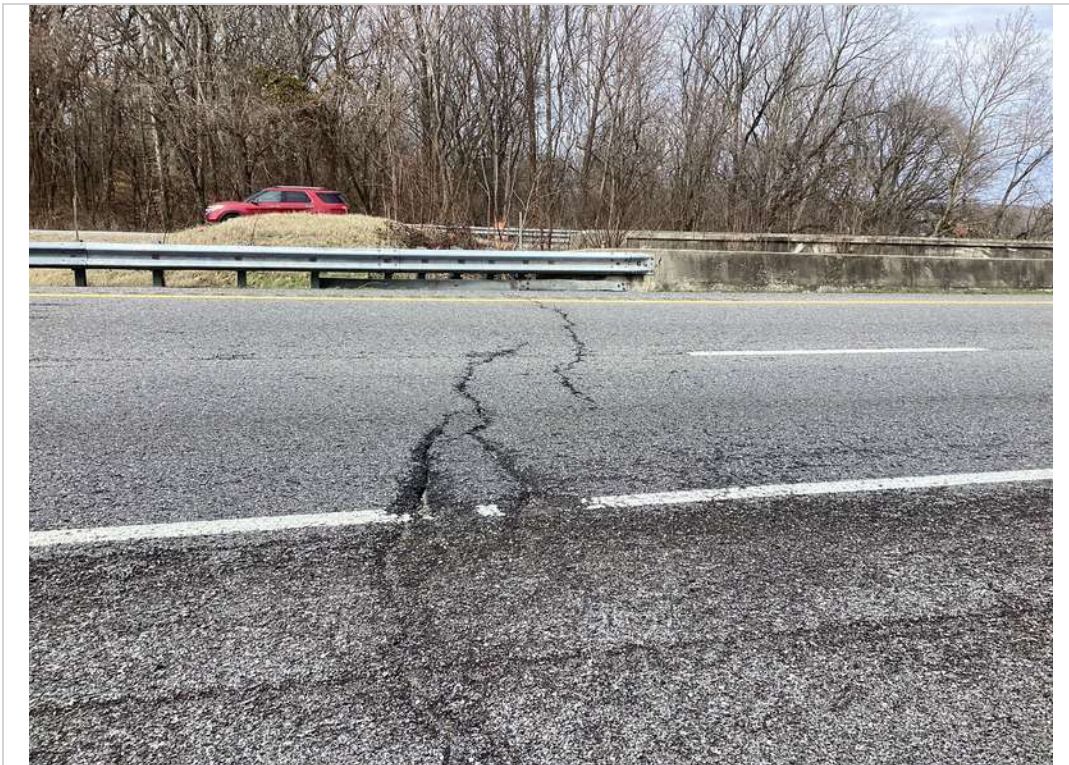
Approach 1 wide asphalt cracks and moderate potholes

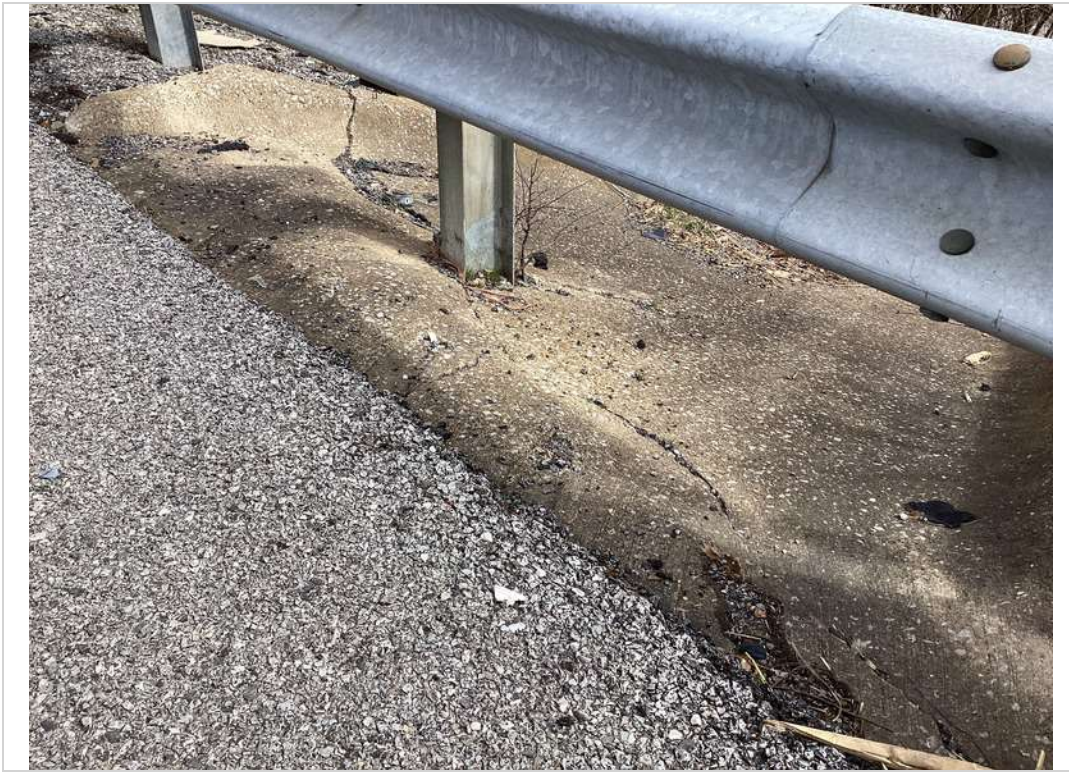
Approach 2 right concrete embankment drain moderate cracks and moderate spall

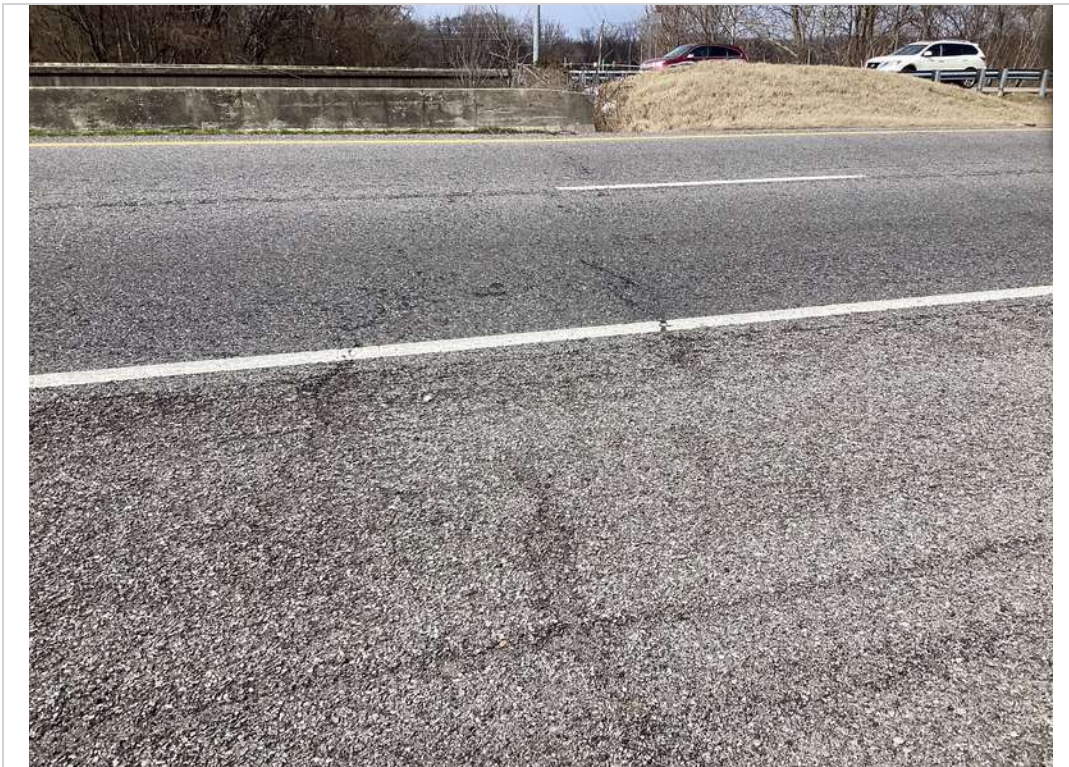
Approach 2 wide asphalt cracks

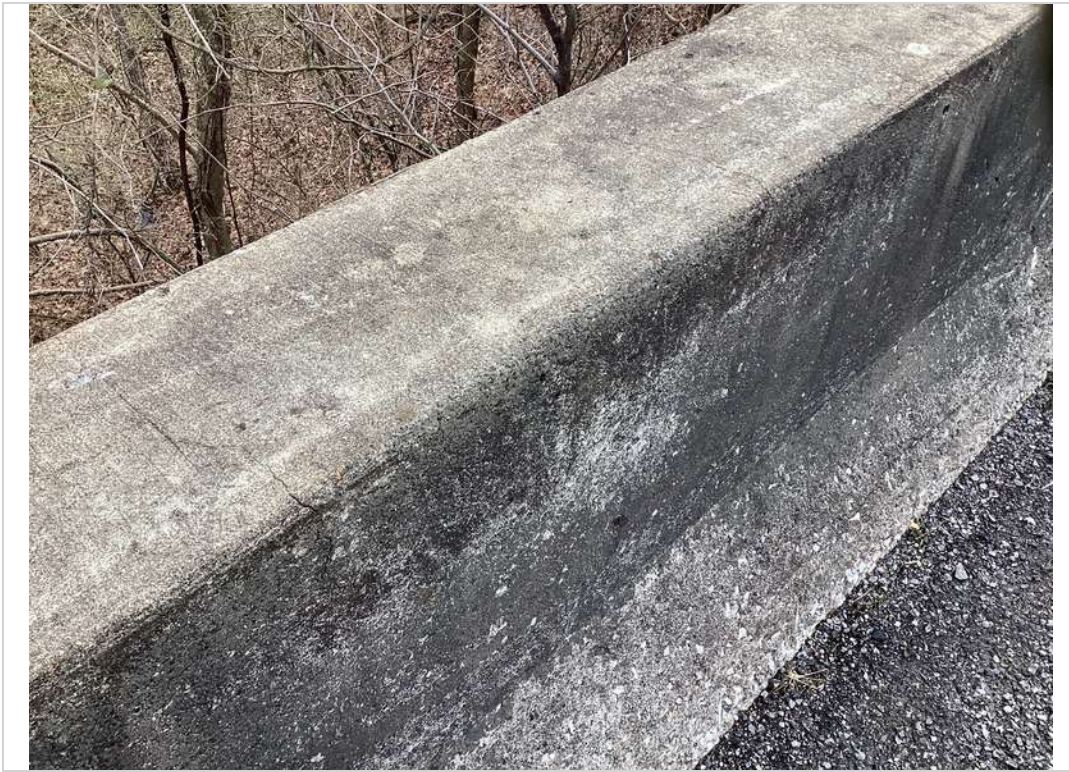
All spans left and right parapet hairline cracks spaced 1'-6" apart

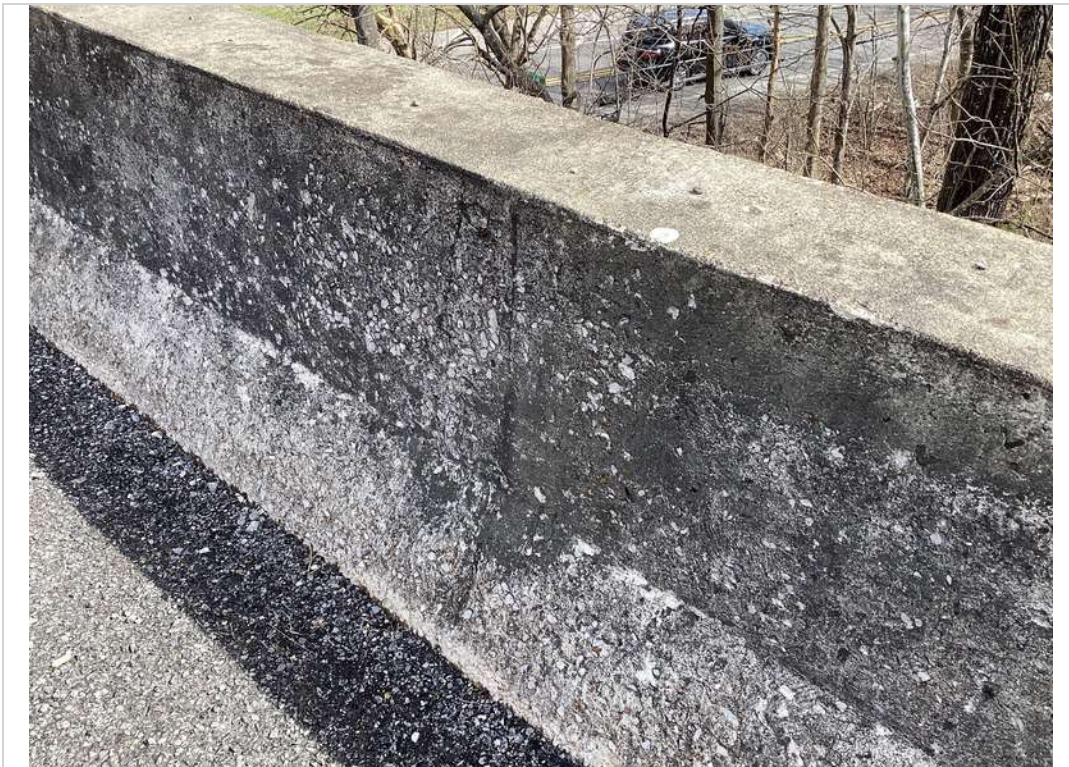
Left and right parapet widespread light scaling with exposed aggregate all spans

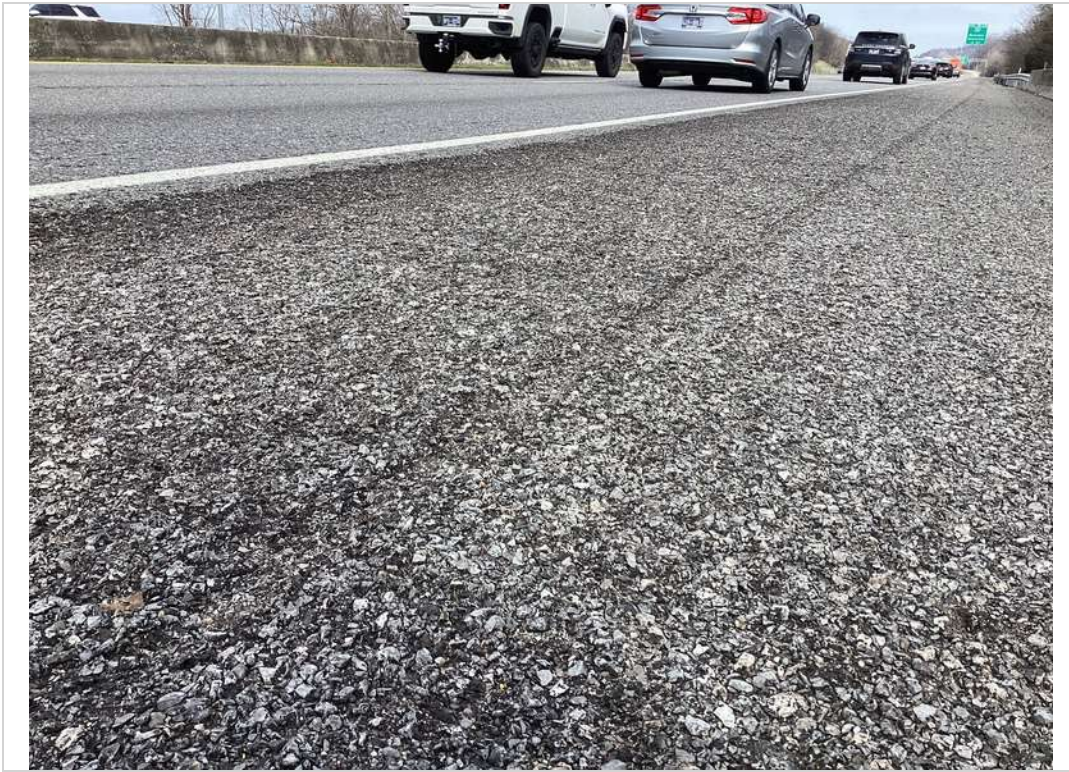
Wearing surface coarse and loose aggregate on right shoulder all spans

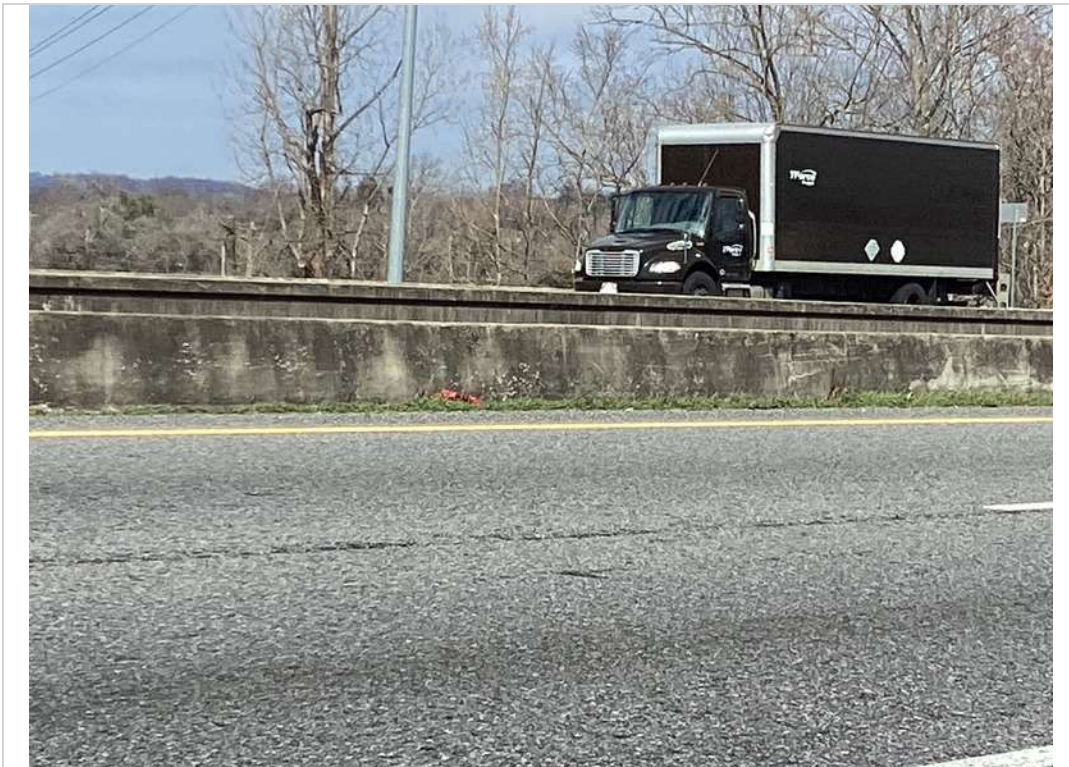
Light vegetation growth along left parapet all spans

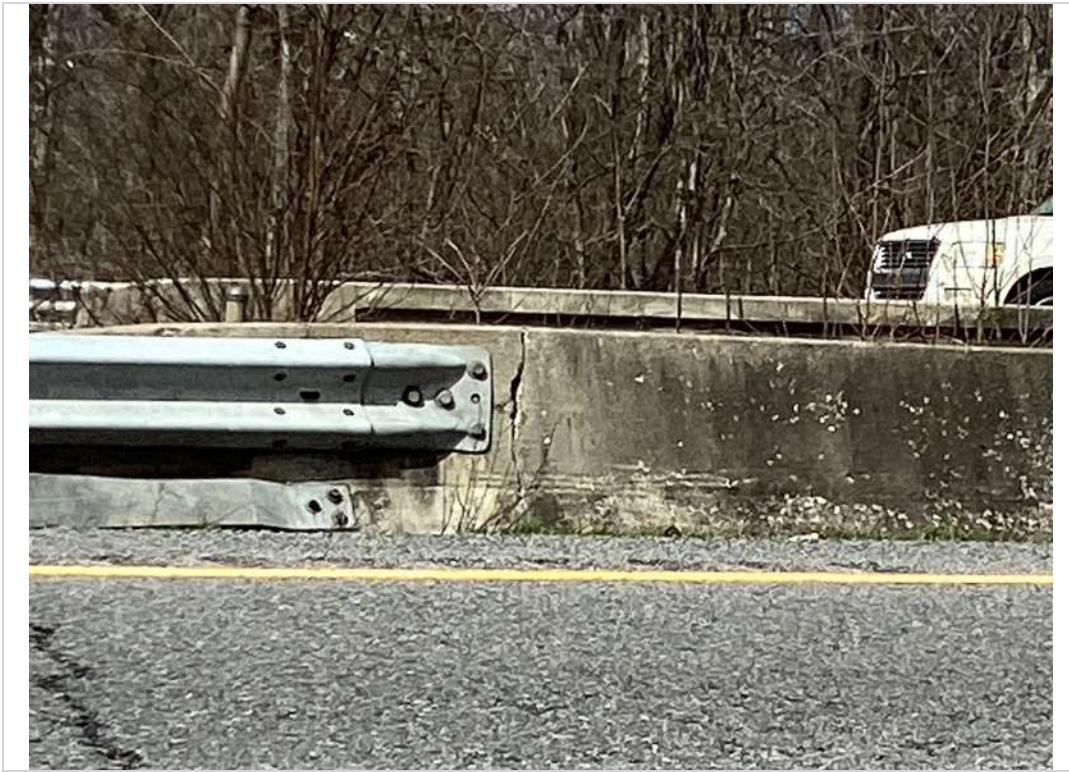
Beginning Span 1 left parapet spall

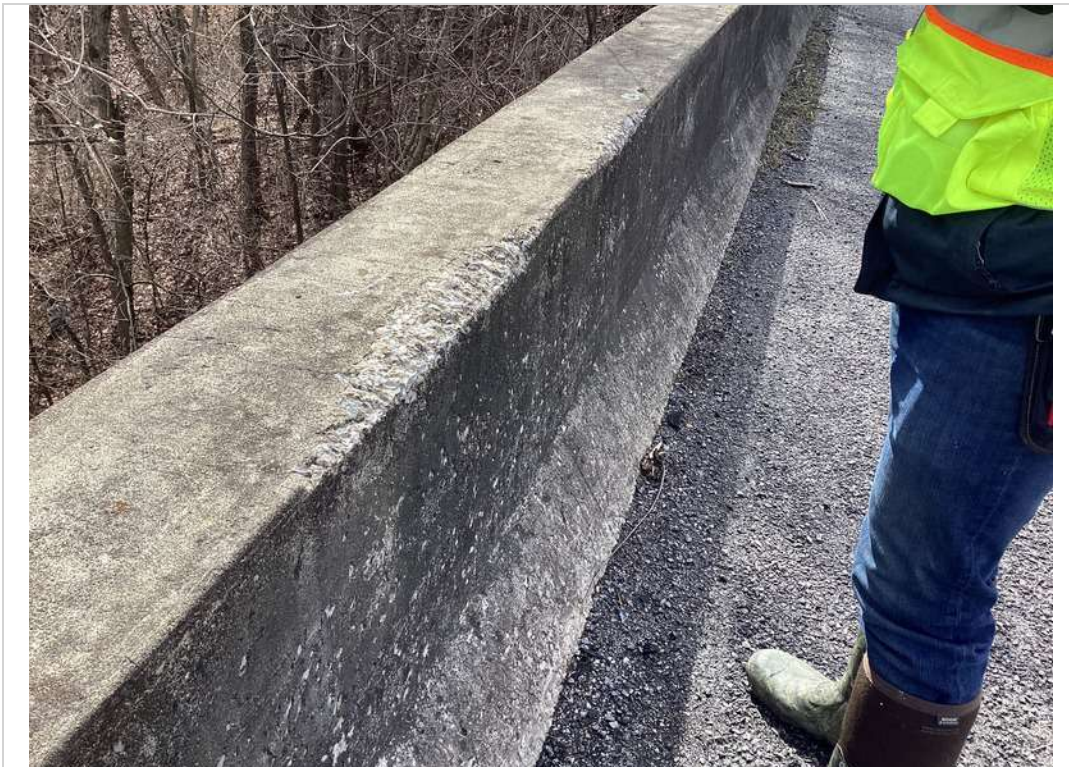
Span 1 right parapet spalls

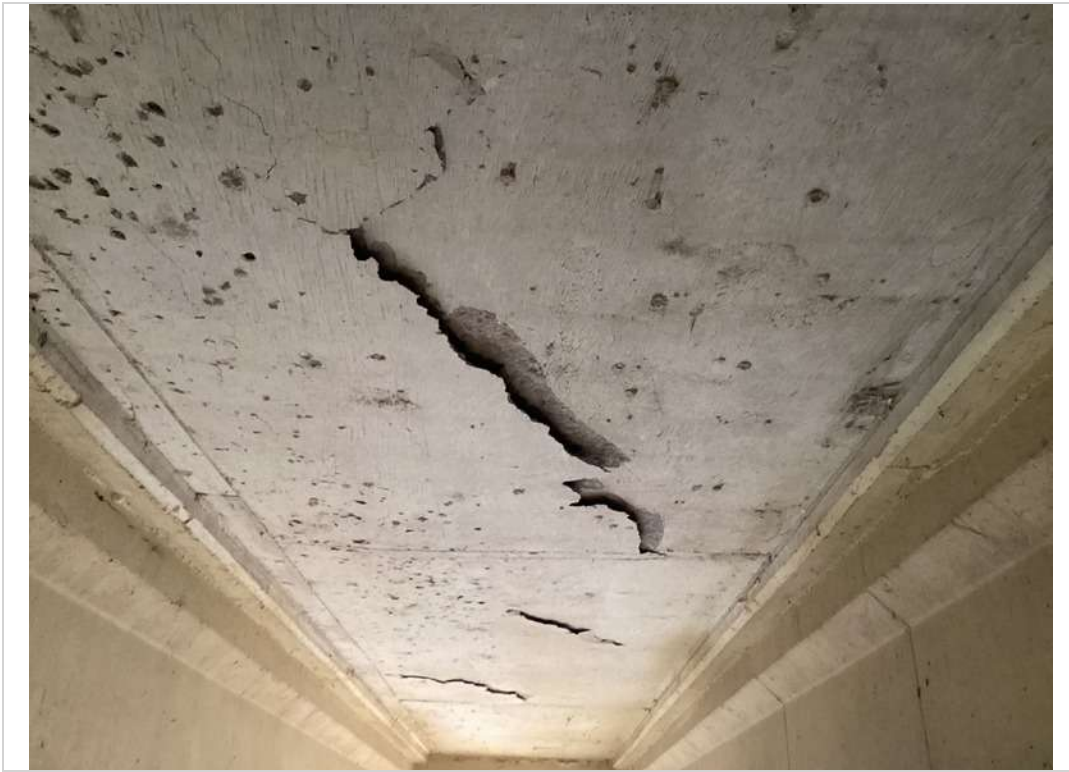
Span 1 Bay A delam from Abutment 1 to midspan

| Date Added | Recommendation | Priority |
|---|---|---|
| 02/14/2025 | REPAIR DECK DELAMINATION IN SPAN NO. 1 BAY "A" | 3 |

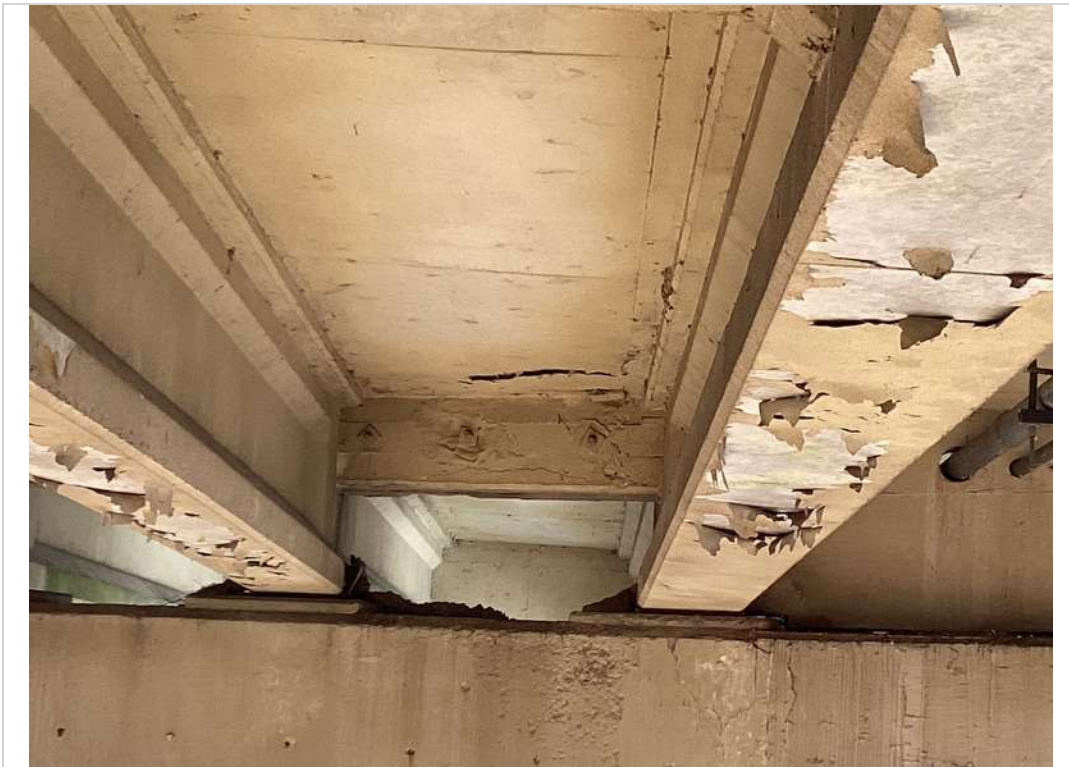
Span 1 above Bent 1 in Bay D delam and diaphragm moderate crack

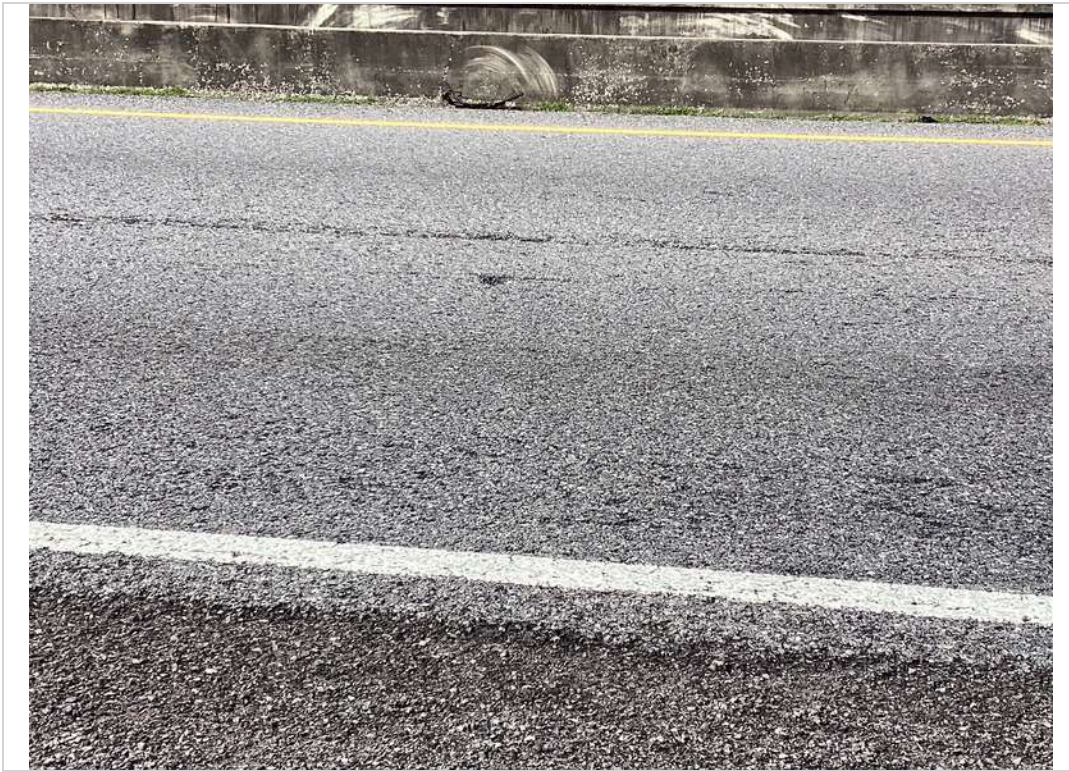
Span 2 pothole

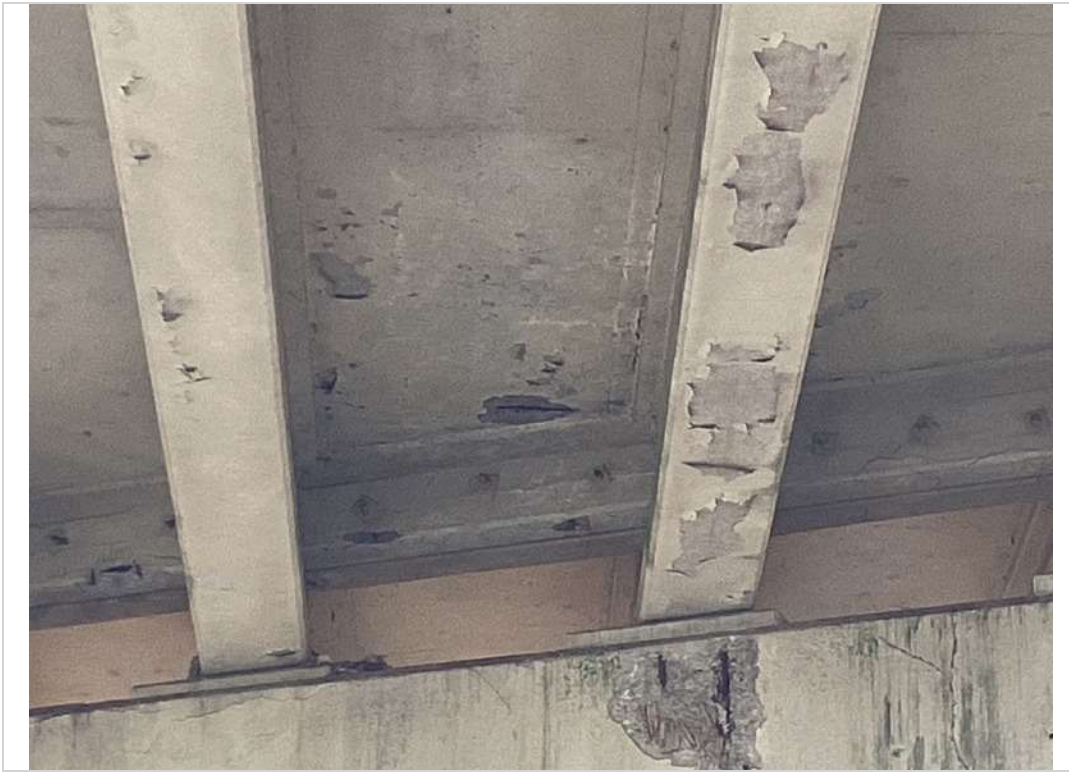
Span 2 Bay C spall with exposed rebar

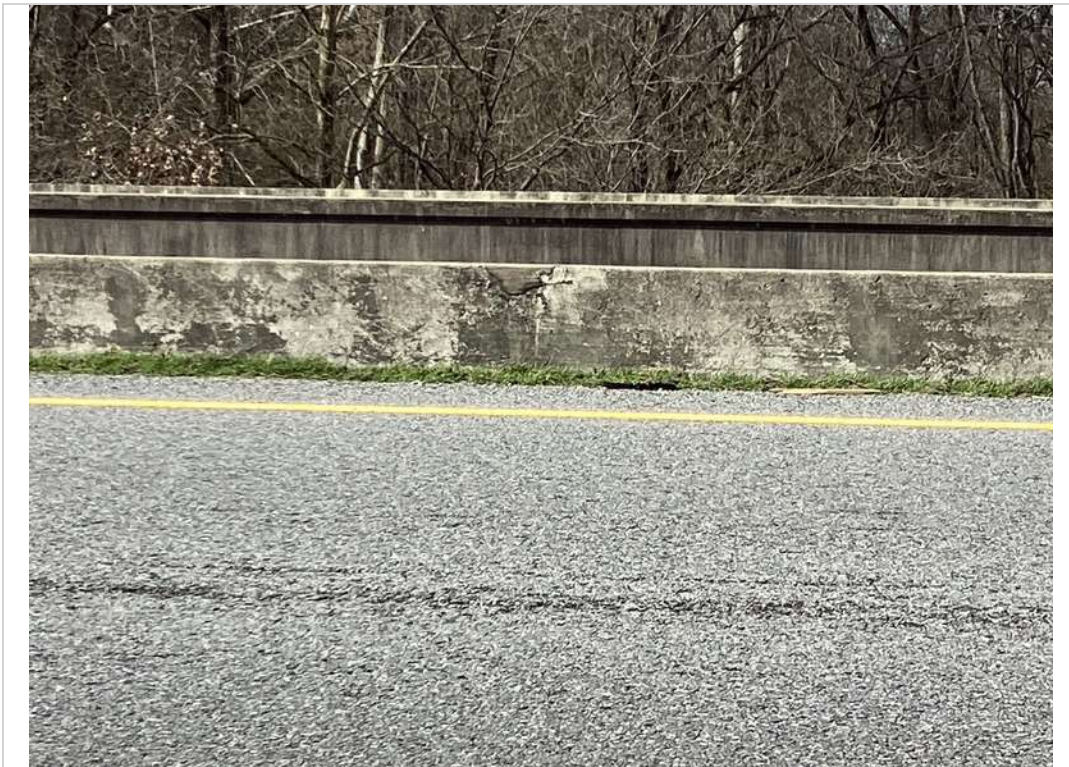
Span 3 left parapet delam patch

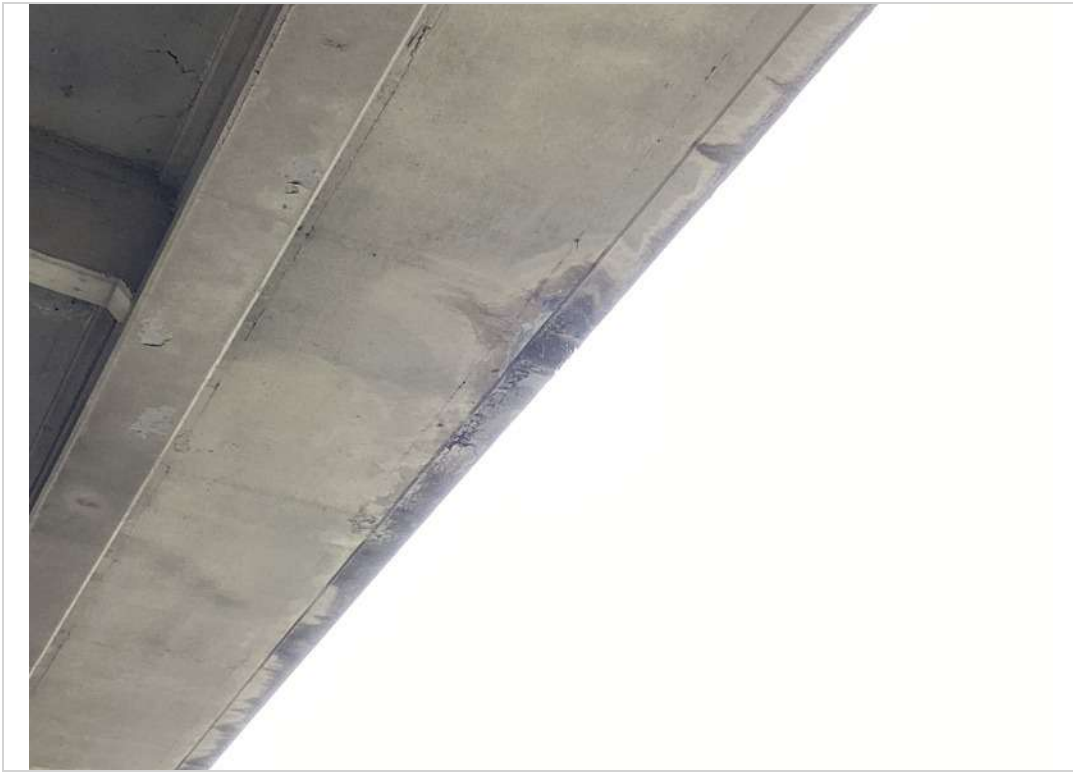
Span 3 left overhang spalls with exposed rebar and water leakage

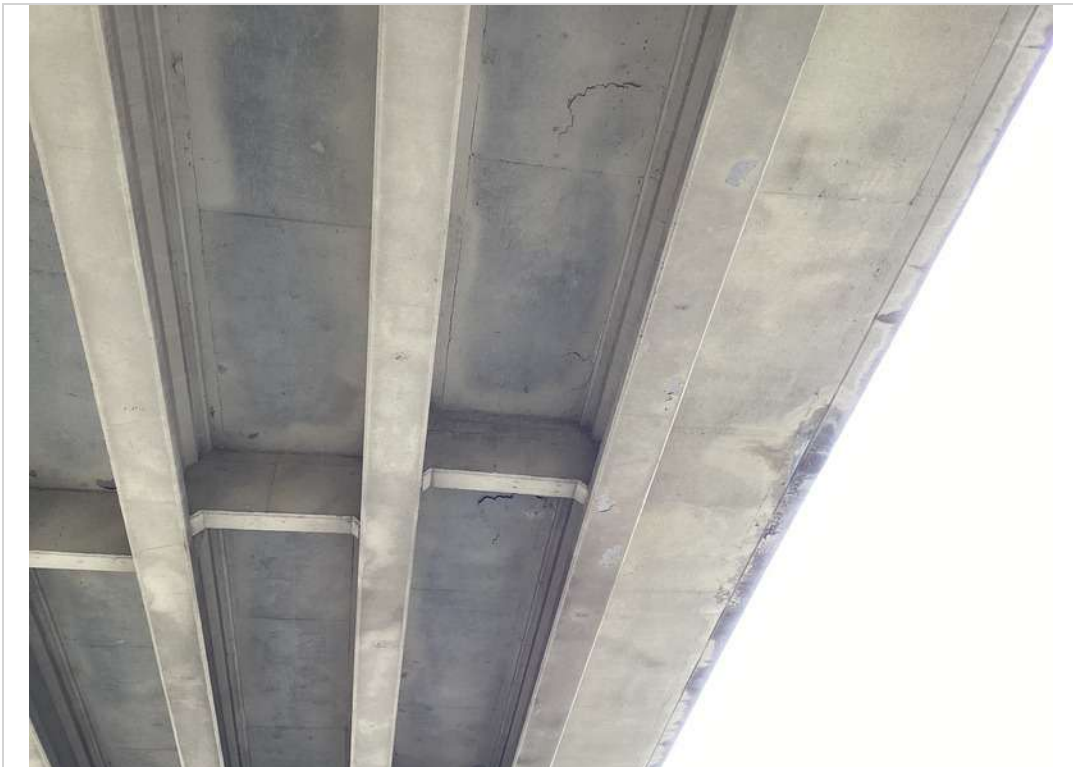
Span 3 Bay A delams

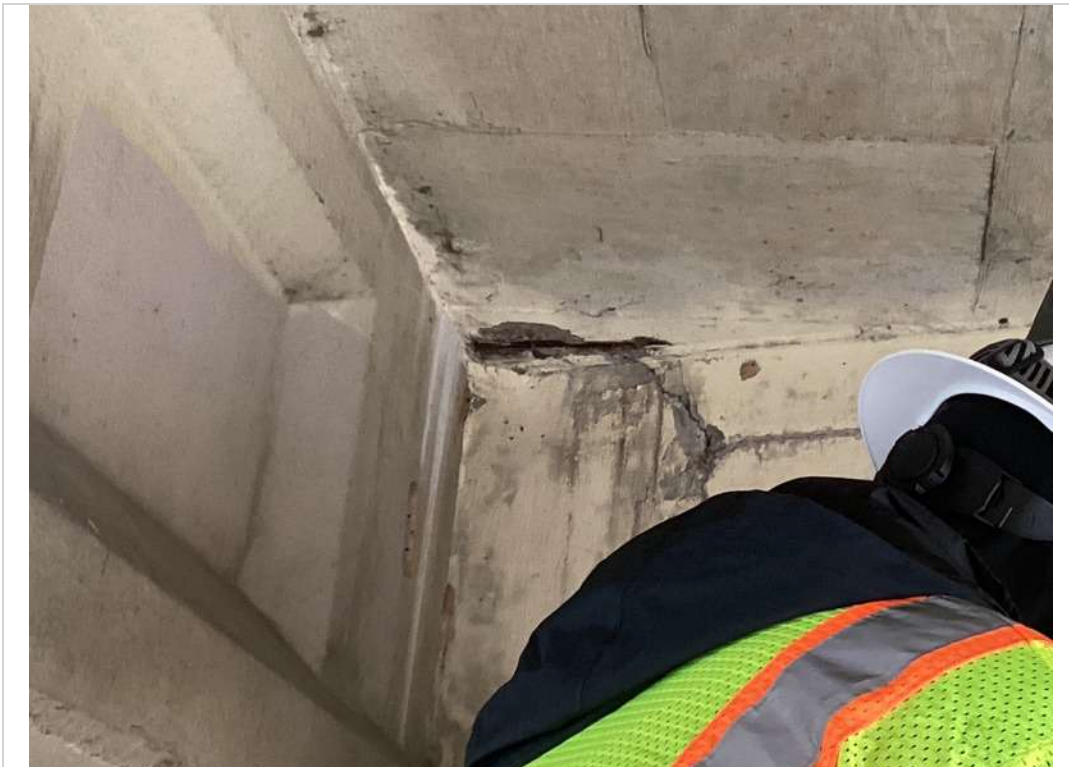
End of Span 4 Bay D spall with exposed rebar

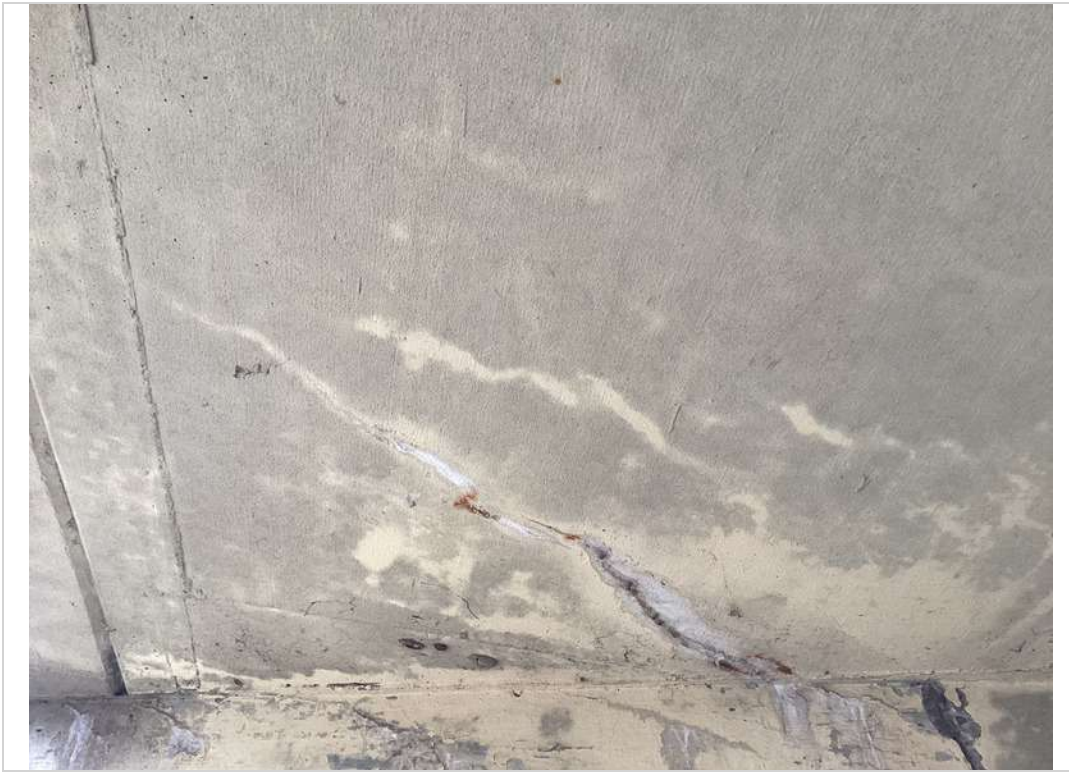
End of Span 4 left overhang hairline cracks with eff

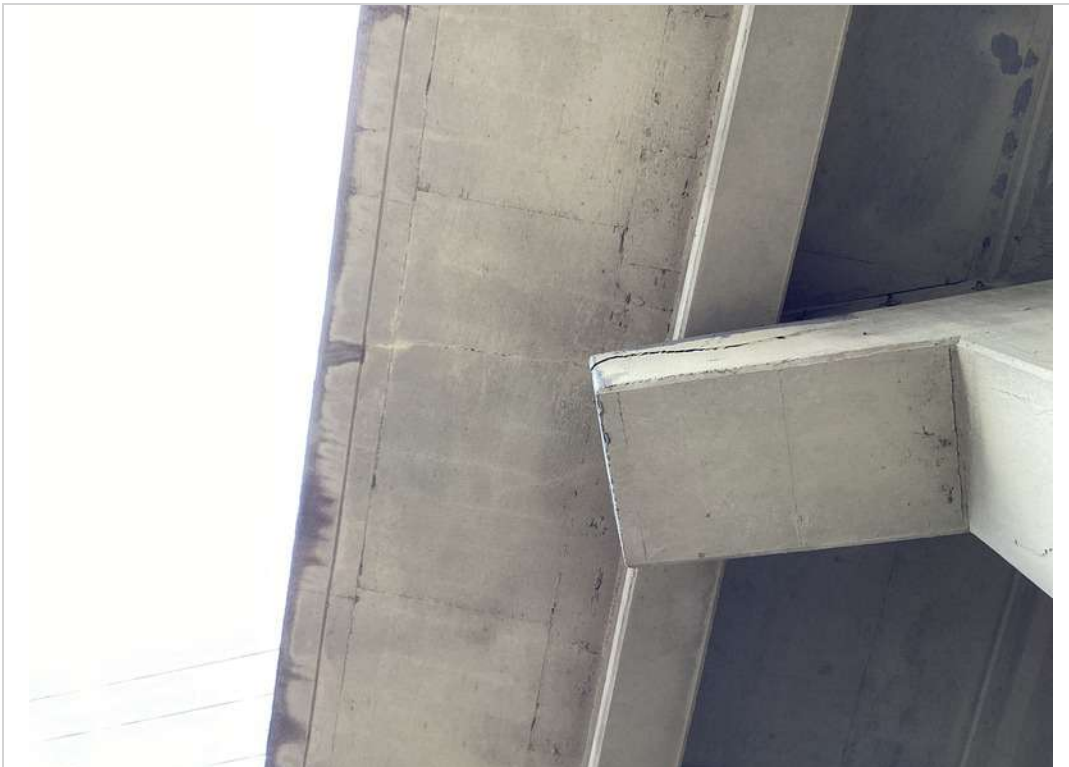
Beginning and end of Span 3 left overhang isolated hairline crack with eff. typical on right overhang

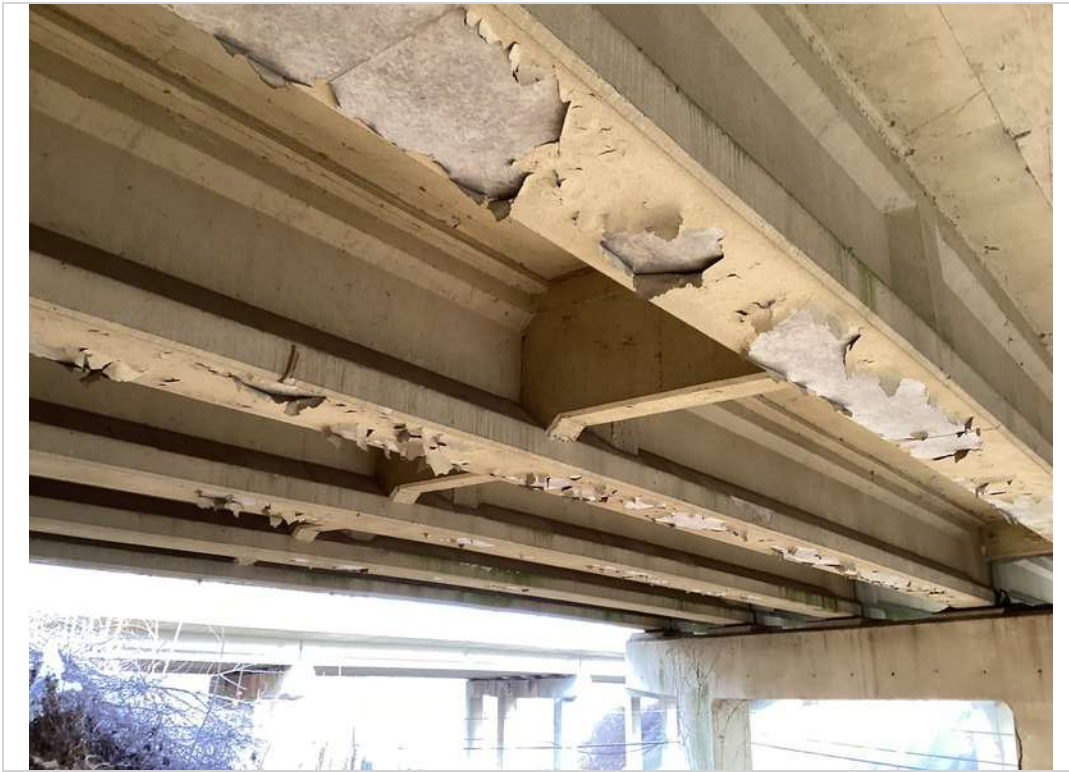
Typical texture coat failure all spans

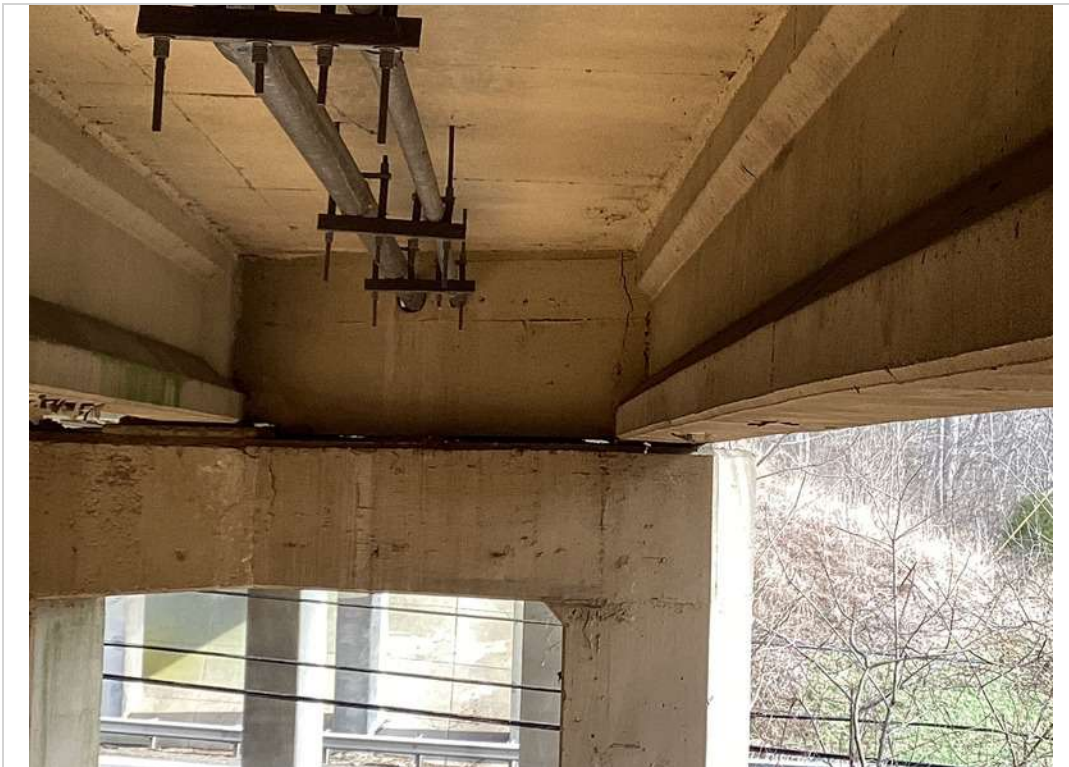
Bent 1 front Bay E diaphragm crack. Typical over Bent 1

| Date Added | Recommendation | Priority |
|---|---|---|
| 02/14/2025 | REPAIR DIAPHRAGMS AT BENT NO. 1, 2, AND 3 | 0 |

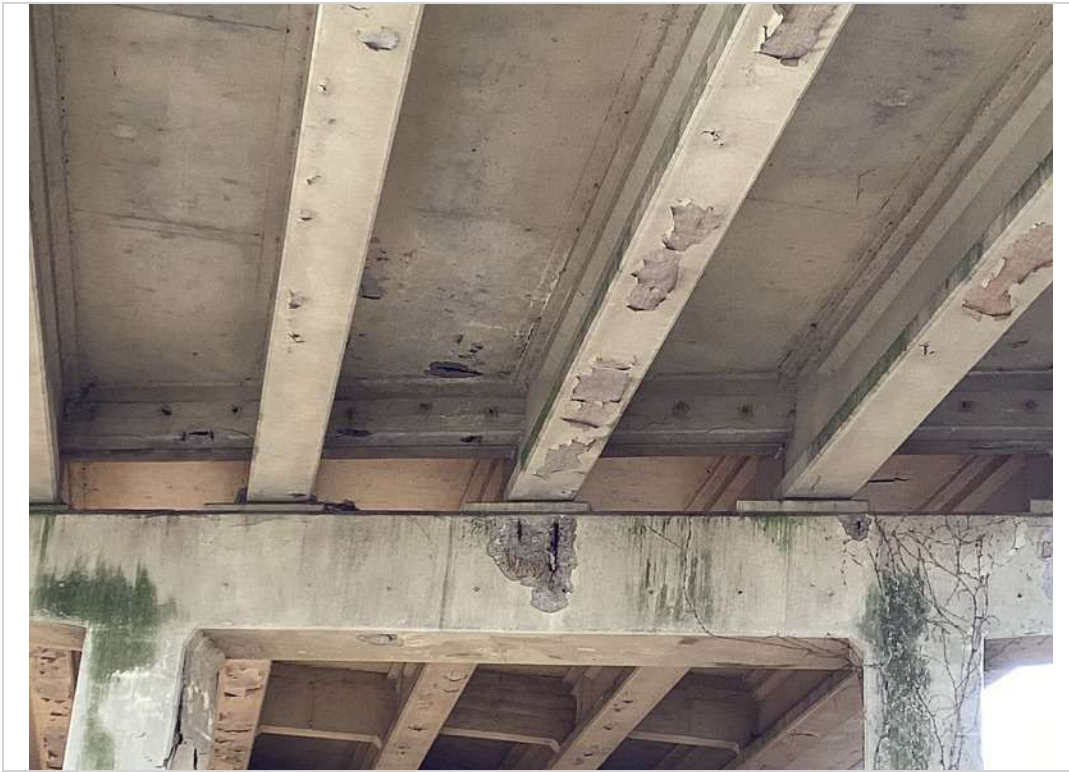
Diaphragms over back of Bent 1 some spalls with exposed rebar and moderate cracks

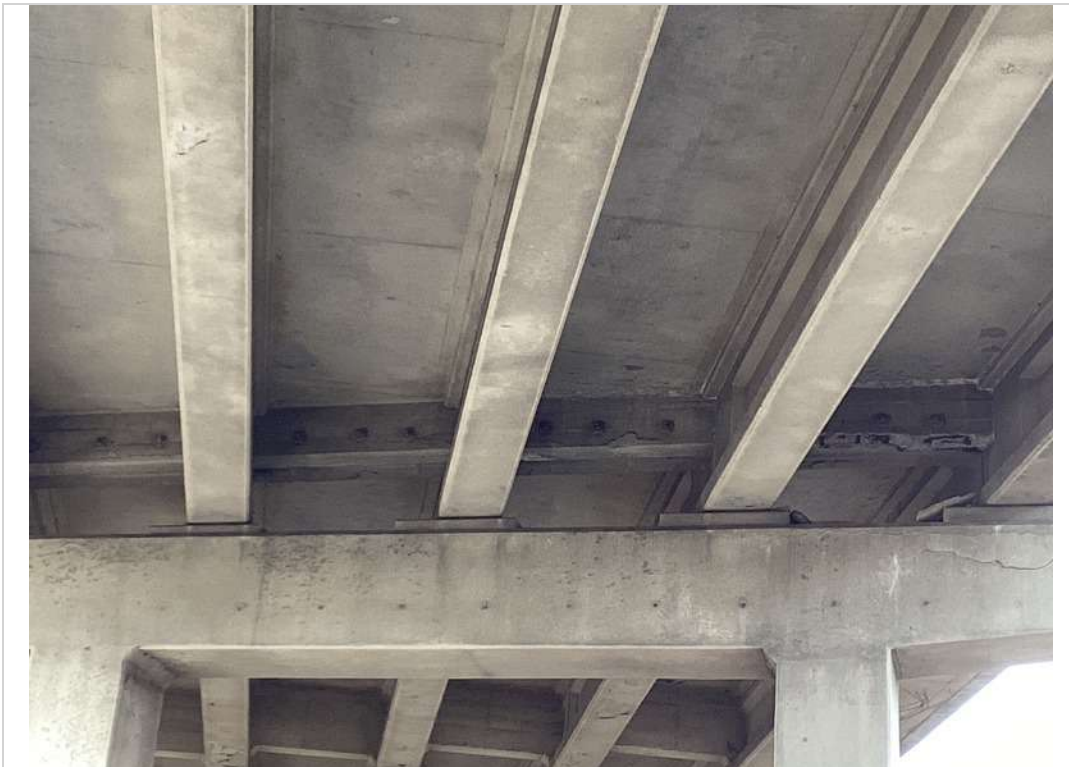
Bent 2 back diaphragms spalls with exposed rebar and delams

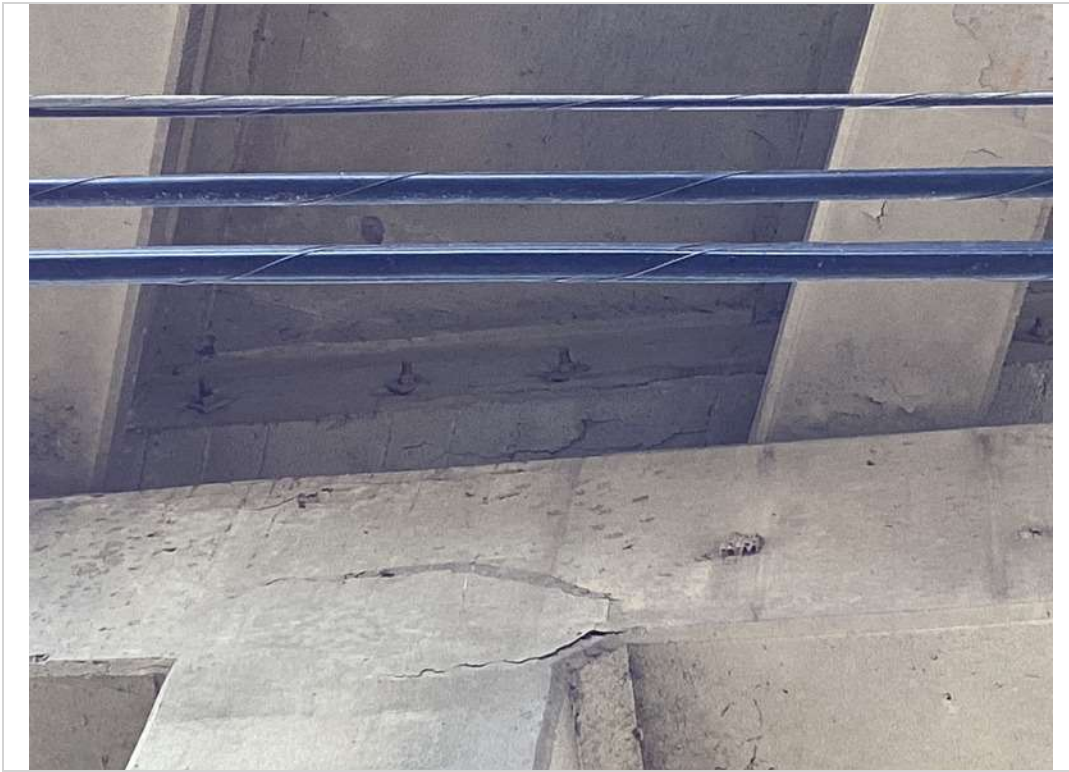
Bent 2 front diaphragms typical moderate cracks on underside

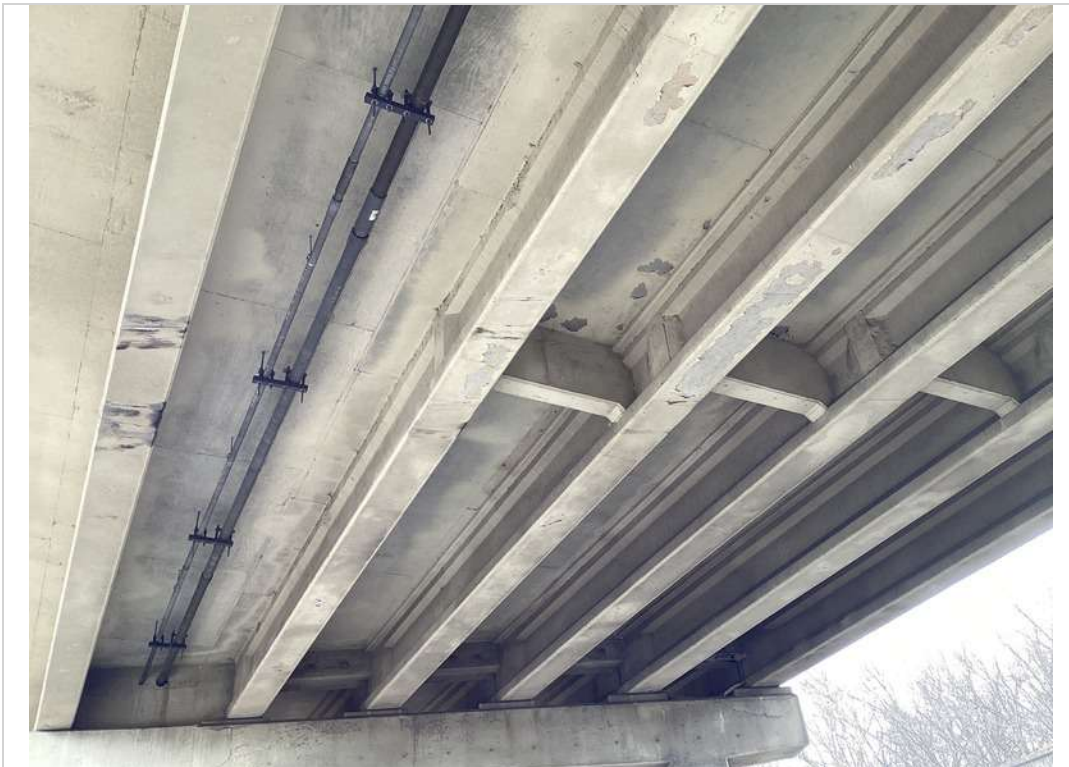
| ELEMENTS | DESCRIPTION | UNITS | TOTAL | CS1 | CS2 | CS3 | CS4 |
|---|---|---|---|---|---|---|---|
| (9999-109) Span 3 Beams D, E, and F collision damage. | | | | | | | |

Span 3 collision damage Beams D-F
