I-65 Crossing I65 / SR106 & HARPETH RV

90 - LAST INSPECTION DATE 02/14/2025

| IDENTIFICATION | |
|---|---|
| (8) Structure Number | 94I00650005 |

Bridge 94I00650005 is a 4-span bridge on a 70 degree skew composed of a cast-in-place concrete deck supported by prestressed AASHTO Type II beams. The bridge has a total length of 193'-10.25", an out-to-out width of 44'-0", a roadway width of 40'-5", and carries 2 lanes of traffic. The maximum span length is 52'-10.125". On February 14, 2025 a Michael Baker inspection team performed a 1-day Routine Inspection on the bridge. Korbin Hinson and Sean Bonner inspected the top of deck, superstructure, and substructure from the ground. The weather conditions were sunny and 28 degrees.

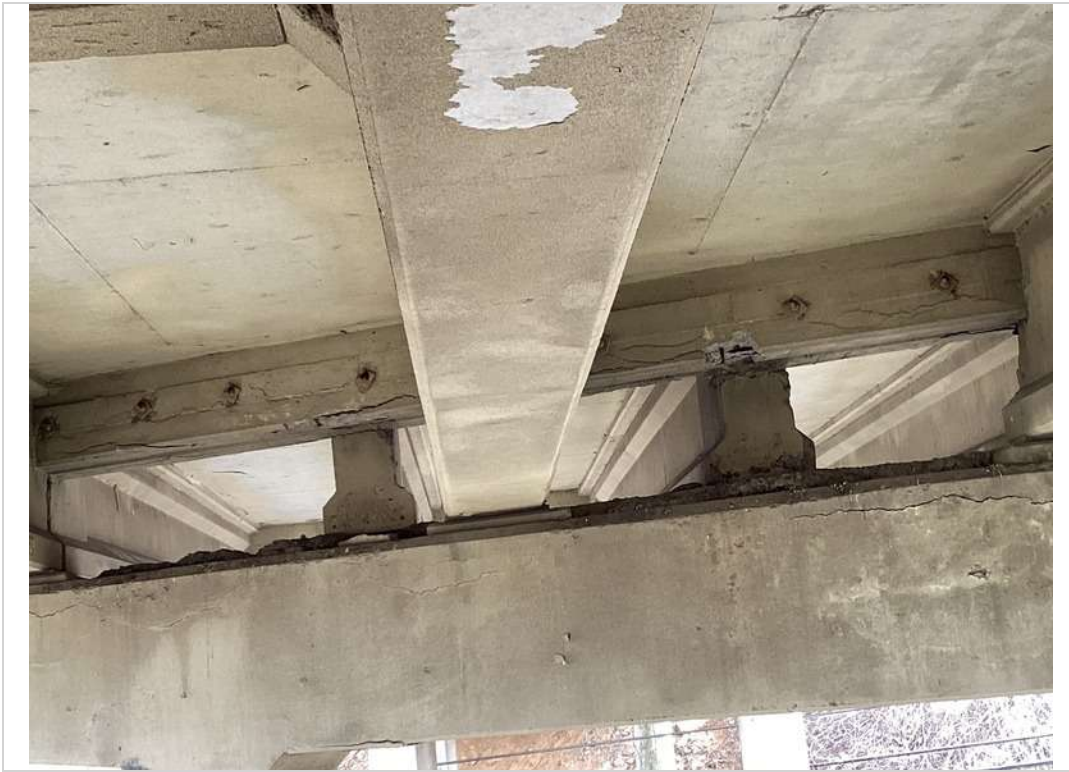
Bent 3 back typical diaphragms delam and spall with exposed rebar

| Date Added | Recommendation | Priority |
|---|---|---|
| 02/14/2025 | REPAIR DIAPHRAGMS AT BENT NO. 1, 2, AND 3 | 0 |

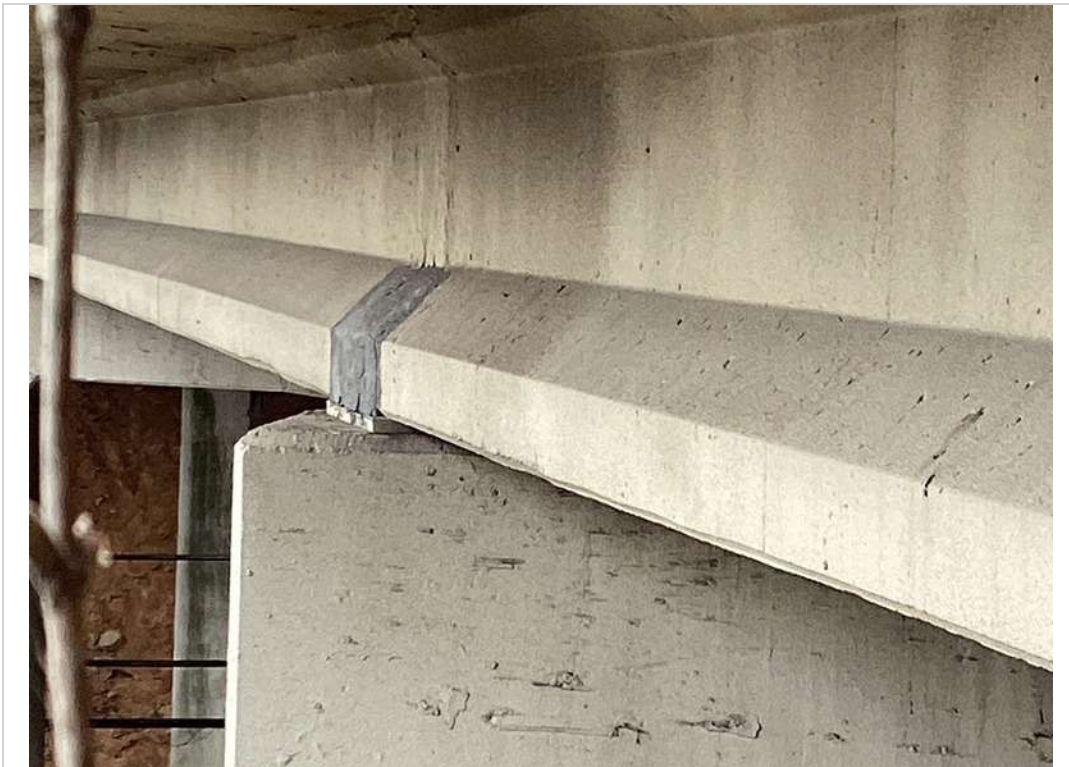
Beginning Span 4 Beam E cracked patch in bottom flange

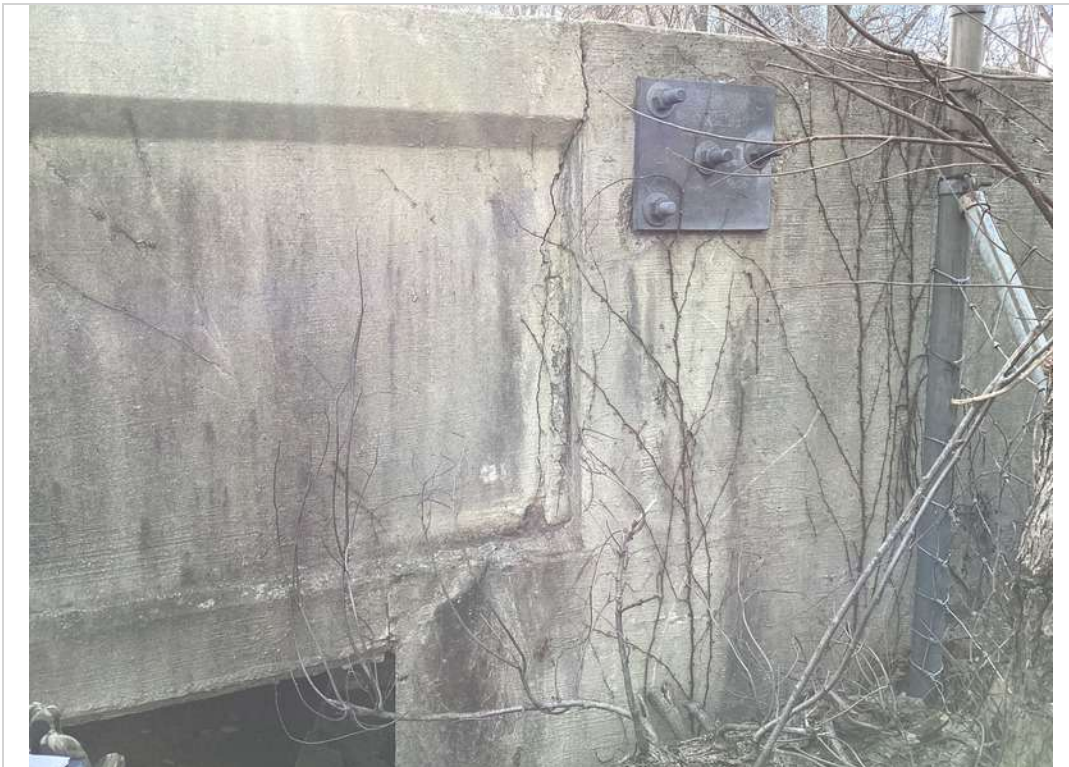
Abutment 1 parapet and wingwall crack typical both sides

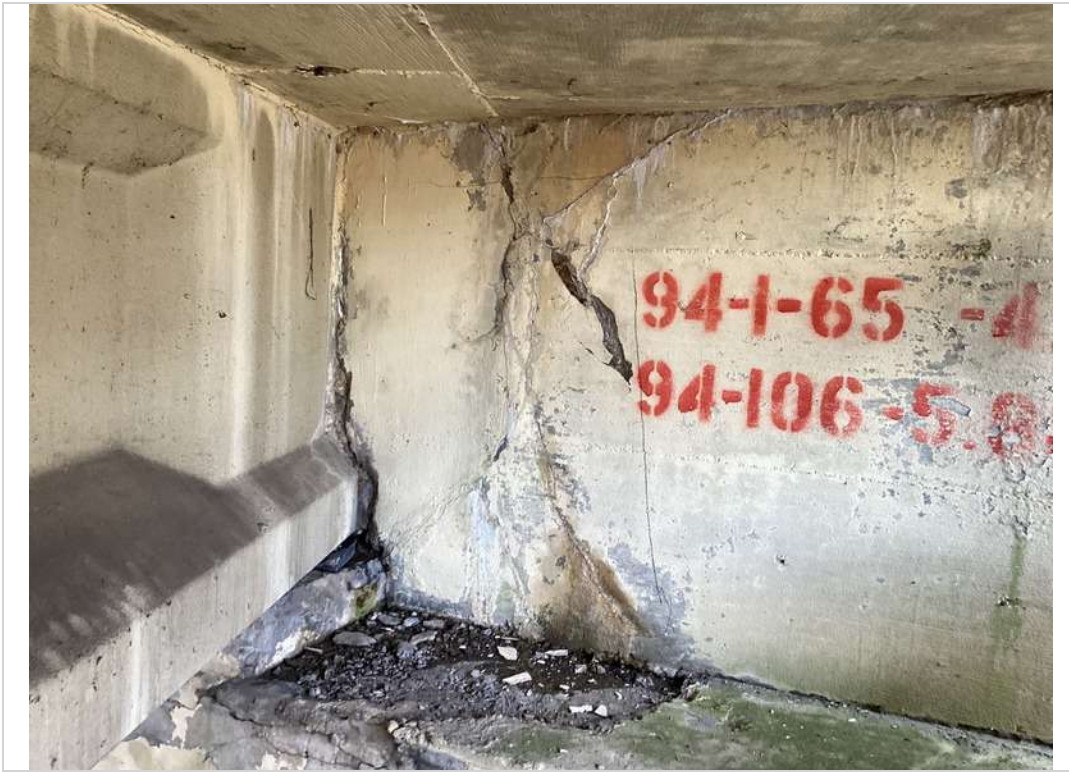
Abutment 1 backwall left of Beam A delam and eff and top of cap spall

| Date Added | Recommendation | Priority |
|---|---|---|
| 07/11/2005 | REPAIR CAPBEAM AT ABUTMENTS NO.1 AND 2 | 2 |

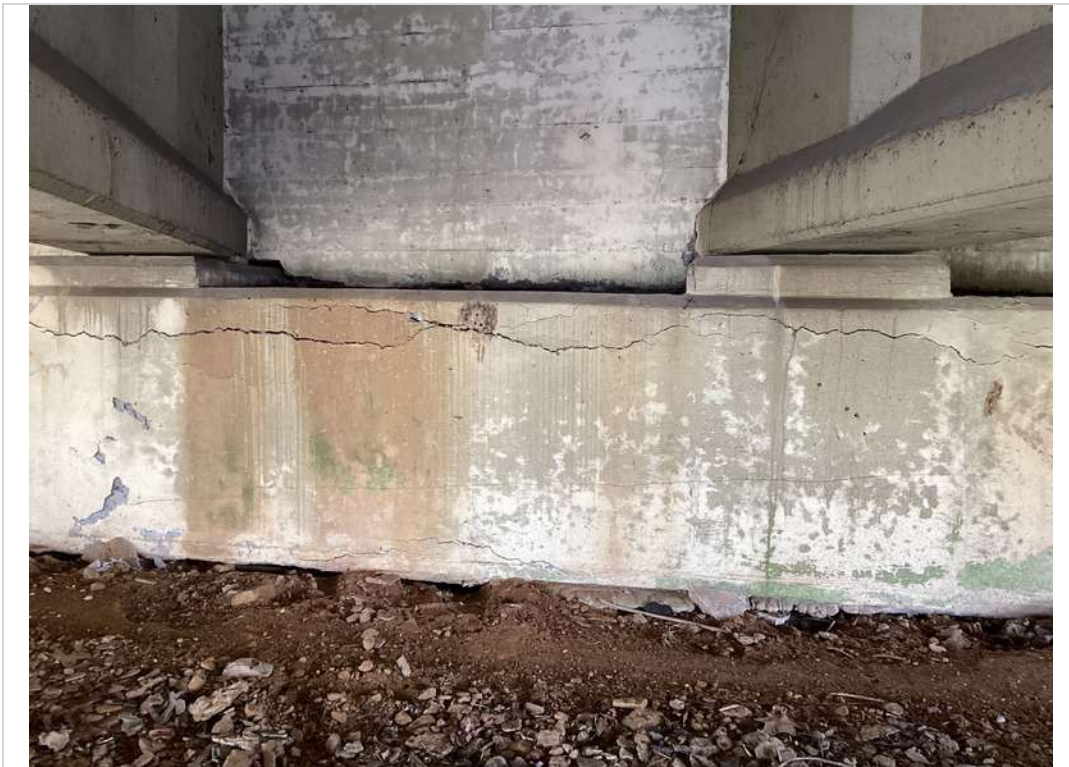
Abutment 1 Bay B delam Bay B and undermining

| Date Added | Recommendation | Priority |
|---|---|---|
| 02/14/2025 | REPAIR UNDERMINING AT ABUTMENT NO. 1 | 3 |

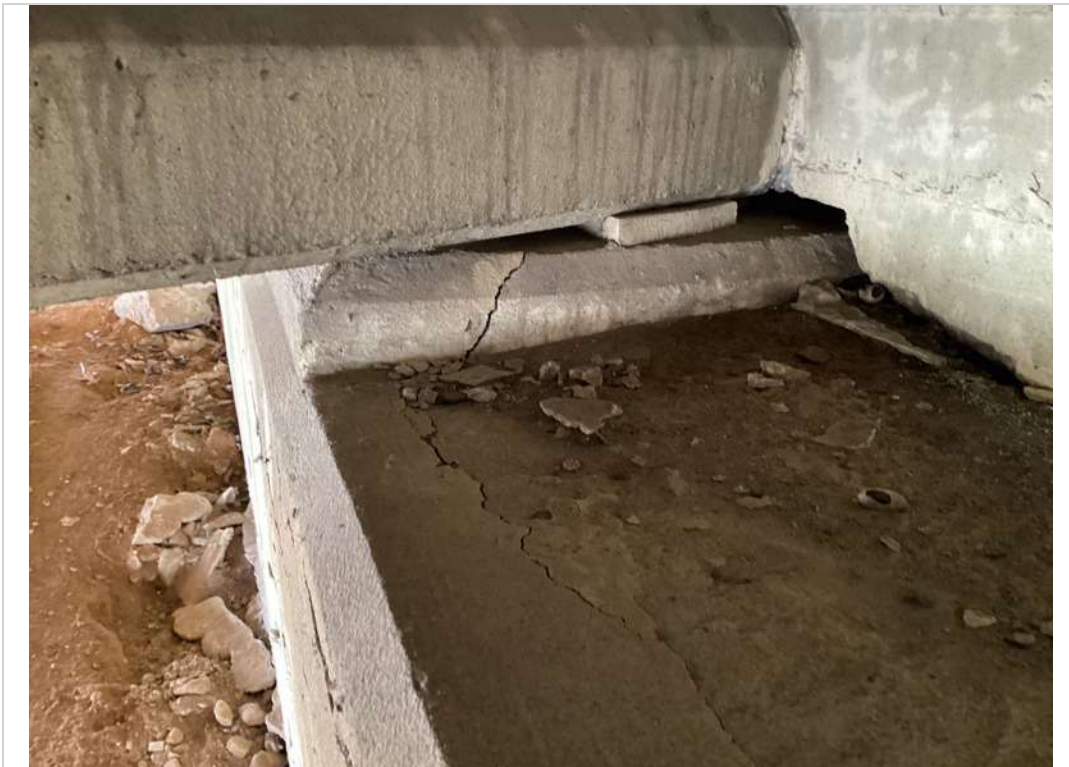
Abutment 1 Riser C crack

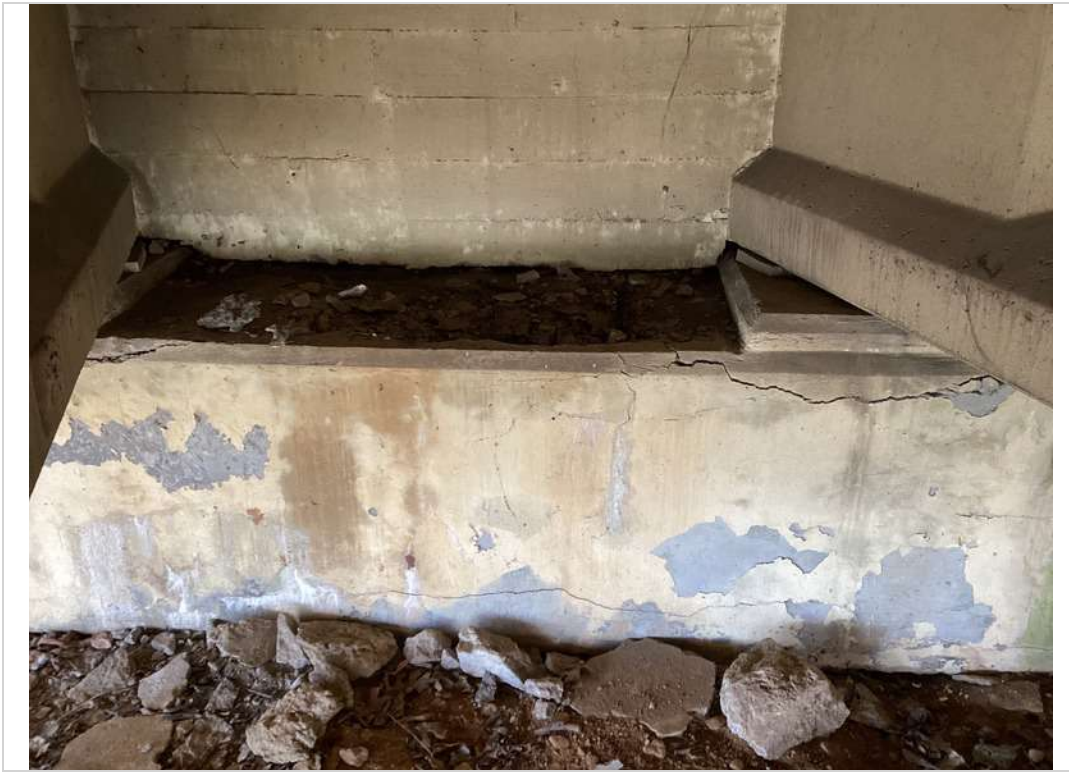
Abutment 1 Bay D crack in cap w/eff and moderate spall with exposed rebar on top of cap

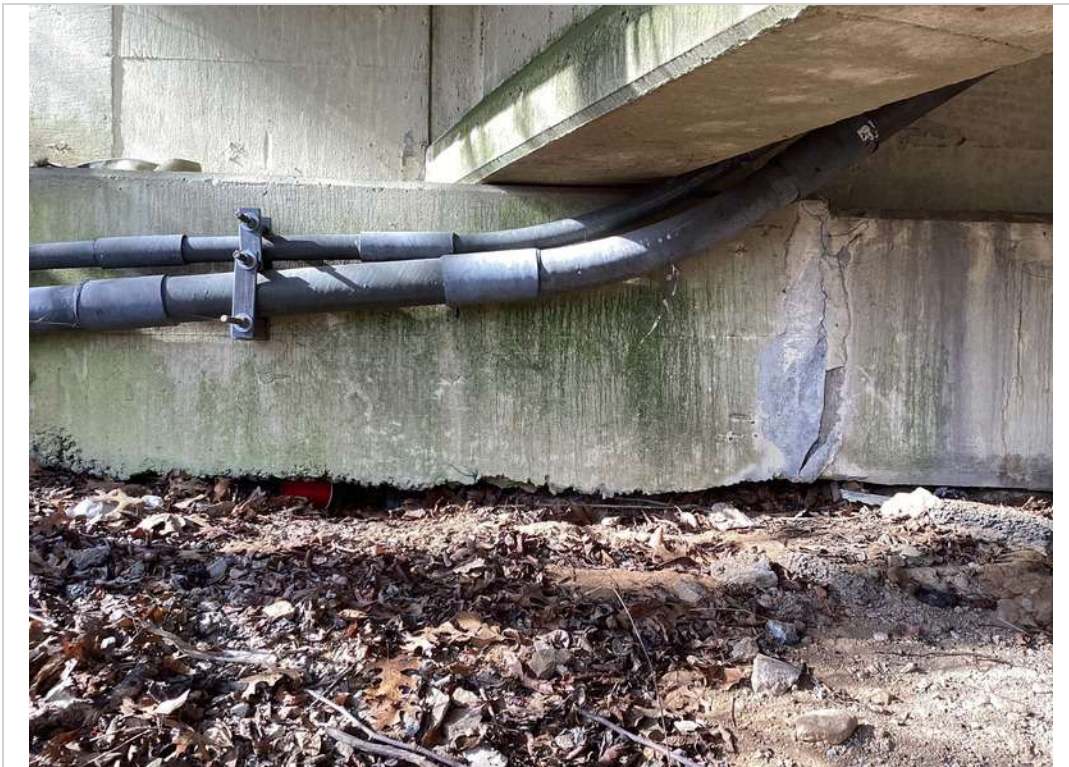
| <b>Abutment Piles</b> | (Fair) | Abutment 1 exhibits 1 exposed pile with surface corrosion due to undermining. No section loss is present in the pile. |

Abutment 1 right end of cap undermining with 1 exposed pile with minor corrosion

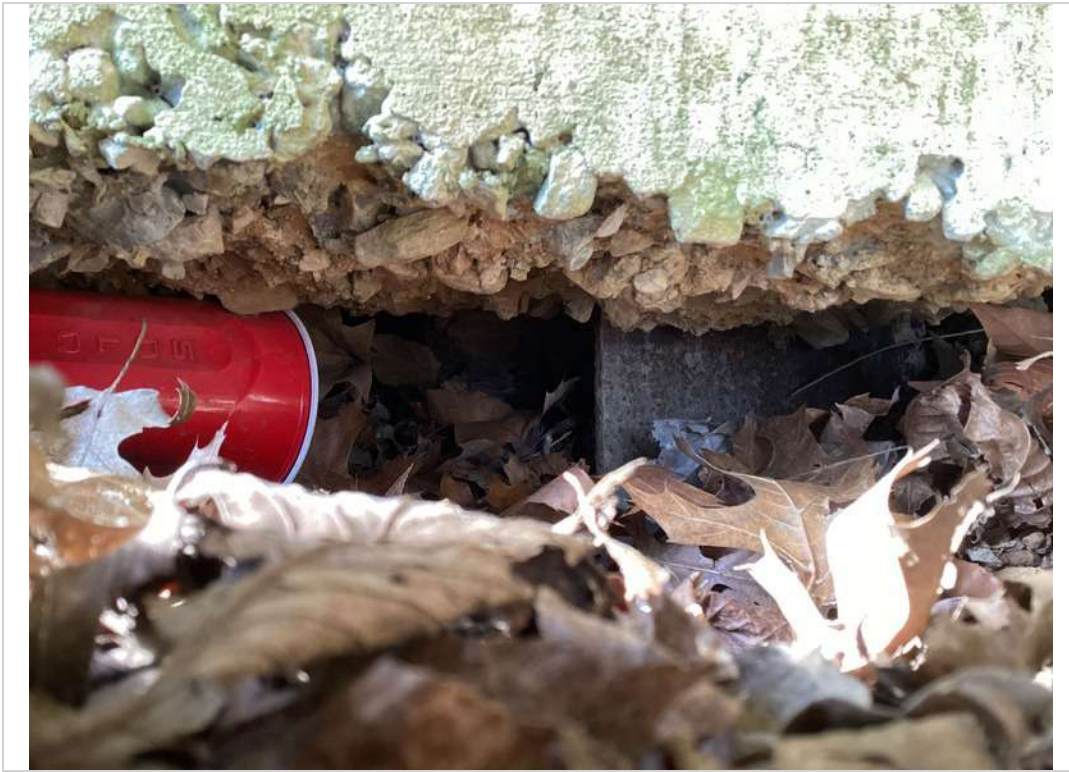
Abutment 1 right end of cap undermining with 1 exposed pile with minor corrosion

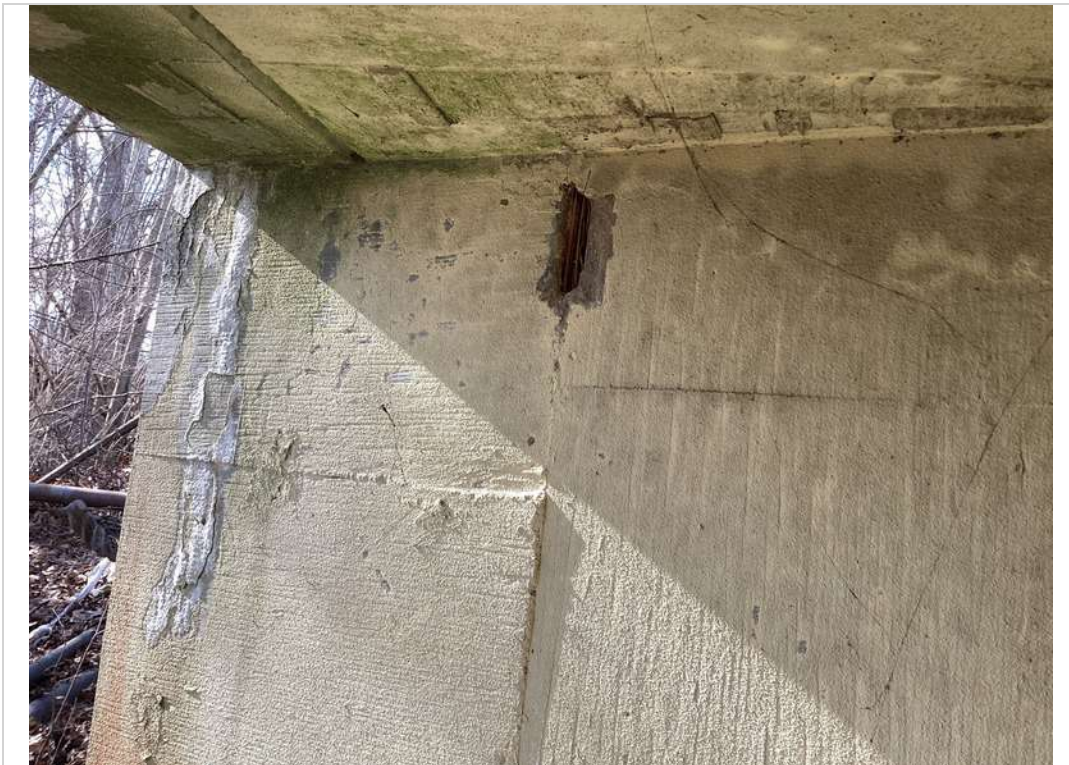
Abutment 1 right end of backwall minor spall with exposed pad between wing and backwall

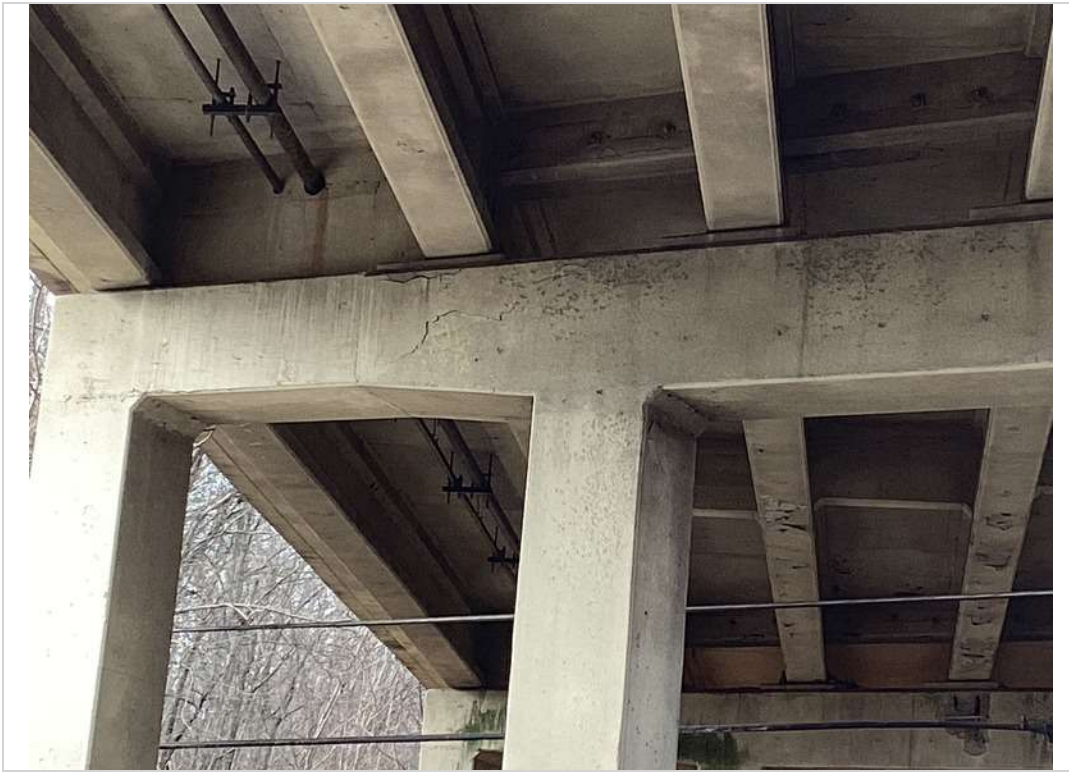
Delam in bent cap typical

| Date Added | Recommendation | Priority |
|---|---|---|
| 07/11/2005 | REPAIR CAPBEAM AT ALL BENTS. | 3 |

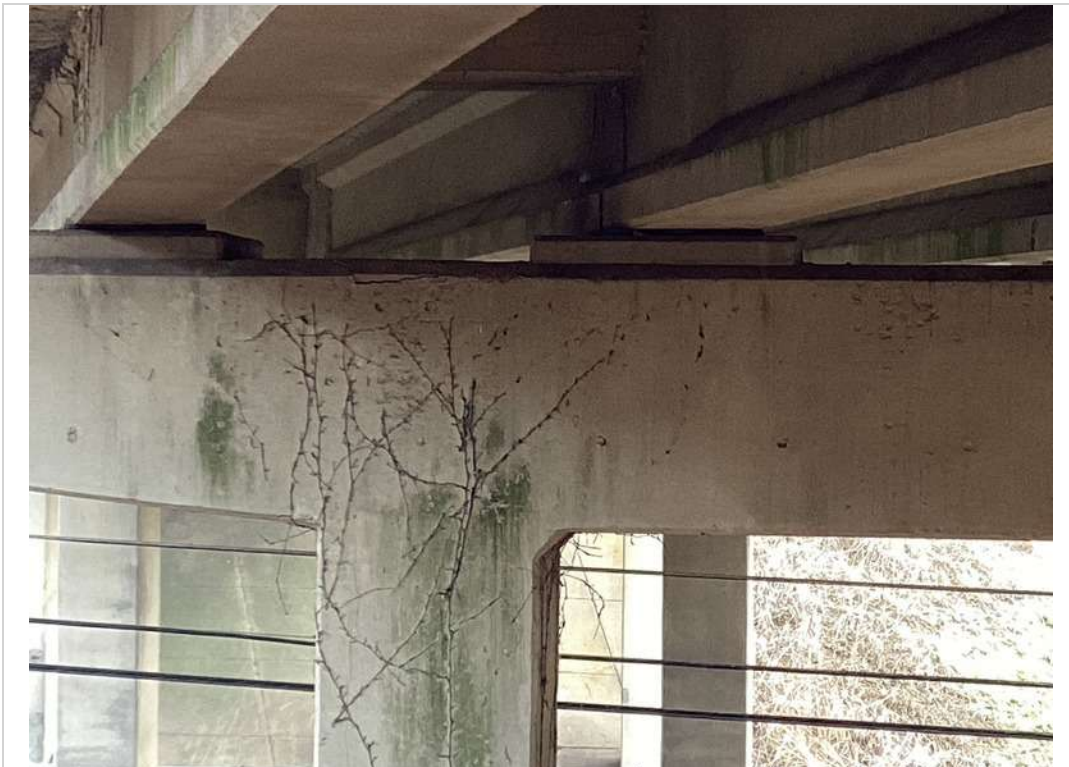
Bent 1 front moderate crack above Column A

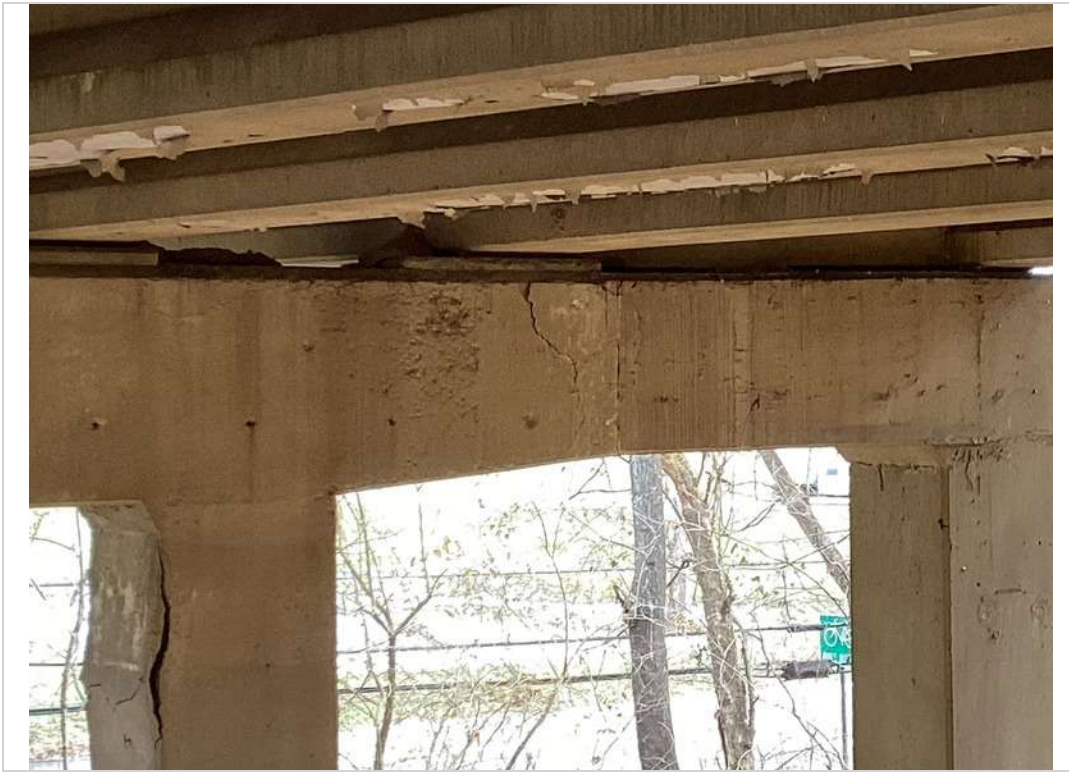
Bent 1 front cap between Column B and C hairline crack, delam, and honeycombing

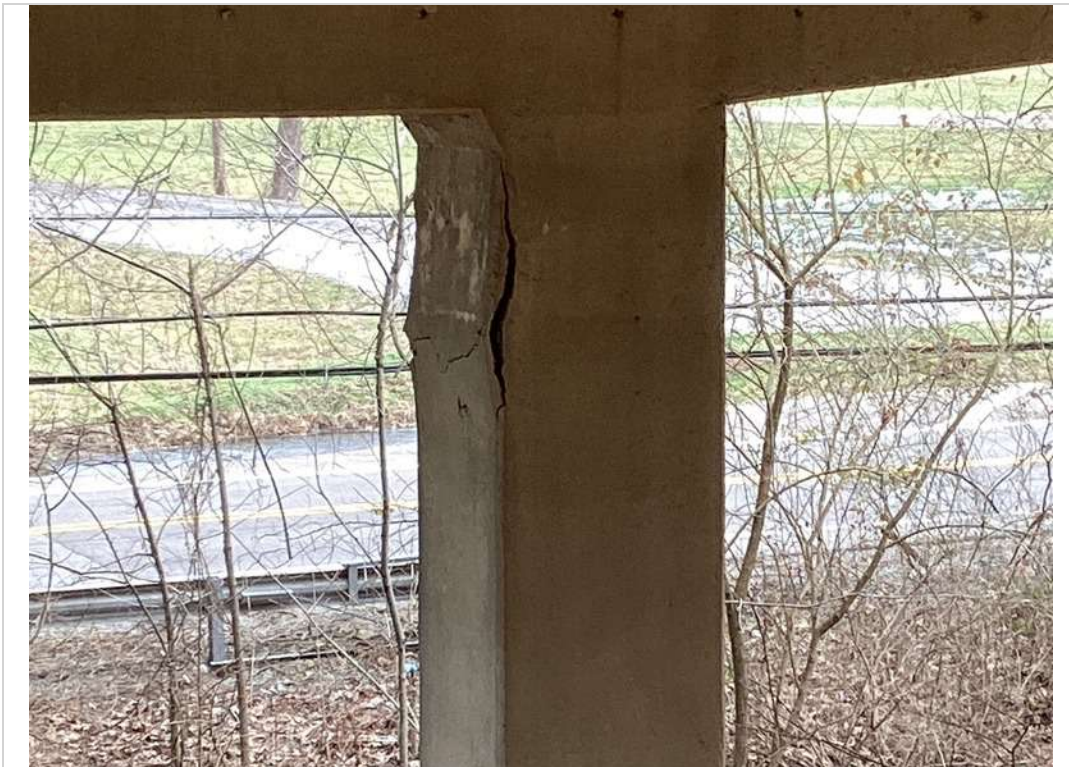
Bent column delam typical

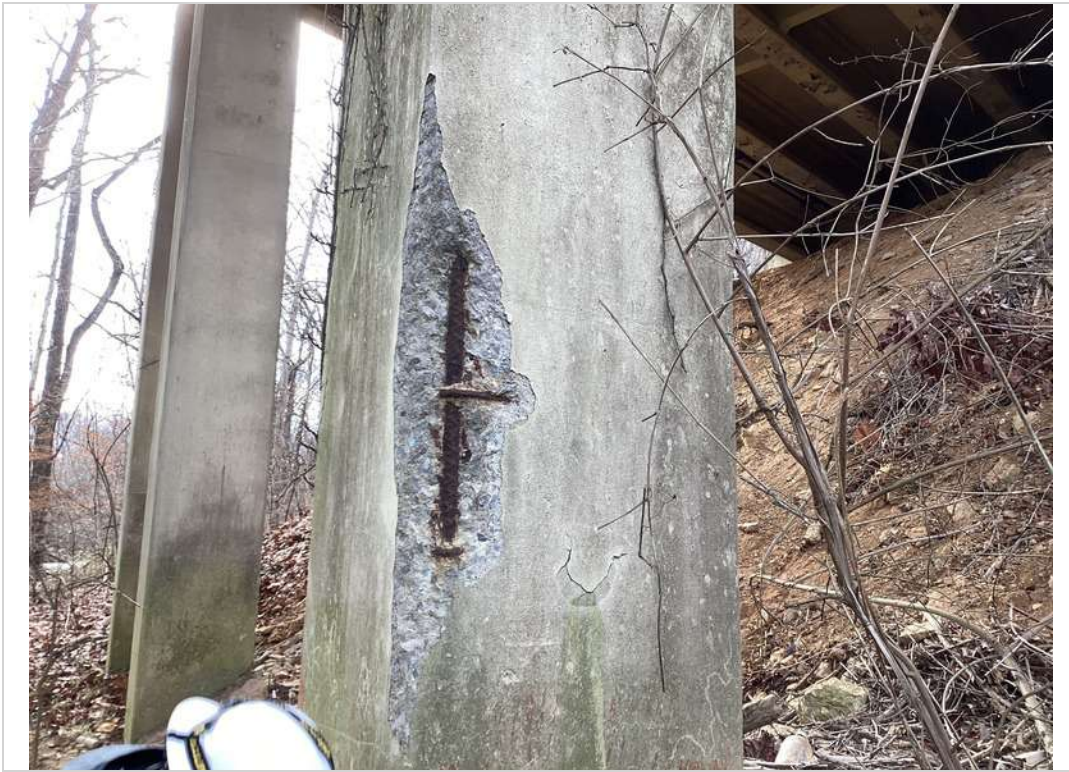
Bent 1 back Column A spall with exposed rebar

| Date Added | Recommendation | Priority |
|---|---|---|
| 02/02/2017 | REPAIR COLUMN " A " AT BENTS NO. 1 AND 2 | 3 |

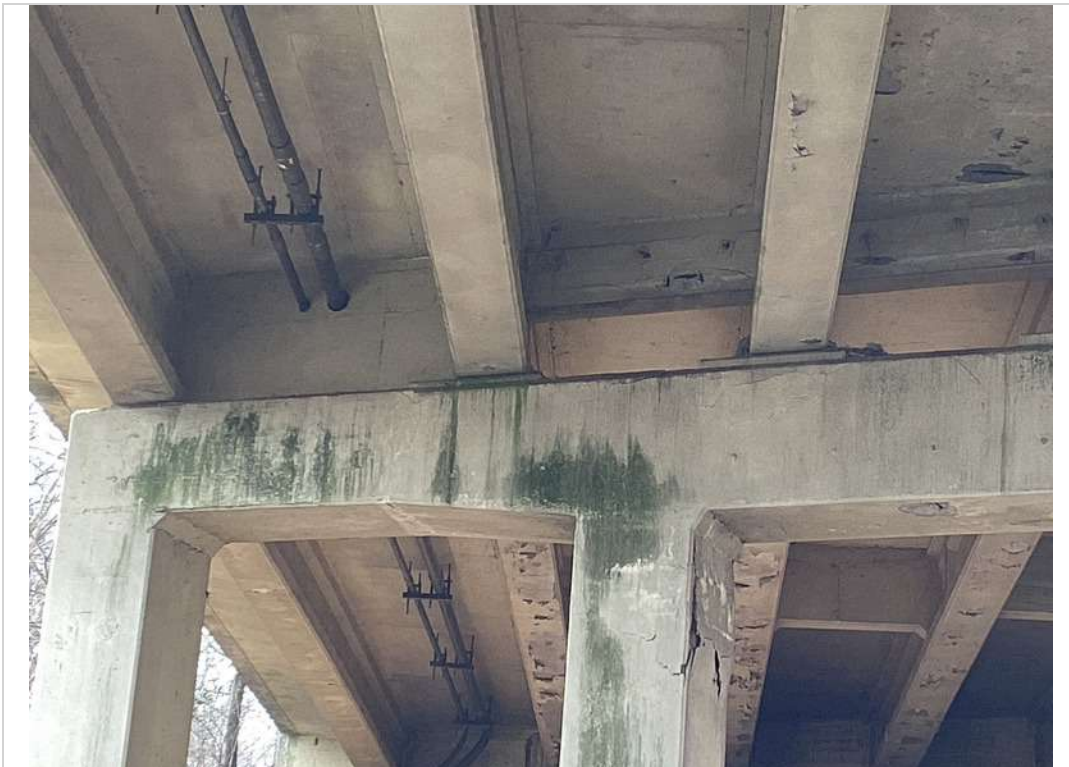
Moderate cracks in caps of bent typical

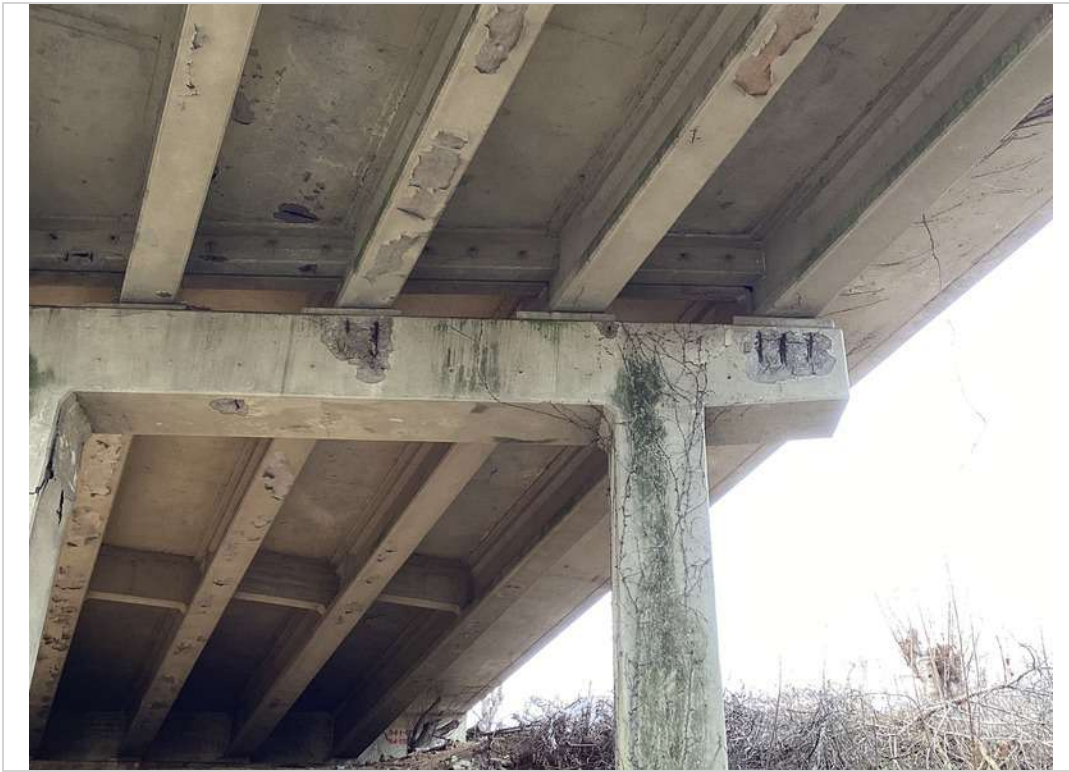
Bent 1 back spalls with exposed rebar

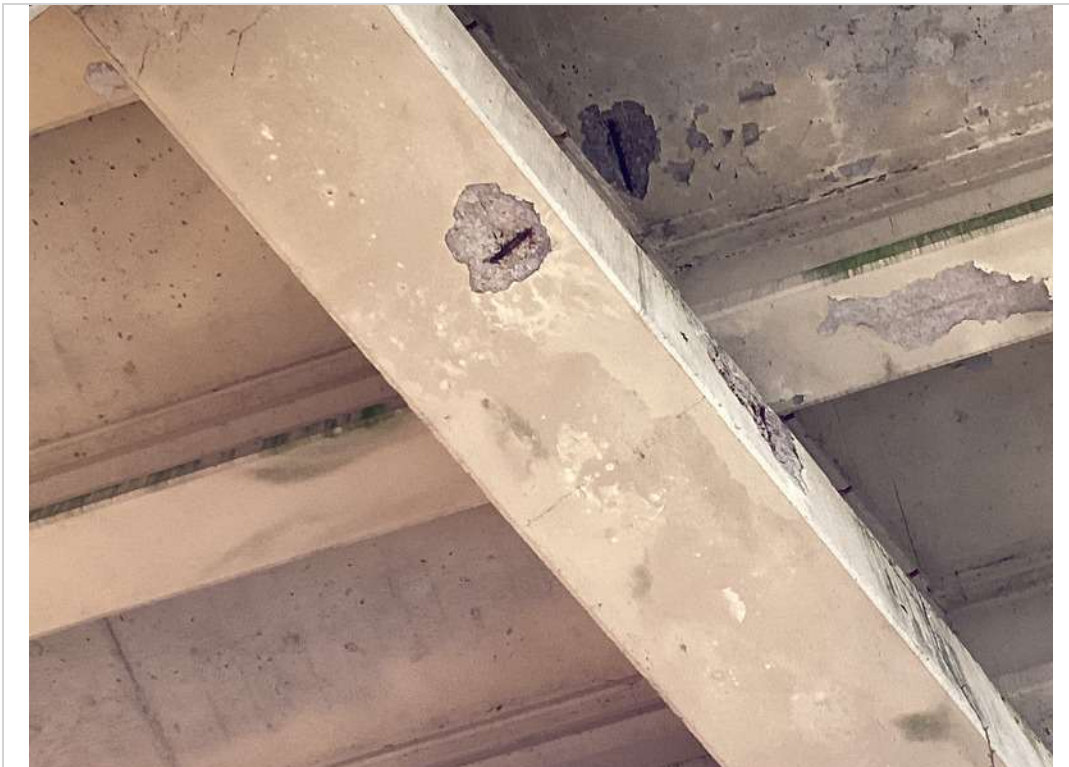
Bottom Bent 1 cap spall with exposed rebar

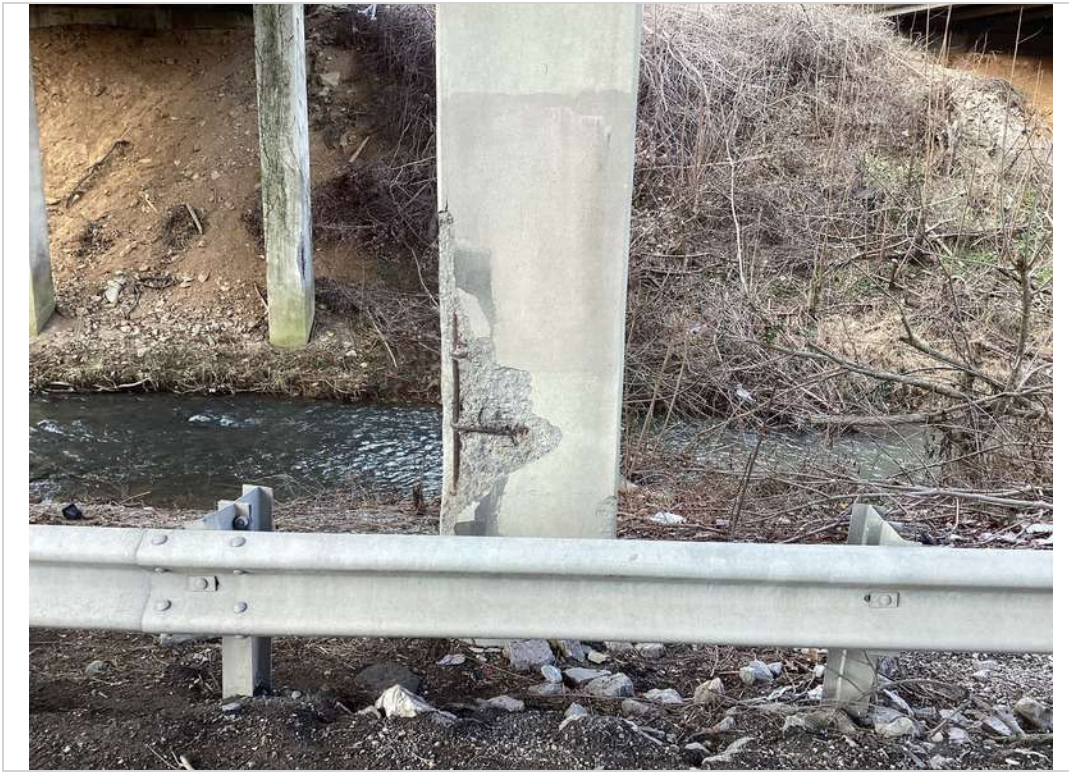
Bent 2 back Column A spall with exposed rebar

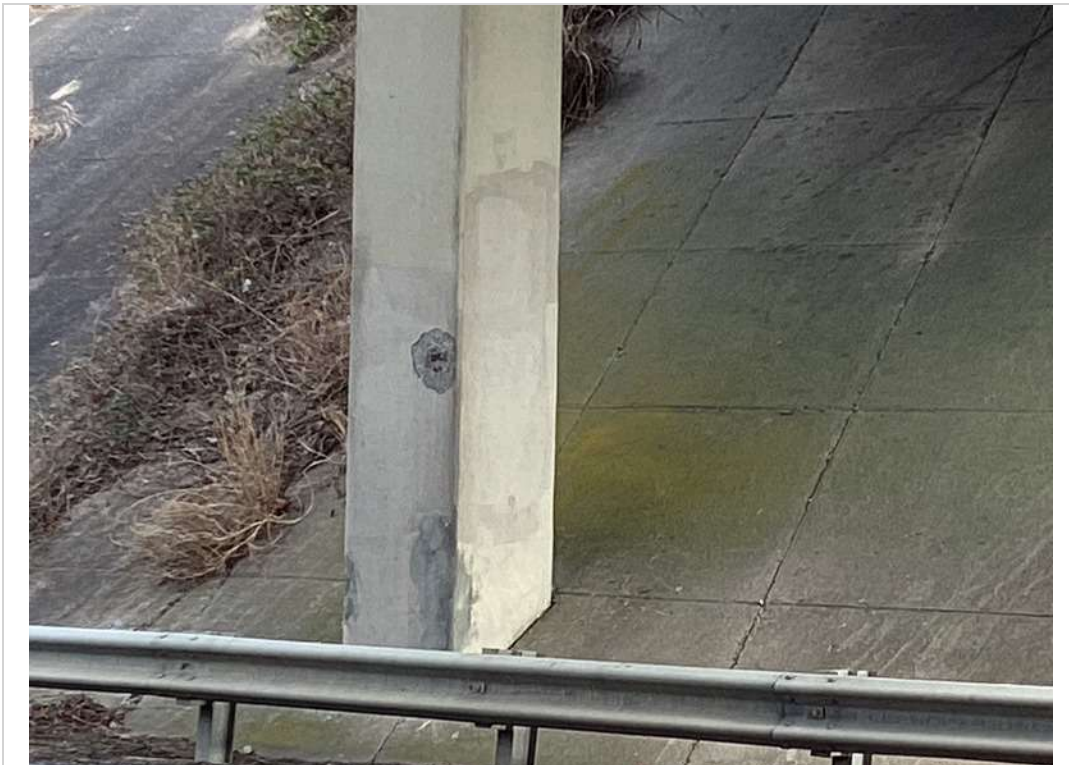
Bent 3 front Column A spall with exposed rebar

| Date Added | Recommendation | Priority |
|---|---|---|
| 02/14/2025 | REPAIR COLUMN "A" AND "B" AT BENT NO. 3 | 3 |

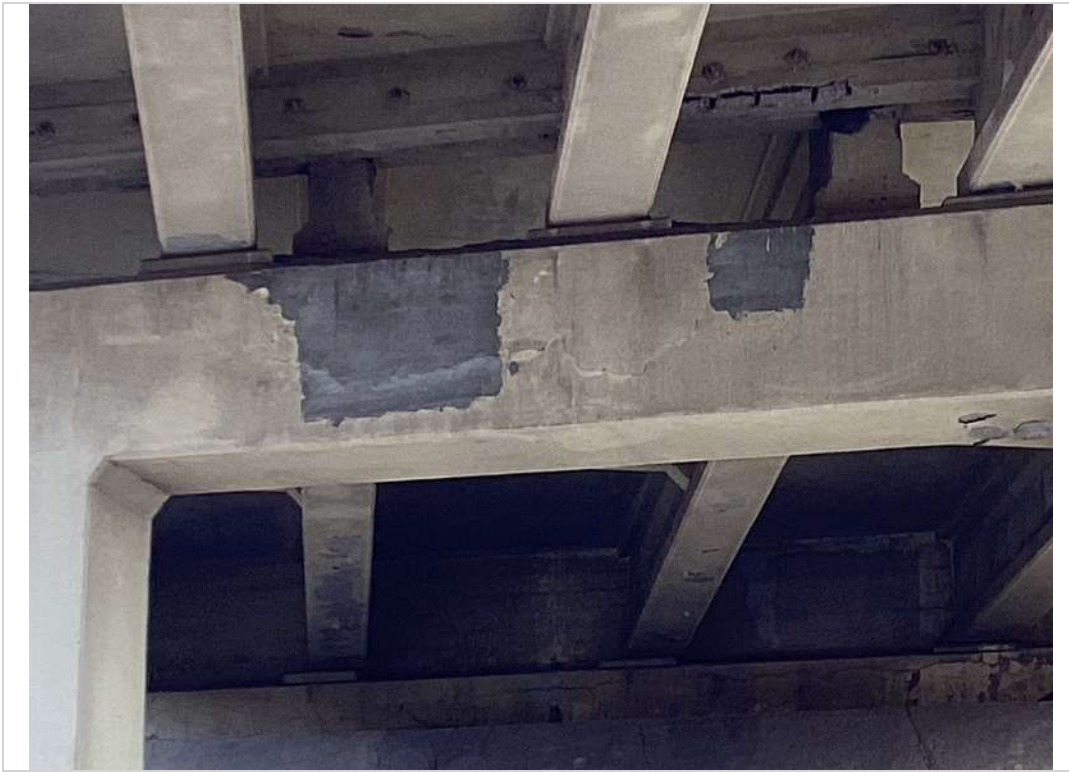
Bent 3 front typical unsound patch with eff

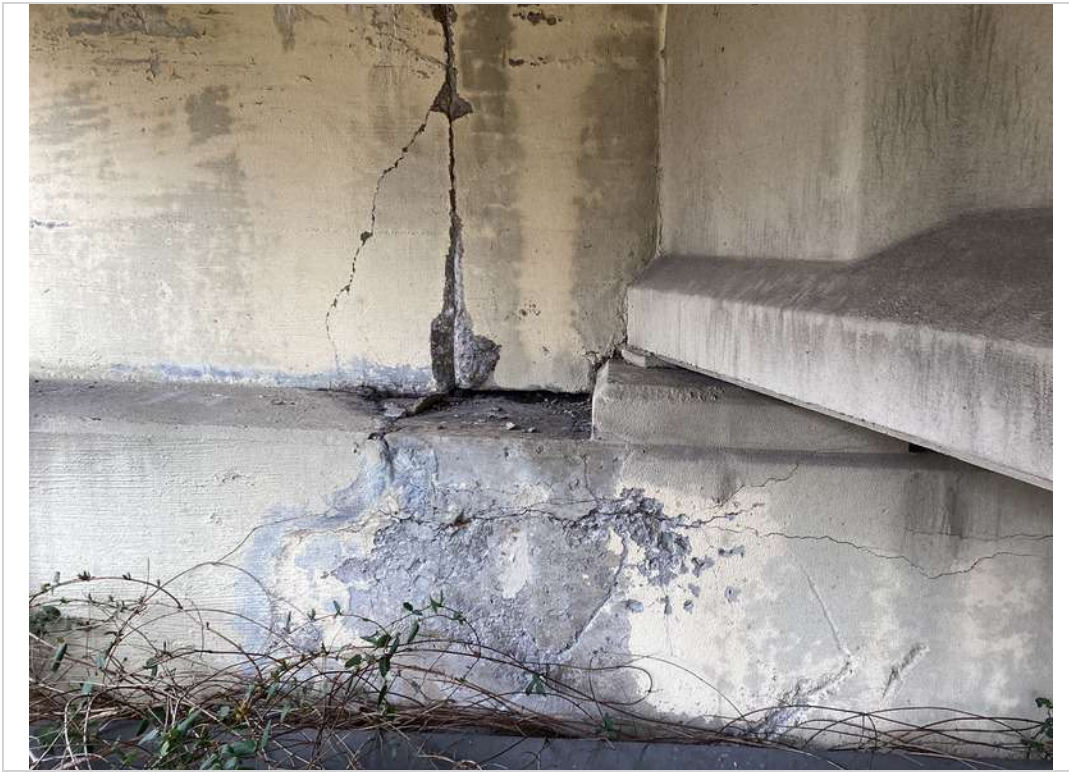
Abutment 2 backwall and cap left end cracks, spalls, and delam

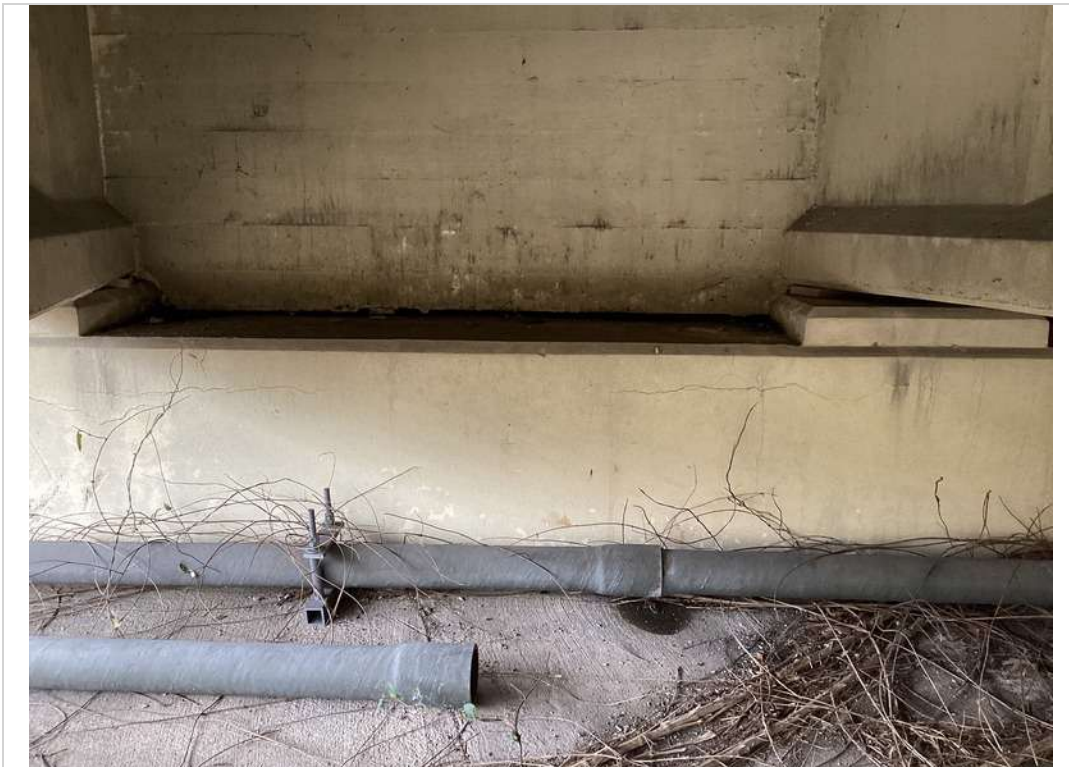
Abutment 2 cap Bay B cracks

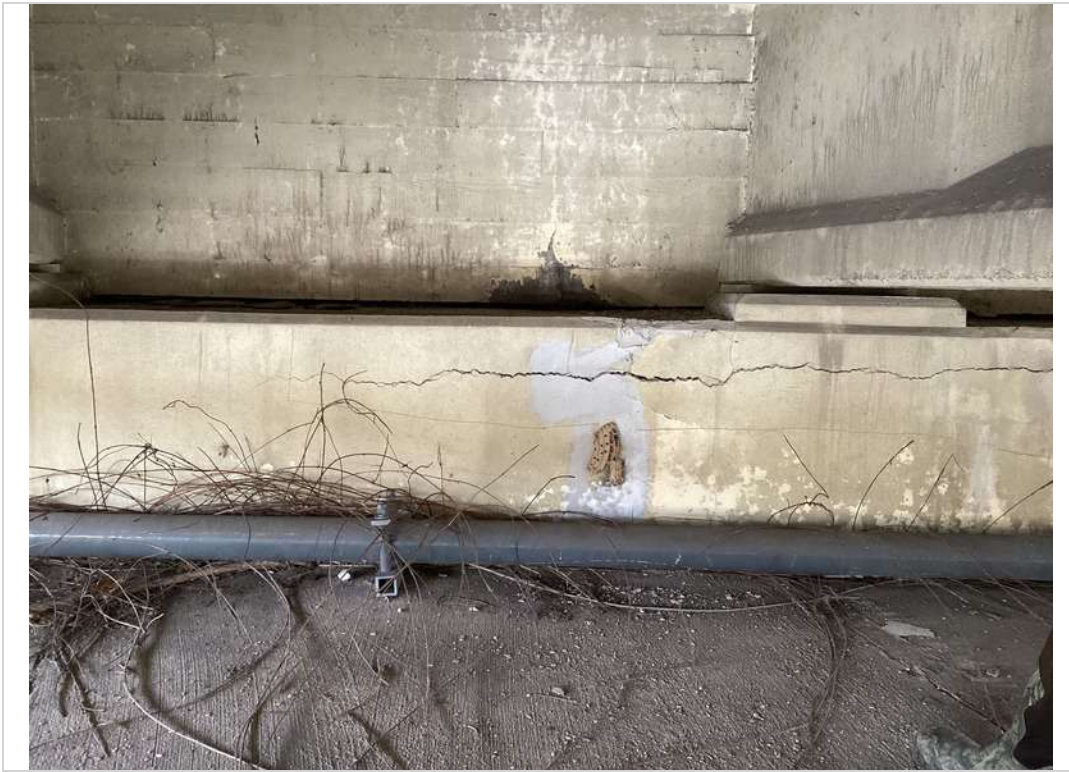
Abutment 2 Bay B cap delam and backwall hairline crack

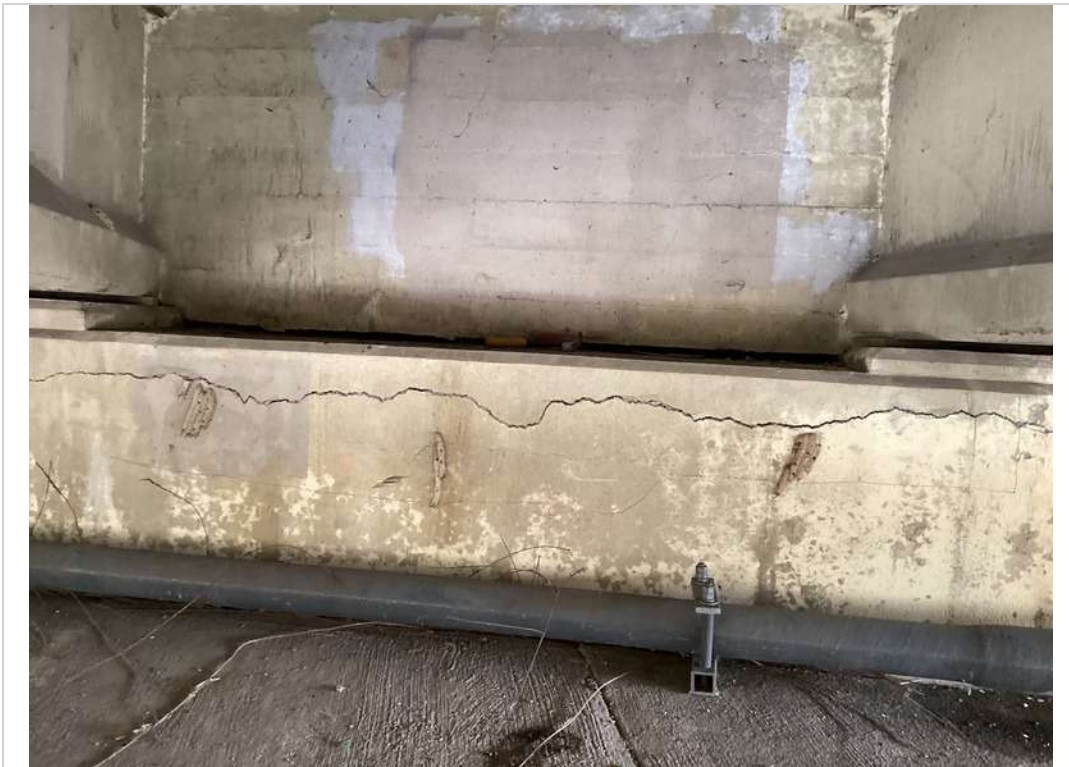
Abutment 2 cap Bay C delam

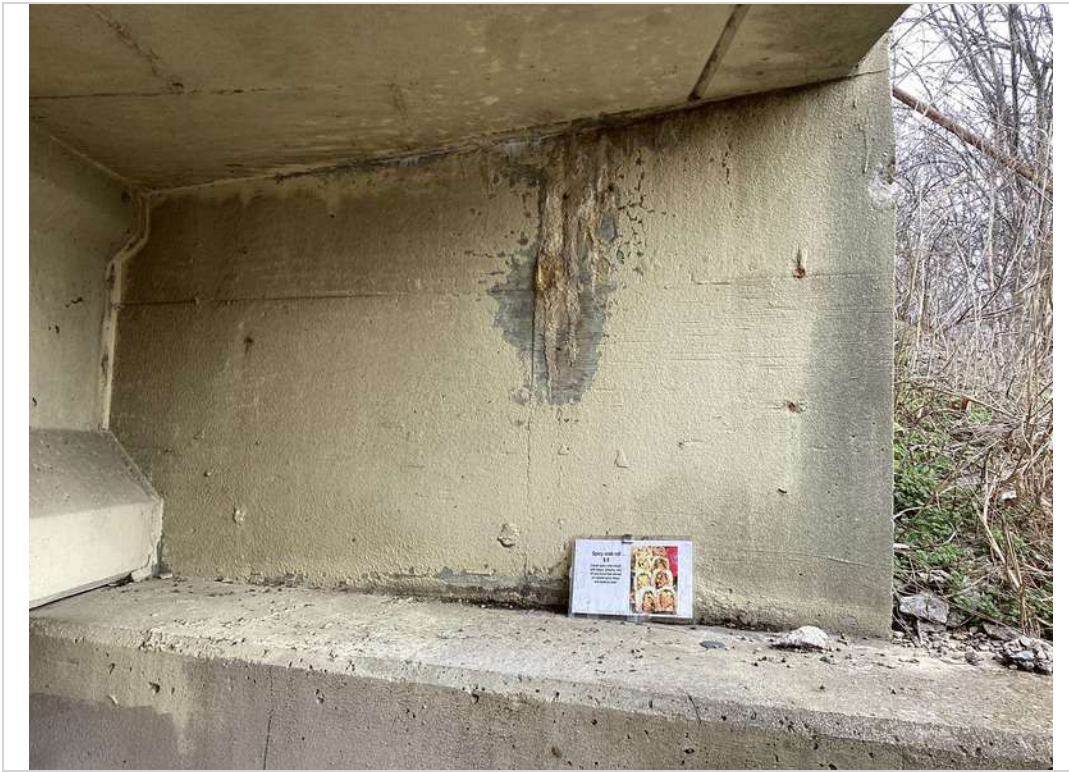
Abutment 2 right end of backwall heavy eff and minor spall

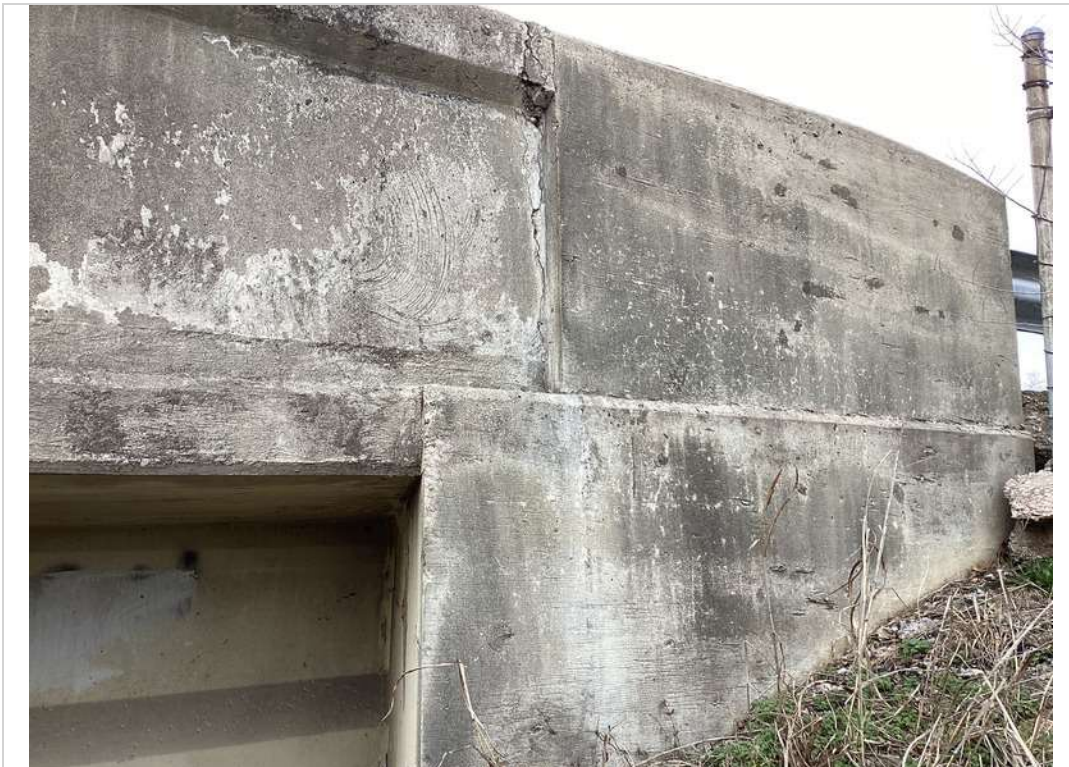
Abutment 2 right parapet over wingwall moderate crack
