I-65 Crossing I65 / SR106 & HARPETH RV

90 - LAST INSPECTION DATE 02/14/2025

| IDENTIFICATION | |
|---|---|
| (8) Structure Number | 94I00650005 |

Bridge 94I00650005 is a 4-span bridge on a 70 degree skew composed of a cast-in-place concrete deck supported by prestressed AASHTO Type II beams. The bridge has a total length of 193'-10.25", an out-to-out width of 44'-0", a roadway width of 40'-5", and carries 2 lanes of traffic. The maximum span length is 52'-10.125". On February 14, 2025 a Michael Baker inspection team performed a 1-day Routine Inspection on the bridge. Korbin Hinson and Sean Bonner inspected the top of deck, superstructure, and substructure from the ground. The weather conditions were sunny and 28 degrees.

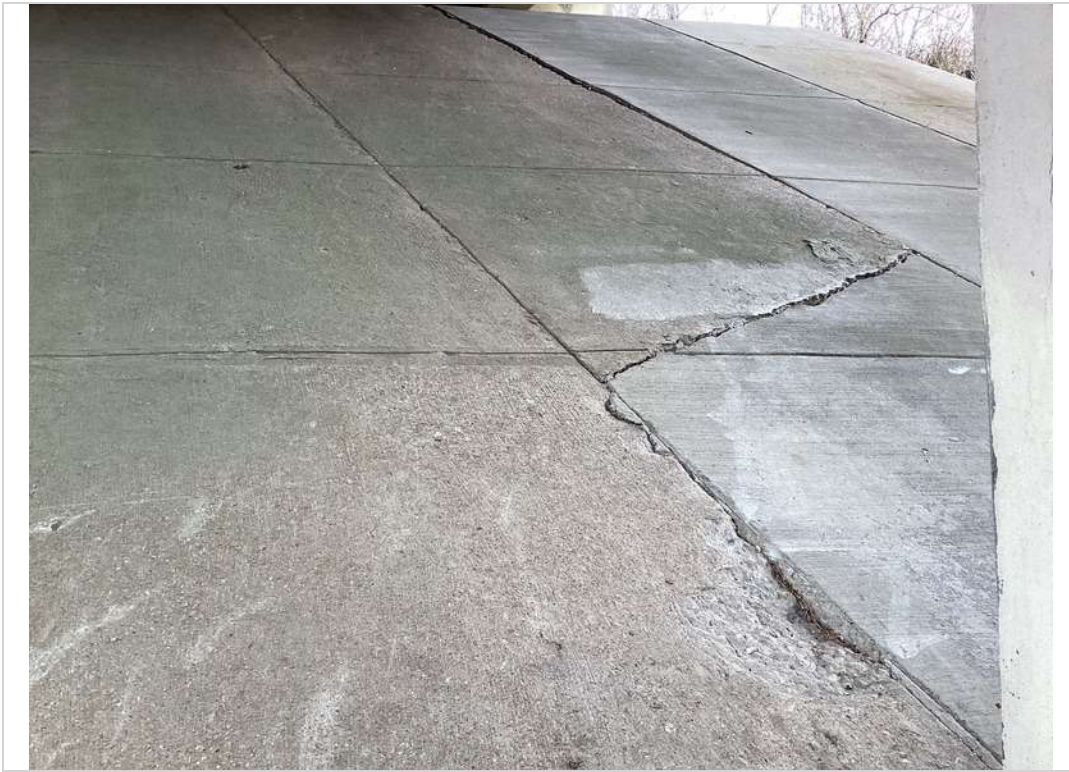
| <b>Abutment Slope Paving</b> | (Fair) | Abutment 2 slope paving exhibits some wide cracks and moderate spalls. |

Abutment 2 slope paving typical isolated spall and isolated crack
