I-65 Crossing I65 / SR106 & HARPETH RV

90 - LAST INSPECTION DATE 02/14/2025

| IDENTIFICATION | |
|---|---|
| (8) Structure Number | 94I00650006 |

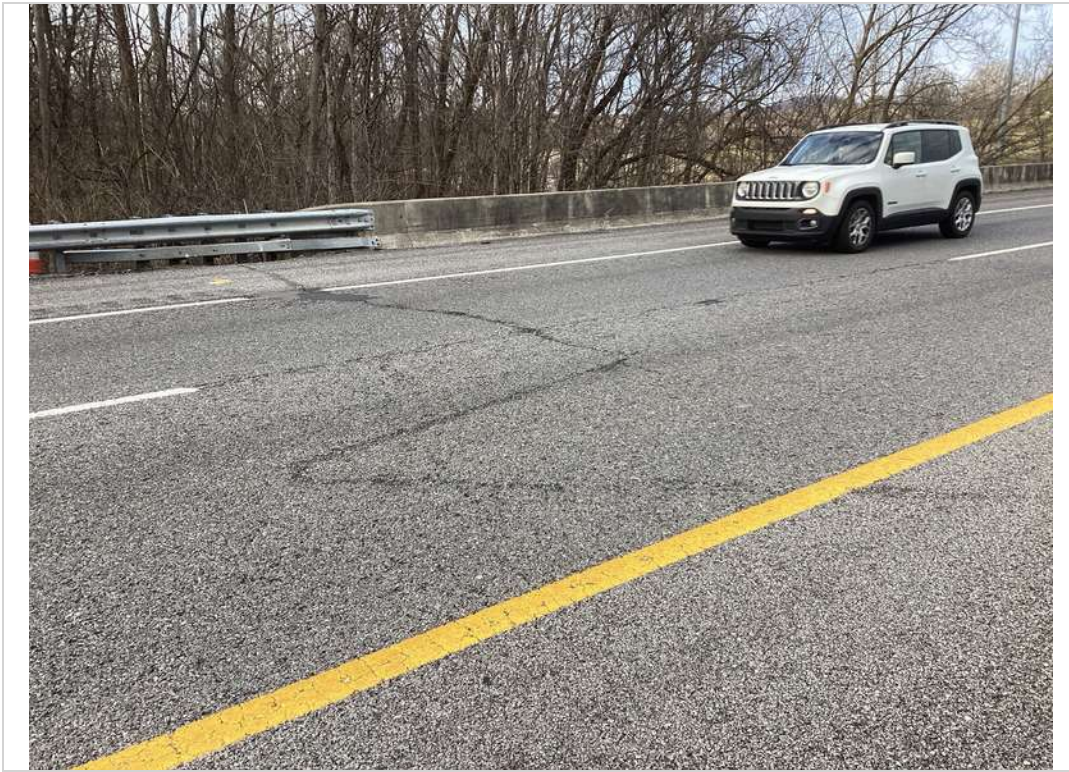
Wide crack and patch at beginning of bridge

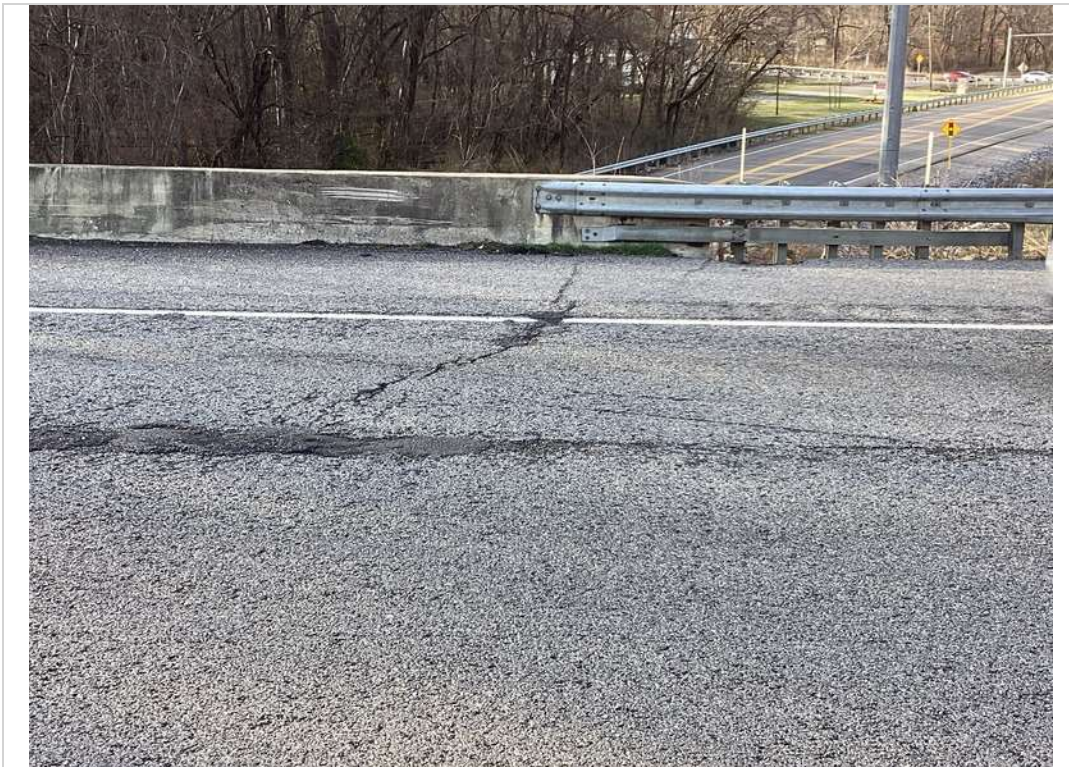
Wide crack in wearing surface at end of bridge

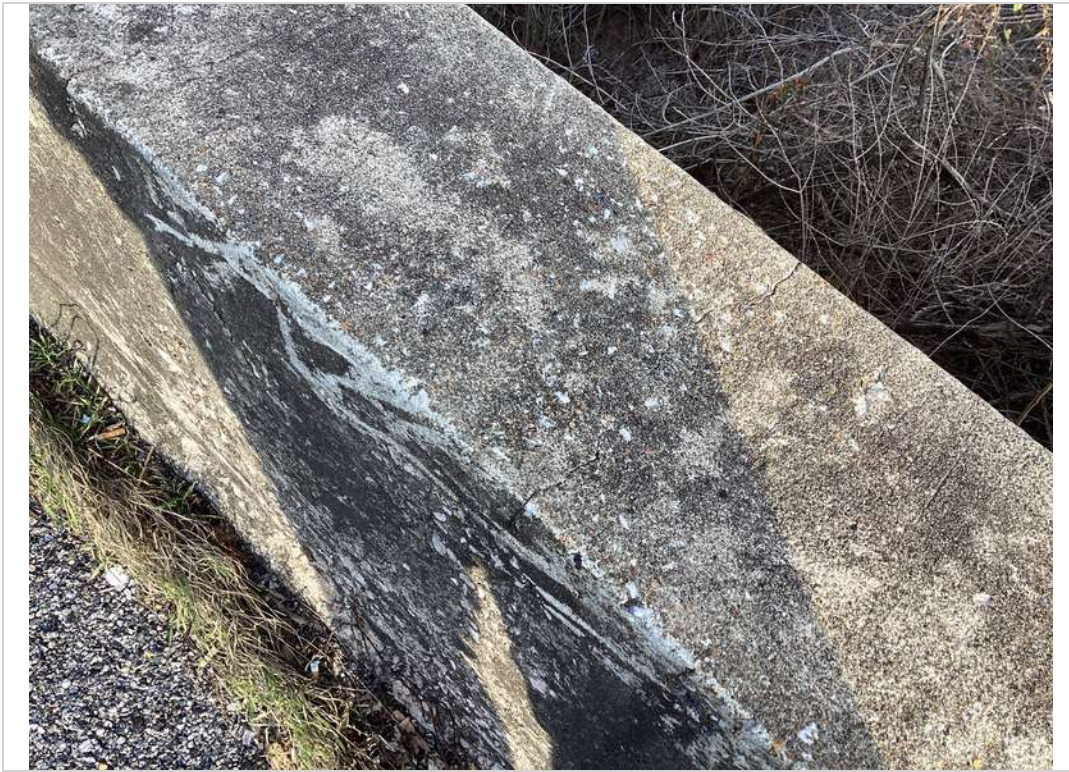
Typical HL crack in both parapets all spans

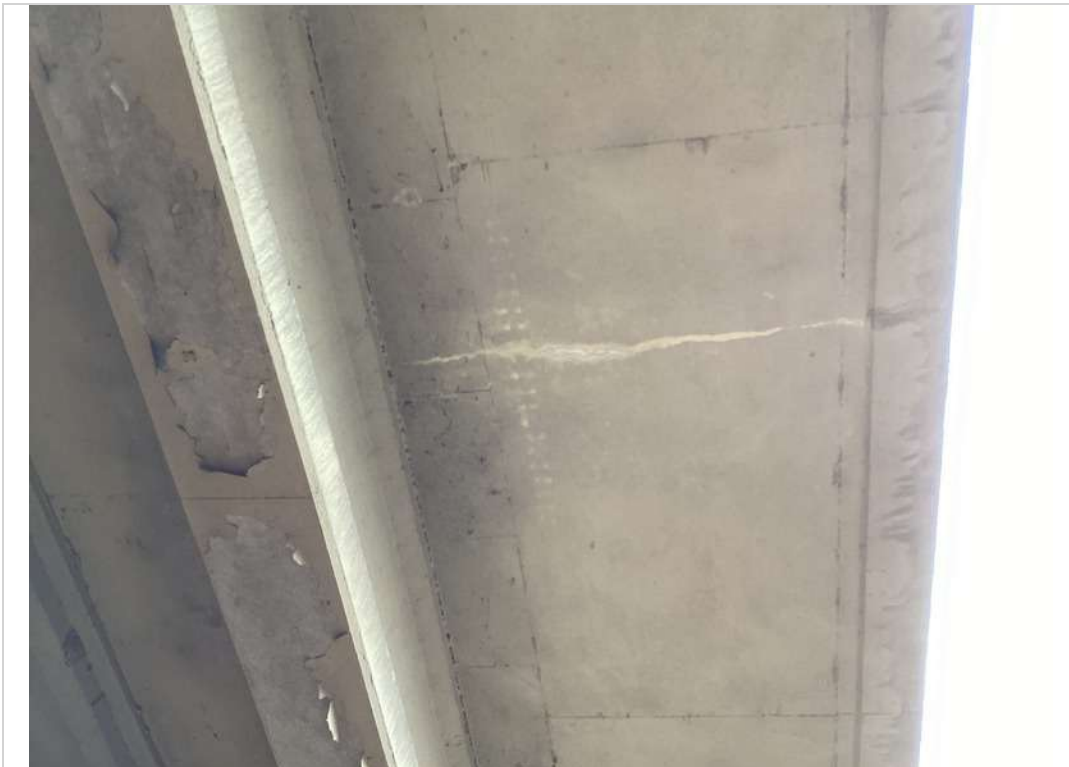
Span 1 crack w/ eff in right overhang

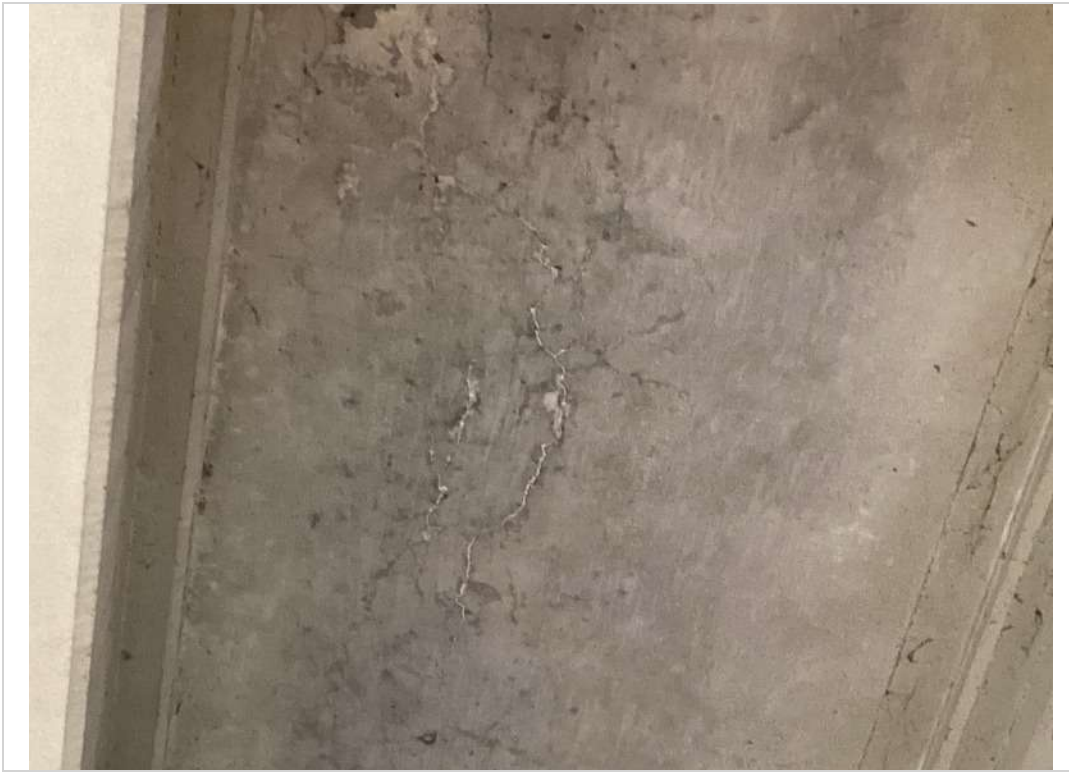
Span 1 HL cracks w/ eff in Bay C

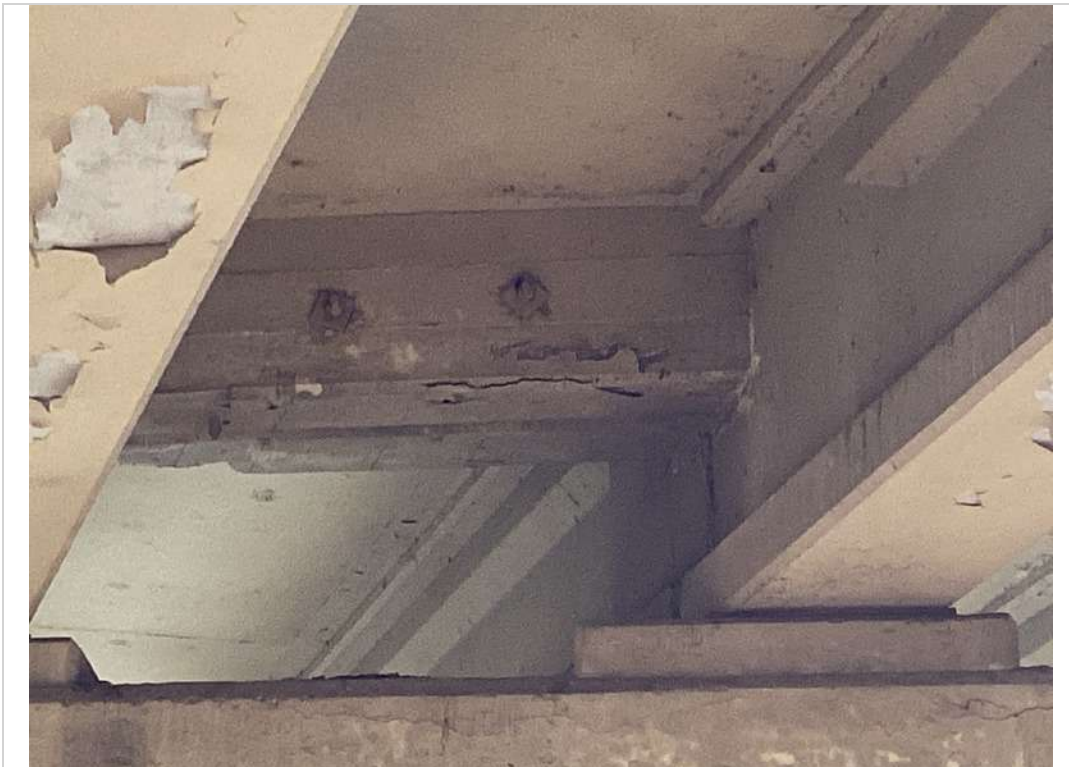
Span 1 delam in forward diaphragm

| Date Added | Recommendation | Priority |
|---|---|---|
| 04/02/2002 | REPAIR DIAPHRAGMS IN SPANS 1, 2 & 3 | 3 |

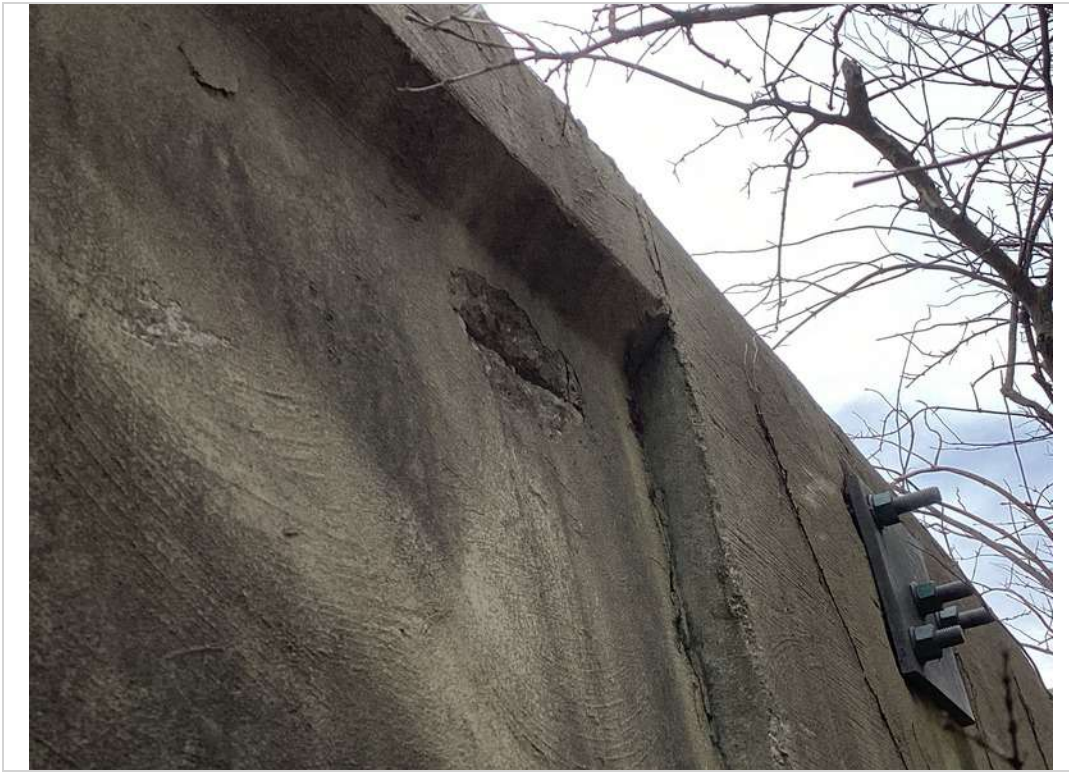
Span 1 spall w/ exposed rebar on left parapet over Abutment 1

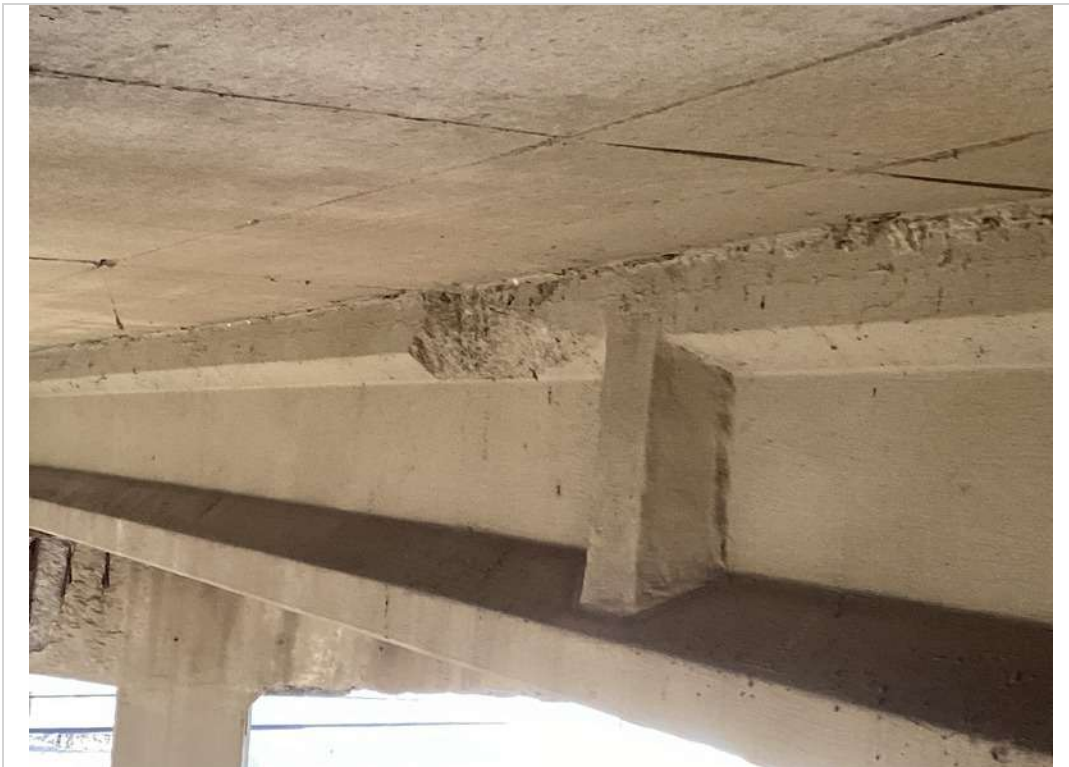
Span 1 spall on left side top flg of Beam B

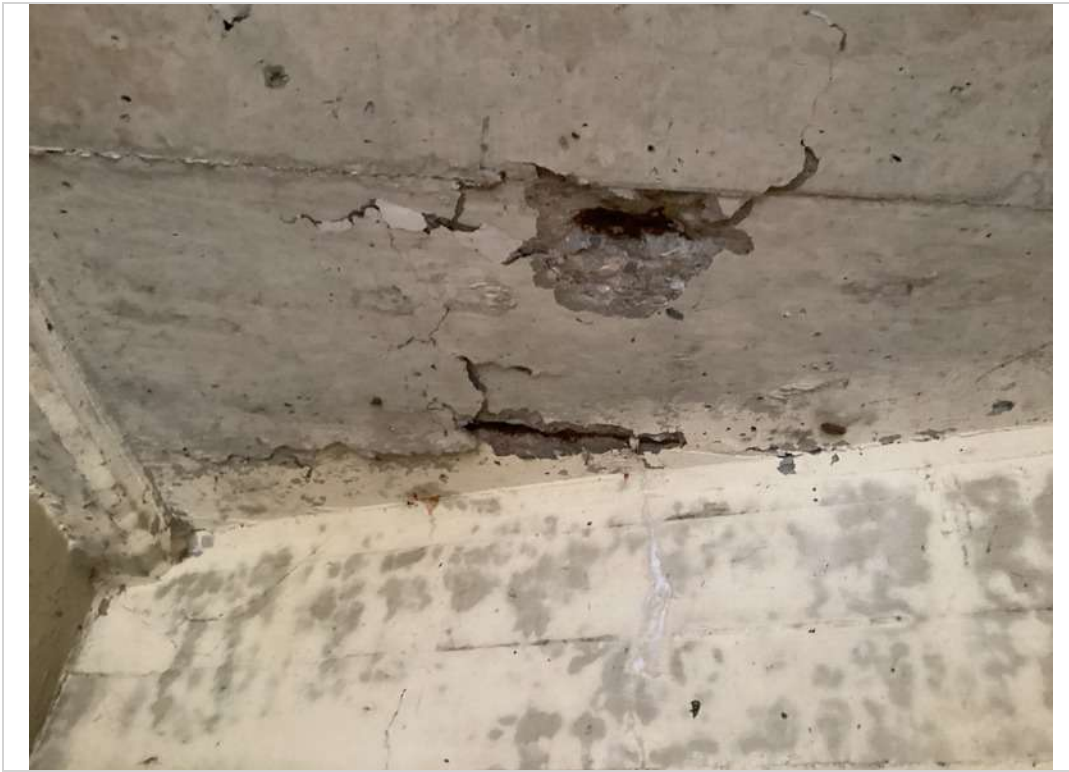
Span 1 spall w/ exposed rebar in Bay C over Abutment 1

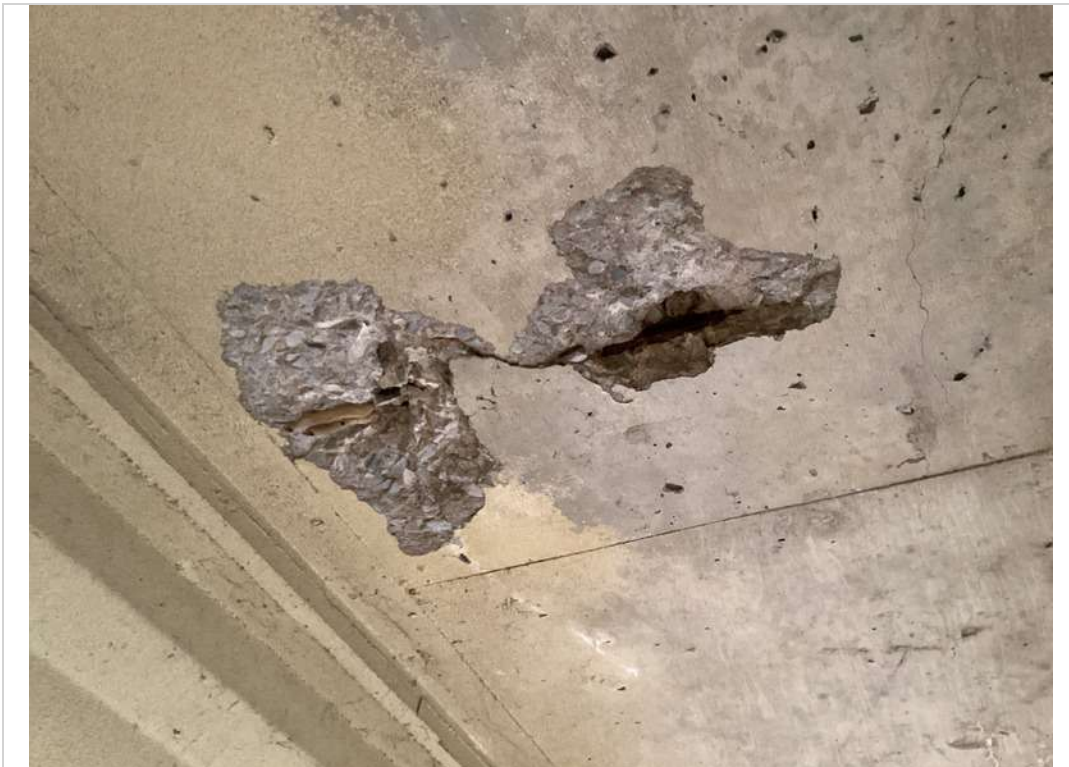
Span 1 spall w/ exposed rebar in Bay C

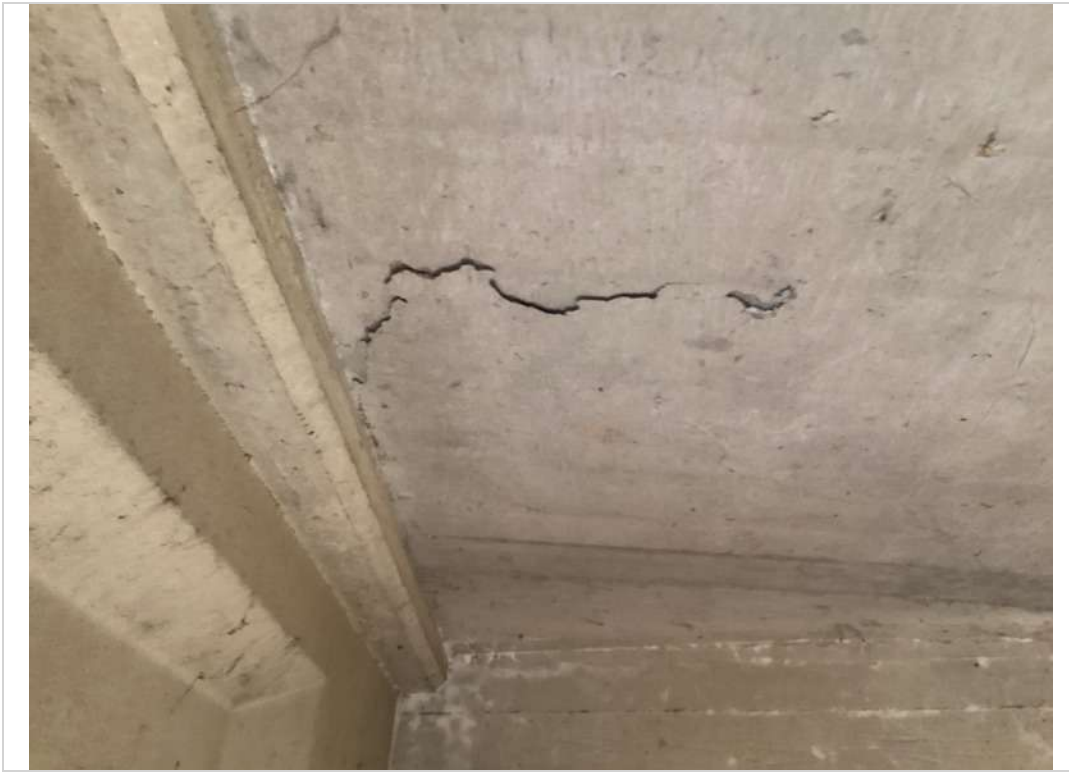
Span 1 delam in Bay E over Abutment 1

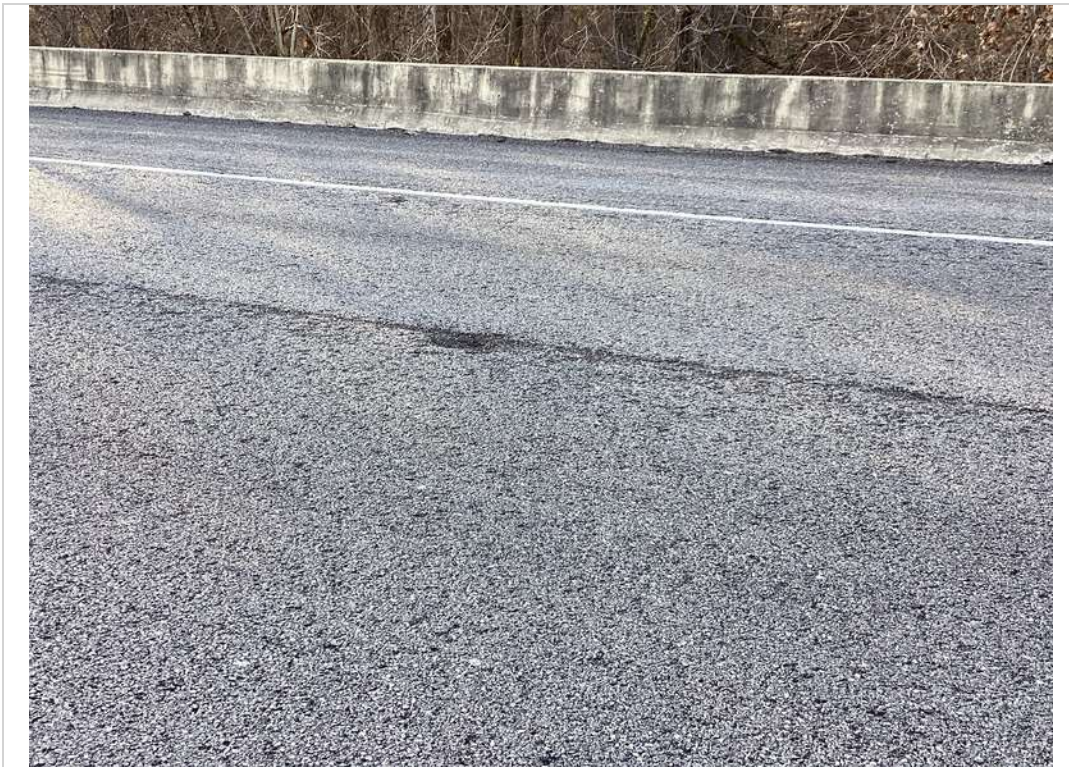
Span 2 pothole in wearing surface

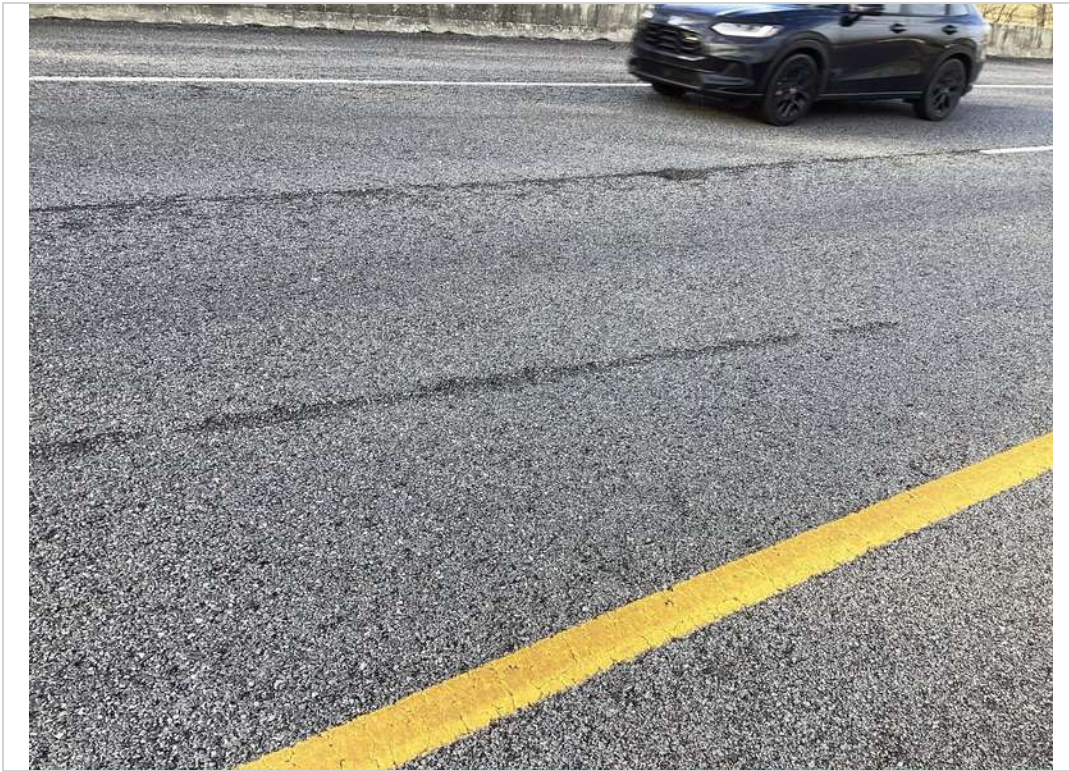
Span 2 gouge in wearing surface

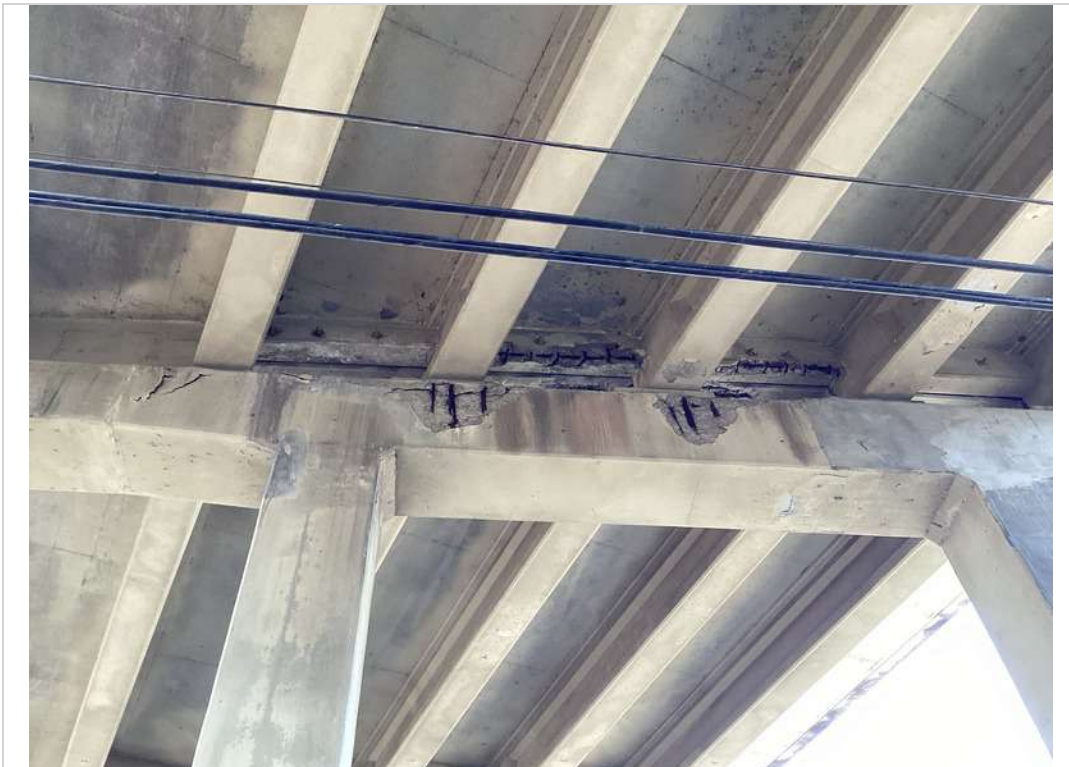
Span 2 spalling w/ exposed rebar in forward diaphragms

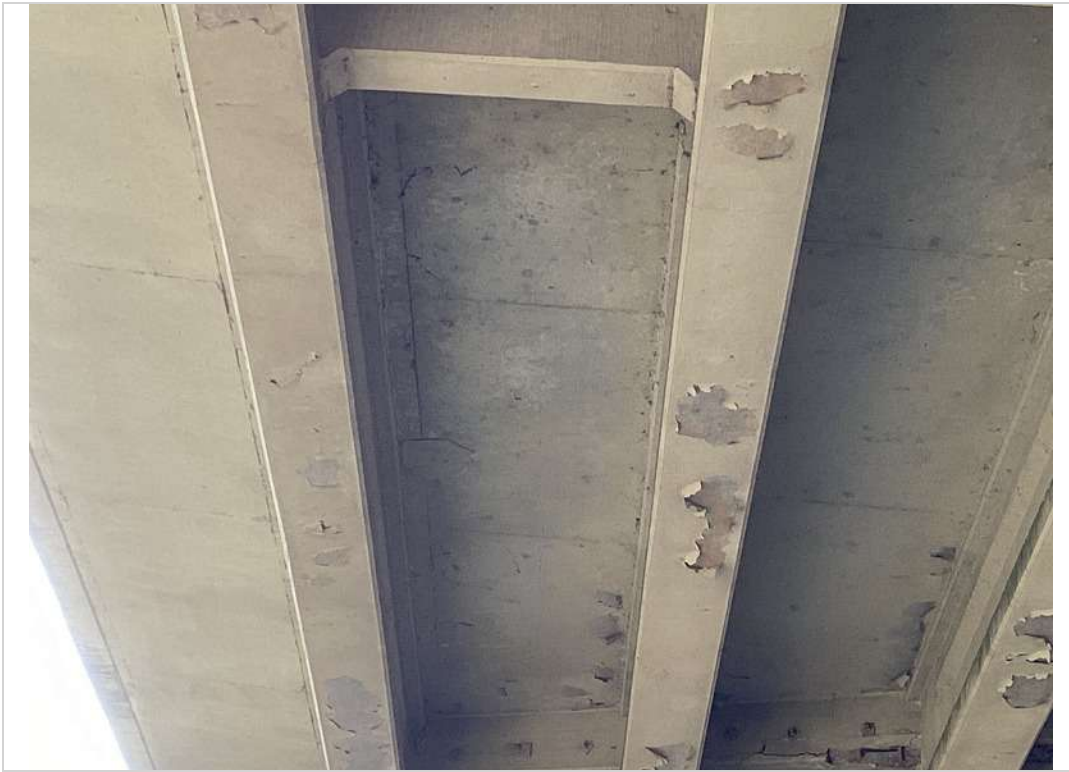
Span 2 delams in Bay E

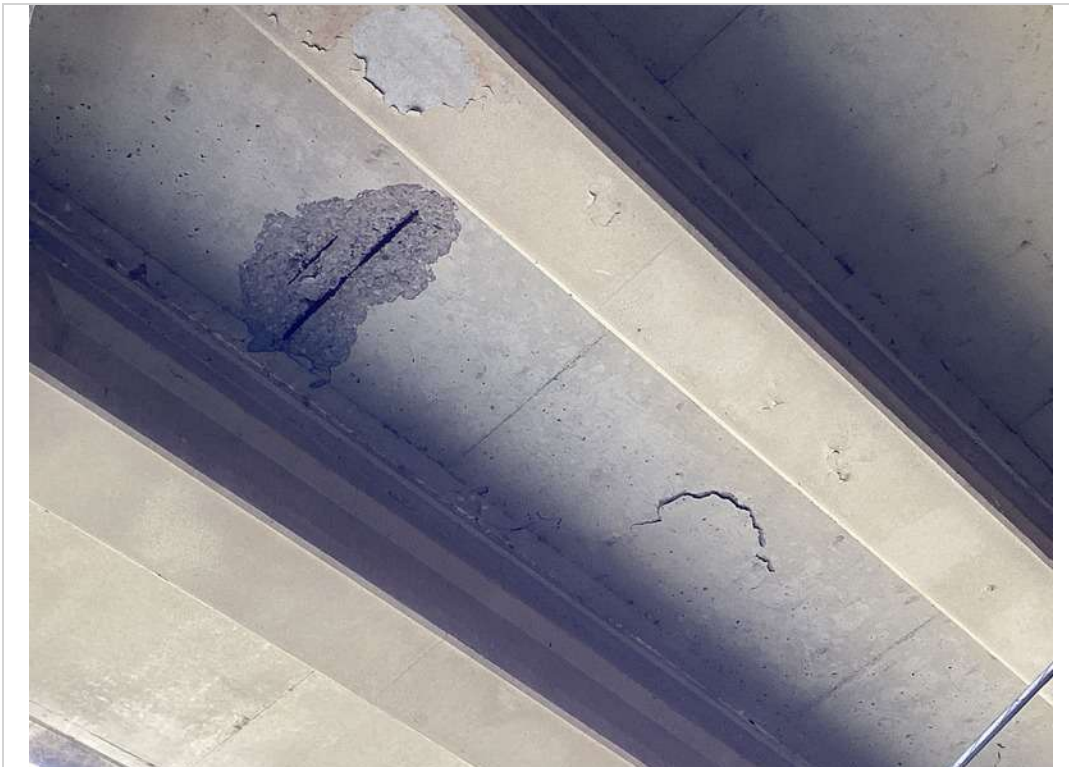
Span 2 delam and spall w/ exposed rebar in Bay E

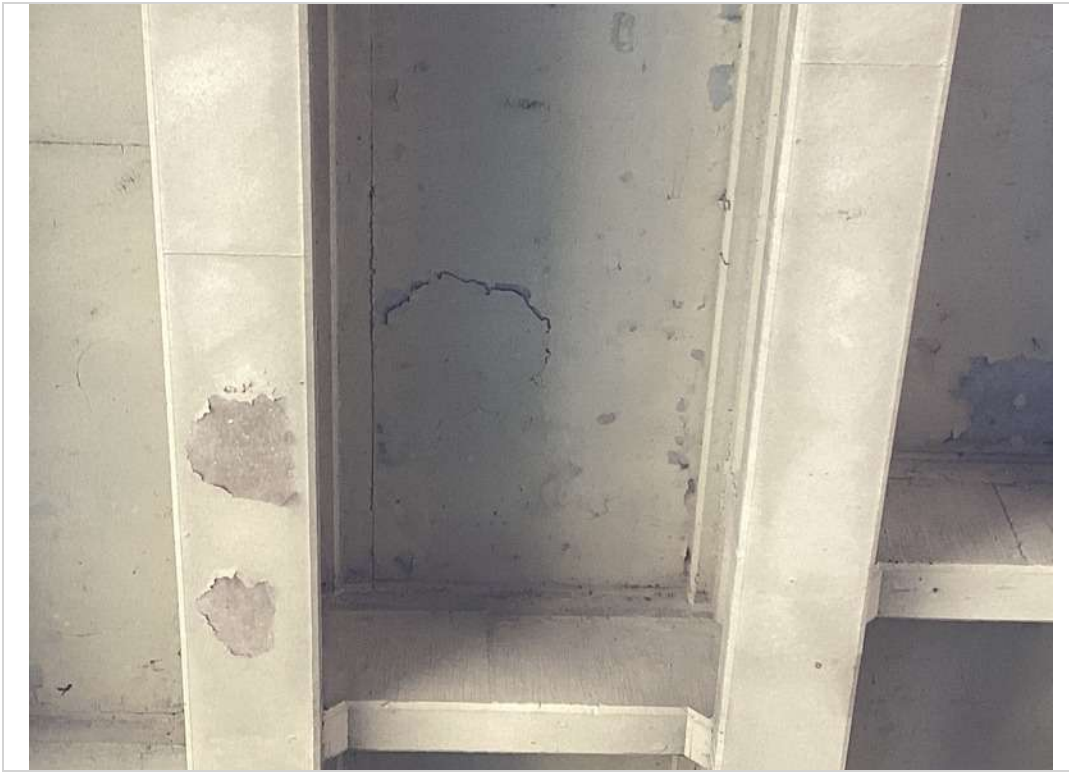
Span 2 delam in Bay C

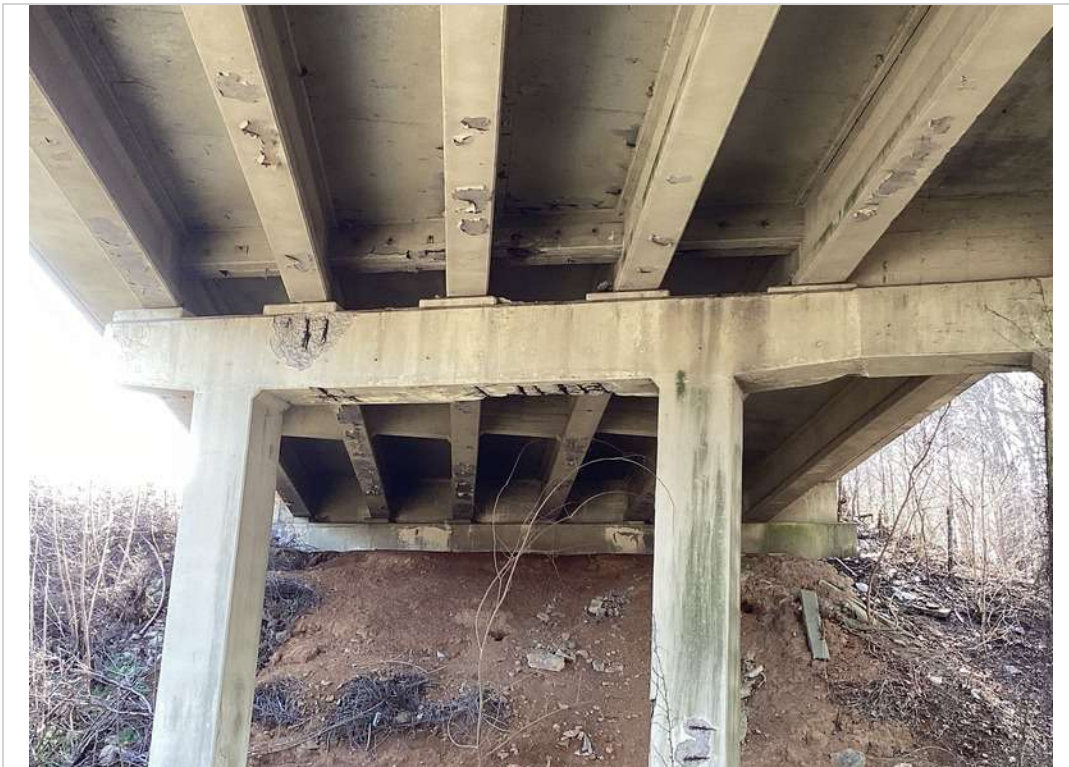
Span 2 spalling w/ exposed rebar and delams in back diaphragms

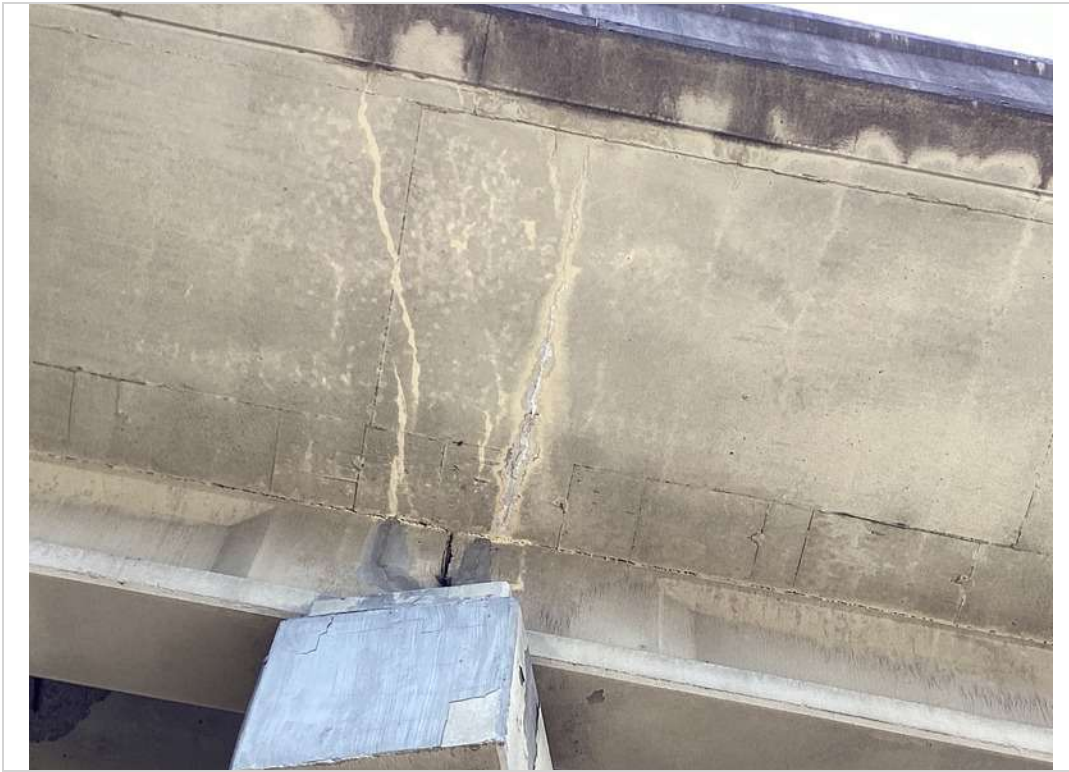
Spans 2 and 3 HL cracks w/ eff in right overhang over Bent 2

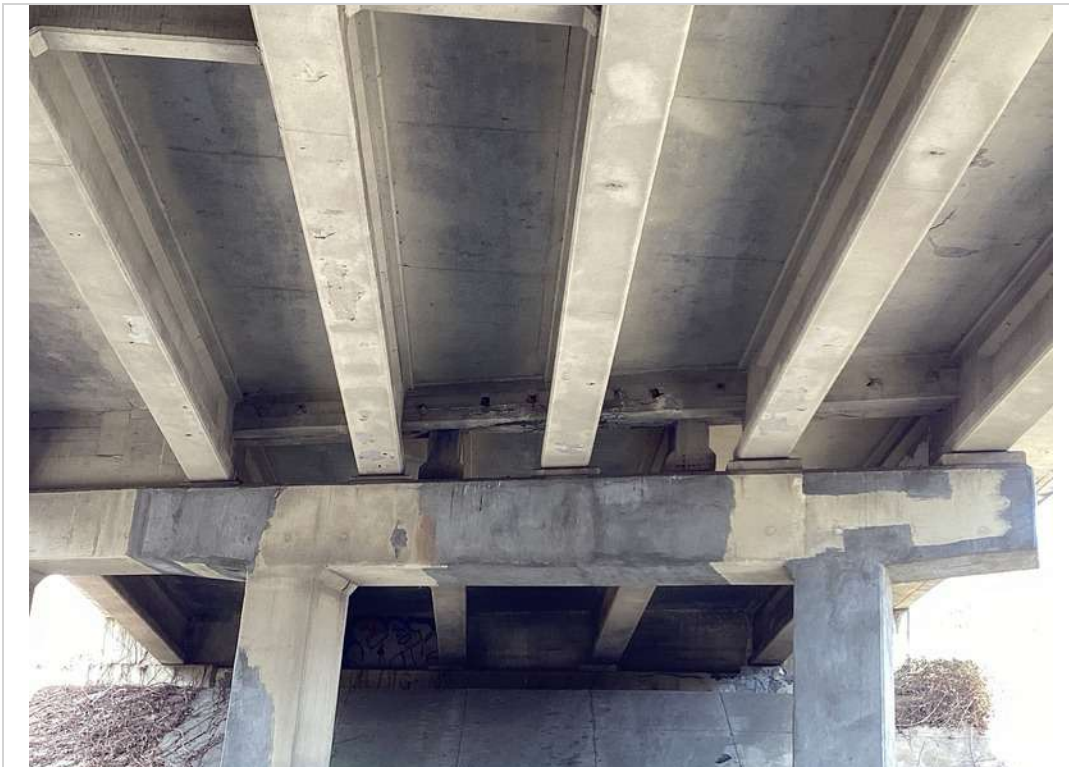
Span 3 mod cracks and delam in forward diaphragms

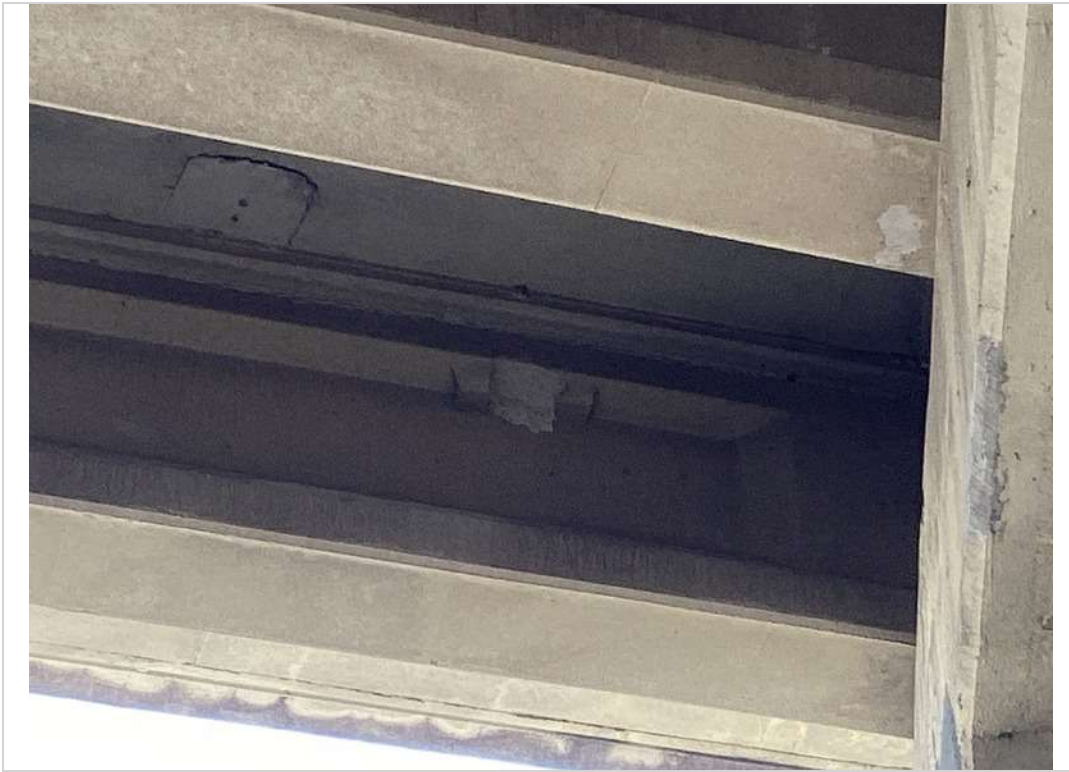
Span 3 delam in top flg left side of Beam F

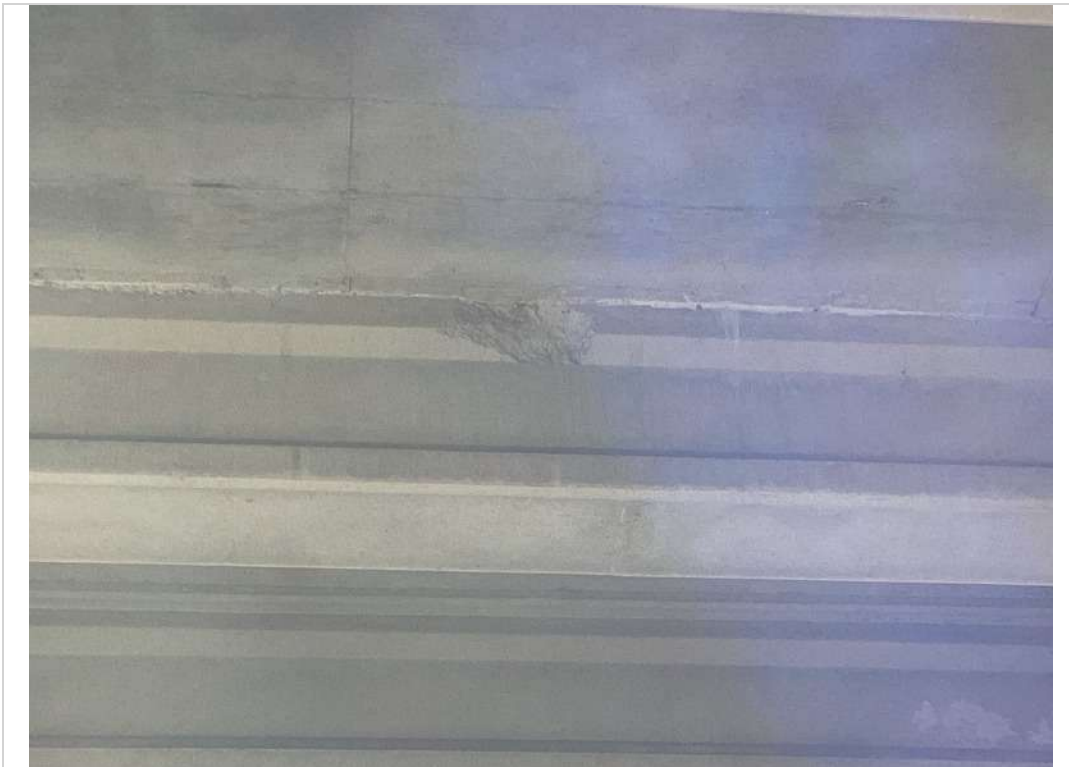
Span 3 spall in top flg left side of Beam B

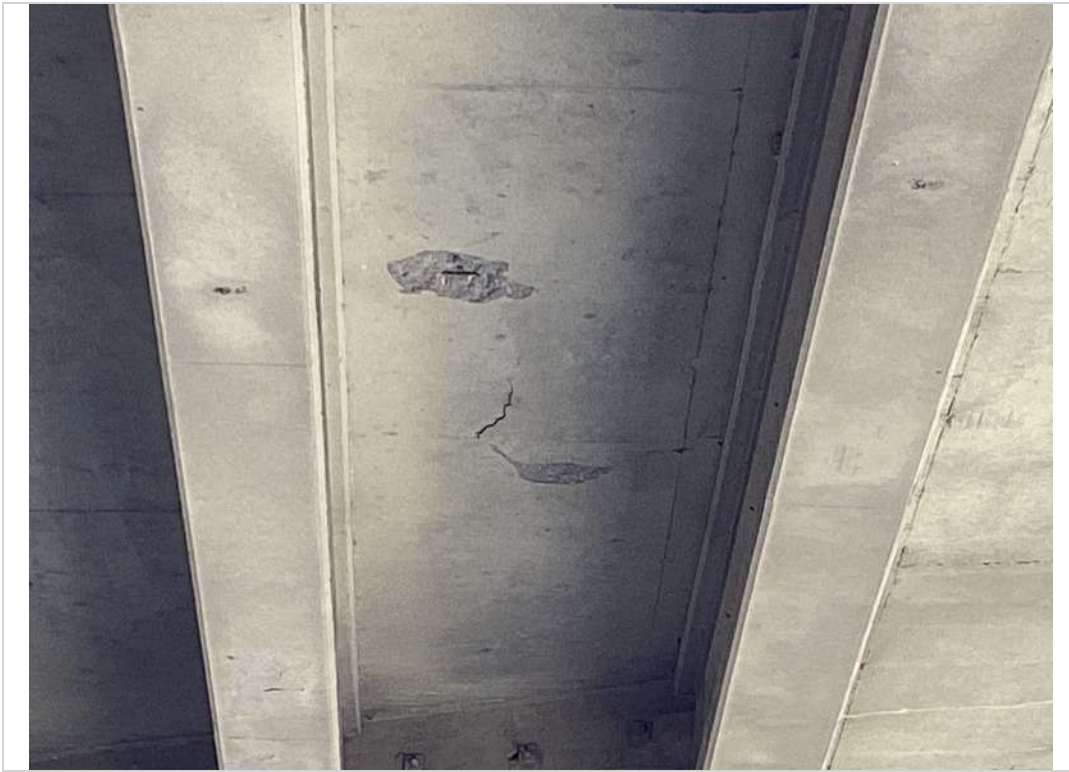
Span 3 delam and spall w/ exposed rebar in Bay E

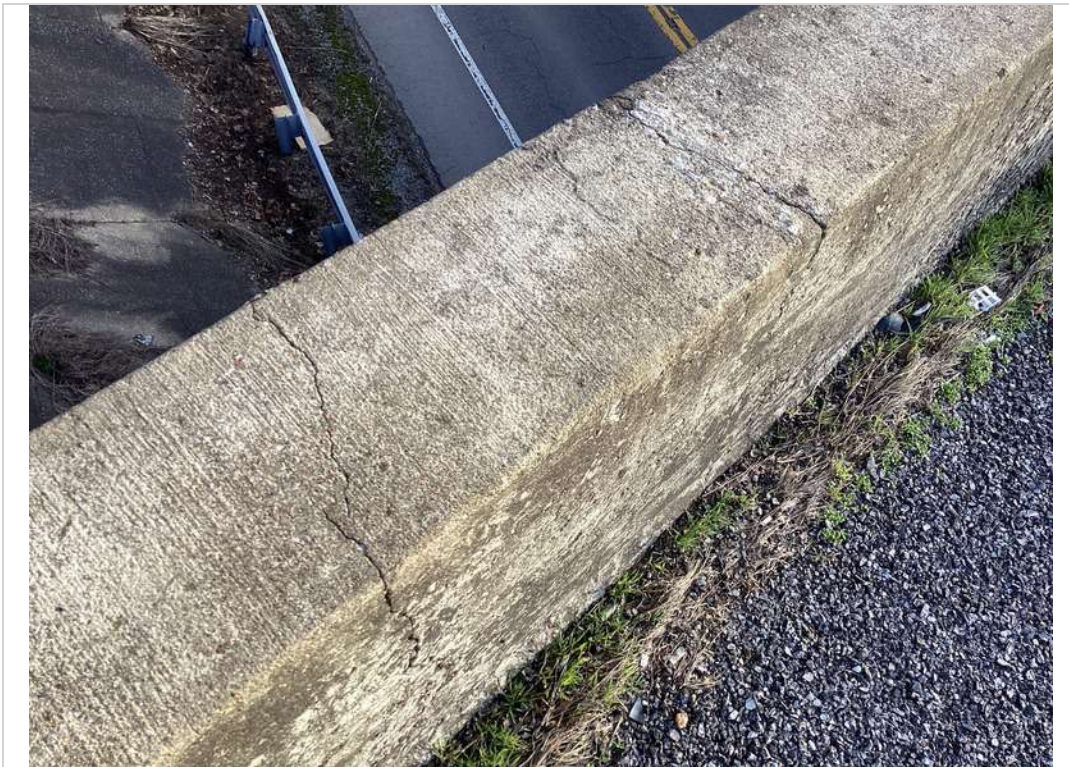
Span 4 moderate cracks in right parapet

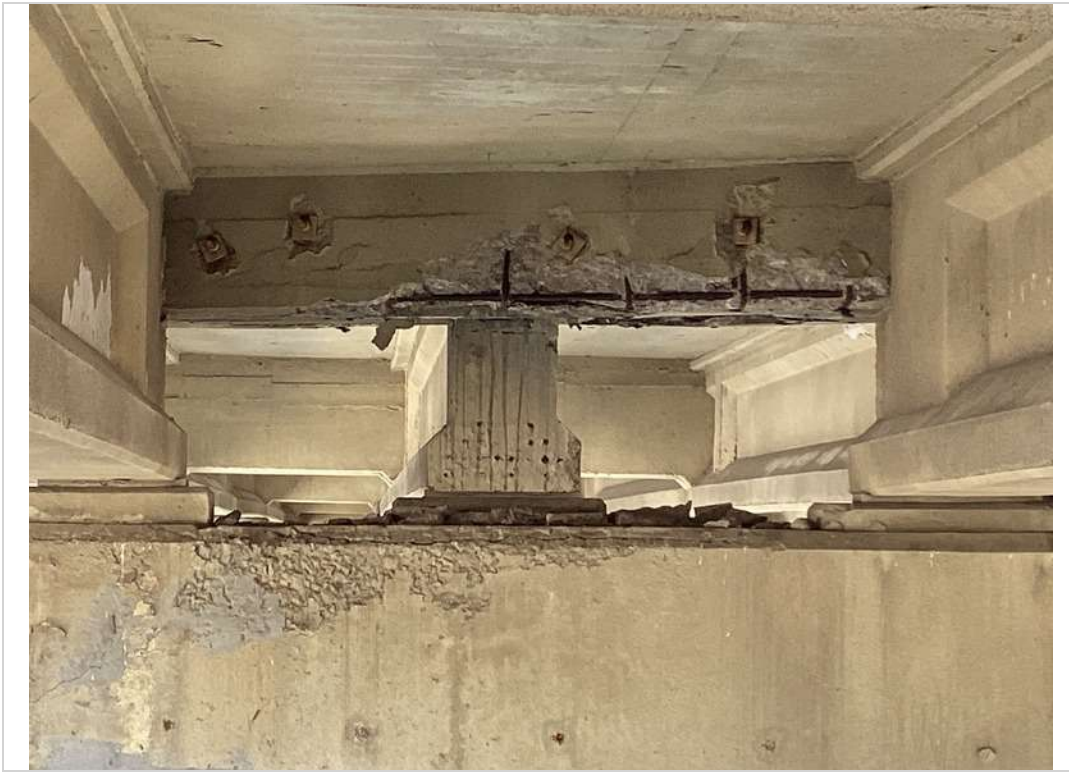
Span 4 spall w/ exposed rebar in back diaphragms

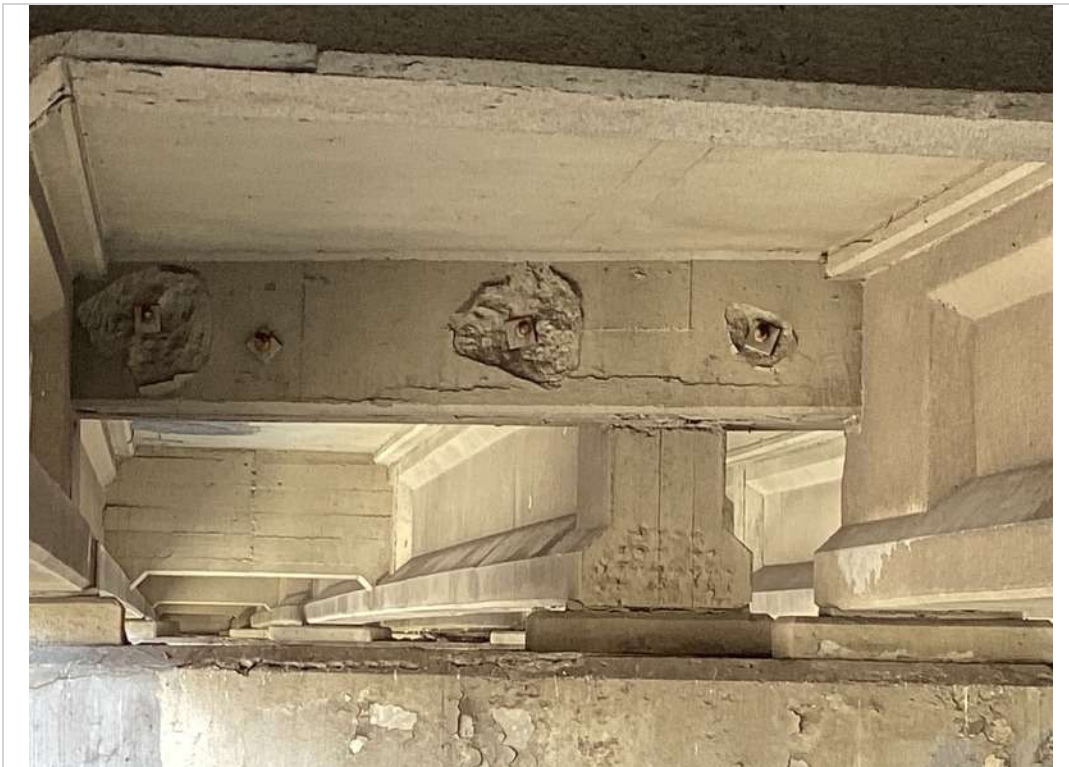
Span 4 delam and spalls in back diaphragms

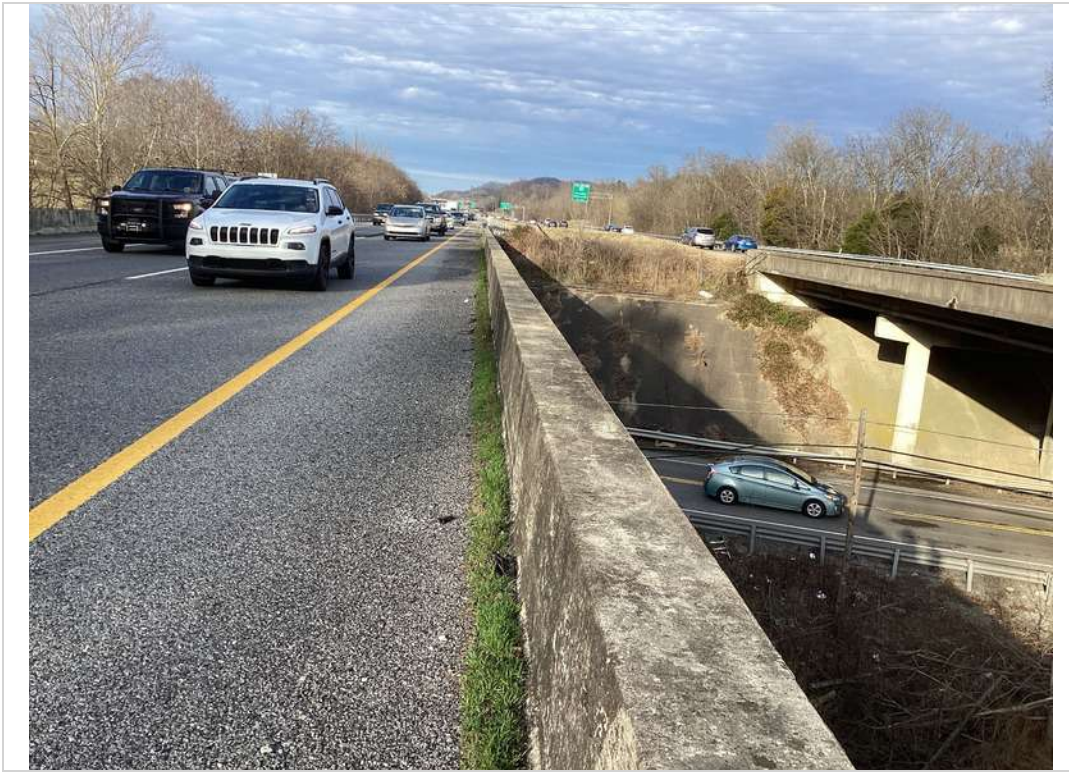
Vegetation growth along right parapet entire bridge length
