I-65 Crossing I65 / SR106 & HARPETH RV

90 - LAST INSPECTION DATE 02/14/2025

| IDENTIFICATION | |
|---|---|
| (8) Structure Number | 94I00650006 |

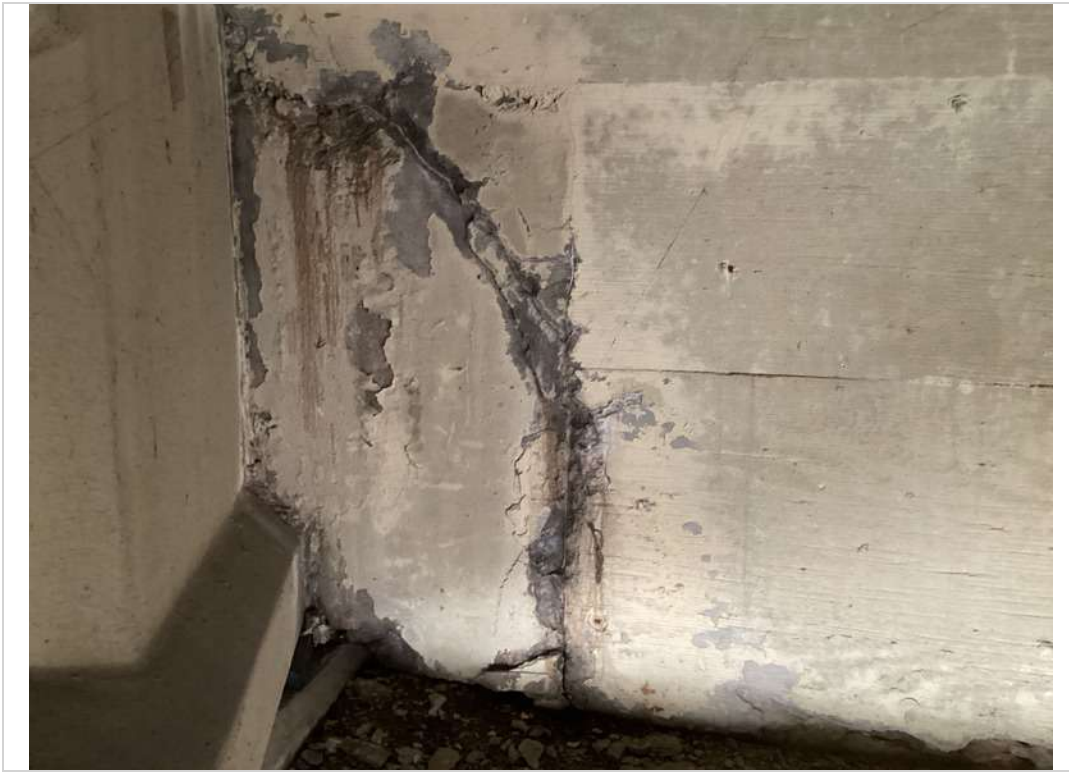
Abutment 1 crack and spalls along construct. joint under Bay A

| Date Added | Recommendation | Priority |
|---|---|---|
| 02/04/2021 | REPAIR CAPBEAM AT ABUTMENT NO. 1 AND 2 | 2 |

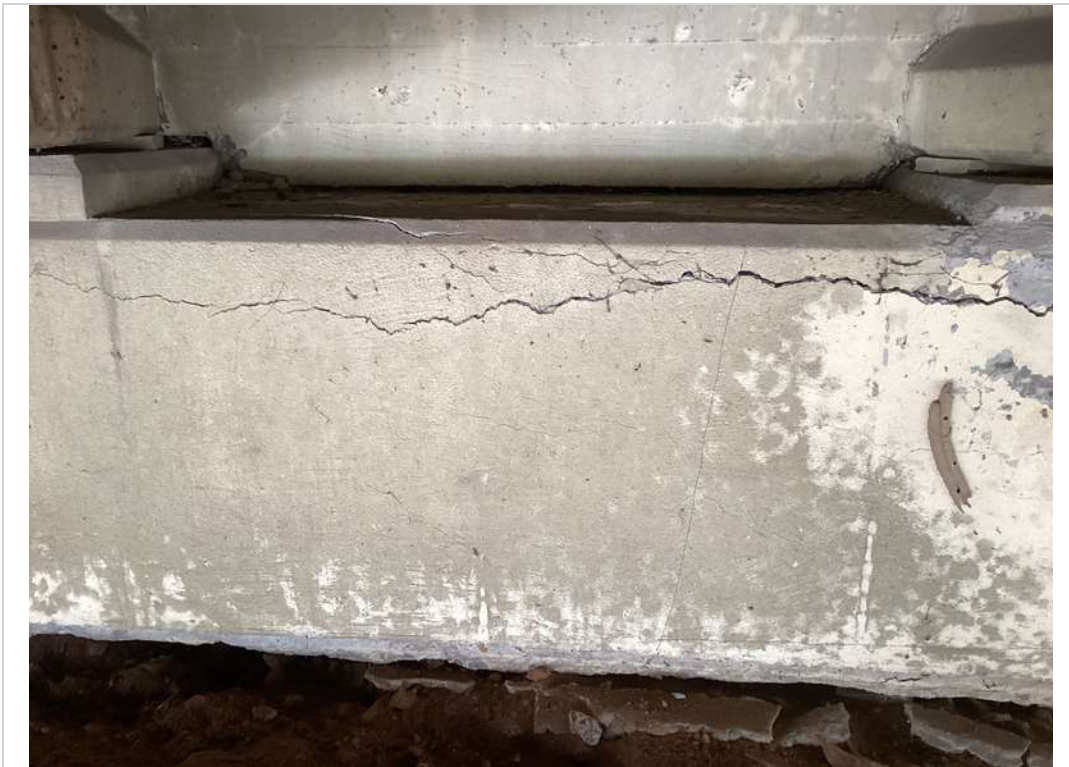
Abutment 1 delam on cap under Bay B

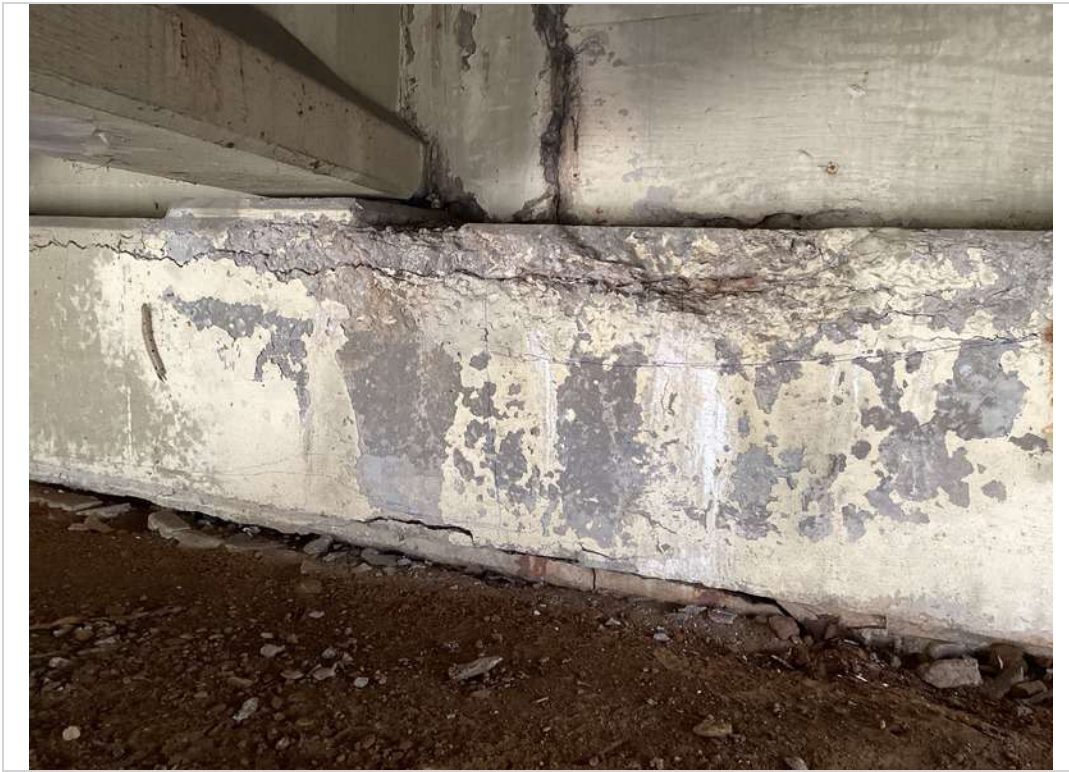
Abutment 1 whole face delam on cap under Beam B and delam and spall on cap under Bay A

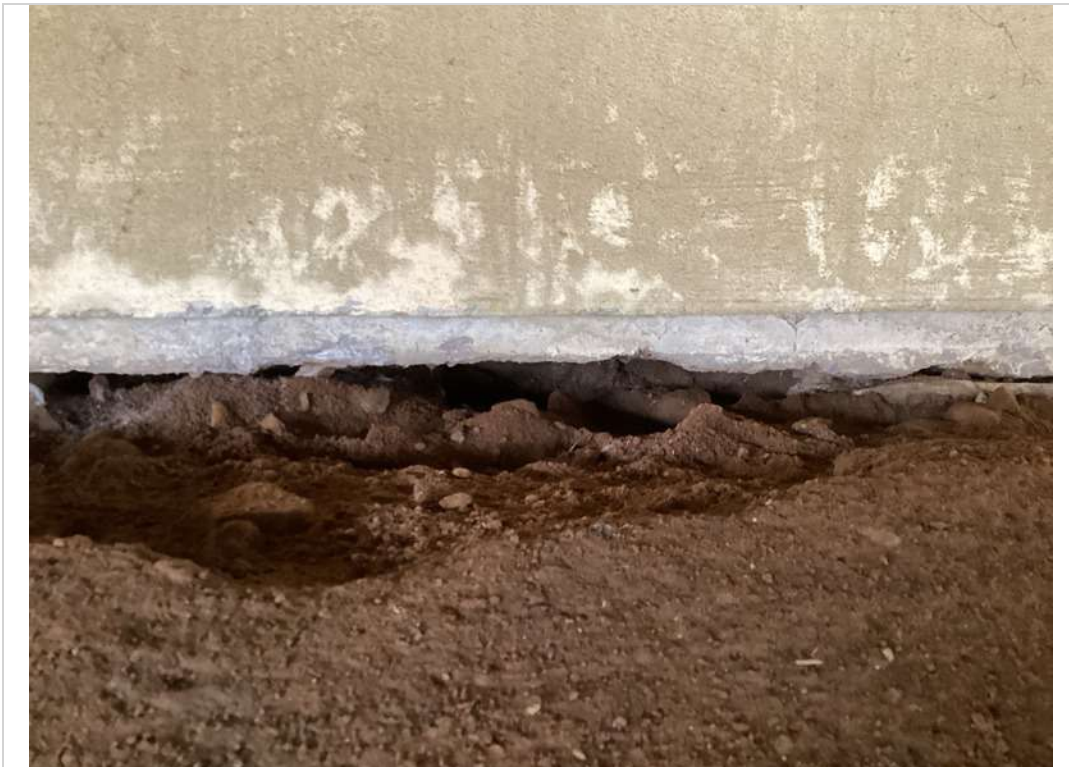
Abutment 1 undermining of cap under Beam C

| Date Added | Recommendation | Priority |
|---|---|---|
| 02/21/2023 | REPAIR EMBANKMENT SETTLEMENT AT ABUTMENT NO. 1 | 3 |

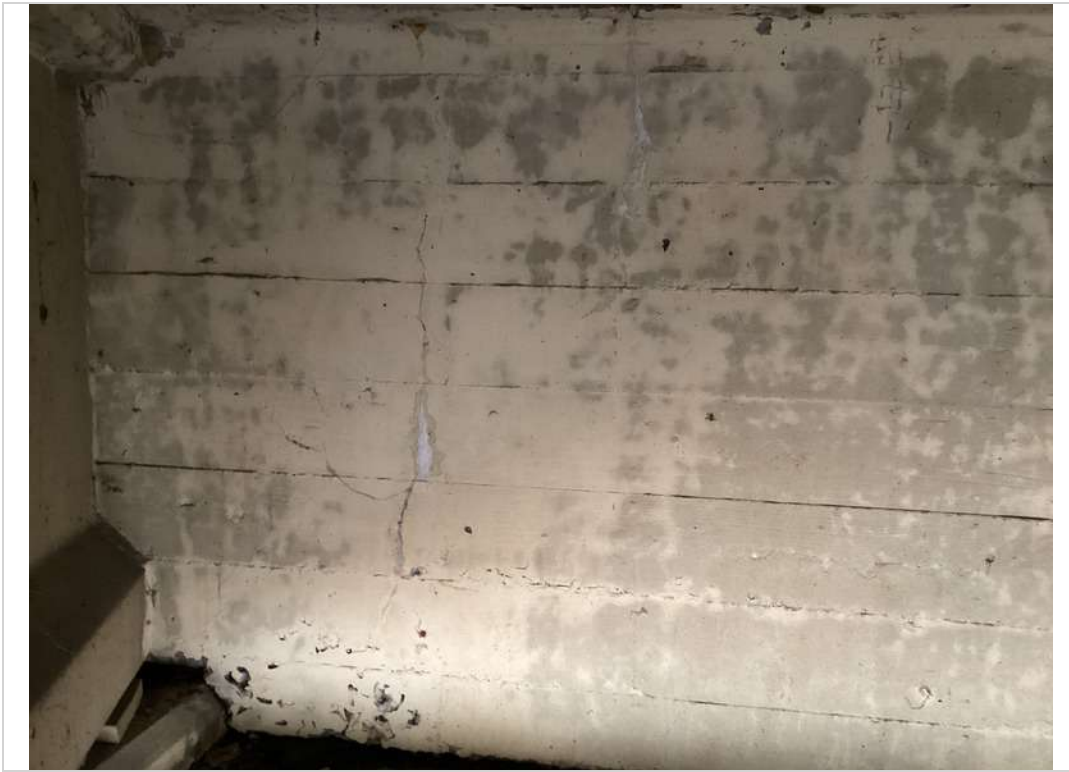
Abutment 1 HL cracks w/ eff on backwall under Bay C

| Date Added | Recommendation | Priority |
|---|---|---|
| 02/14/2025 | Repair the backwalls at Abutments 1 and 2. | 3 |

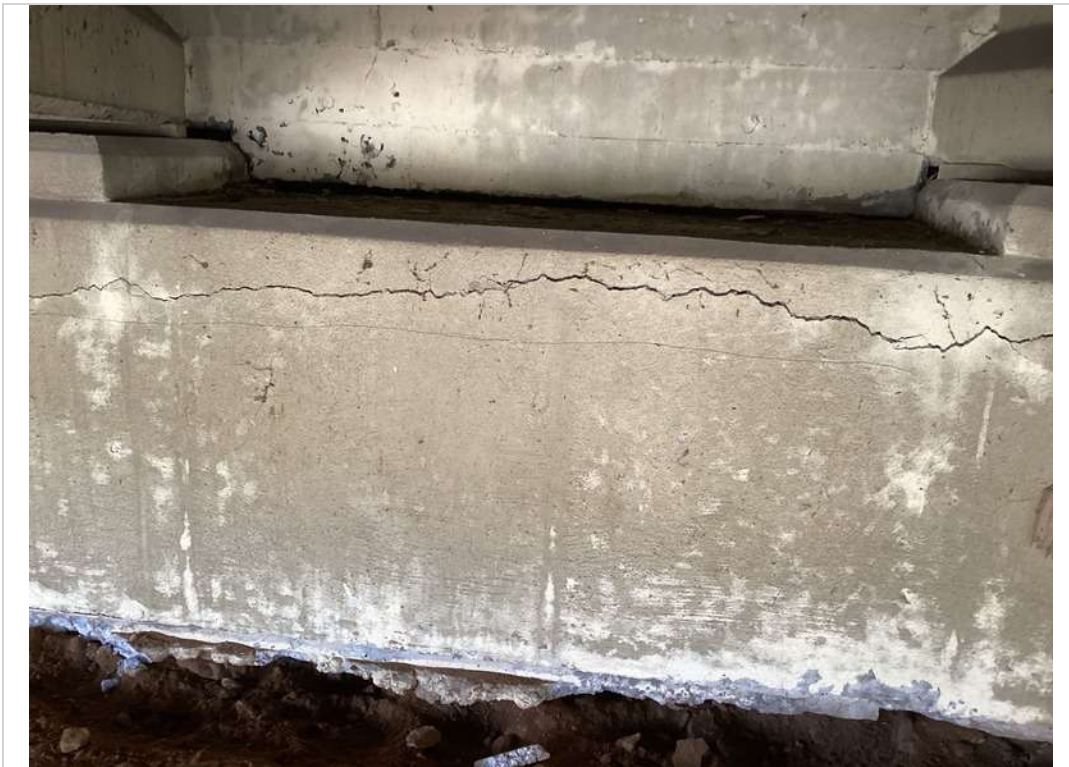
Abutment 1 delam on cap under Bay C

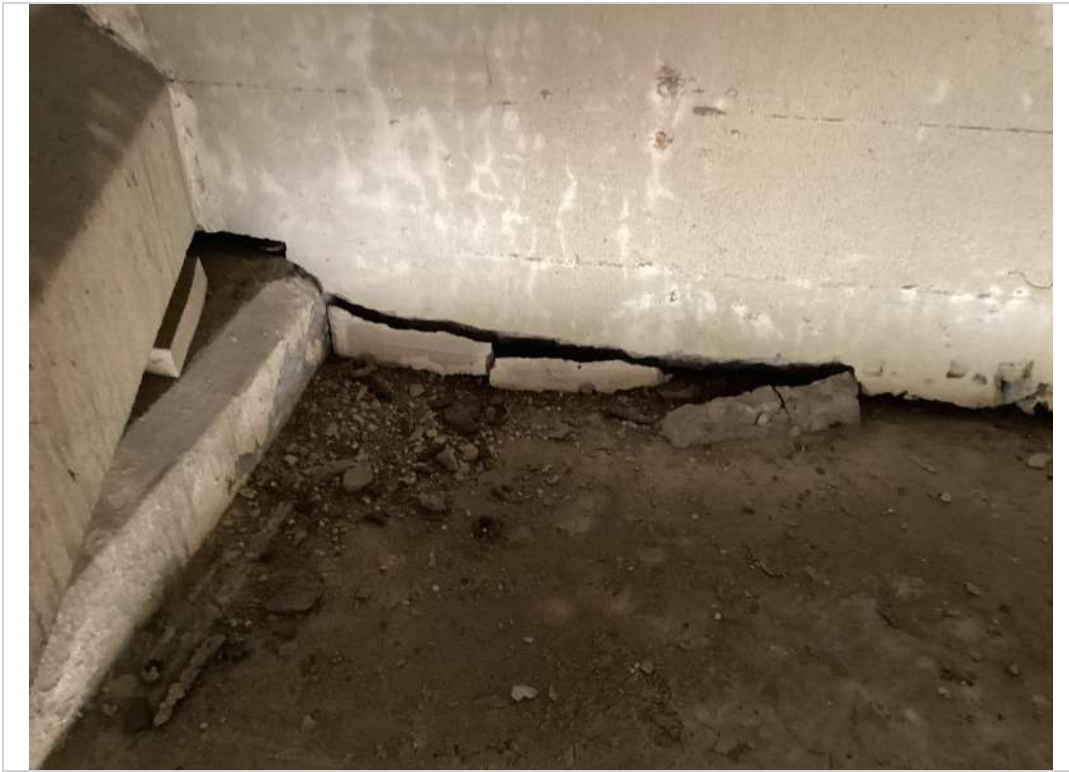
Abutment 1 spall on backwall under Bay D

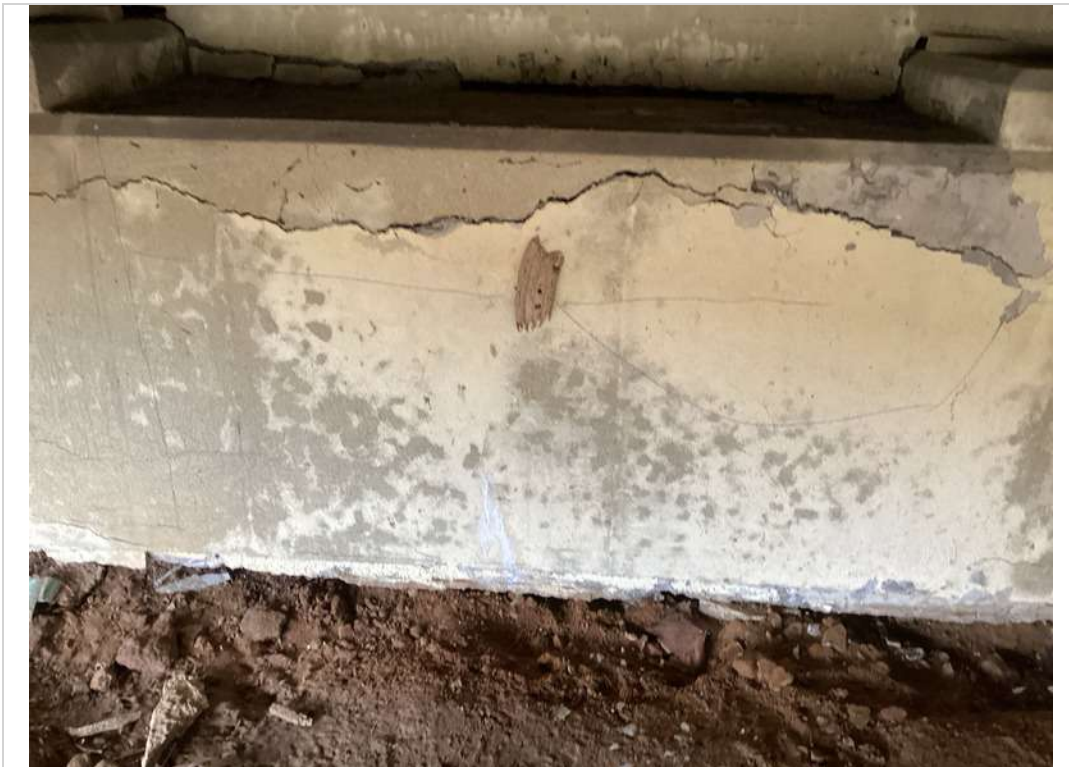
Abutment 1 delam on cap under Bay D

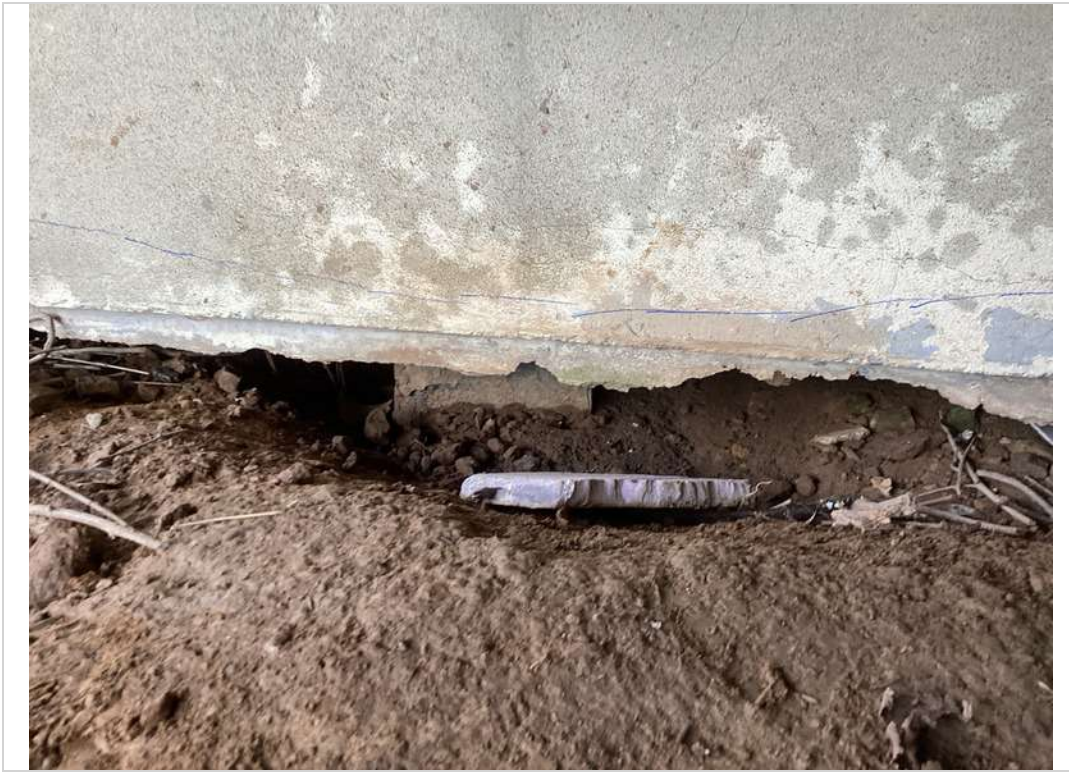
Abutment 1 undermining of cap w/ exposed pile w/ laminar corrosion under Bay E

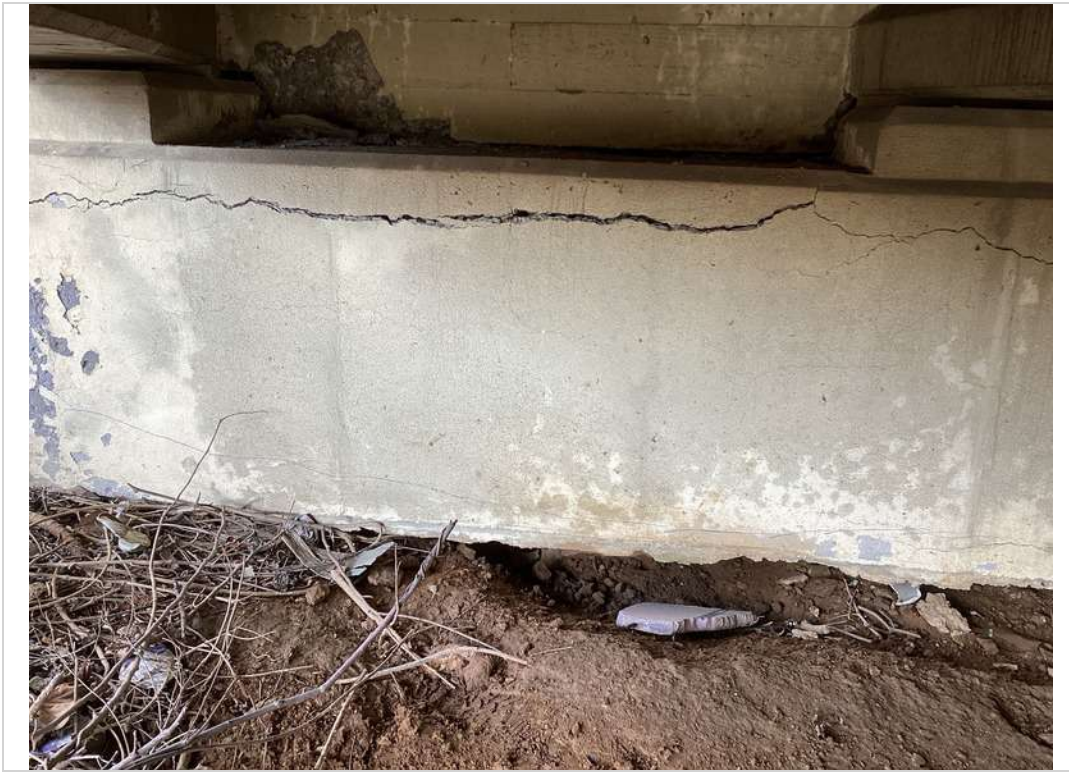
Abutment 1 delam on cap under Bay E

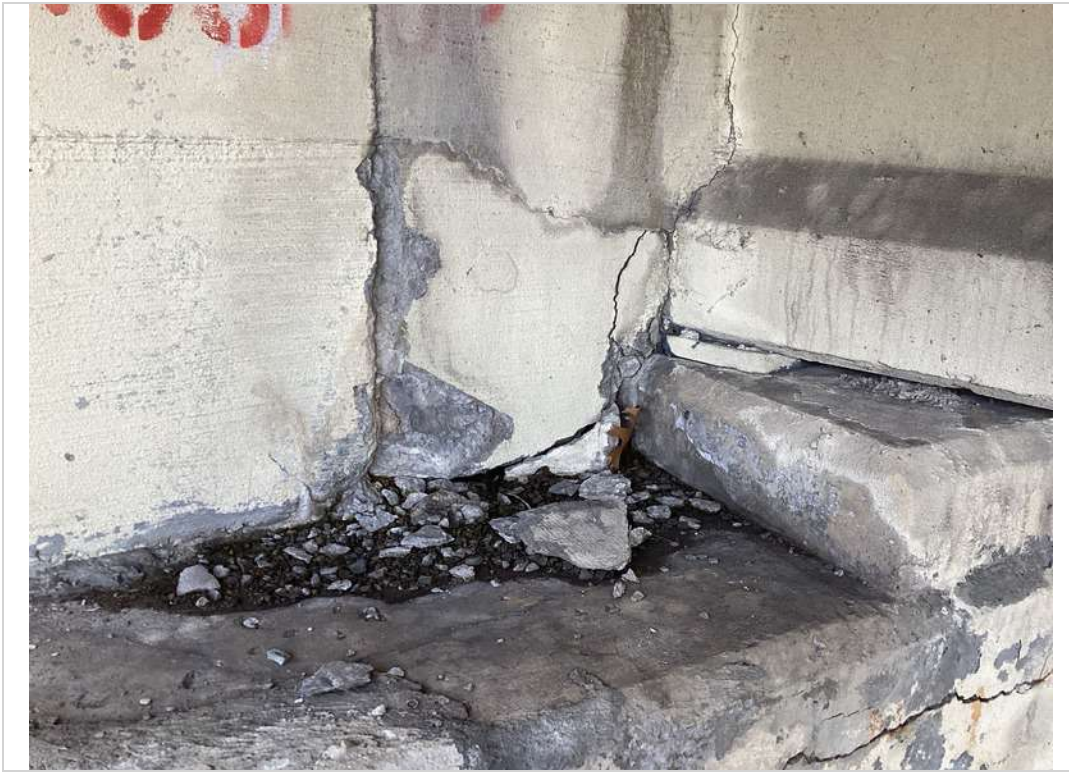
Abutment 1 spalls on backwall under right overhang

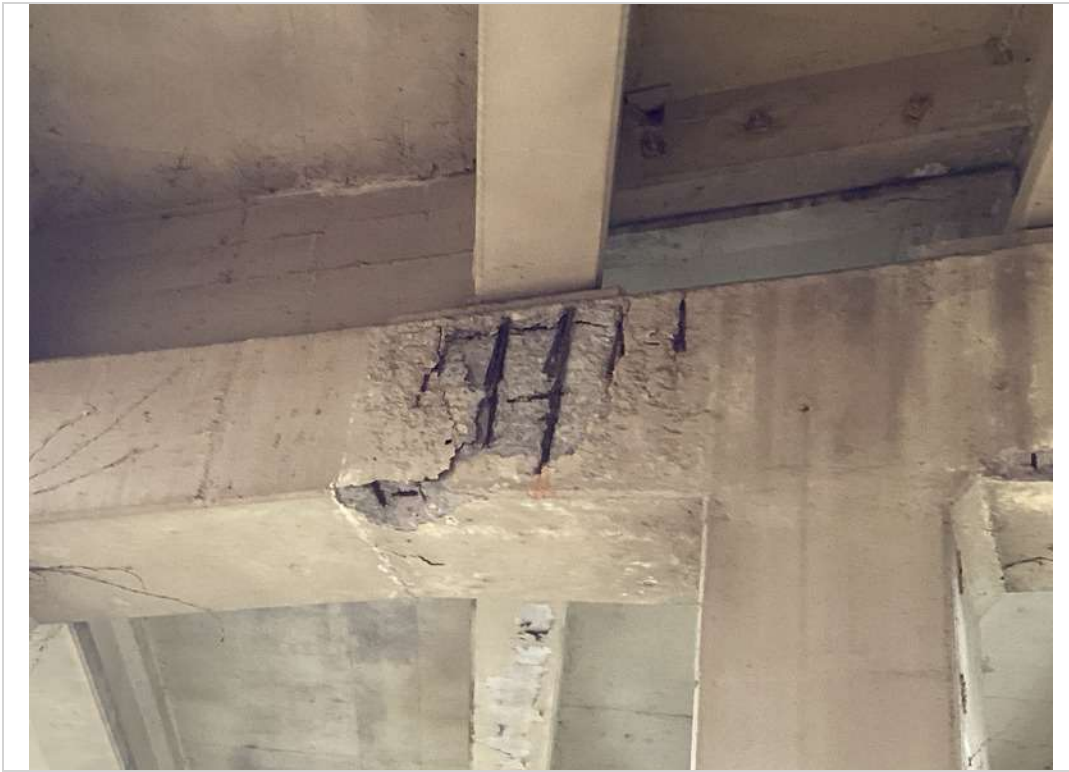
Bent 1 spall w/ exposed rebar on front of cap under Beam B

| Date Added | Recommendation | Priority |
|---|---|---|
| 02/04/2021 | REPAIR CAPBEAM AT BENTS NO. 1 AND 2 | 2 |

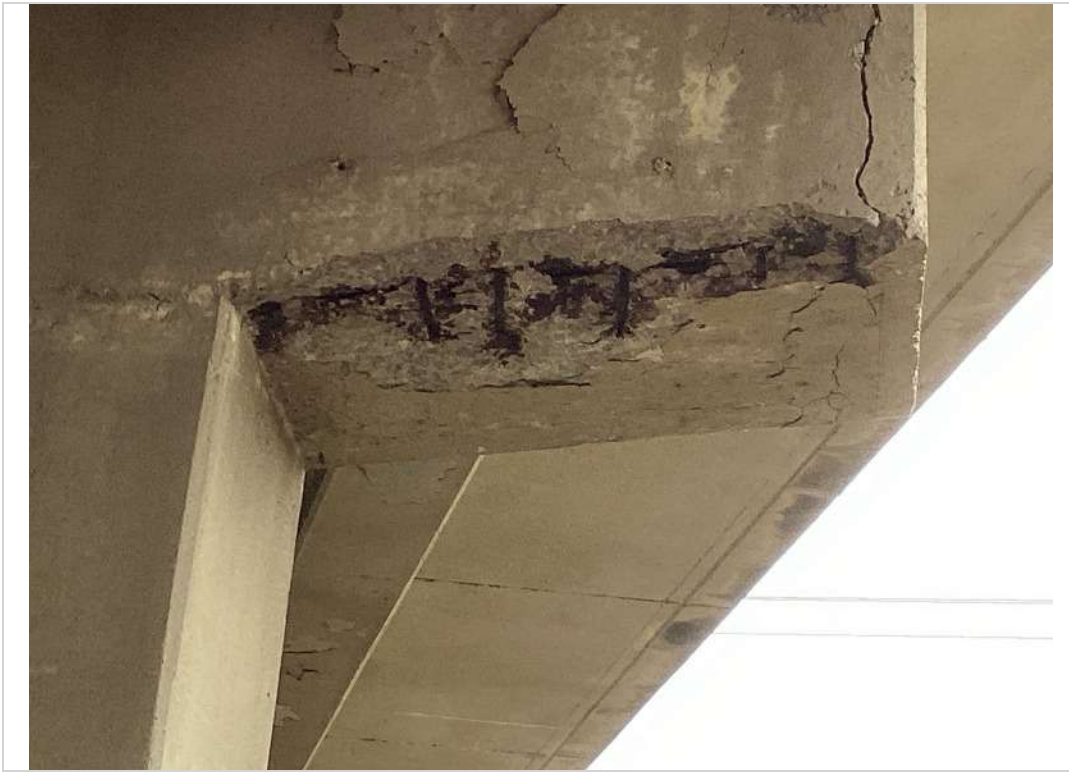
Bent 1 spall w/ exposed rebar on underside of cap to the right of Column C

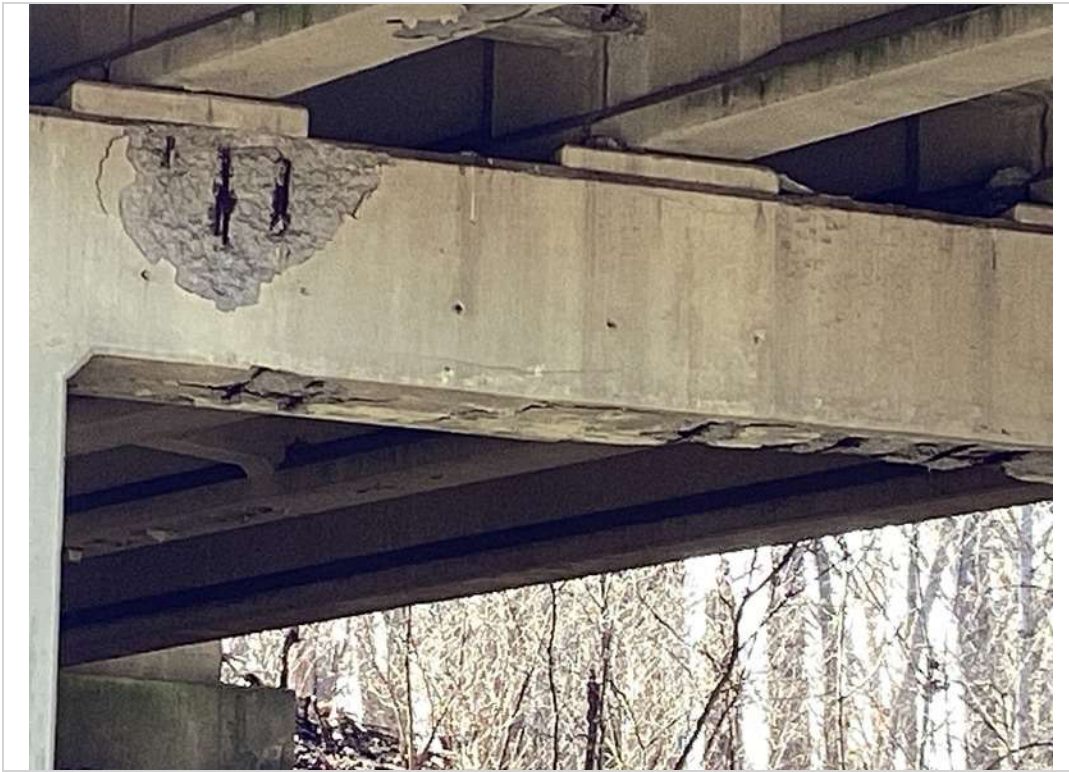
Bent 1 1/16" crack in back of cap

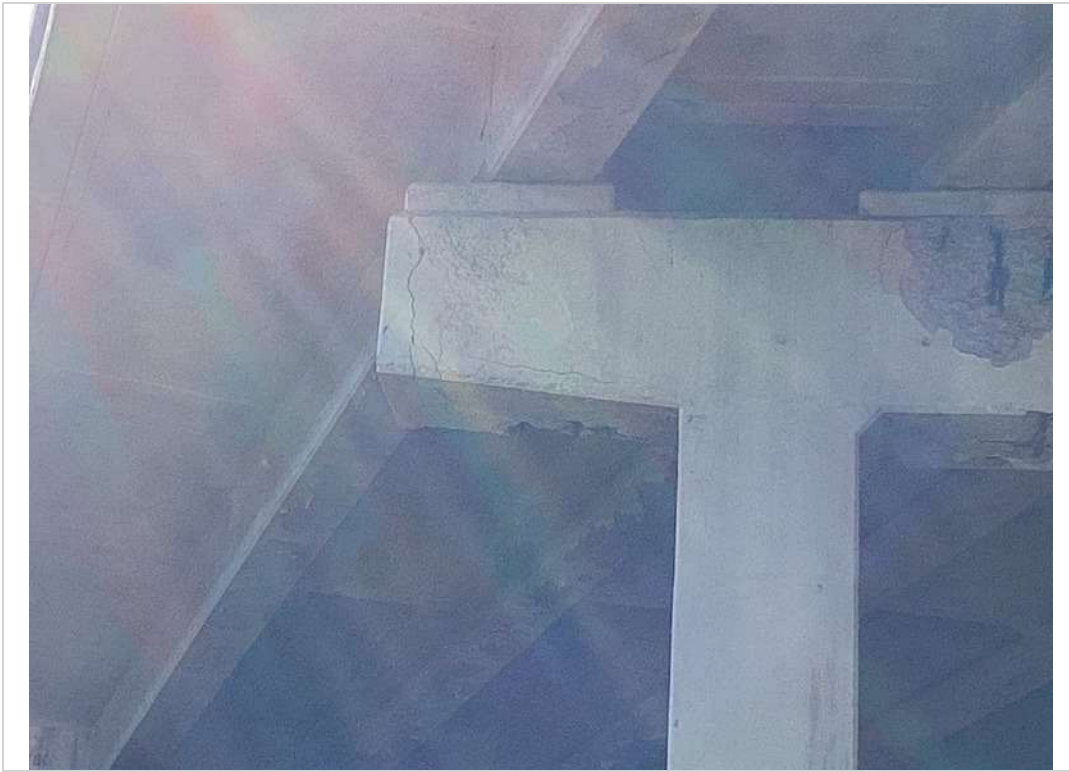
Bent 1 moderate cracks at right end and bottom of cap

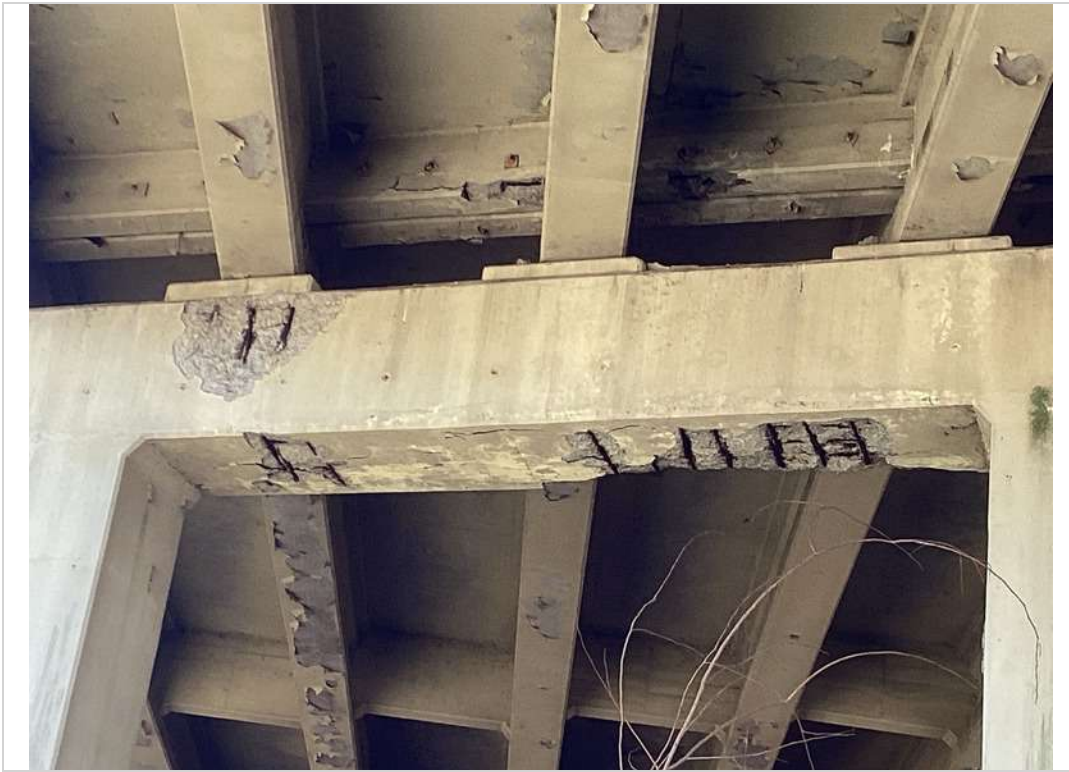
Bent 1 spalls w/ exp. rebar on back and bottom faces of cap

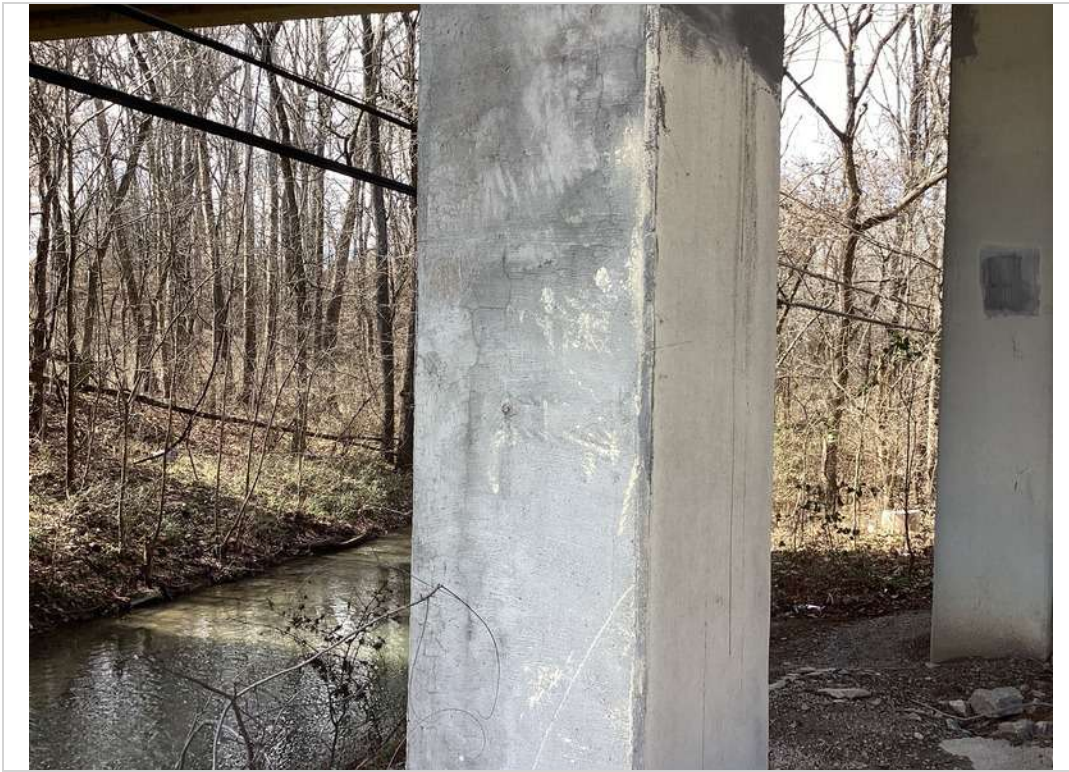
Bent 2 HL map cracking in right face of Column C

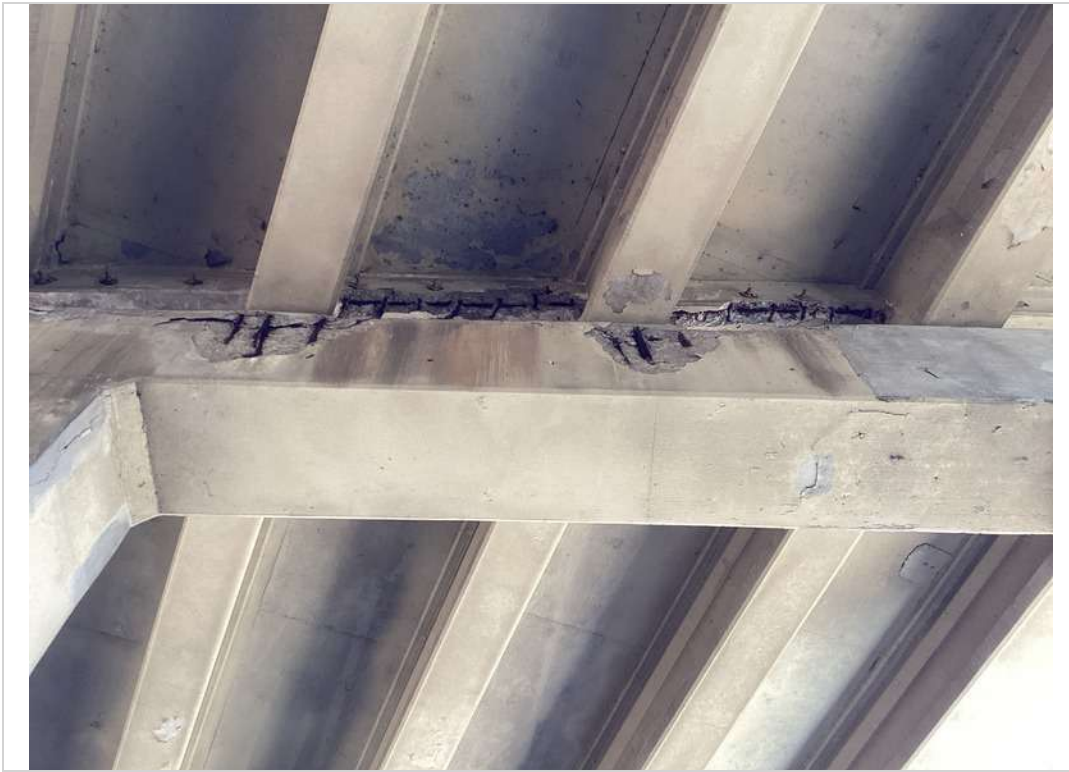
Bent 2 spalls w/ exposed rebar in front face of cap

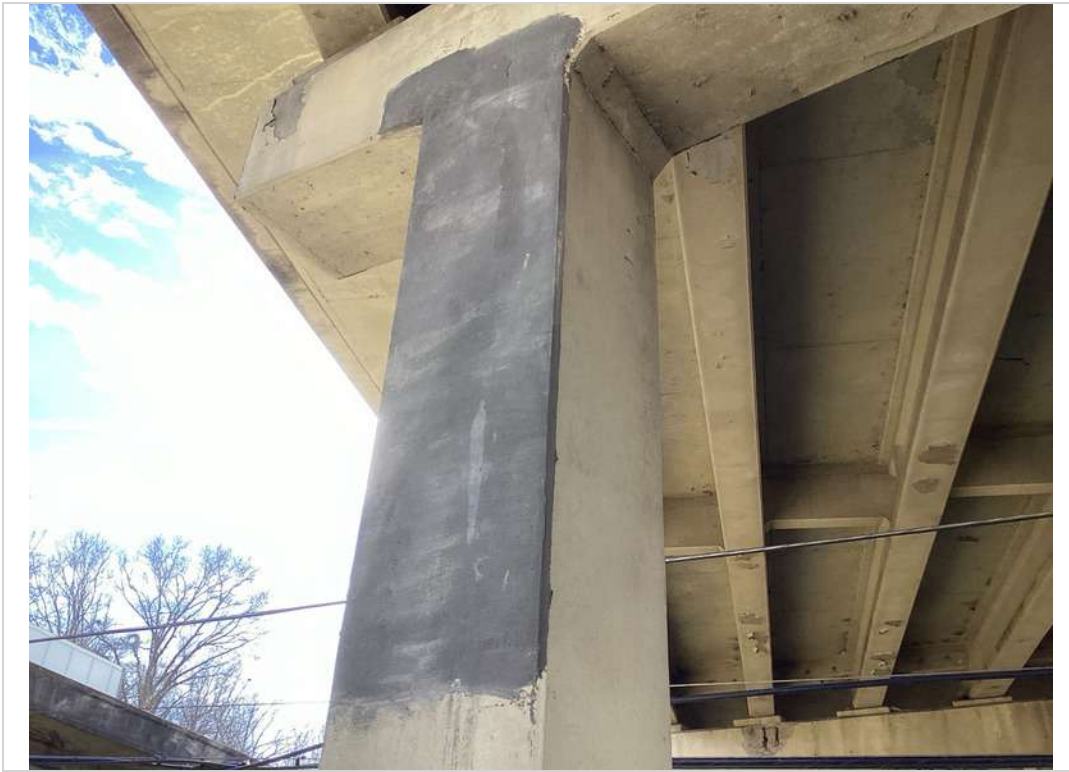
Bent 2 patch with HL cracks on back face of Column C

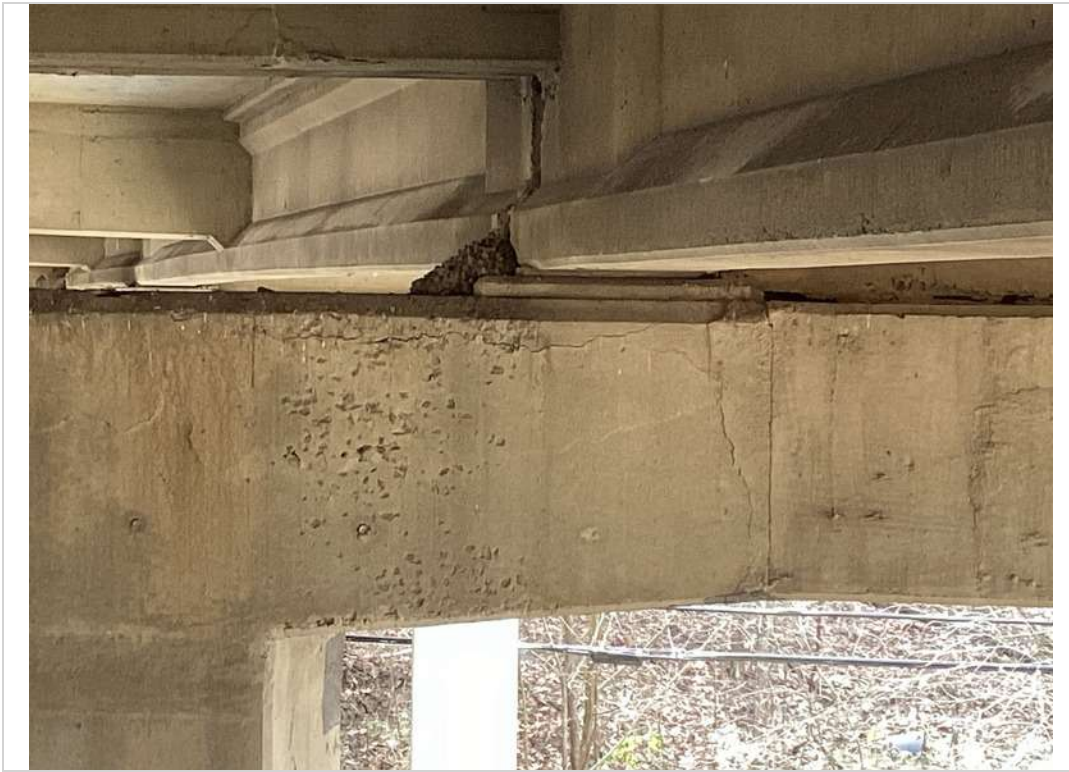
Bent 3 delam and HL crack in back of cap under Beam B

| Date Added | Recommendation | Priority |
|---|---|---|
| 02/14/2025 | Repair Cap and Columns A & B in Bent 3 | 3 |

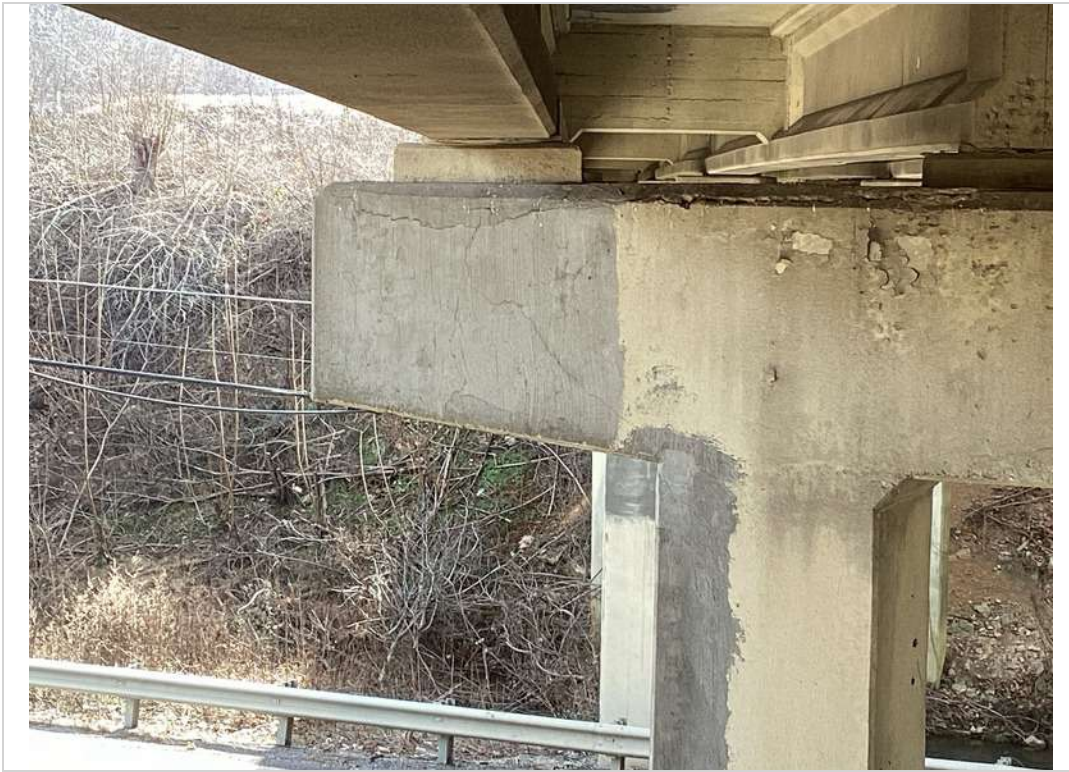
Bent 3 HL map cracking in back of cap to the right of Column C

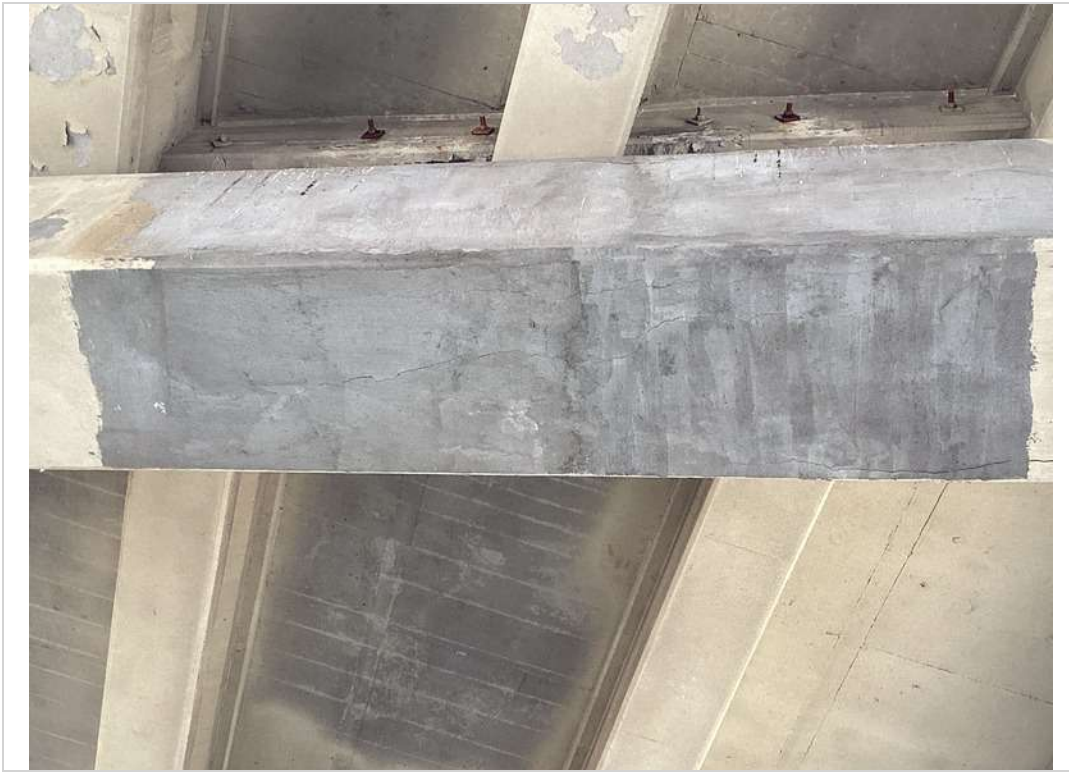
Bent 3 delam in patch on underside of cap between Columns B and C

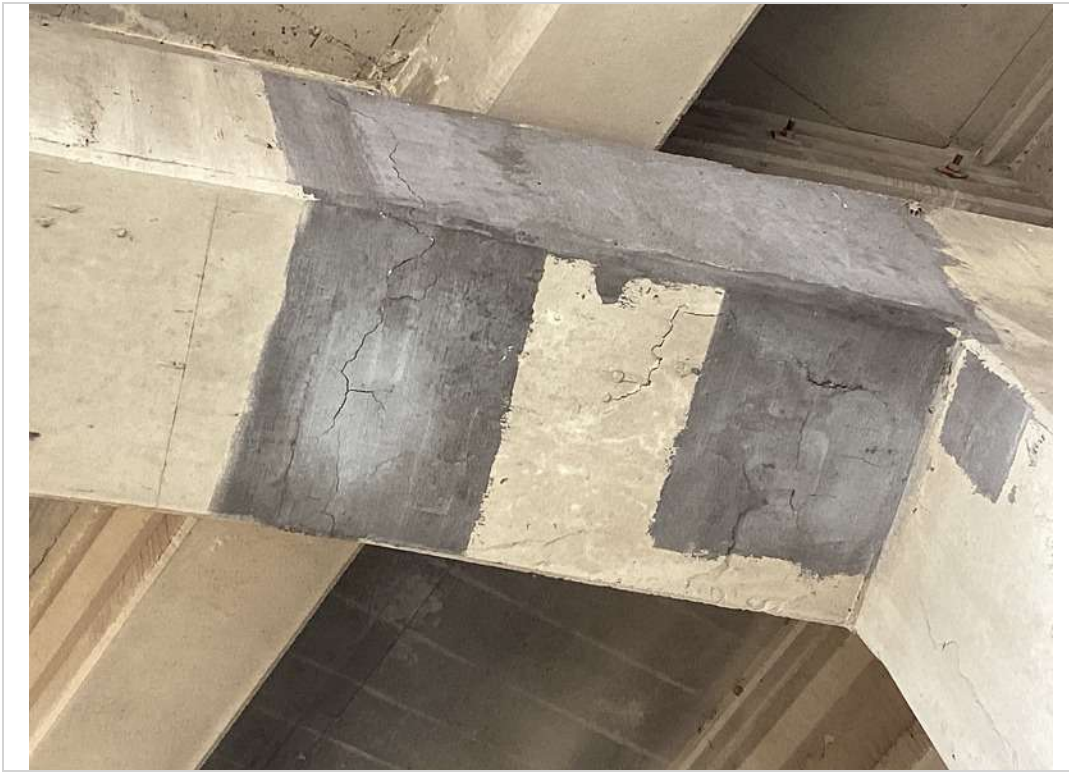
Bent 3 delam and moderate cracks on underside of cap between Columns A and B

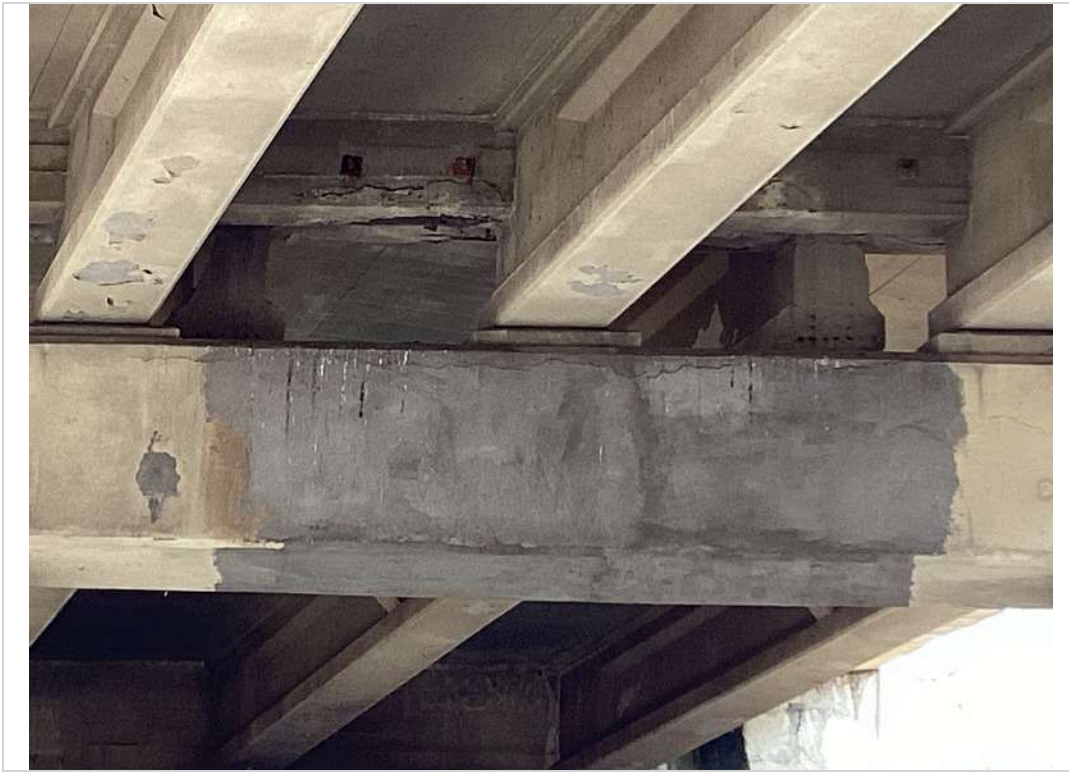
Bent 3 mod crack through patch on front of cap

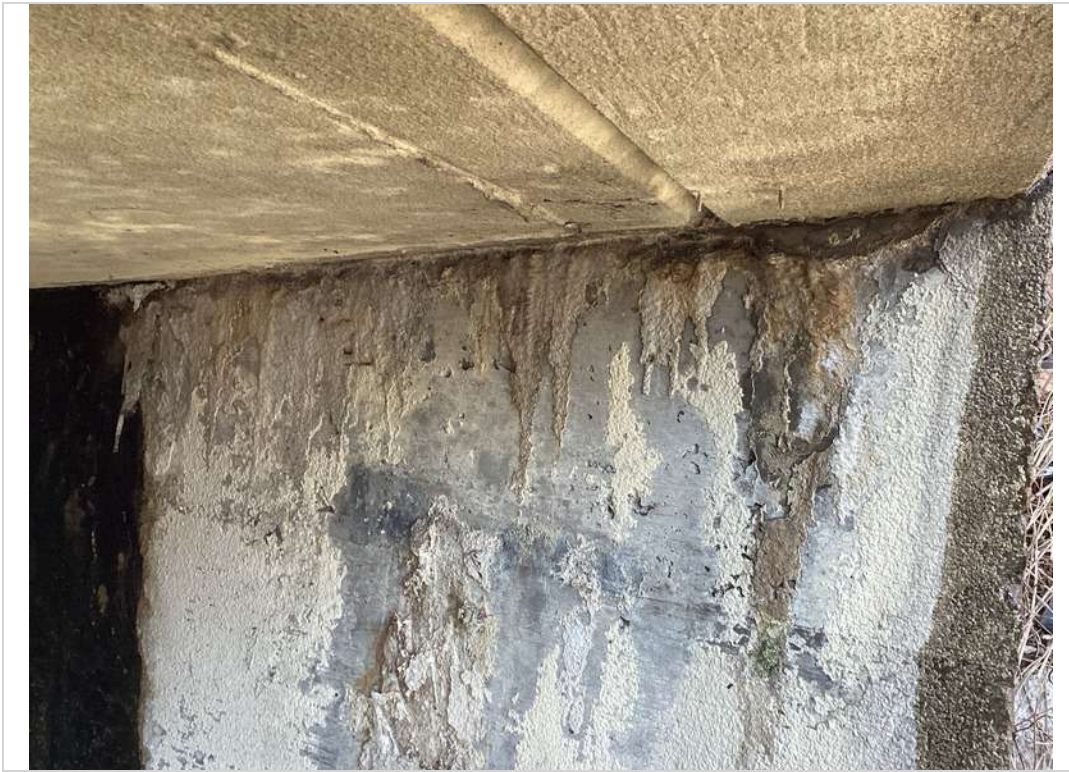
Abutment 2 heavy eff on backwall under right overhang

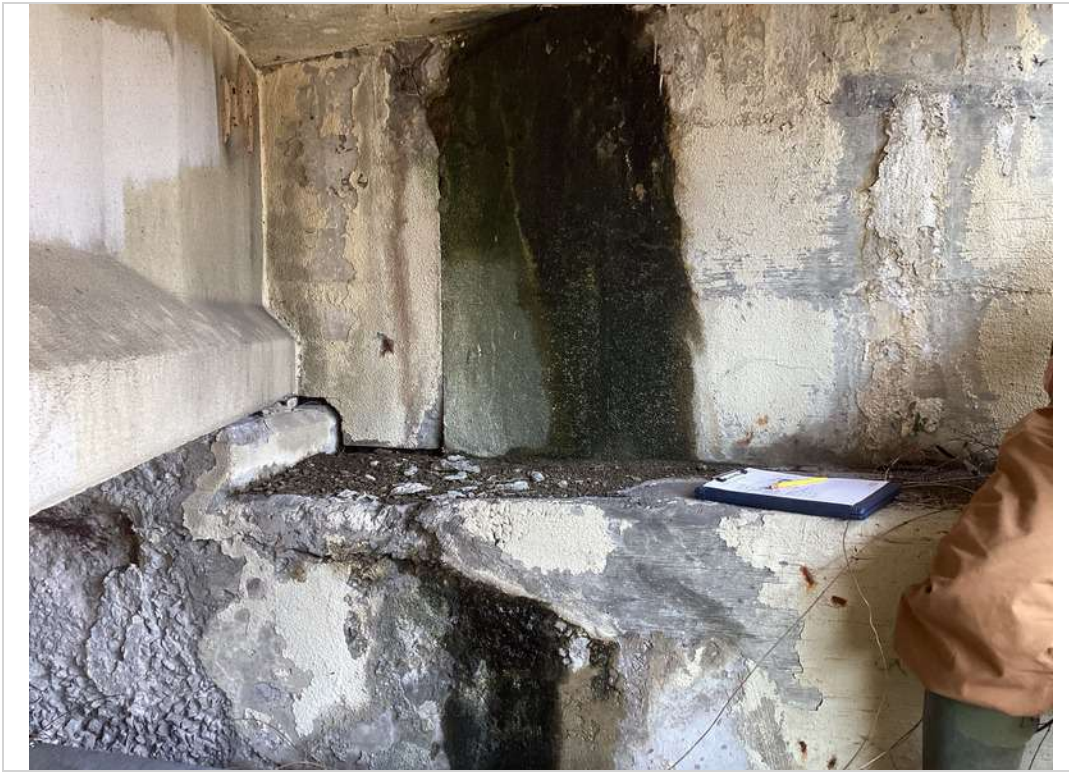
Abutment 2 water leakage and staining of backwall and cap under right overhang

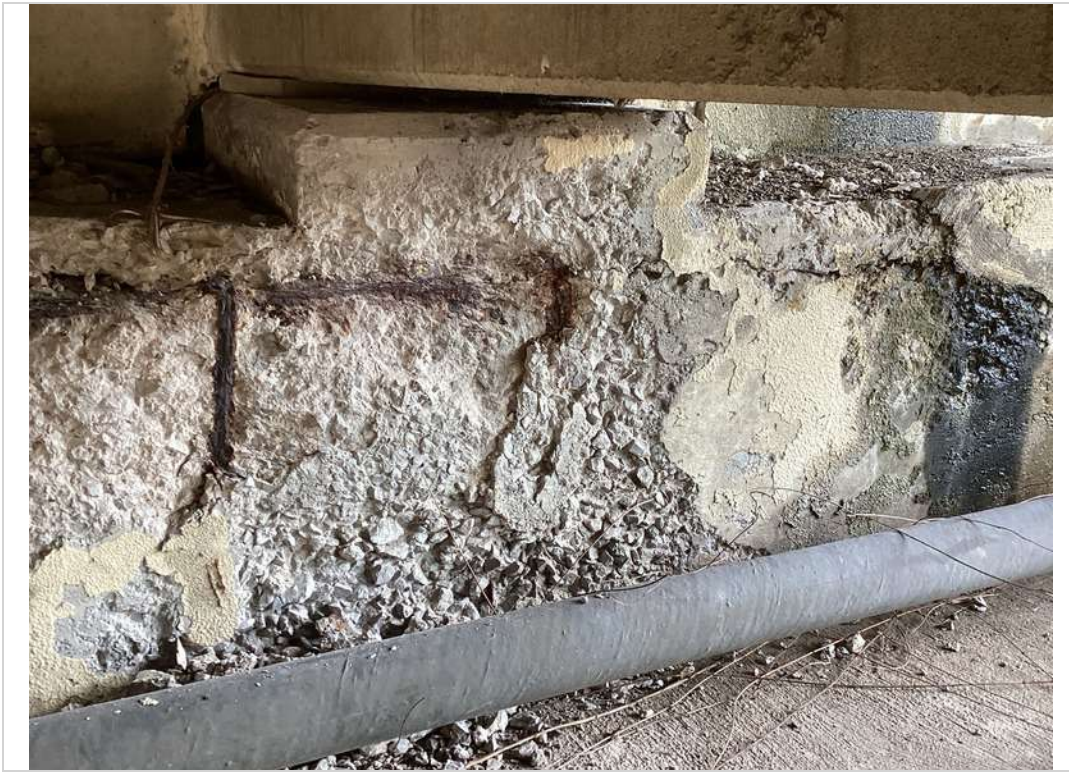
Abutment 2 spalling w/ exposed rebar on cap under Beam E
