I-65 Crossing I65 / SR106 & HARPETH RV

90 - LAST INSPECTION DATE 02/14/2025

| IDENTIFICATION | |
|---|---|
| (8) Structure Number | 94I00650006 |

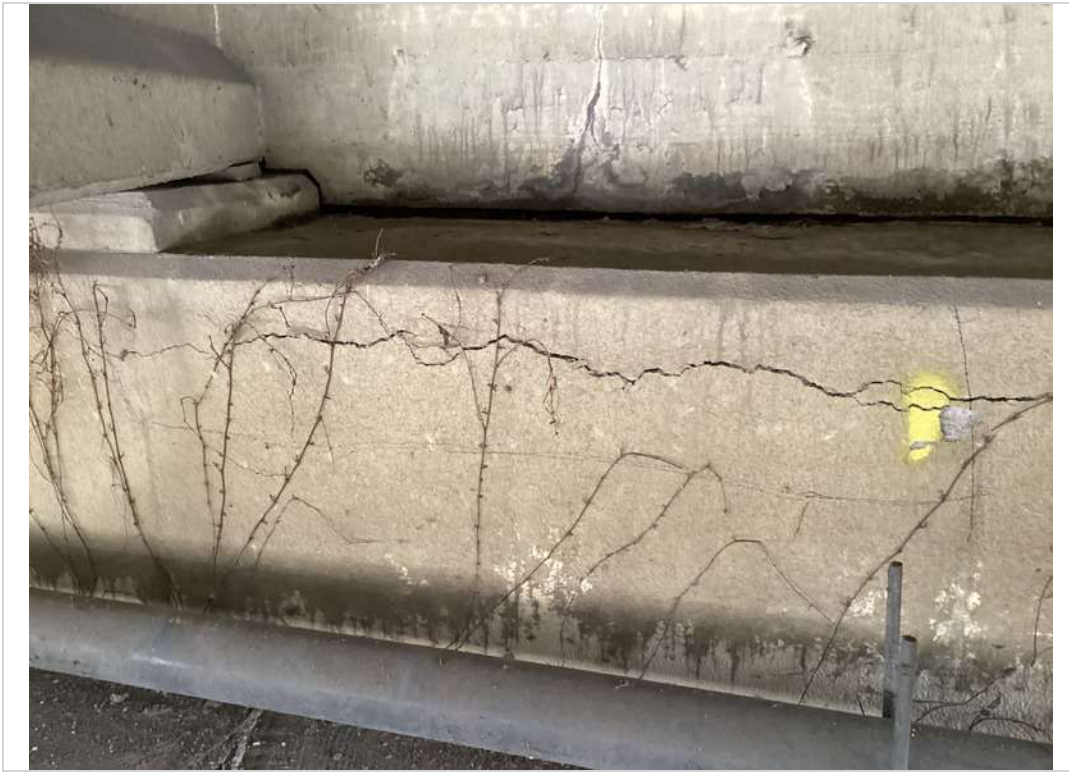
Abutment 2 delam on cap under Bay C

| Date Added | Recommendation | Priority |
|---|---|---|
| 02/04/2021 | REPAIR CAPBEAM AT ABUTMENT NO. 1 AND 2 | 2 |

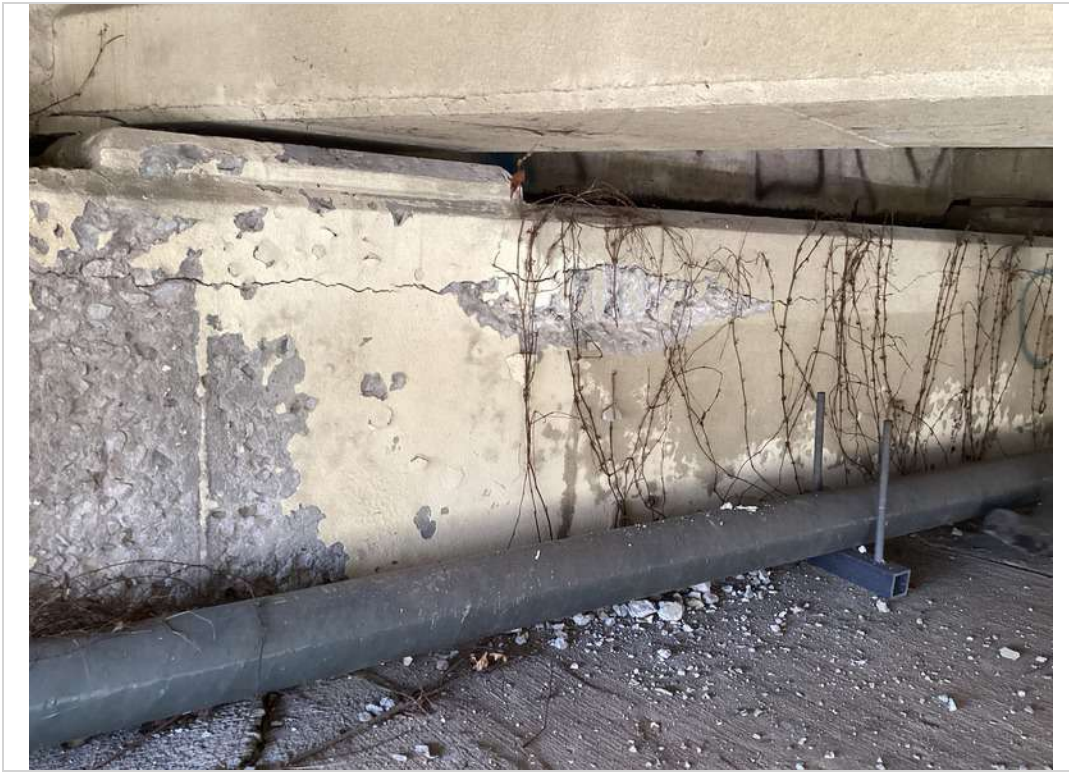
Abutment 2 spalling and wide crack on cap under Bay B

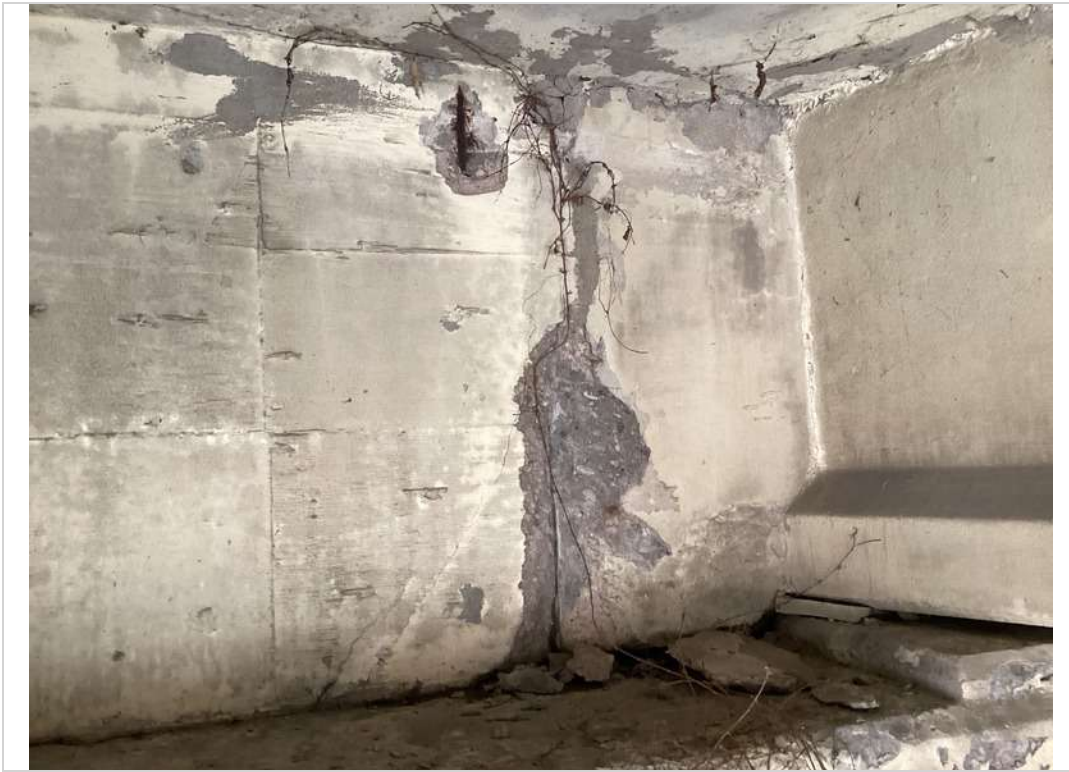
Abutment 2 spalls w/ exposed rebar in backwall of Bay A

| Date Added | Recommendation | Priority |
|---|---|---|
| 02/14/2025 | Repair the backwalls at Abutments 1 and 2. | 3 |

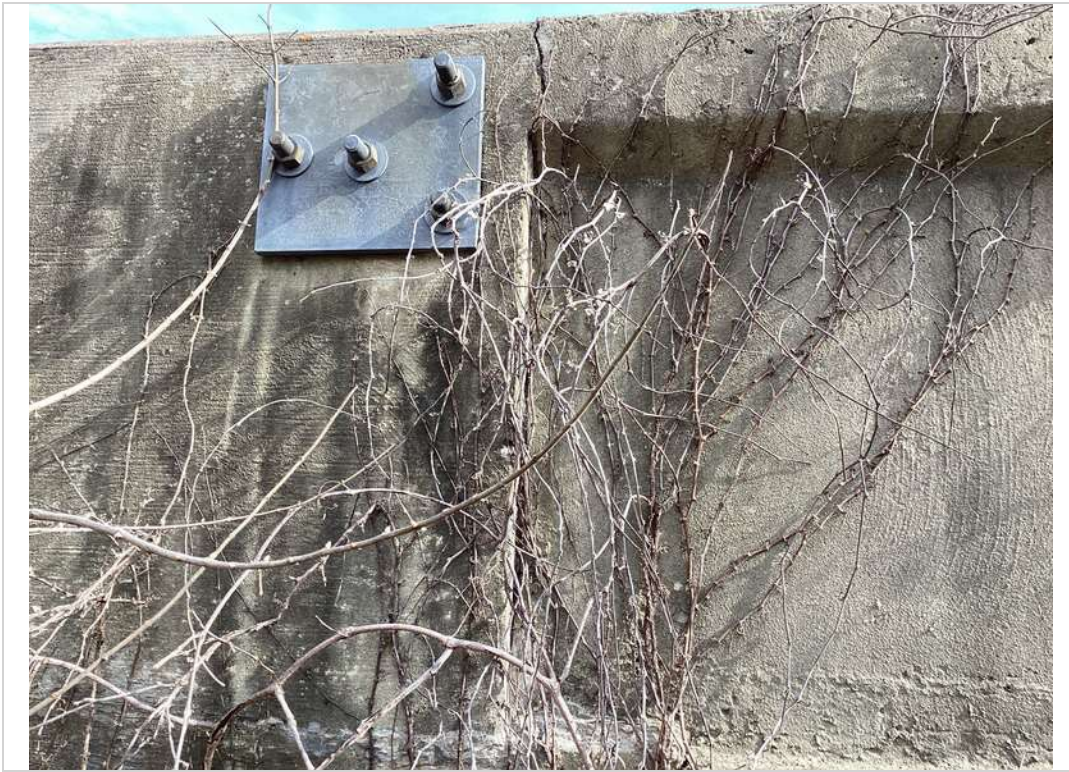
Abutment 2 1/16" crack in parapet over left wingwall

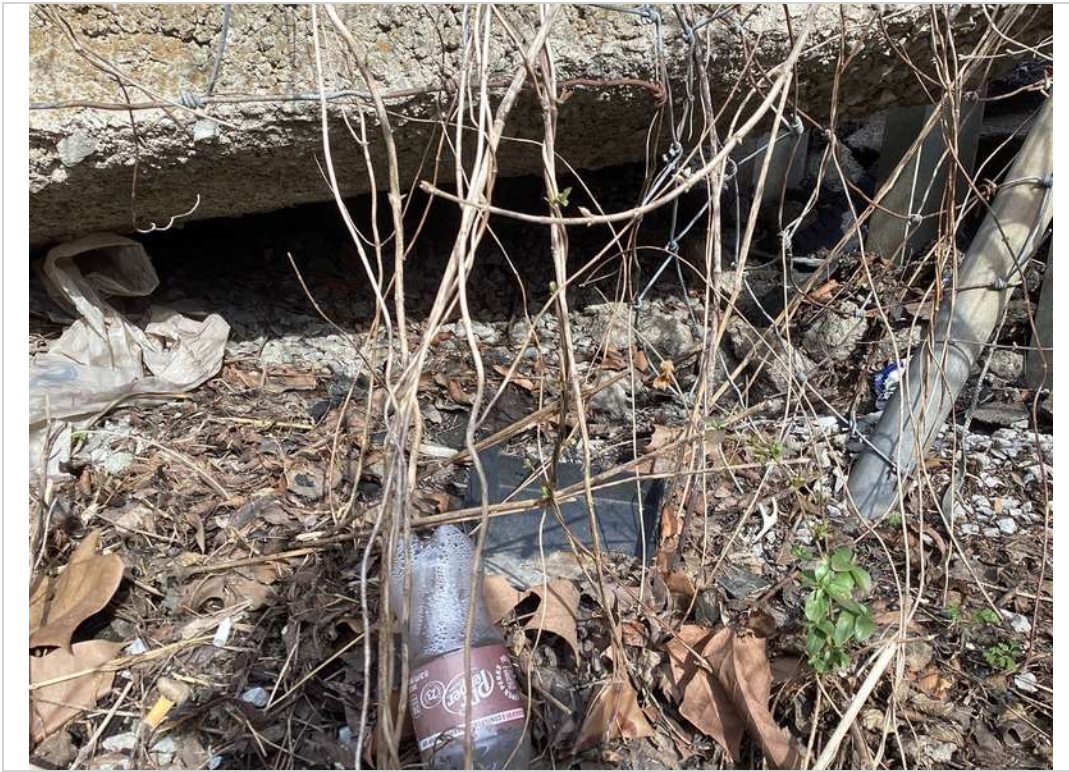
Approach 2 left concrete embankment drain is cracked and heavily undermined.

Abutment 2 undermining of left embankment drain

| Date Added | Recommendation | Priority |
|---|---|---|
| 02/21/2023 | REPAIR APPROACH DRAIN AT APPROACH NO. 2, LEFT SIDE | 3 |
