# Bridge Maintenance Recommendations

Bridge Location No.: 94 - I0065 - 4.79 L

Crossing: SR 106&HARPETH RIVER

INSPECTION TEAM'S SUMMARY  
BRIDGE NUMBER 94-I65-4.79 (LEFT LANE)  
I-65 OVER SR-106 & HARPETH RIVER

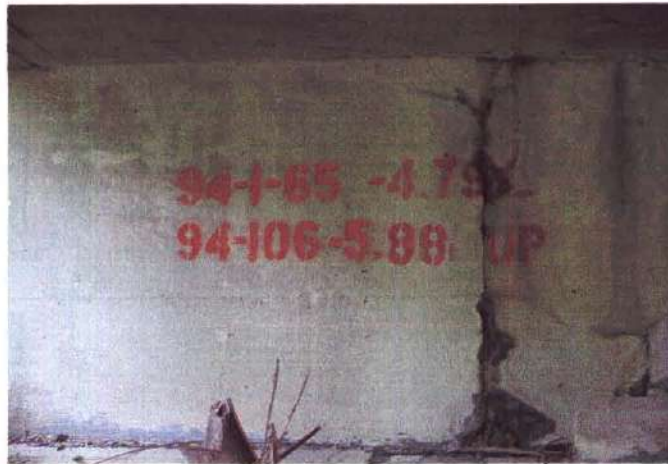
Br. No. Abutment No. 1

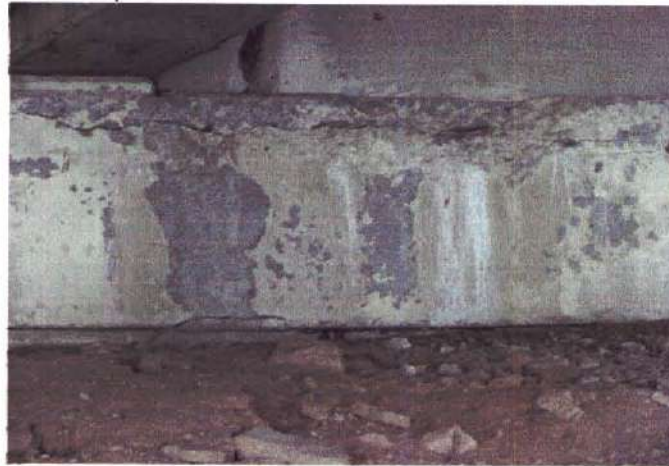
Spall @ Lt. Side of Abutment No. 1

The abutment No. 1 cap is fair to poor with open cracks, heavy spalls, and exposed rebars. The bent cap No. 1 is poor with rebar exposure, popouts open cracks, and delamination. Bent columns in bent No. 1 are poor with delamination, heavy spalls, rebar exposure, and section loss.

REPAIR ABUTMENT CAP NO. 1

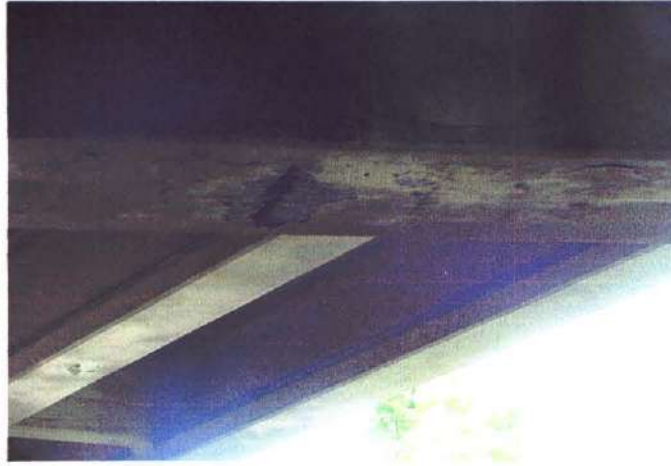
Spall & Rebar, Bottom of Bent Cap No. 1

-0- REPAIR BENT CAP NO. 1

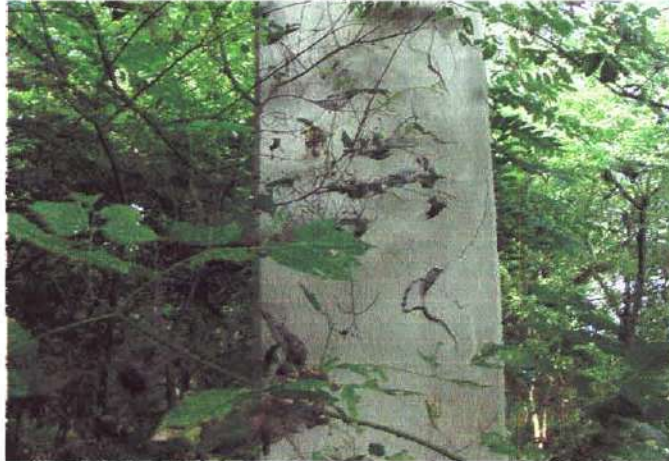
Cracks in Column "B" Bent No. 1

-0- REPAIR COLUMN "B" AND "C" AT BENT NO. 1

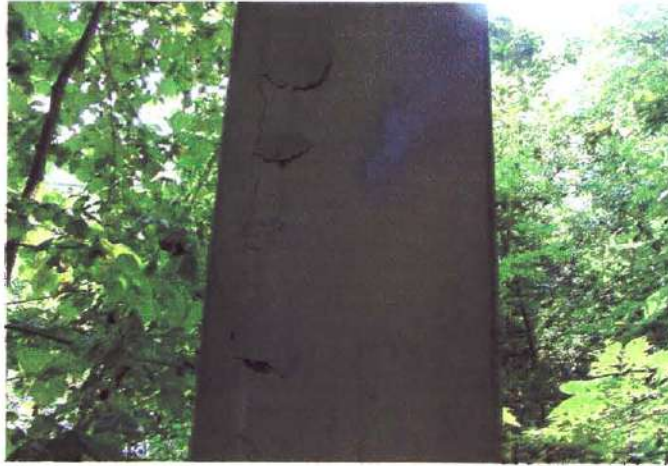
Cracks in Column "C" Bent No. 1

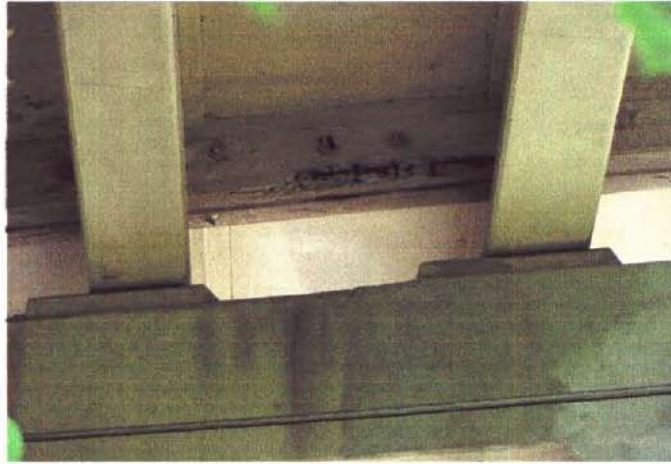
Spall & Rebar in Diaphragm @ Bent No.2

The parapets are fair due to some light cracks. The beams are rated good. The diaphragms are fair to poor with open cracks, spalls, rebar exposure, and section loss.

REPAIR DIAPHRAGMS IN SPANS NO. 1, 2, AND 3

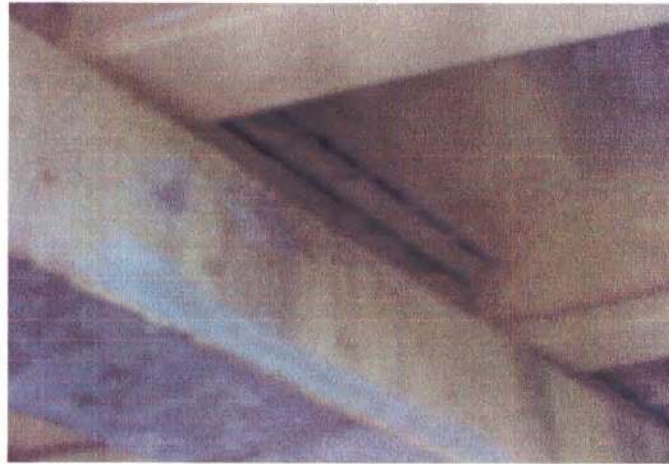
Spall & Rebar in Diaphragm @ Bent No.3

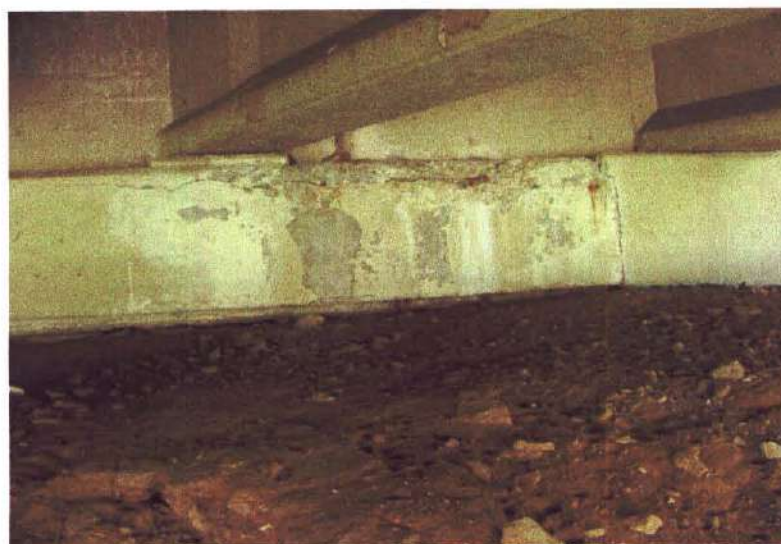
SPALL @ LT. SIDE OF ABUTMENT NO. 1

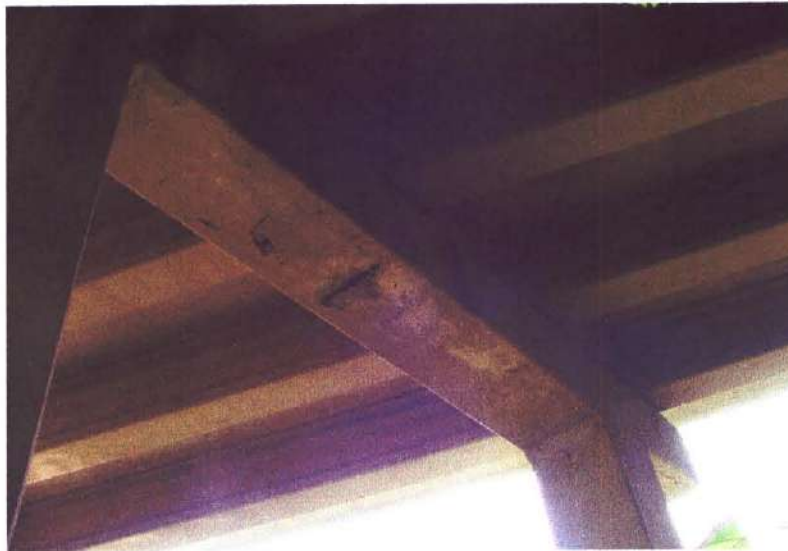
SPALL & REBAR, BOTTOM OF BENT CAP NO. 1

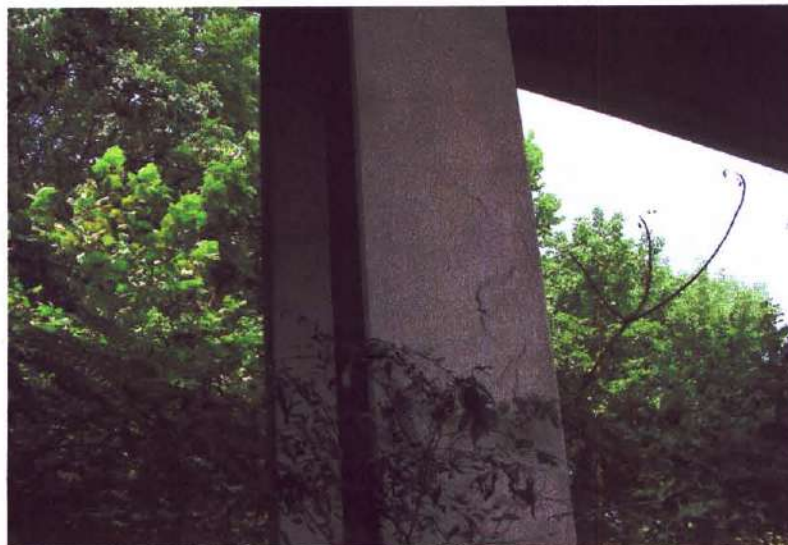
CRACKS IN COLUMN "B", BENT NO. 1

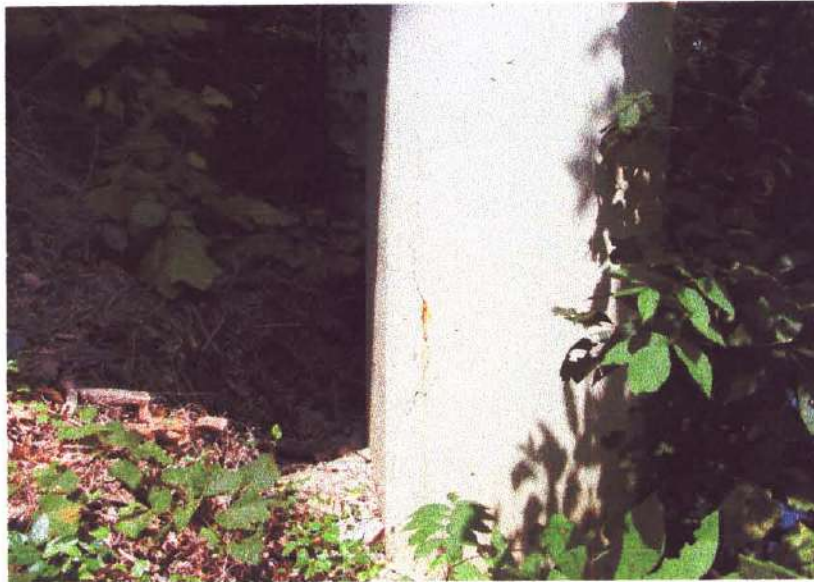
CRACKS IN COLUMN "C", BENT NO. 1

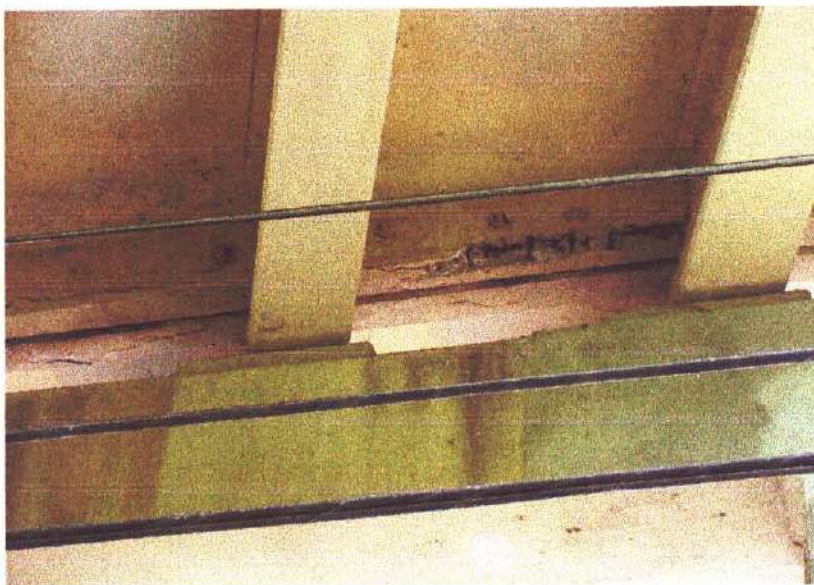
SPALL & REBAR IN DIAPHRAGM @ BENT NO. 2

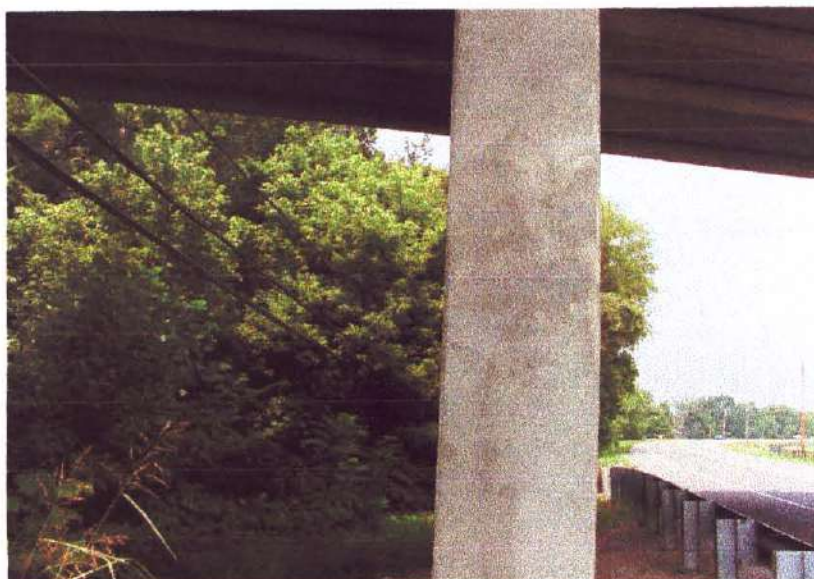
CRACKS, SPALL, & REBAR IN COLUMN "C", BENT NO. 2-REPAIRED

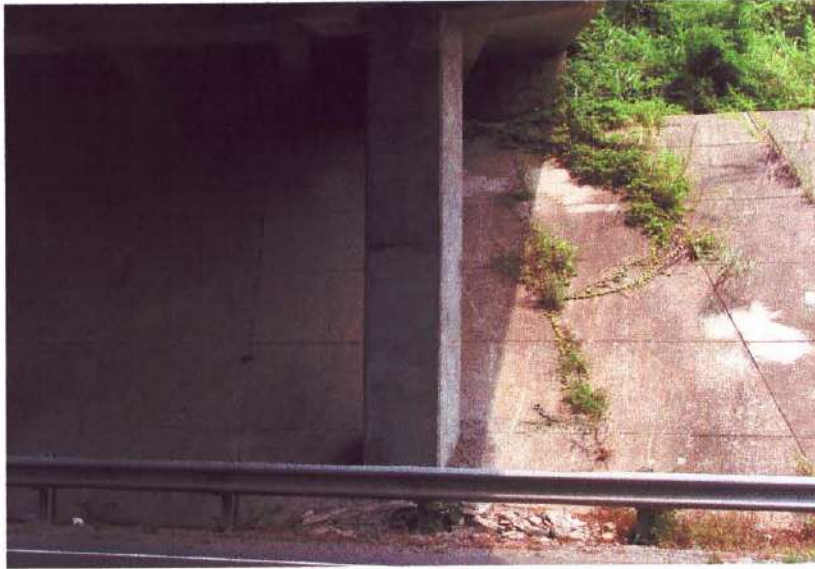
CRACKS, SPALL, & REBAR IN COLUMN "C", BENT NO. 3-REPAIRED

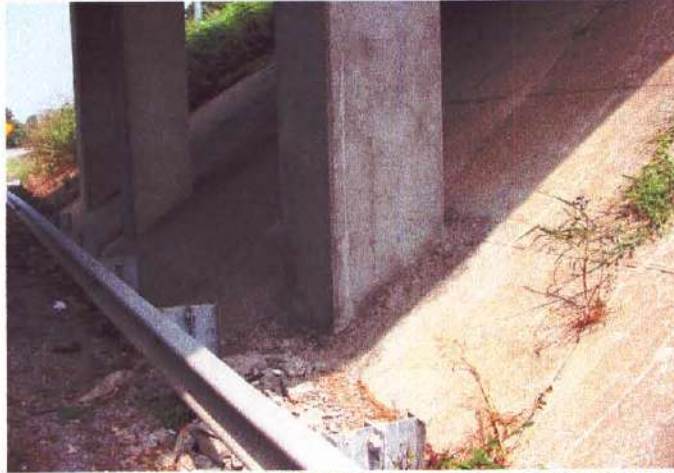
CRACKS & SPALL ON COLUMN "C", BENT NO. 3 @ BOTTOM (REPAIRED)

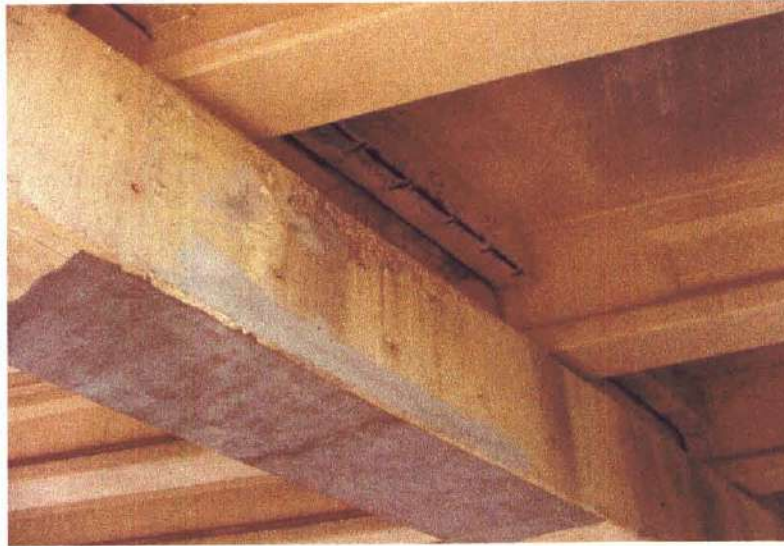
SPALL & REBAR IN DIAPHRAGM, BACK OF BENT NO. 3
