Hamilton County

Cursory Inspection Report

Location: 33-03578-00.80

Inspection Date: April 7, 2022

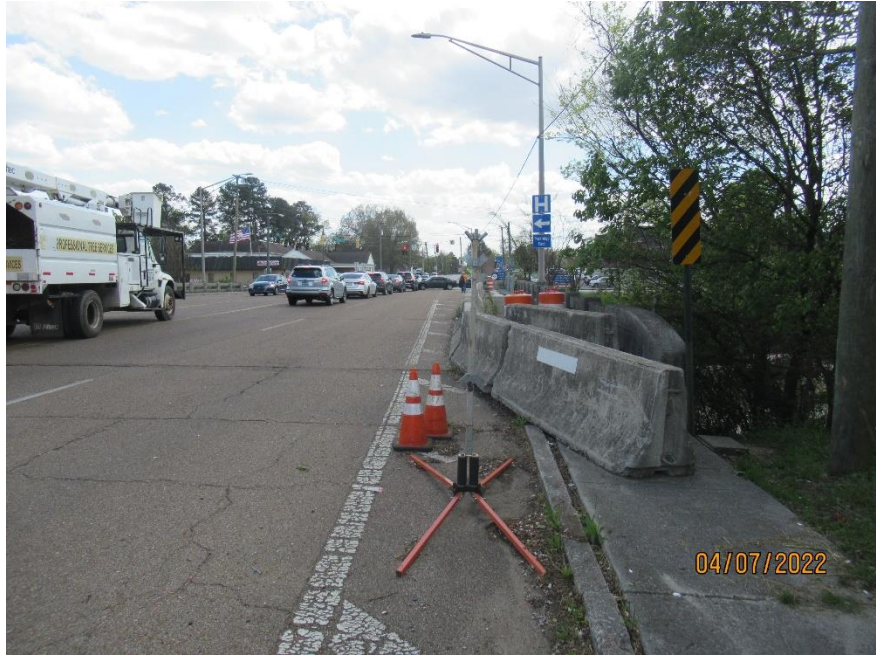
TRAFFIC CONTROL - LOOKING BACK - "SIDEWALK CLOSED" SIGN IS MISSING

Recommendations: Monitor the deck, superstructure, and substructure until permanent repairs have been designed and executed. Tighten sign bolts and monitor sign connections to Beam "B", Span #2. Monitor separation between Beams in Spans No. 1 and No. 4. Replace the missing "Sidewalk Closed" sign at Approach #2.

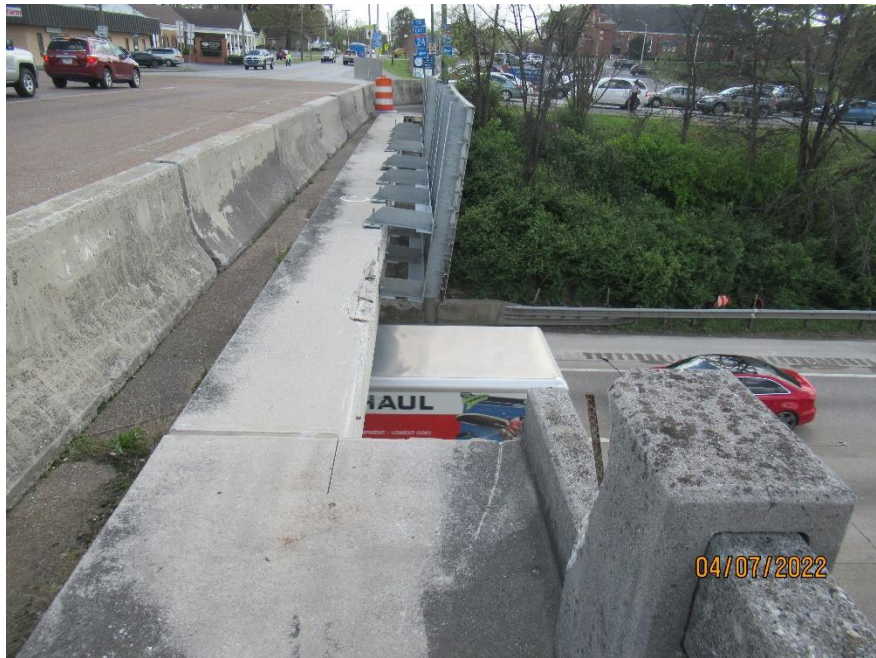
BEAM "A" REMOVED - SPAN #2 - LOOKING AHEAD

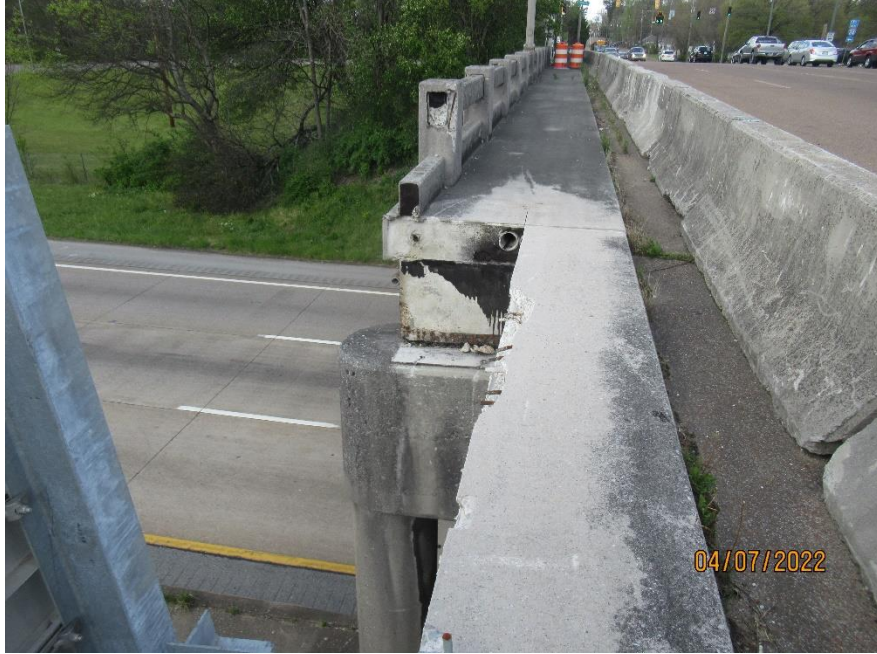
BEAM "A" REMOVED - BENT #2

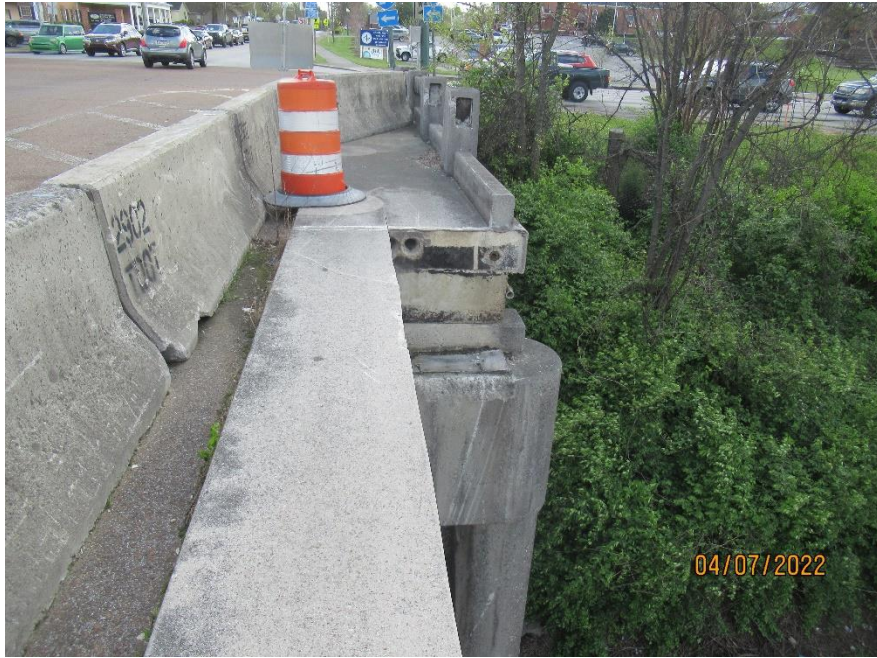
BEAM "A" REMOVED - BENT #1

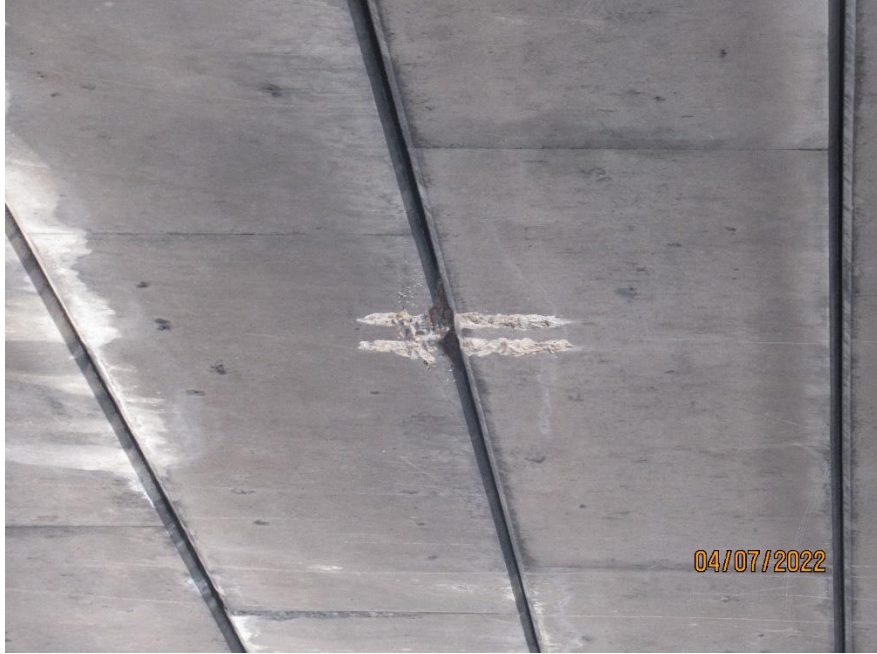
SPALLED BEAMS - "F" AND "G" - SPAN #2

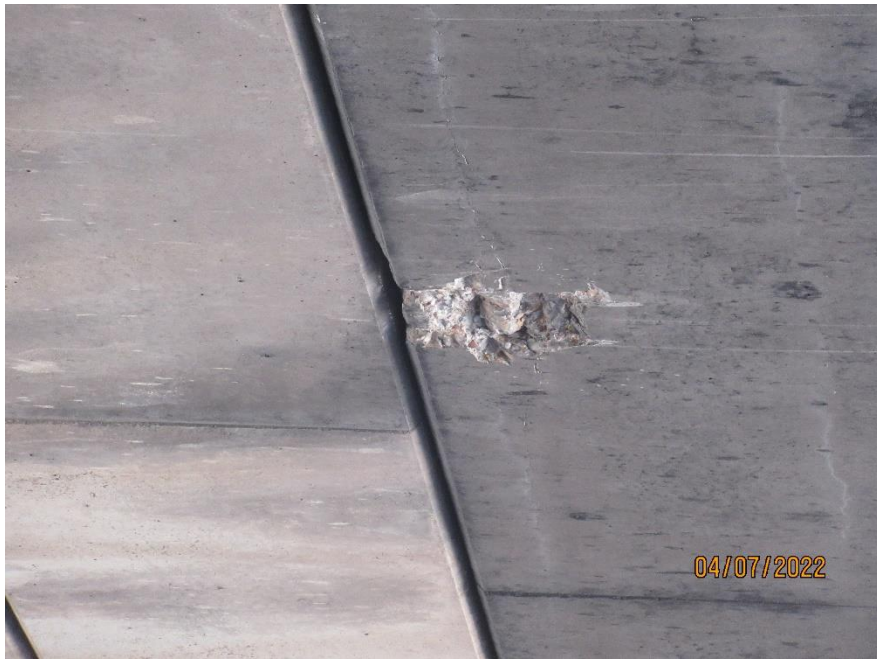
SPALLED BEAMS "P" AND "Q" - SPAN #2

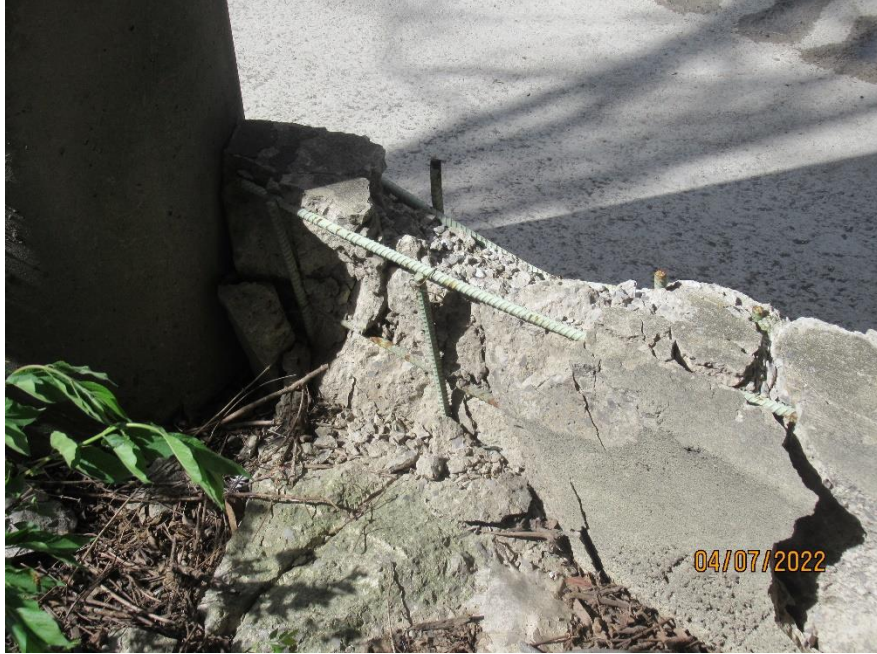
DAMAGE TO PARAPET - FROM BEAM REMOVAL – BENT #1

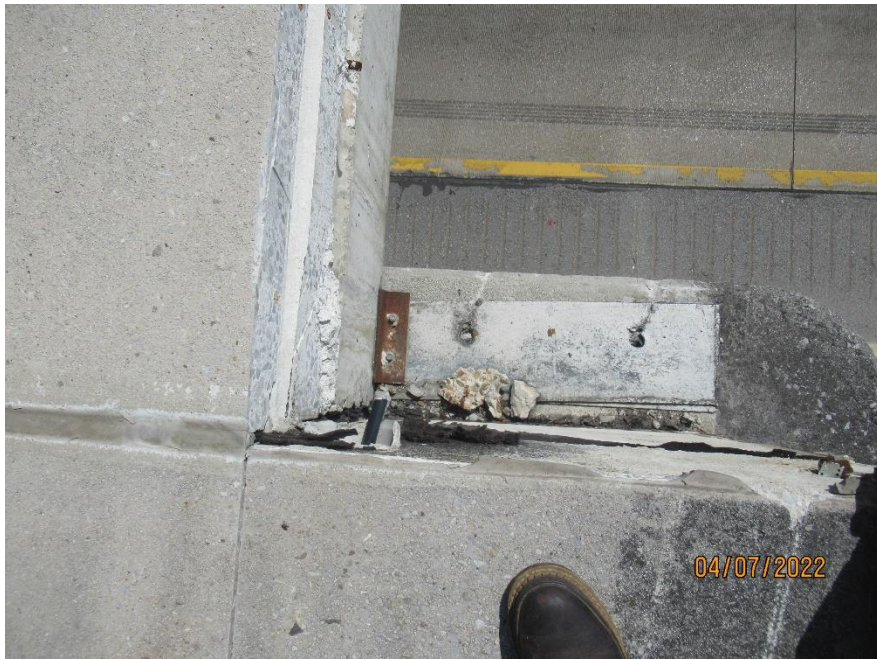
ANGLE IRON INSTALLED AFTER THE CURSORY INSPECTION OF 7-23-2020

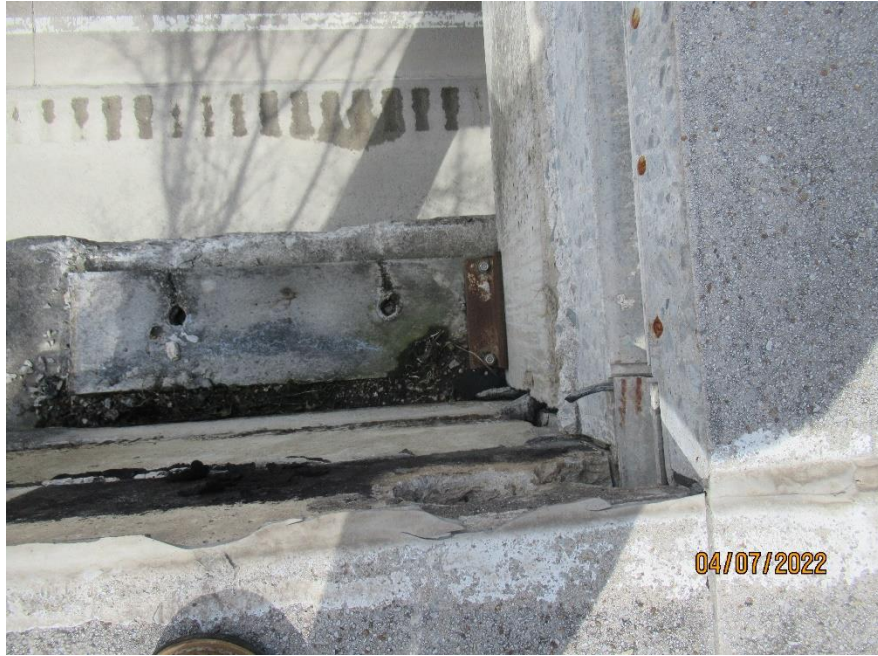
ANGLE IRON INSTALLED AFTER THE CURSORY INSPECTION OF 7-23-2020

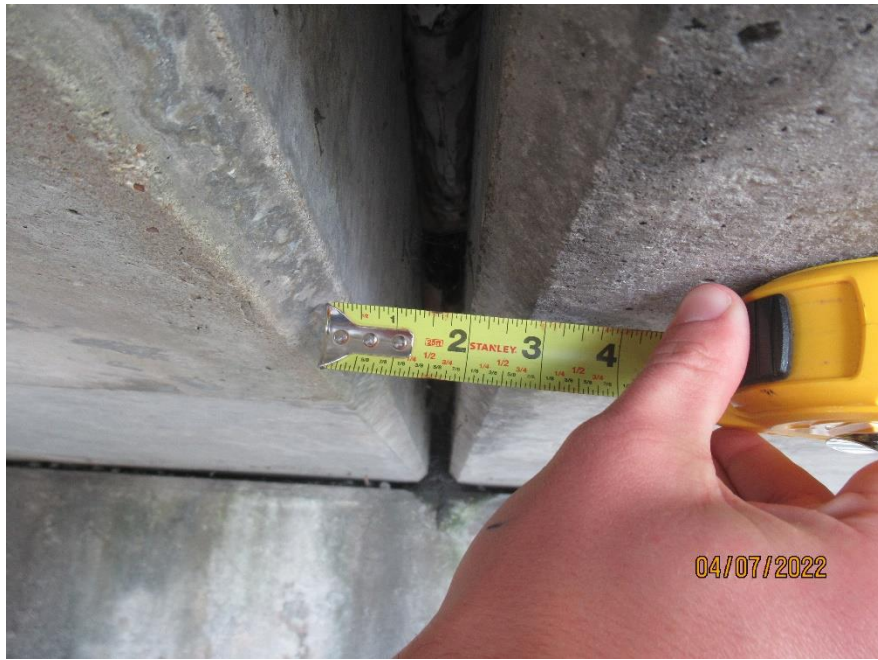
2" GAP BETWEEN BEAMS "A" AND "B" - SPAN #1

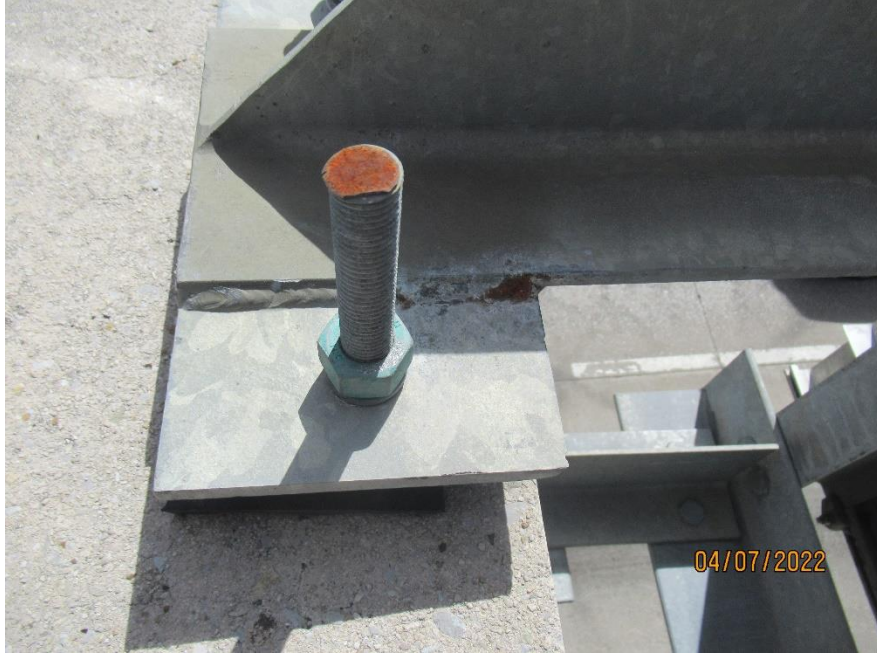
LEFT BACK OF SIGN - WELD

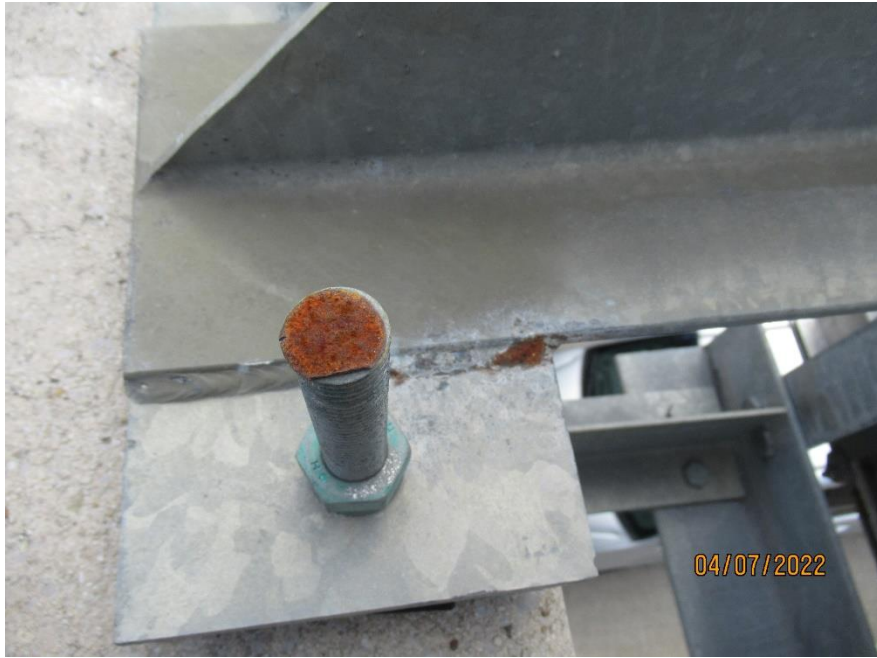
LEFT BACK OF SIGN - WELD

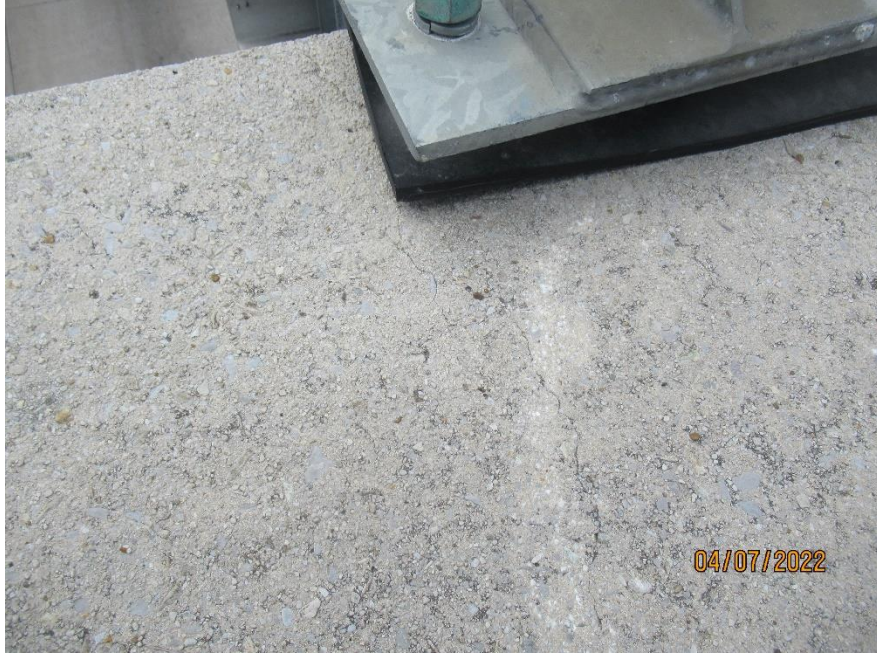
LEFT BACK OF SIGN – LEFT CORNER - CRACK

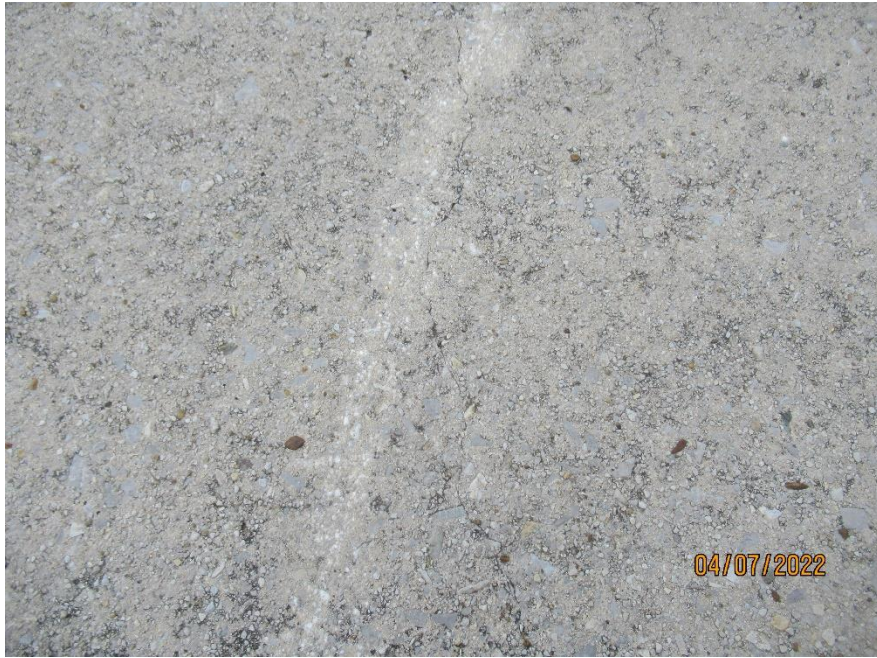
LEFT BACK OF SIGN – LEFT CORNER - CRACK

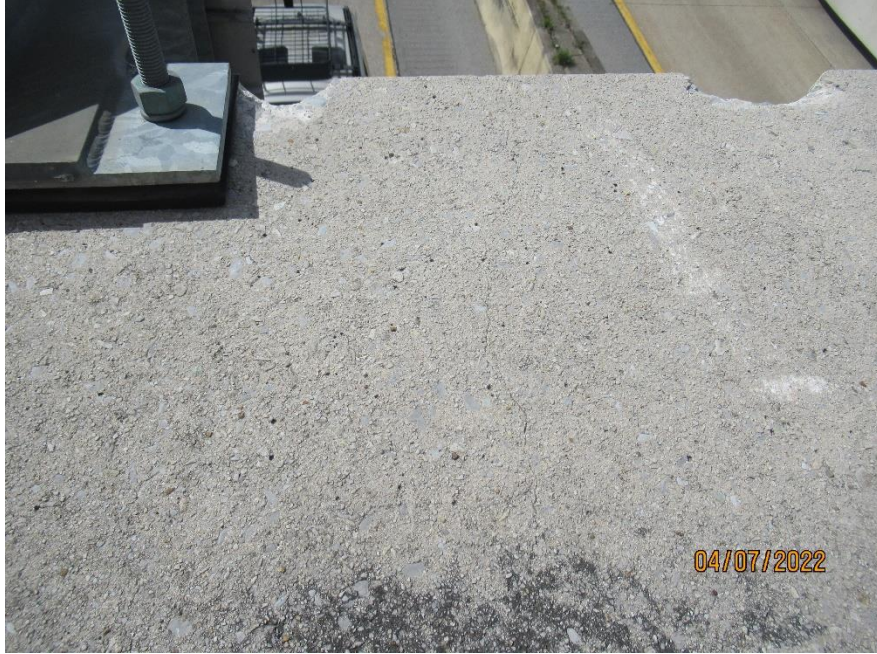
BACK OF SIGN - RIGHT CORNER - CRACK

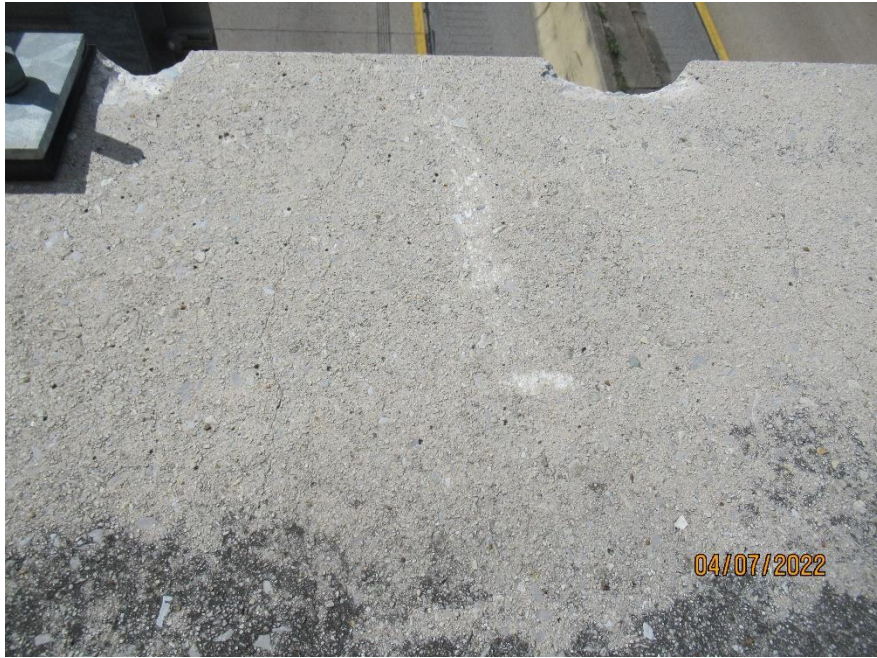
BACK OF SIGN - RIGHT CORNER - CRACK

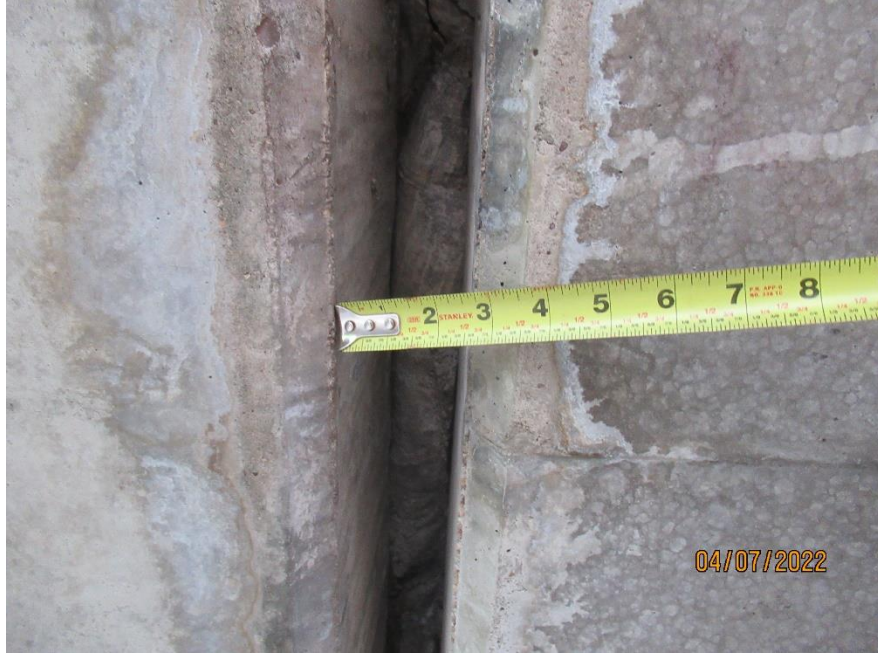
2.5" GAP BETWEEN BEAMS "B" AND "C" IN SPAN #4

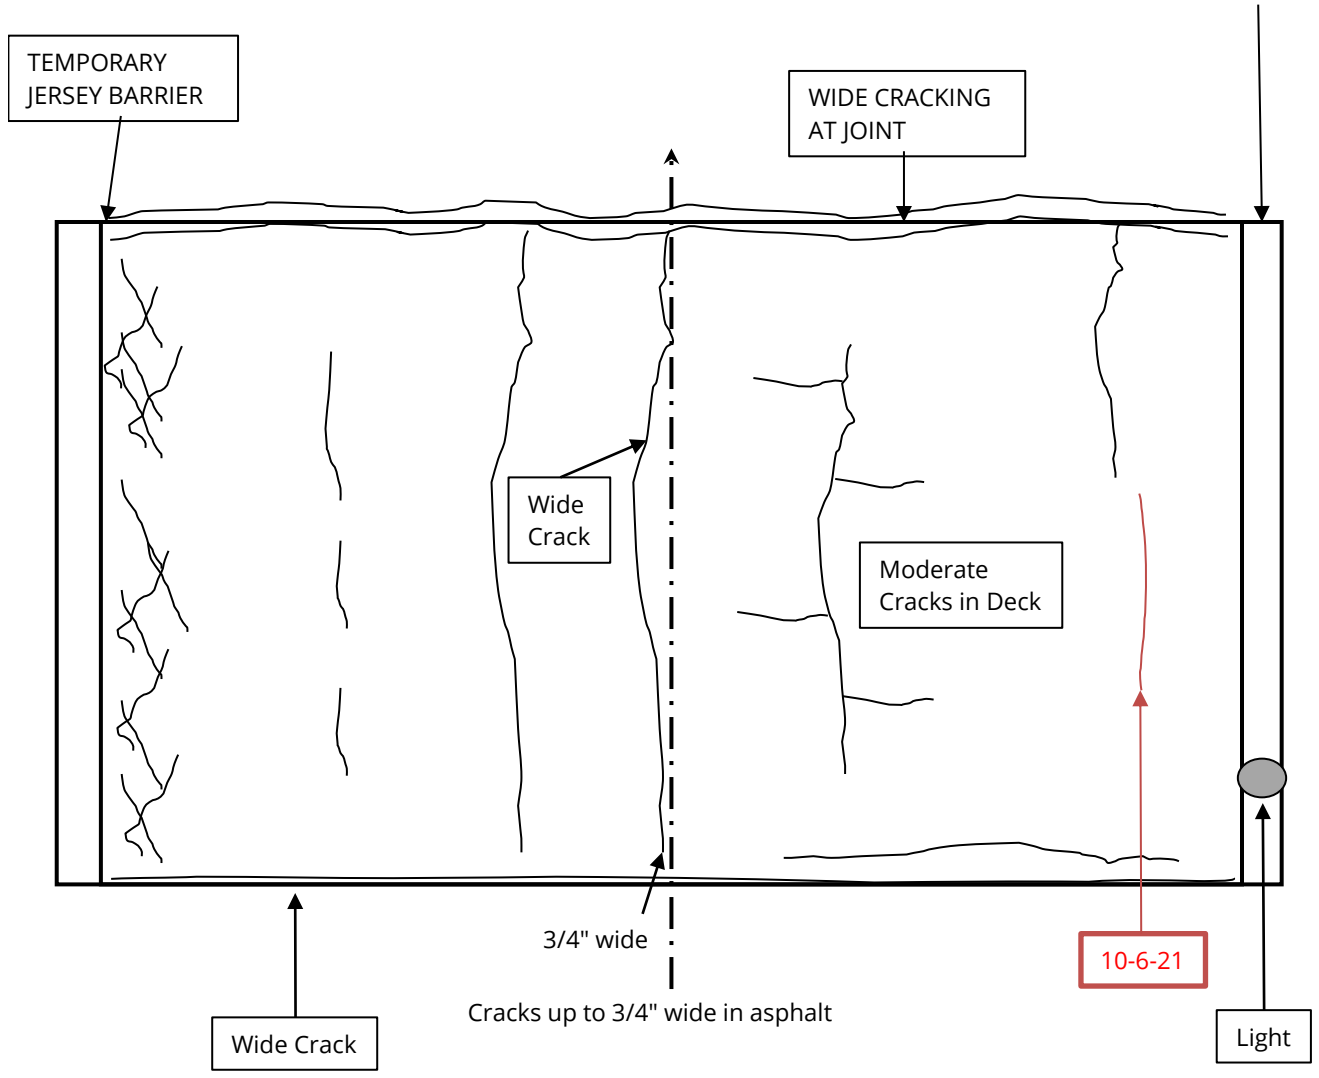
Note: Spalled areas (4'10"x7"x7" and 6"x2"x6") with rebar exposed exist on the left outside edge of the sidewalk behind the concrete barrier.

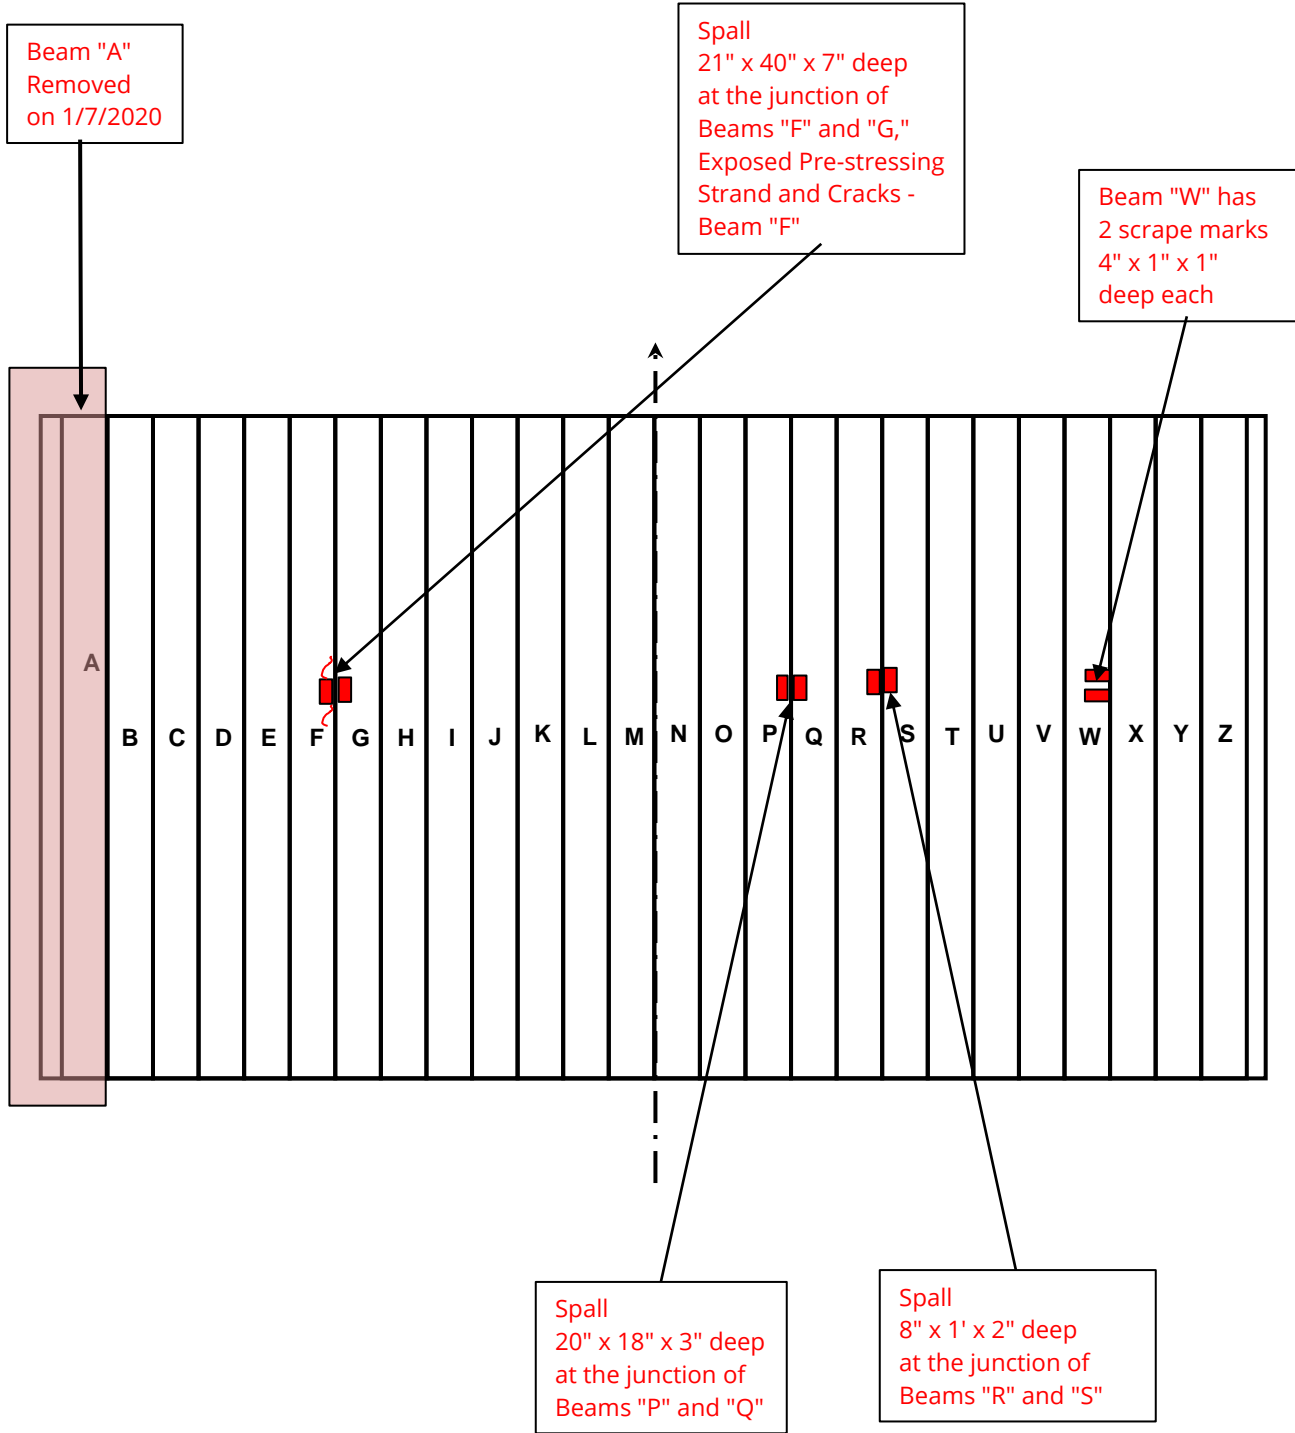
WATER LEAKAGE EXISTS BETWEEN SOME BEAMS

30"x10"x1.5" side face
spall 8" X 2' X 1.5" deep
with 1' of cable exposed

HAIRLINE SURFACE CRACKS IN BEAMS "B" AND "X"

spall 3" X 3" X 2" deep

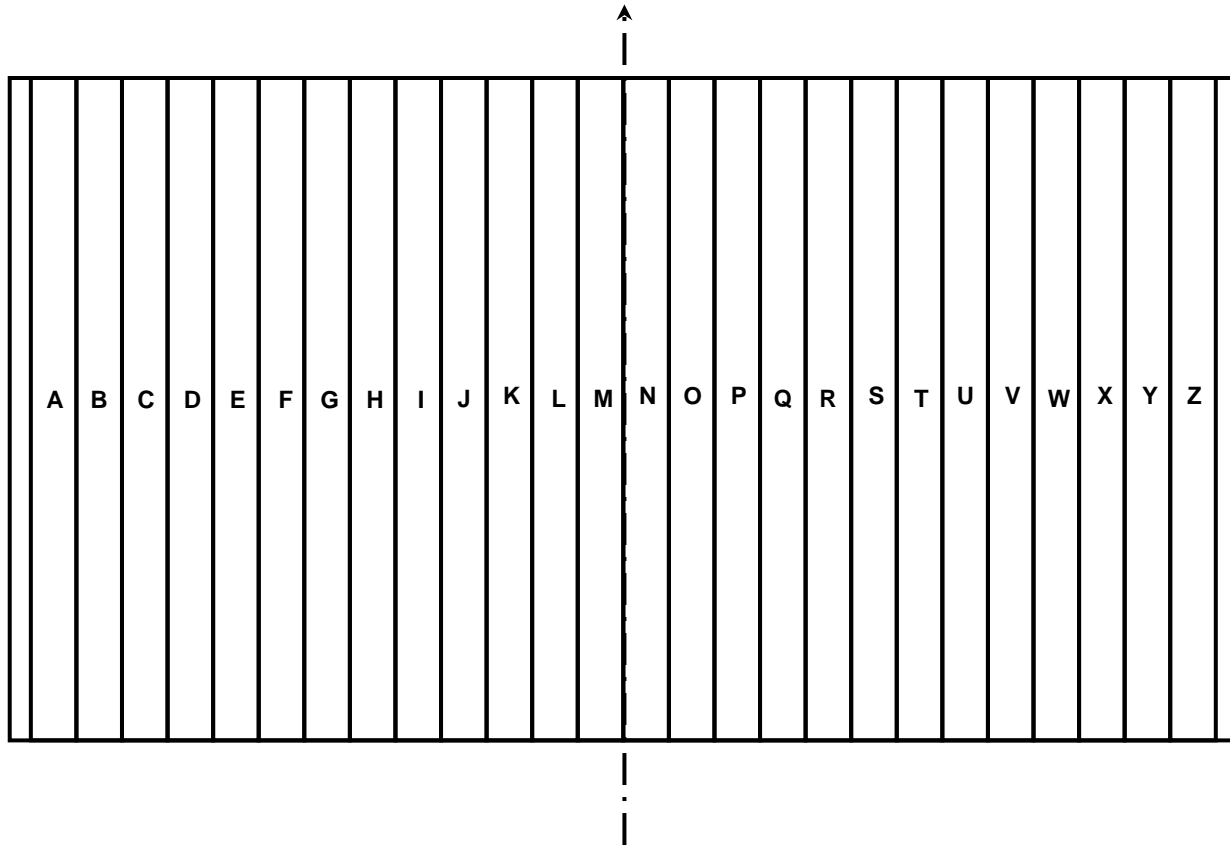
WATER LEAKAGE BETWEEN SOME BEAMS
UP TO 2.5" BETWEEN BEAMS "B" AND "C"
UP TO 1" BETWEEN ALL OTHER BEAMS

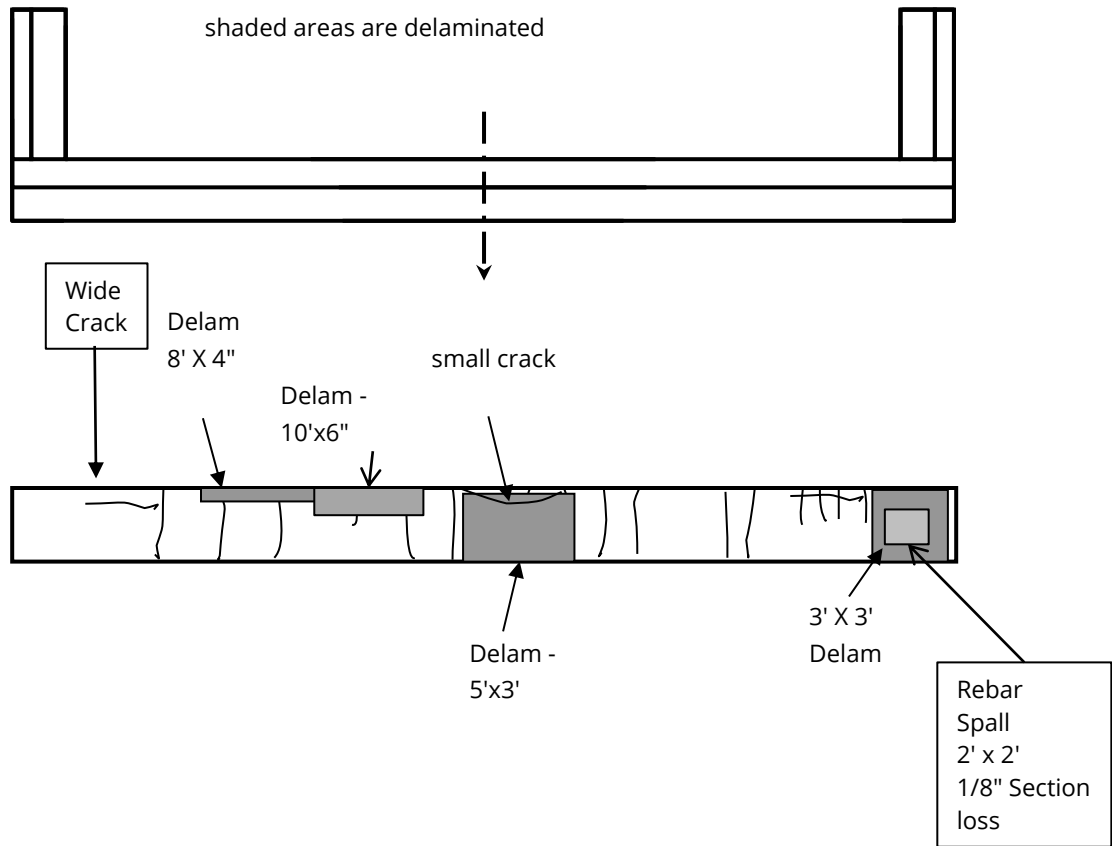
WATER LEAKAGE ON CAP
