Hamilton County

Regular Inspection Report

Location: 33-03610-01.58

4 Span Bridge

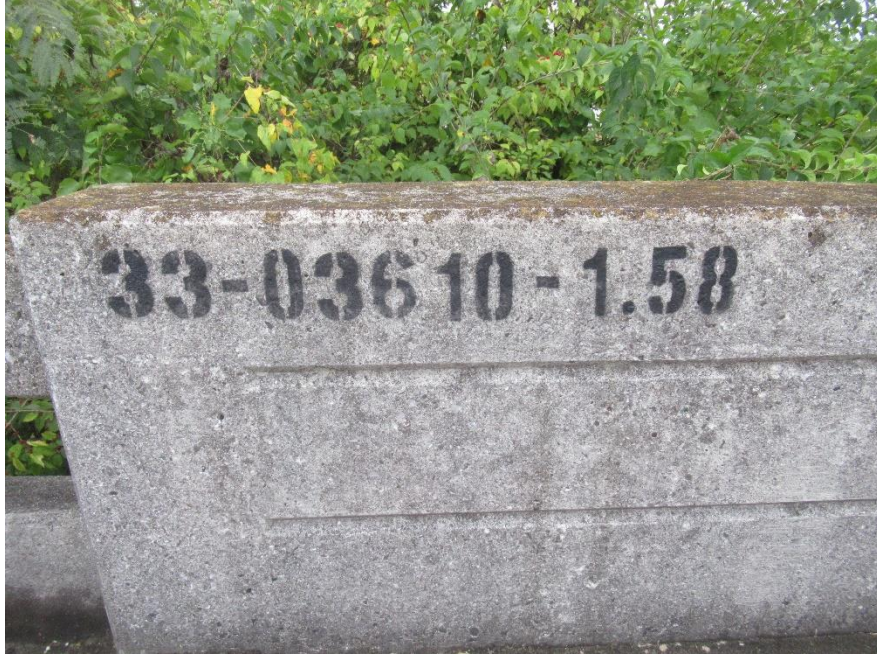
BRIDGE NO. - BRIDGE RAIL - #1 RIGHT SIDE

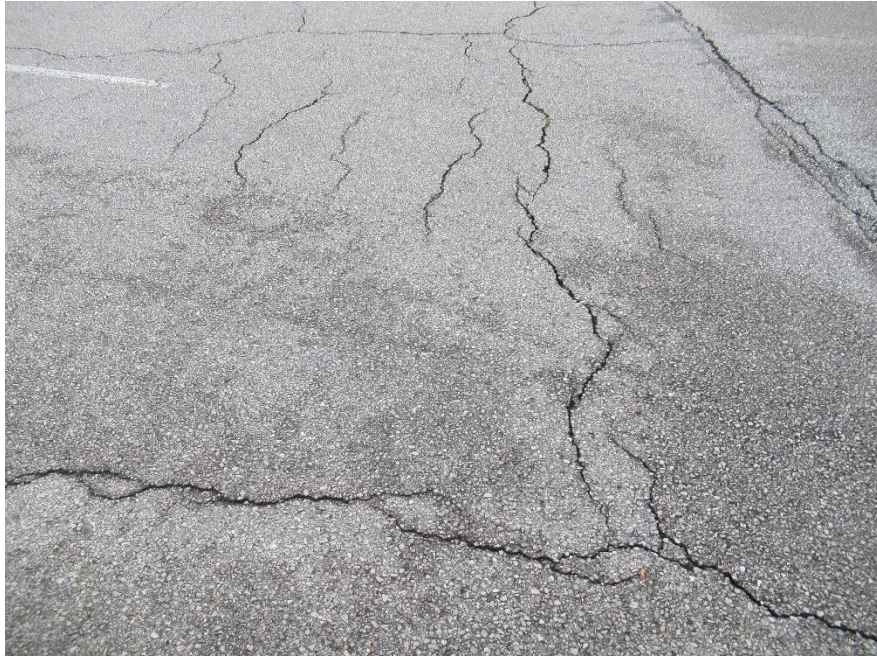
CRACKS IN WEARING SURFACE

Rating	Comments
Wearing Surface	FAIR	ASPHALT, CRACKS OVER JOINTS, WIDE CRACKS.
Deck - Structural Condition	FAIR	PRESTRESS CONCRETE BOX BEAMS HAVE LEAKAGE.
Curbs	GOOD	>=6"
Median	NONE	CLOSED - NO BARRIER.
Sidewalks	POOR	SETTLED AND UNEVEN AT APPROACHES.
Paint	NA	
Drains	NA	
Lighting Standards	GOOD	SPAN 2 - LEFT HAS EXPOSED WIRES AND SPAN 3 - RIGHT.
Utilities	NONE	
Joint Leakage	POOR	HEAVY.
Expansion Joints	NV	OVERLAYED.

SUGGESTED ROUTINE MAINTENANCE AND COMMENTS
REPAIR CRACKS SPALLS AND DELAMINATIONS IN DECK SUPERSTRUCTURE AND SUBSTRUCTURE
REPAIR UNDERMINING AT ABUTMENT NO. 2 LEFT SIDE
REMOVE HANGING ELECTRICAL LINE ON LOOKING AHEAD SIDE OF BENT NO. 3
INSTALL PADDLEBOARD SIGNS AT APPROPRIATE LOCATIONS (APPROACH NO. 2)
LEVEL THE WEARING SURFACE AT BOTH APPROACHES
REPAIR APPROACH SIDEWALKS
BRIDGERAILS ARE SUBSTANDARD

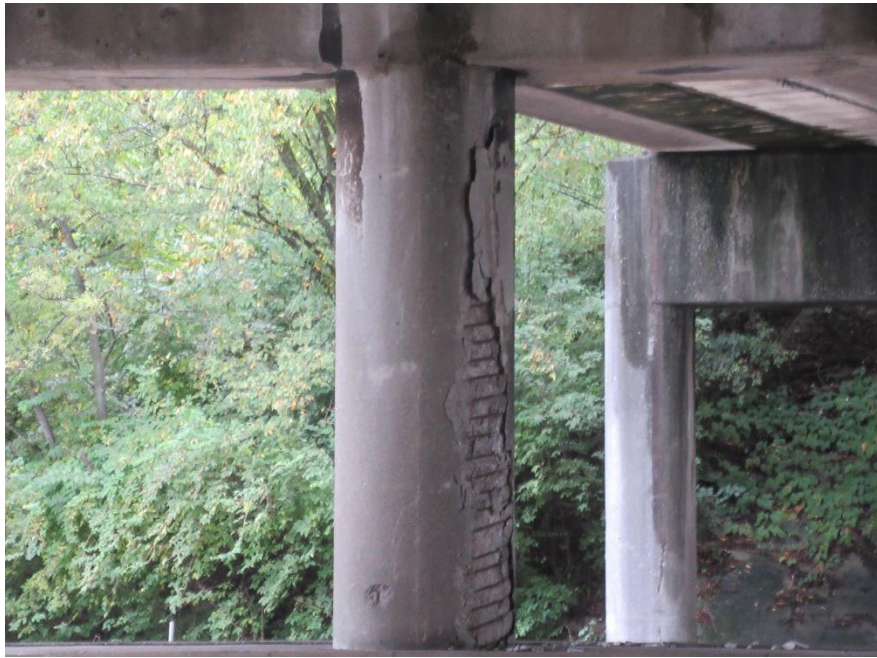
BENT #2 - COLUMN "B" - REBAR/SPALL/DELAMINATION

Bridge Seat:	GOOD	<i>NO VISIBLE DEFECTS FOUND.</i>
Caps	FAIR	<i>SIGNIFICANT REBAR SPALLS, DELAMINATION.</i>
Columns / Shaft	FAIR	<i>BENTS 2 AND 3 - SIGNIFICANT REBAR SPALLS.</i>
Pier / Crash Walls:	NA	
Plumb	GOOD	<i>NO VISIBLE DEFECTS FOUND.</i>
Footings	NV	
Piles	NV	
Piles Need Replacement:	NO

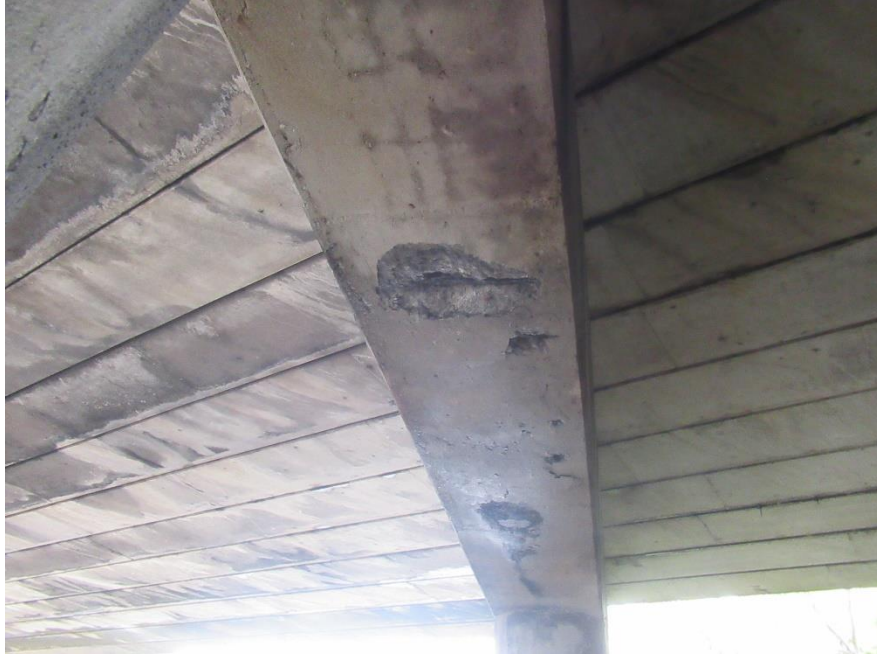
BOTTOM OF CAP - BENT #1 - BETWEEN COLUMNS "D" AND "E"

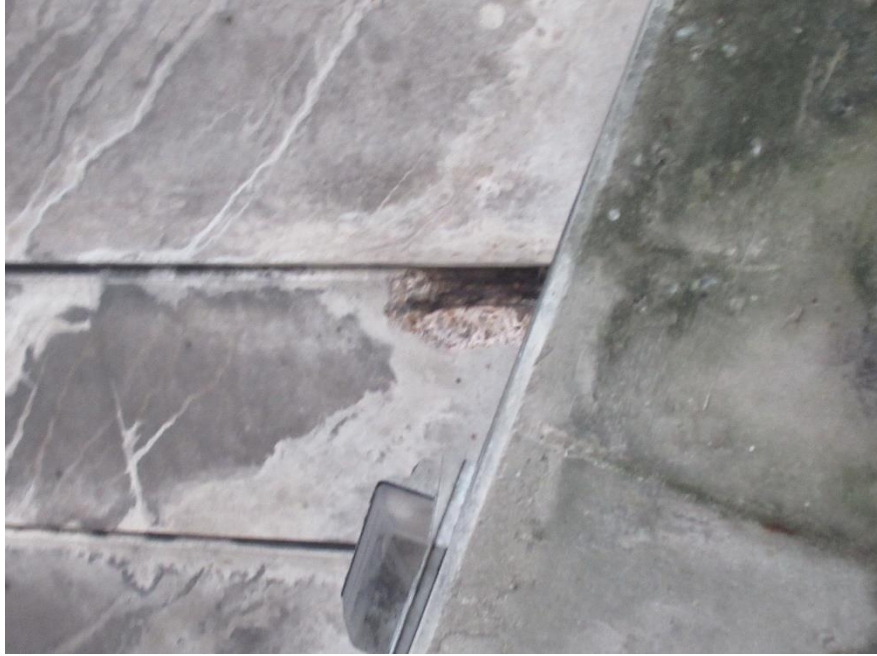
END OF BEAM "F" SPAN #2 - SPALL/REBAR

The superstructure is rated "FAIR". The beams have spalls and hairline cracks, one spall in span #3 has section loss on exposed strands.

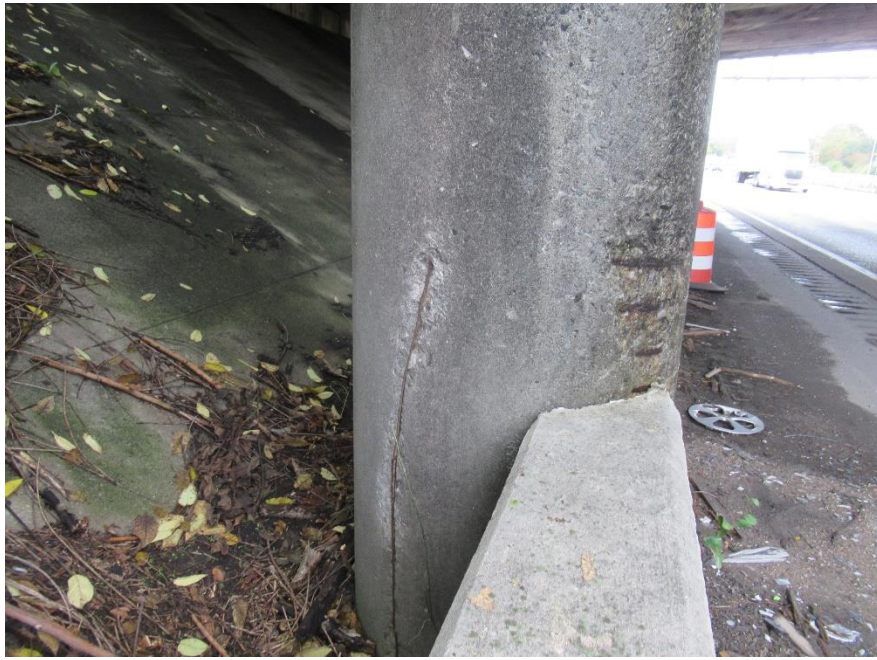
BENT #1 - COLUMN "F" - REBAR/SPALLS

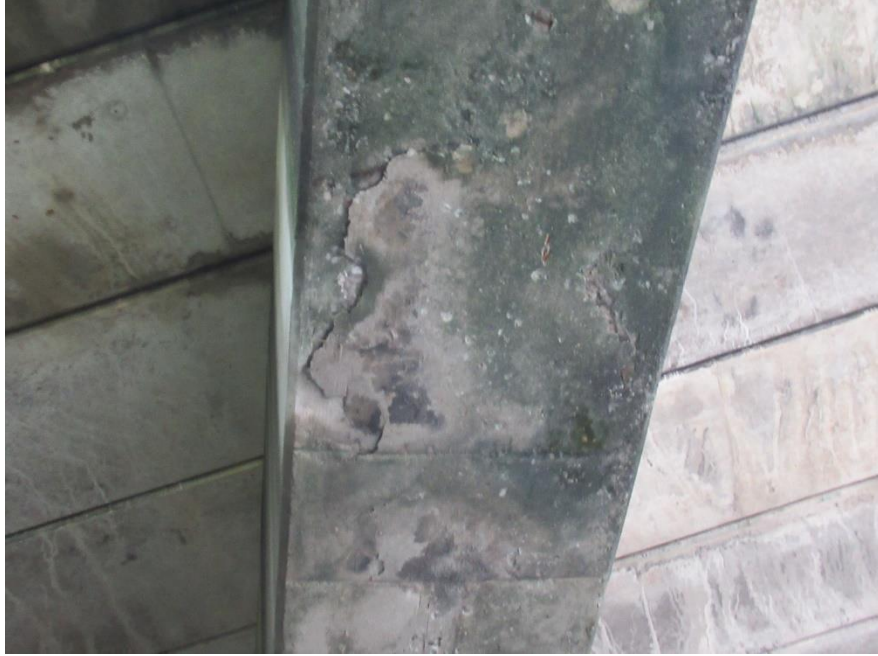
BOTTOM OF CAP - BENT #3 - BETWEEN COLUMNS "A" AND "B" - DELAM

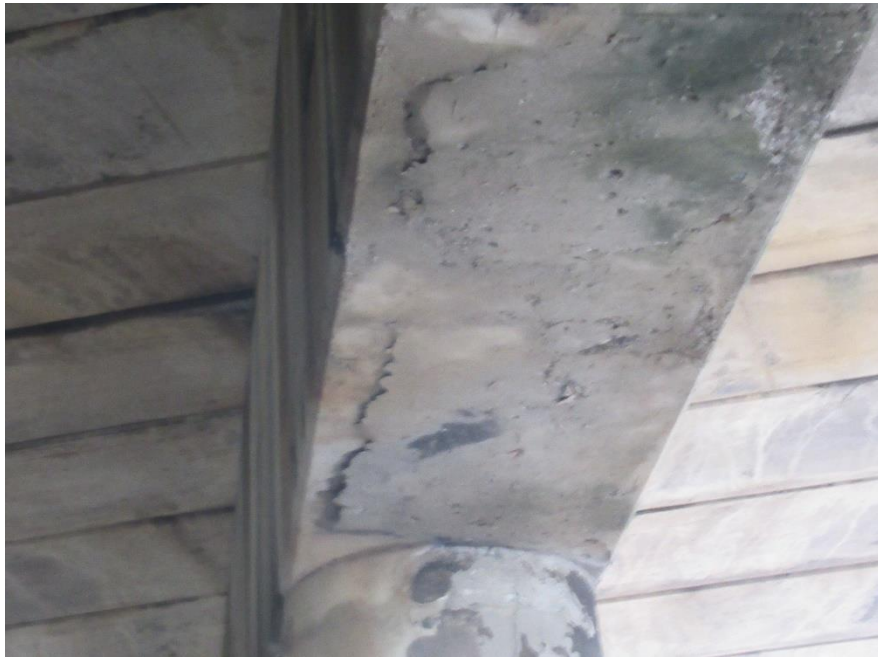
BOTTOM OF CAP - BENT #3 - BETWEEN COLUMNS - "B" AND "C" - DELAM

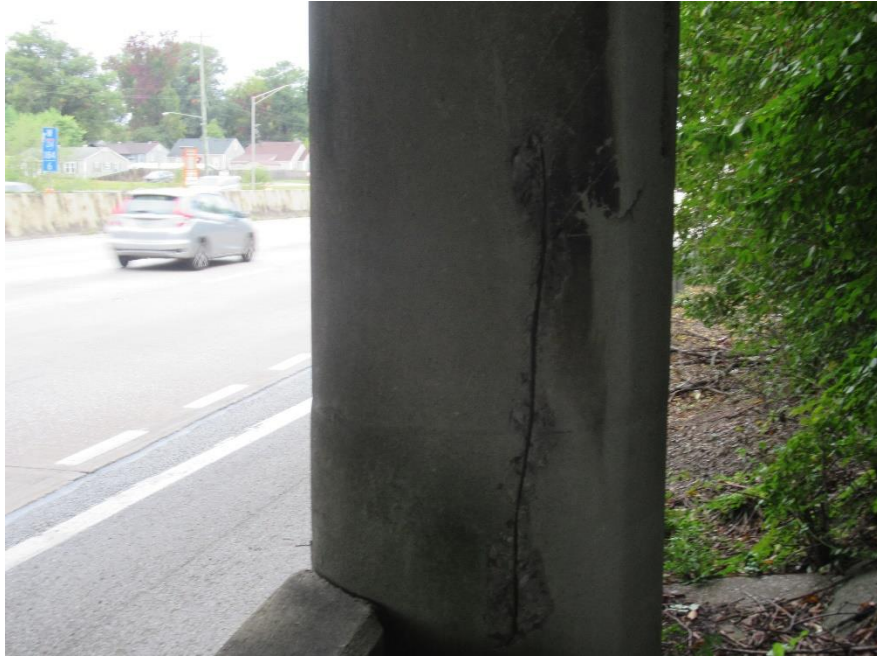
BENT #3 - COLUMN "A" - REBAR SPALL

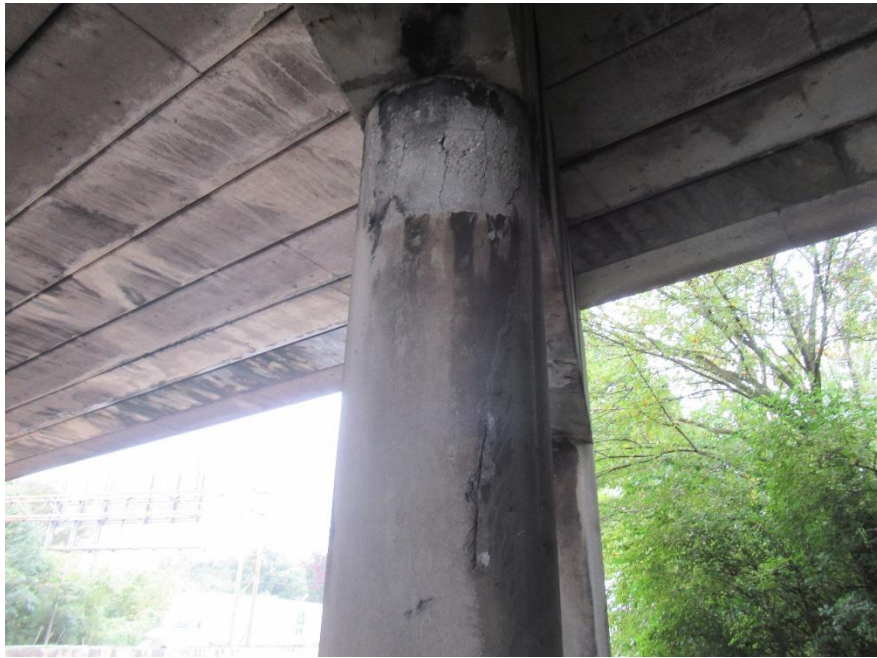
BENT #3 - COLUMN "B" - DELAM/SPALLS

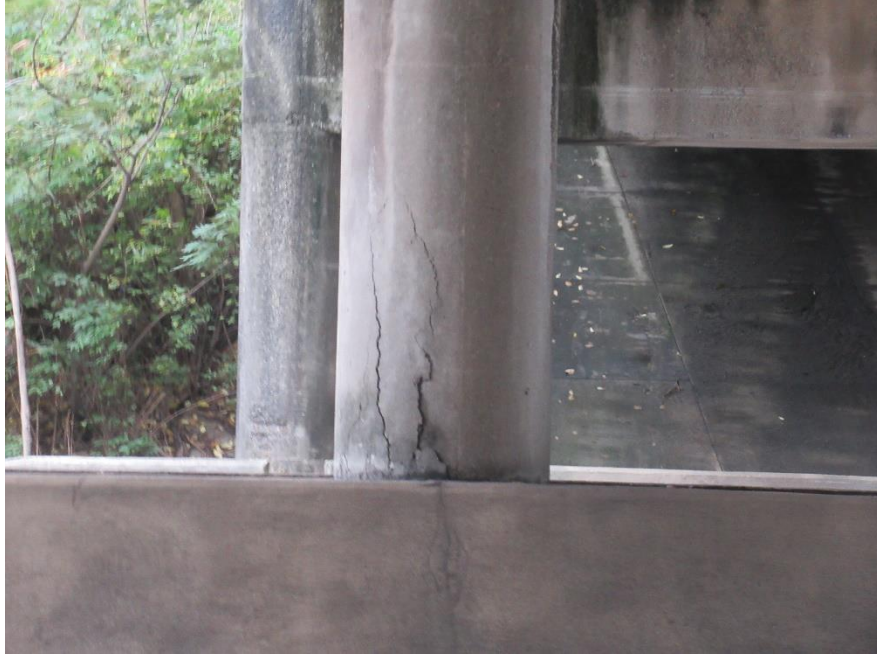
BENT #2 - COLUMN "E" - DELAMINATION

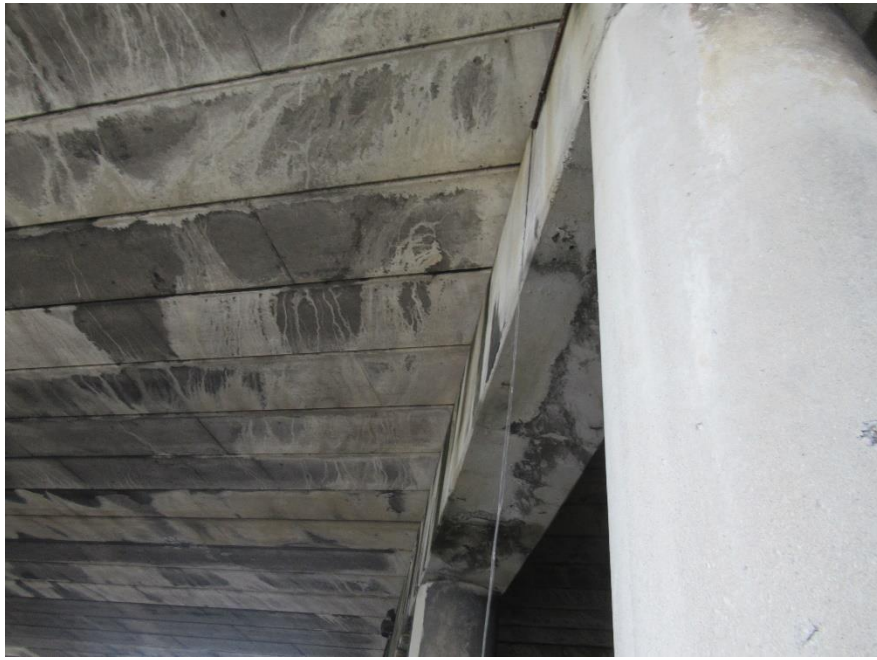
BENT #3 - COLUMN "E" - LOOSE ELECTRIC WIRING

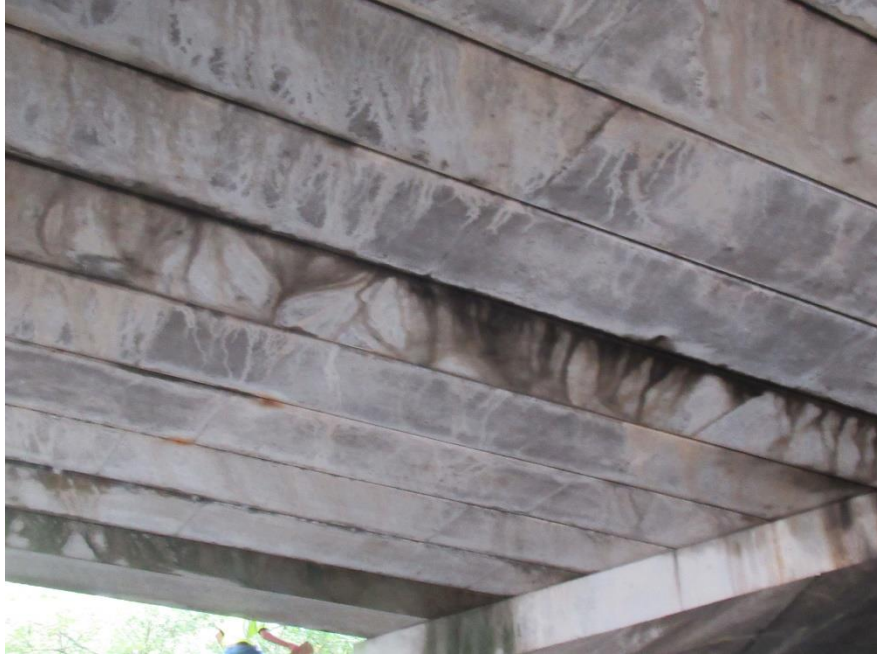
BOTTOM OF DECK - SPAN #3 - LEAKAGE

The deck is rated "FAIR". The box beams have heavy leakage coming through the joints.

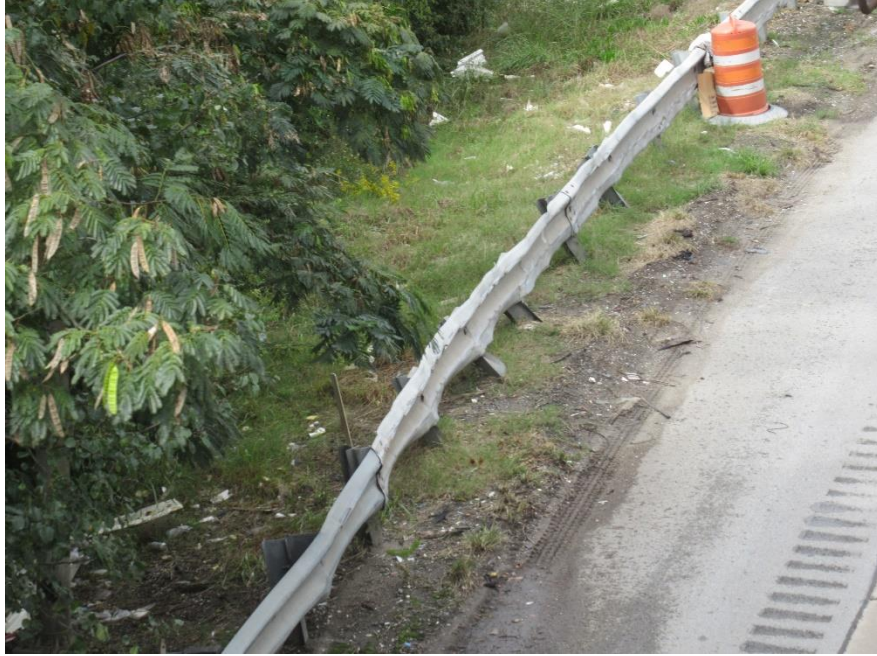
UNDERPASS EASTBOUND - #1 RIGHT - DAMAGED GUARDRAIL

The underpass is rated "GOOD". The underpass transitions and approach rails are substandard. The Eastbound Approach #1 Guardrail is damaged.

REPAIR APPROACH RAIL AT APPROACH #1, RIGHT

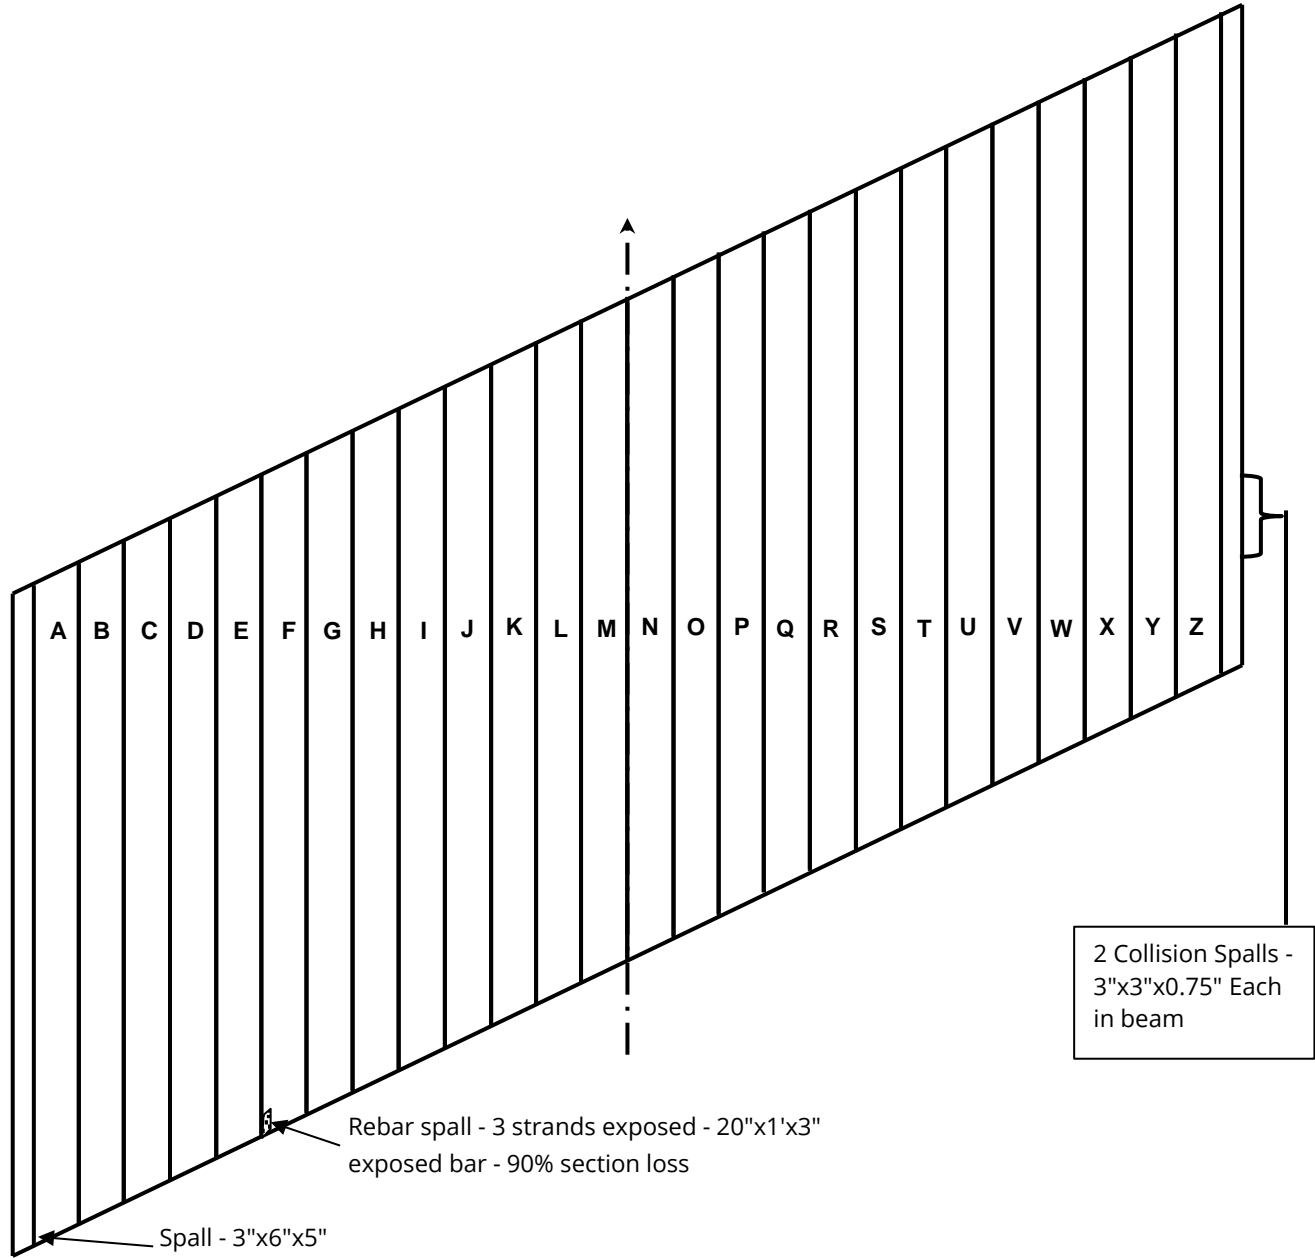
There is leakage between the beams.

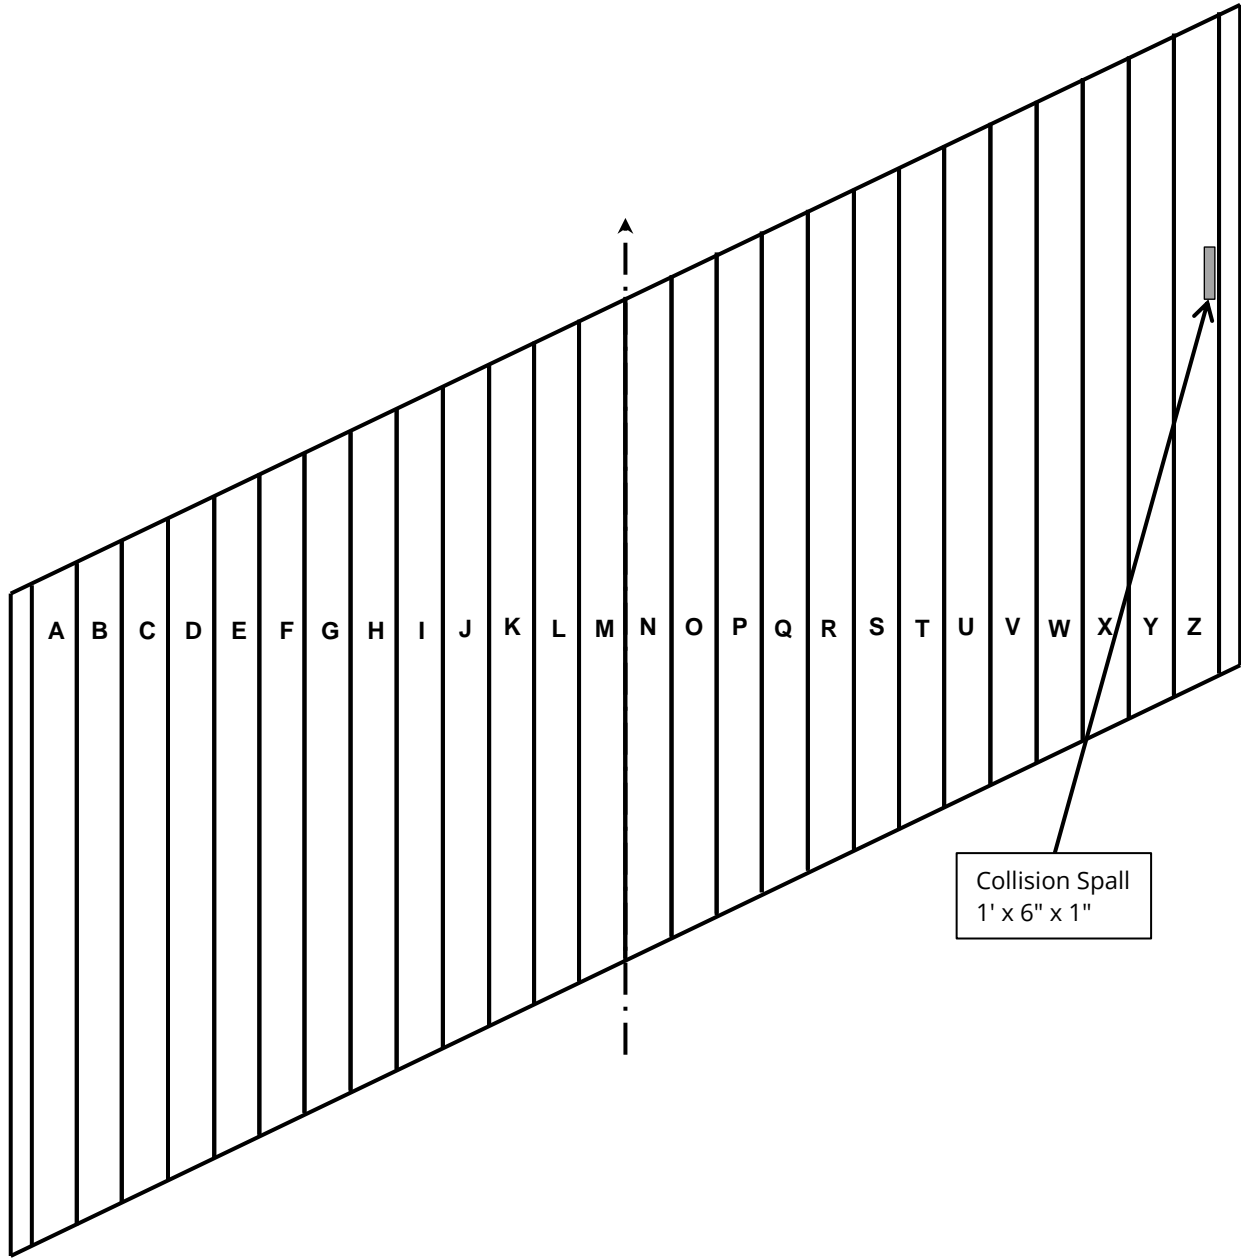
There is leakage between the beams.

Collision Spall
1' x 6" x 1"

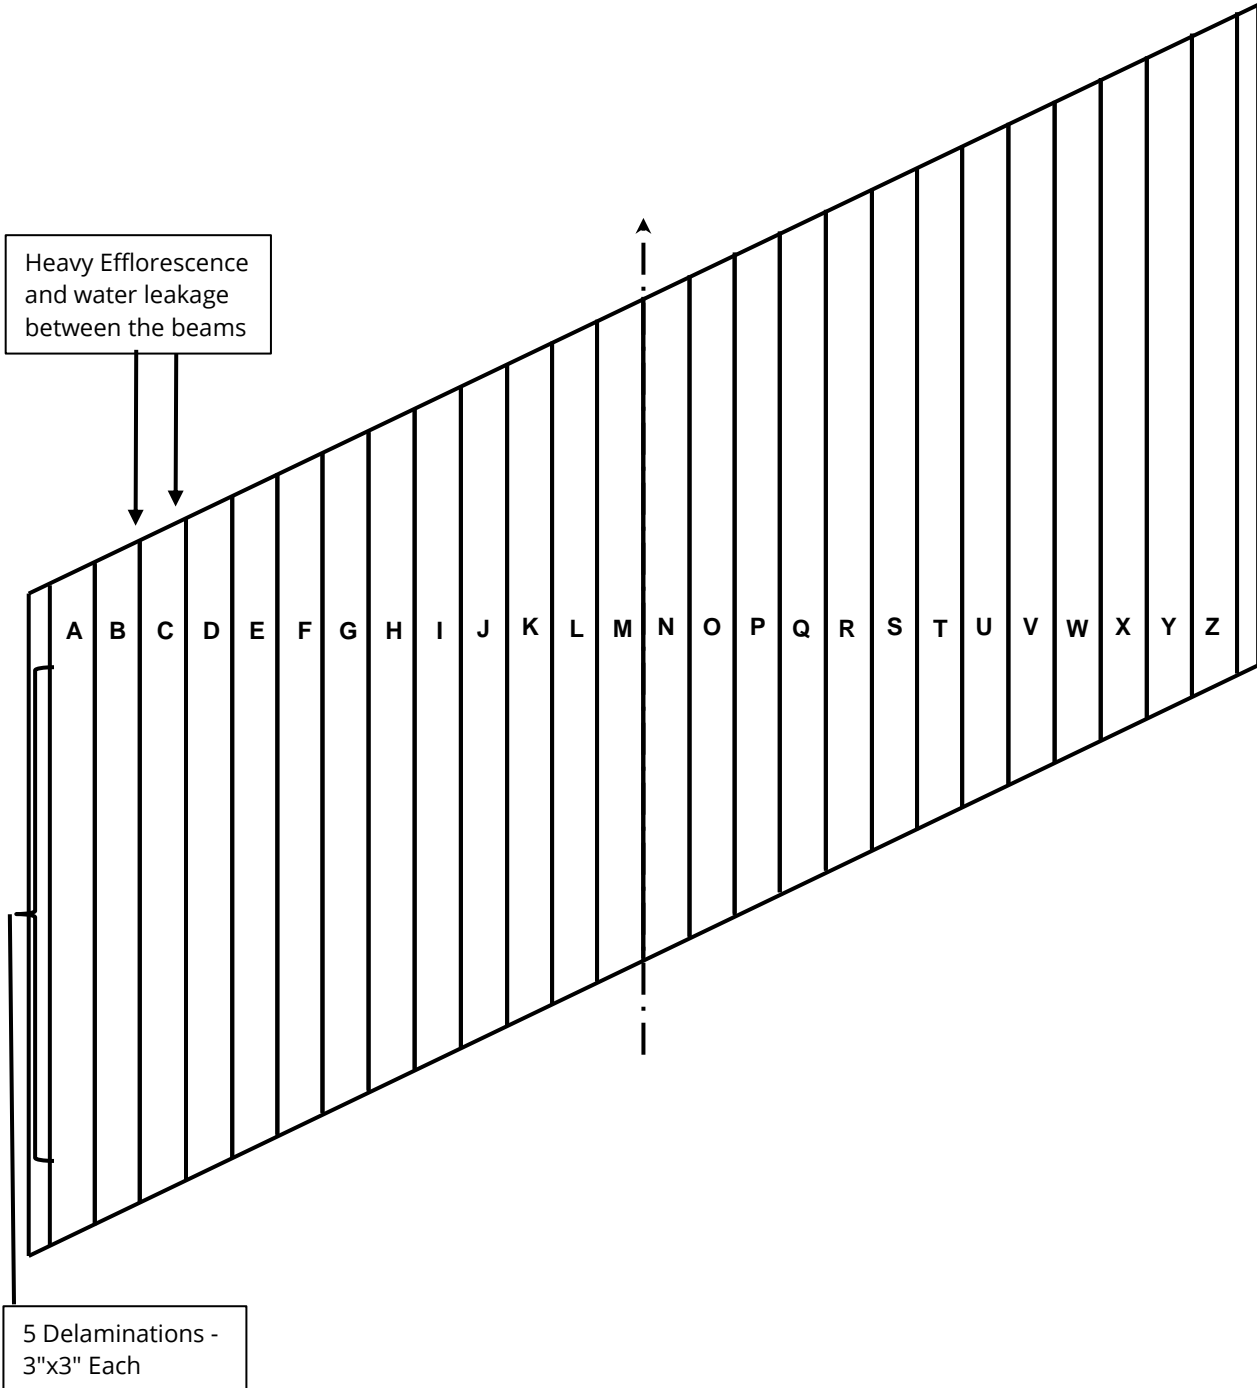
There is leakage between the beams.

Heavy Efflorescence
and water leakage
between the beams

5 Delaminations -
3"x3" Each

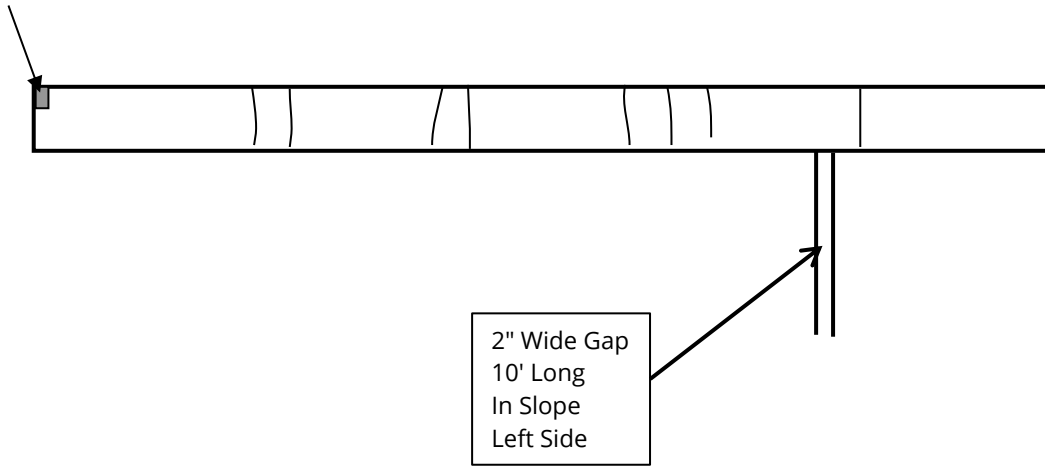
Rebar spall - 10" X 7" x 1"

shaded areas are delaminated
cracks are hairline unless noted otherwise

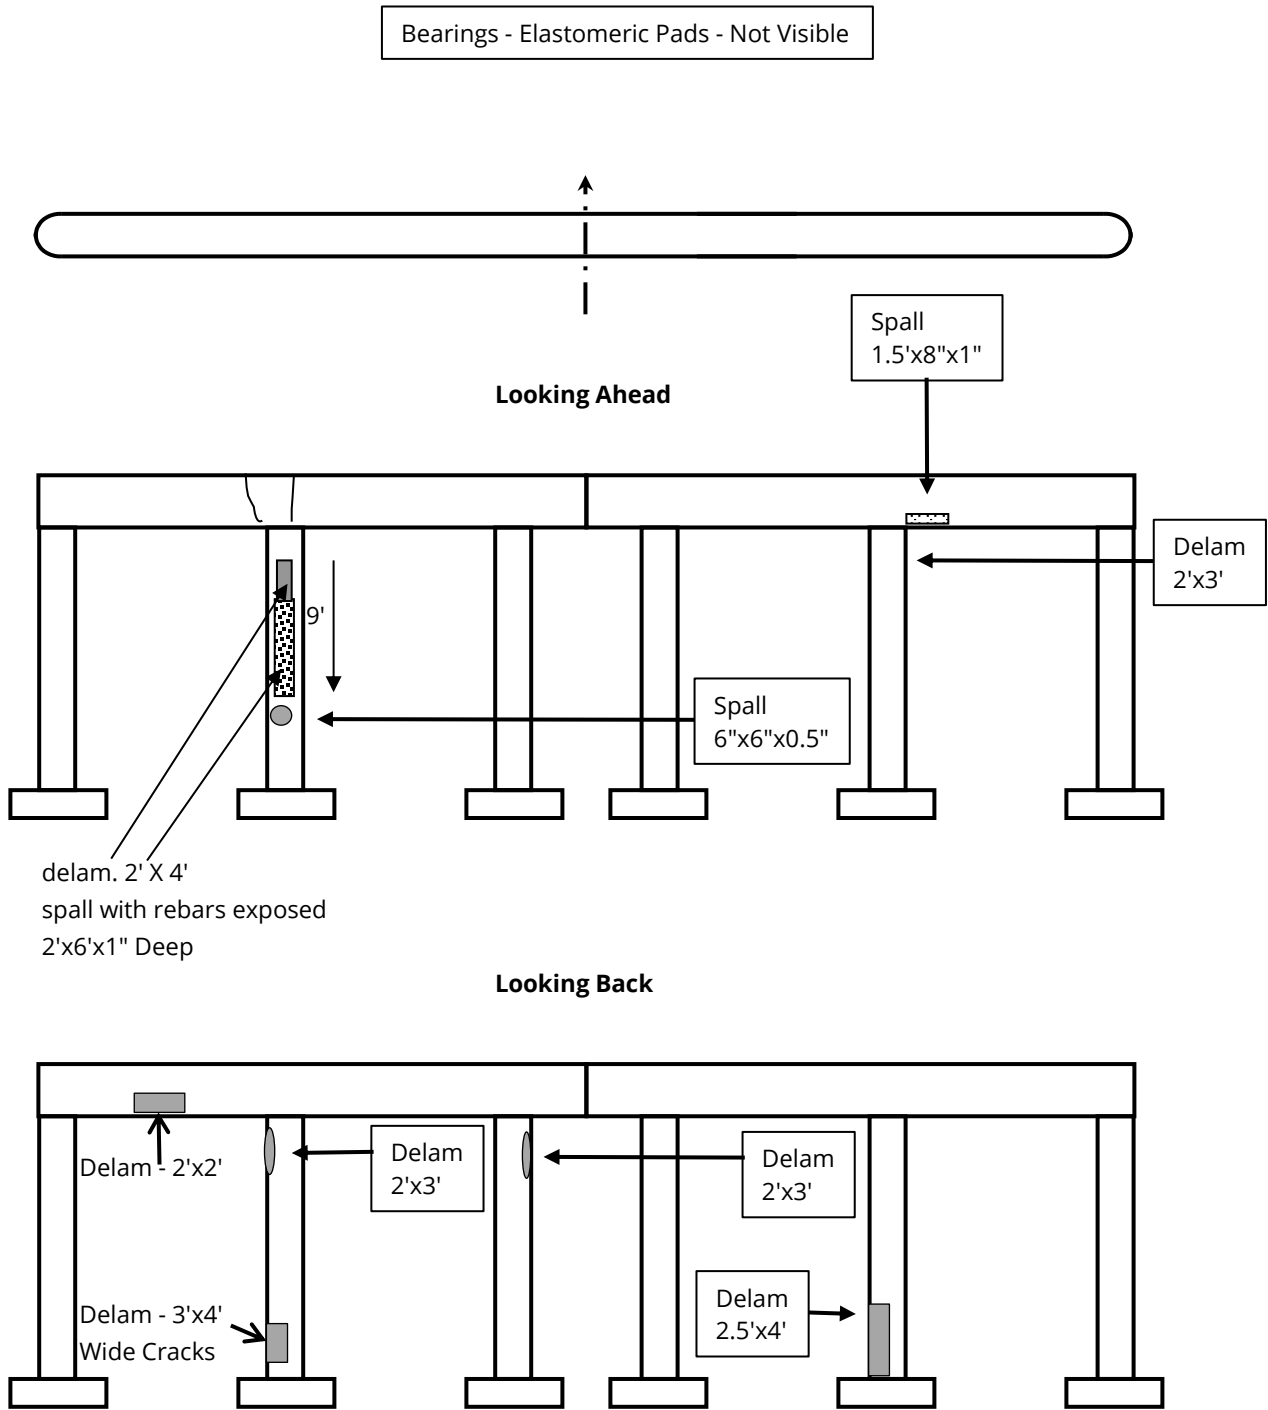
Inspector's Notes:
Median wall has collision damage.

1. Delam: 3'x2.5'
2. Delam: 3'x2.5' (on bottom)
3. Exposed Wire: 2'x4"x1"
4. Wire Exposed: 3'x4"x1" (side of column)

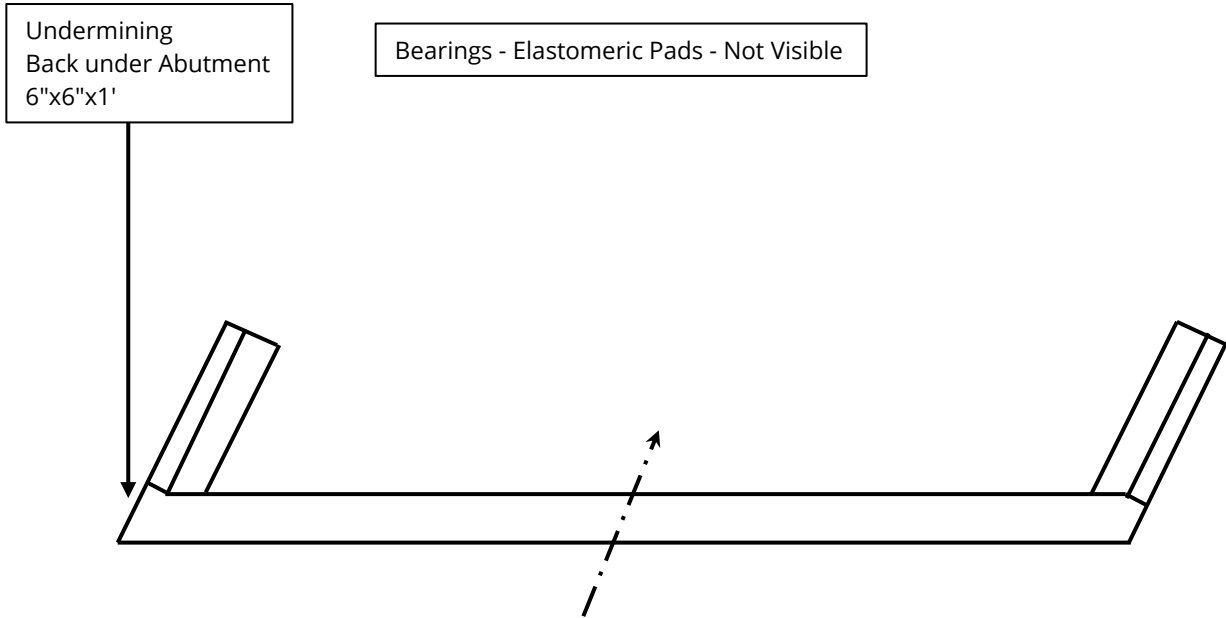
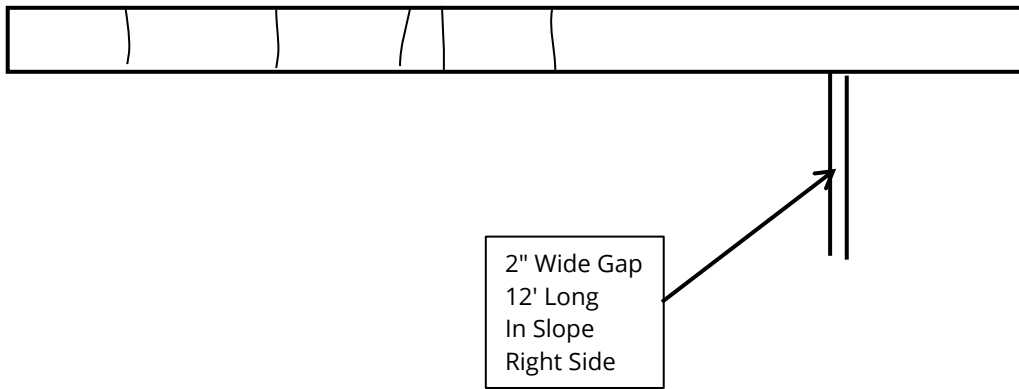
Abutment 2

All cracks are hairline.
