### Cursory Inspection Report

Location: 33-I0024-13.58

2 Barrel Culvert

Inspection Date: April 4, 2022

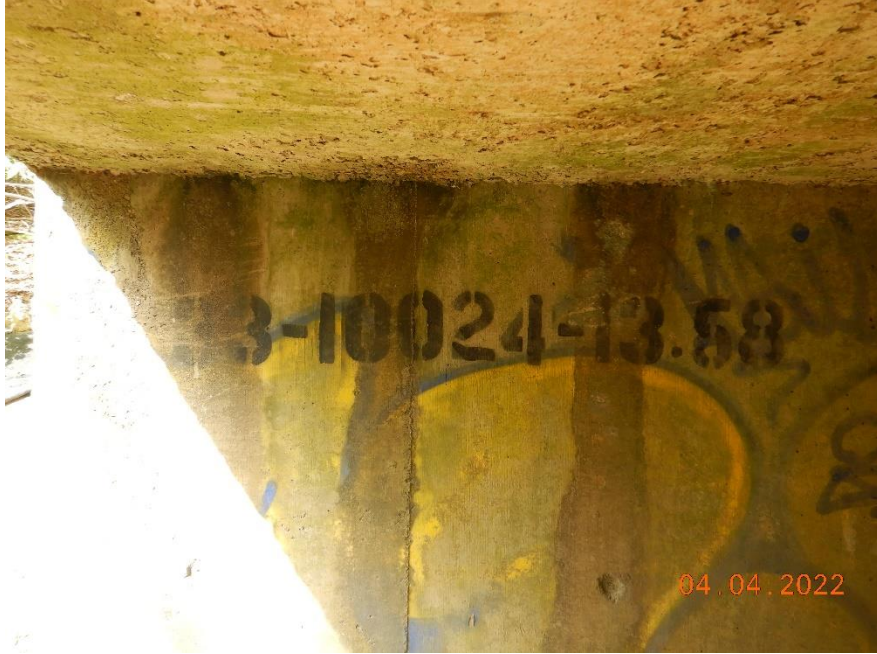
**BRIDGE NUMBER - BARREL #1 - EXTERIOR WALL RIGHT**

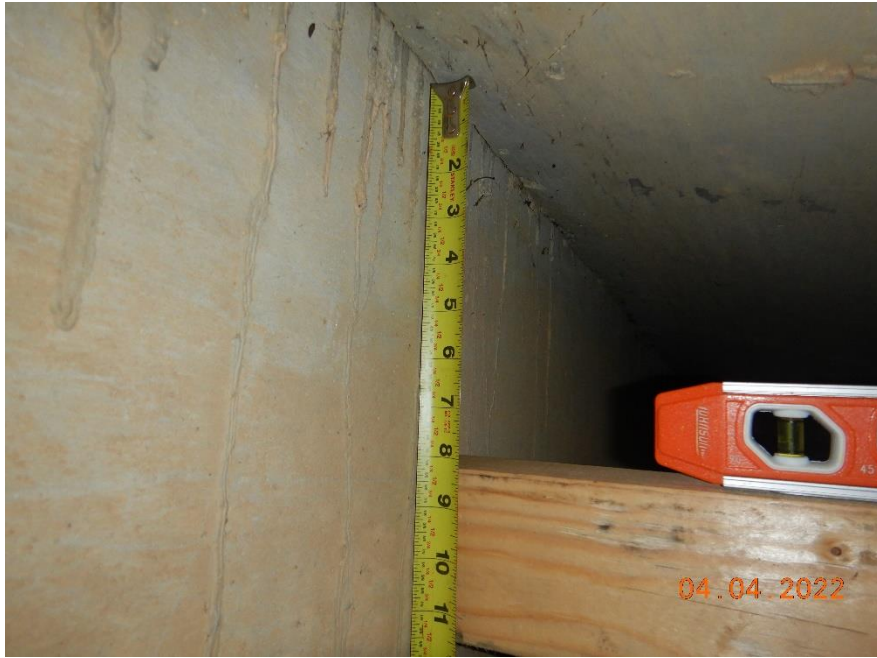
**BARREL #1 - MEASUREMENT OF SAG IN THE ROOF – MEASURED AT THE EXTERIOR WALL**

The sag in Barrel #1 has worsened. It is now as great as 8 1/4", distributed over 82 feet in length in Barrel #1. There is a sag of up to 5 3/4" distributed over a length of 82 feet in Barrel #2. From the best the inspectors could determine, the sagged area is located under the parking lot of a medical clinic. The floor of the culvert could not be observed due to sediment accumulation of approximately 1' to 1.5' in both barrels. There are wide cracks, spalls, rebar spalls, and delaminations in the sagged area. There are also spalls, rebar spalls, delaminations and cracks throughout the culvert. There are moderate and wide cracks in wingwalls #1 and #2 on the right. The inspectors were Jonathan Edwards (Team Leader), and Wes Spencer.

REPAIR THE ROOFS OF BOTH BARRELS (SAG, REBAR SPALLS, WIDE CRACKS) ASAP

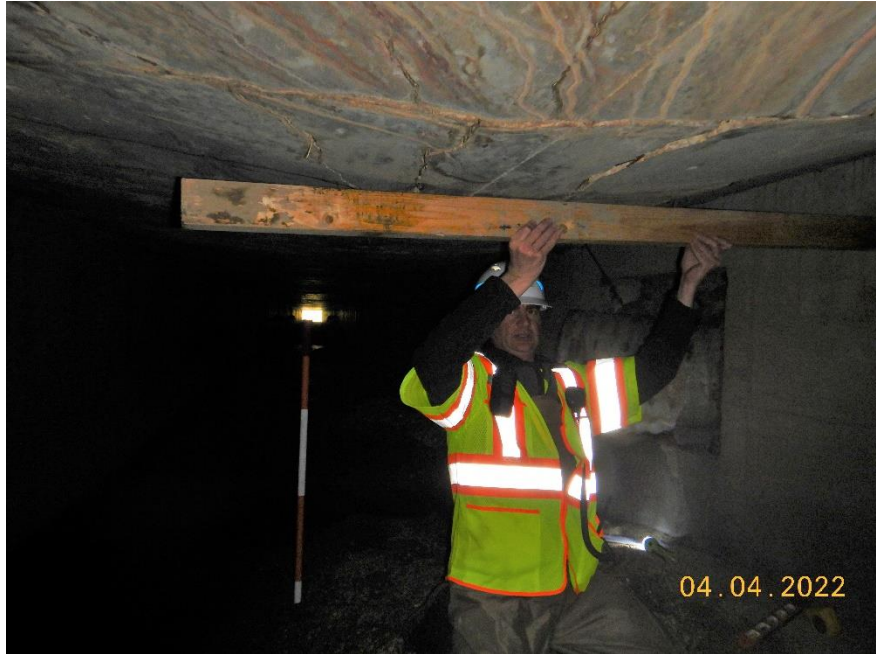
BARREL #1 - MEASUREMENT OF SAG IN THE ROOF

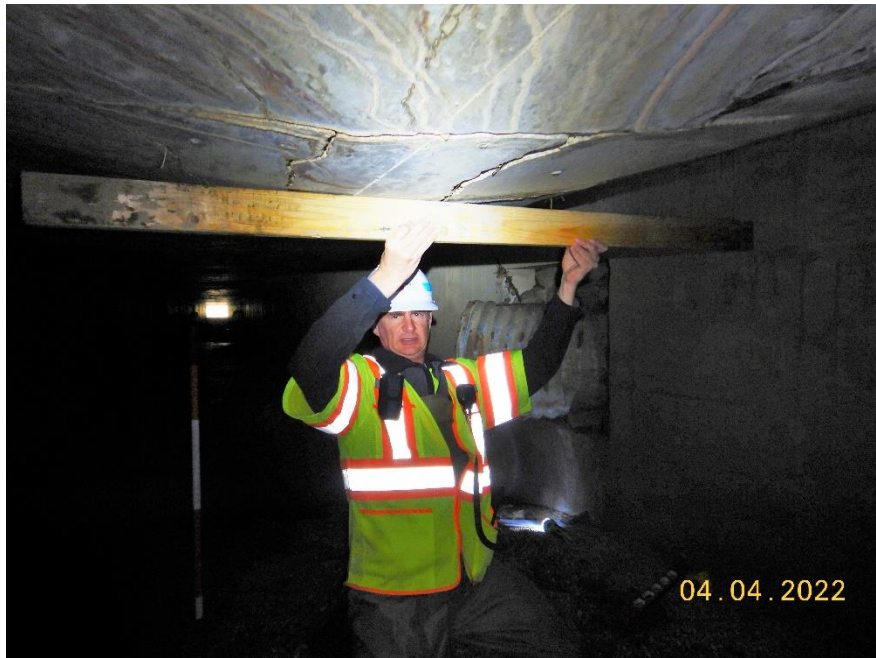
BARREL #1 - MEASUREMENT OF SAG IN THE ROOF

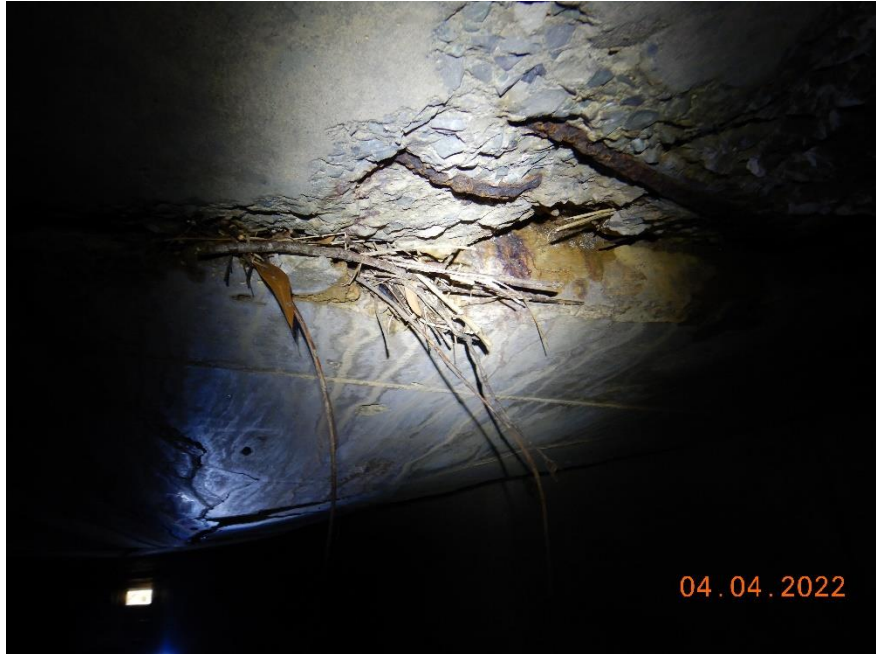
**BARREL #1 - SPALL WITH EXPOSED REBAR**

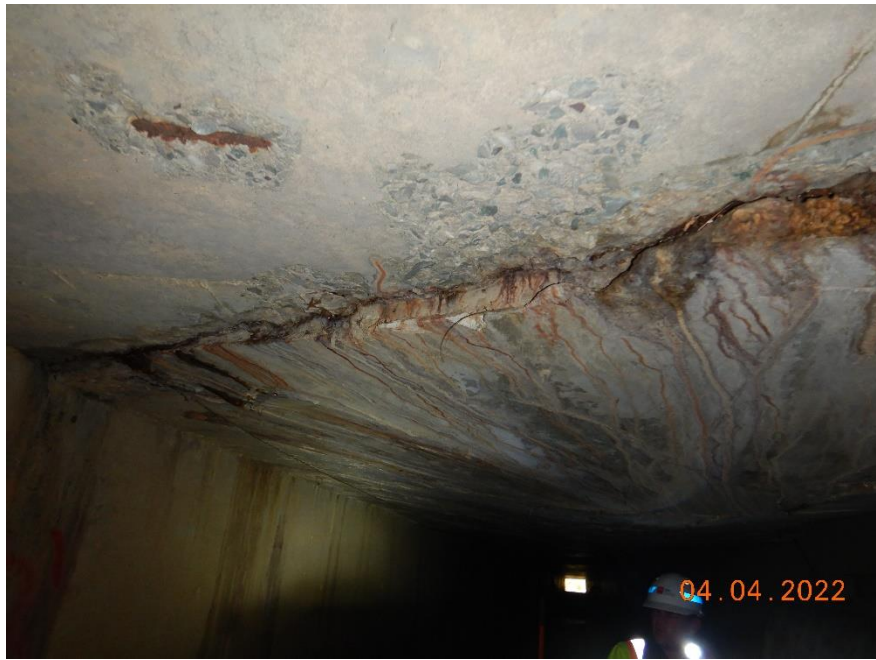
**BARREL #1 - OFFSET AT THE CONSTRUCTION JOINT**

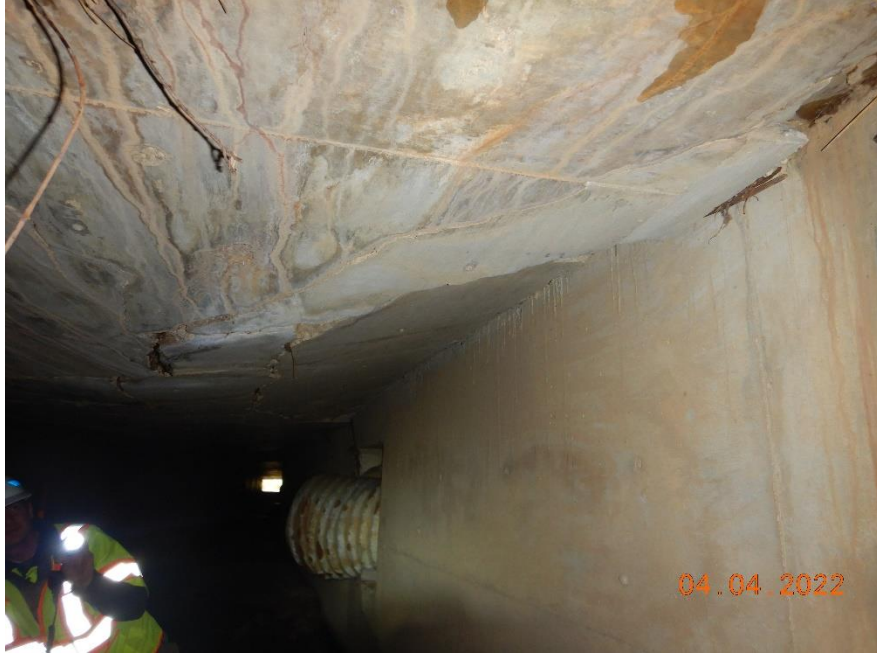
**BARREL #1 - SAG IN ROOF AND DELAMINATIONS**

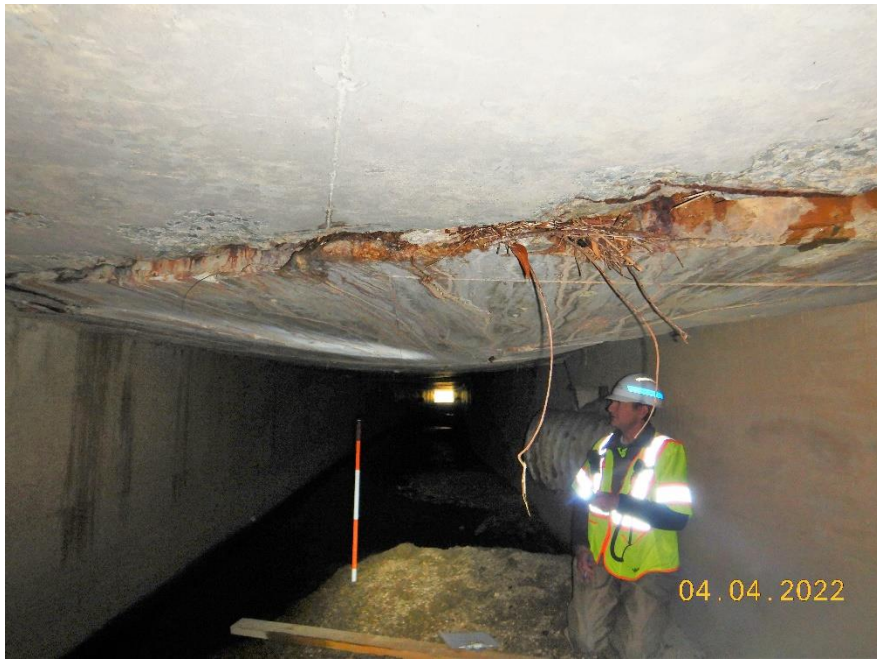
**BARREL #1 - ROOF - SAG – OFFSET AT CONSTRUCTION JOINT - LOOKING TOWARD THE  
OUTLET**

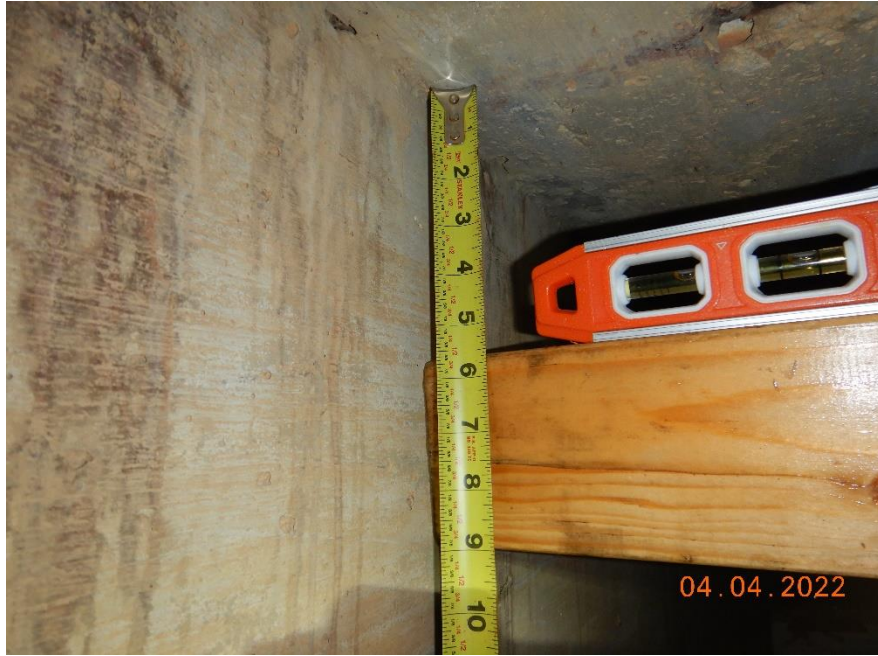
BARREL #2 - MEASUREMENT OF SAG IN THE ROOF – TAKEN AT THE INTERIOR WALL

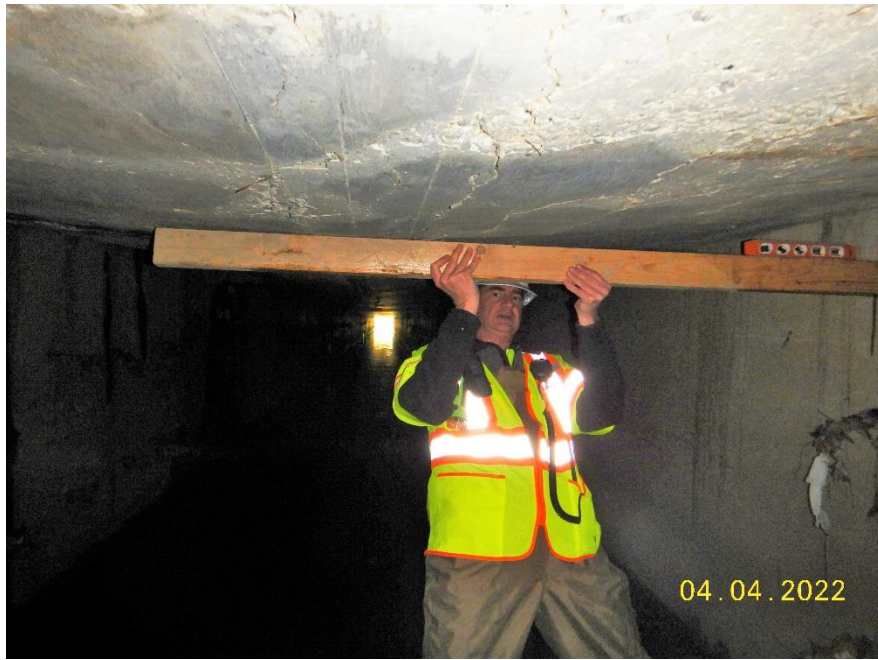
BARREL #2 - MEASUREMENT OF SAG IN THE ROOF

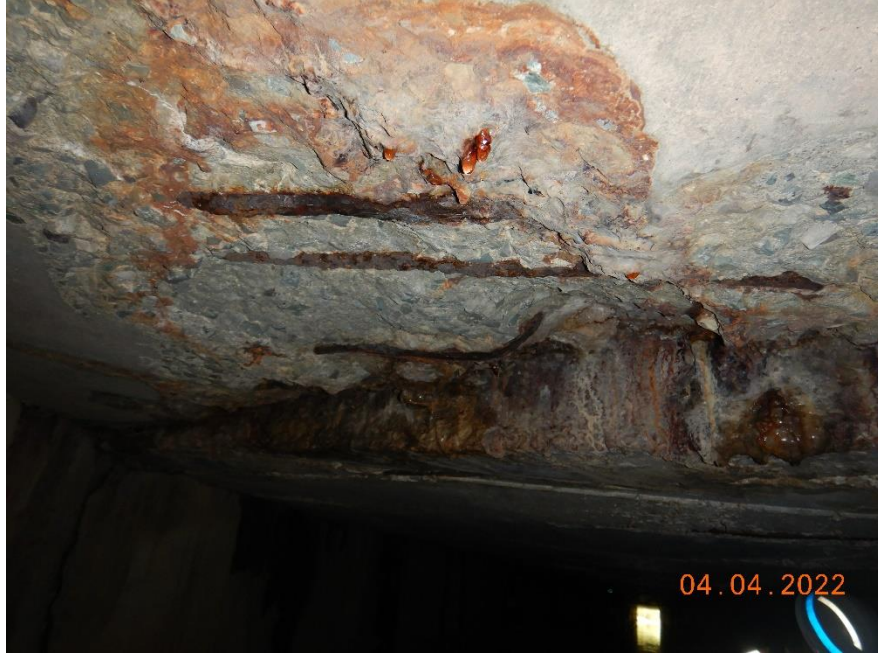
**BARREL #2 - SPALL - EXPOSED REBAR - OFFSET AT CONSTRUCTION JOINT**

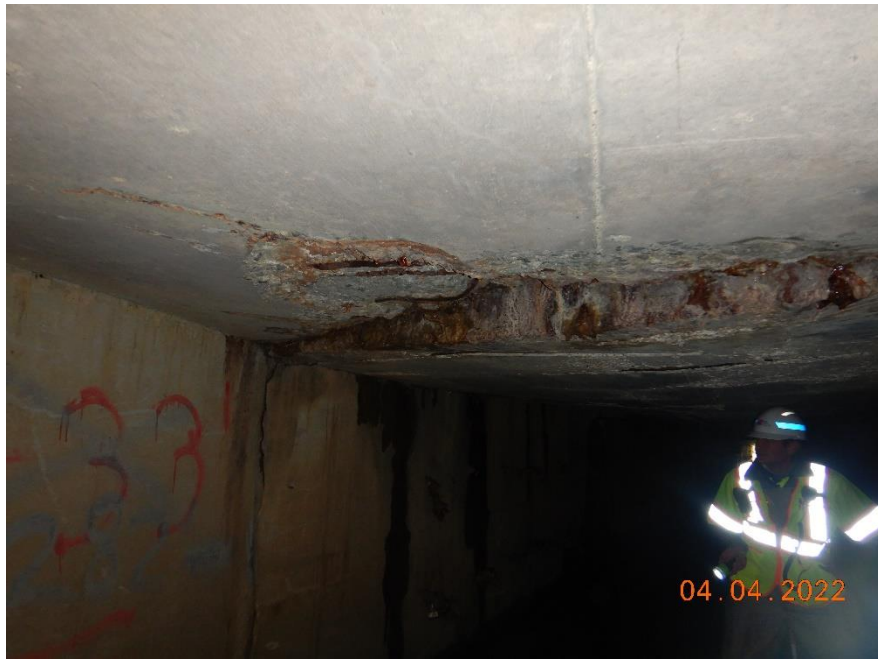
**BARREL #2 - OFFSET AT CONSTRUCTION JOINT**

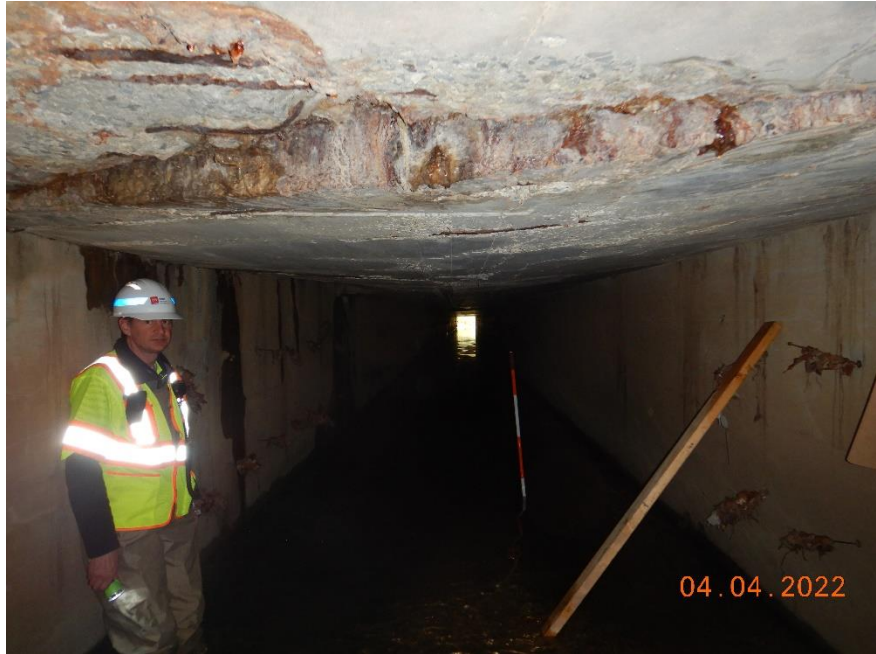
**BARREL #2 - SAG IN ROOF- OFFSET AT CONSTRUCTION JOINT – LOOKING TOWARD THE OUTLET**

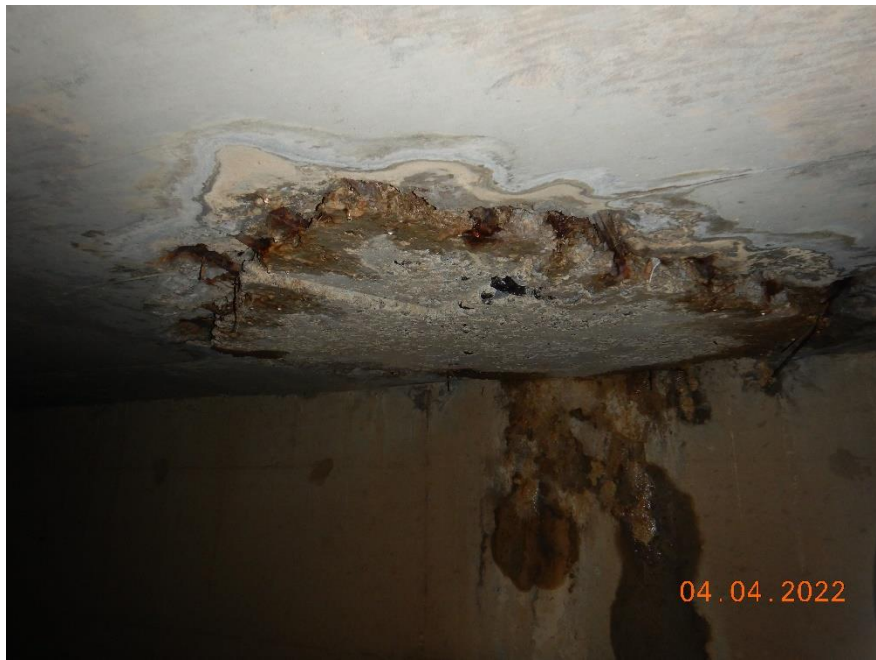
**BARREL #2 - DELAMINATION-SPALL - EXPOSED REBAR – 115 FEET FROM THE INLET – 5 FEET X 5 FEET**
