Hamilton County

Regular Inspection Report

Location: 33-I0075-02.68

3 Span Bridge

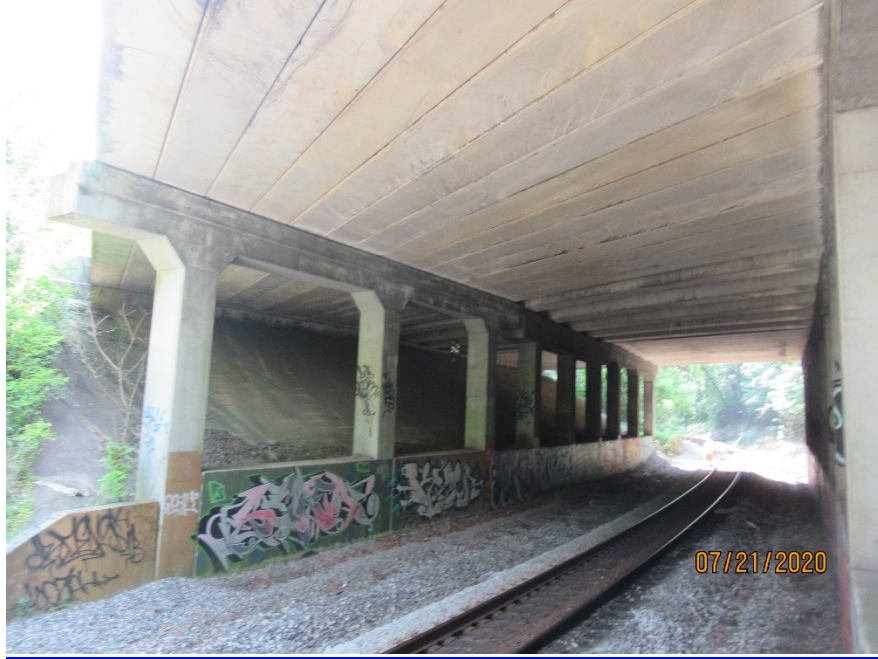
BOTTOM OF DECK

The deck is rated "GOOD". Hairline to wide cracks exist in the wearing surface. On the bottom of the deck, hairline to moderate cracks, some with efflorescence, are present.

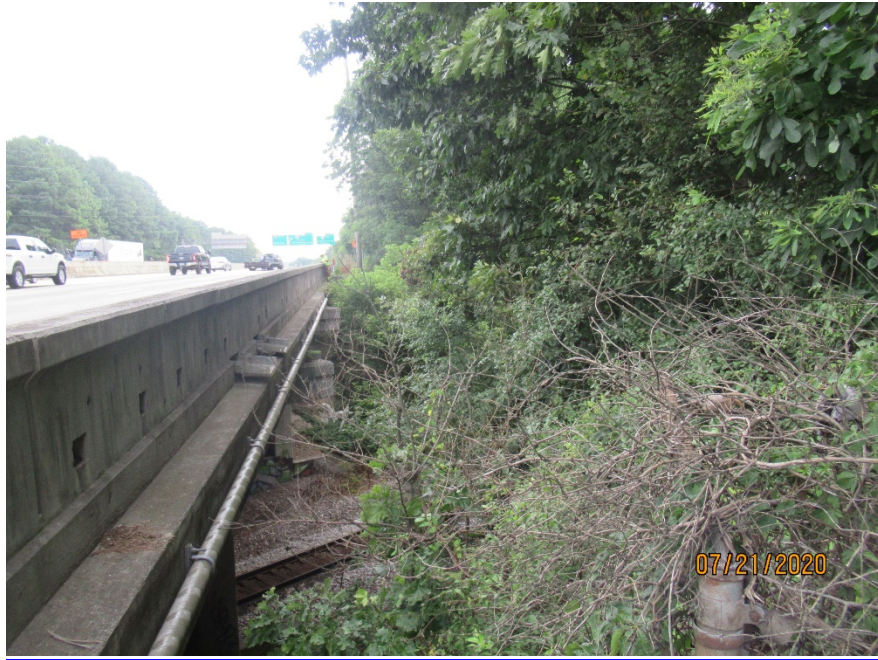
UTILITIES - BEAM "II" OVERHANG

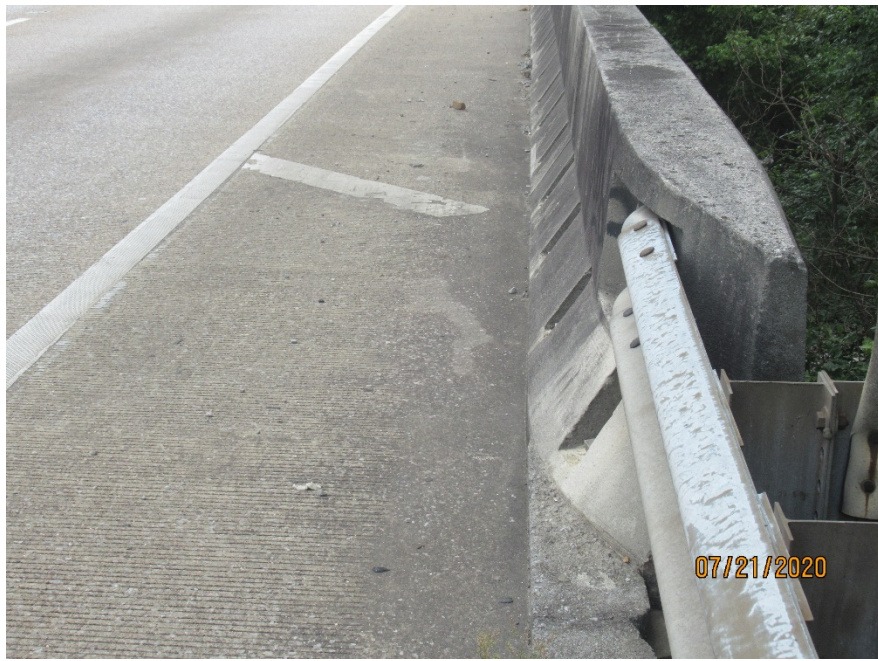
TRAFFIC SAFETY FEATURES

Rating	Standard/ NonStandard	Comments
Bridgerailing	GOOD	Standard	NO VISIBLE DEFECTS FOUND
Transitions	GOOD	Nonstandard	NO SHOE
Approach Rail	GOOD	Standard	NO VISIBLE DEFECTS FOUND
Guardrail Terminal	GOOD	N/A	>100'
Median	GOOD		Closed With Barrier

No.	RECOMMENDATIONS	REPAIR DATE	REPAIRED BY
1.	REPAIR UNDERCUTTING AT ABUTMENT #1, LEFT		
2.	APPROACH GUARDRAIL TRANSITIONS ARE SUBSTANDARD

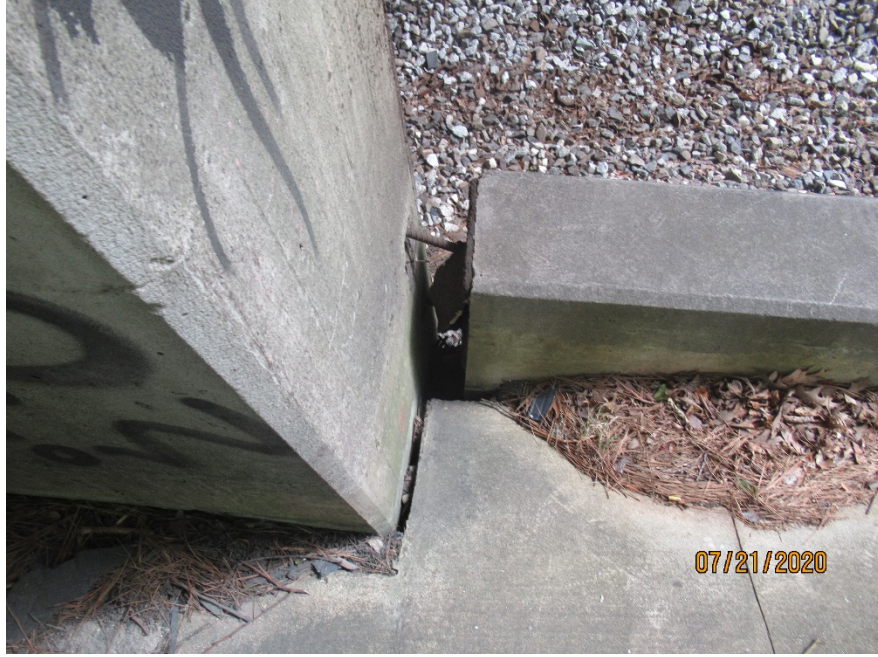
SEPARATION OF RETAINING WALL - BENT #1, RT

Bridge Seat:	GOOD	<i>NO VISIBLE DEFECTS FOUND</i>
Caps	GOOD	<i>DELAMINATION, MODERATE CRACKS</i>
Columns / Shaft	GOOD	<i>FEW MINOR SPALLS</i>
Pier / Crash Walls:	NA	
Plumb	FAIR	<i>BENT #1, RT WALL SEPARATING FROM COLUMN TO 4.5"</i>
Footings	NV	
Piles	NV	
Piles Need Replacement:	NV

The substructure is rated "GOOD". Hairline to moderate cracks, some with efflorescence, exist in the abutments. At Bent #1, right, the retaining wall has rotated out exposing steel. Delamination and moderate cracks are present in the bents.

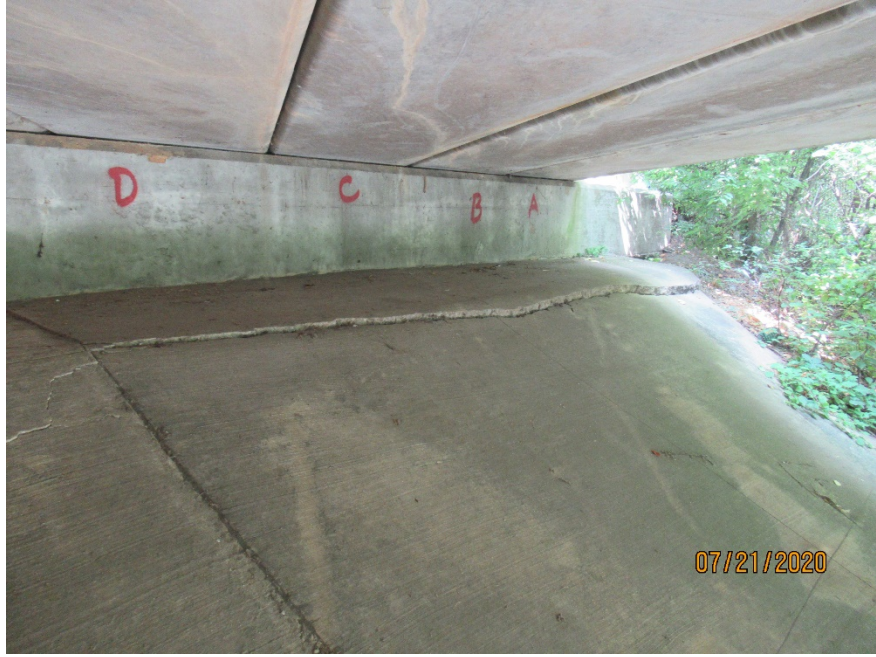
CRACK/SETTLEMENT IN SLOPE PAVEMENT - #1, LT

Wide Cracks - Top of Slope - Soil Visible Beneath Slope Paving

Wide Cracks - Middle and Bottom of Slope -

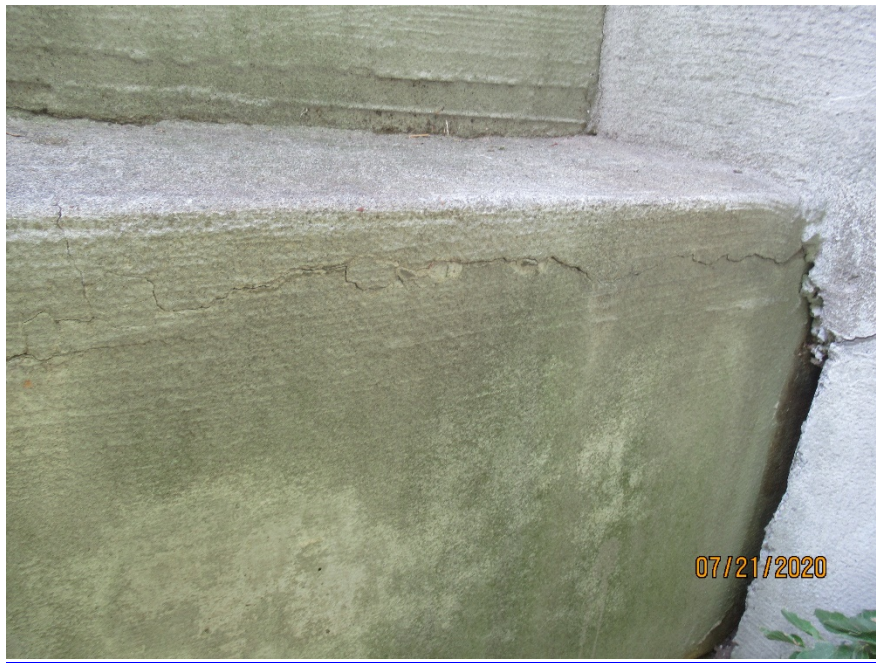
CRACK - BEAM "A", LT FACE AT ABUTMENT #1

The superstructure is rated "FAIR". Hairline to wide cracks exist in the beams along with delamination, patches, rebar popouts and a spall with prestressed cable exposed.

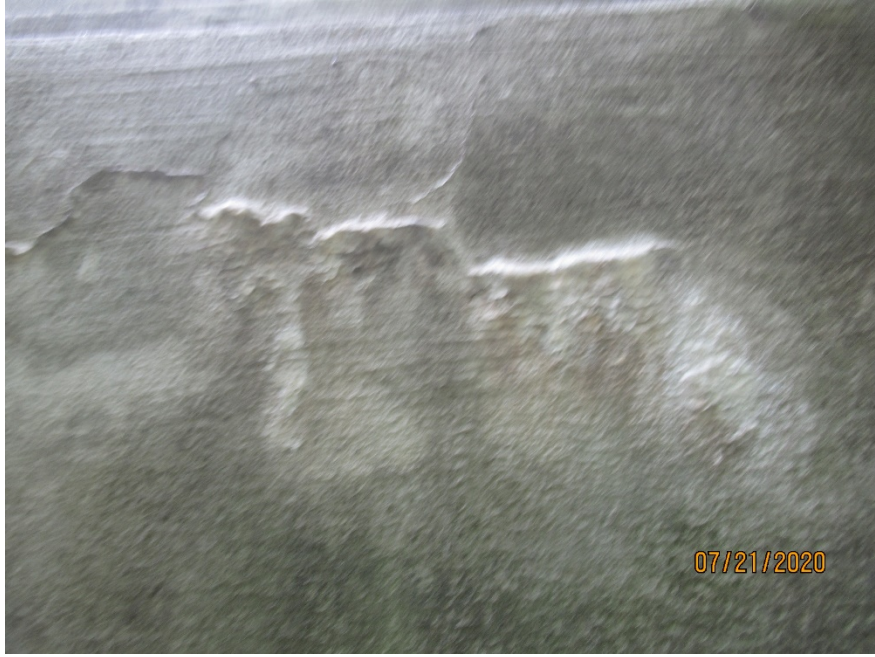
CRACK W/ EFFLORESCENCE - BEAM "A", LT FACE AT ABUTMENT #1

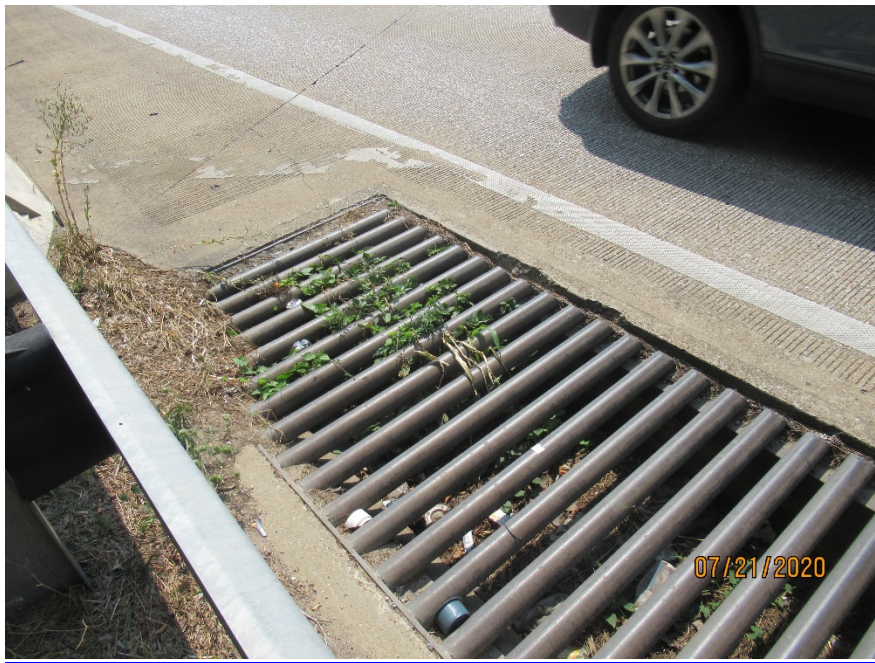
DRAIN CLOGGED - APPROACH #1, LT

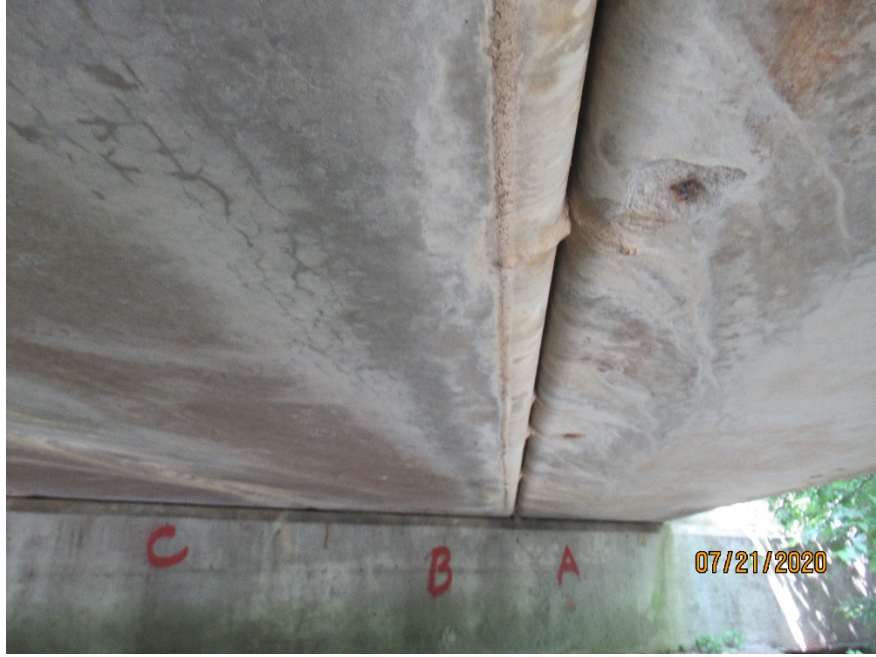
EFFLORESCENCE ACCUMULATION BETWEEN BEAMS "A" AND "B" – SPAN #1

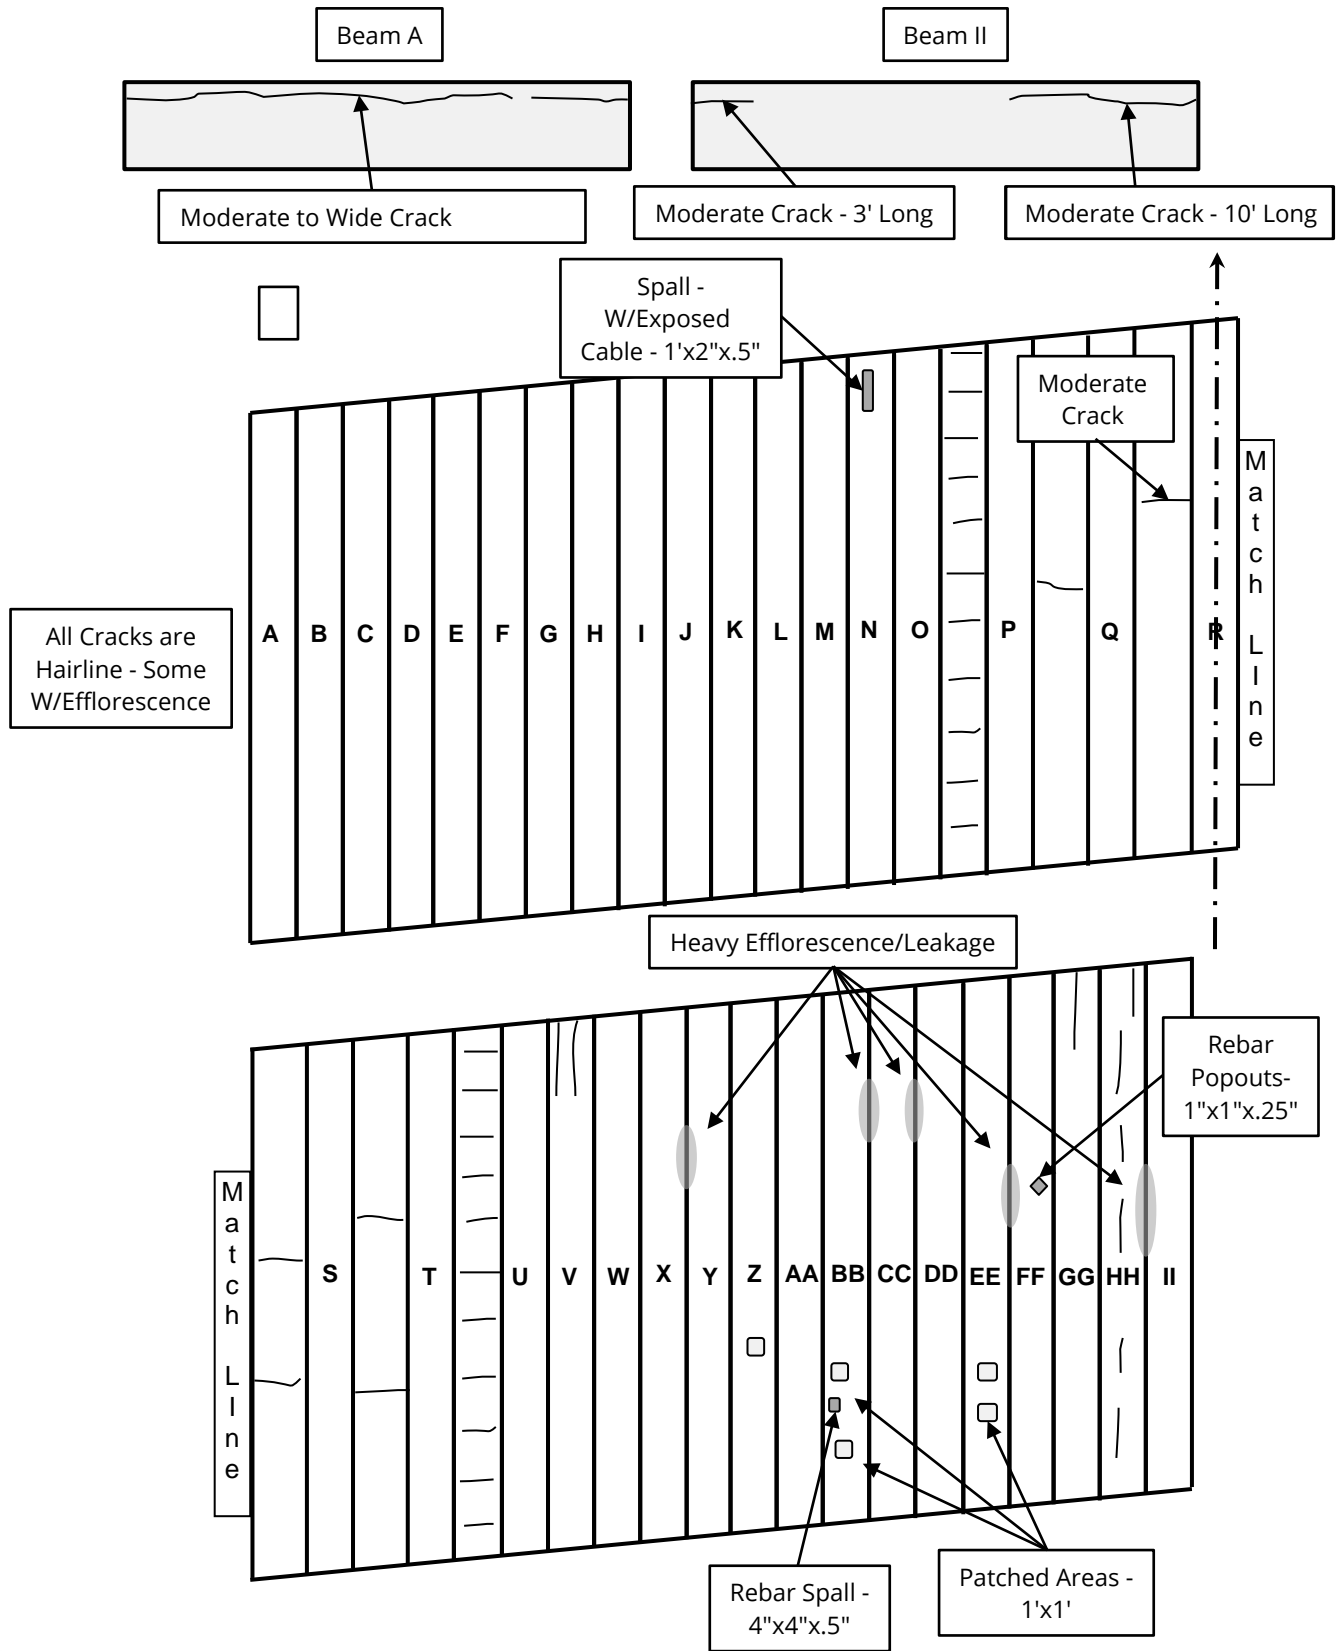
Rust Stains are present on some beams.
Cracks W/Efflorescence present in Bay between beams O and P and T and U.

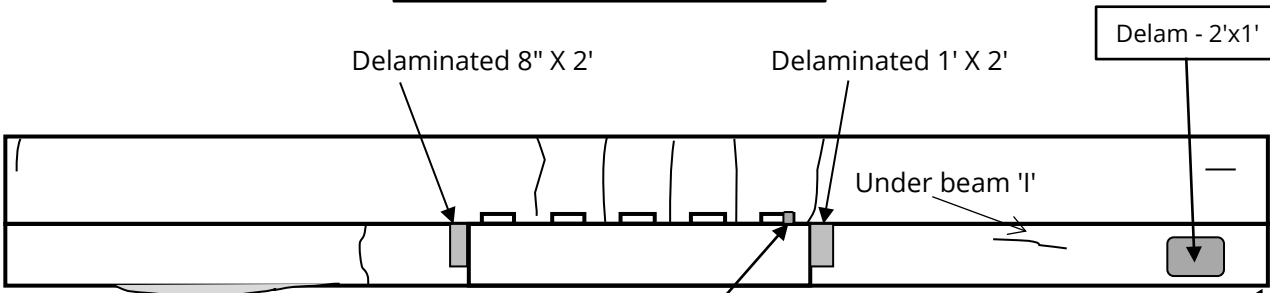
Gap of 3" between slope pavement and abutment

Spall - 6"x2"x1"

Undercutting - 2.8'x6"x3' Back Under
