HAMILTON COUNTY

33-03609-01.13
33I00240063 (I-24 LM 14.08)
Spring Creek OVER I-24 Westbound
3-SPAN

BRIDGE INSPECTION REPORT

Field Report No. 23 Date 10/3/2016
Previous Report No. 22 Date 10/9/2014
Plans: DESIGN

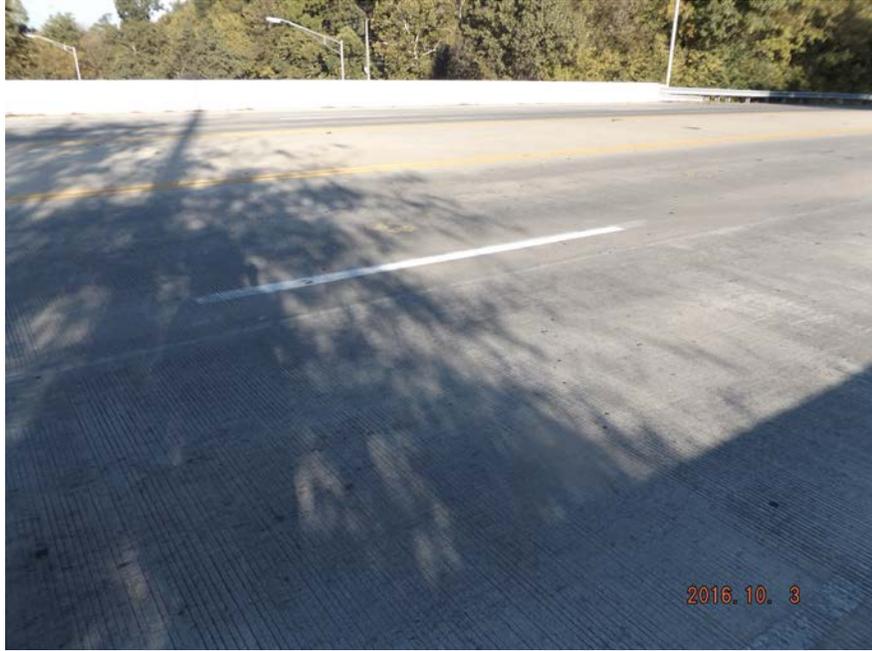
WEARING SURFACE

Rating	Comments
Wearing Surface	GOOD	<i>HAIRLINE CRACKS. SMALL CRACKS AT SPAN ENDS.</i>
Deck - TRIMS Item 58	6	
Deck - Structural Condition	N/A	<i>ASPHALT ON TOP OF HOLLOW BOX BEAMS</i>
Curbs	NA	
Median	GOOD	<i>CLOSED - NO CURB</i>
Sidewalks	NONE	
Paint	NA	
Drains	NONE	
Lighting Standards	NONE	
Utilities	NONE	
Joint Leakage	GOOD	
Expansion Joints	GOOD

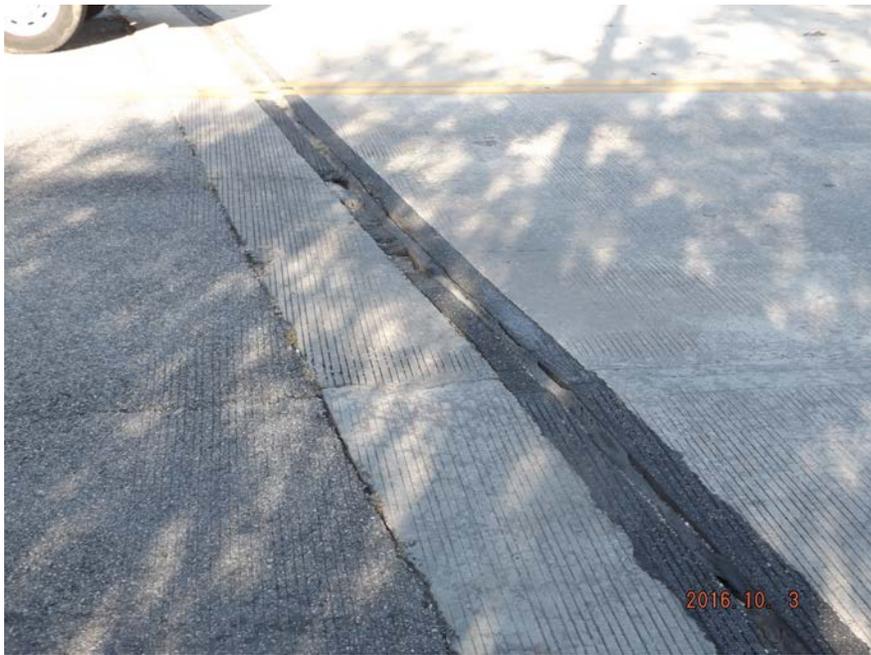
APP. 1 R/SIDE-VOIDS-FILLER MISSING-UNEVEN

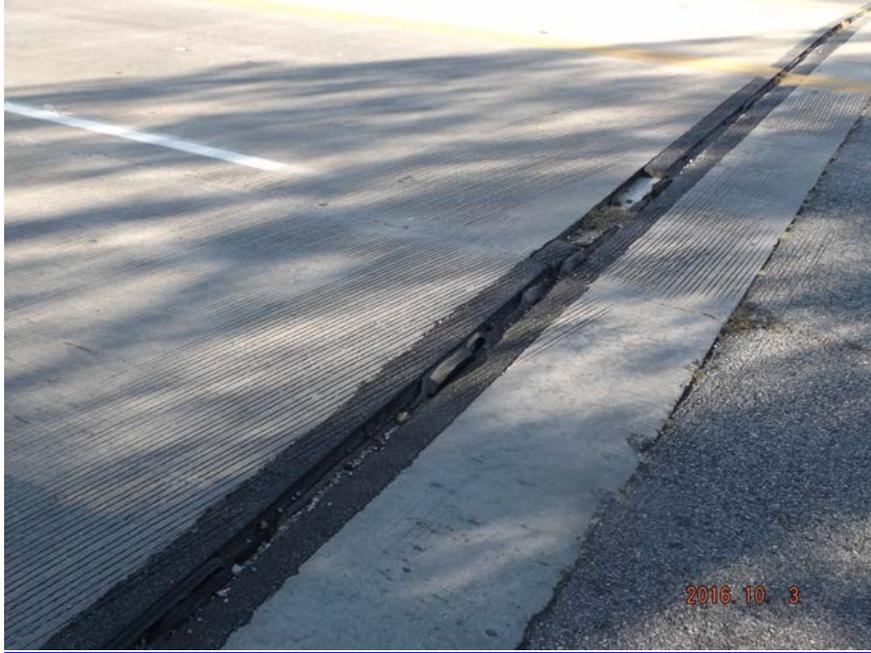
APP. 2-R/SIDE-VOIDS-FILLER MISSING-UNEVEN

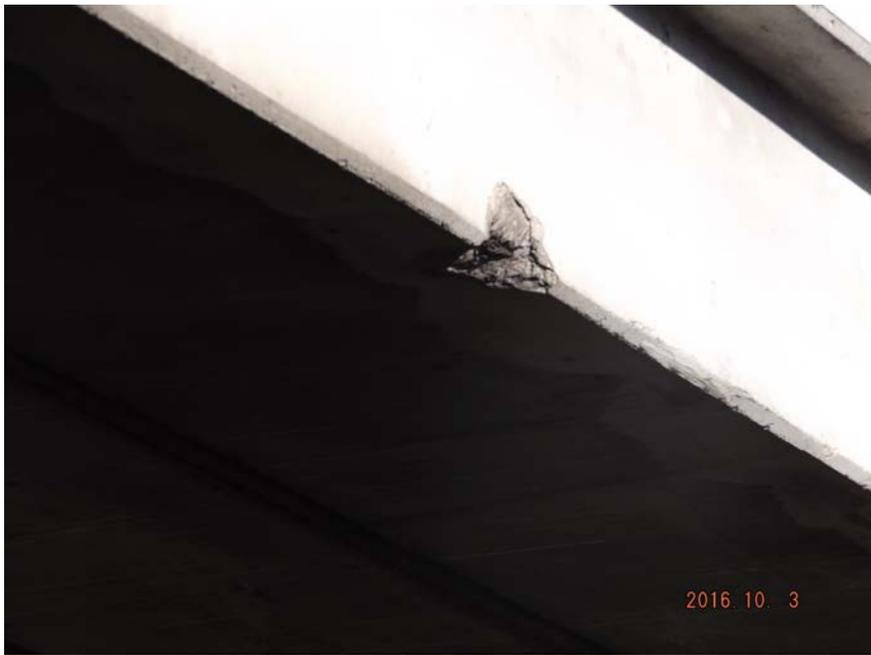
R/SIDE-BEAM X-COLLISION SPALL

Super: TRIMS Item 59	5	
Bearing Devices	GOOD	
Girders or Beams	GOOD	<i>BEAM X - COLLISION SPALL</i>
Floor Beams	NA	
Stringers	NA	
Diaphragms	NA	
Bracing	NA	
Paint	NEEDEDE	<i>SPAN 2 - BEAM X - PROTECT EXPOSED REBAR WITH RUSTPROOF PAINT</i>
Alignment of Members	GOOD	
Trusses - General	NA	
Portals	NA	
Bracing	NA

SPAN 2 - BEAM X - PROTECT EXPOSED REBAR WITH RUSTPROOF PAINT

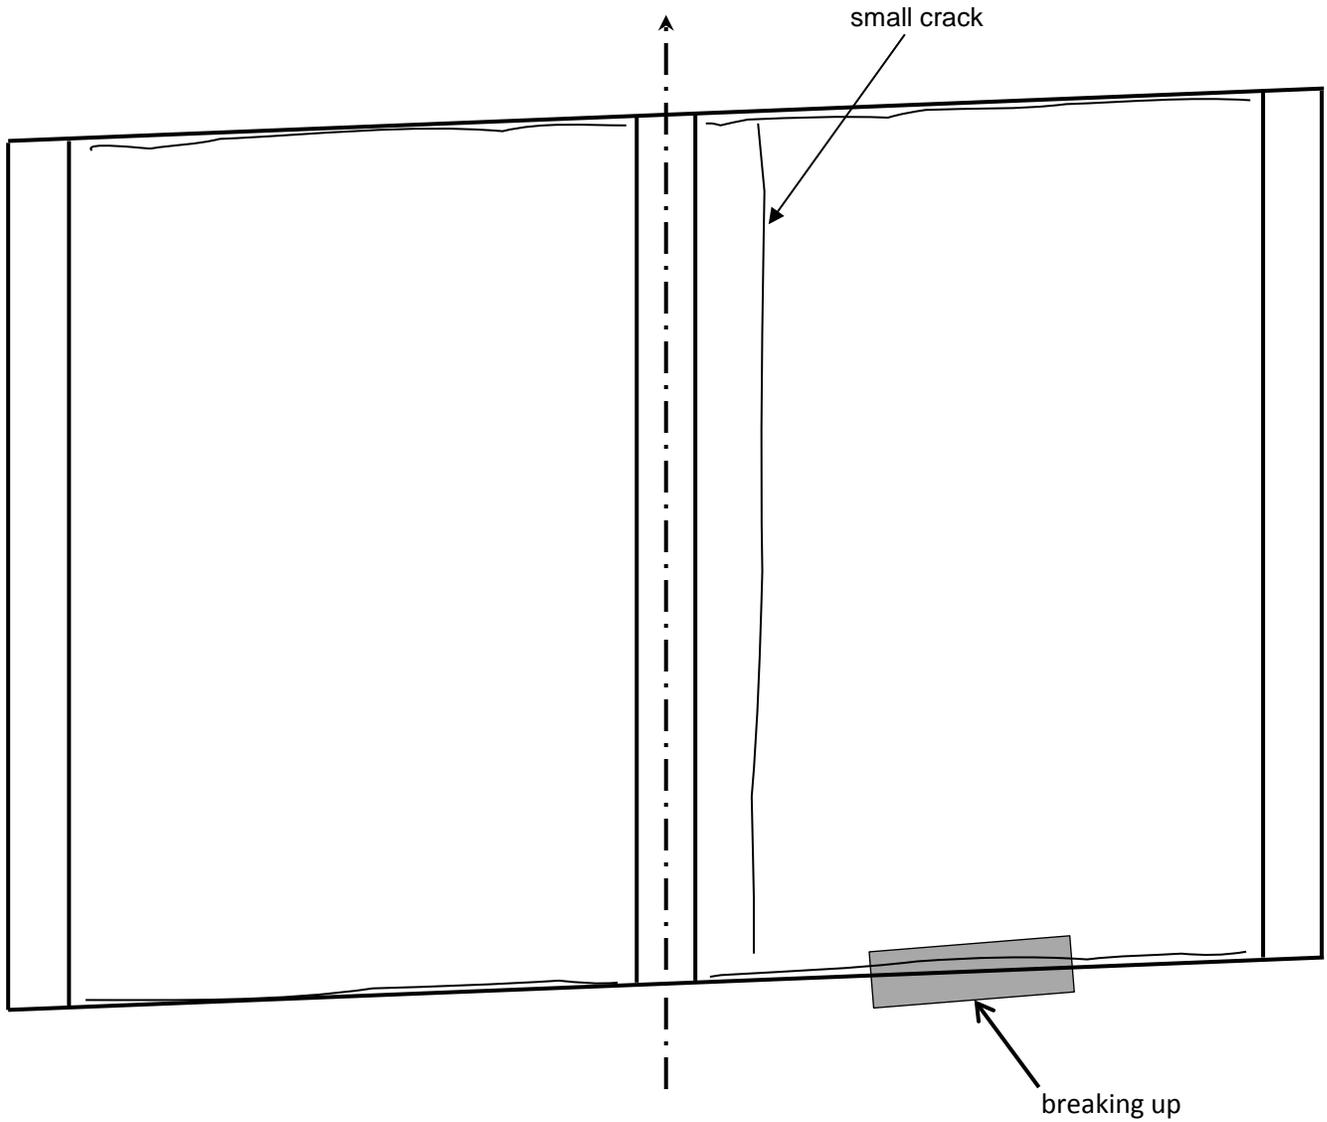
Top of Deck Span No. 1

Wearing surface: G HL cracks

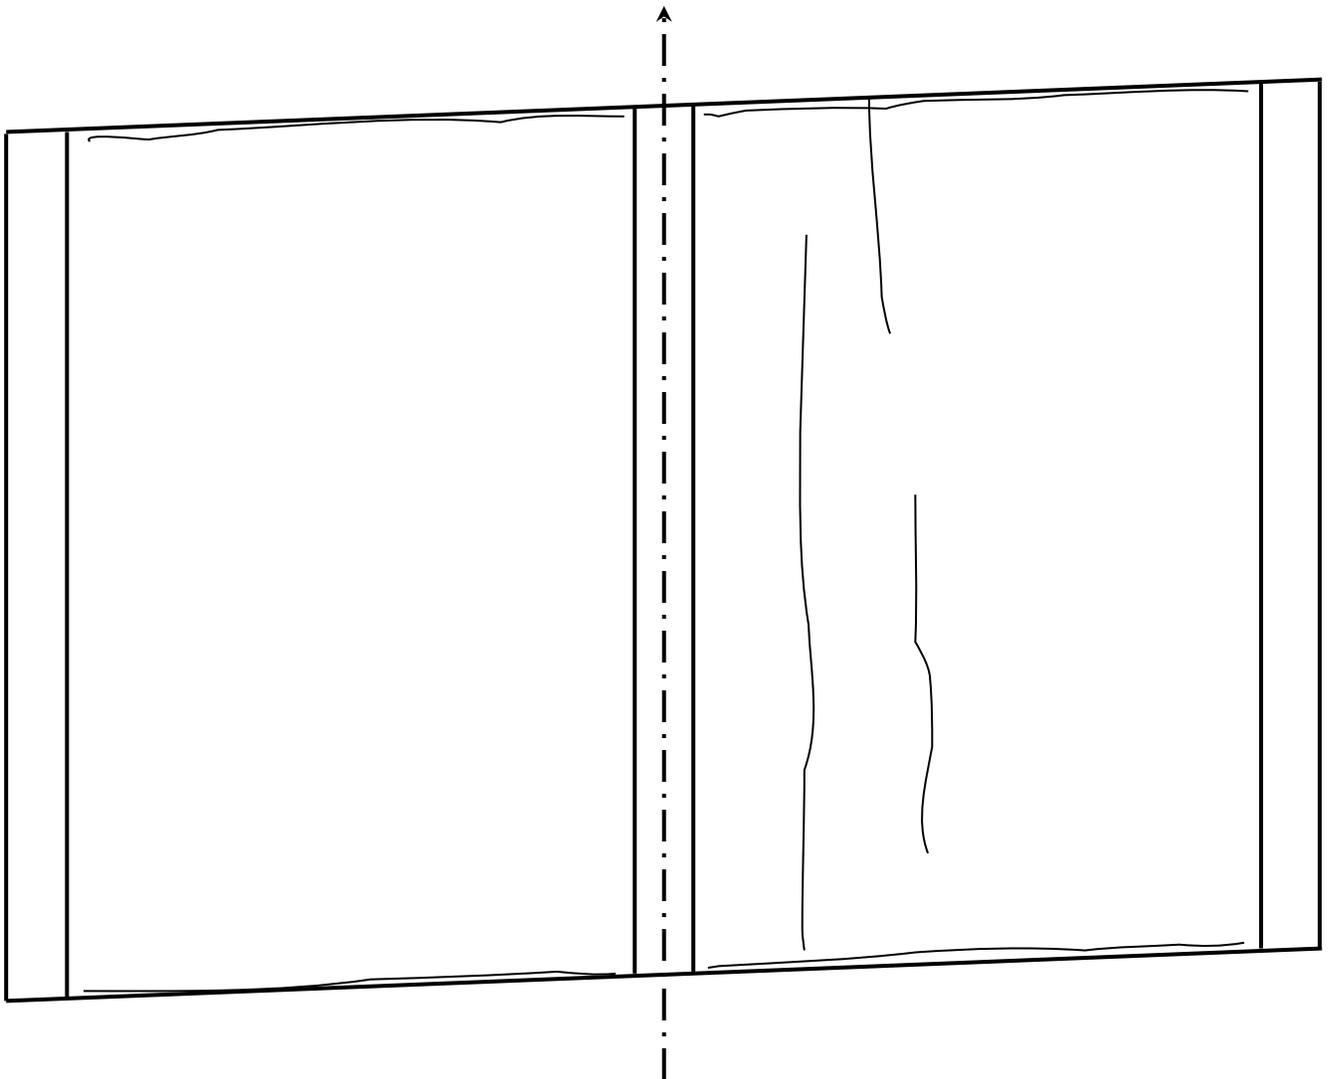
Top of Deck Span No. 2

Wearing Surface: G HL cracks

small-large cracks over joints

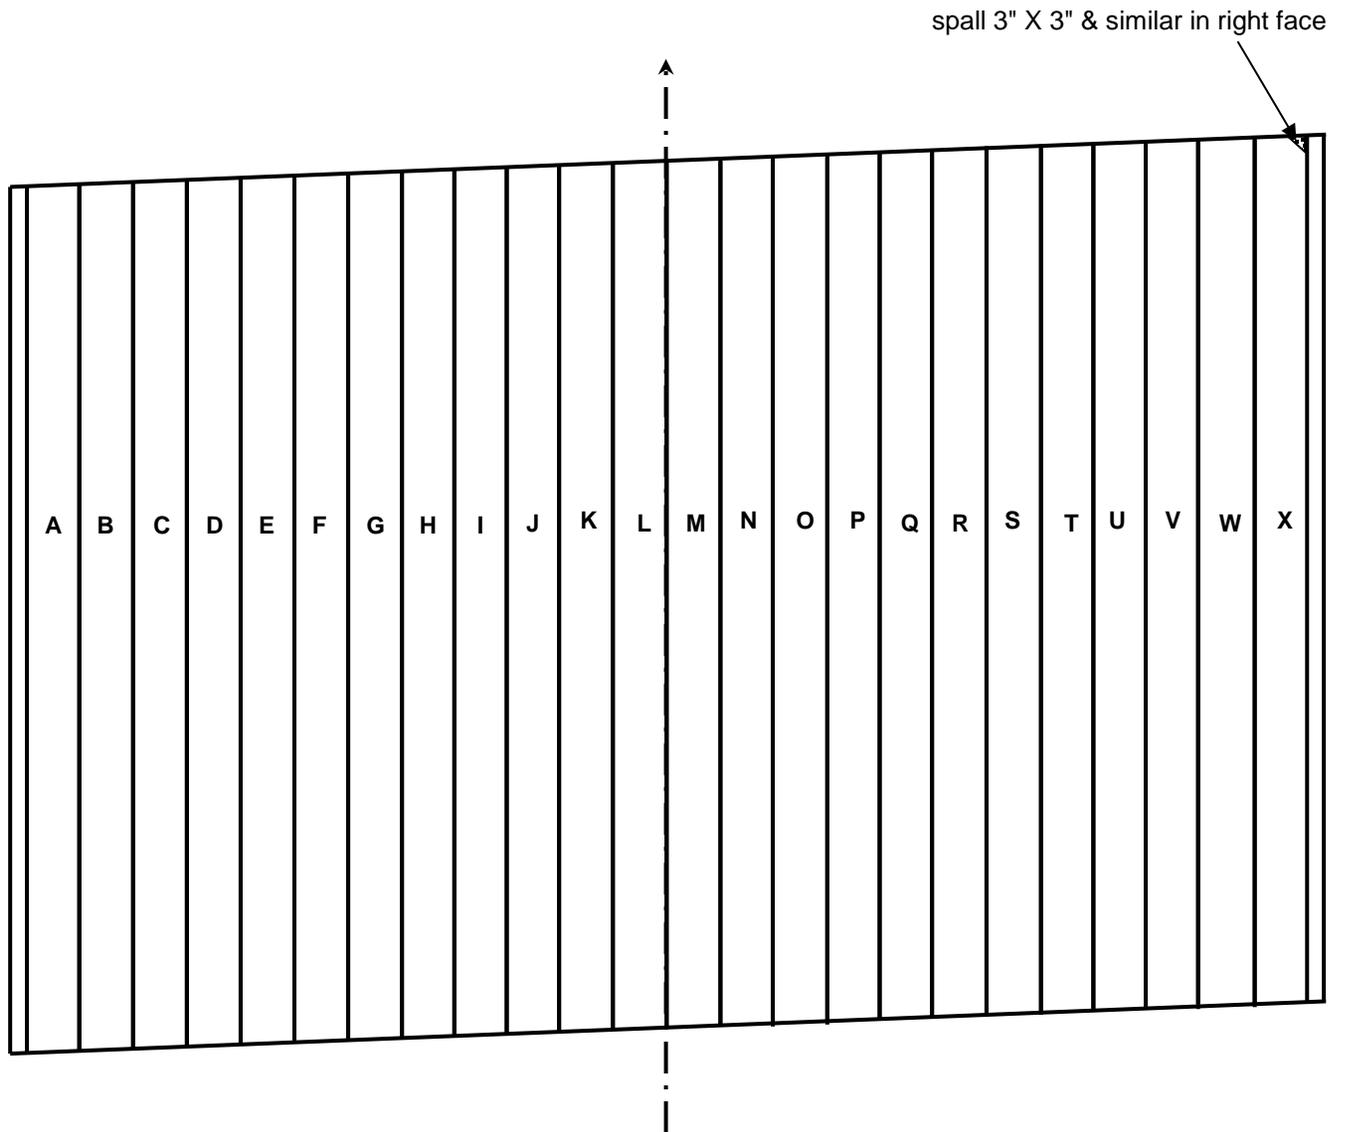
Bottom of Deck Span No. 1

Beams: G C & J - HL cracks. S - HL crack w/ rust stains. A, B, W, & X - eff between beams

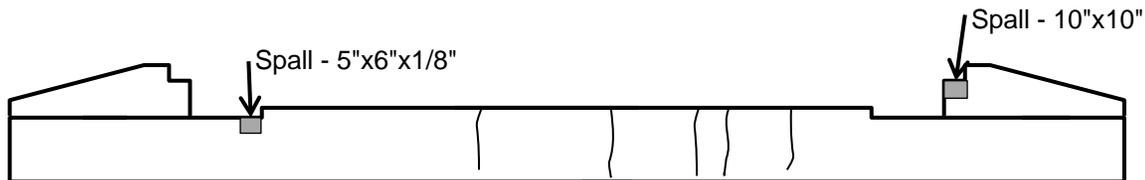
Abutment No. 1

cracks are hairline & hairline-small

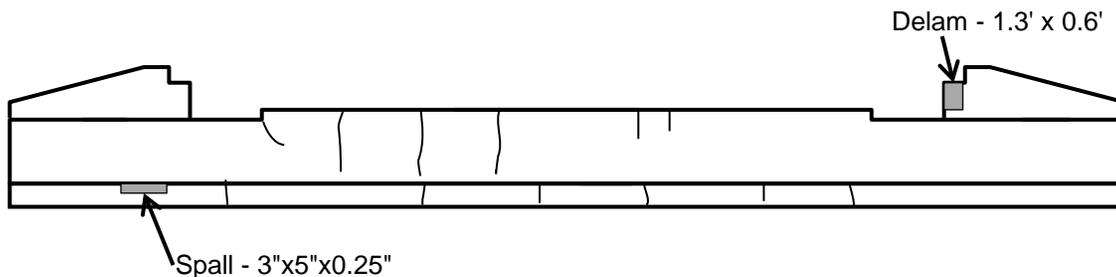
Abutment No. 2

cracks are hairline & hairline-small
