## Hamilton County

### Regular Inspection Report

Location: 33-I0075-01.38

3 Span Bridge

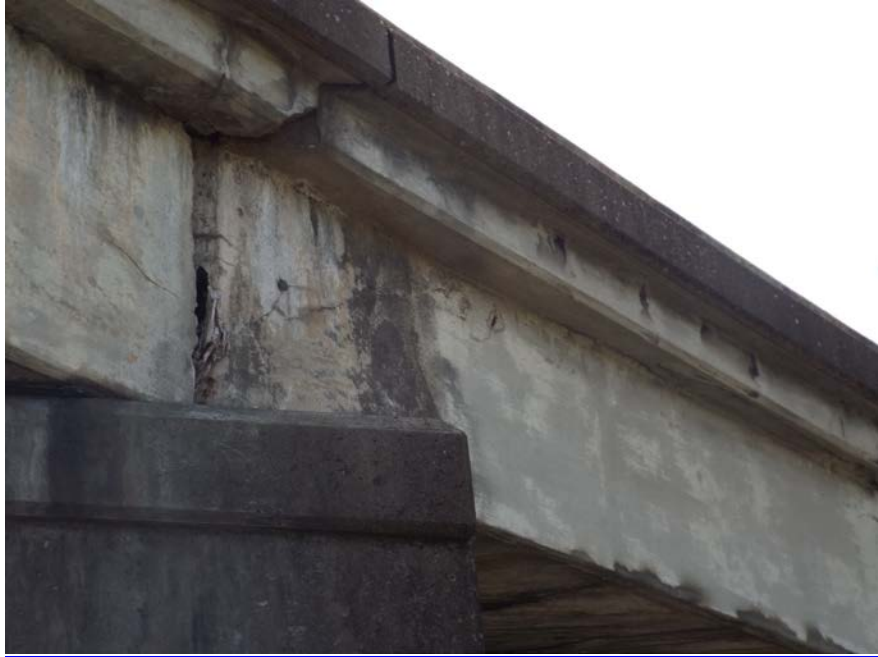
BEAM K - CRACKS AT BENT 1

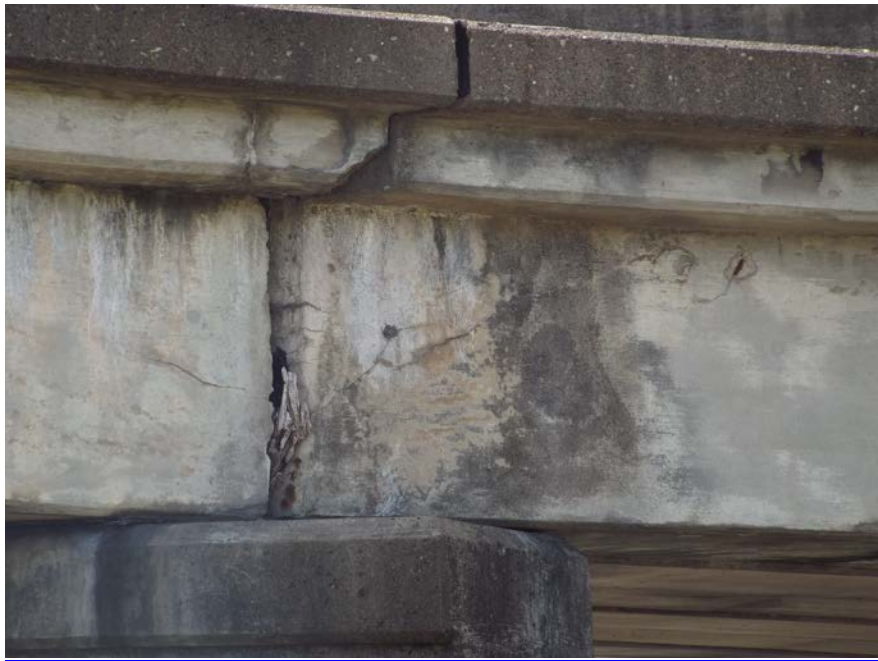
BEAM K - CRACKS AT BENT 1

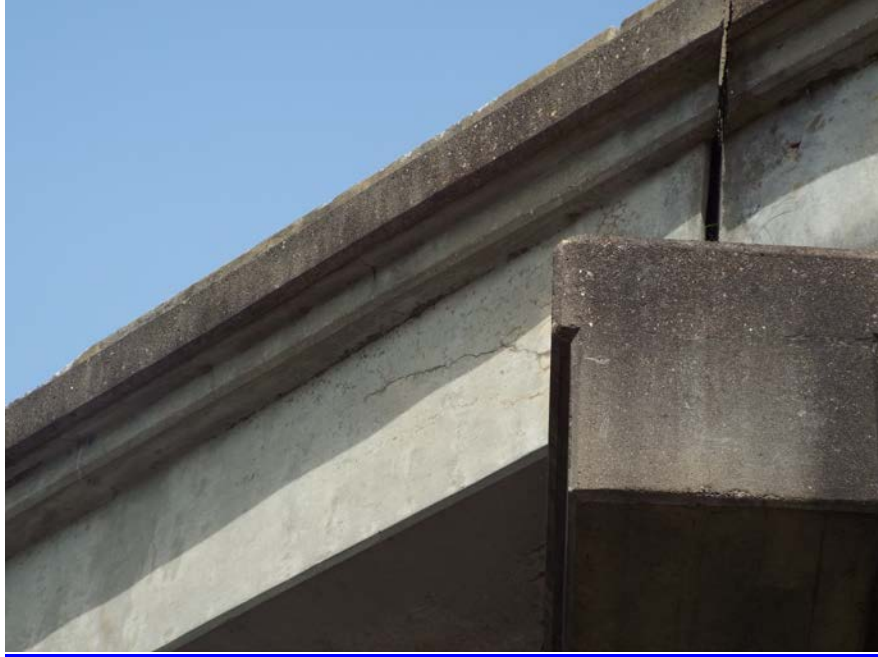
BEAM A - SPAN 2 - CRACK

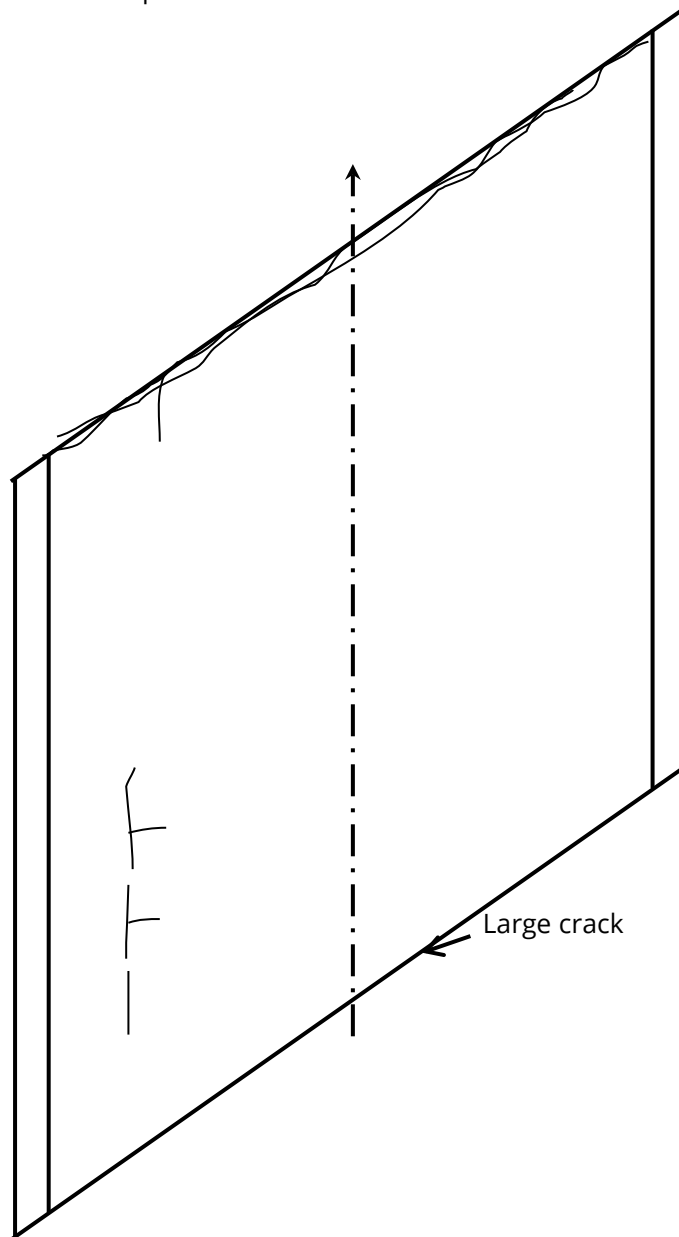
Bridge Rail: F collision spalls

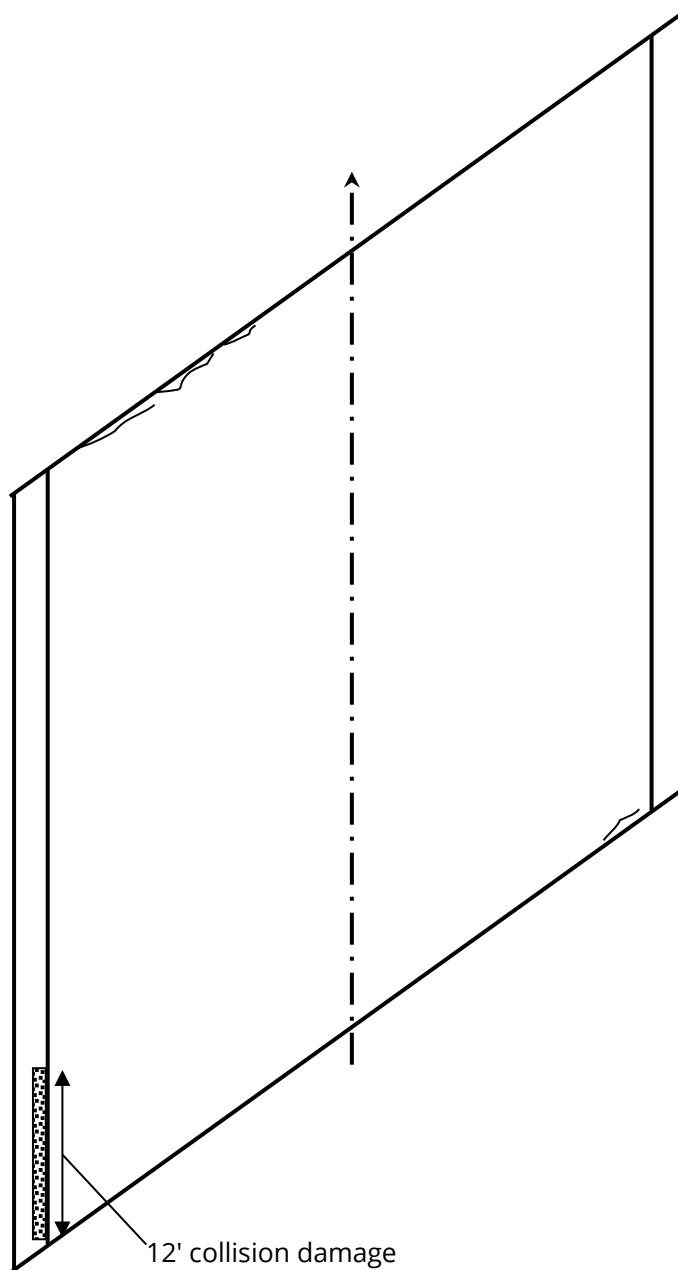
Bridge Rail: F collision spalls

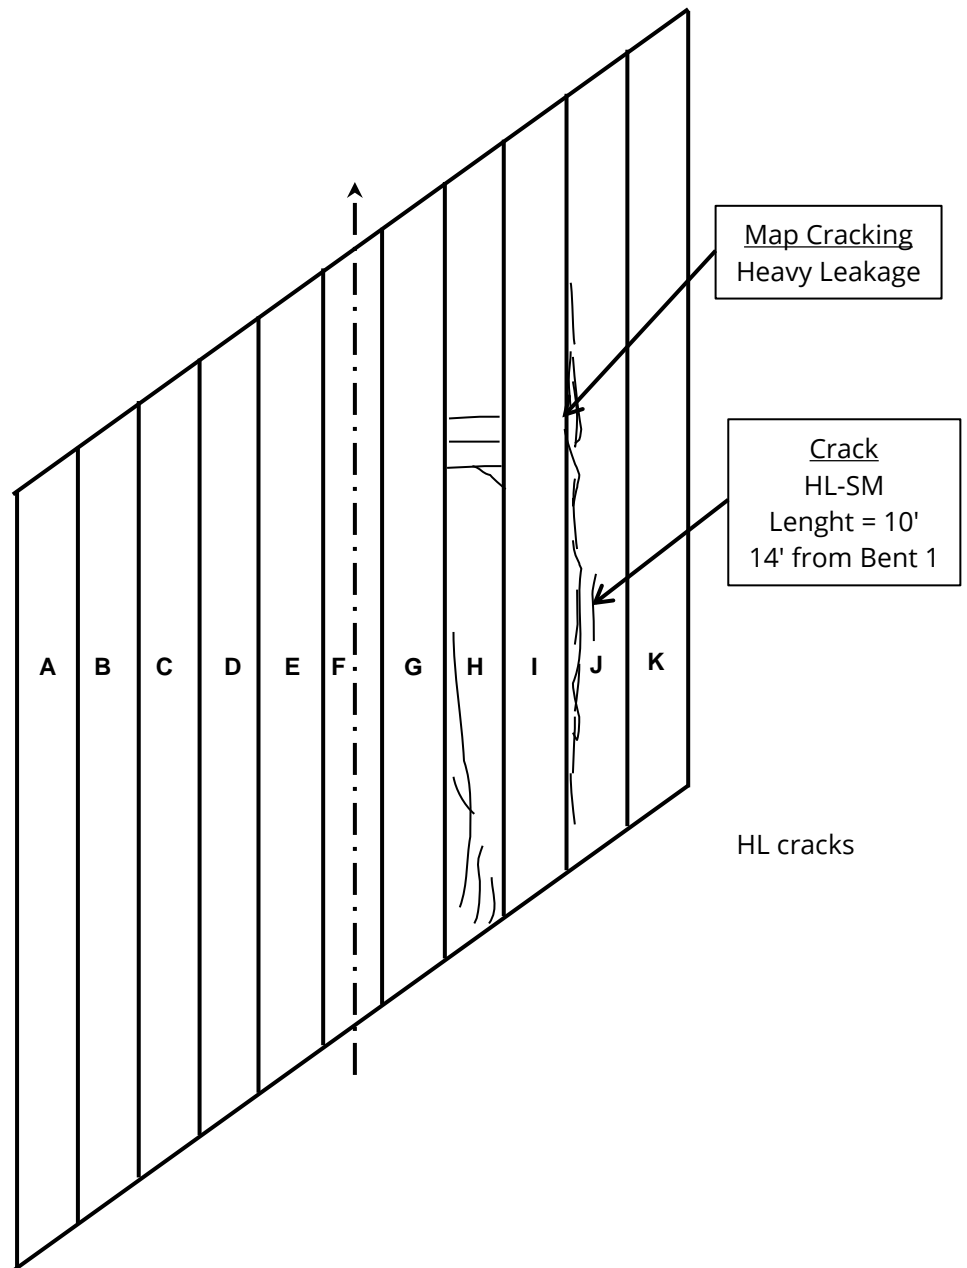
Beams: GF HL cracks

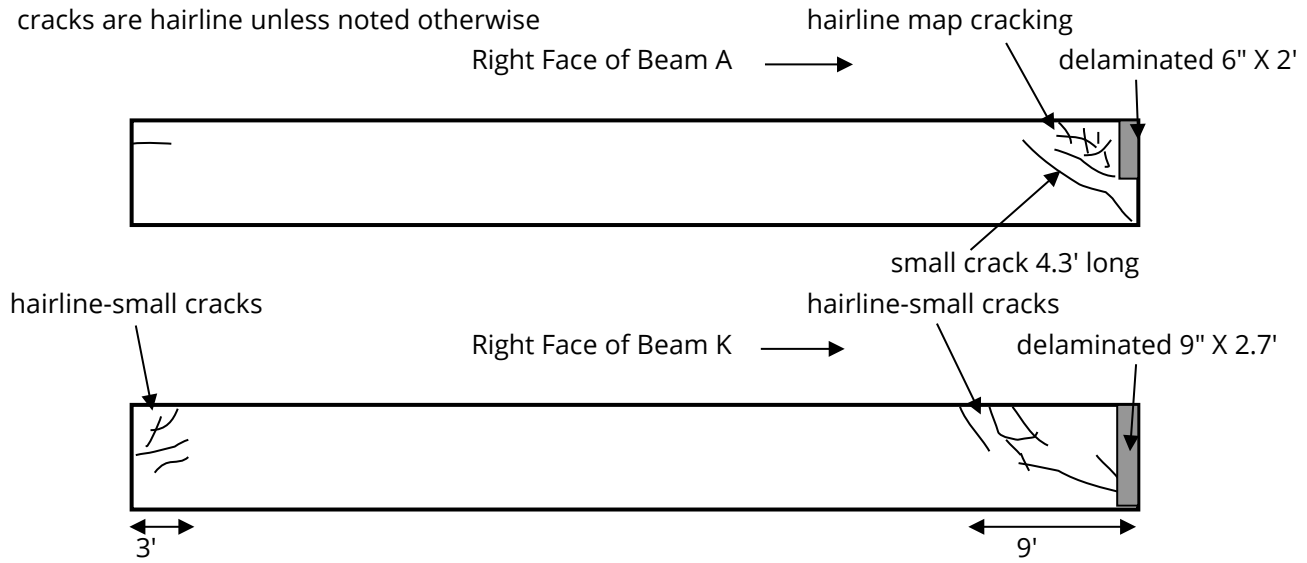
cracks are hairline unless noted otherwise

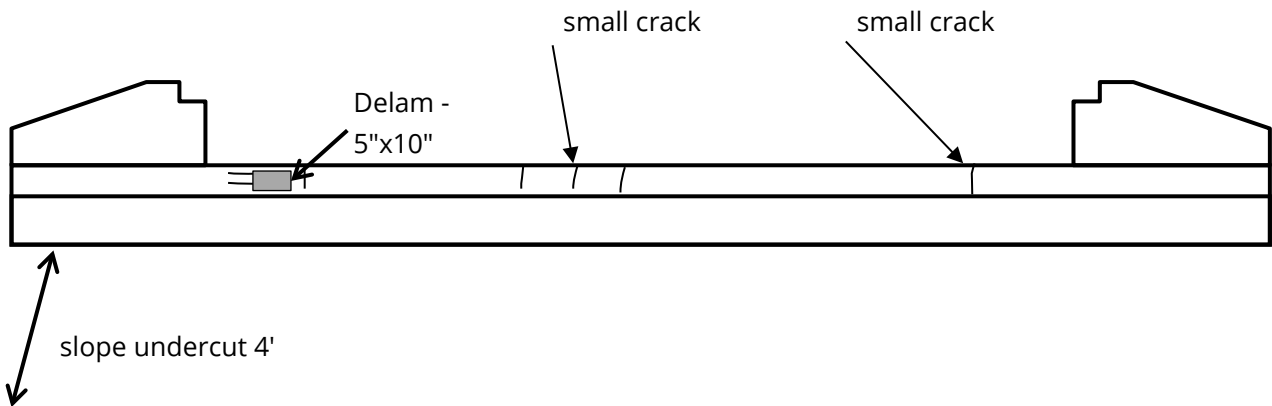
Walls: G SM cracks

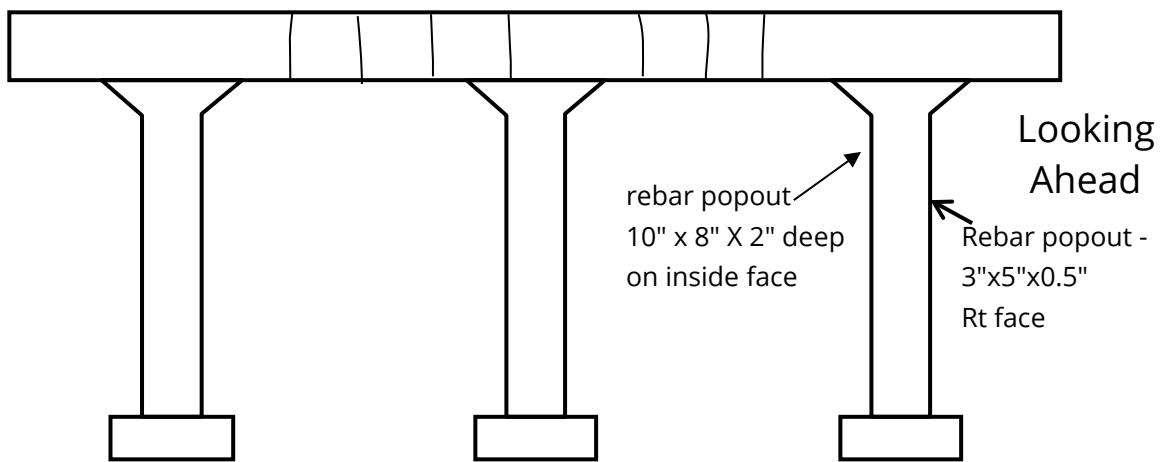
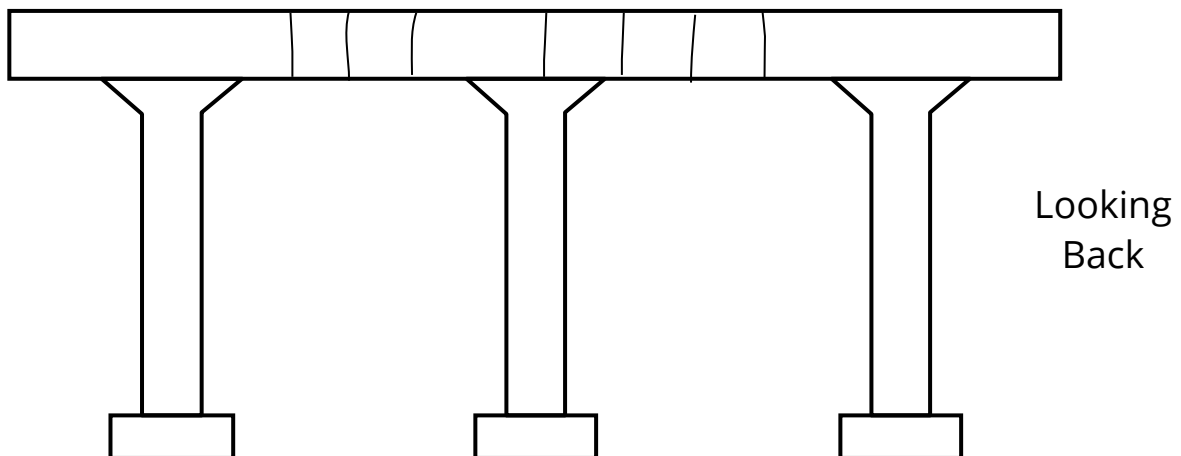
Columns: GF Heavy vegetation growth around  
base of columns  
Cap: G

**SUGGESTED ROUTINE MAINTENANCE AND COMMENTS**  
 CLEAR VEGETATION FROM ABUTMENT #1, Right
