Hamilton County

Regular Inspection Report

Location: 33-I0075-01.41

Inspection Date: July 12, 2016

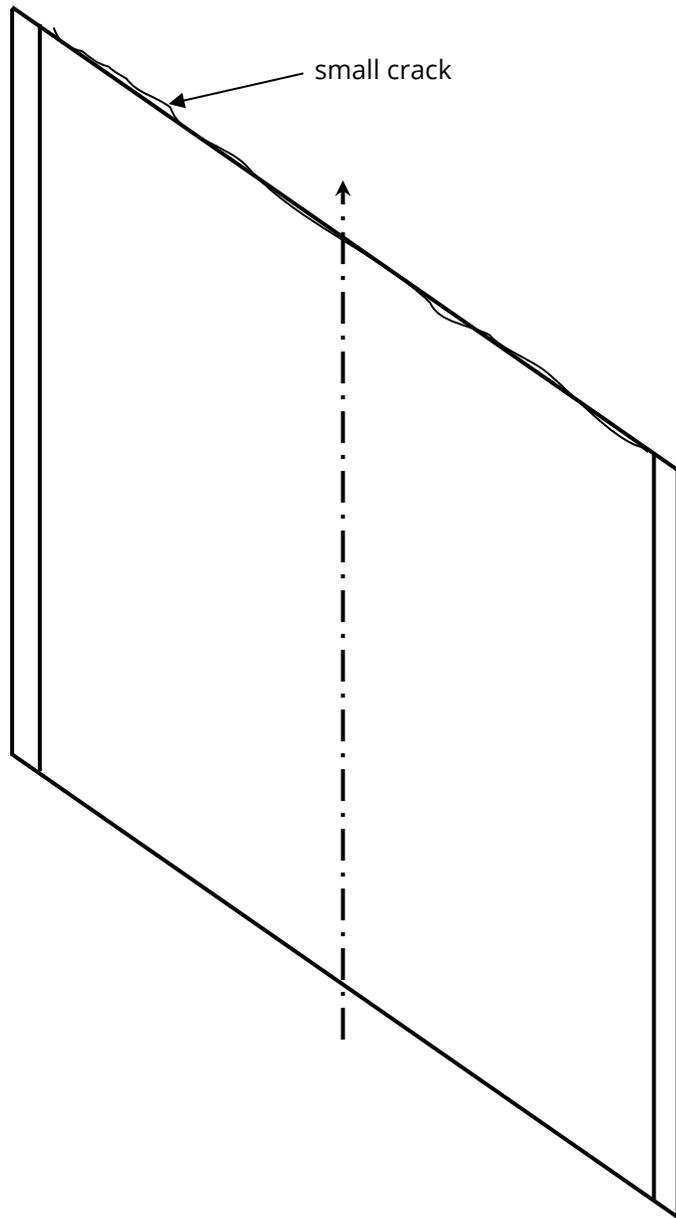
Bridge Rail: GF HL vertical cracks

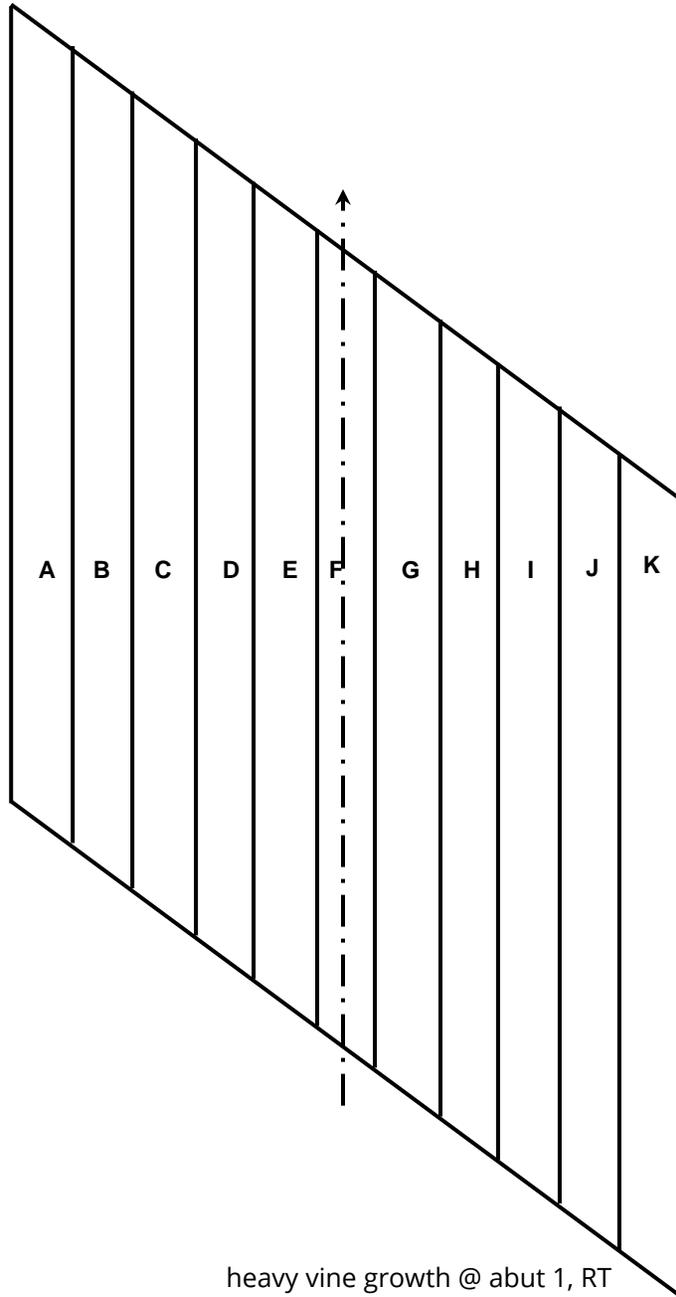
heavy vine growth @ abut 1, RT
between beams J & K

Beams: G, 'J', 'H', 'E' - rebar popouts 3"x3"

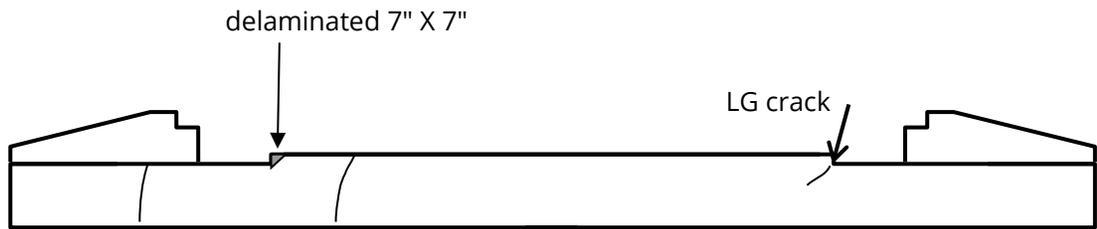
cracks are hairline

Slope - Undercut 6 ft
