HAMILTON COUNTY

33-03609-01.08
33I00240079 (I-24 LM 14.08)
Spring Creek OVER I-24 Eastbound
3-SPAN

BRIDGE INSPECTION REPORT

Field Report No. 23 Date 10/3/2016
Previous Report No. 22 Date 10/9/2014
Plans: DESIGN

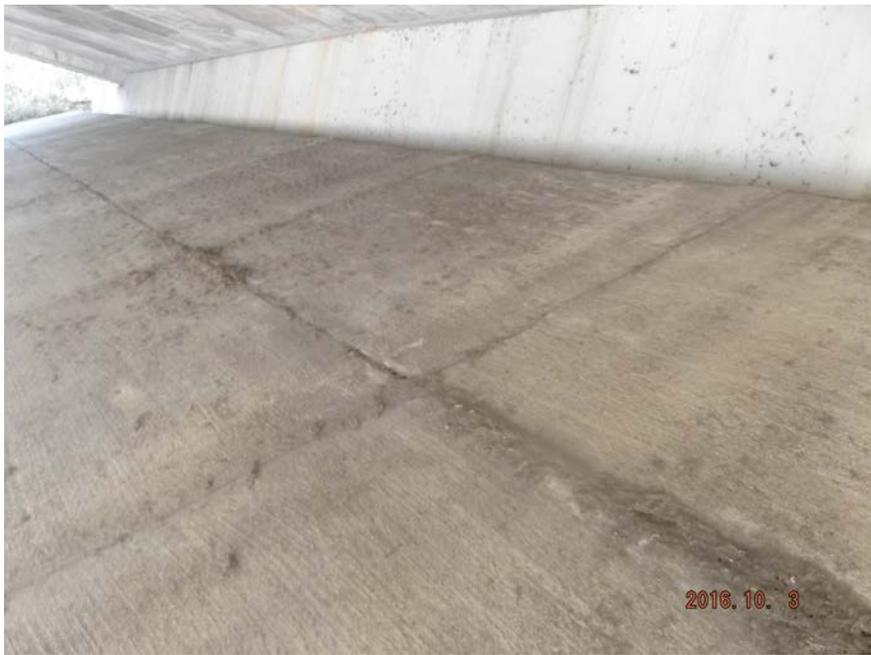
GENERAL BARREL CONDITION-ABUTMENT 2-TYPICAL

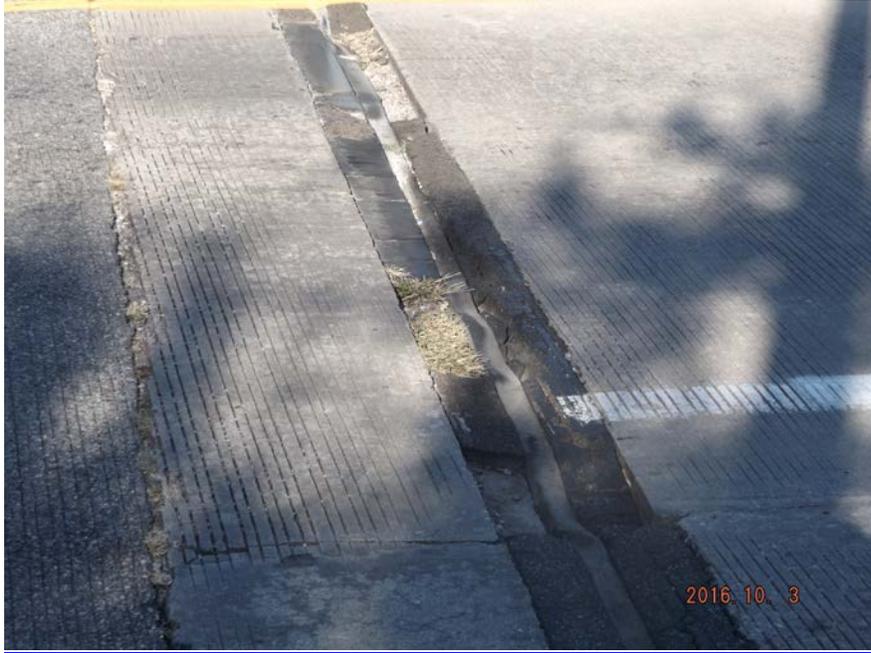
APP. 1 R/SIDE-VOIDS-FILLER MISSING

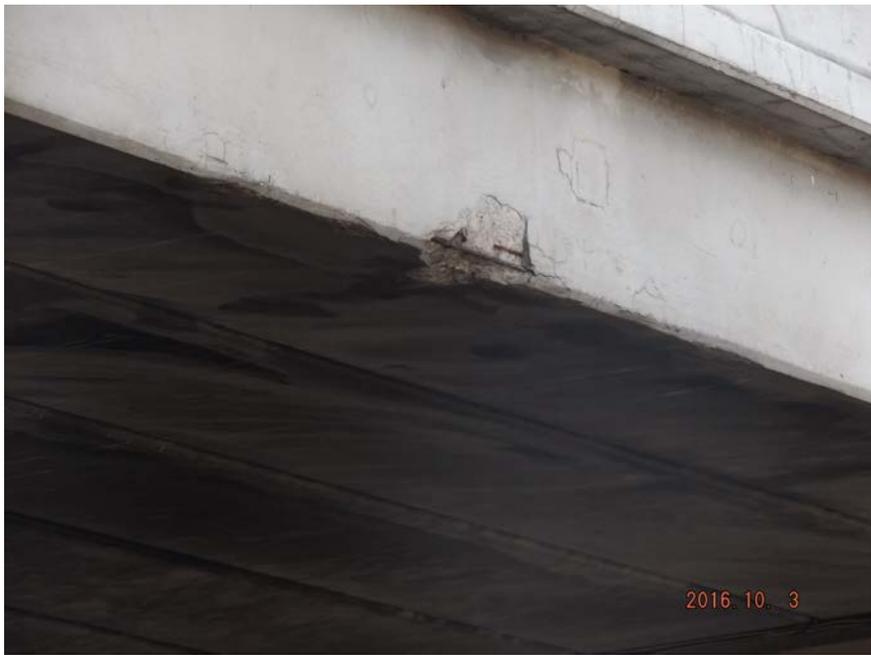
BEAM A-L/SIDE-COLLISION REBAR SPALL

Super: TRIMS Item 59	5	
Bearing Devices	GOOD	
Girders or Beams	GOOD	<i>SMALL COLLISION SPALL. CRACKS, DELAM, PATCHES.</i>
Floor Beams	NA	
Stringers	NA	
Diaphragms	NA	
Bracing	NA	
Paint	NEEDED	<i>SPAN 2 - BEAMS A & X - EXPOSED REBAR NEEDS A PROTECTIVE COAT OF RUSTPROOF P</i>
Alignment of Members	GOOD	
Trusses - General	NA	
Portals	NA	
Bracing	NA

SUGGESTED ROUTINE MAINTENANCE AND COMMENTS
BEAM A & X - PAINT EXPOSED REBAR WITH RUSTPROOF PROTECTION

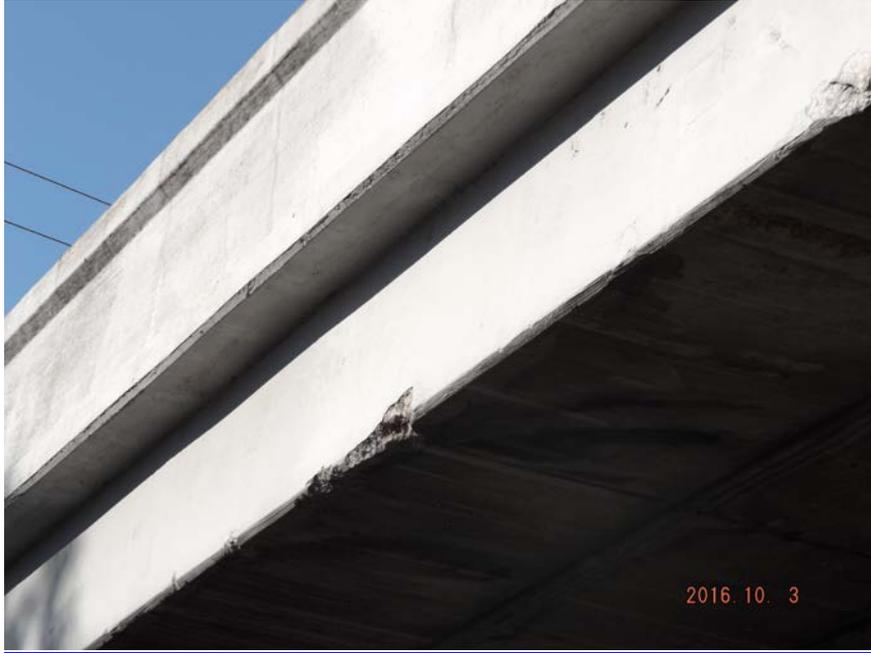
BEAM X R/SIDE-COLLISION SPALLS

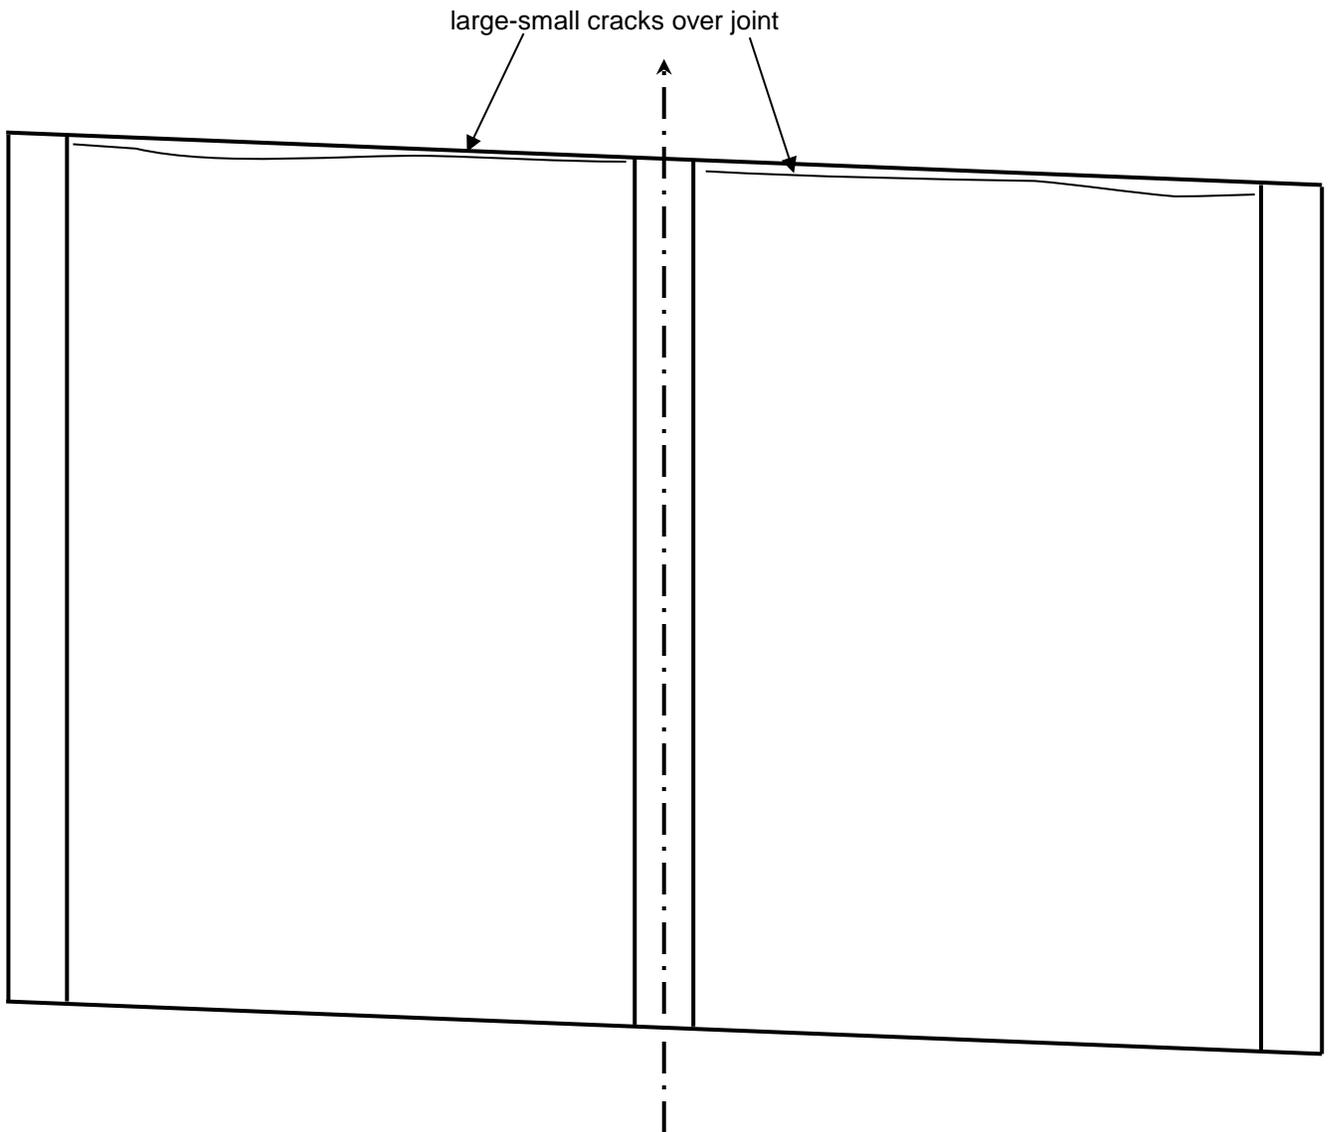
Top of Deck Span No. 3

App Rail: G Minor collision dmg

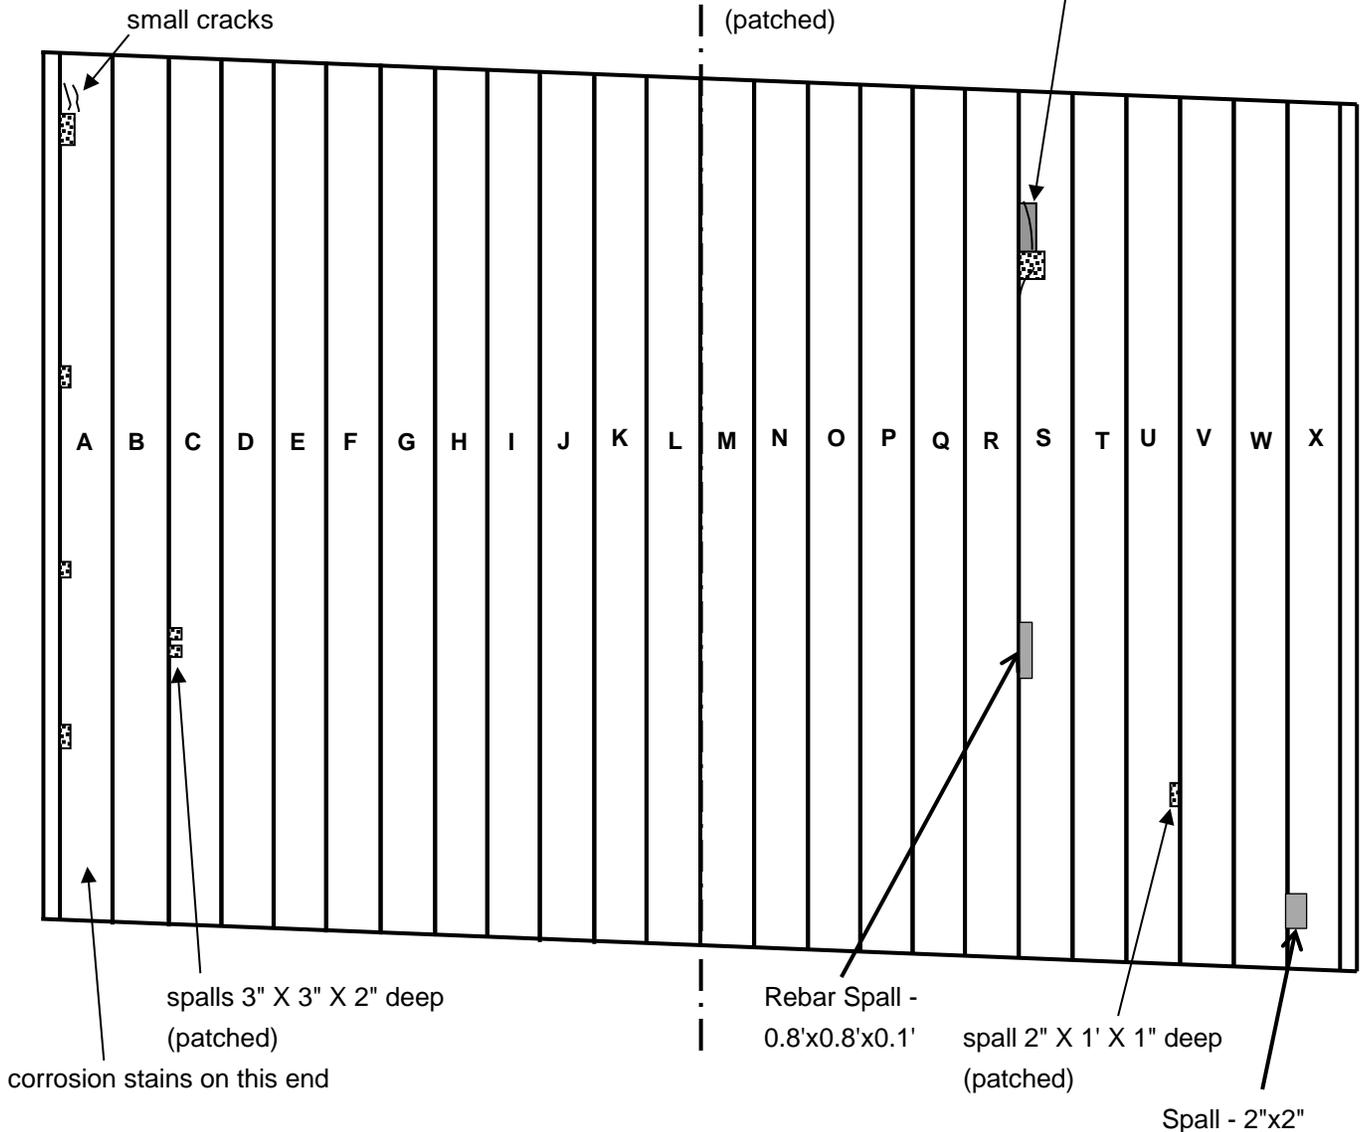
Bottom of Deck Span No. 2

spalls in beam A (top to bottom):

1.7' X 3' X 1" deep, 8" X 1.6' X 1" deep

5" X 7" X 1" deep, and

10" X 2.6' X 1" deep with strand completely exposed (patched)

small & hairline-small cracks, delaminated 1.3' X 3' & spall with strand exposed 2' X 2.4' X 2" deep at 6' from end (patched)

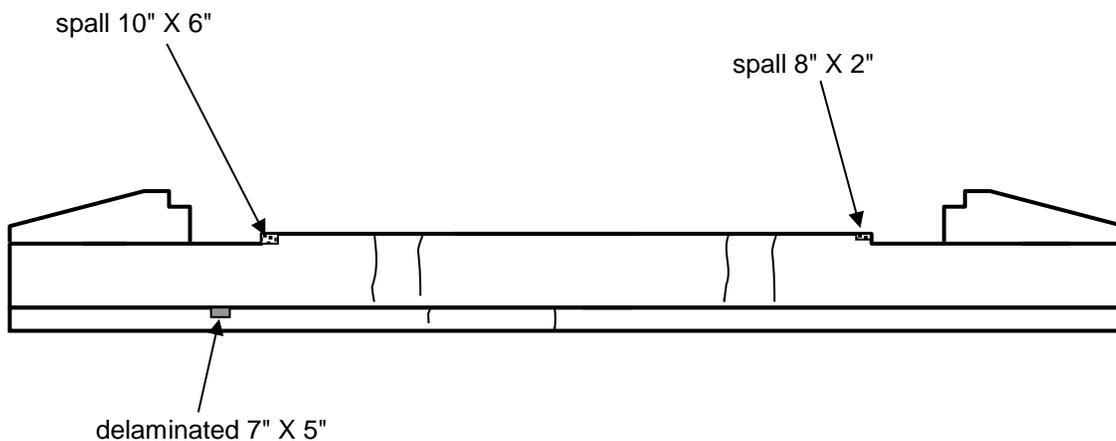
Abutment No. 1

cracks are hairline
