## Hamilton County

### Regular Inspection Report

Location: 33-I0075-01.17-RIGHT

Inspection Date: July 19, 2016

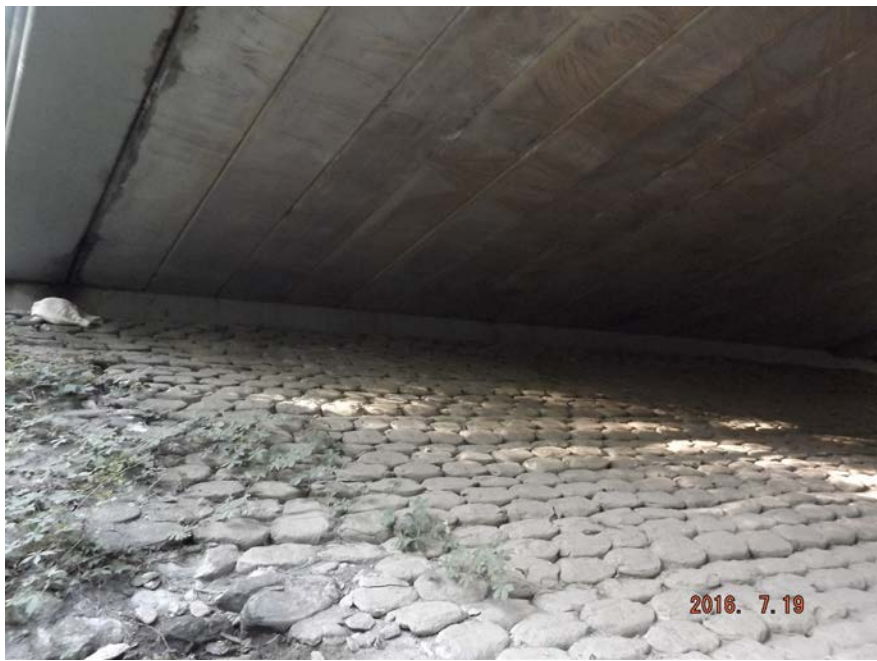
ABUTMENT

Caps:	GOOD	
Breastwall:	G-F	HL CRACKS W/ EFF, SPALL, DELAM @ CJs.
Wings:	GOOD	
Backwall	GOOD	
Bearing Surface:	GOOD

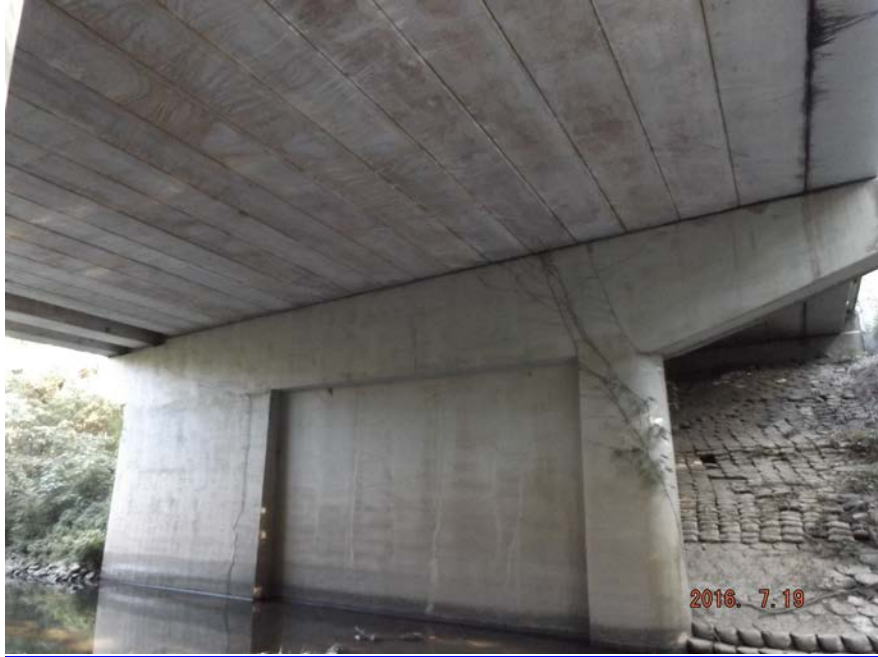
BENT

Caps:	GOOD	HL cracks
Columns:	GOOD	Walls - HL cracks
Bearing Surface:	GOOD

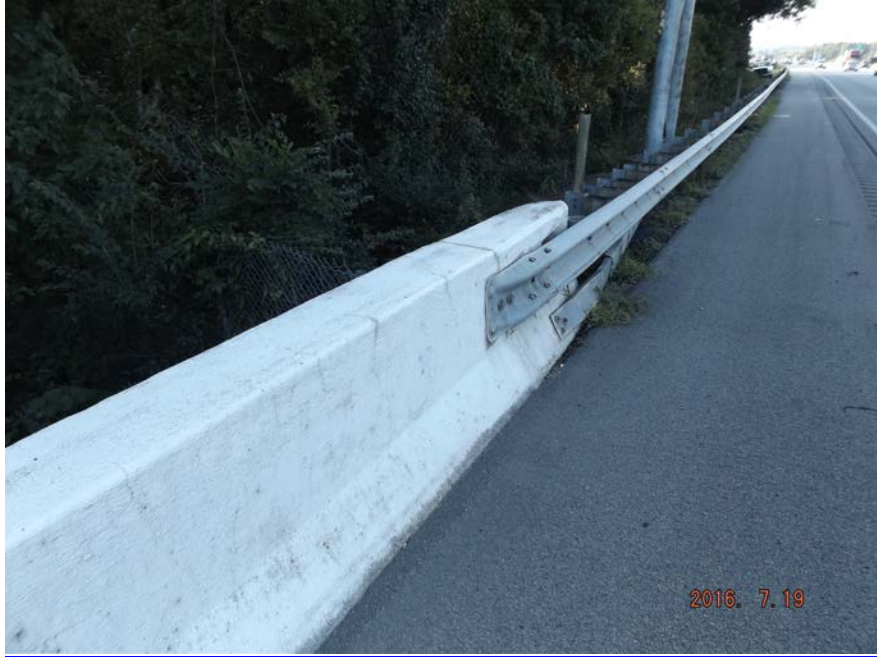
TRAFFIC SAFETY FEATURES

Bridge Rail:	GOOD	STANDARD	
Transitions:	GOOD	STANDARD	
Approach Rail:	GOOD	STANDARD	
Terminals:	N/A	STANDARD	>100 FEET

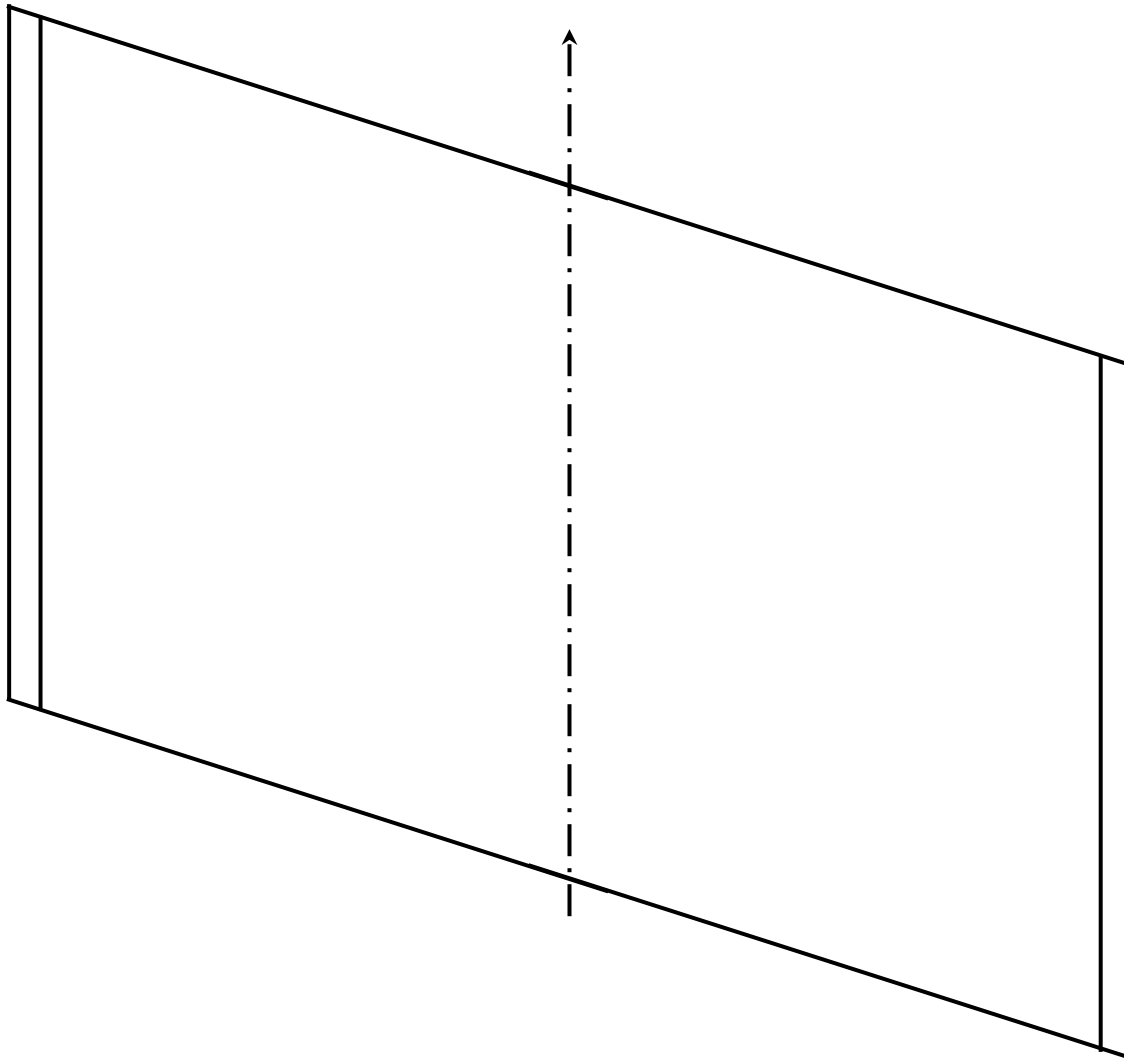
Beams: G

Deck: GF

cracks are hairline with efflorescence

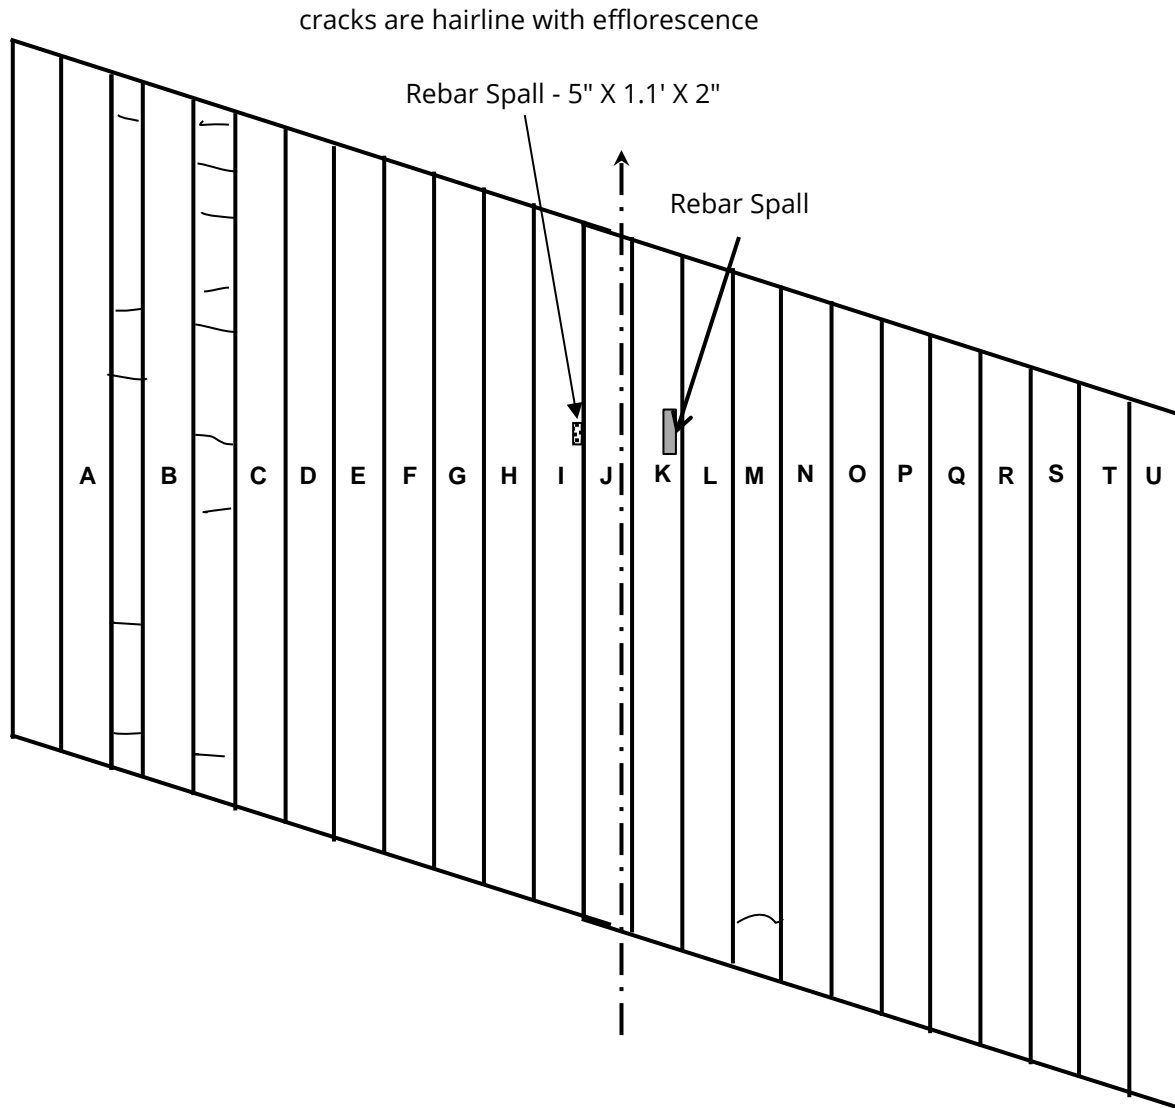
Beams: G 'J' - sag

Deck: GF

Eff leakage between beams

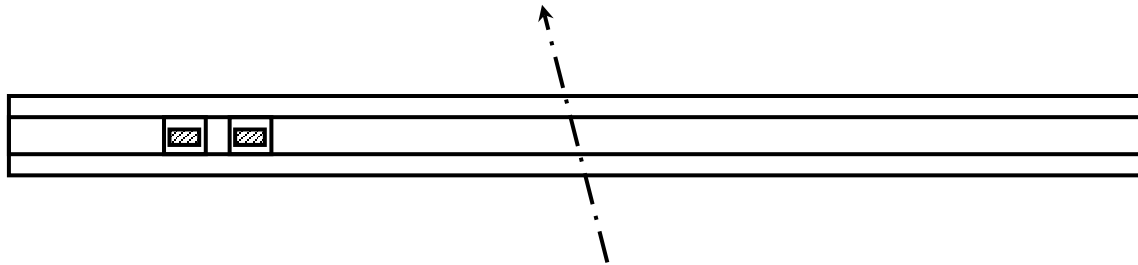
cracks are hairline
