## Hamilton County

### Regular Inspection Report

Location: 33-I0075-01.17-LEFT

I-75 - Southbound

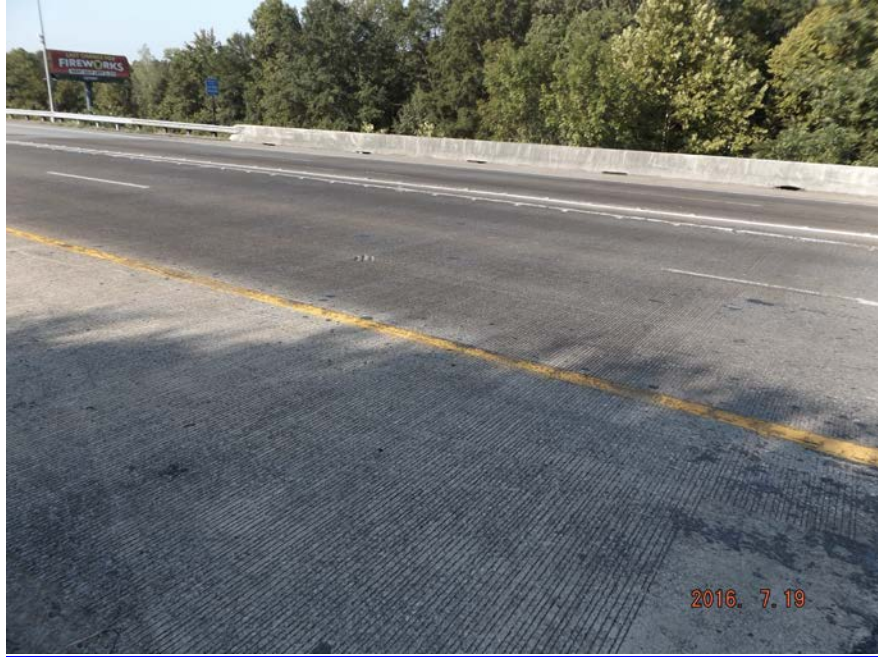
WEARING SURFACE

Rating	Comments
Wearing Surface	FAIR	<i>NUMEROUS NARROW CRACKS, FEW GOUGES. PATCHES AT BRIDGE ENDS.</i>
Deck - Structural Condition	FAIR	<i>HL CRACKS W/ EFF.</i>
Curbs	NA	
Median	NONE	
Sidewalks	NONE	
Parapet	N/A	
Railing	N/A	
Paint	NA	
Drains	GOOD	
Lighting Standards	NONE	
Utilities	NONE	
Joint Leakage	NA	
Expansion Joints	NONE

<b>SUGGESTED ROUTINE MAINTENANCE AND COMMENTS</b>
SEAL CRACKS IN DECK WEARING SURFACE, SPAN NO.ALL
REPAIR BRIDGERAIL ON RIGHT SIDE APPROACH 2

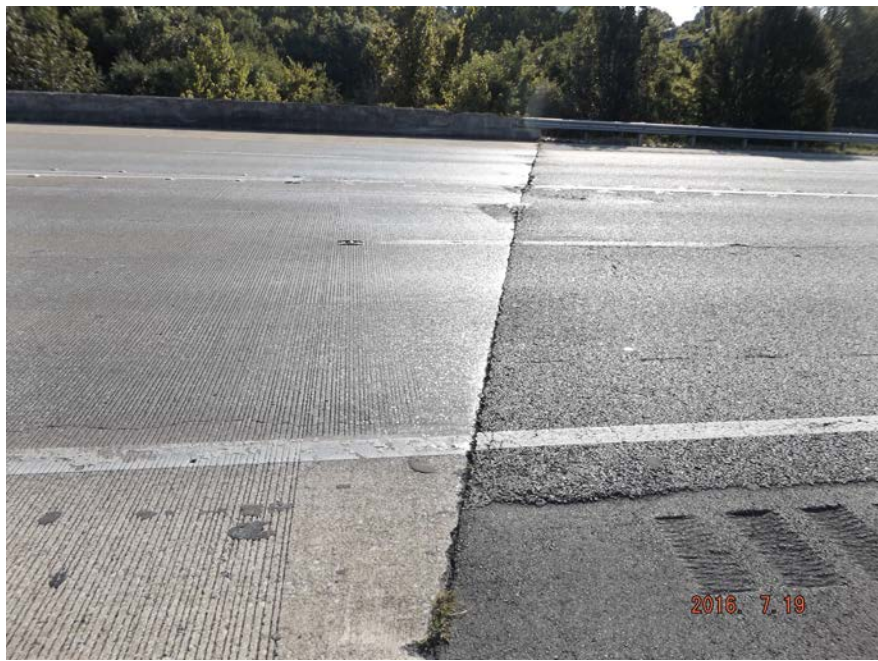
APPROACH 2

Rating	Comments
Alignment	GOOD	<i>No speed reduction required</i>
Slab	NA	
Joints	NA	
Pavement	FAIR	<i>SETTLED, CRACKS, POTHOLE, VOIDS, PATCHES</i>
Embankment	GOOD	
Drains	NA	<i>NONE</i>

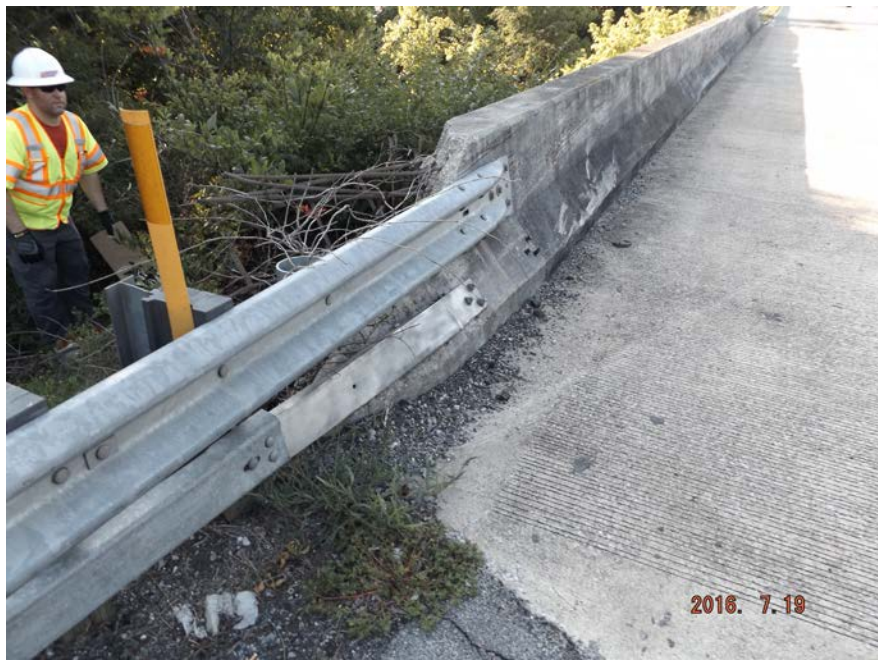
APPROACH 2 - RIGHT - RAIL DAMAGE

Rating	Standard/ SubStandard	Comments
Bridgerailing	F-P	STANDARD	<i>SIGNIFICANT COLLISION DAMAGE TO RIGHT PARAPET</i>
Transitions	GOOD	STANDARD	
Guardrail	GOOD	STANDARD	
Guardrail Terminal	N/A	STANDARD	<i>&gt;100 FEET</i>

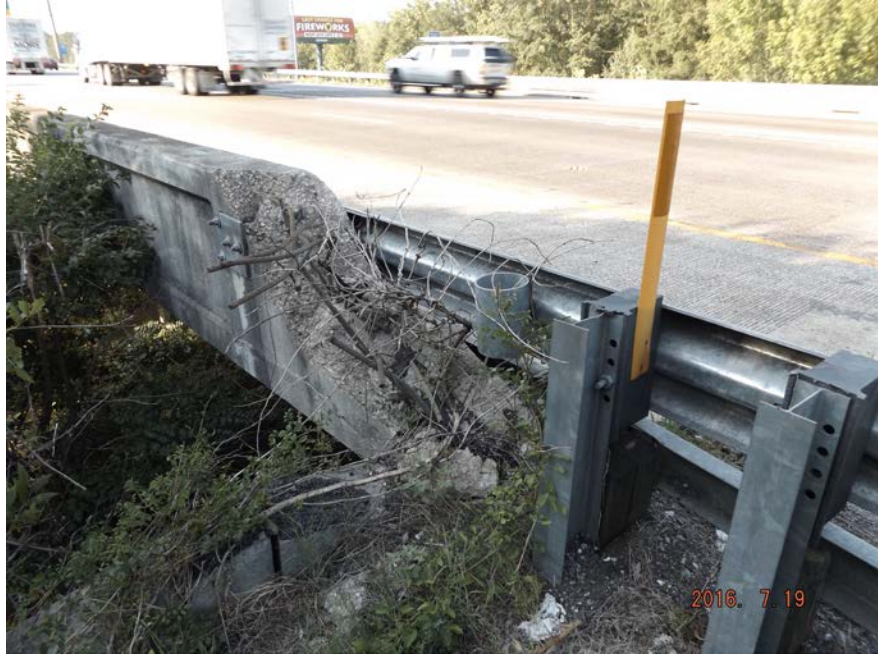
APPROACH 2 - RIGHT - RAIL DAMAGE

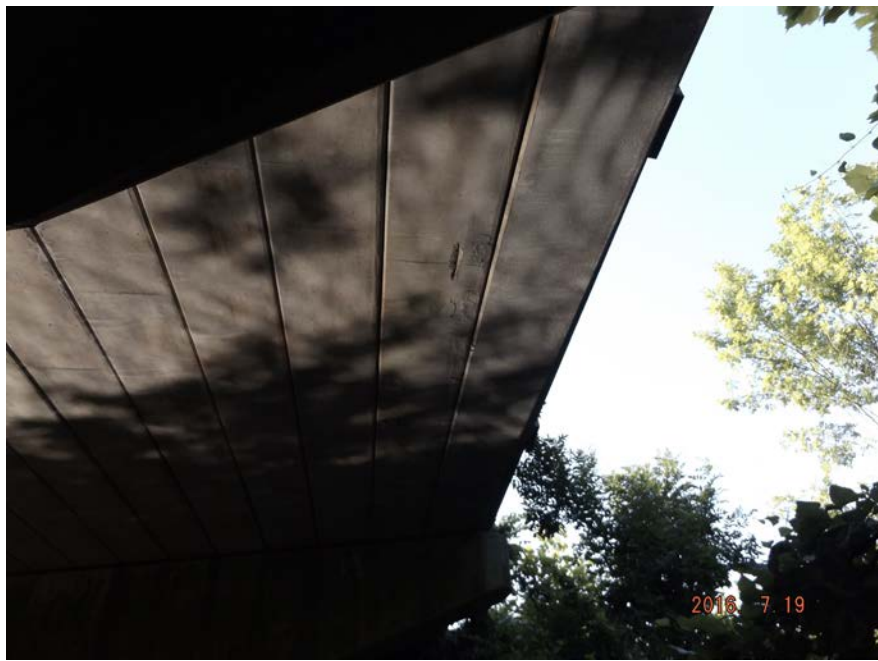
SPAN 2 - BEAM B - REBAR SPALL

Bearing Devices	GOOD	<i>Abutments - N/A - Integral, Bents - Fixed</i>
Girders or Beams	G-F	<i>HL CRACKS, DELAMS, REBAR SPALL, PATCHES</i>
Floor Beams	NA	
Stringers	NA	
Diaphragms	GOOD	
Bracing	NA	
Trusses - General	NA	
Portals	NA	
Bracing	NA	
Paint	NA	
Alignment of Members	GOOD

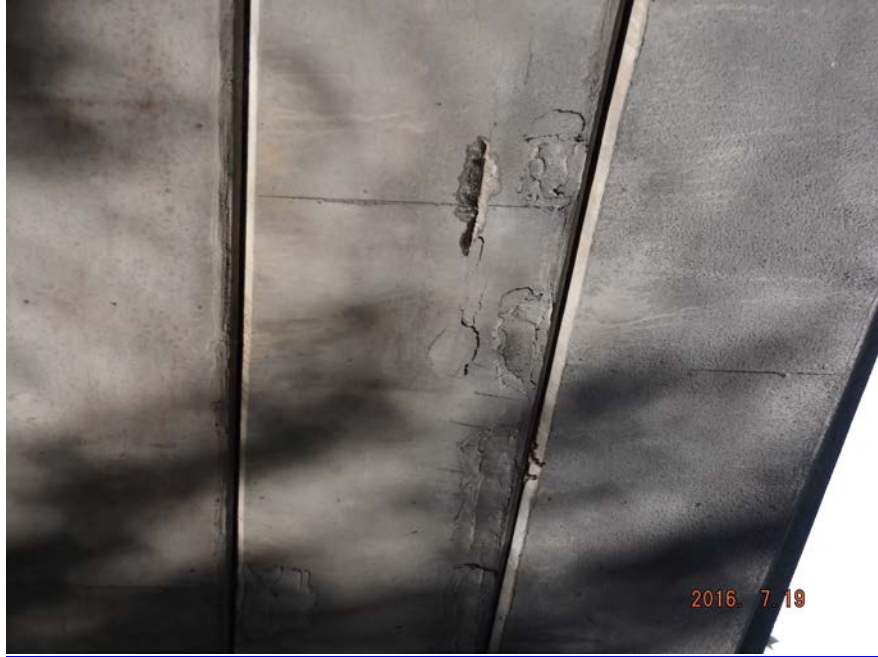
SPAN 2 - BEAM B - REBAR SPALL

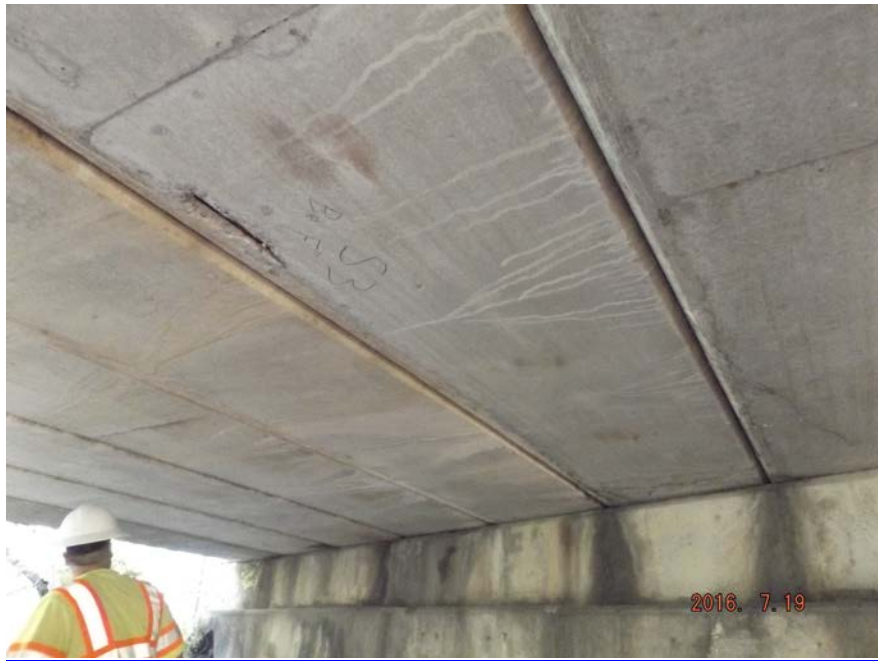
SPAN 3 - BEAM F - REBAR SPALL

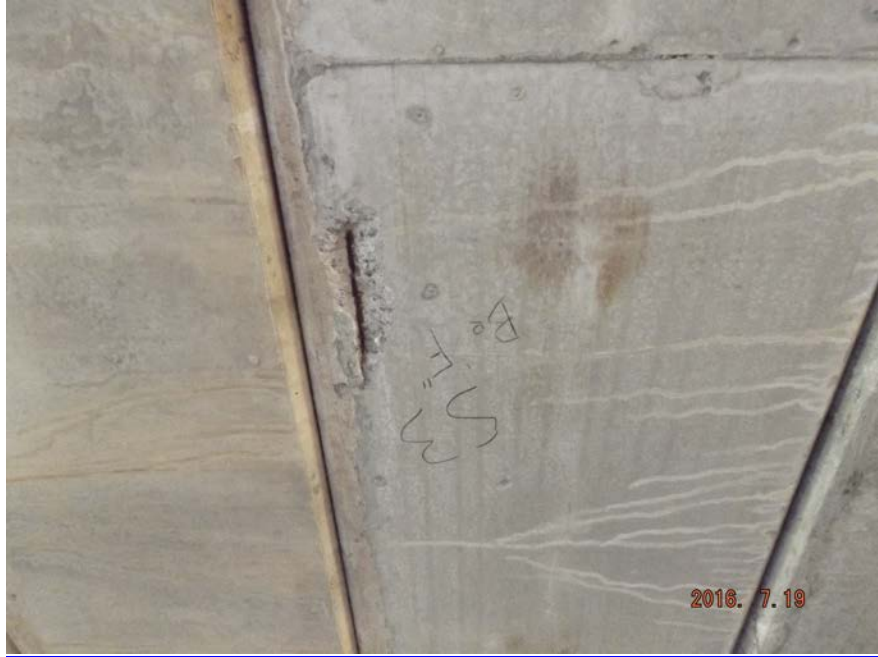
SPAN 3 - BEAM F - REBAR SPALL

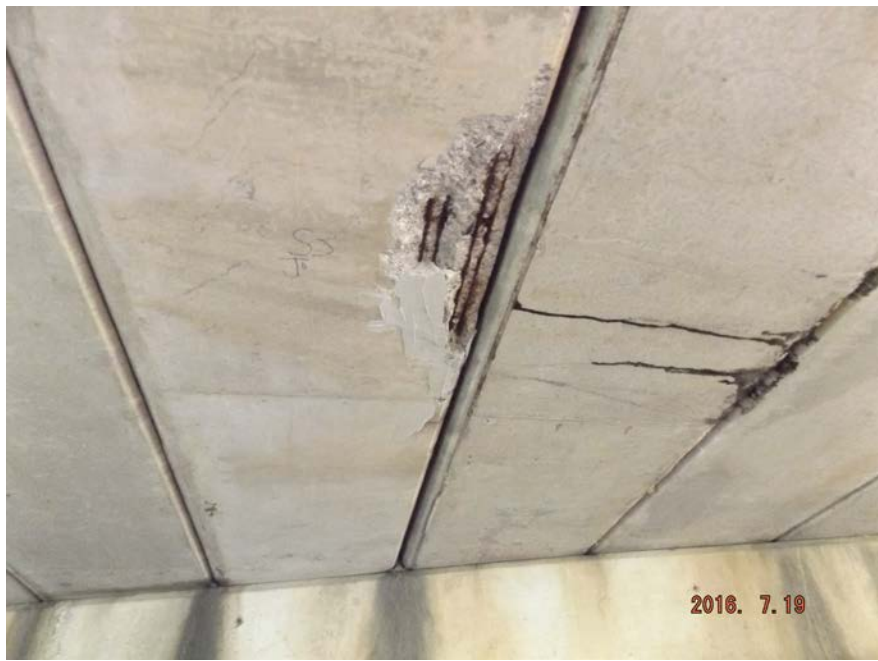
SPAN 3 - BEAM J - REBAR SPALL

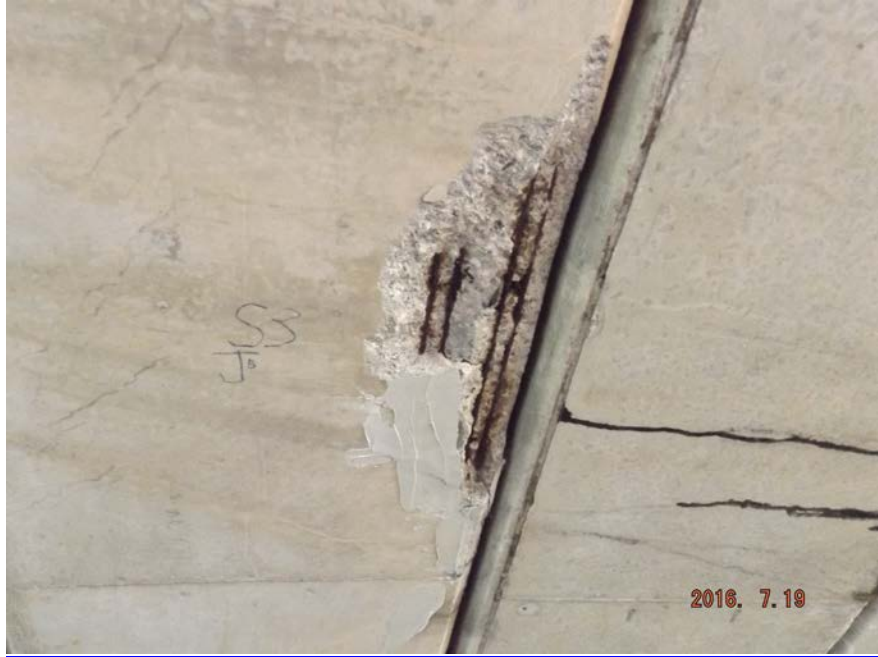
SPAN 3 - BEAM J - REBAR SPALL

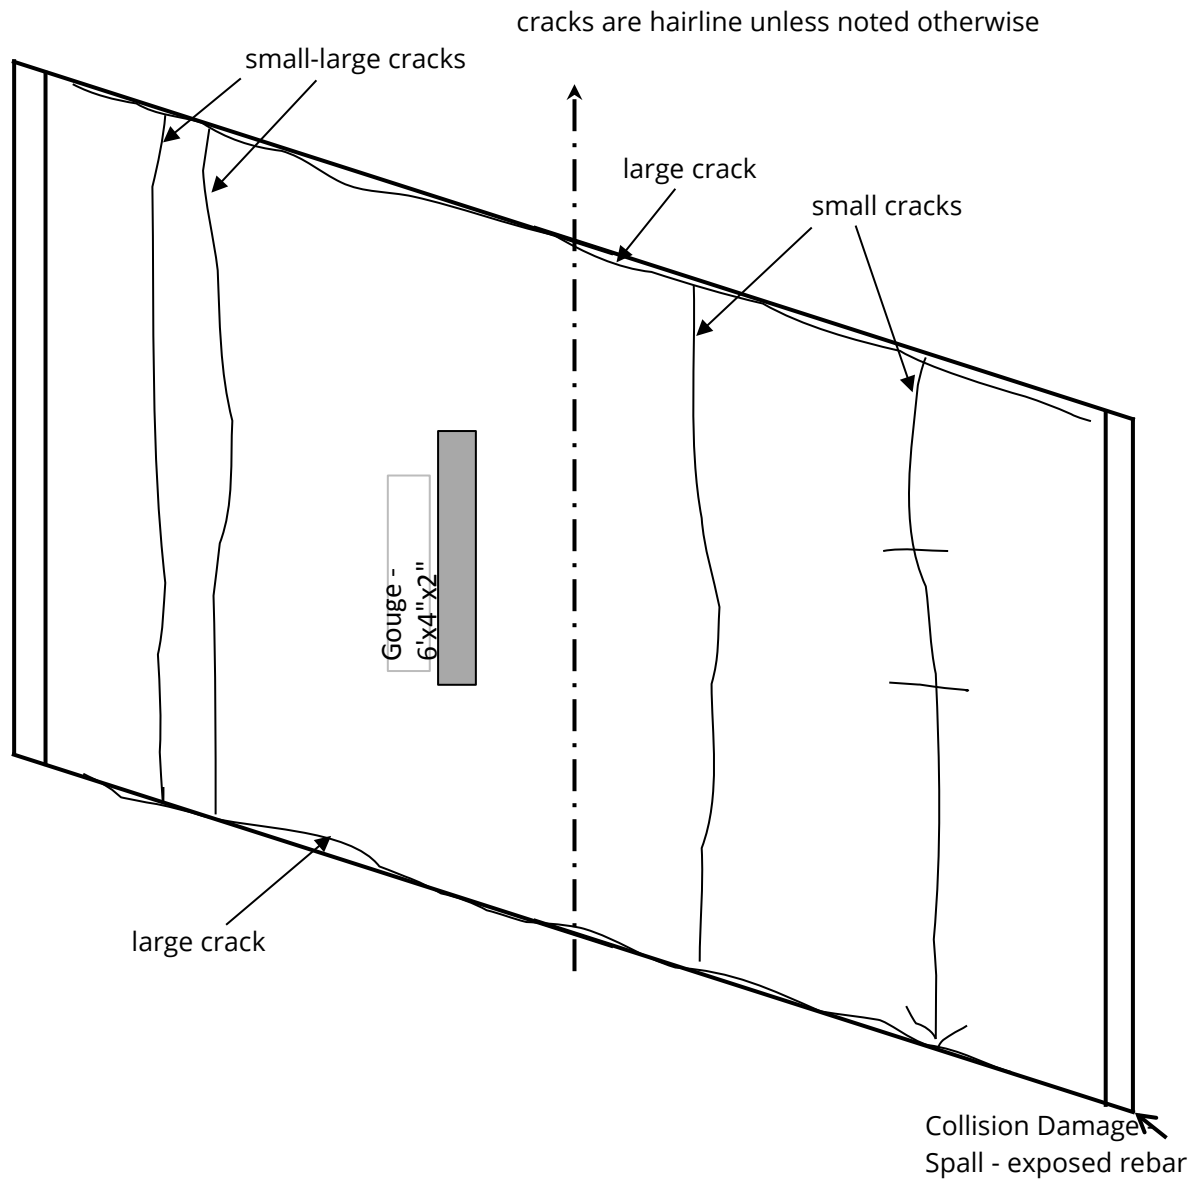
Wearings Surface: F

Bridge Rail: F Collision damage - RT

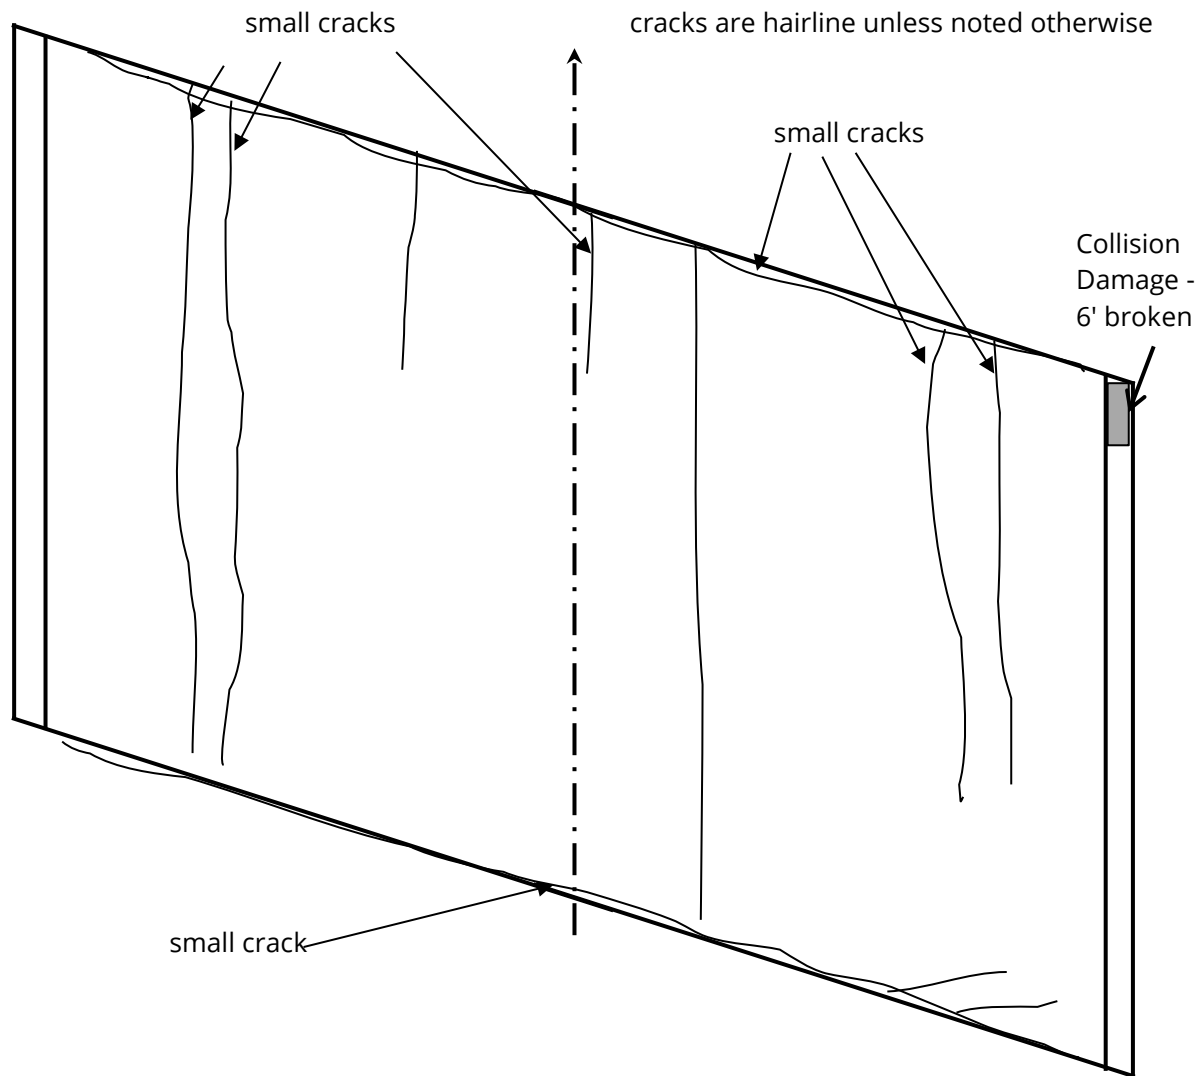
Embankment: G  
App Pvmt: F Settled  
App Rail: G  
Wearing Surface: F  
Bridge Rail: F Collision damage - RT

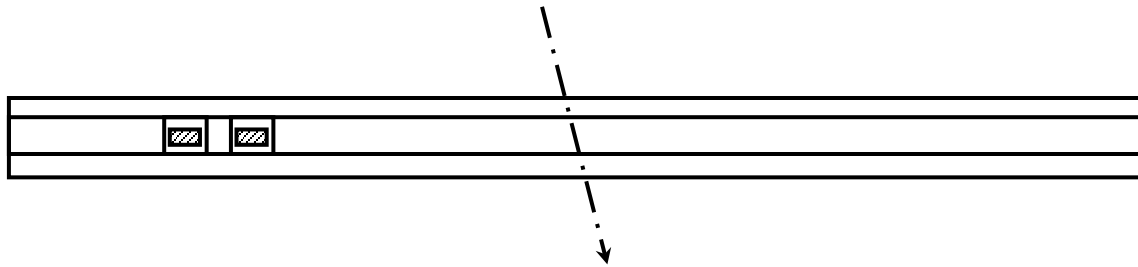
cracks are hairline

6" wide delaminated at construction joint

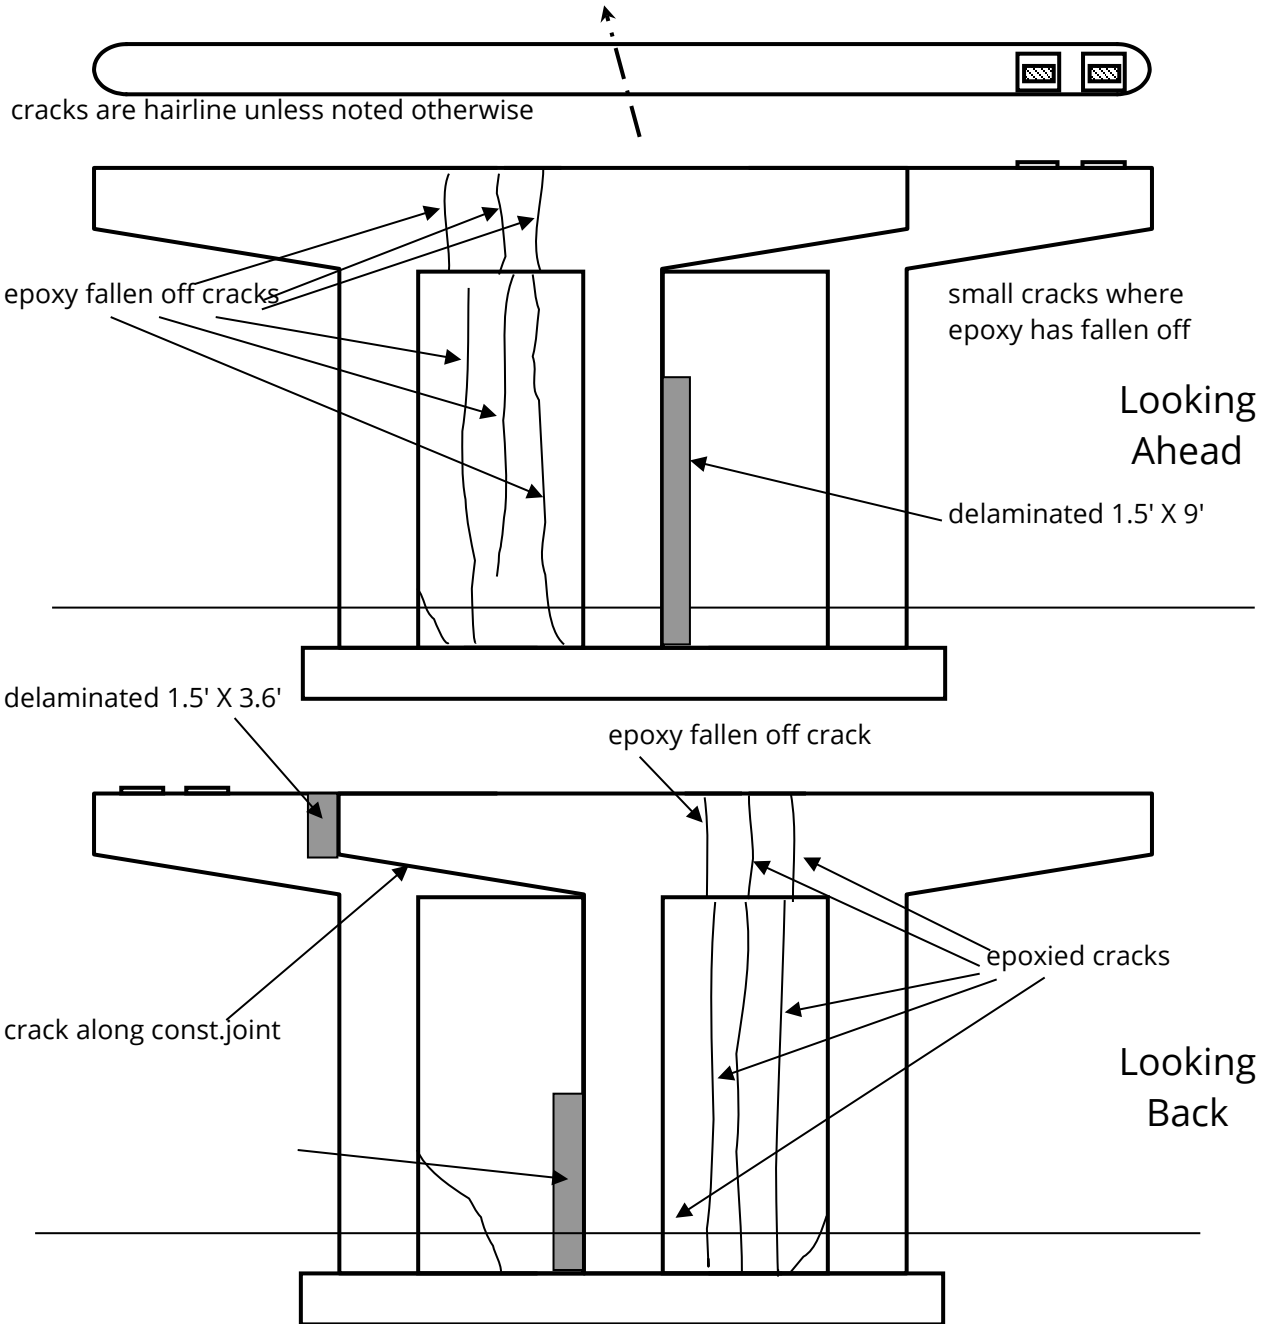
Wings: G  
Walls: G  
Bearings: None Integral  
Slope: F Sliding, steep

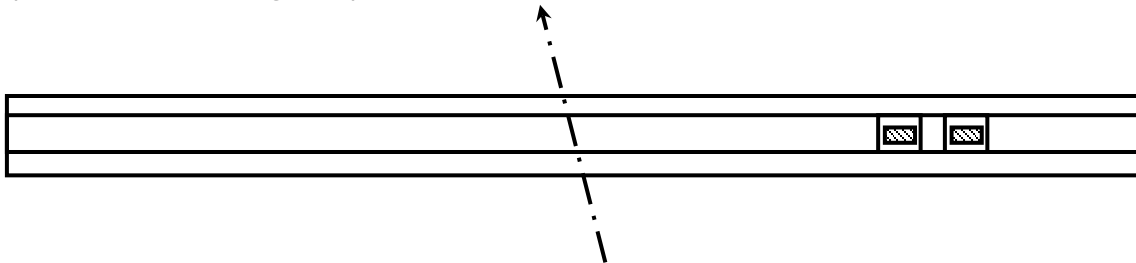
cracks are hairline with efflorescence unless noted otherwise

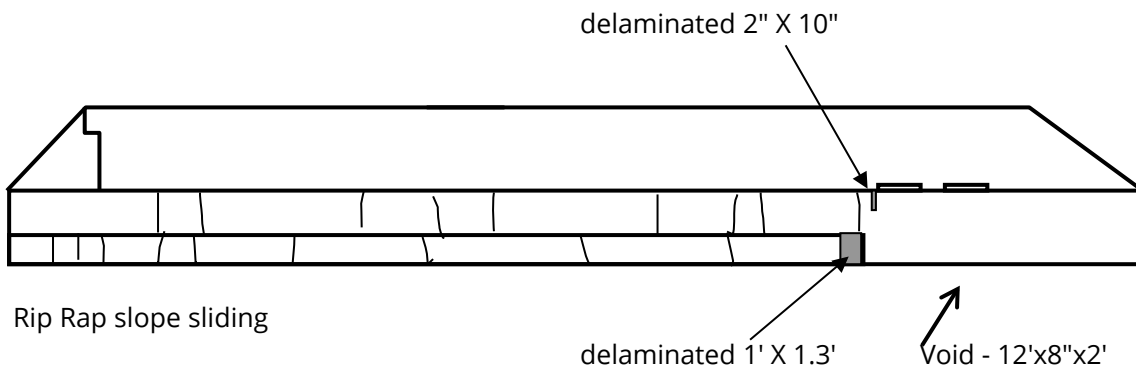
This void has been filled with concrete and rip rap, but is still settling and some parts opened back up
