Hamilton County

Regular Inspection Report

Location: 33-I0075-01.29

Inspection Date: July 12, 2016

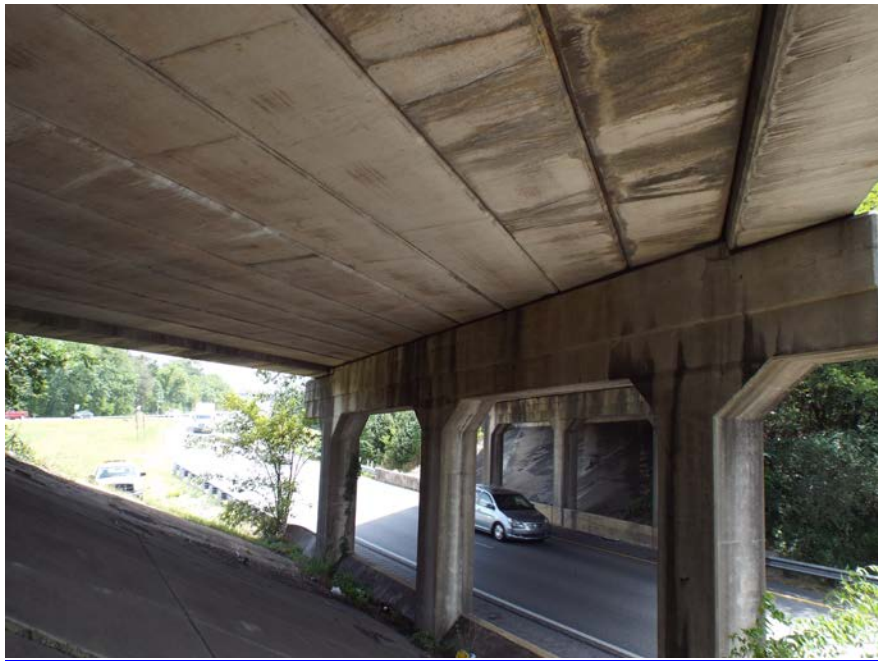
SPAN 3

Bearing Devices	GOOD	<i>Elastomeric pads</i>
Girders or Beams	G-F	<i>HL CRACKS, MAP-CRACKING, DELAMS, REBAR POPOUTS. BEAM "F" VIBRATES UNDER HEAVY LIVE LOADS.</i>
Floor Beams	NA	
Stringers	NA	
Diaphragms	NA	
Bracing	NA	
Trusses - General	NA	
Portals	NA	
Bracing	NA	
Paint	NA	
Alignment of Members	G-F	<i>1" MISALIGNMENT SPAN 3</i>
