## Hamilton County

### Regular Inspection Report

Location: 33-I0075-01.91

4 Span Bridge

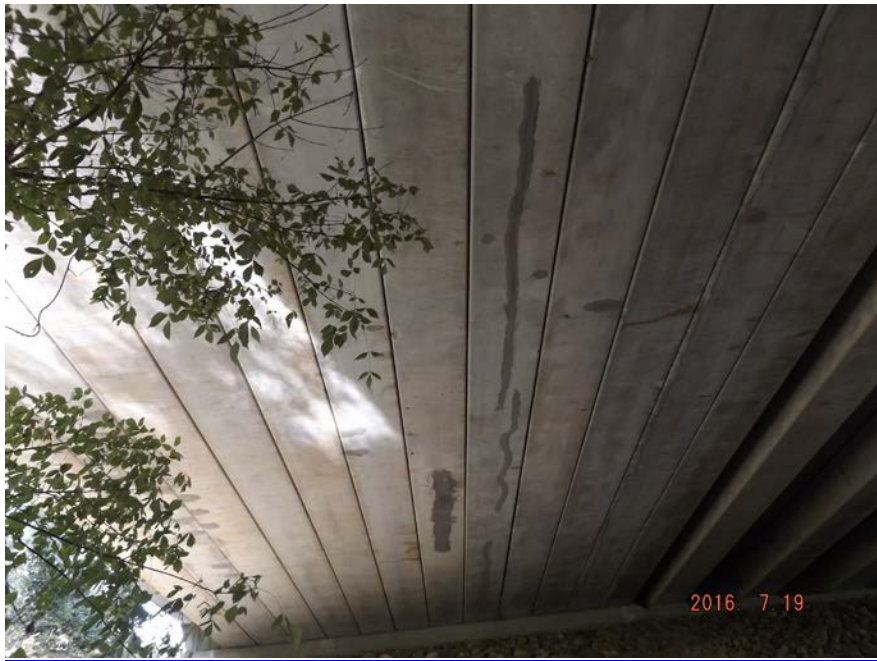
**SPAN 1 - LEFT - PATCHED CRACKS/DELAMS**

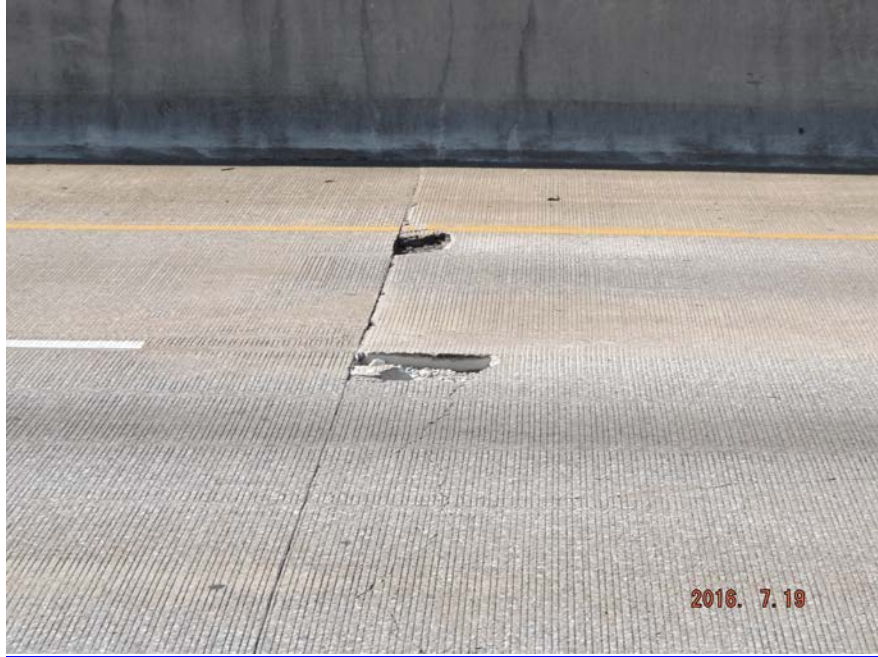
APPROACH 1 - SB - POTHOLE

Approach Pvm:	POOR	Approach 1 - Left/Right potholes
Deck - Wearing Surface:	FAIR	NUMEROUS NARROW CRACKS. SPALL.

<b>SUGGESTED ROUTINE MAINTENANCE AND COMMENTS</b>
CLEAR DRAINS IN SPAN NO. 4 , RT.
Approach 1 - SBL - Repair potholes
CLEAR APPROACH DRAINS
REPAIR BRIDGERAIL ON RIGHT SIDE OF SPAN NO.2, 3 & 4.

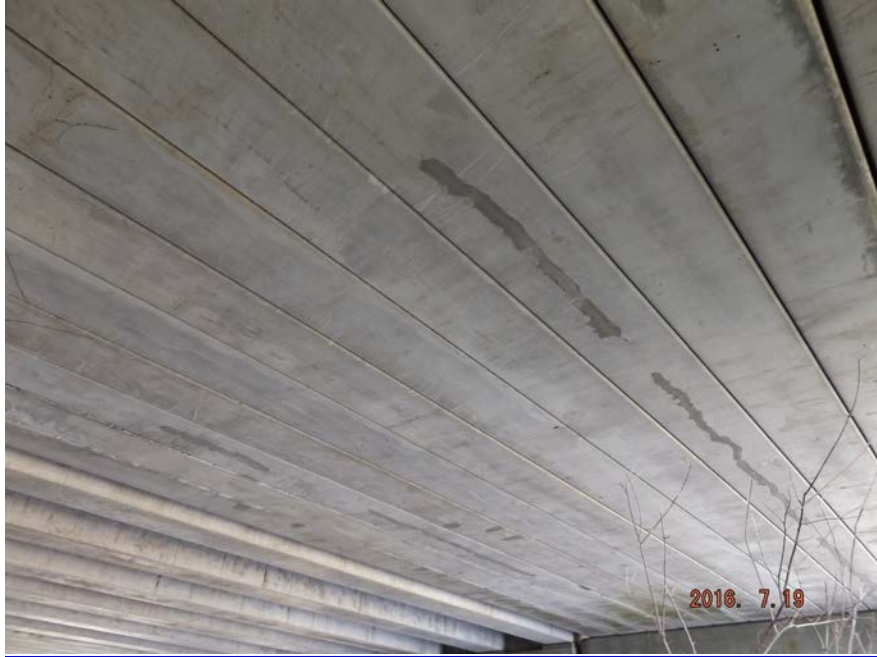
SPAN 3 - LEFT - CRACK REPAIRS

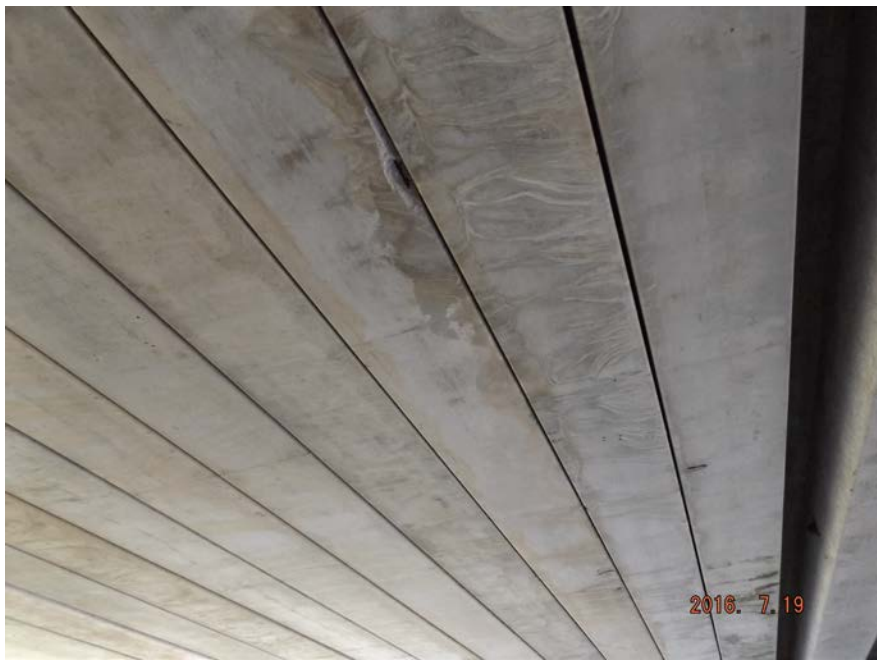
SPAN 3 - BEAM U - REBAR SPALL

Beams:	G-F	HL CRACKS, DELAMS, REBAR SPALLS, PATCHES, COLLISION SPALLS.
Bearings:	GOOD	Abutments - None - Integral, Bents - Fixed

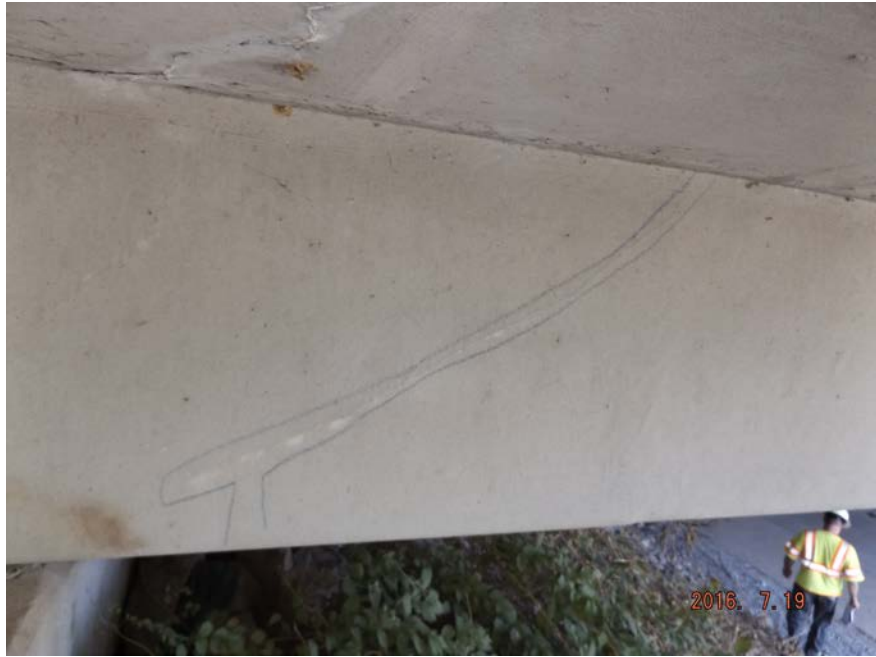
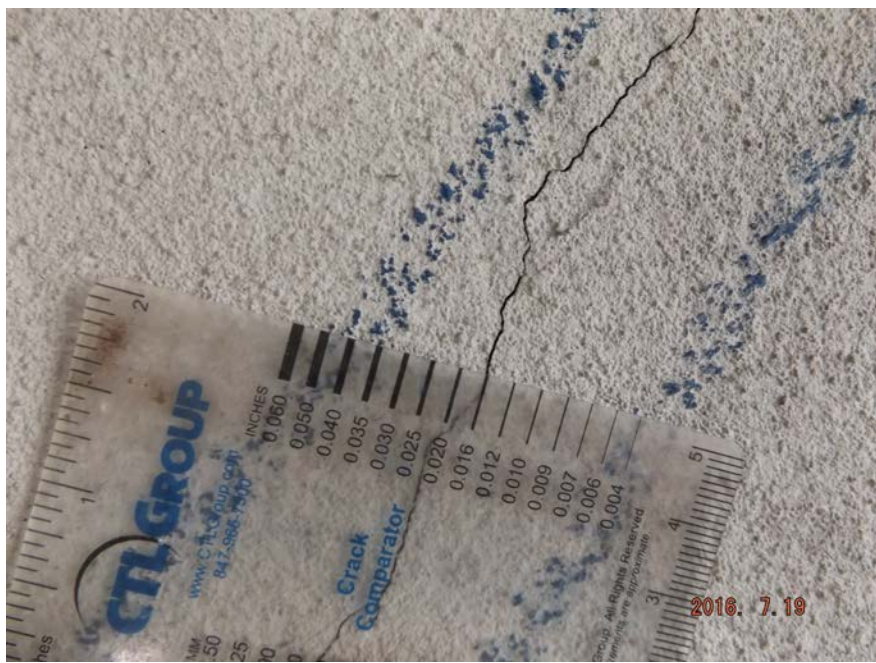
**SPAN 4 - BEAM A - ABUTMENT 2 - SHEAR CRACK**

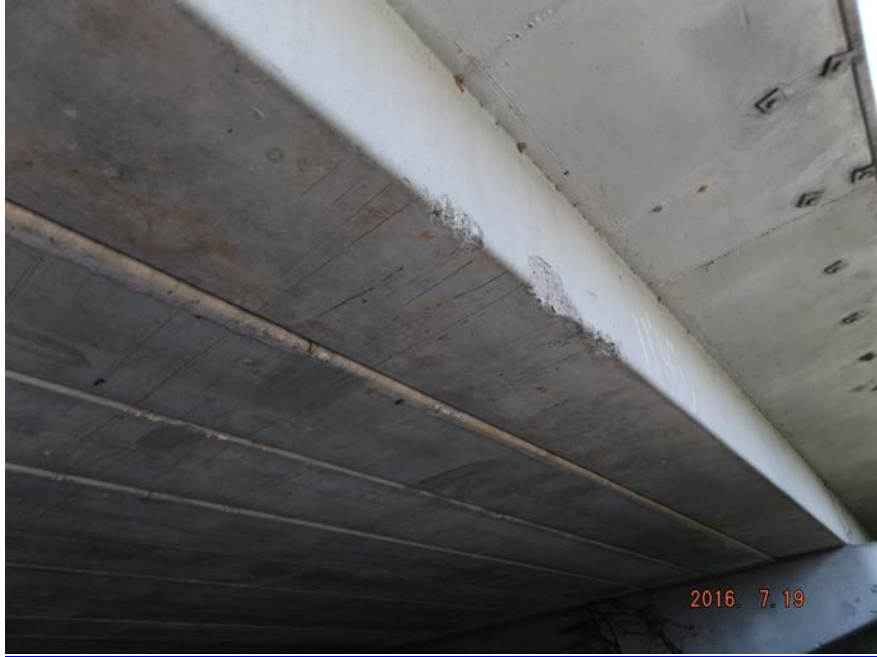
SPAN 4 - BEAM A - MID SPAN - SPALLS

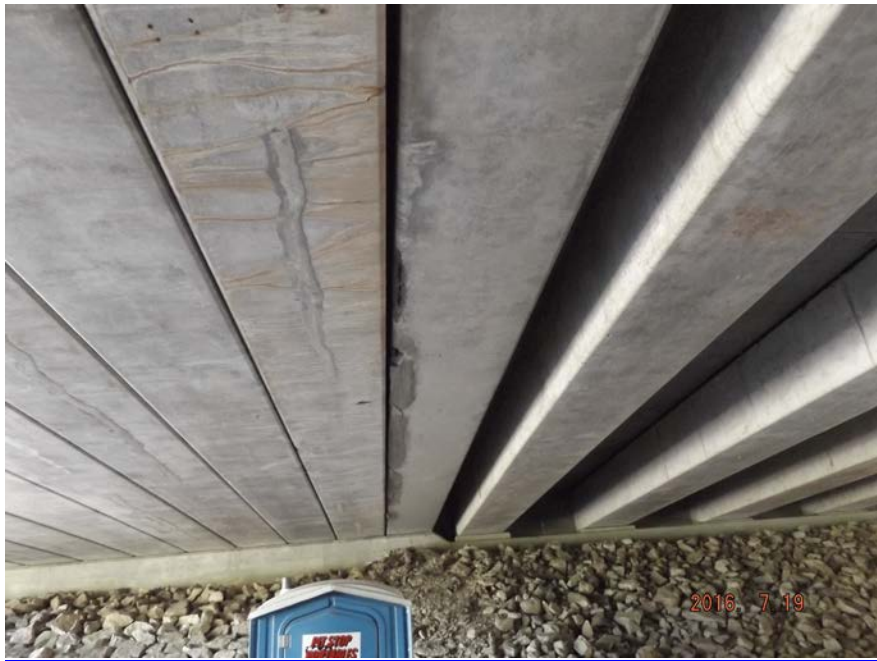
SPAN 4 - BEAM L - REBAR SPALLS

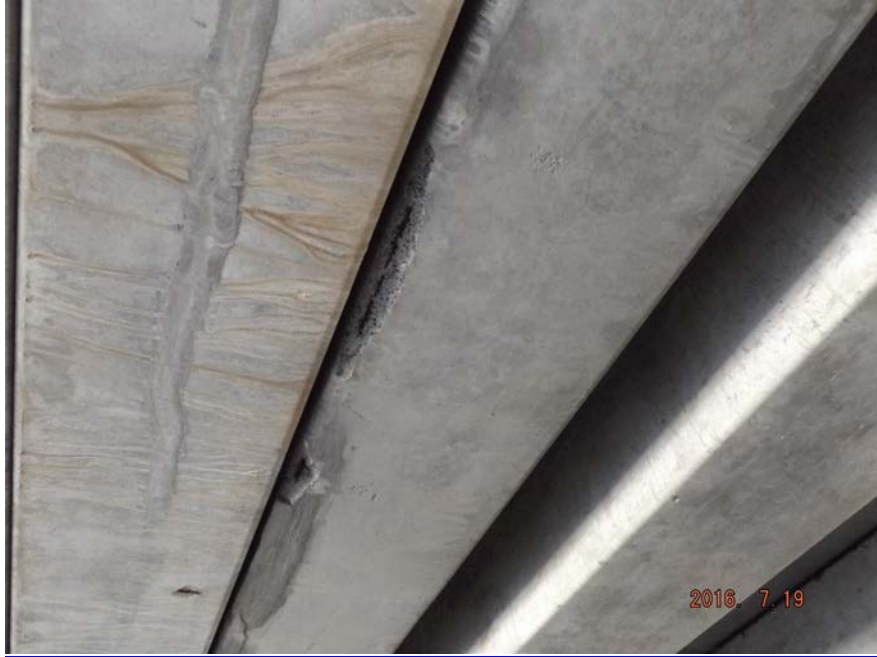
**SPAN 4 - BEAM L - REBAR SPALLS**

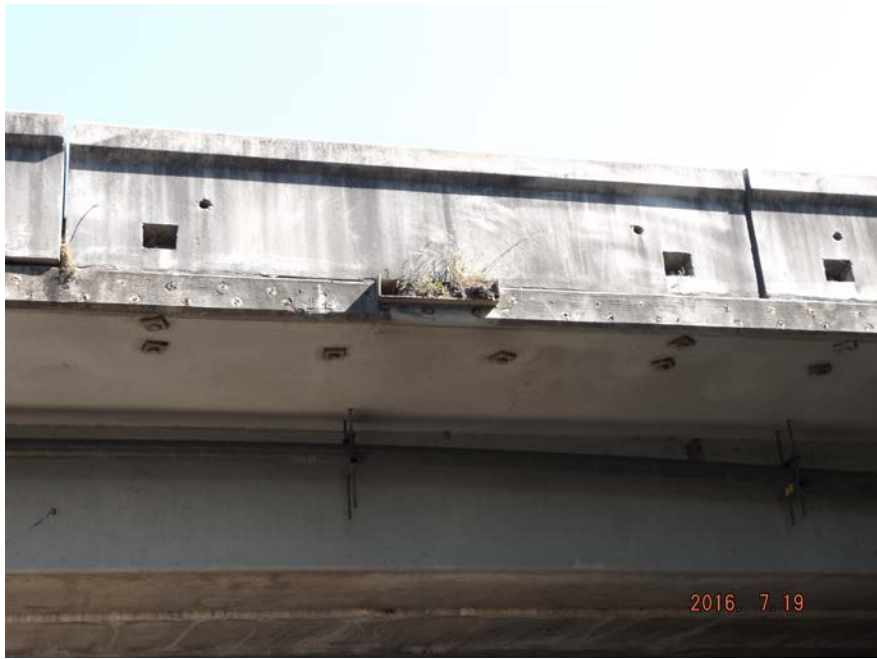
**SPAN 4 - RIGHT - DRAIN CLOGGED**

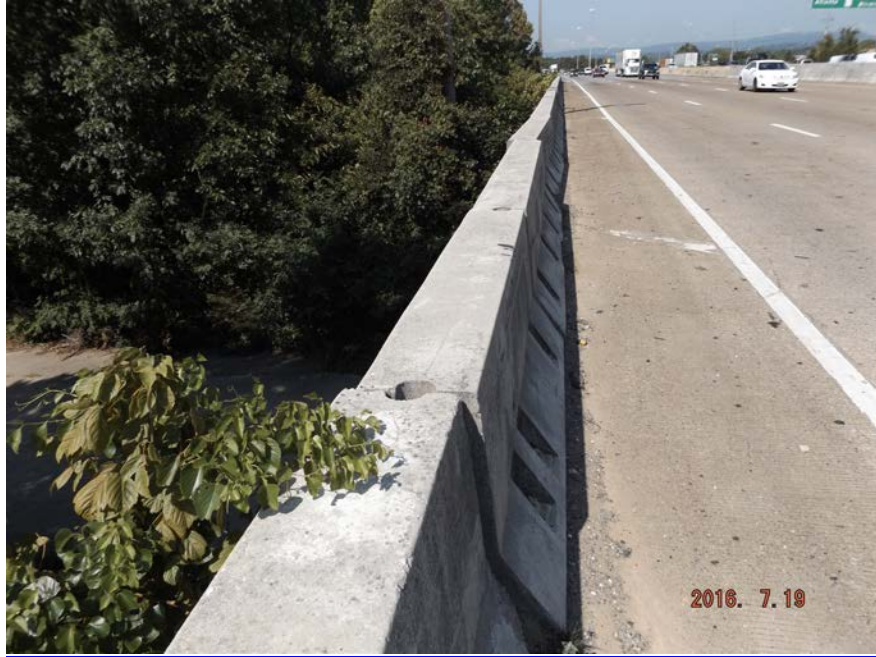
SPAN 4 - RIGHT - BRIDGE RAIL - COLLISION DAMAGE

Bridge Rail:	POOR	STANDARD	SIGNIFICANT DAMAGE AT RIGHT SIDE
Transitions:	FAIR	NONSTANDARD	METAL BLOCKS
Approach Rail:	FAIR	NONSTANDARD	METAL BLOCKS
Terminals:	FAIR	NONSTANDARD	> 100' from bridge end

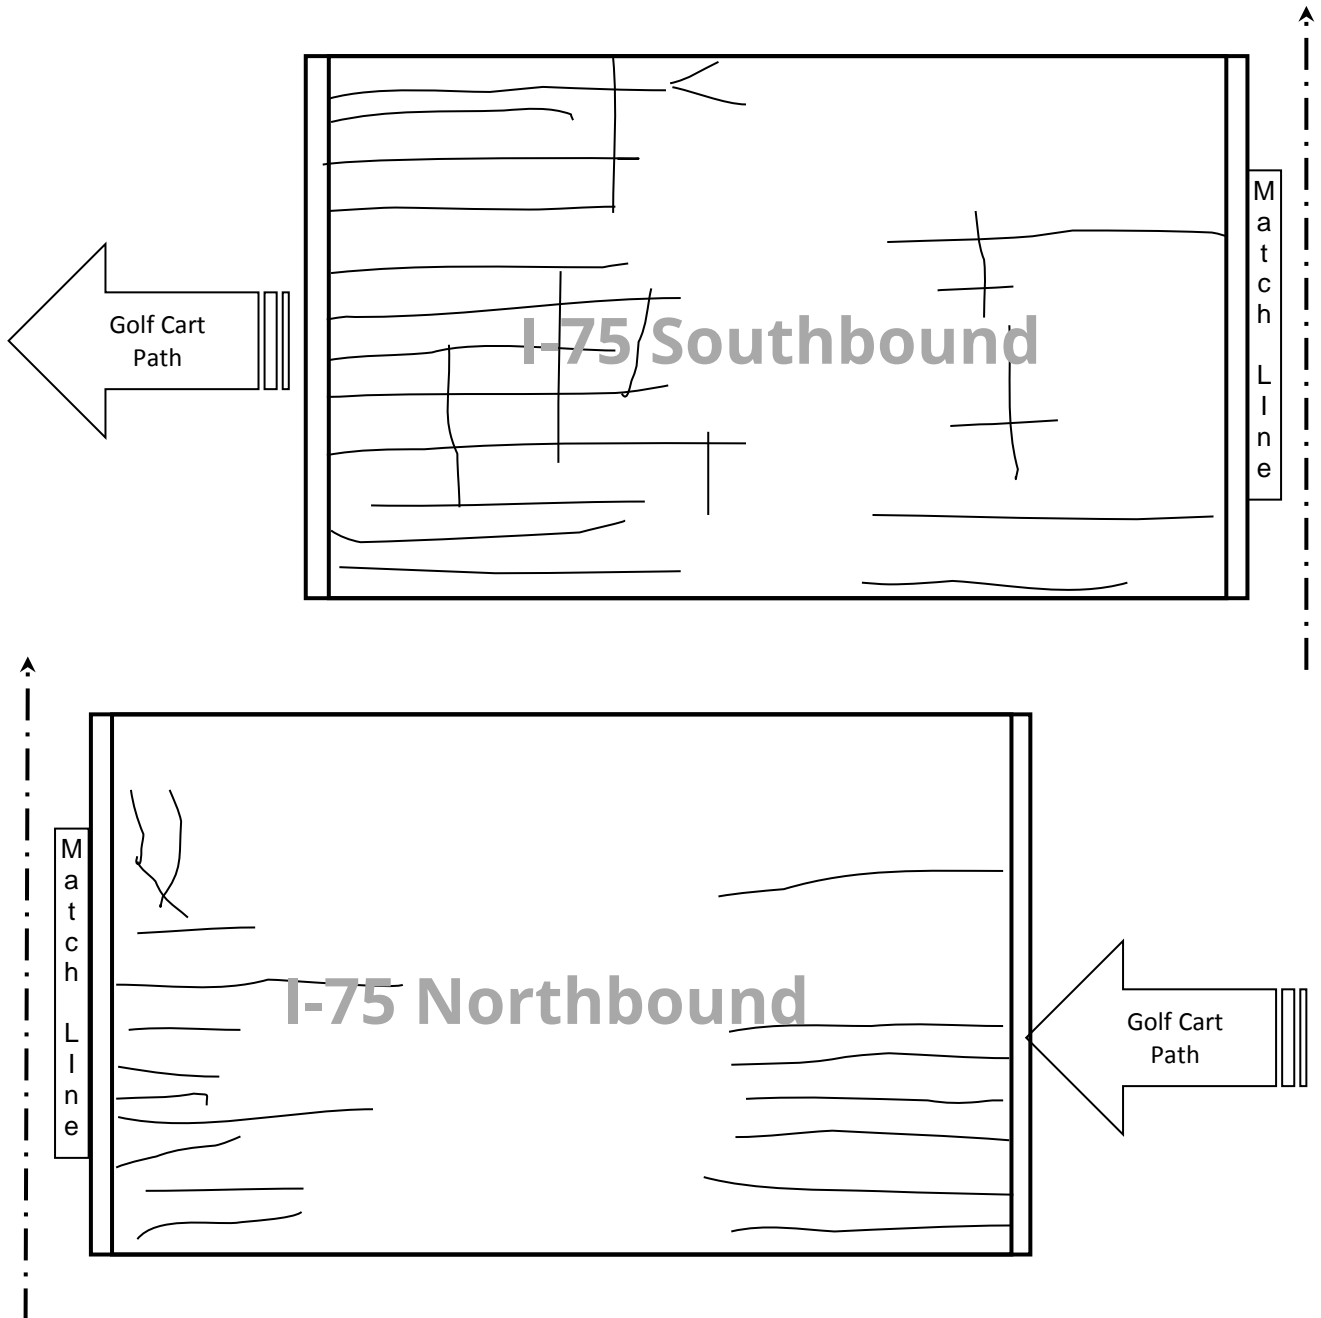
- Embankment G
- App Pvmt: GF
- App Rail: Nonstandard - metal blocks
- Wearing Surface; F
- Bridge Rail: GF **Damaged. Misaligned**

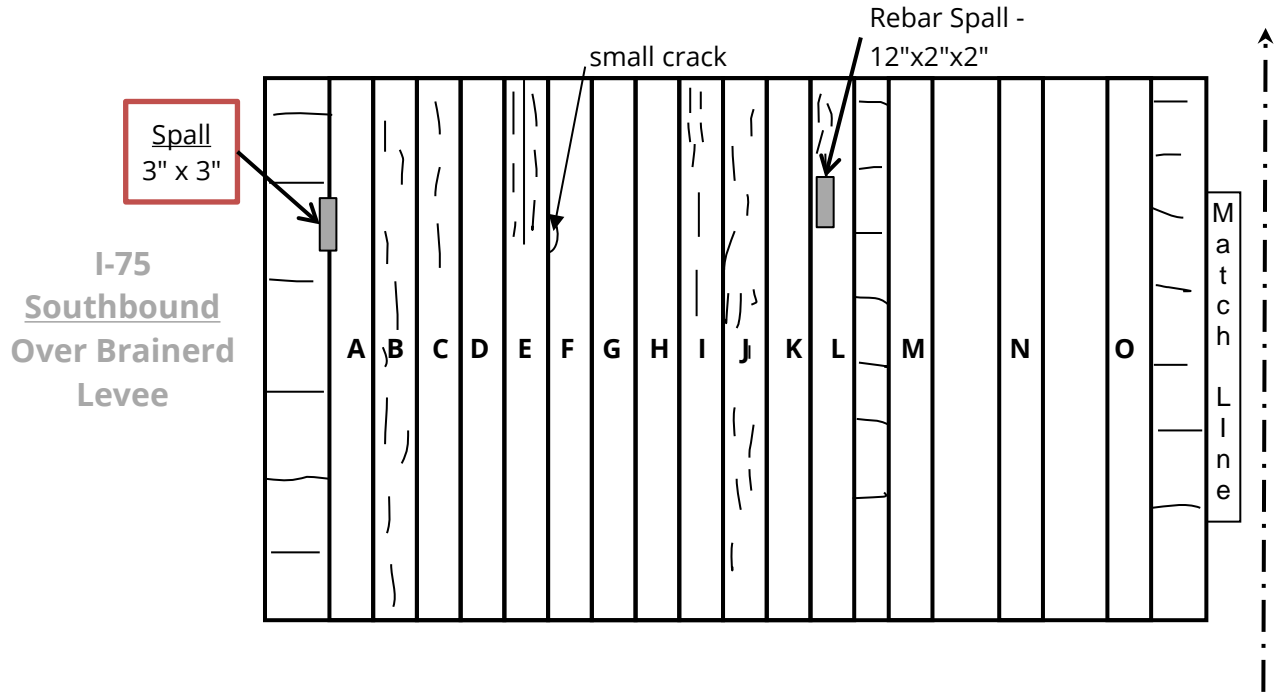
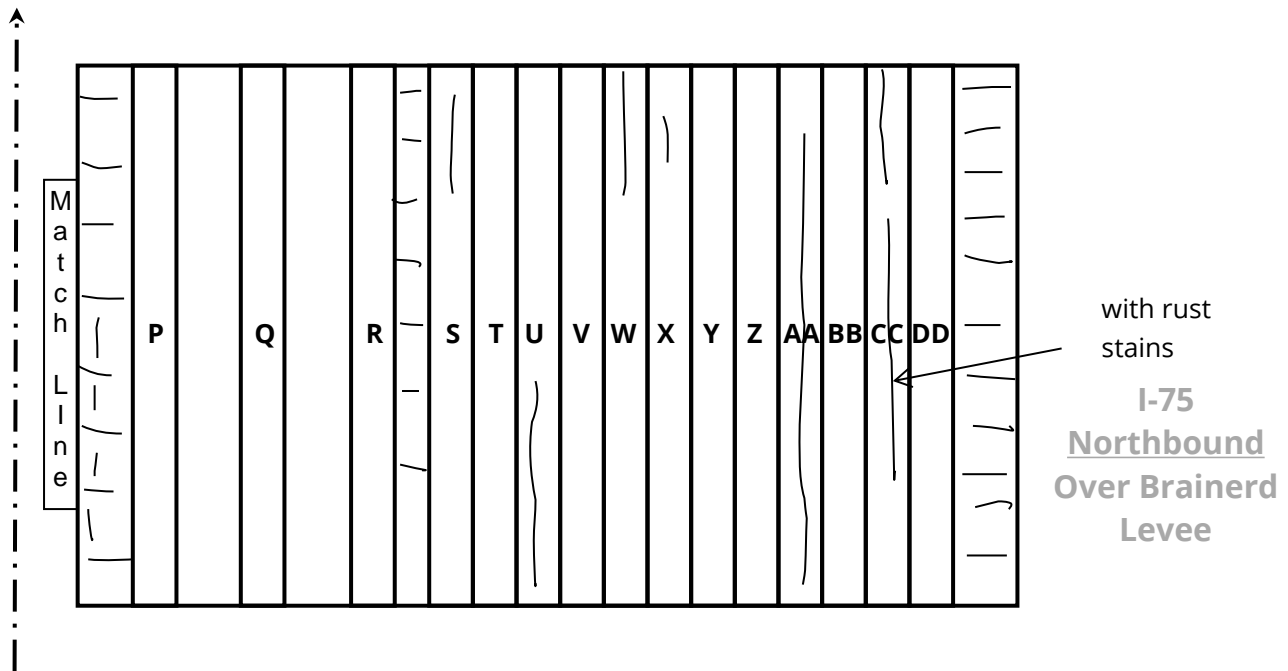
Beams: GF Several areas are patched

Deck: GF **Small rebar popouts throughout**

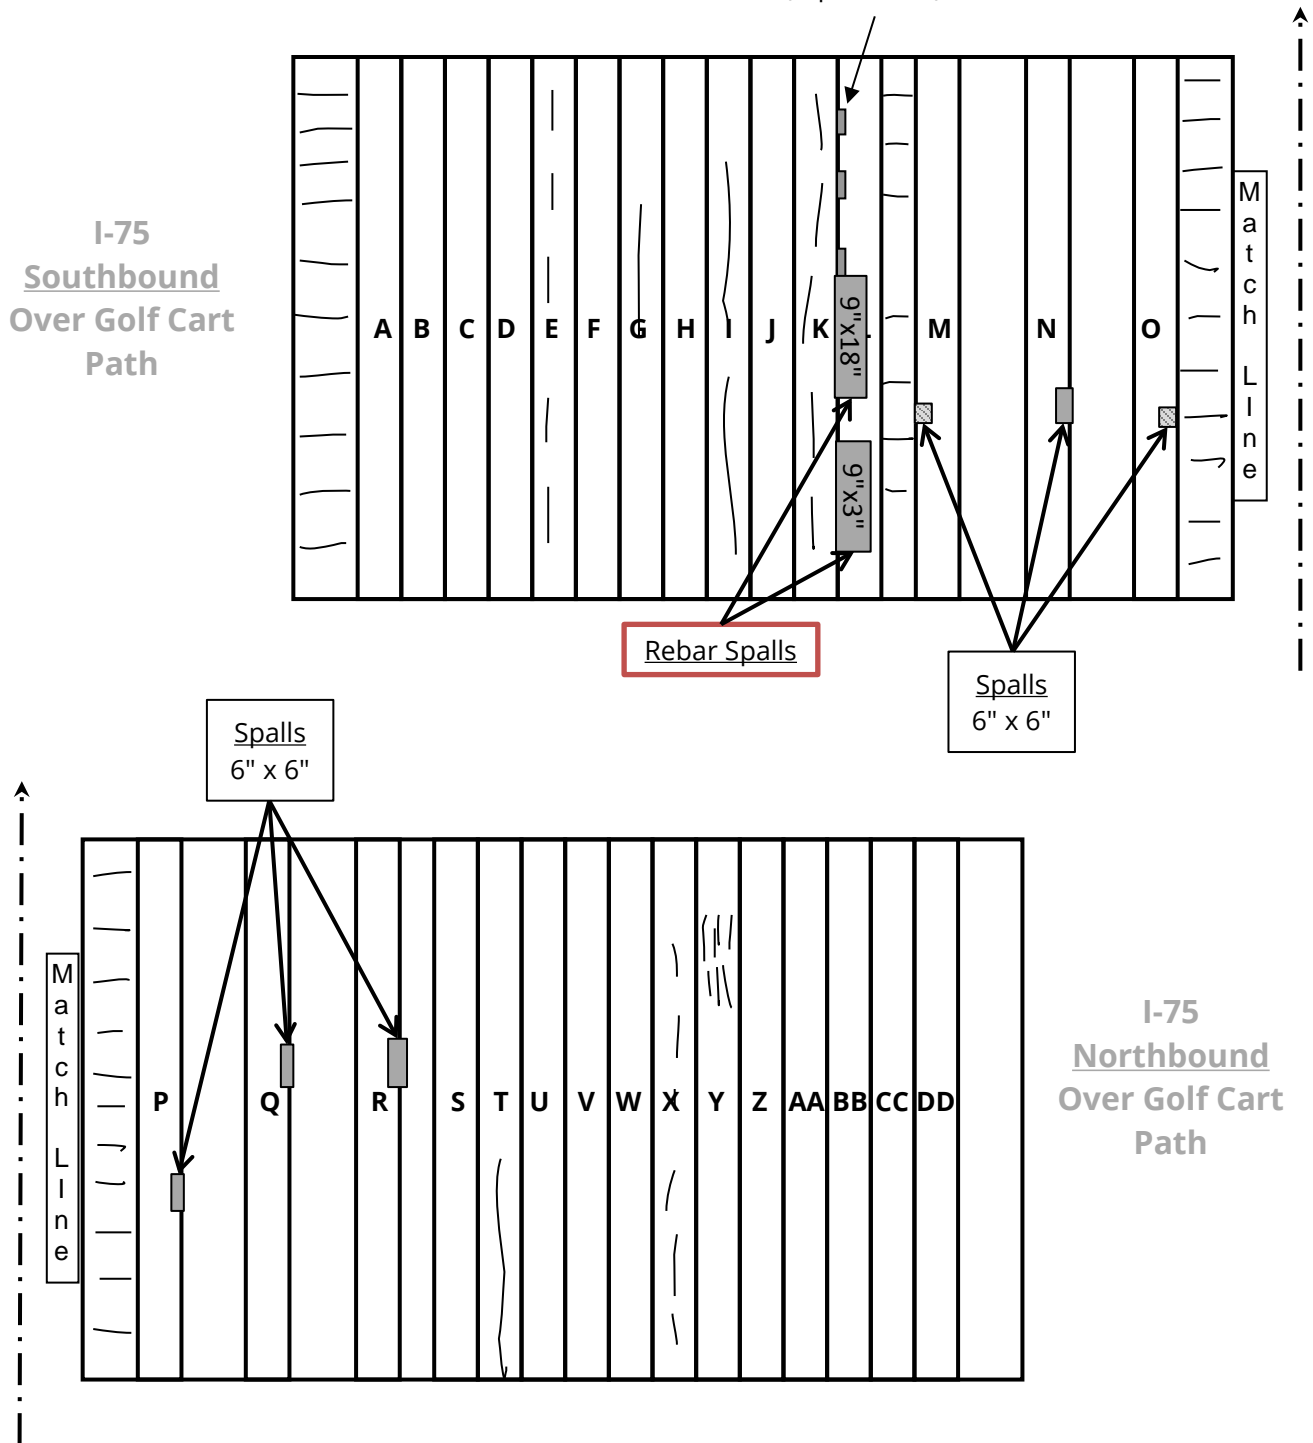
delaminated areas (top-bottom) 3" X 2', 5" X 1.7', & 4" X 4.5'
