Hamilton County

Regular Inspection Report

Location: 33-I0075-02.68

3 Span Bridge

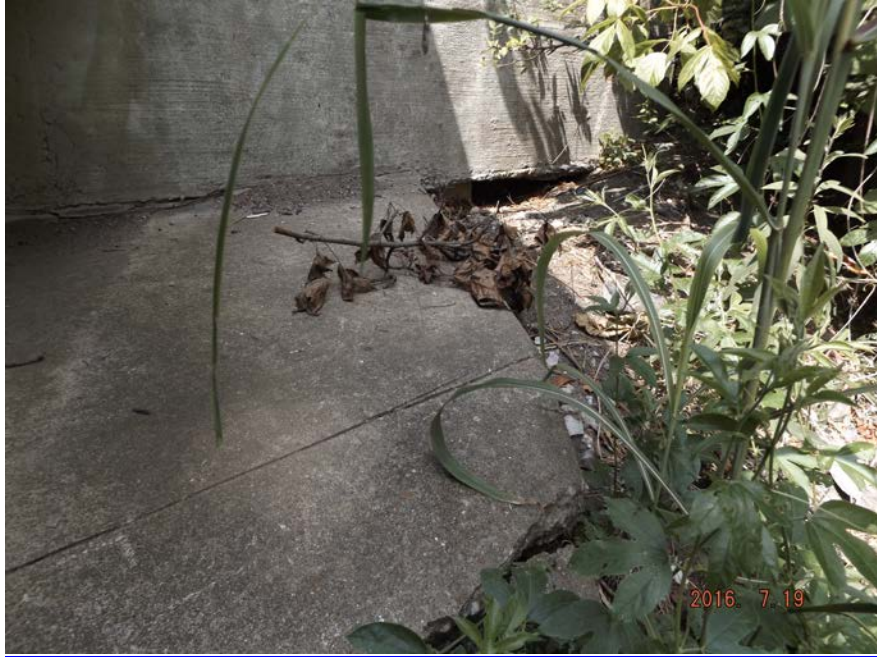
ABUTMENT 1 - LEFT - UNDERCUTTING

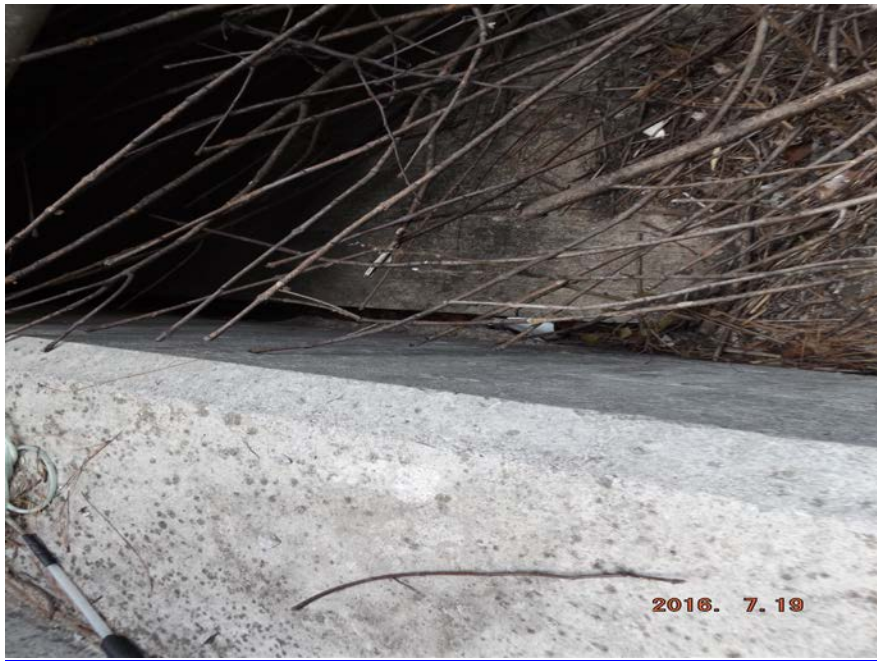
ABUTMENT 2 - LEFT - SEPARATION OF CONCRETE SLOPE

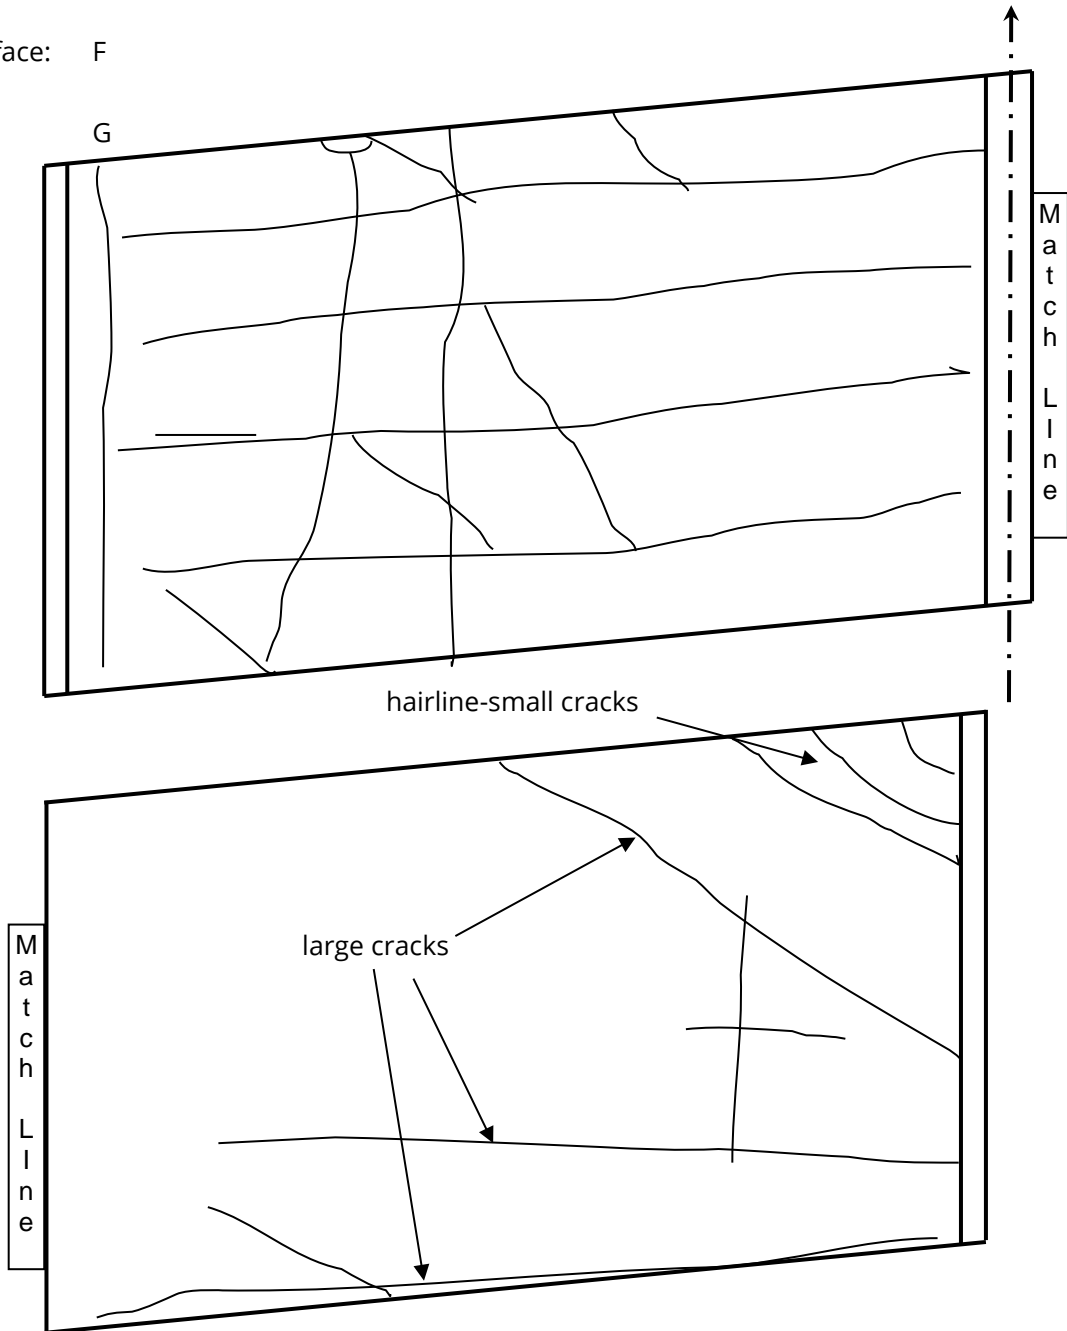
Beams: G 'A' - HL cracks w/ eff

Deck: GF 1C2 HL CRACK W/EFF

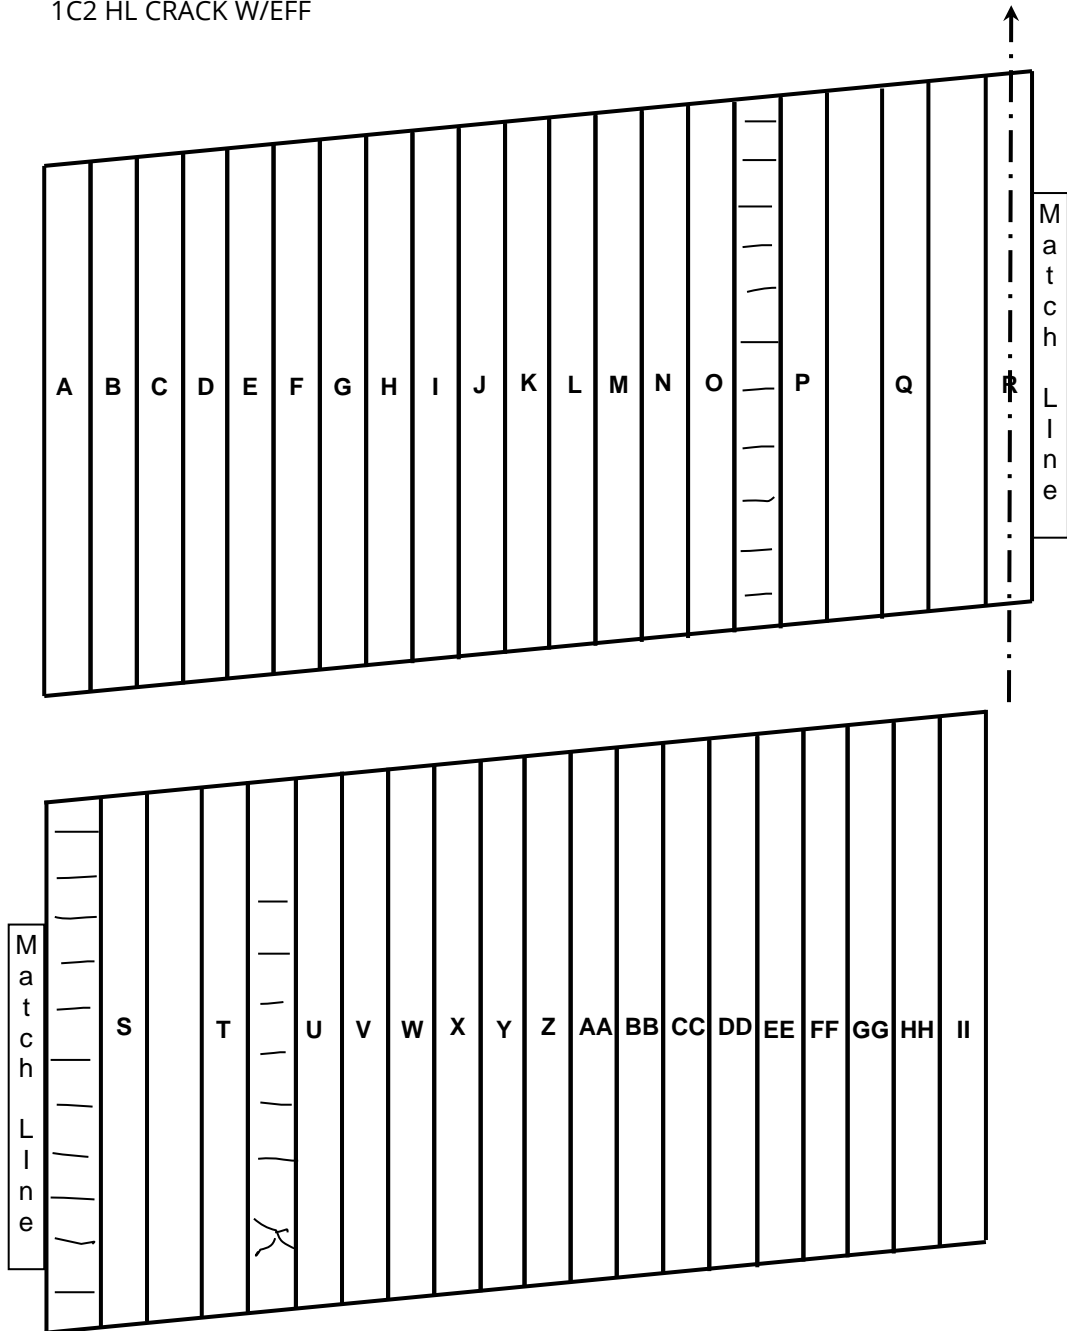
Beams: G 'N' - Rebar spall

Deck: GF 2B5, 2C4, 2D4, 2D5, 2E3, 2E4 - HL CRACKS

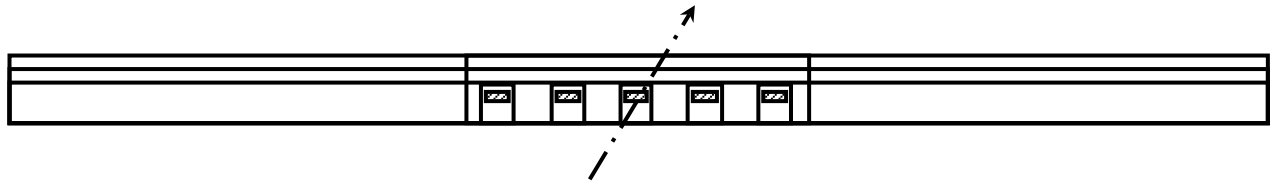
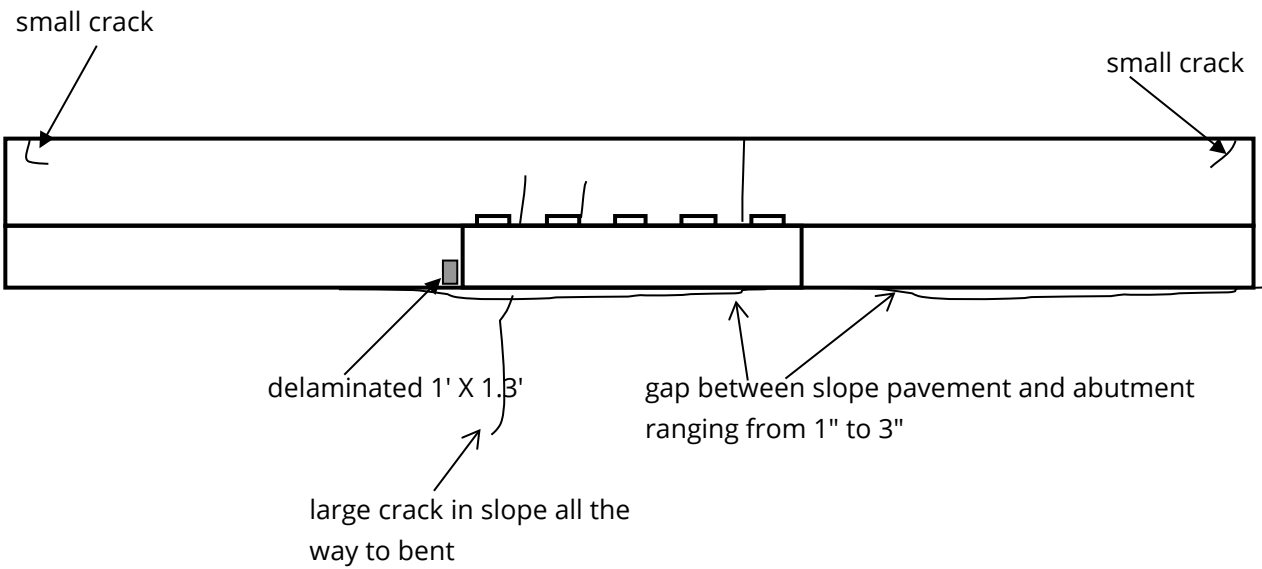
Walls: G some patches of honeycomb and scaling, few small cracks
