# UNDERWATER BRIDGE INSPECTION REPORT

I-65 (Interstate 65) over  
Cumberland River  
Structure No. 19I00650145  
Davidson County, Tennessee

August 2023  
Project No. 16023014.07

Tennessee Department of Transportation  
Suite 1200, James K. Polk Building  
505 Deaderick Street, Nashville, TN 37243-0338

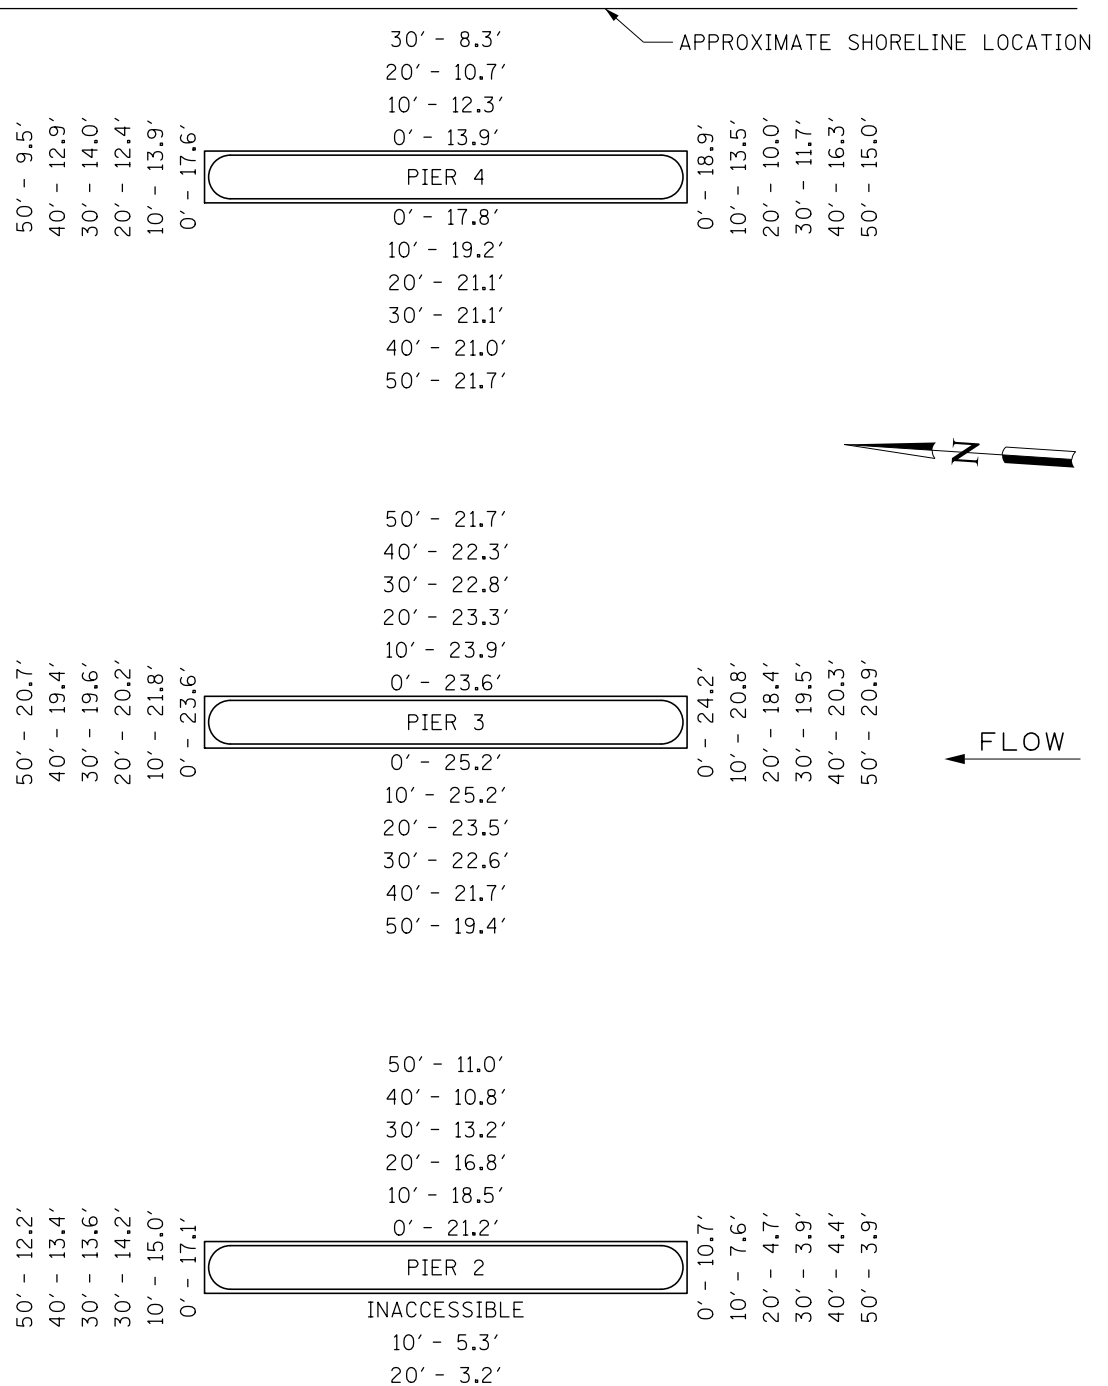
### SOUNDING PLAN

A comparison of the soundings recorded during the previous inspection on July 15, 2020 and the soundings taken during this inspection revealed a tolerable change in the channel bottom profile in the vicinity of the structure. The footing exposure at Piers 2 through 4 is not a concern at this time given that the bottom of the concrete seal was embedded a minimum of 1.5 feet below the current channel bottom and the pier is pile supported. The channel bottom configuration should continue to be closely monitored during future underwater inspections to verify that the footing exposure at Piers 2 through 4 is not increasing and that all footings remain adequately embedded in the channel bottom.

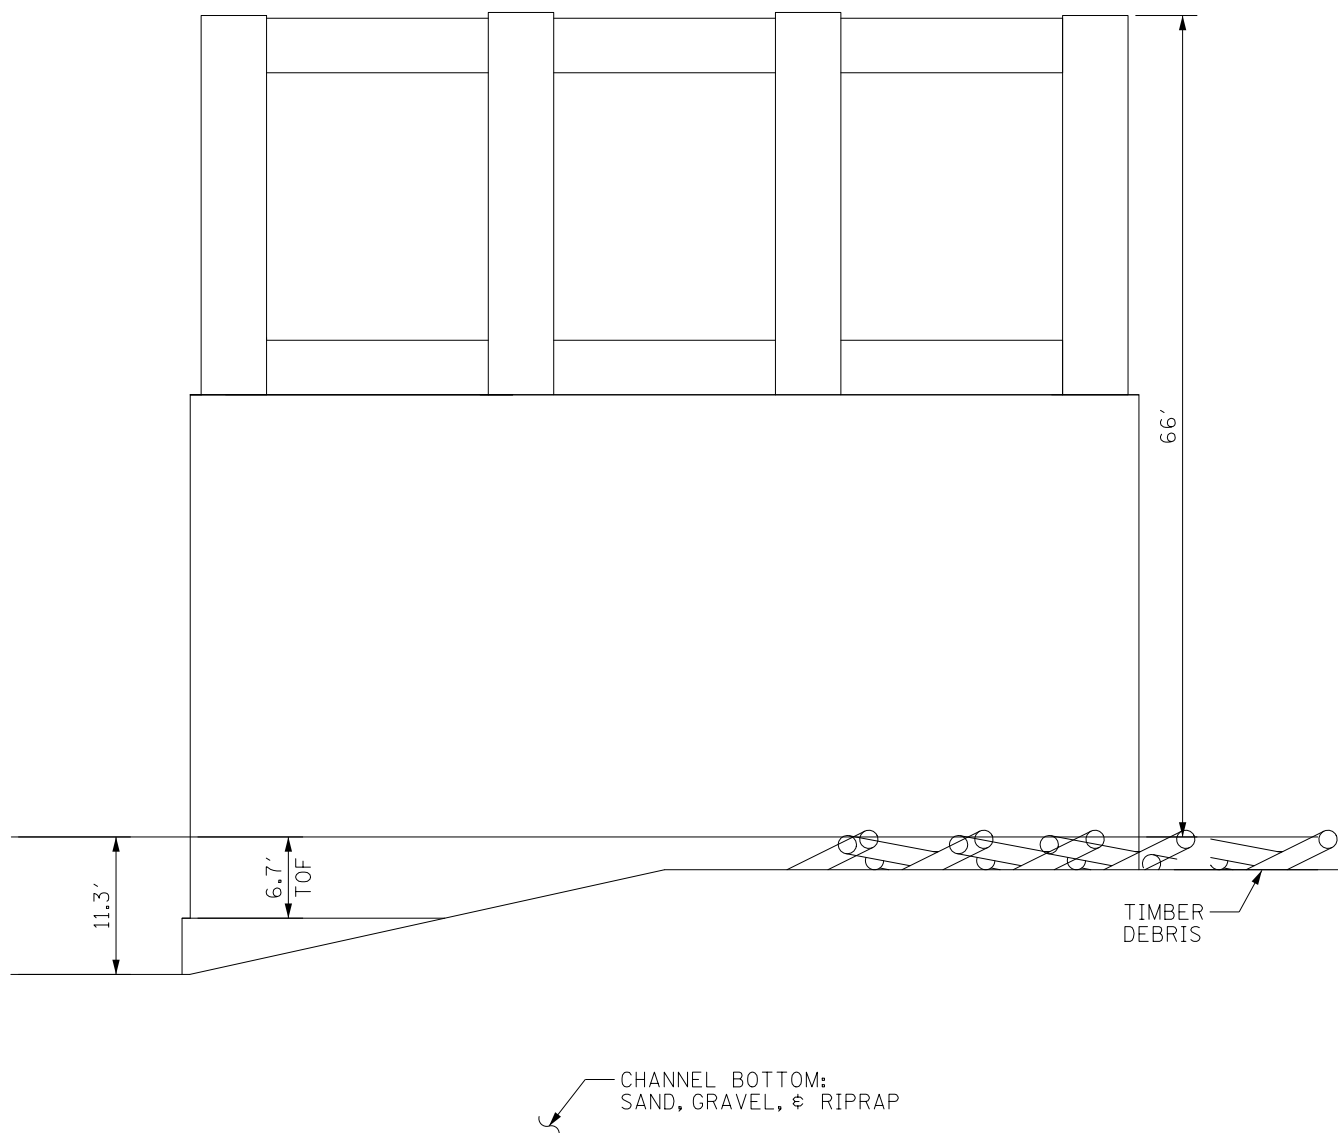
PIER 2 - ELEVATION  
LOOKING EAST

The channel bottom around Pier 2 consisted of sand, gravel, and riprap. Top and sides of footing was observed, however, no undermining was detected. Major debris build up around the upstream nose of the Pier was observed. Refer to Figure 3 through 5 in Exhibit 1 for detailed inspection notes of Pier 2. Refer to Photograph 5 in Exhibit 2 for views of Pier 2 and typical concrete condition at the waterline.

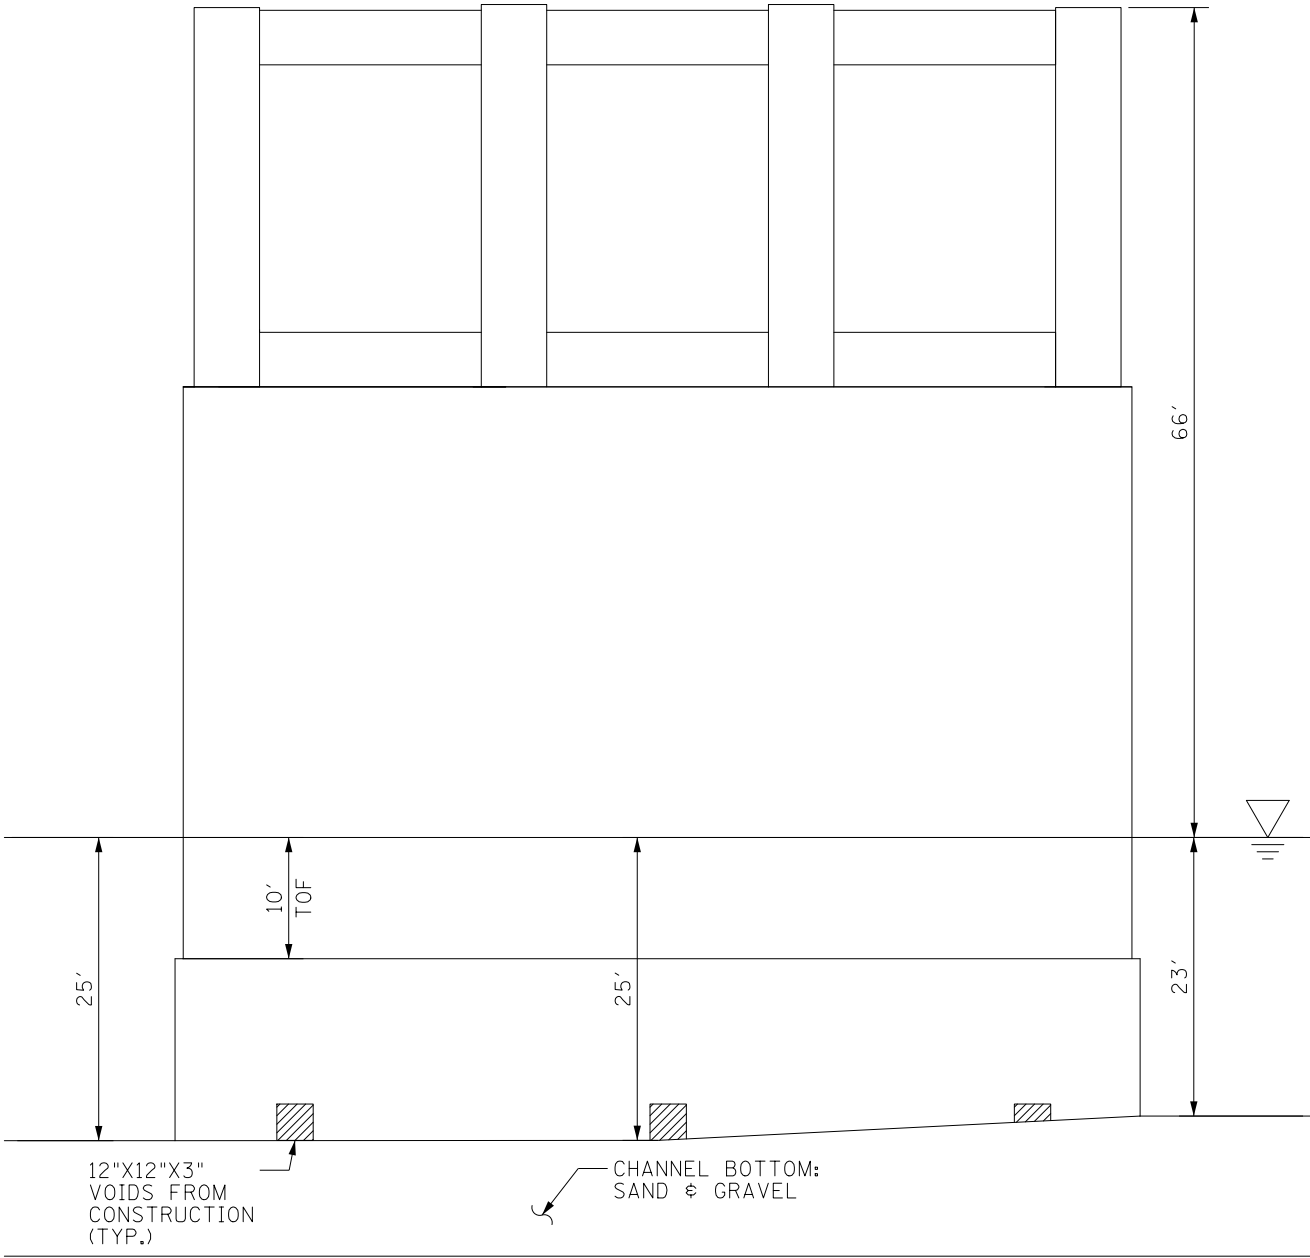
PIER 3 - ELEVATION  
LOOKING WEST

The channel bottom around Pier 3 consisted of sand and gravel. The top and sides of footing was observed, however, no undermining was detected. Moderate debris build up was observed on the east face of the Pier. Six voids were observed, three on the east face and three on the west face. Each void had approximate dimensions of 1'x1'x3". The voids

were left over from construction and are not a structural concern. Refer to Figure 6 through 8 in Exhibit 1 for detailed inspection notes of Pier 3. Refer to Photograph 6 in Exhibit 2 for views of Pier 3 and typical concrete condition at the waterline.

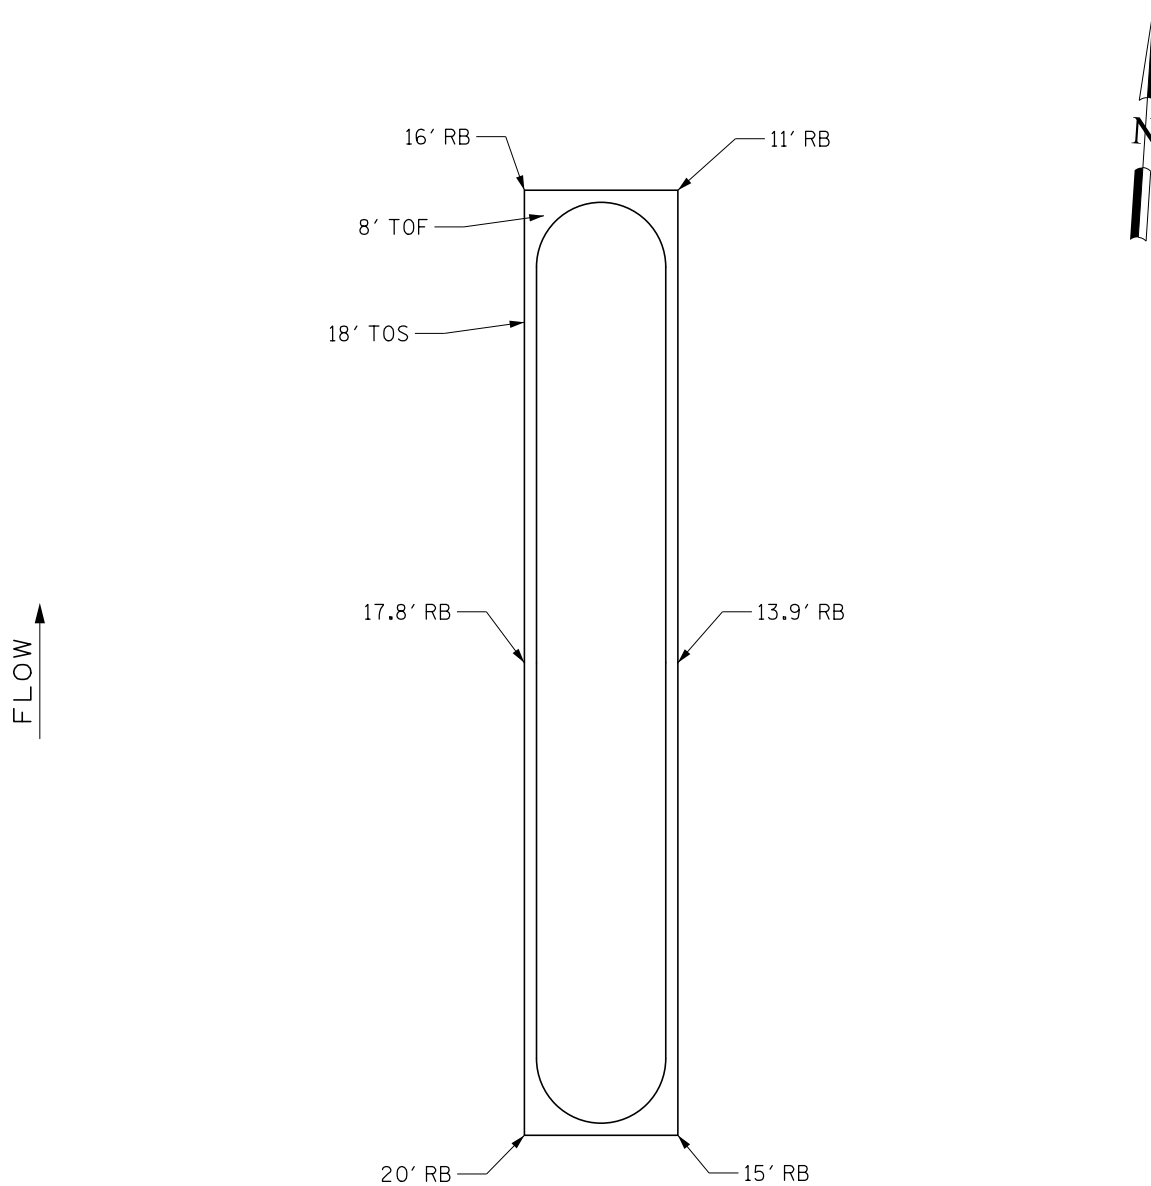
PIER 4 - FOOTING

The channel bottom around Pier 4 consisted of sand, gravel, and riprap. Top and side of footing was observed, however, no undermining was detected. A submerged vehicle was located on the downstream end of the Pier. The sub footing was exposed approximately 1.5 feet on the upstream, channel side corner of the Pier. Refer to Figure 9 through 11 in Exhibit 1 for detailed inspection notes of Pier 4. Refer to Photograph 6 in Exhibit 2 for views of Pier 4 and typical concrete condition at the waterline.

- Monitor debris accumulation at Pier 2.
- Monitor sub footing exposure at Pier 4.

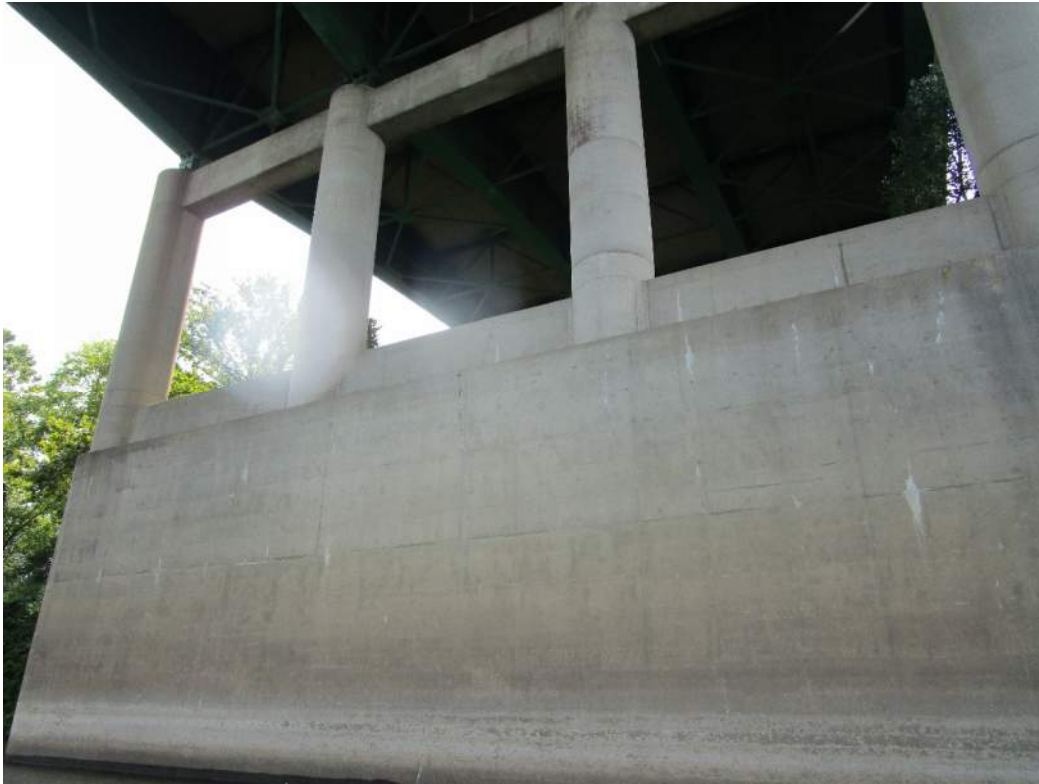
Pier 2, looking west

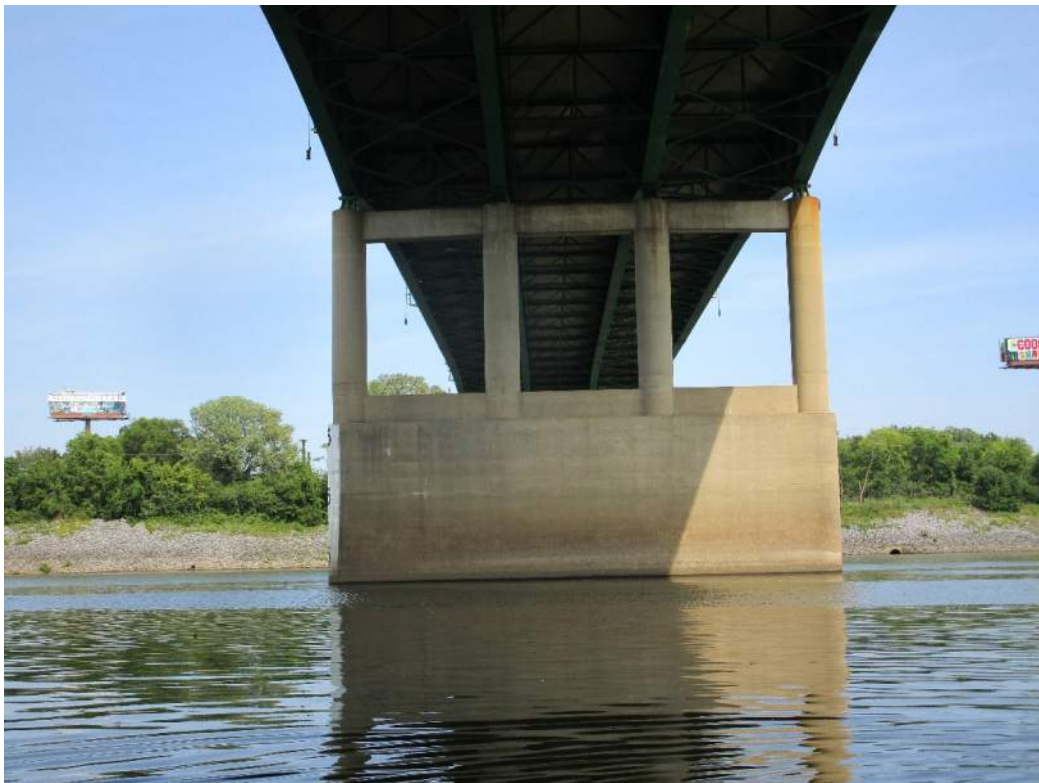
Pier 3, looking east

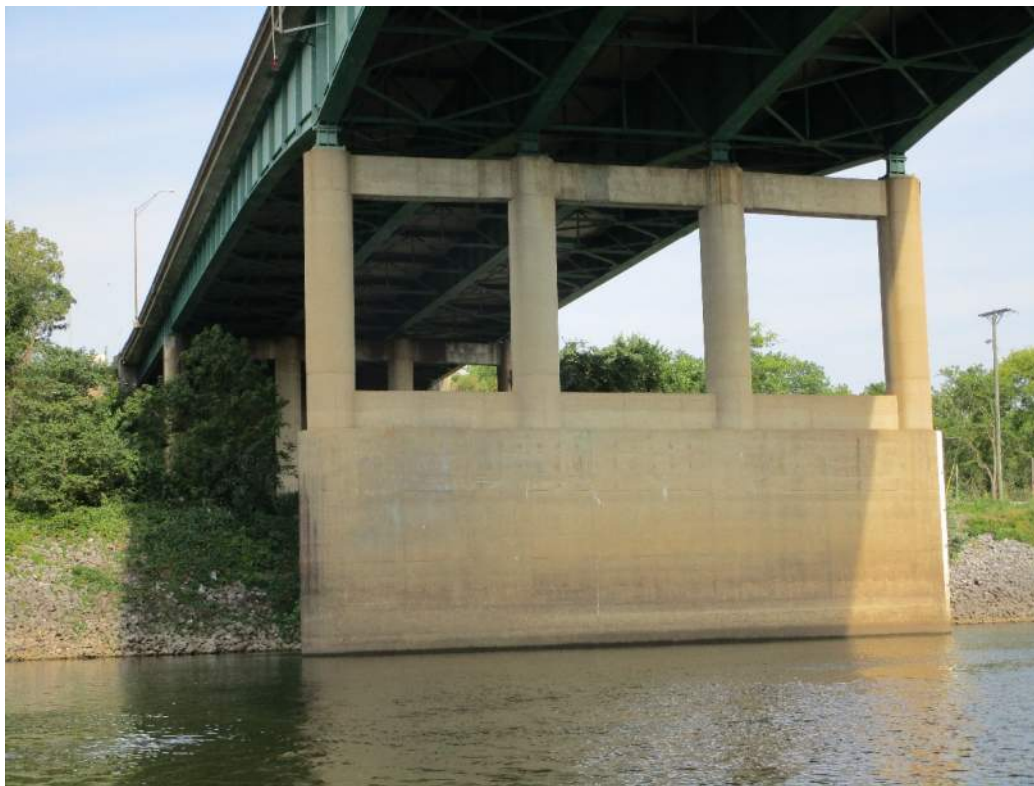
Pier 4, looking east

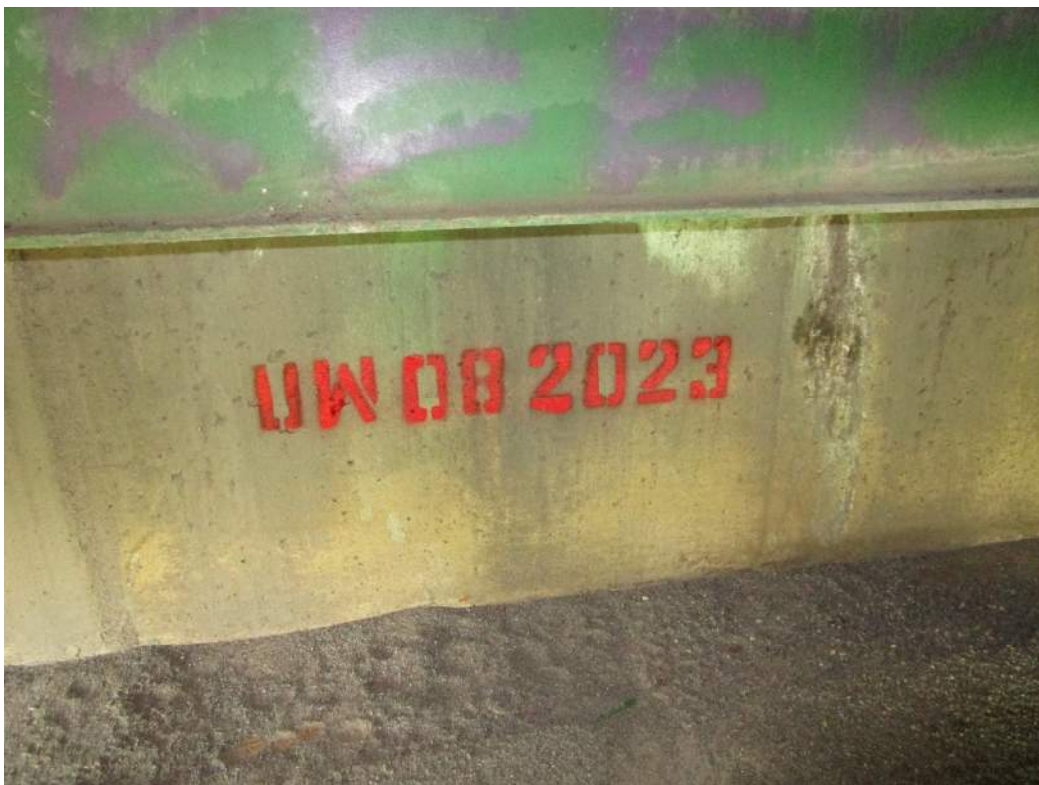
Underwater inspection marking, Abutment 1
