HILLSBORO BLVD. Crossing CFW RAILROAD

# Routine Bridge Inspection Report

City of Manchester in Coffee County	
Federal ID	16SR0020015
Location	16-SR002-14.28
Description	Hillsboro Road over CFW Railroad
GPS Coordinates	35.480250, -86.085800
Date	10/12/2023
Overall Condition	Fair

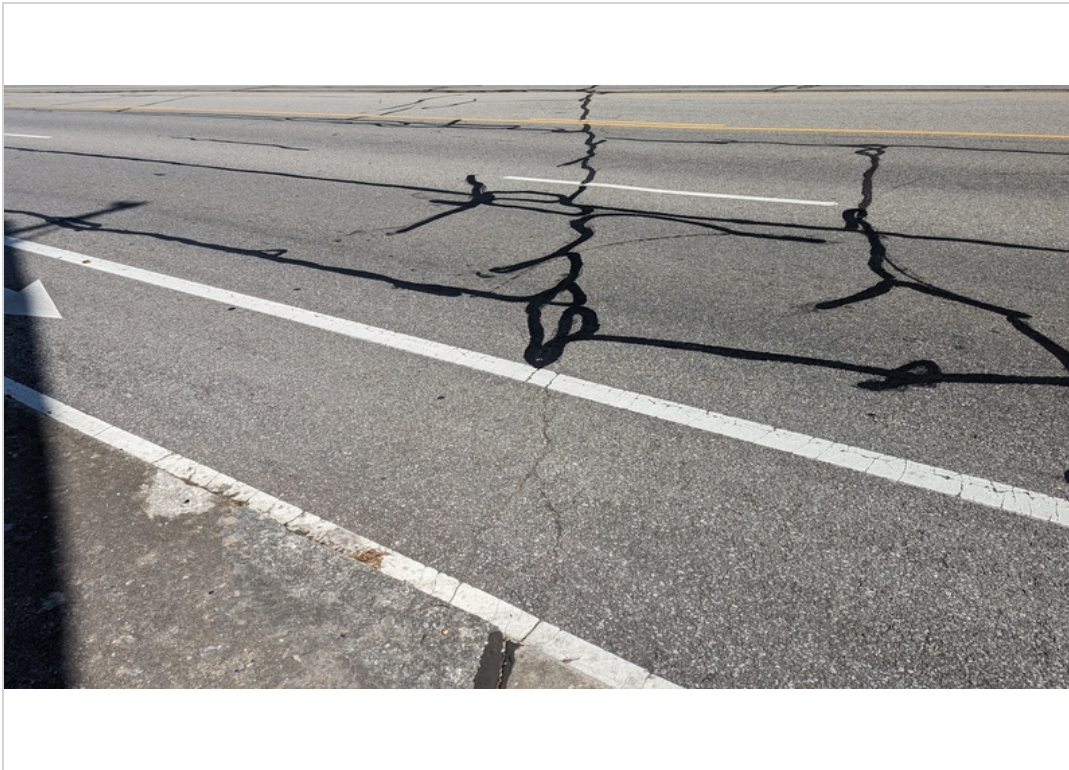
Typical sealed cracks in wearing surface

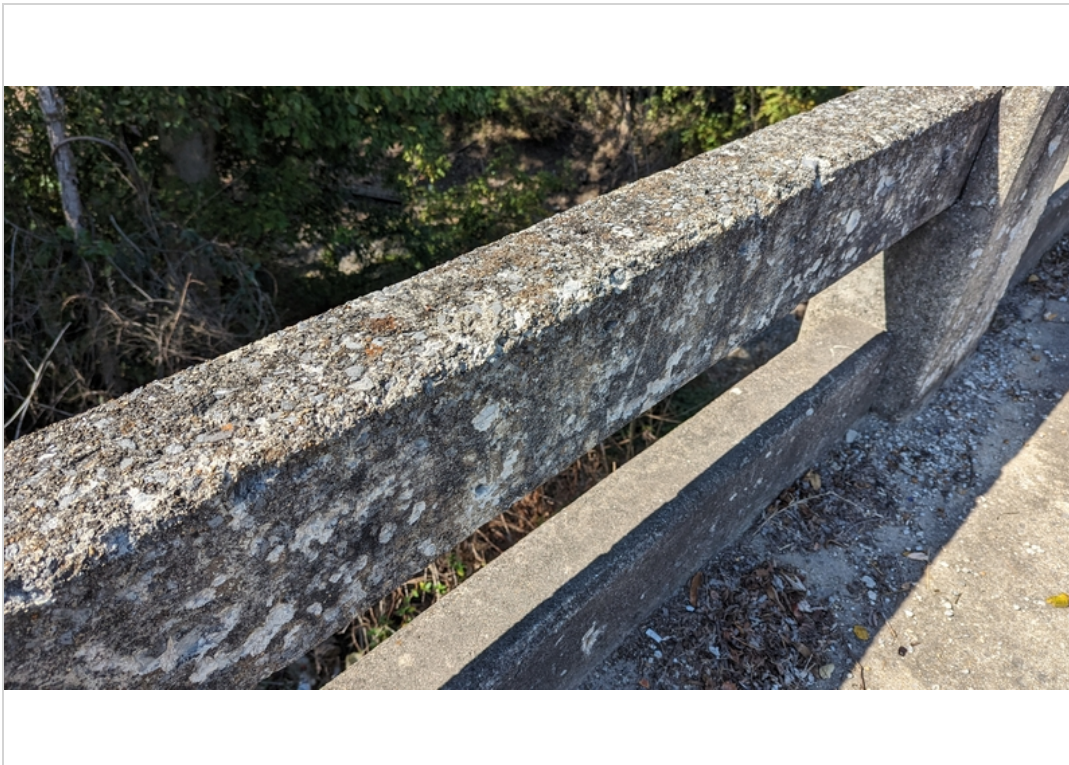
Typical scaling on bridge rail

Bridge Railing Rating (Fair) Scaling throughout and some rebar pop-outs

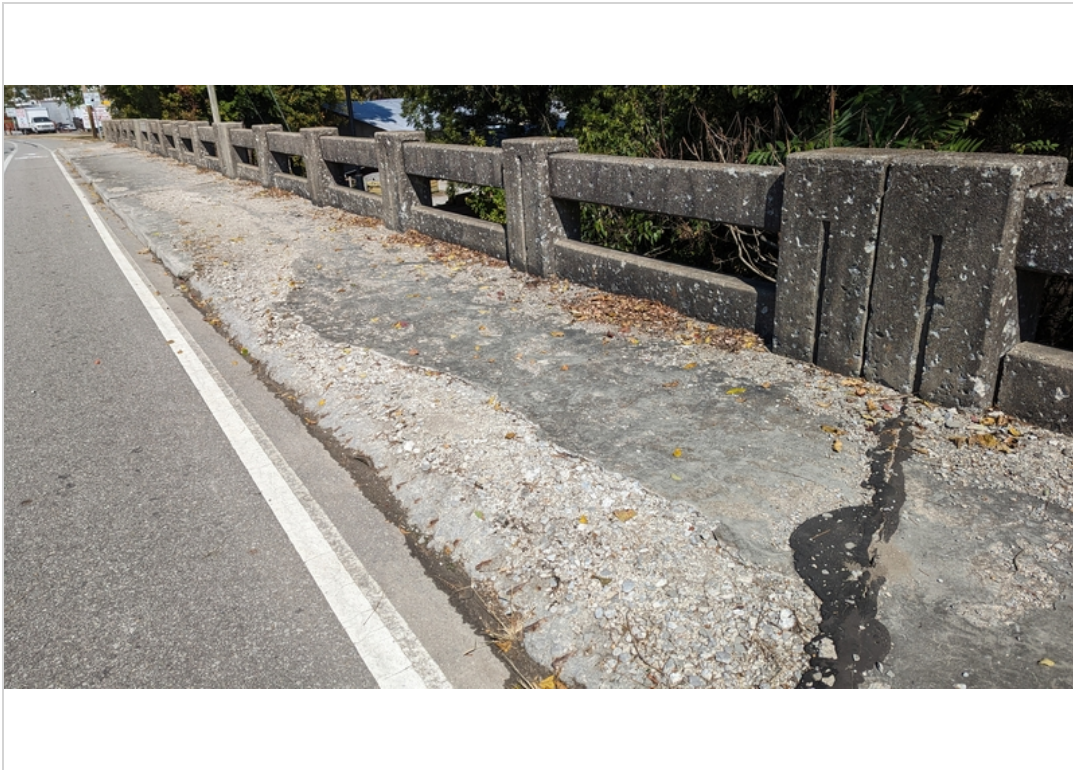
Typical sidewalk deterioration

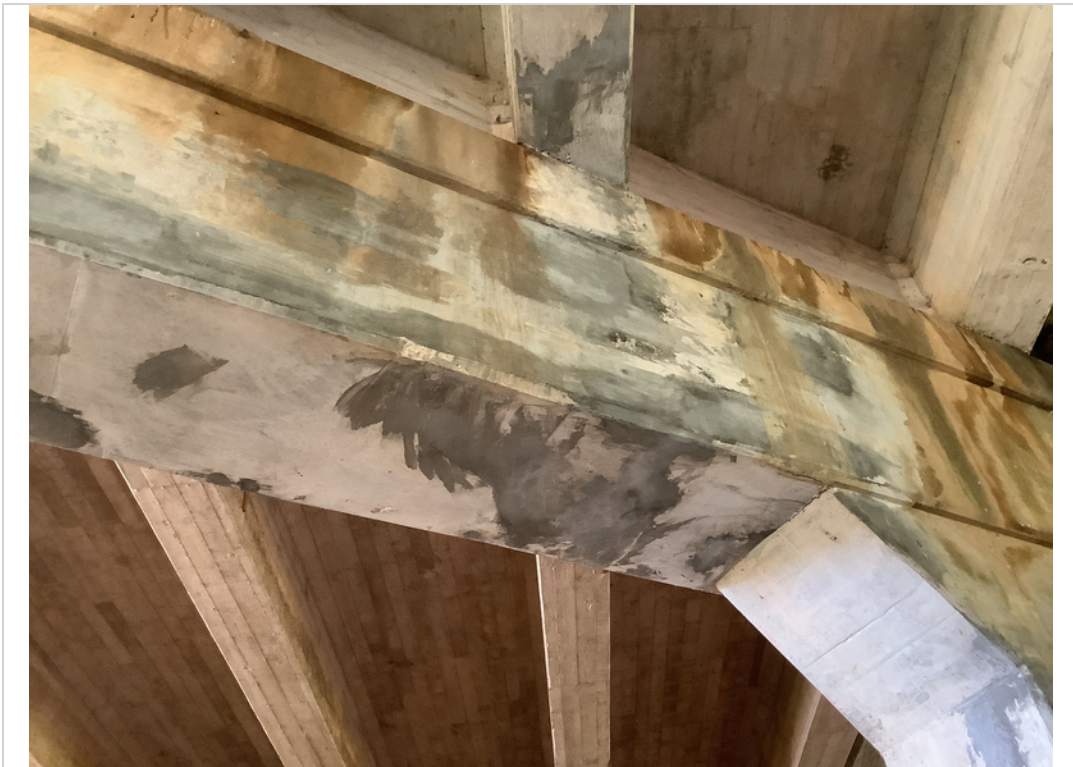
Typical repaired area

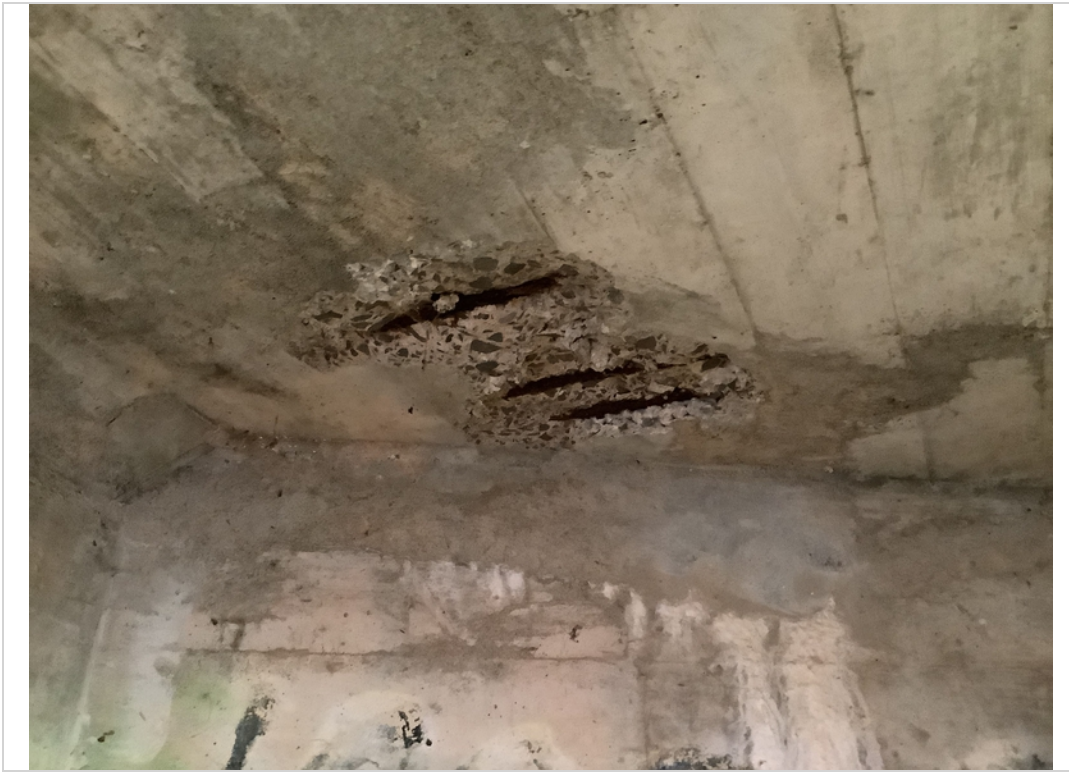
Typical spall with exposed rebar in bottom of deck

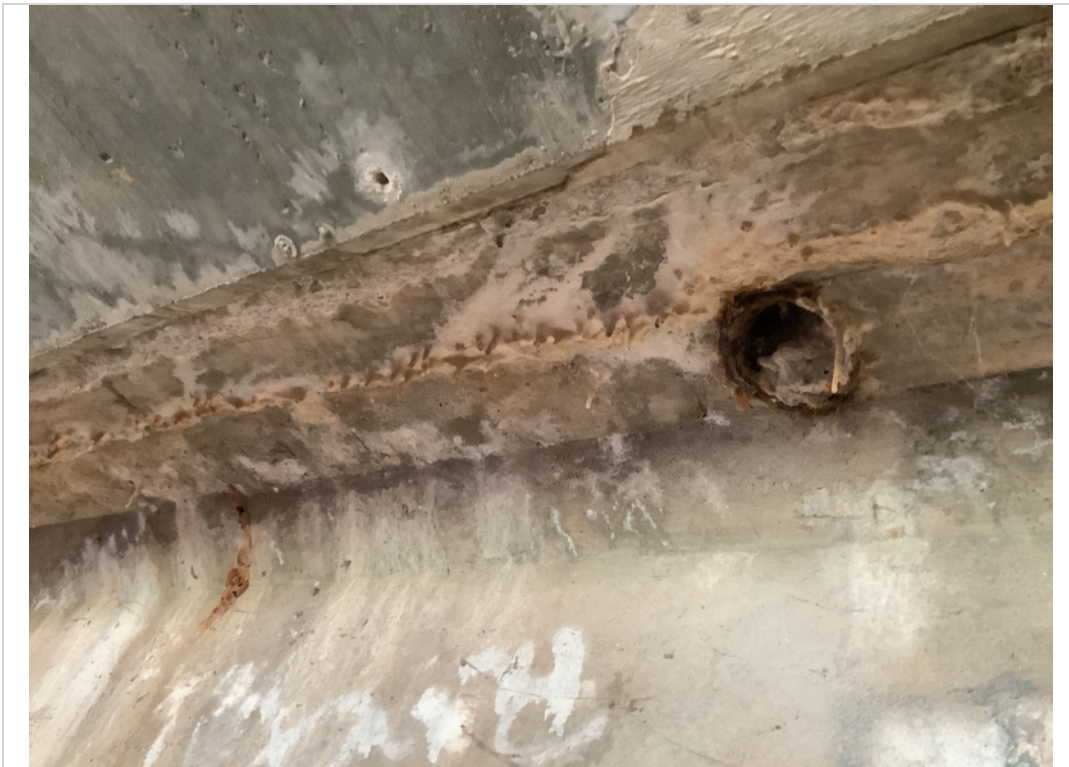
Typical moderate efflorescence in bottom of deck

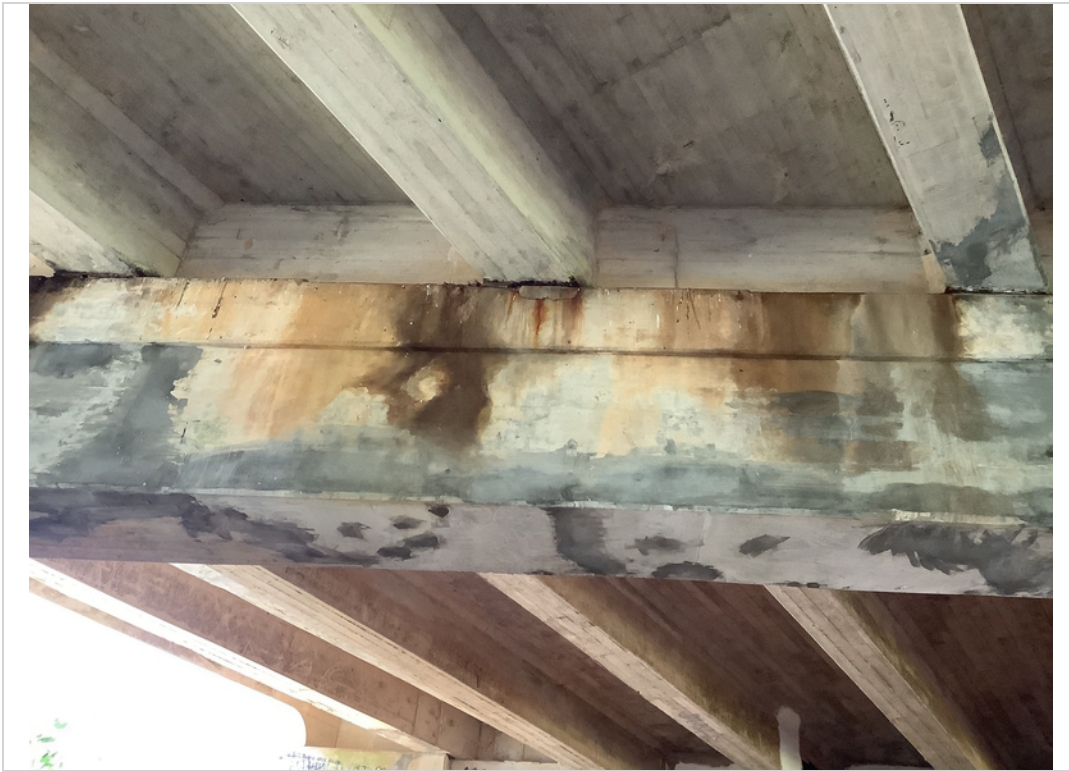
Typical delaminated area

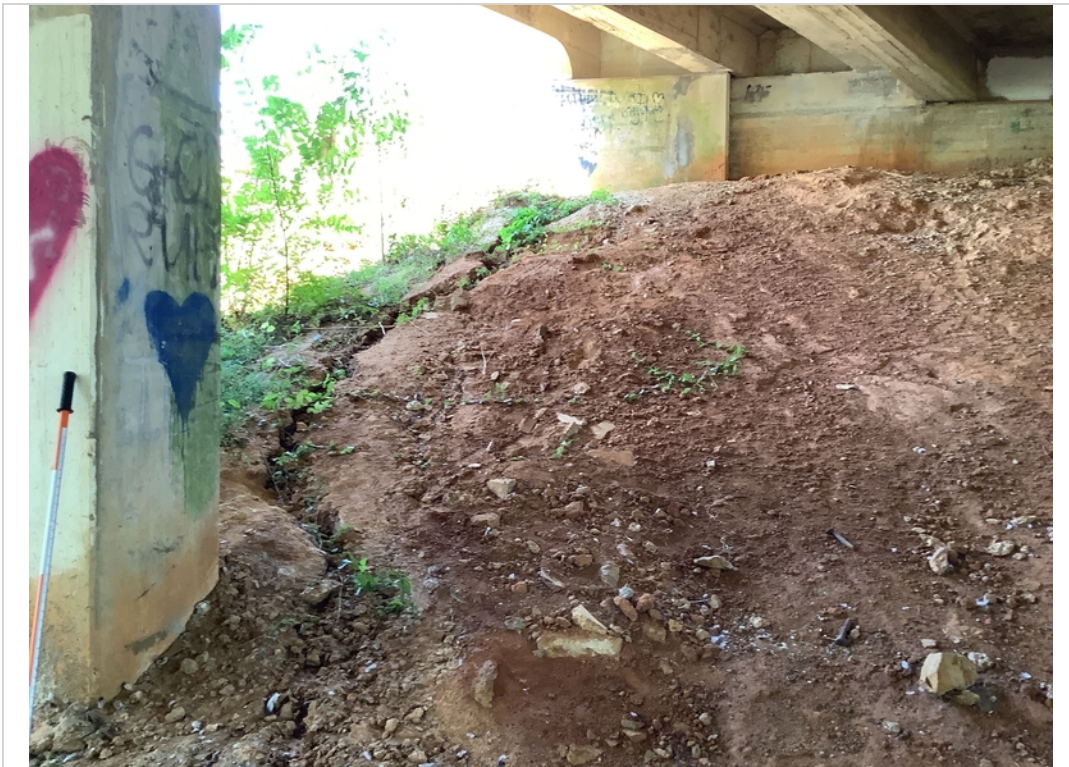
Typical embankment erosion at abutments

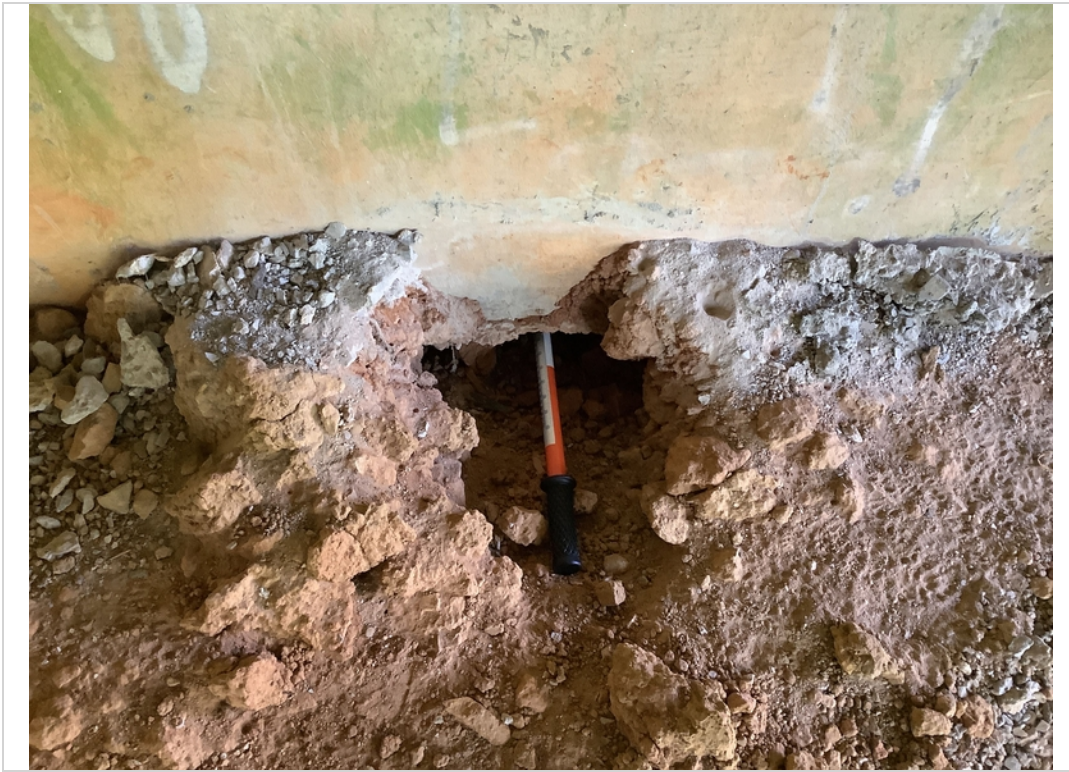
Typical void at abutment #1

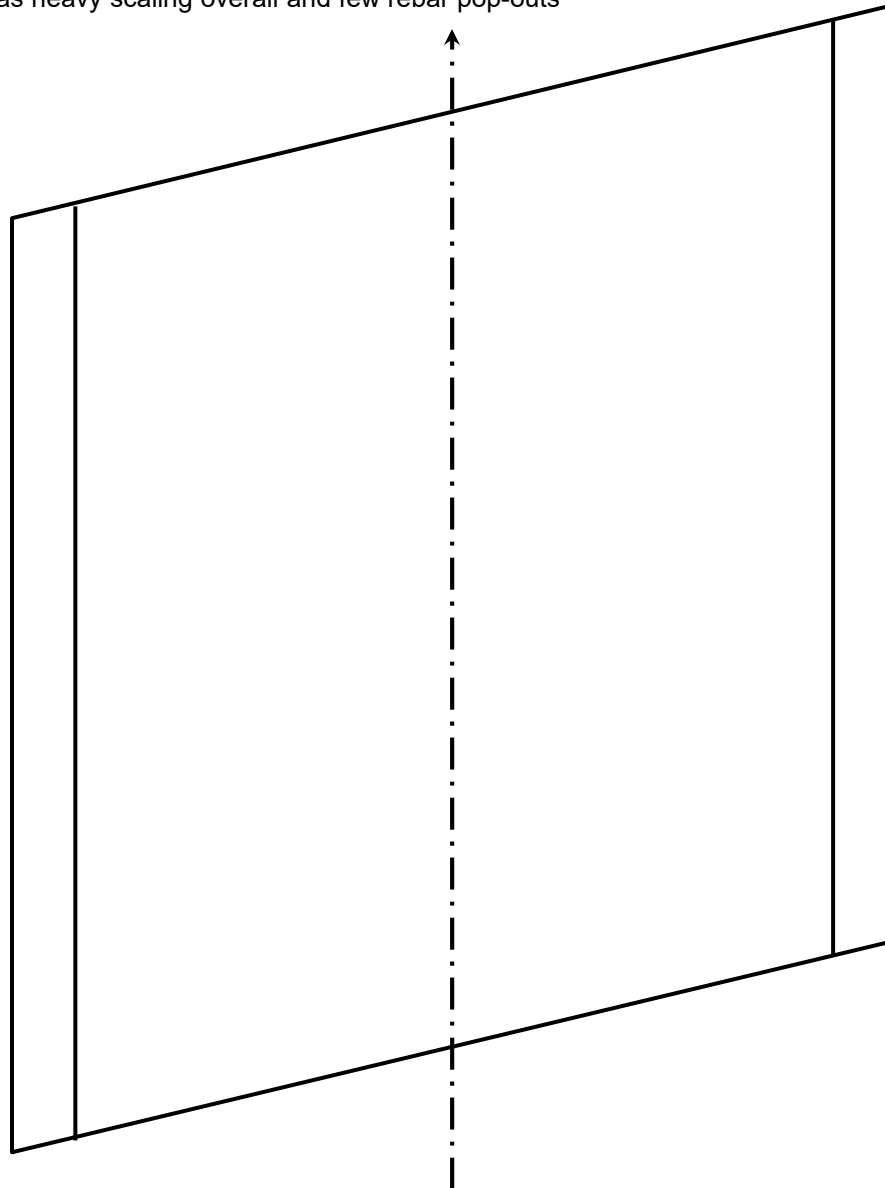
# Top of Deck Span No. 1

Sidewalks have large areas of heavy to severe scaling with some delamination

Bridge railing has heavy scaling overall and few rebar pop-outs

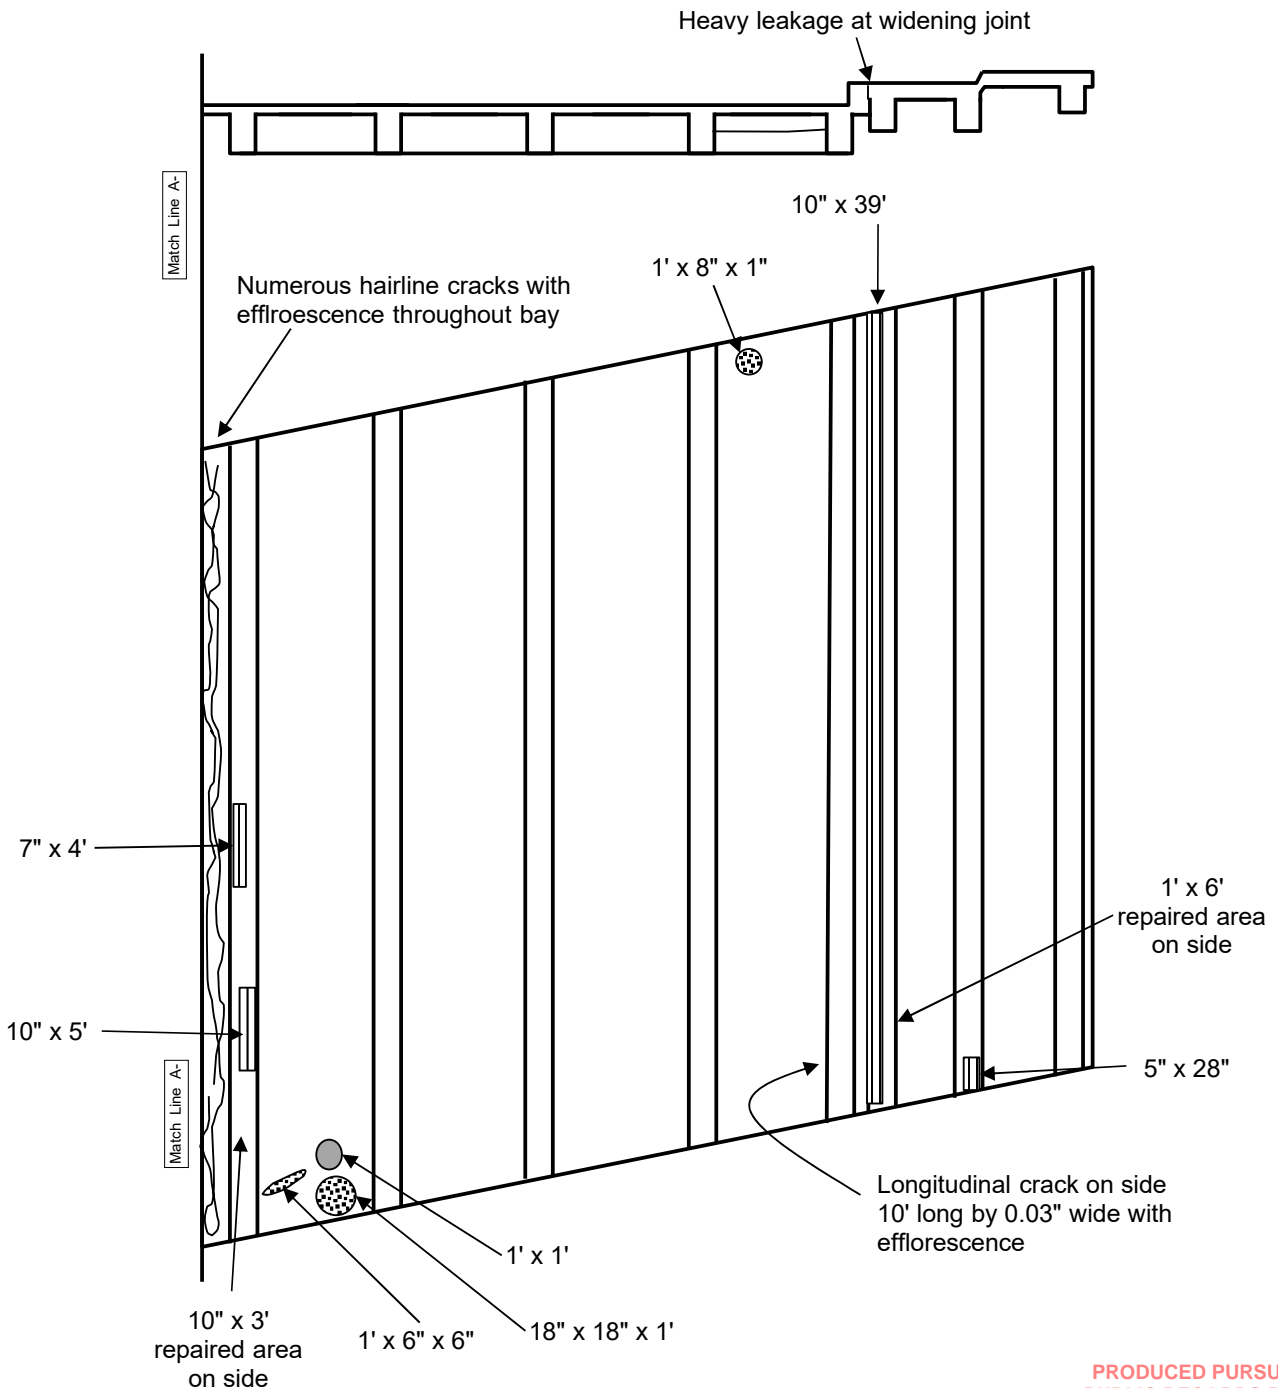
# Bottom of Deck Span No. 1R

All spalls have exposed rebar

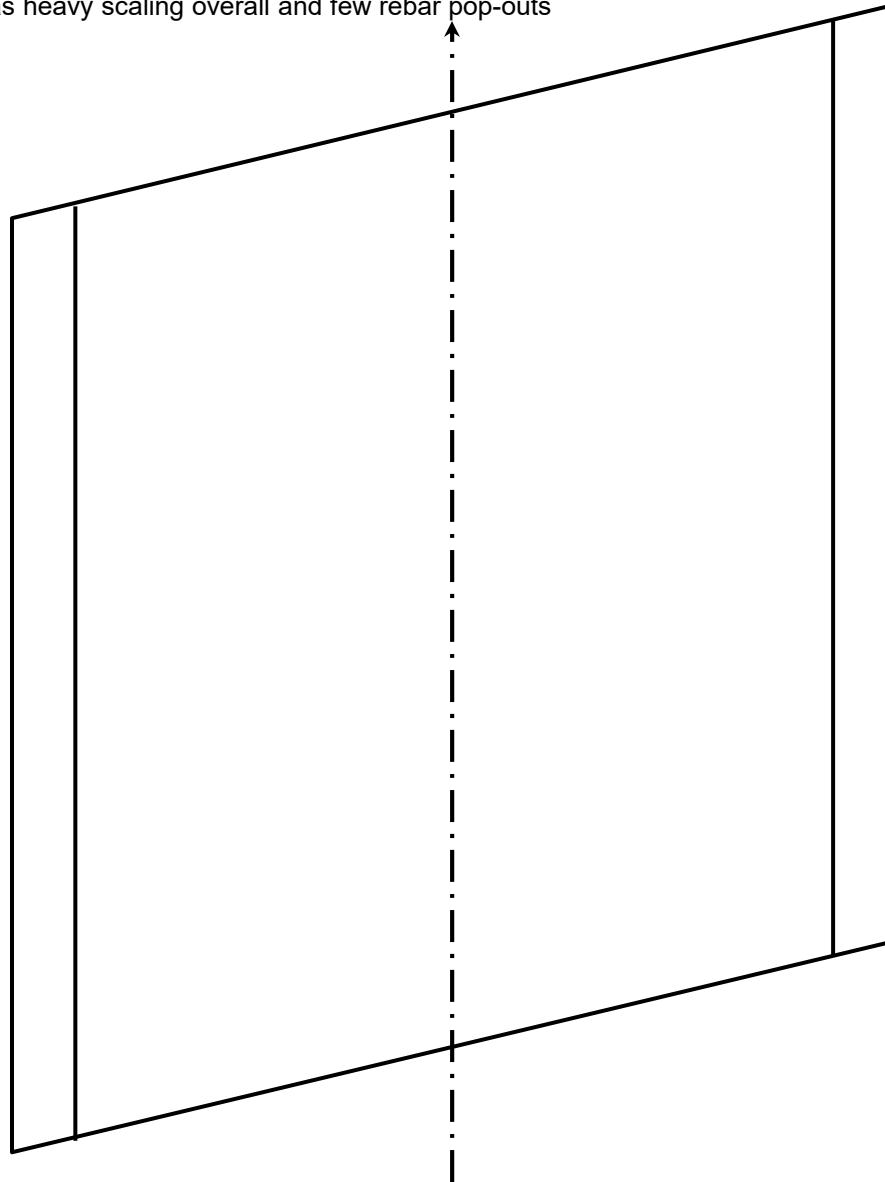
# Top of Deck Span No. 2

Sidewalks have large areas of heavy to severe scaling with some delamination

Bridge railing has heavy scaling overall and few rebar pop-outs

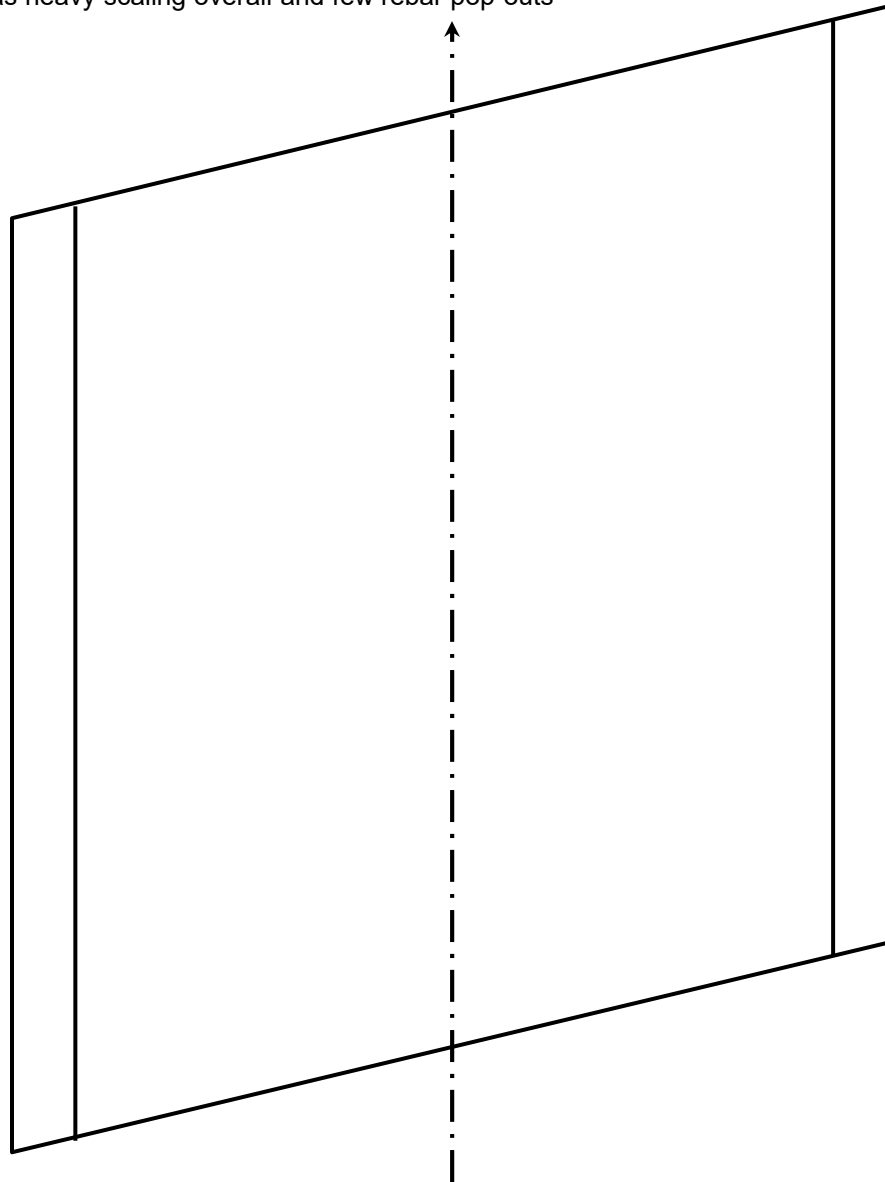
# Top of Deck Span No. 3

Sidewalks have large areas of heavy to severe scaling with some delamination

Bridge railing has heavy scaling overall and few rebar pop-outs

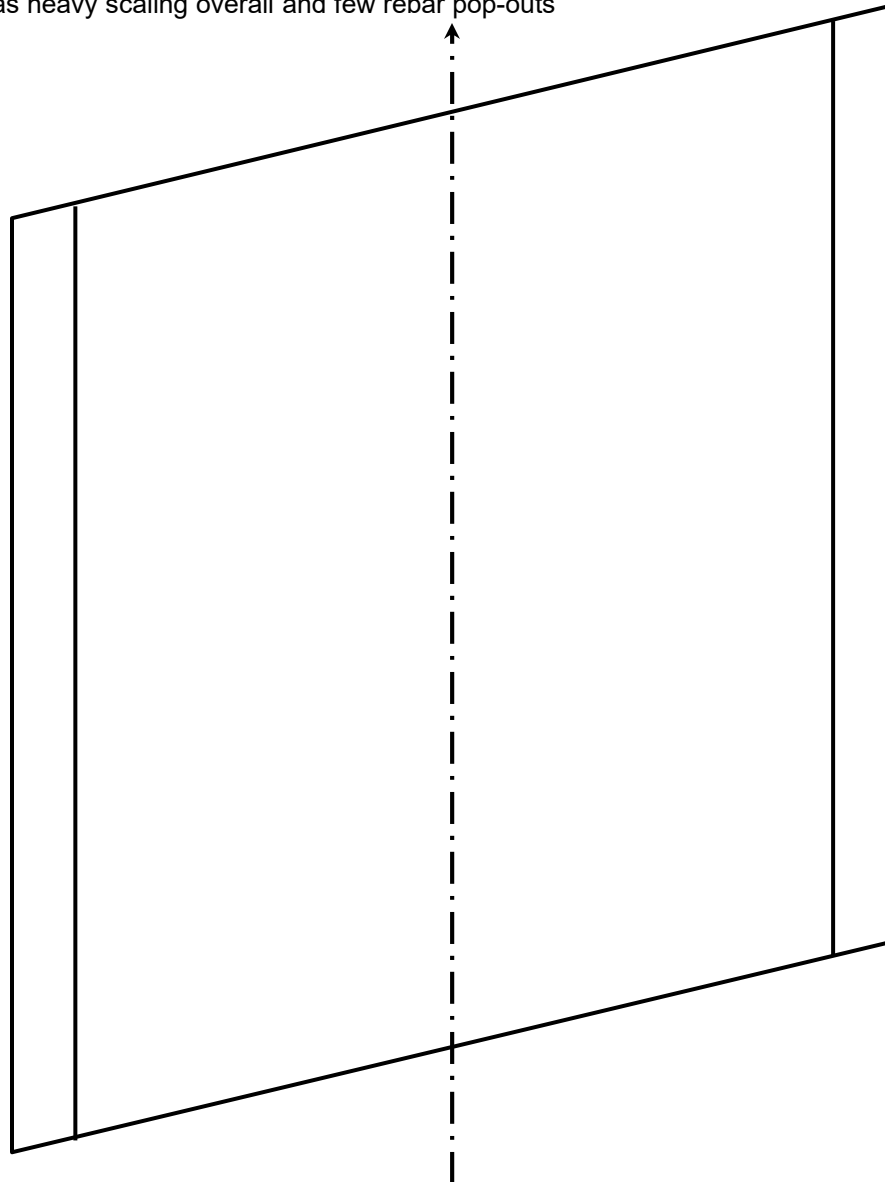
# Top of Deck Span No. 4

Sidewalks have large areas of heavy to severe scaling with some delamination

Bridge railing has heavy scaling overall and few rebar pop-outs

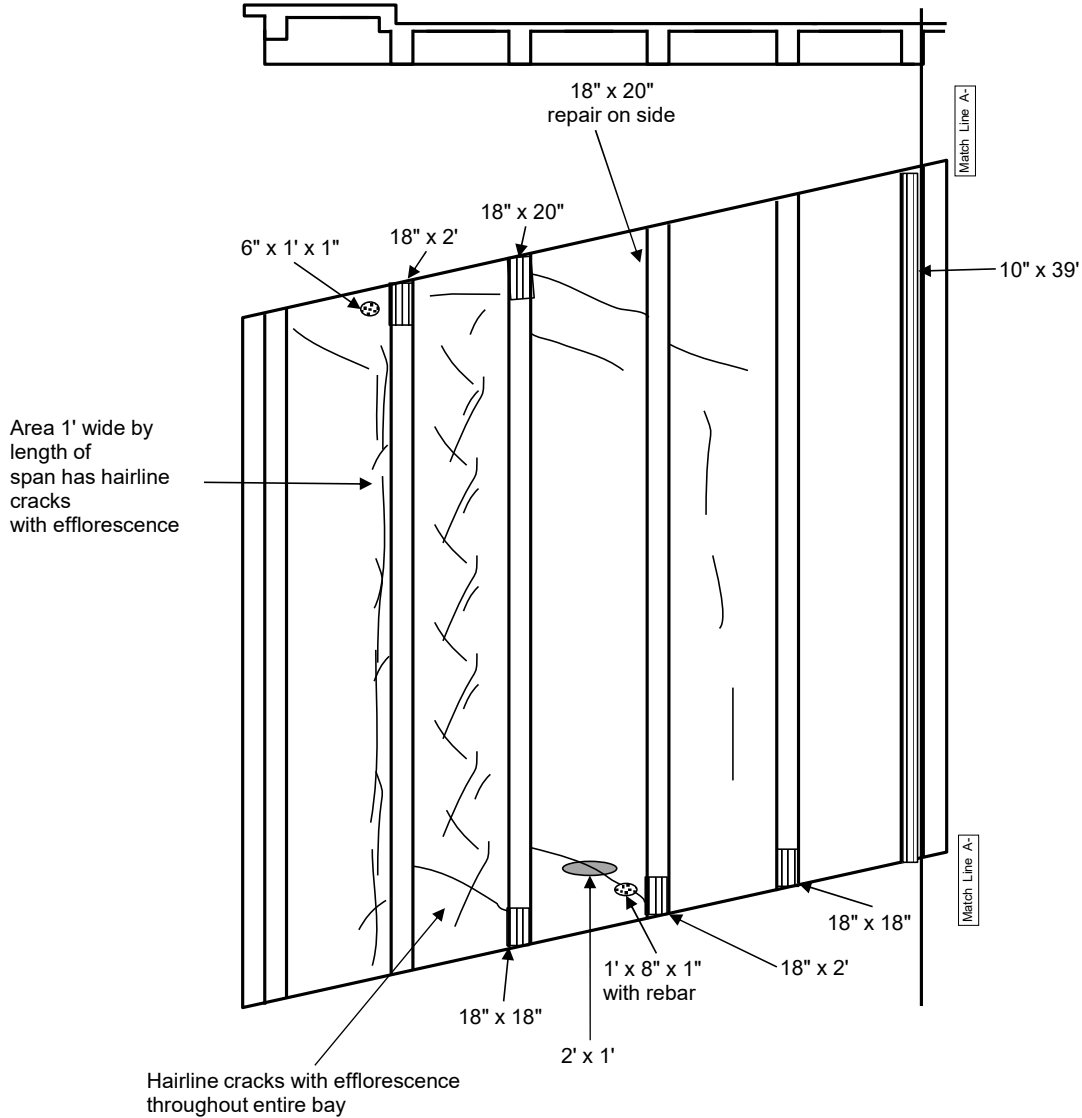
All cracks are hairline with efflorescence

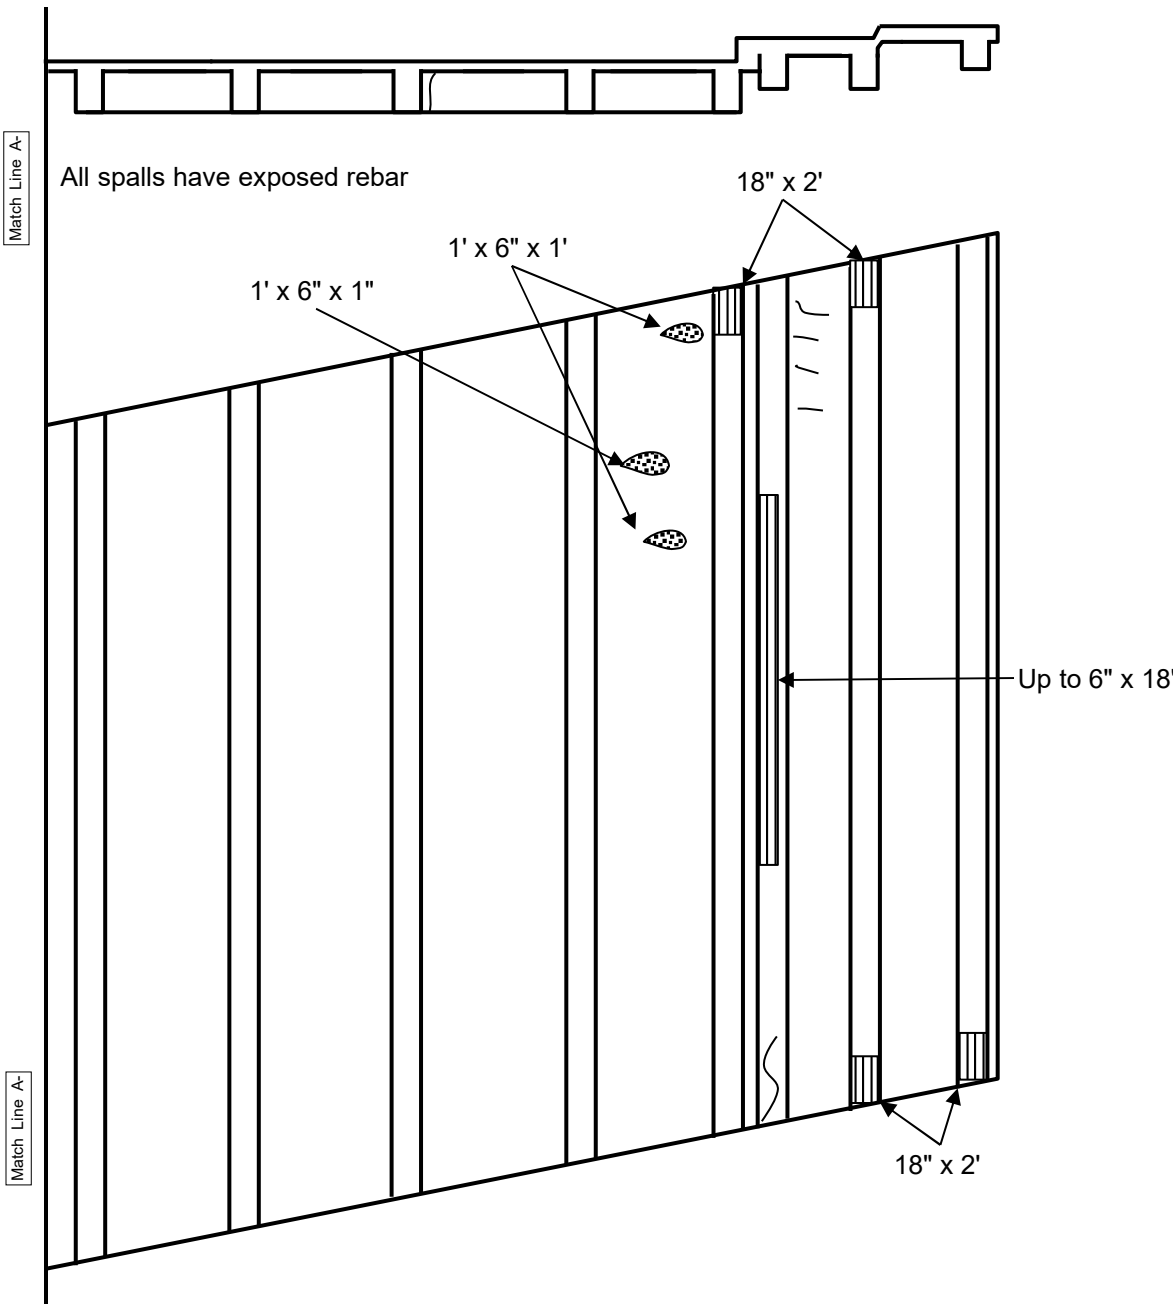
Bottom of Deck Span No. 4R

Heavy leakage at widening joint

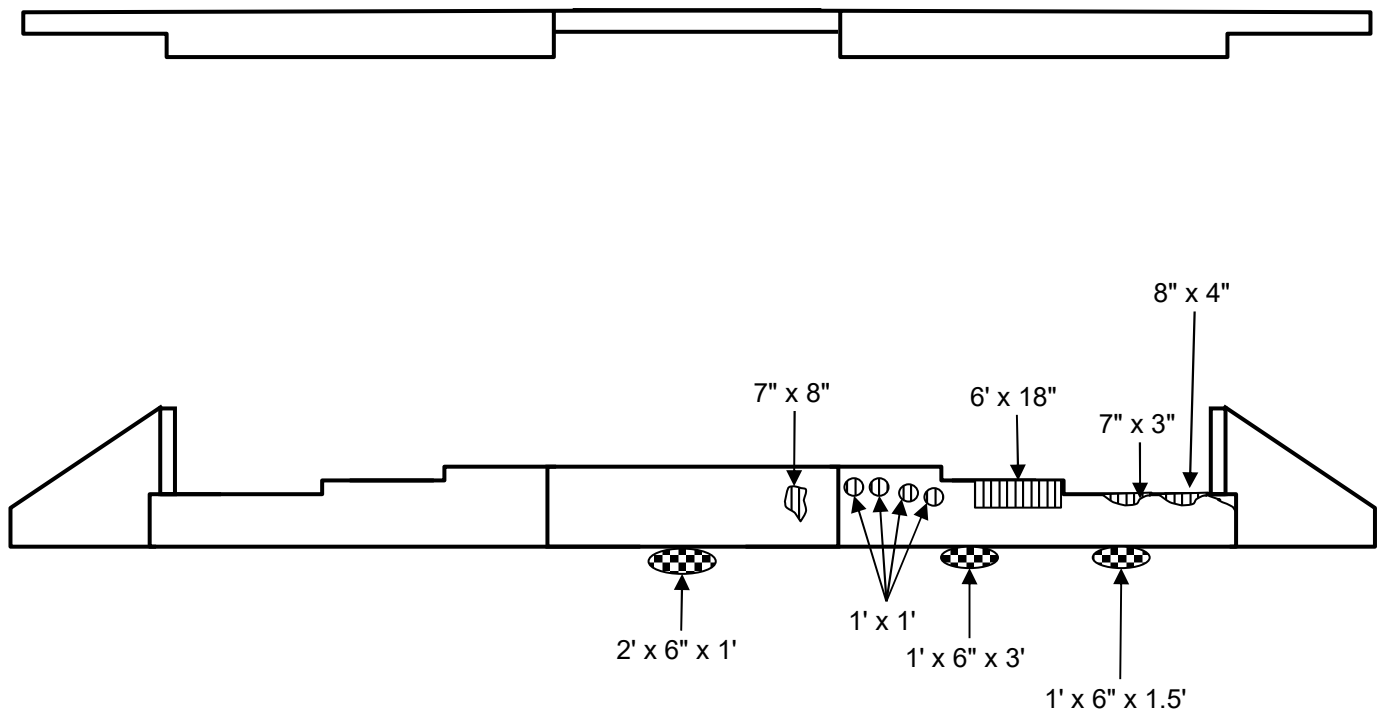
# Abutment No. 1

cracks are hairline

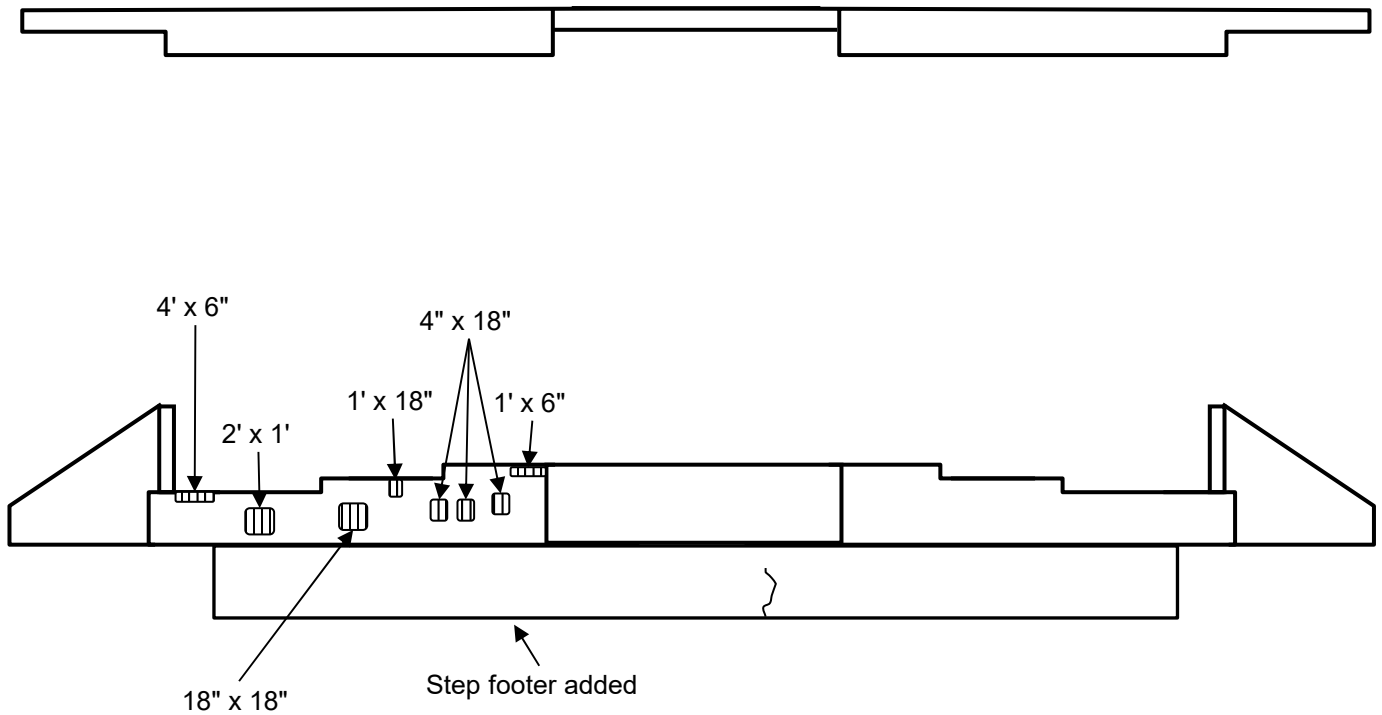
# Abutment No. 2

All cracks are hairline unless otherwise noted
