TENNESSEE DEPARTMENT OF TRANSPORTATION ASBESTOS SURVEY REPORT

Bridge 16I00240029 (16-SR055-14.77R)
SR-55 North Bound Over I-24, LM 14.77
Coffee County

TDOT Project No.: 16S055-S1-005, PIN: 134889.00

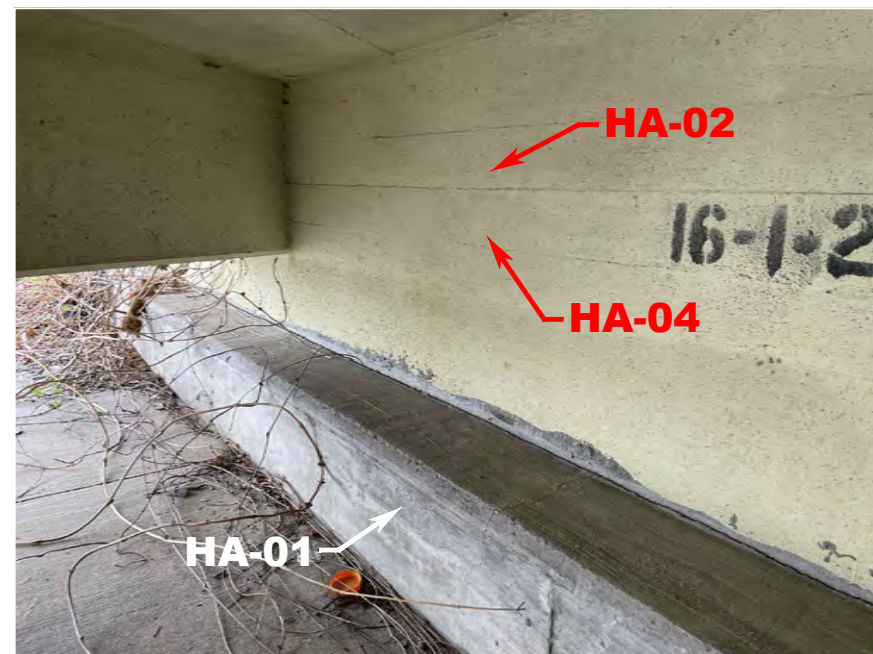
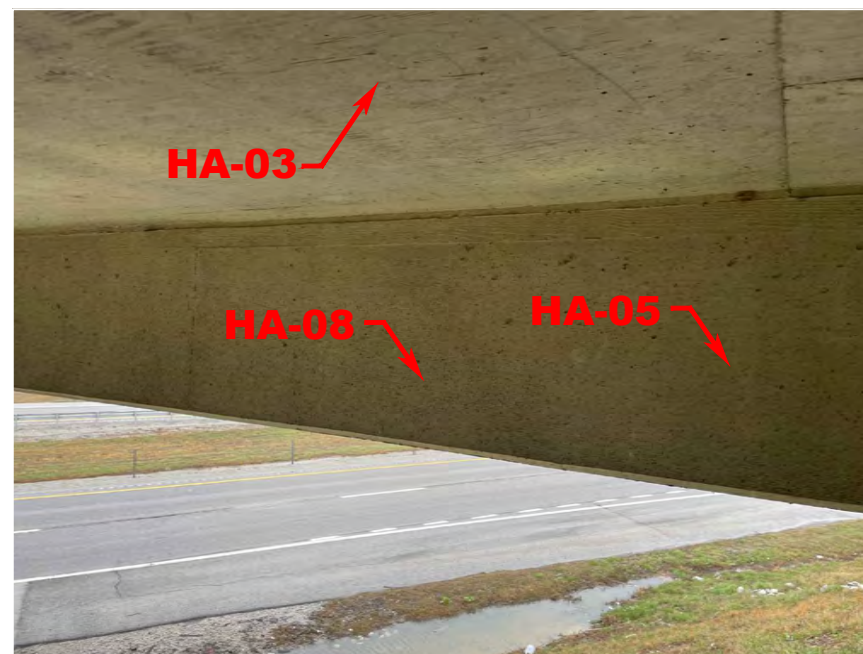
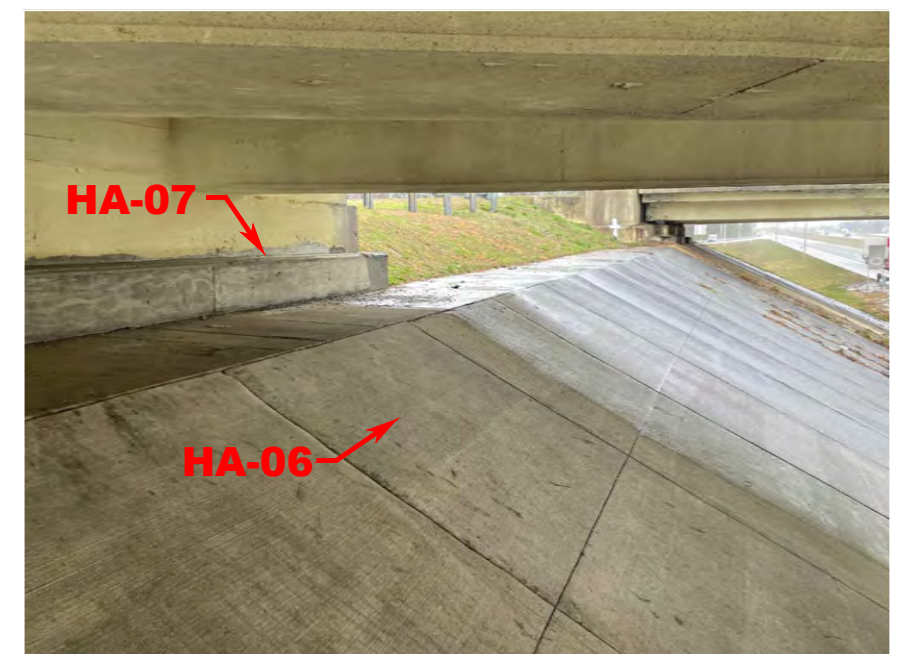
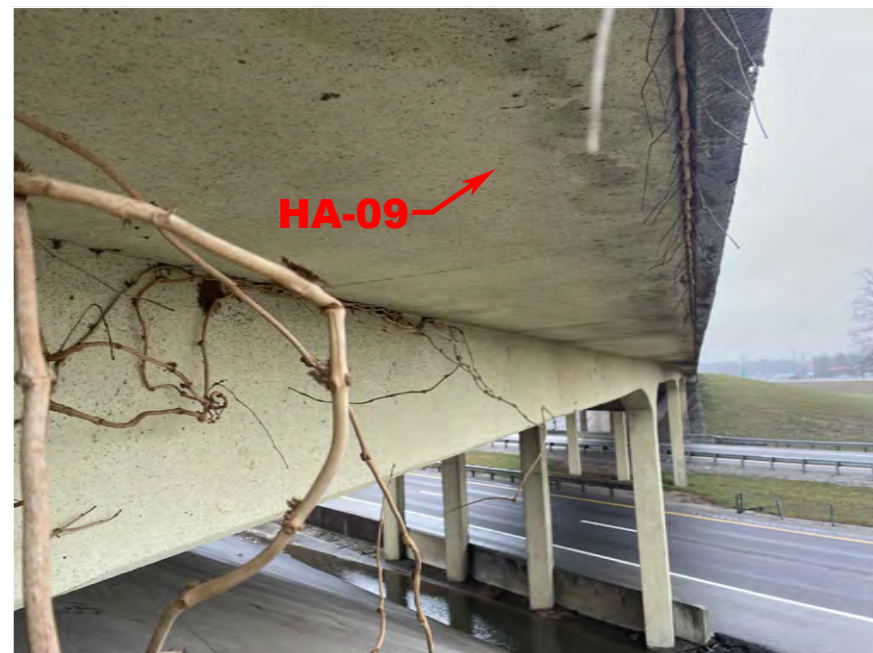
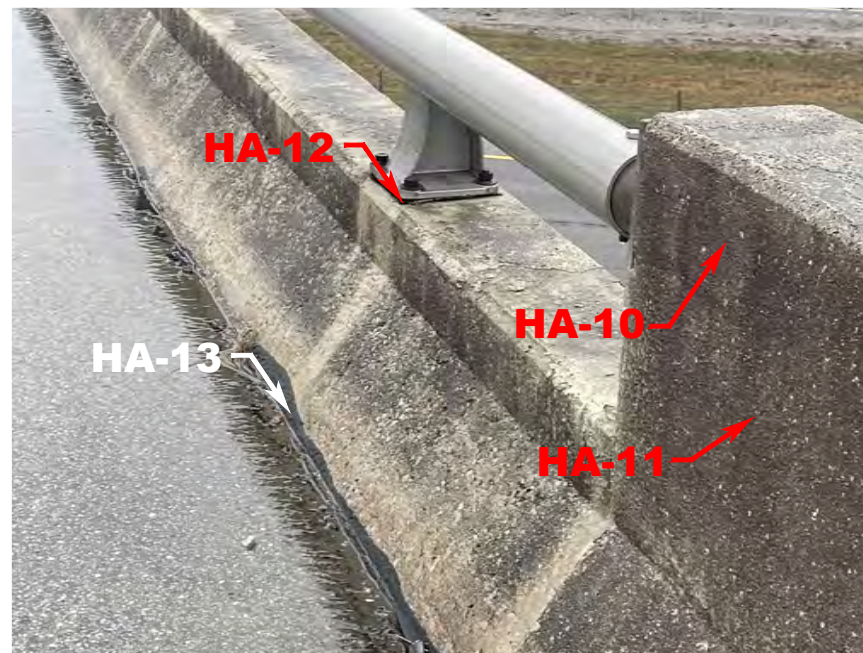
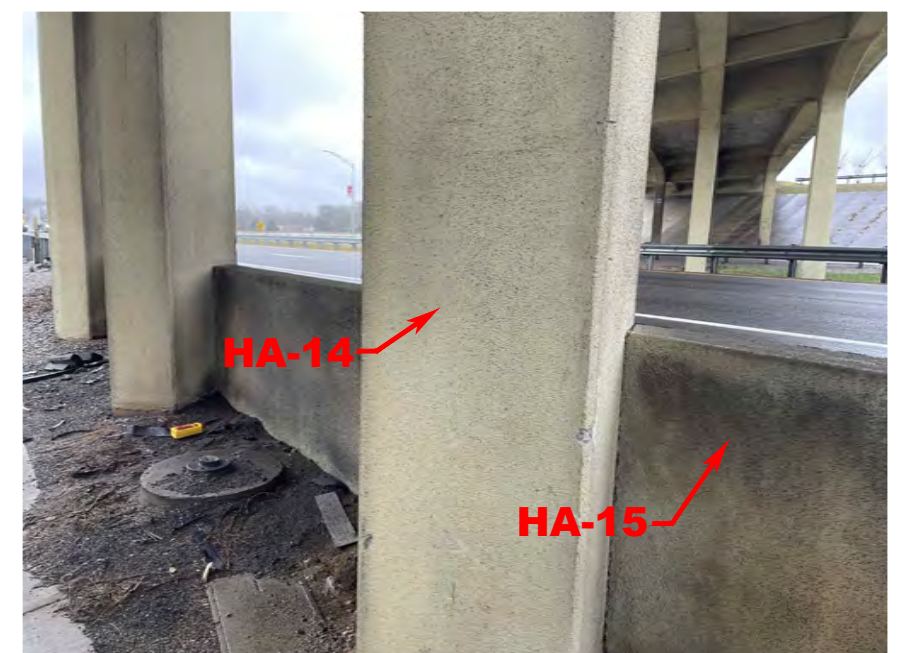
FIGURE 2 HOMOGENEOUS AREAS

- HOMOGENEOUS AREA SAMPLE LOCATIONS ARE GENERALIZED; ACTUAL SAMPLES WERE COLLECTED FROM RANDOM LOCATIONS ACROSS THE STRUCTURE.
- MATERIALS CONTAINING ASBESTOS ARE MARKED IN RED.

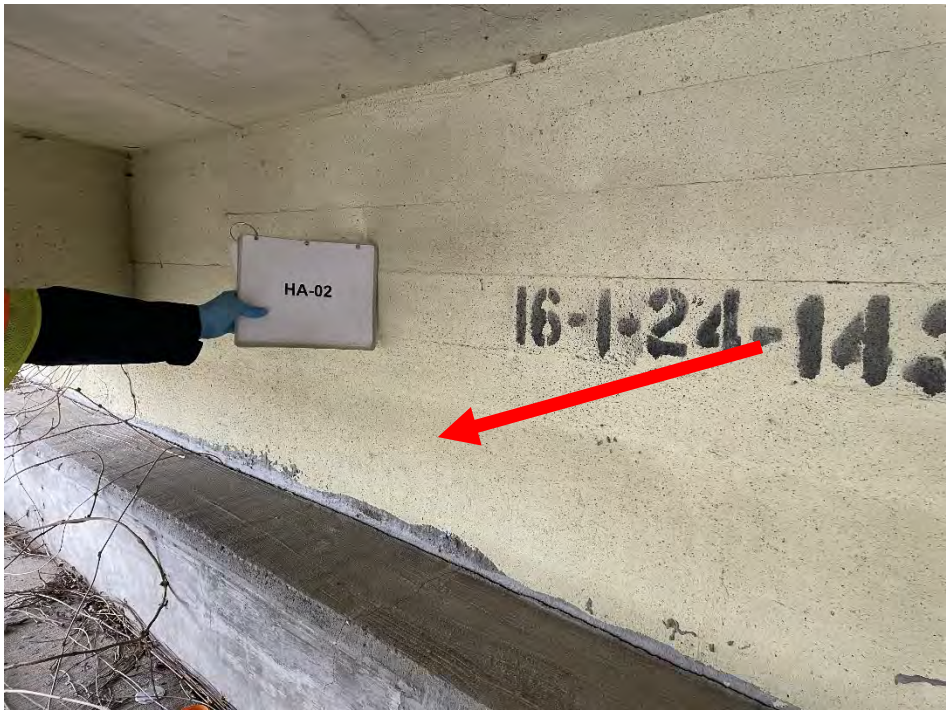
The end walls are coated with a thin light green and yellowish textured material. Three samples of the coating were collected from this HA. A utility knife was used to collect these samples.

Andy Watts	
Date:	
03/06/2024	
Description:	
Photograph 4 –	
HA-02	
End Wall Coating	
This HA Contained 3% Chrysotile

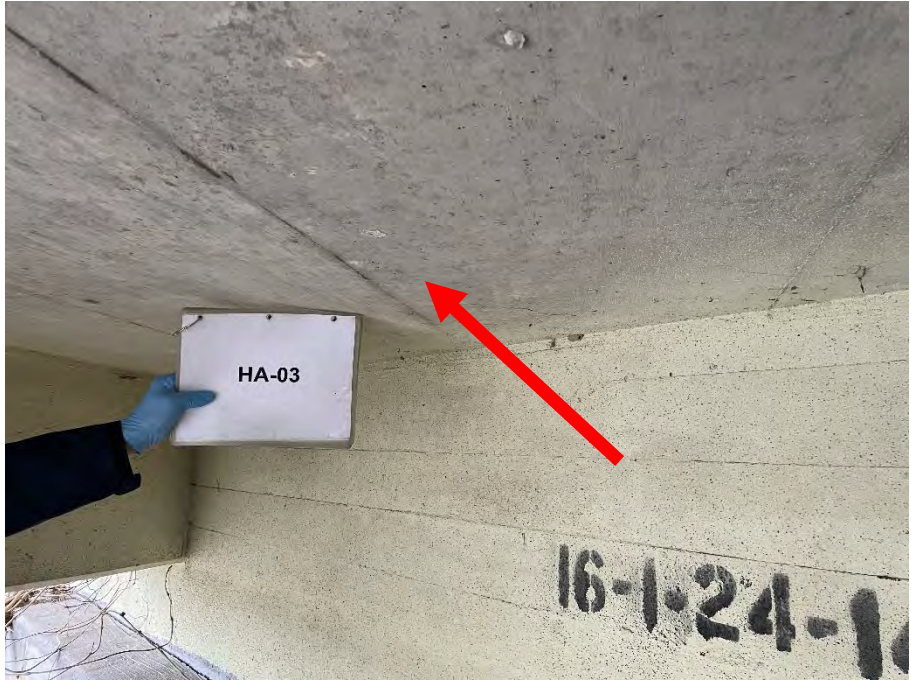
The bottom of the decking is made of concrete. Three samples were collected from this HA. A hammer and chisel were used to collect these samples.

Andy Watts	
Date:	
03/06/2024	
Description:	
Photograph 5 –	
HA-03	
Bottom of Decking	
This HA Contained 3% Chrysotile in the Coating Layer

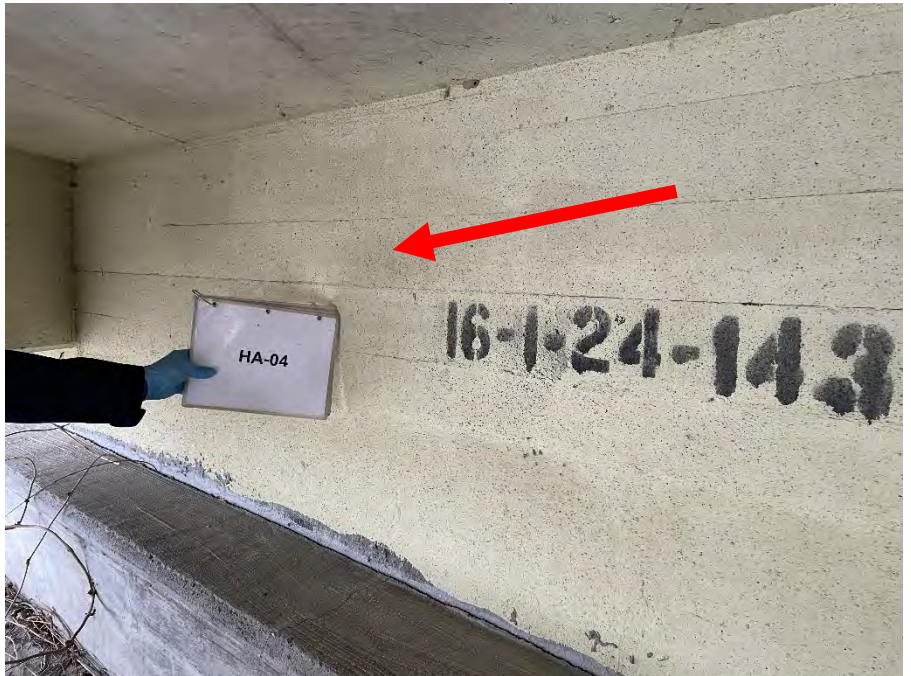
The end walls are made of concrete. Three samples were collected from this HA. A hammer and chisel were used to collect these samples.

Andy Watts	
Date:	
03/06/2024	
Description:	
Photograph 6 –	
HA-04	
End Wall	
This HA Contained 3% Chrysotile in the Coating Layer

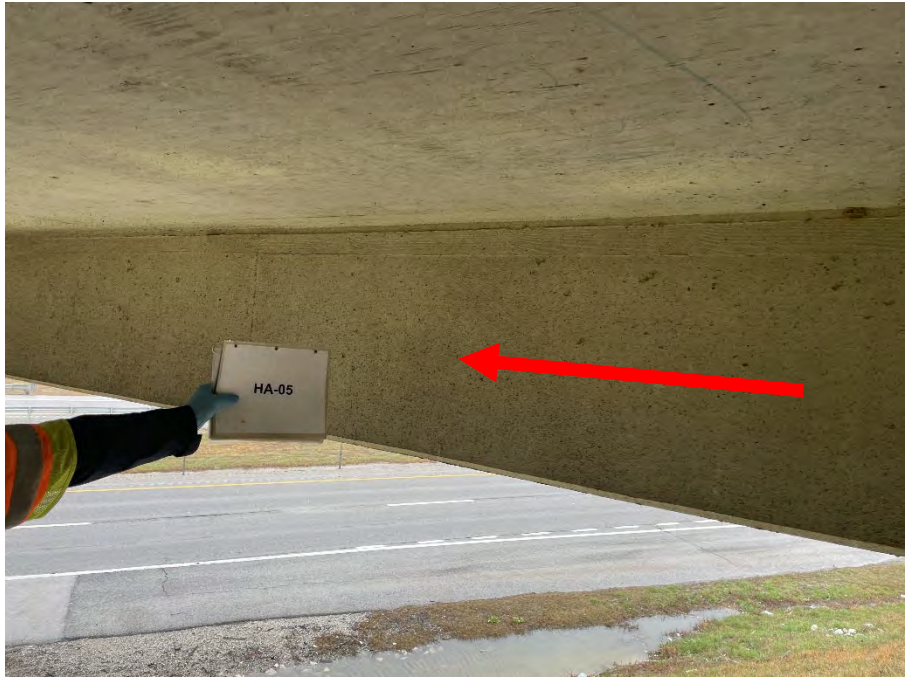
The longitudinal girders are made of concrete. Three samples were collected from this HA. A hammer and chisel were used to collect these samples.

Andy Watts	
Date:	
03/06/2024	
Description:	
Photograph 7 –	
HA-05	
Longitudinal Girder	
This HA Contained 3% Chrysotile in the Coating Layer

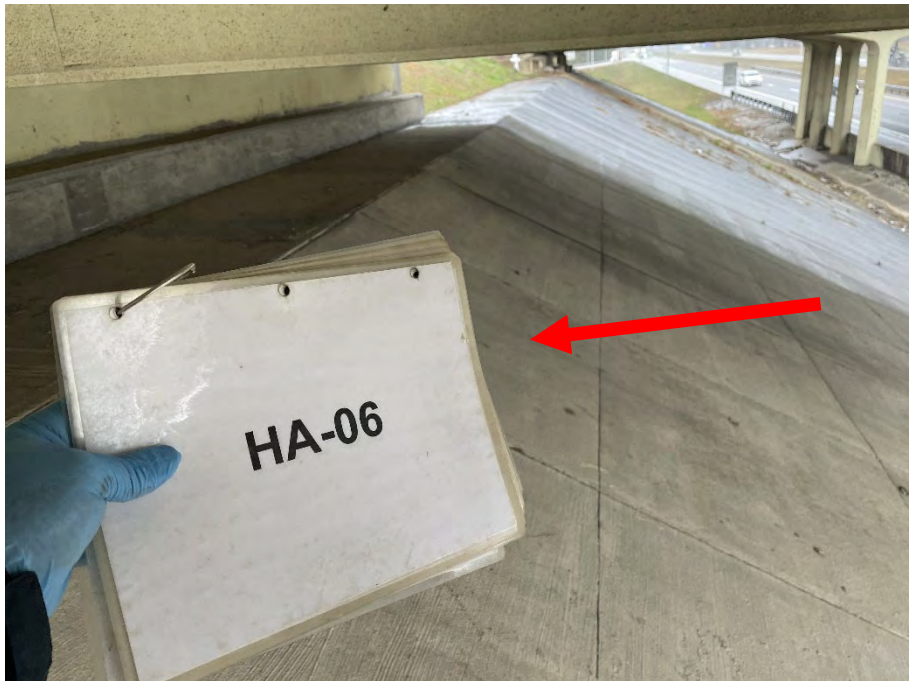
The sloping walls are made of concrete. Three samples were collected from this HA. A hammer and chisel were used to collect these samples.

Andy Watts	
Date:	
03/06/2024	
Description:	
Photograph 8 –	
HA-06	
Sloping Wall	
This HA Contained 3% Chrysotile in the Coating Layer

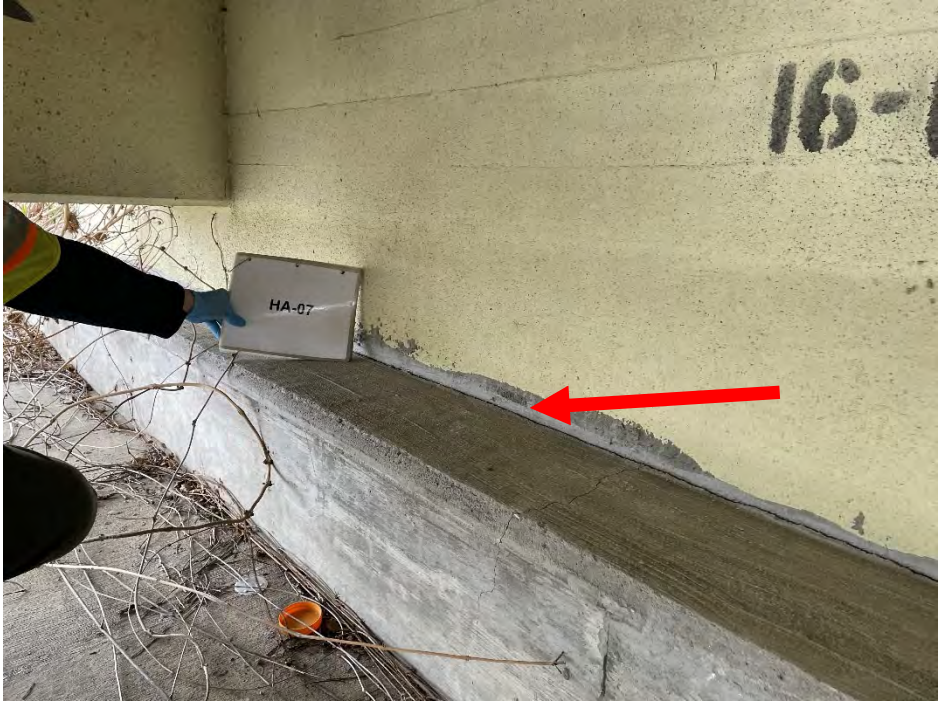
Concrete patching was present in multiple locations on the bridge. Three samples were collected from this HA. A hammer and chisel were used to collect these samples.

Date:	
Description:	
Photograph 9 – HA-07 Concrete Patching This HA Contained 3% Chrysotile in the Coating Layer

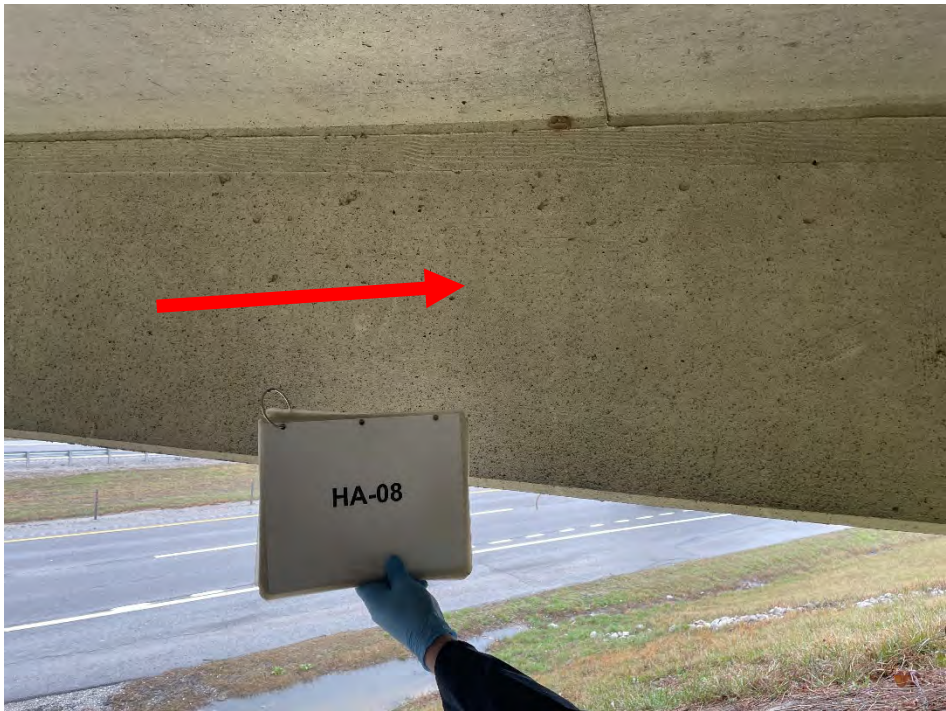
The longitudinal girders are coated with a thin light green and yellowish textured material. Three samples of the coating were collected from this HA. A utility knife was used to collect these samples.

Date:	
Description:	
Photograph 10 – HA-08 Longitudinal Girder Coating This HA Contained 3% Chrysotile

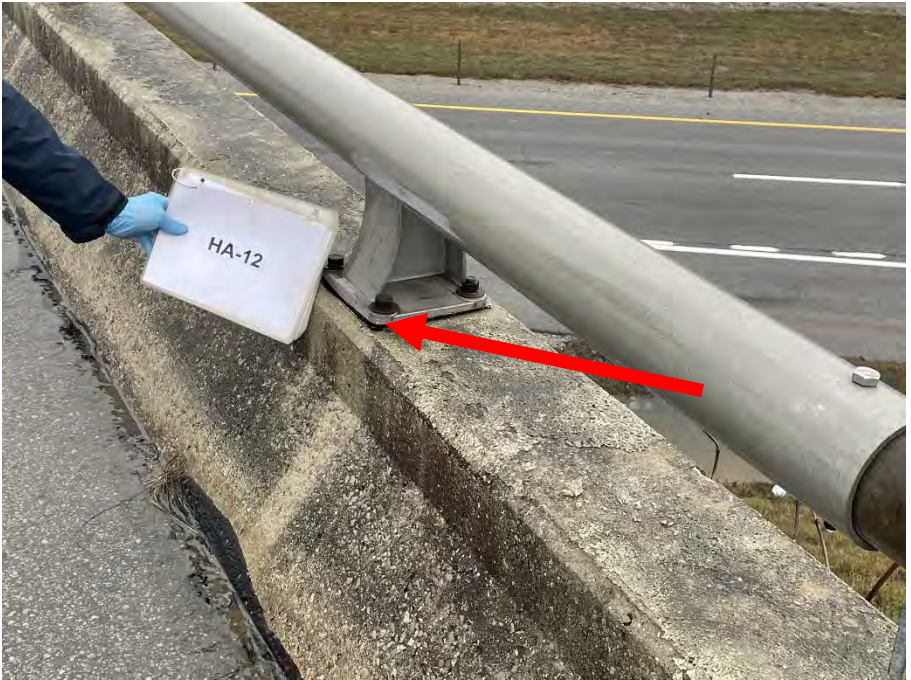
Padding is present between the parapets and the guardrails. Three samples were collected from this HA. A utility knife was used to collect these samples.

Date: 03/06/2024	
Description: Photograph 14 – HA-12 Padding Between Parapet and Guardrail This HA Contained 3% Chrysotile in the Coating Layer

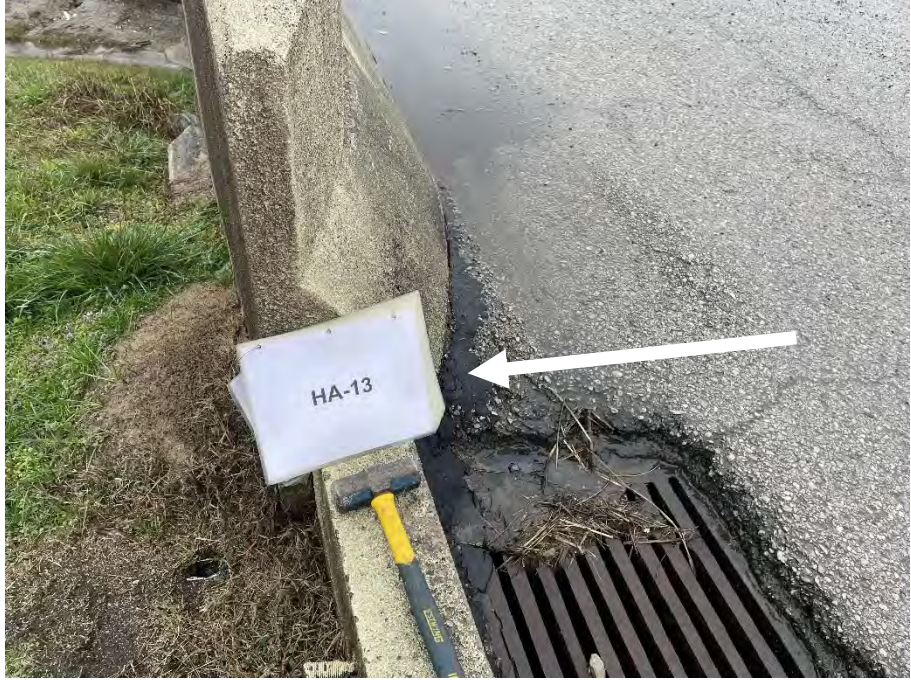
There is black tar located on top of the decking. Three samples were collected from this HA. A utility knife was used to collect these samples.

Date: 03/06/2024	
Description: Photograph 15 – HA-13 Black Tar on Top of Decking

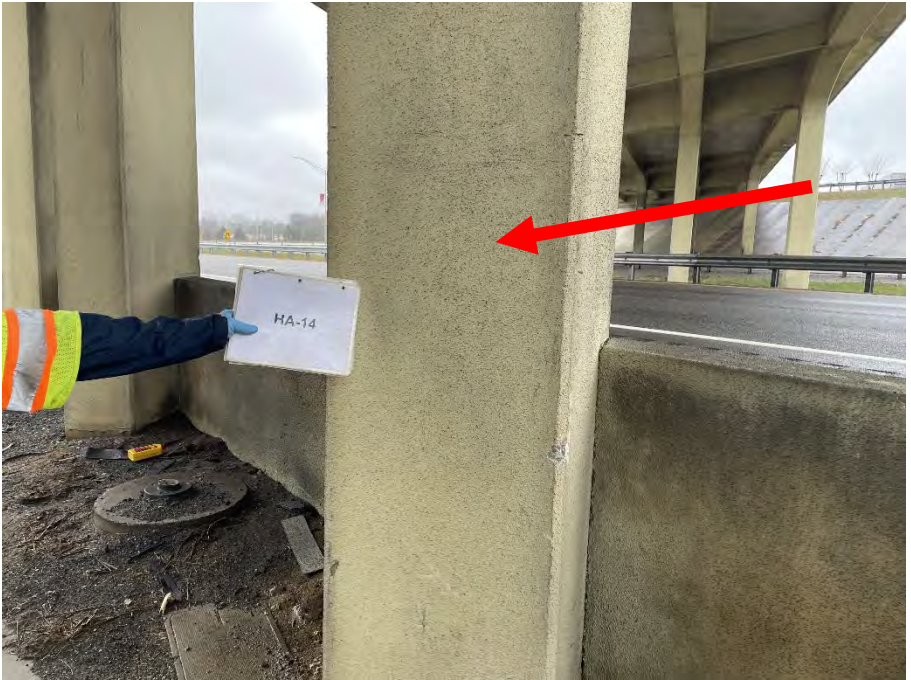
The bents are made of concrete. Three samples were collected from this HA. A hammer and chisel were used to collect these samples.

Date: 03/06/2024	
Description: Photograph 16 – HA-14 Bent This HA Contained 3% Chrysotile in the Coating Layer

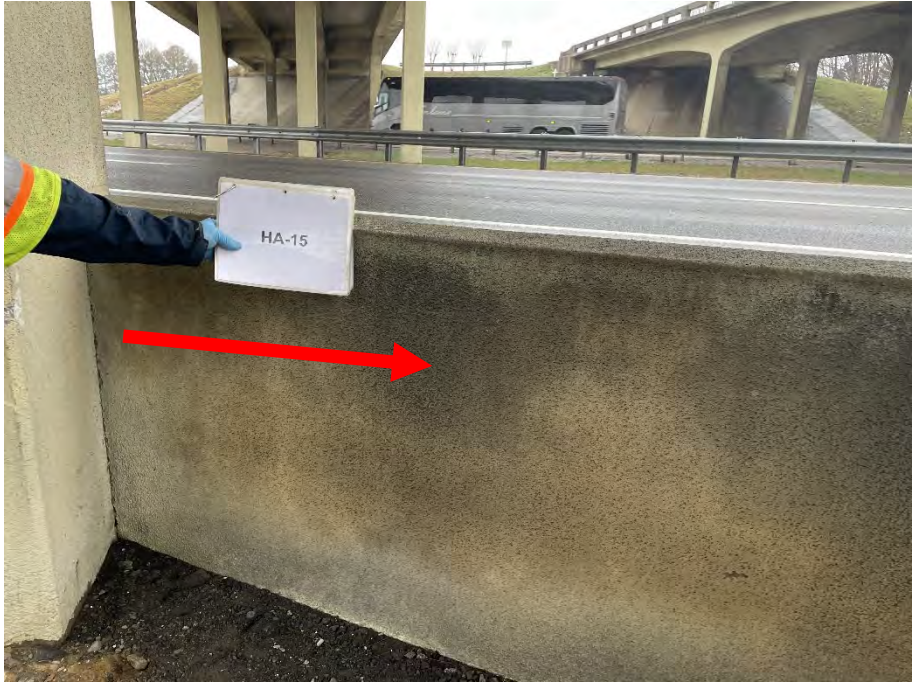
The bent support wall is made of concrete. Three samples were collected from this HA. A hammer and chisel were used to collect these samples.

Date: 03/06/2024	
Description: Photograph 17 – HA-15 Bent Support Wall This HA Contained 3% Chrysotile in the Coating Layer

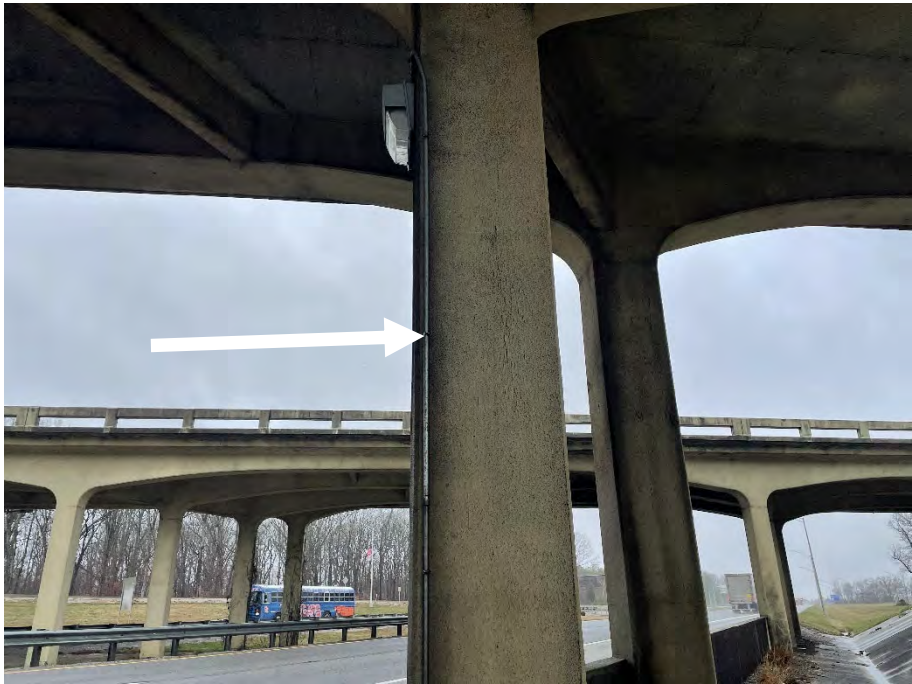
There are two 2-inch diameter metal utility conduits attached to bents. The conduits connect to lights installed on the bents on the bottom side of the bridge. One light is located on the northeast side of the bridge and one light is located on the southwest side.

Date: 03/06/2024	
Description: Photograph 18 – Utility Conduit on Bent

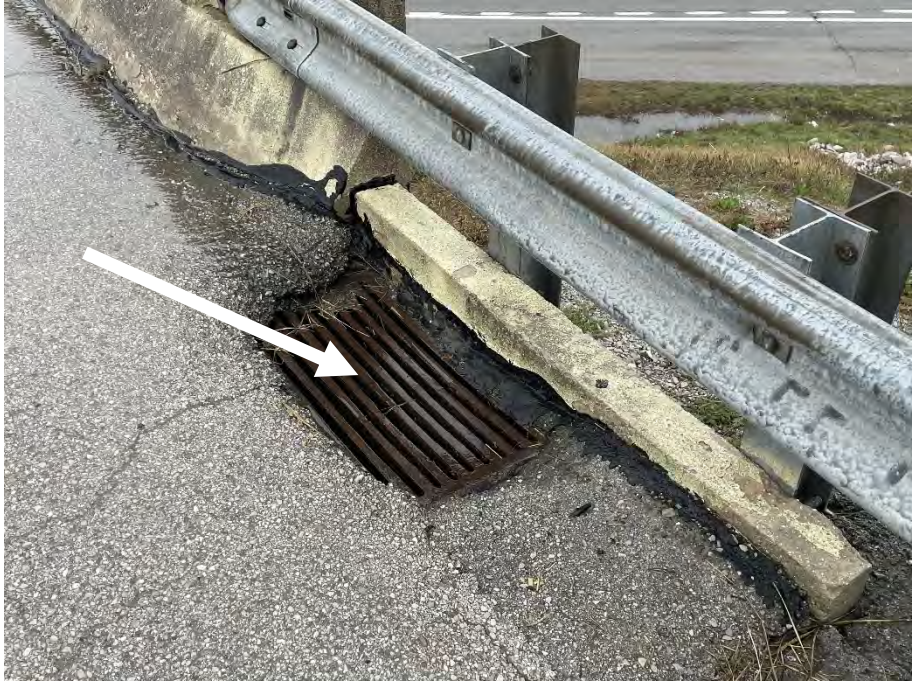
There are two approximately 2-foot by 18-inch rectangular stormwater drains installed on the south side of the bridge. There is one approximately 3-foot by 3-foot square stormwater drain installed on the sloping wall of the bridge. There were no suspected ACM associated with the drainage structures other than the sloping wall which was sampled and identified as HA-06.

Date: 03/06/2024	
Description: Photograph 20 – Stormwater Drain
