TENNESSEE DEPARTMENT OF TRANSPORTATION ASBESTOS SURVEY REPORT

Bridge 16I00240030 (16-SR055-14.77L)
SR-55 South Bound Over I-24, LM 14.77
Coffee County
TDOT Project No.: 16S055-S1-005, PIN: 134889.00

TriAD Project No. PROJ-038302 TDOT W013

04/17/24

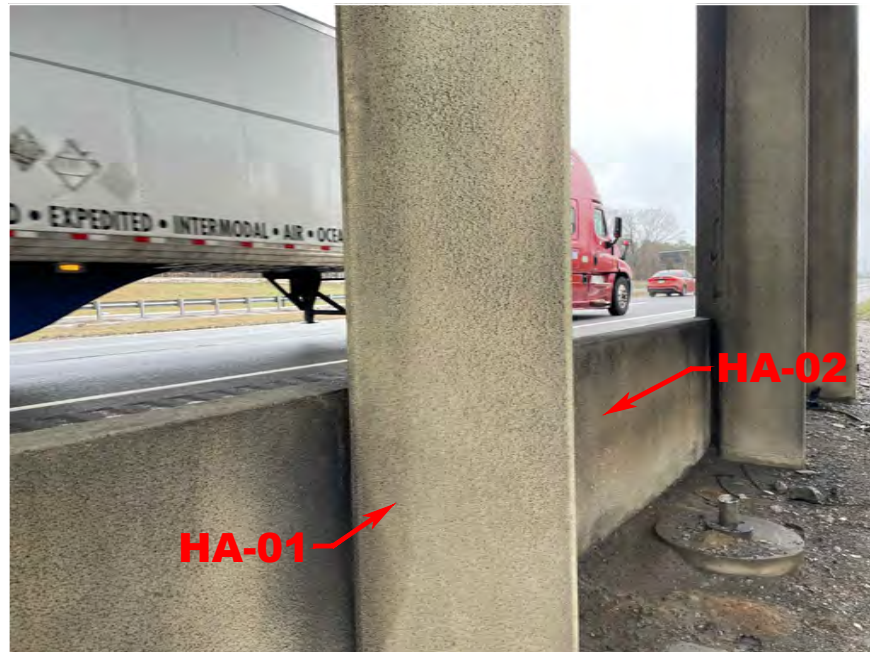
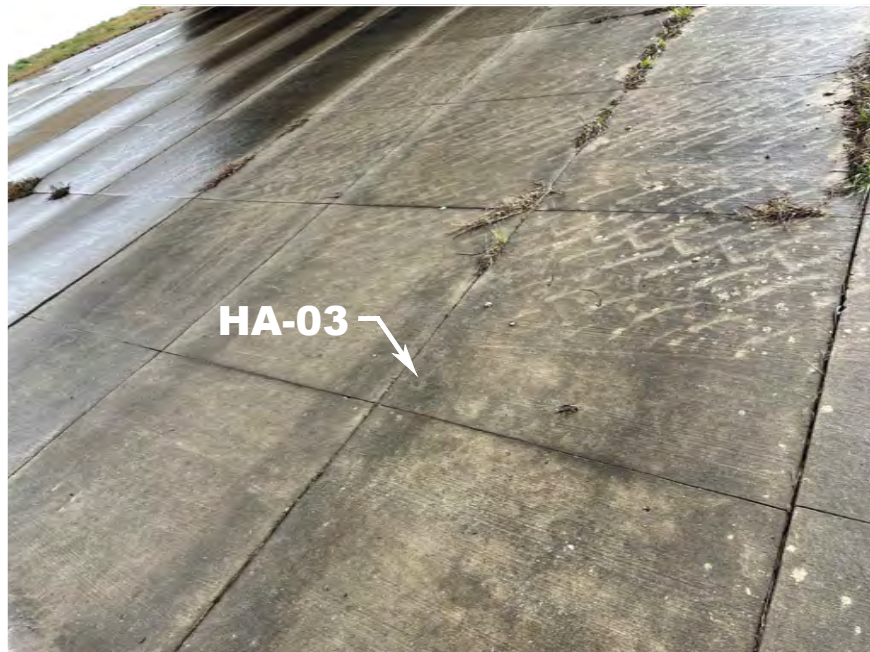
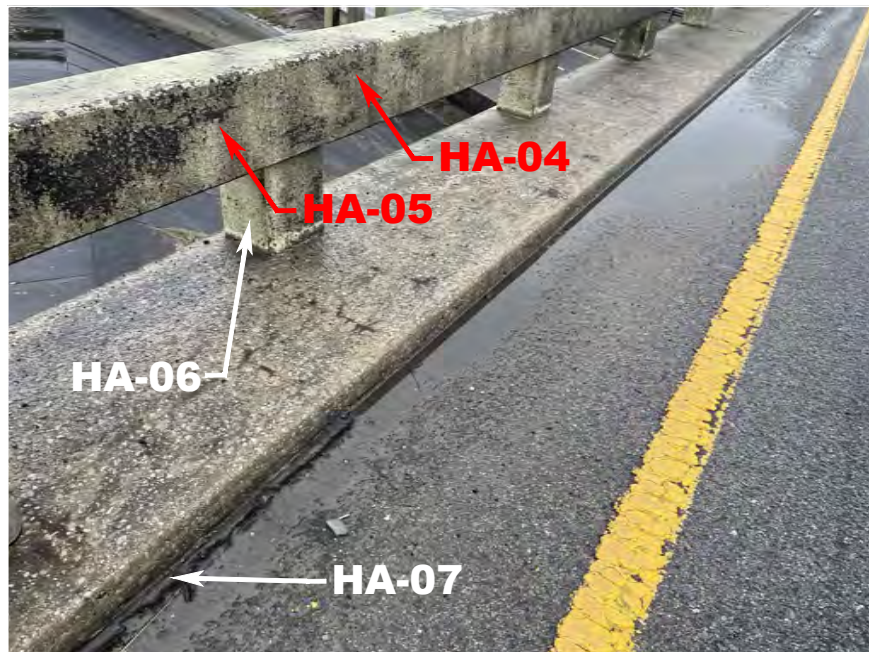
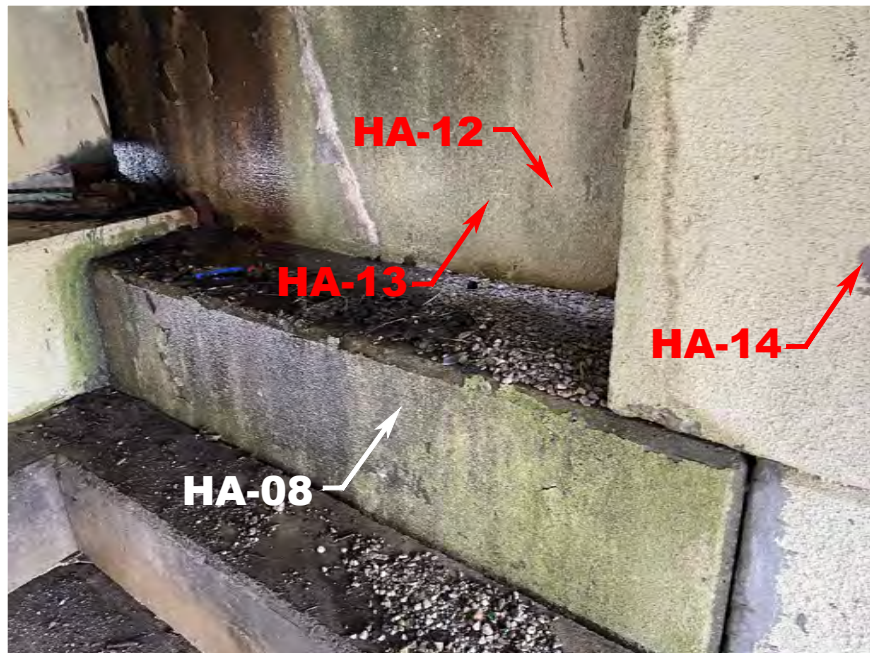
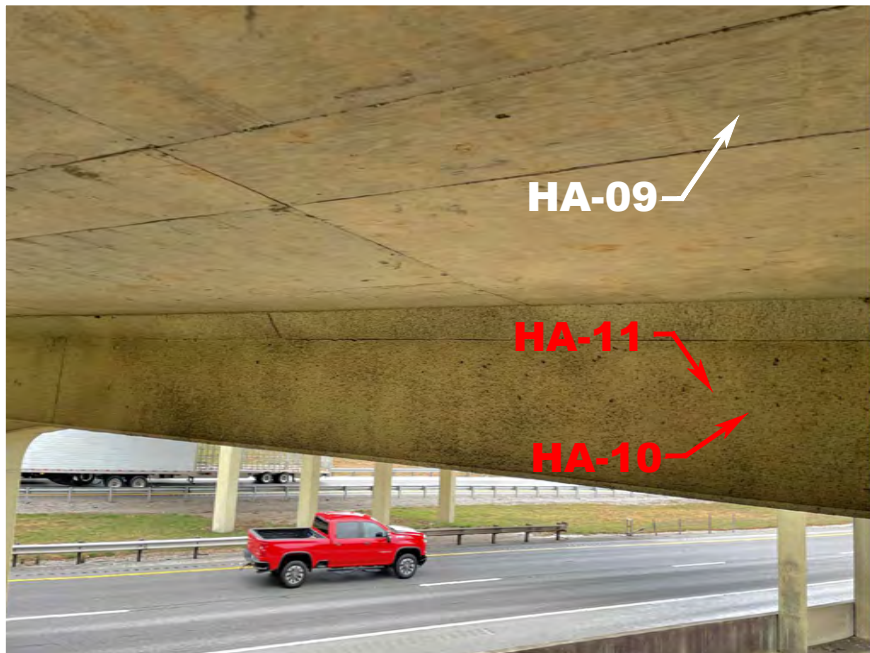
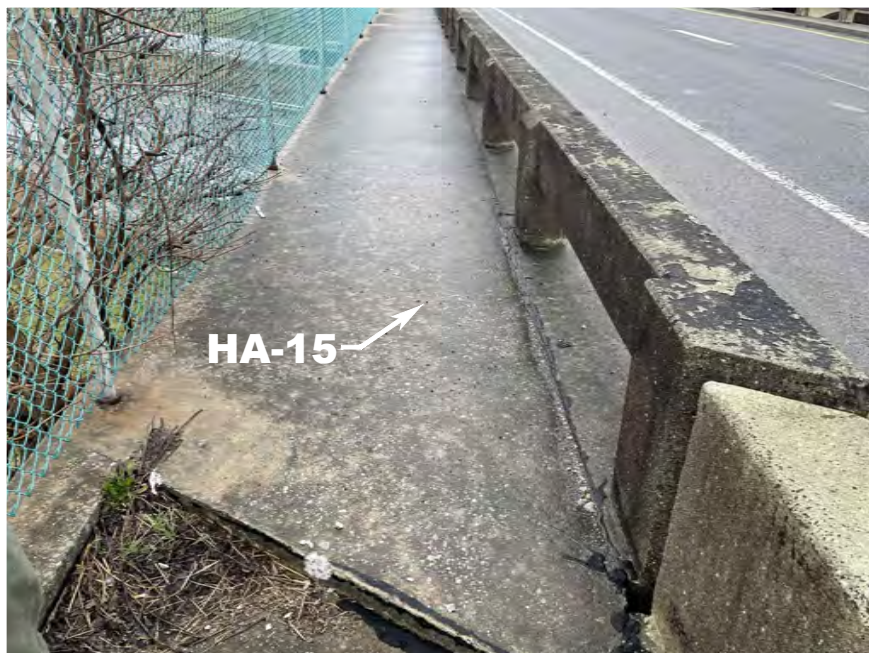
FIGURE 2 HOMOGENEOUS AREAS

Based on the analytical results, 25 of the samples collected contained greater than one percent (1%) asbestos. The material found to be positive for asbestos was the coating applied to multiple components of the bridge. A summary of the sampled material that was found to contain greater than one percent (1%) asbestos is presented in Table 2.

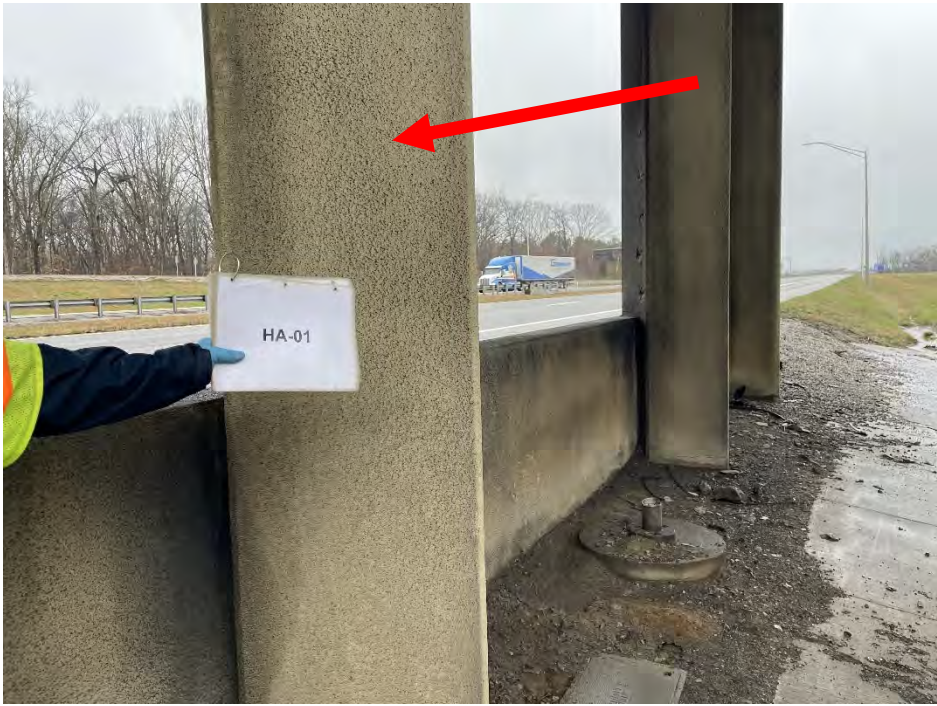
Date: 03/06/2024	
Description: Photograph 3 – HA-01 Bent This HA Contained 3% Chrysotile in the Coating Layer

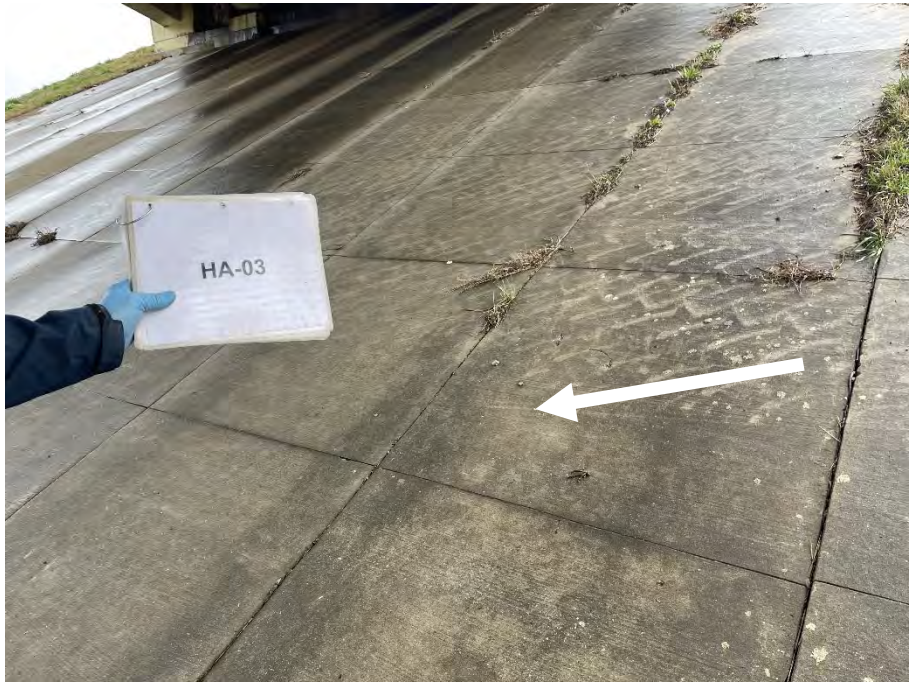
Date: 03/06/2024	
Description: Photograph 5 – HA-03 Sloping Wall

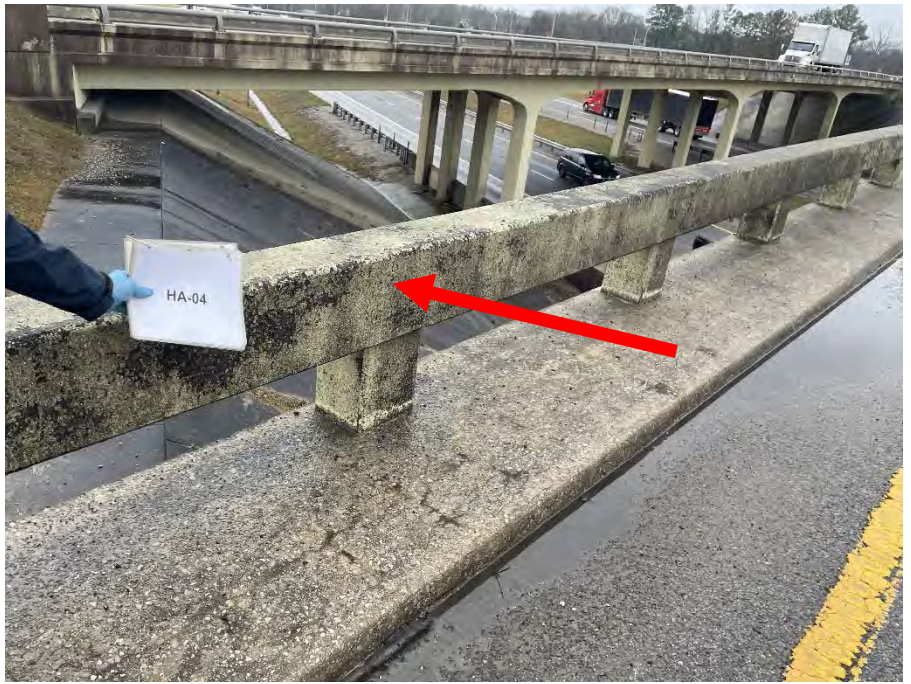
Date: 03/06/2024	
Description: Photograph 6 – HA-04 Concrete Guardrail This HA Contained 3% Chrysotile in the Coating Layer

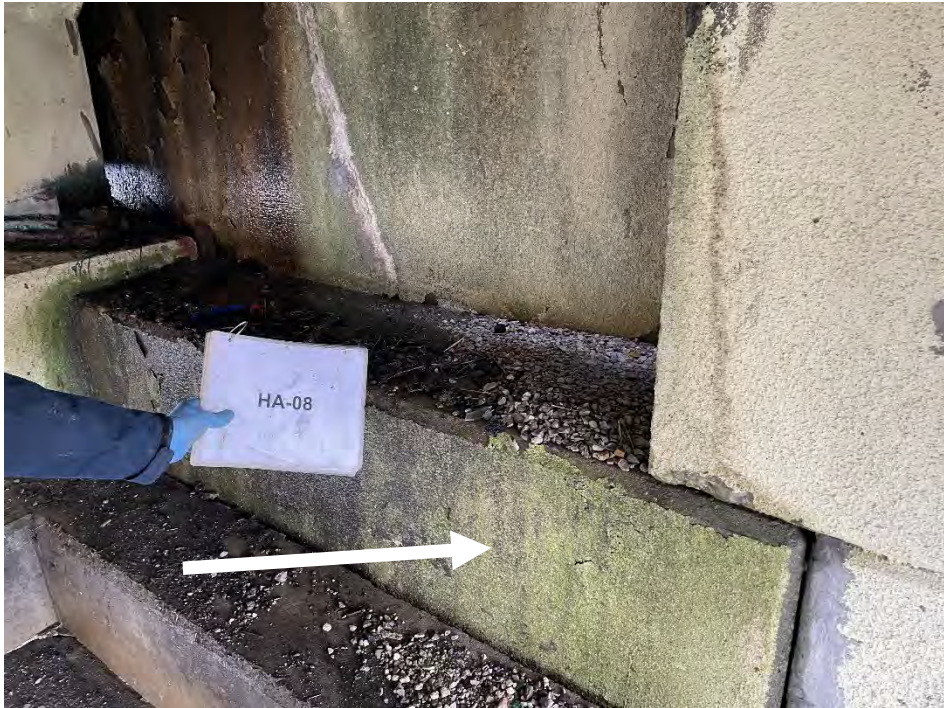
Date: 03/06/2024	
Description: Photograph 10 – HA-08 Abutment

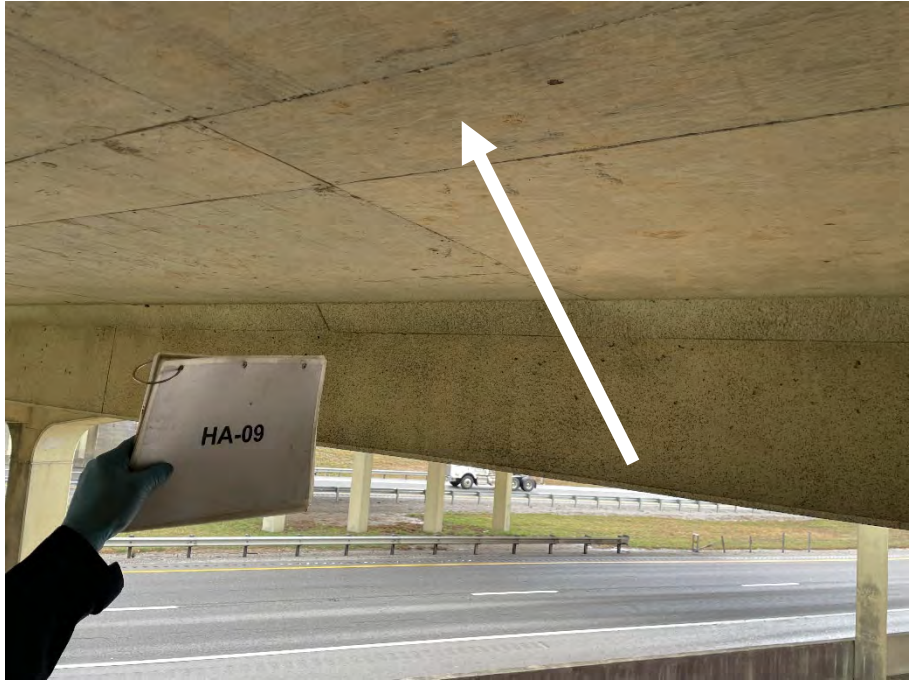
Date: 03/06/2024	
Description: Photograph 11 – HA-09 Bottom of Decking

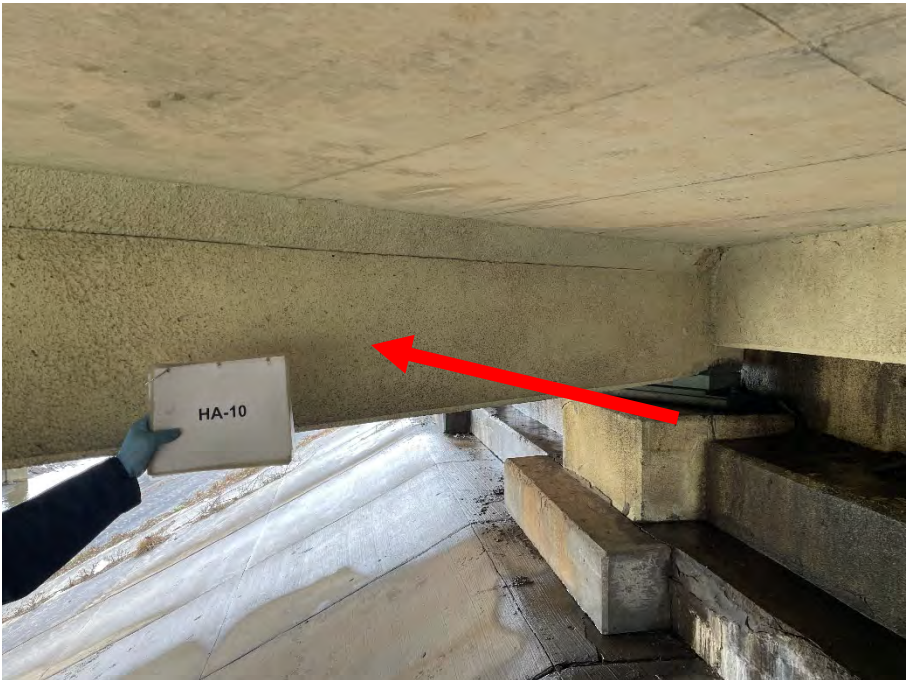
Date: 03/06/2024	
Description: Photograph 12 – HA-10 Longitudinal Girder Coating This HA Contained 3% Chrysotile

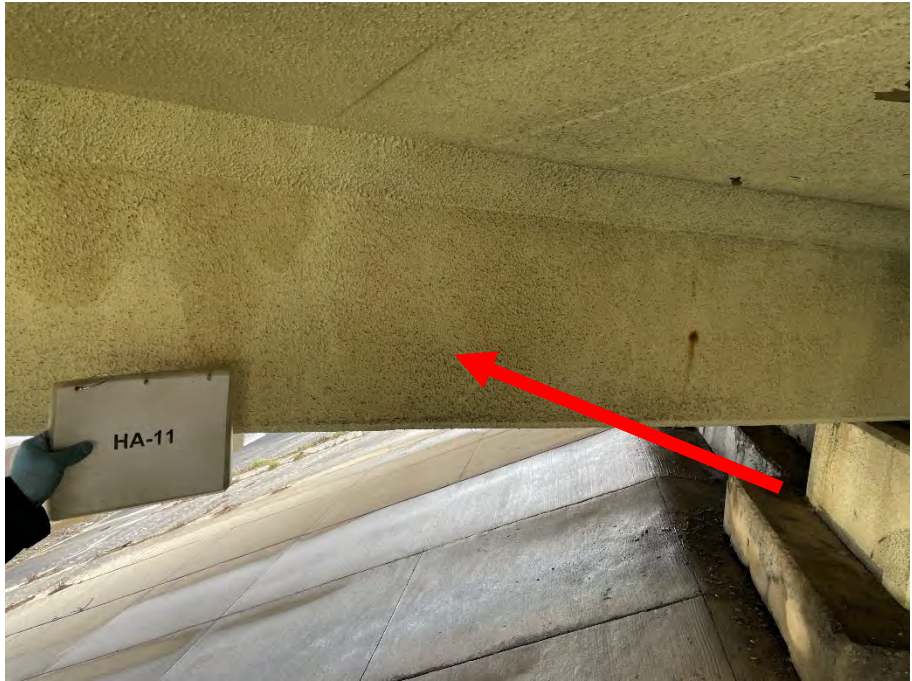
Date: 03/06/2024	
Description: Photograph 13 – HA-11 Longitudinal Girder This HA Contained 3% Chrysotile in the Coating Layer

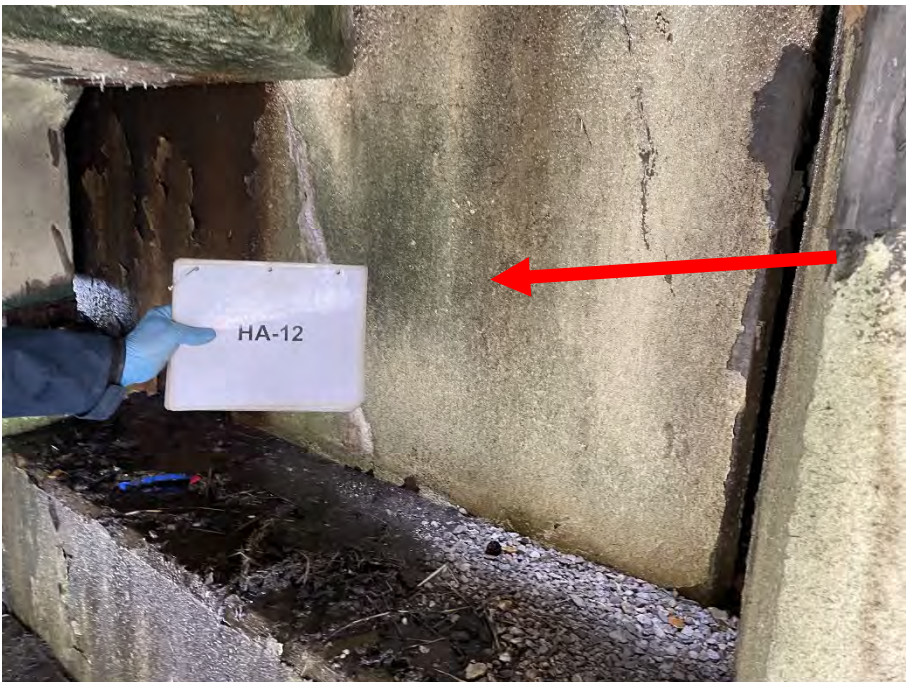
Date: 03/06/2024	
Description: Photograph 14 – HA-12 End Wall This HA Contained 3% Chrysotile in the Coating Layer

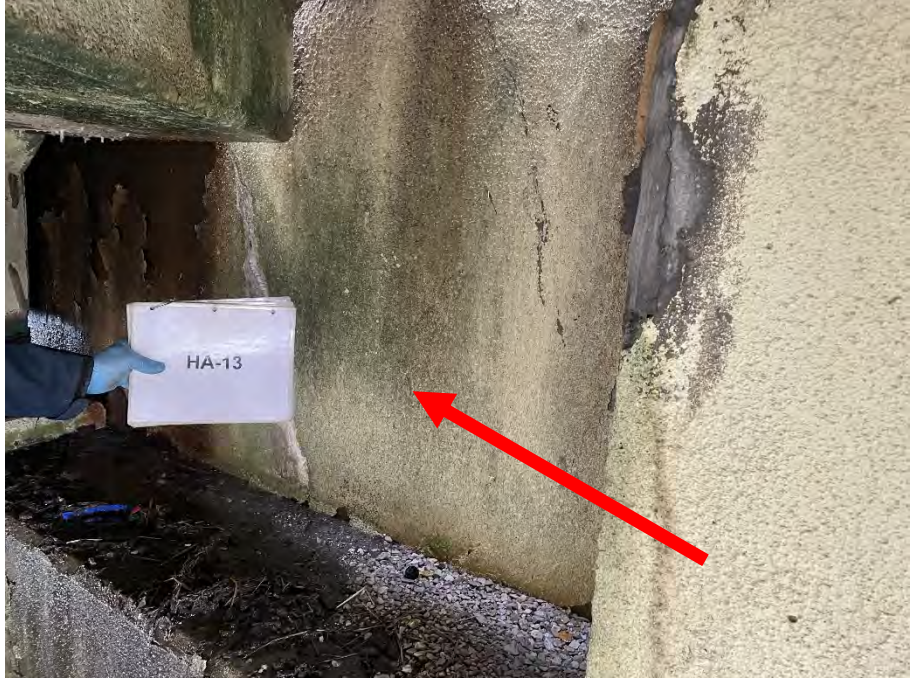
Date: 03/06/2024	
Description: Photograph 15 – HA-13 End Wall Coating This HA Contained 3% Chrysotile

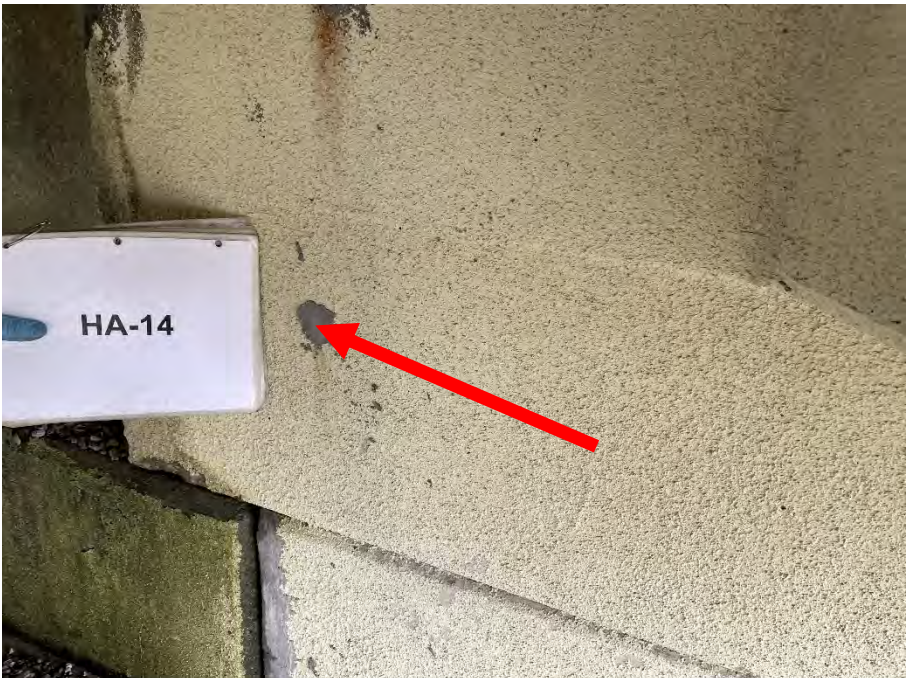
Date: 03/06/2024	
Description: Photograph 16 – HA-14 Concrete Patching This HA Contained 3% Chrysotile in the Coating Layer

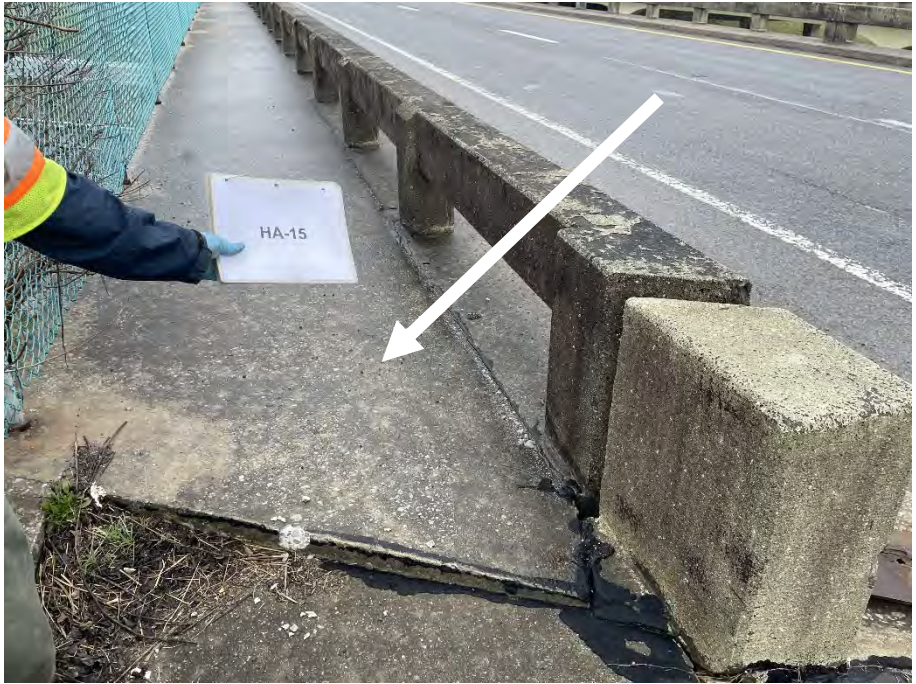
Date: 03/06/2024	
Description: Photograph 17 – HA-15 Sidewalk
