MCMINNILLE HWY. Crossing I24

Routine Bridge Inspection Report

City of Manchester in Coffee County	
Federal ID	16I00240030
Location	16-SR055-14.77-L
Description	McMinnville Highway over I-24, I-24 Milepost 111.20
GPS Coordinates	35.489667, -86.074233
Date	10/25/2023
Overall Condition	Poor

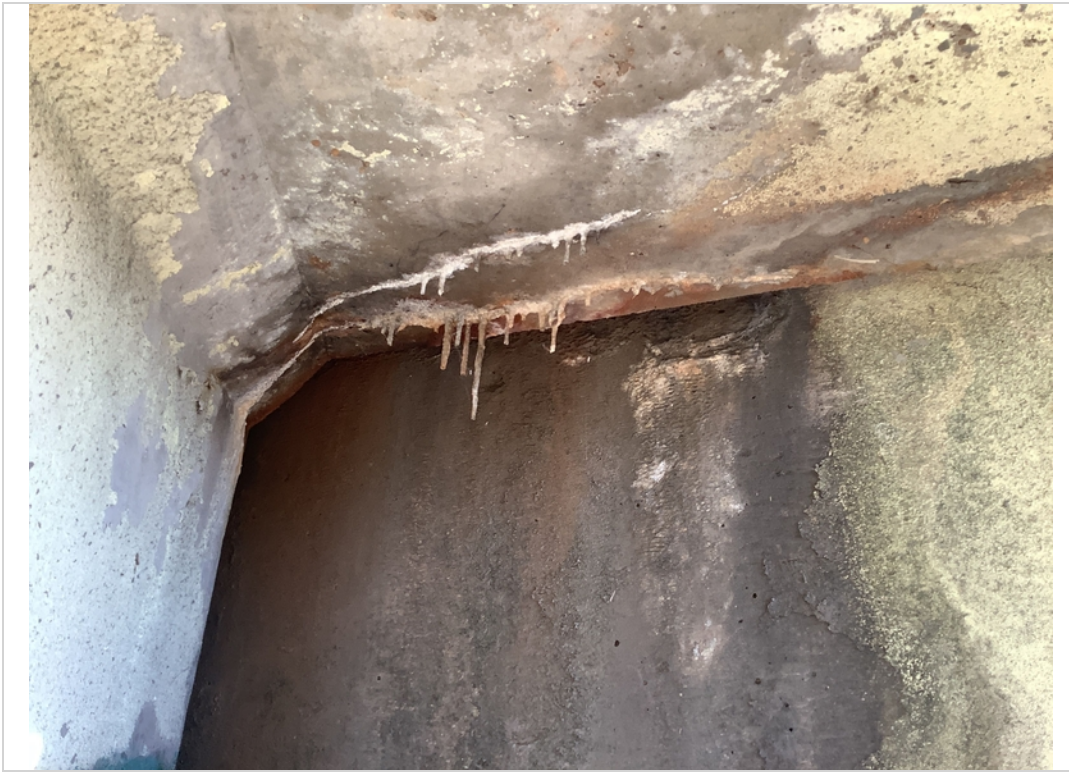
Typical moderate efflorescence in bottom of deck

The deck is rated poor. There is moderate leakage at bay "A" at the construction joints, widespread moderate spalls with exposed rebar in the overhangs and bay "A", delaminated areas, and some cracking with efflorescence. The sidewalks are rated poor due to minor settlement at the bridge ends and having areas of broken concrete. The wearing surface is in poor condition due to having moderate cracking throughout, potholes, and repaired areas.

Date Added	Recommendation	Priority
10/21/2021	CLEAN AND PAINT BEARINGS	
01/19/2010	BRIDGERAILS ARE SUBSTANDARD	
05/19/2004	PROTECT BRIDGESEATS FROM WATER DAMAGE AT BOTH ABUTMENTS	
11/04/2021	REMOVE LOOSE DELAMINATED CONCRETE OVER UNDERPASS ROADWAY	
01/29/2014	APPROACH GUARDRAILS ARE SUBSTANDARD	
10/16/2019	REPAIR ROADWAY EXPANSION DEVICES	
10/25/2023	REPAIR CONCRETE CRACKS, SPALLS, AND DELAMINATED AREAS THROUGHOUT THE STRUCTURE

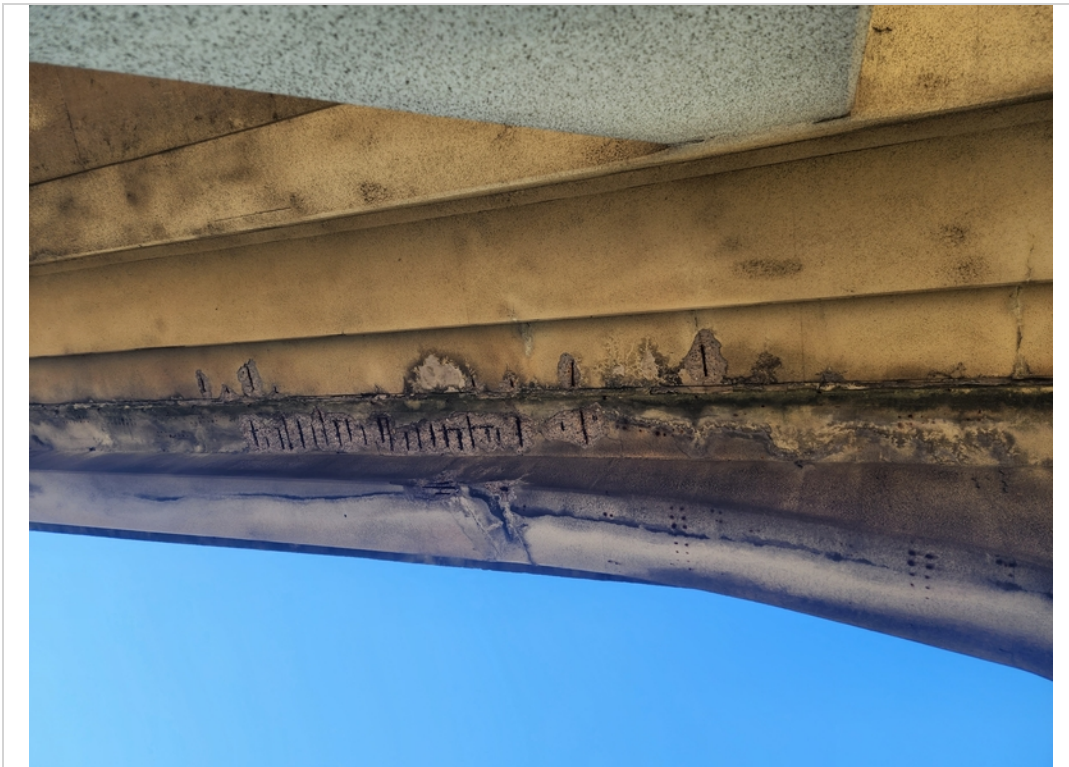
Typical moderate spalls with exposed rebar in bottom of deck bay "A"

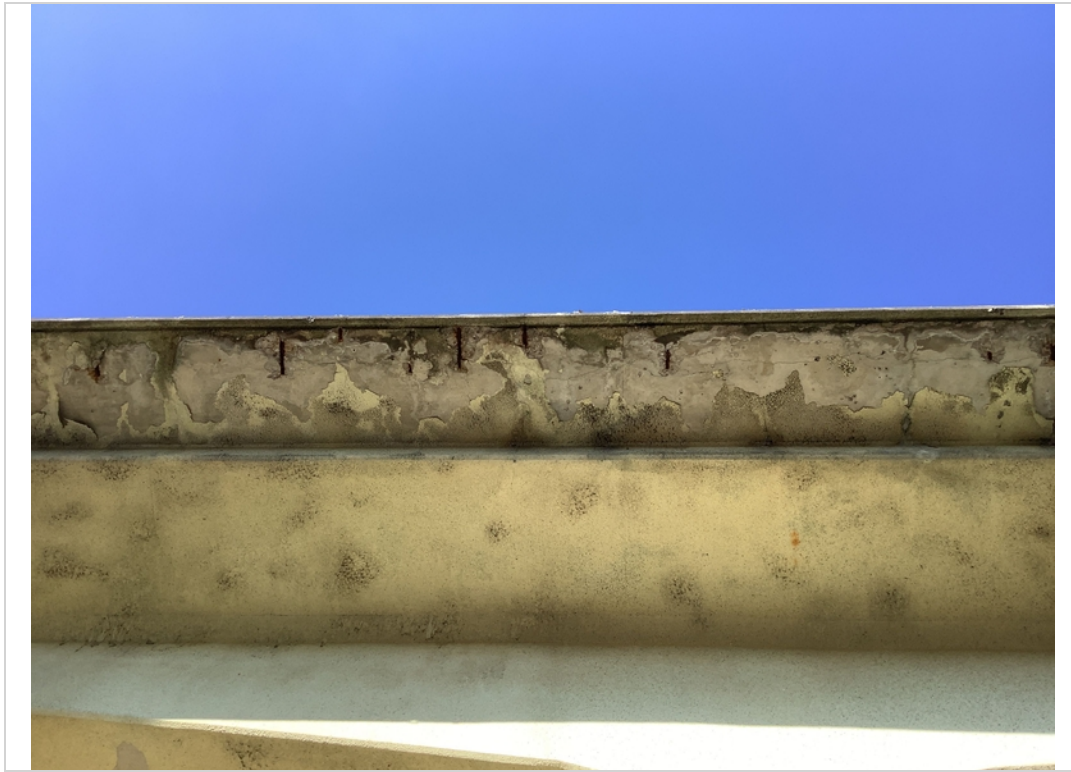
Typical spalls with rebar in right overhangs

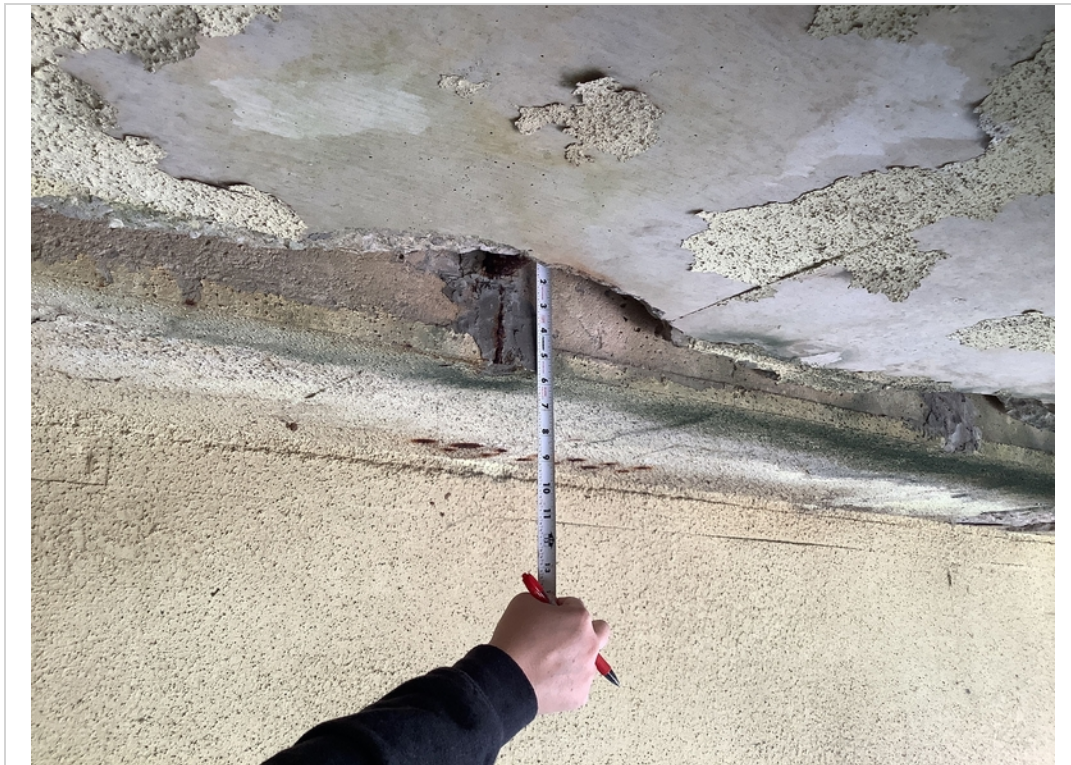
Typical moderate spall in bottom of deck

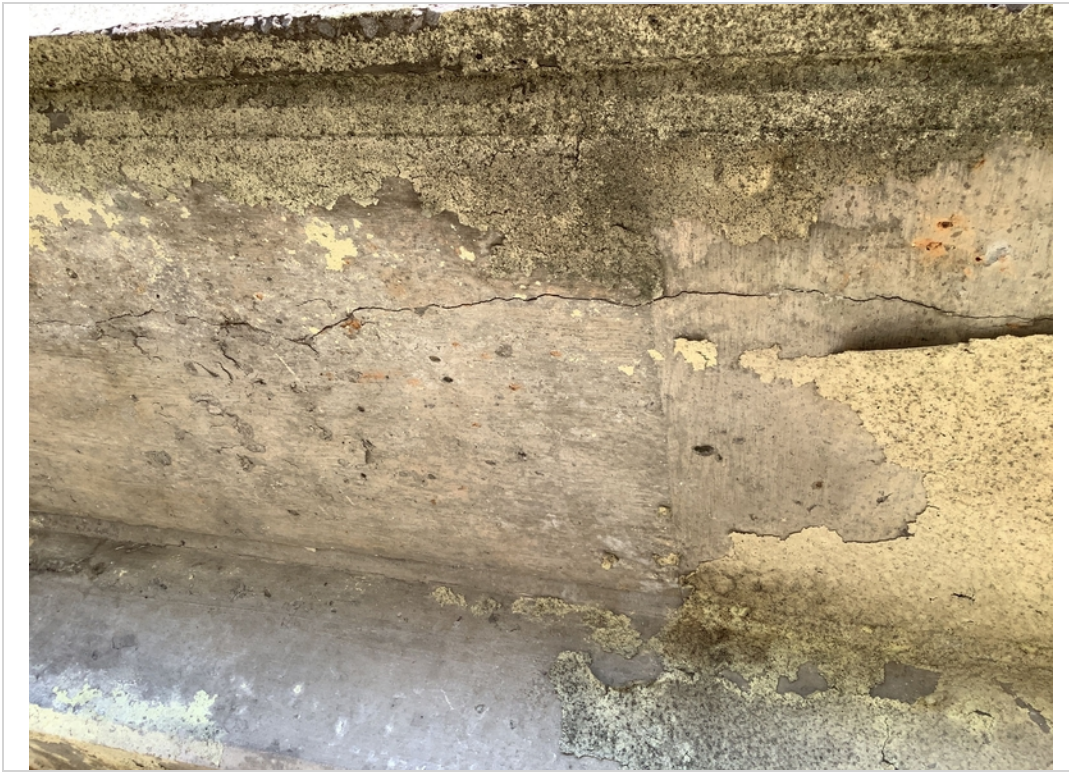
Typical crack in bottom of deck

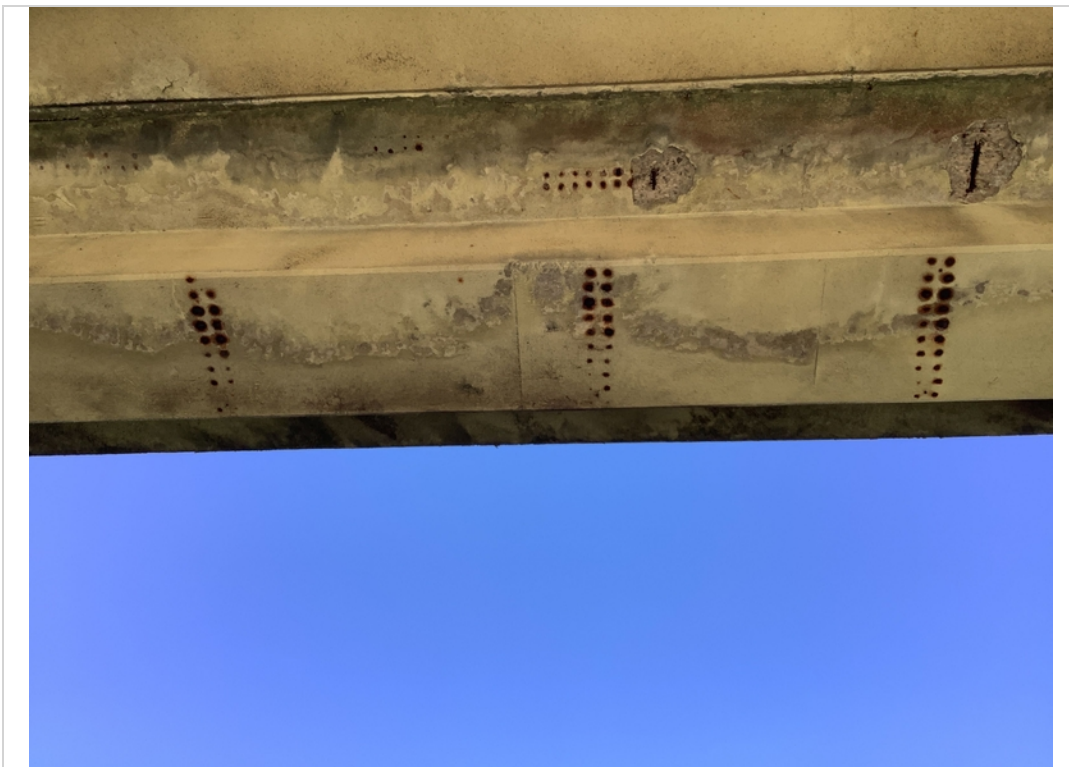
Typical rust staining in bottom of deck

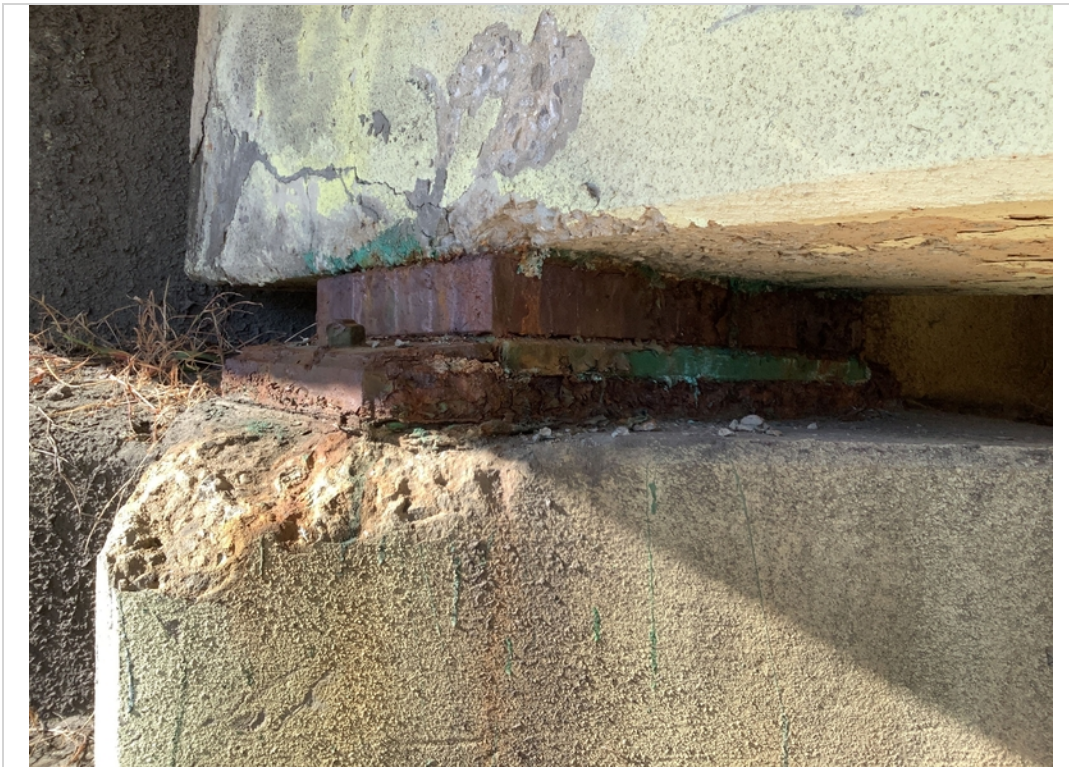
Bearing "C" at abutment #1

Bearing Devices	(Fair)	Corroded at abutment #1 on "A" and "C" due to lack of paint
Girders	(Fair)	Beam "D" has up to 0.125" diagonal cracking over the bearing at abutment #1; beam "A" in span #3 has two moderate spalls exposing prestressing strands; moderate crack and hairline longitudinal crack along length of "A"; cracks on beams "B" and "C" in span #2
Beams	(NA)	
Floor Beams	(NA)	
Stringers	(NA)	
Diaphragms	(Good)	
Superstructure Bracing	(NA)	
Trusses - General	(NA)	
Trusses - Portals	(NA)	
Trusses - Bracing	(NA)	
Superstructure Paint	(Poor)	On bearings. Paint has failed and bearings are corroded at abutment #1 "A" and "C"
Alignment of Members	(Good)

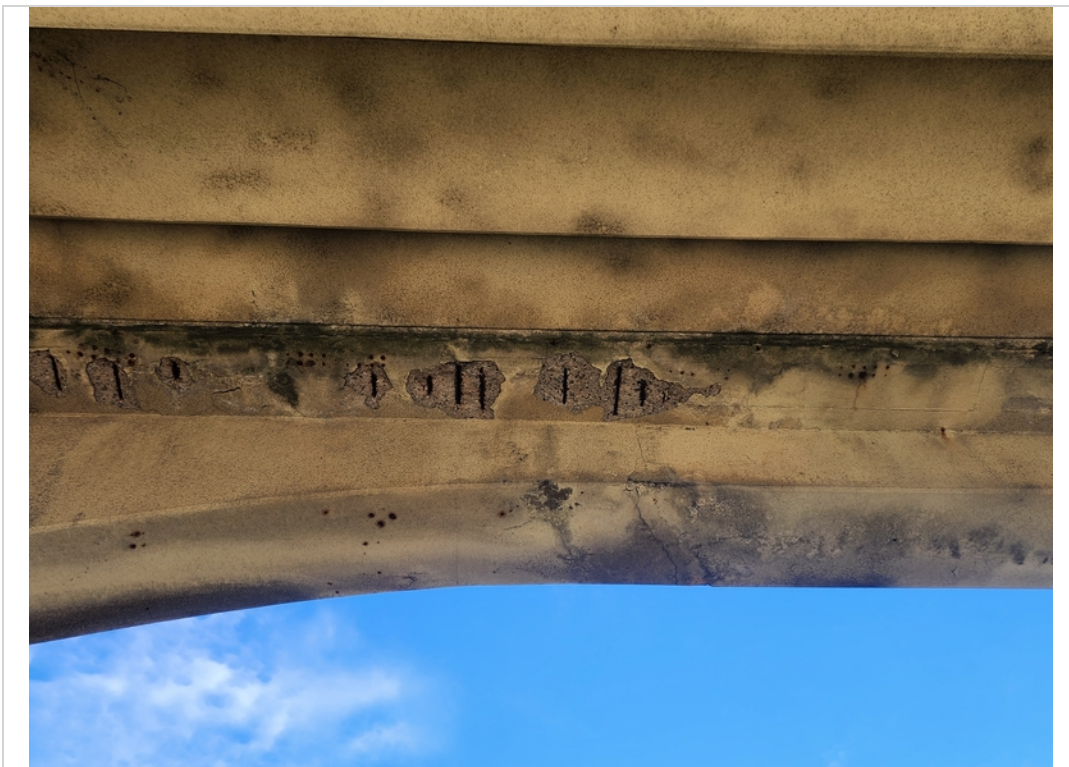
Moderate vertical crack in beam "A" in span #3

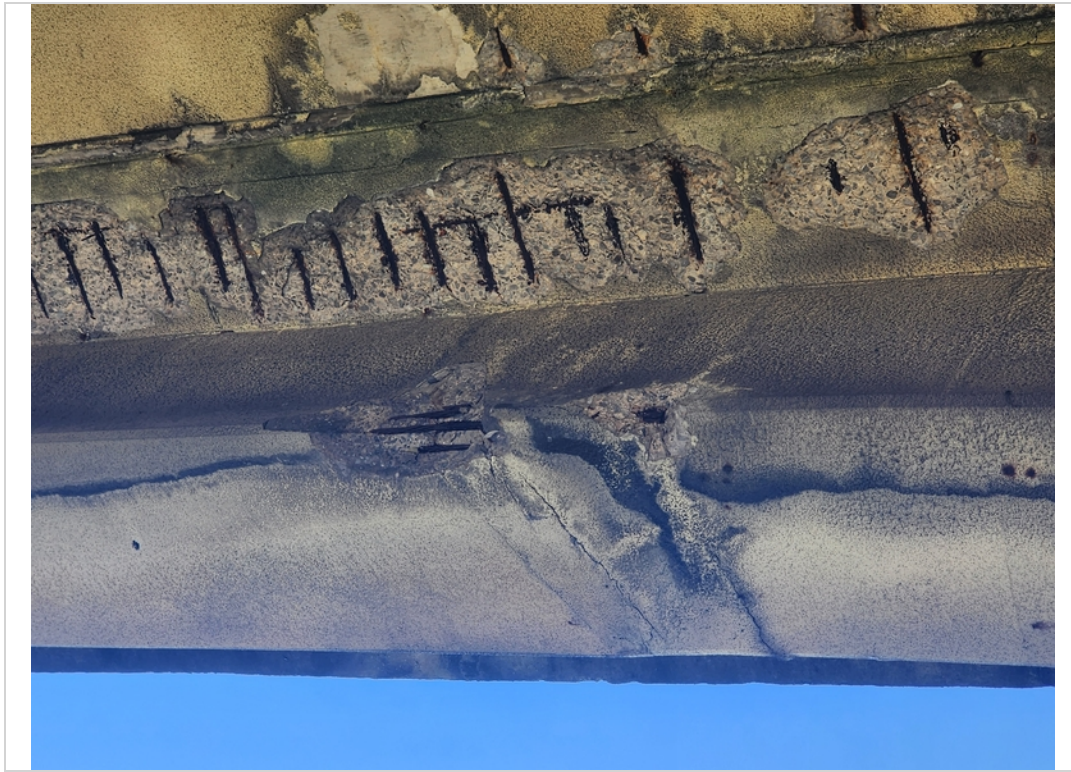
Moderate spall on beam "A" in span #3 with exposed strands

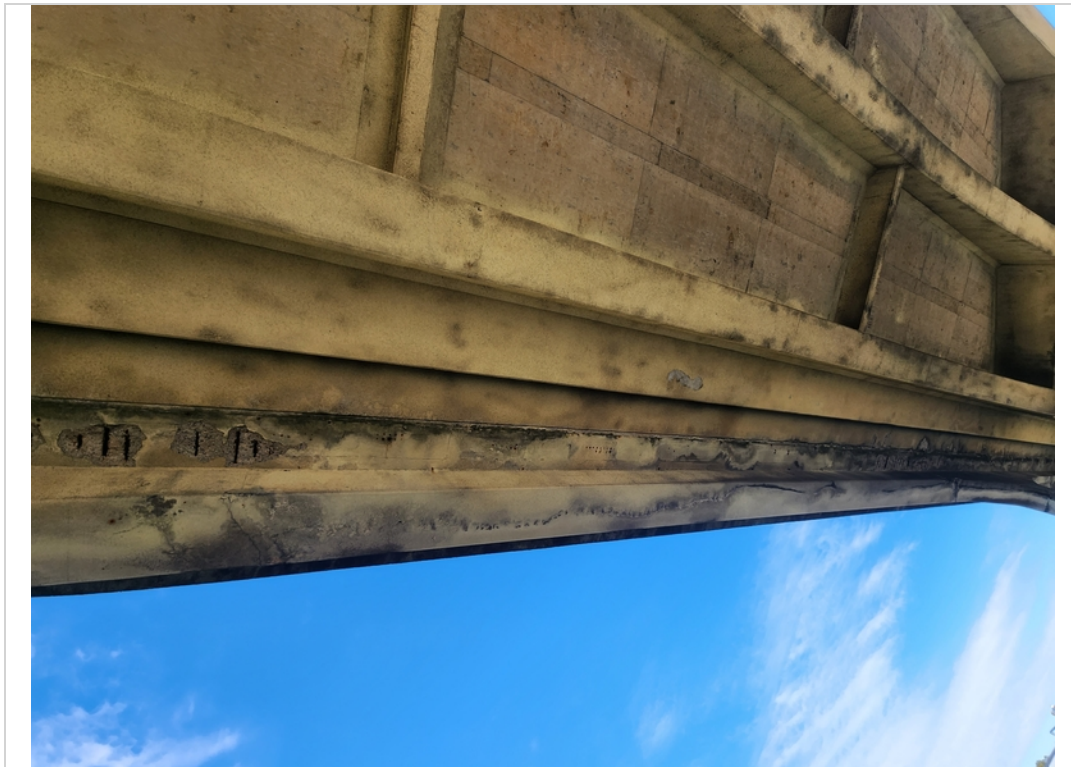
Hairline longitudinal crack along length of beam "A" in span #3

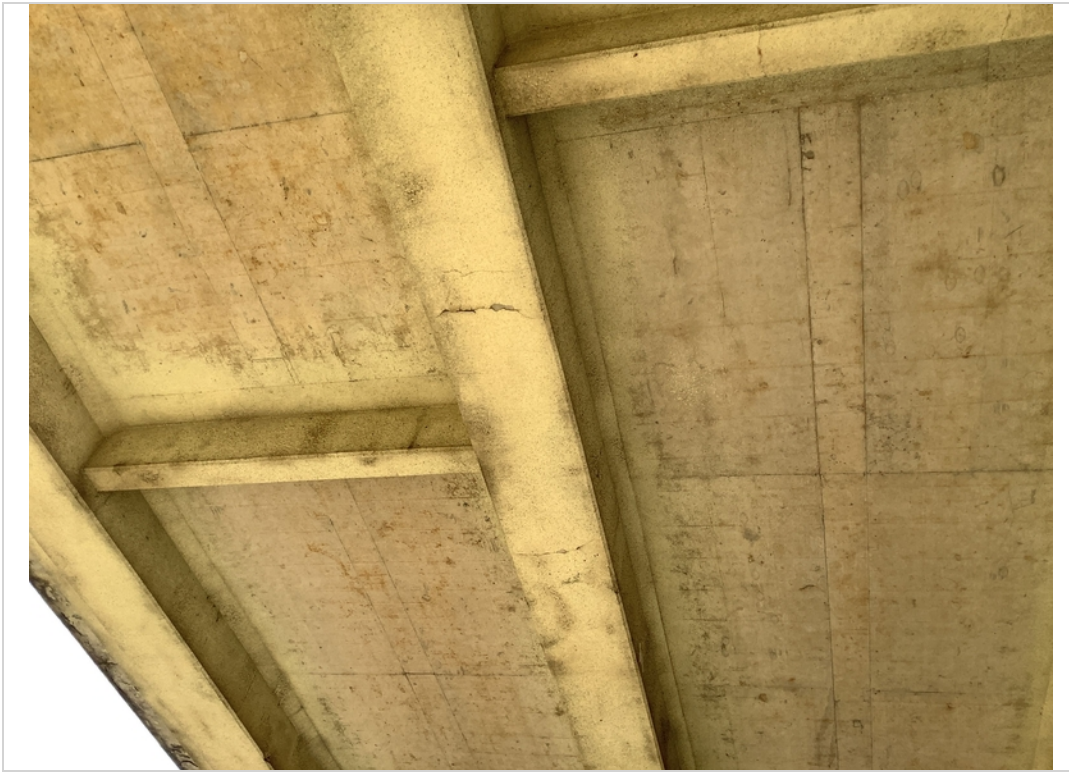
Typical cracks on beams

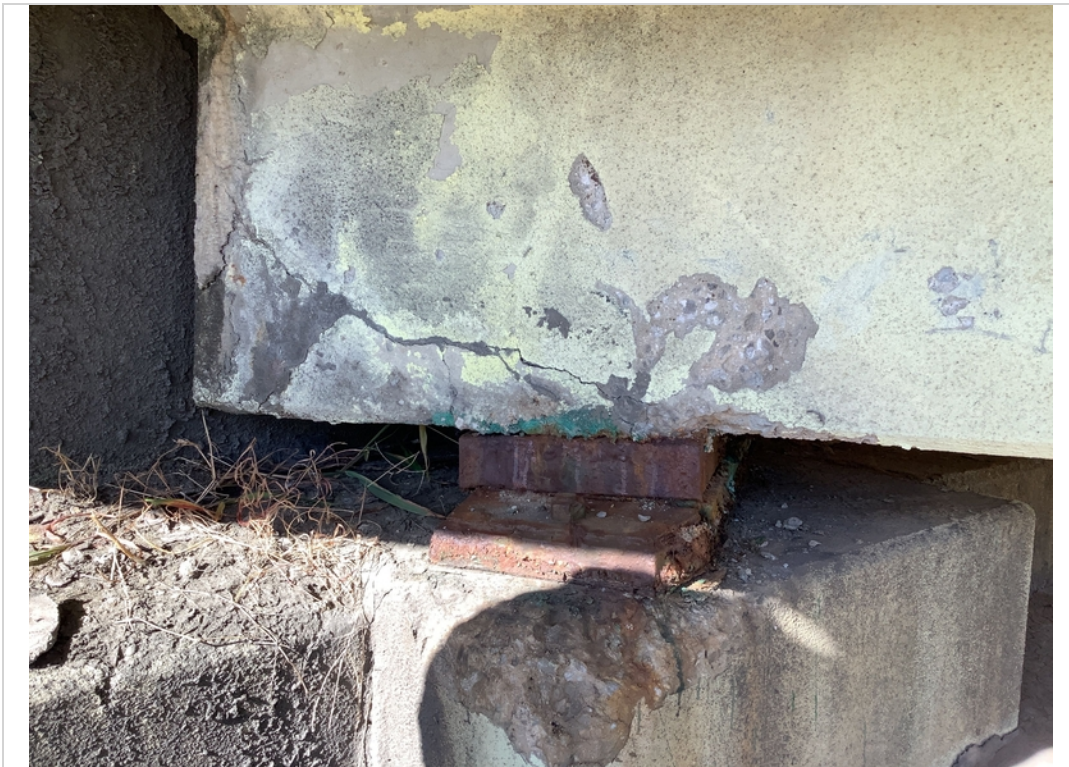
Beam "D" at abutment #1

The superstructure is rated fair. The bearing devices are rated fair due to corrosion at abutment #1 on bearings "A" and "C" due to lack of paint. The beams are rated fair. Beam "D" has up to 0.125 inch diagonal cracking over the bearing at abutment #1. Beam "A" in span #3 has two moderate spalls exposing prestressing stands. Beam "A" in span #3 also has a moderate vertical crack and a hairline longitudinal crack along the beam length. Beams "B" and "C" in span #2 have isolated cracks.

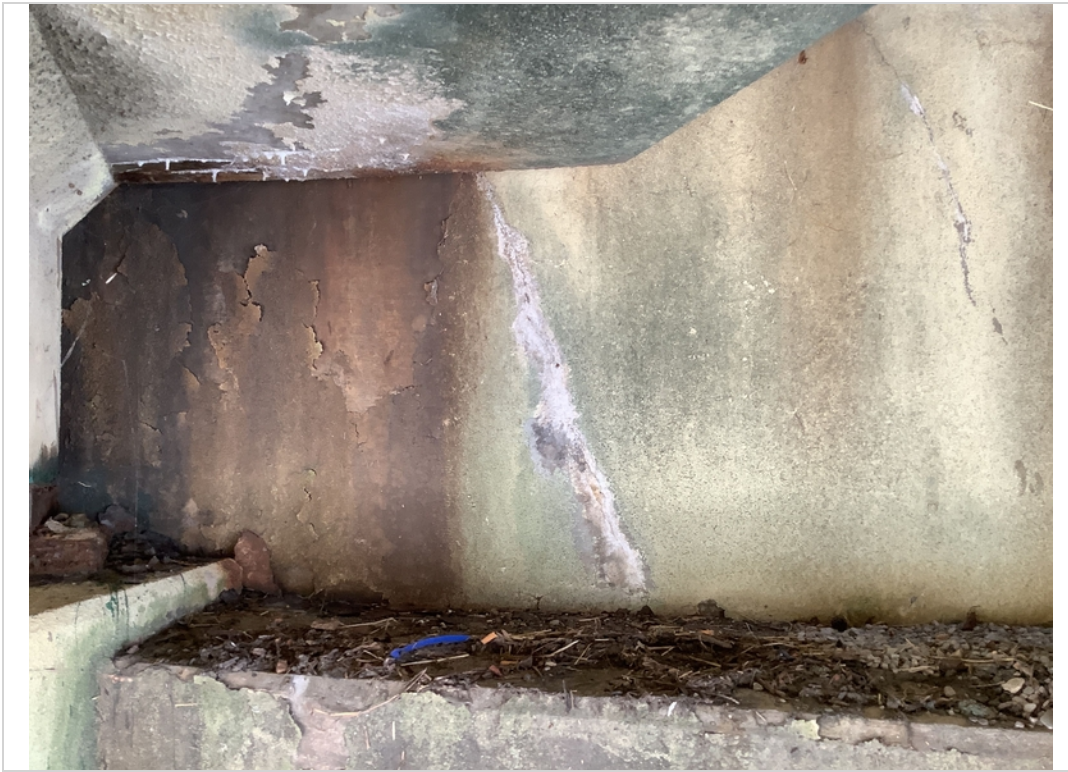
Typical cracks with efflorescence at abutments

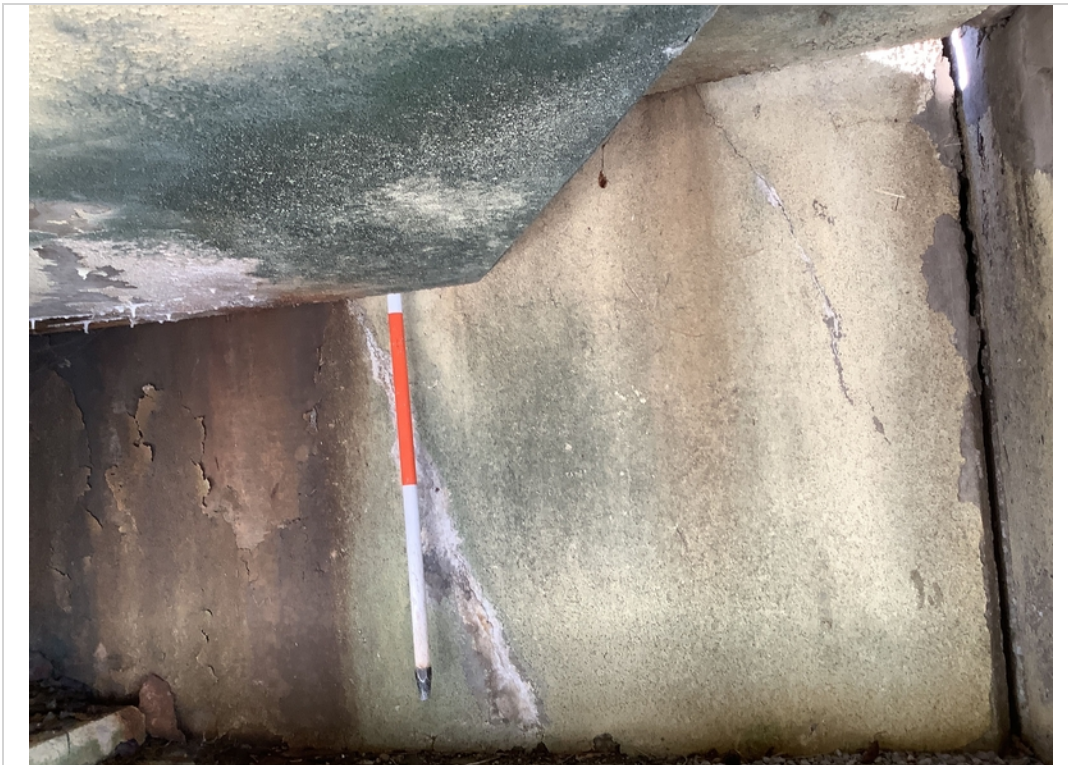
Void between deck and abutment #1 at left side

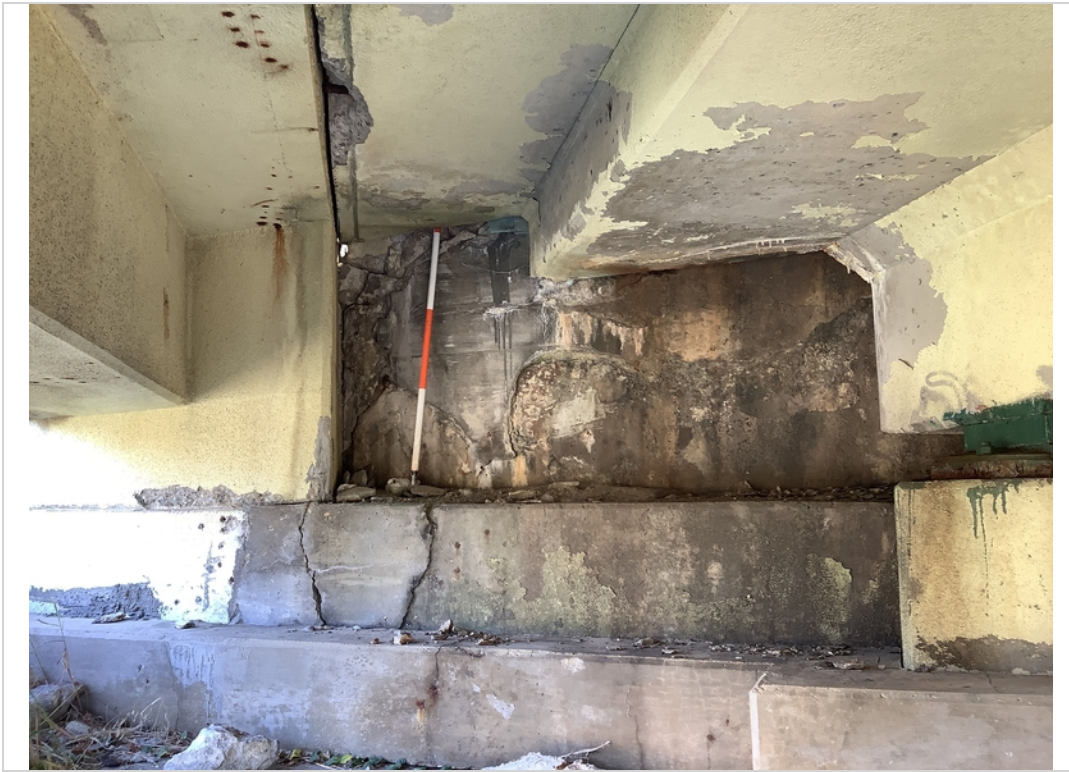
Void between deck and abutment #2 at left side

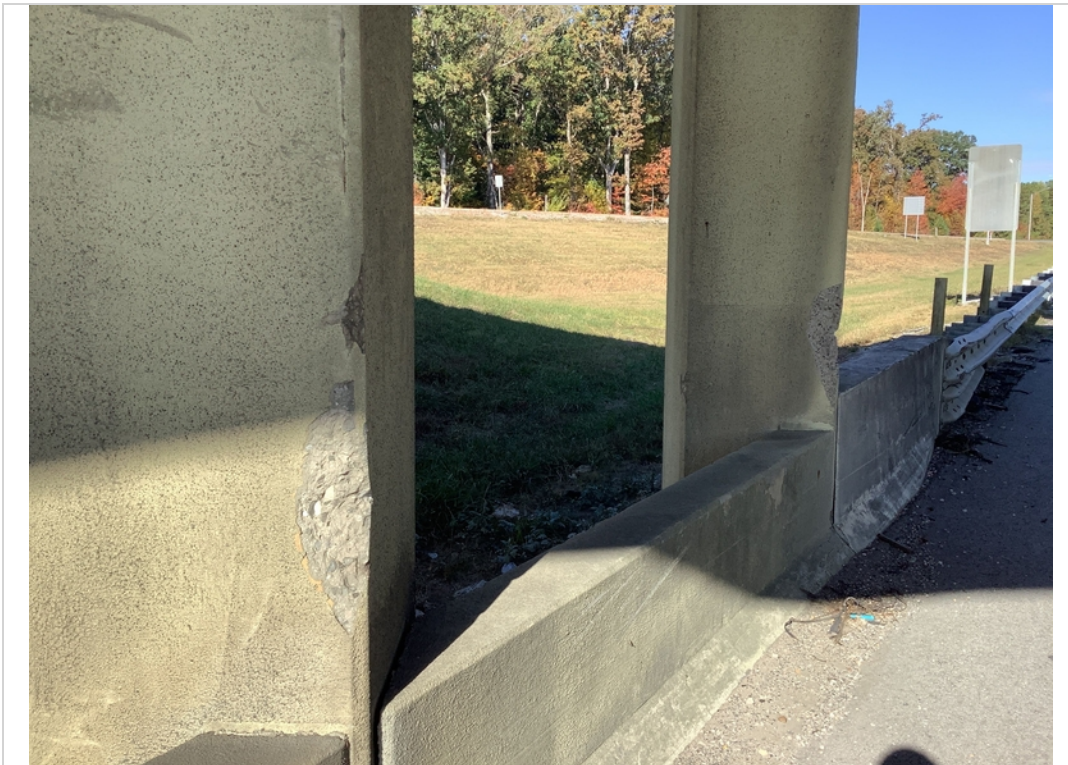
Typical spalls on bent columns from collision damage

Bent Caps	(NA)	
Bent Columns	(Fair)	Spalls at bent #1 from collision damage; rebar pop-outs on columns at bent #3
Bent Plumb	(Good)	
Bent Footing	(Not Visible)	
Bent Piles	(Not Visible)	
Bent Bearing Surface	(NA)	
Piles Need Replacement	(No)

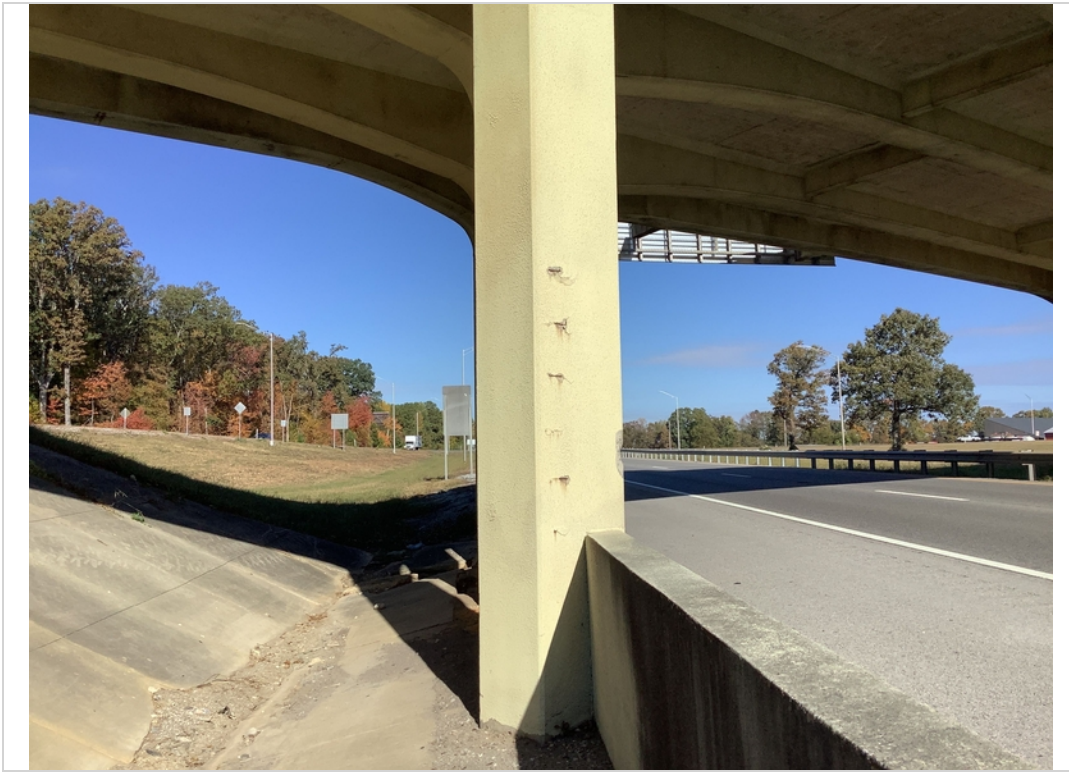
Typical rebar pop-outs on bent columns

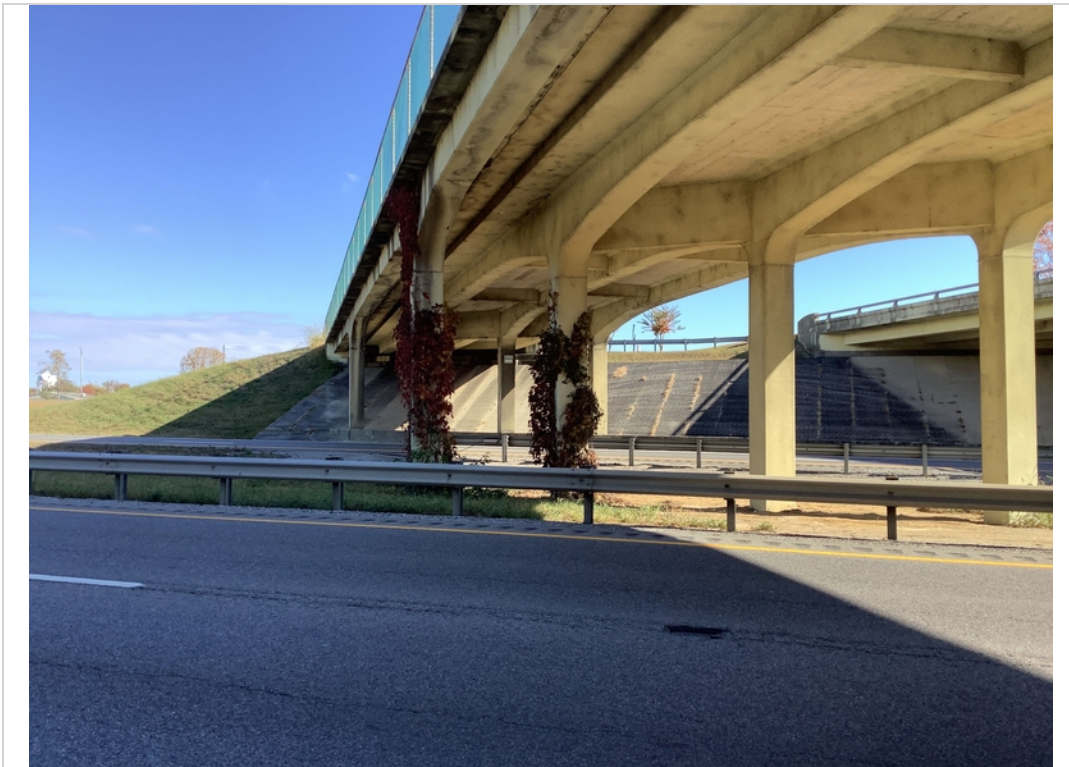
Vegetation growing on bent columns

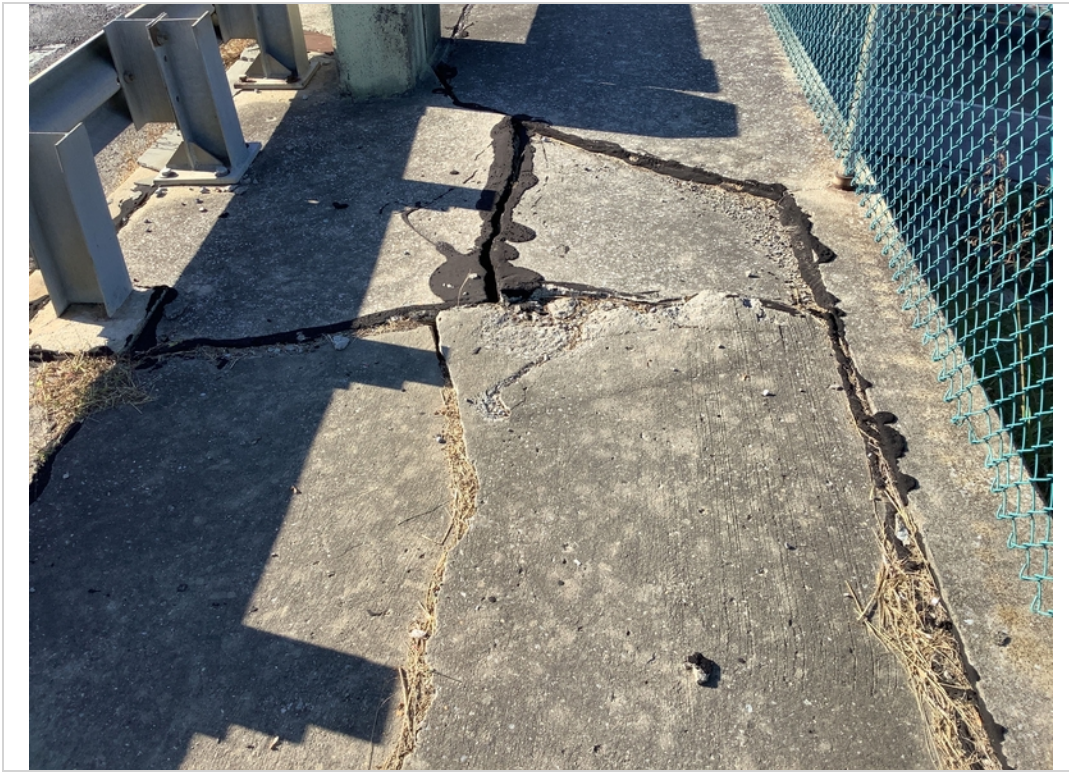
Sidewalk deterioration

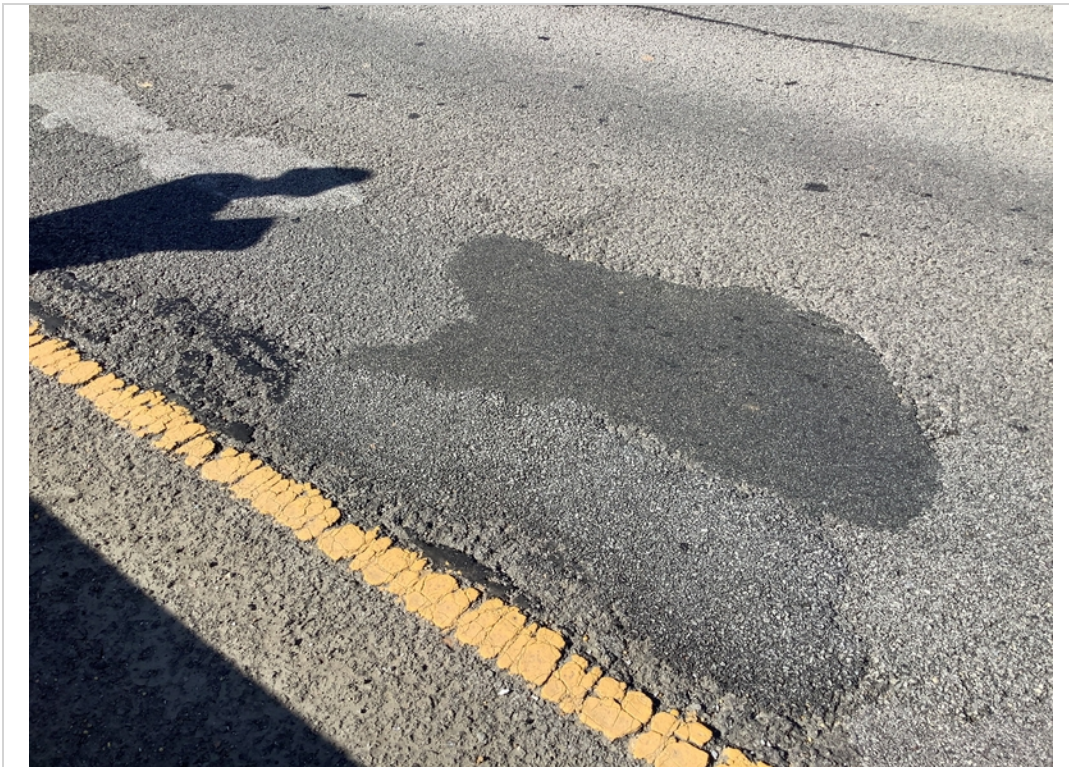
Typical rough and uneven wearing surface

Pavement (Poor) Rough and uneven with up to 2" of settlement over joints

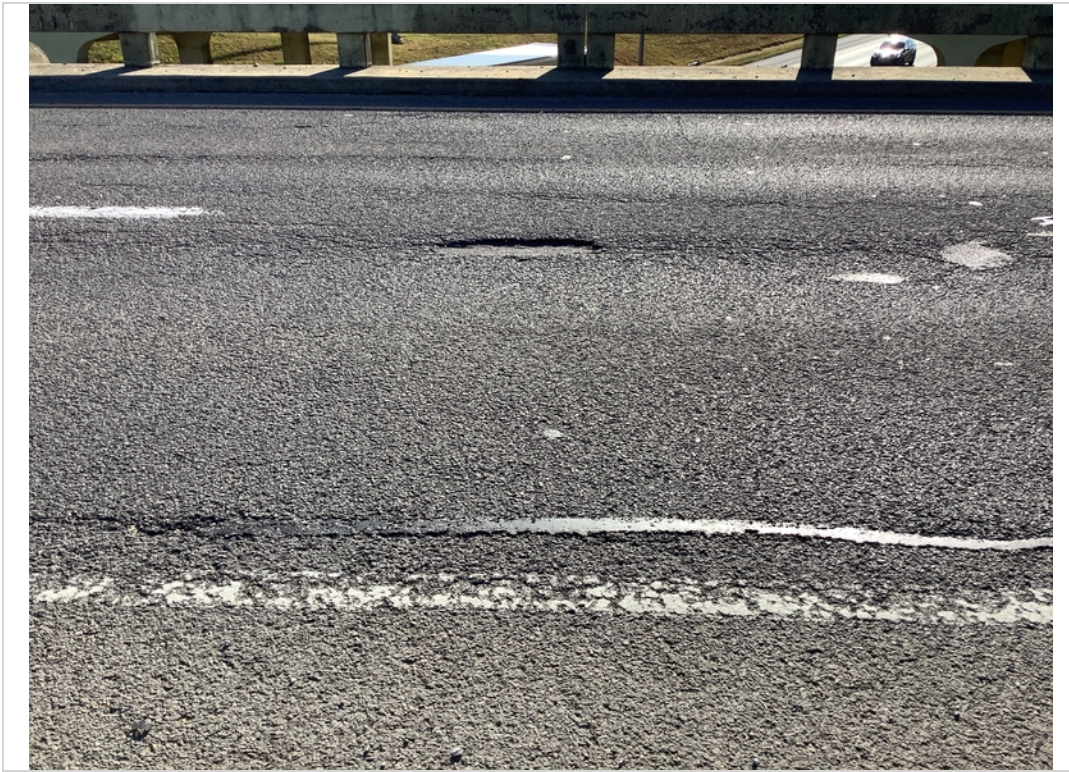
Typical pothole in wearing surface

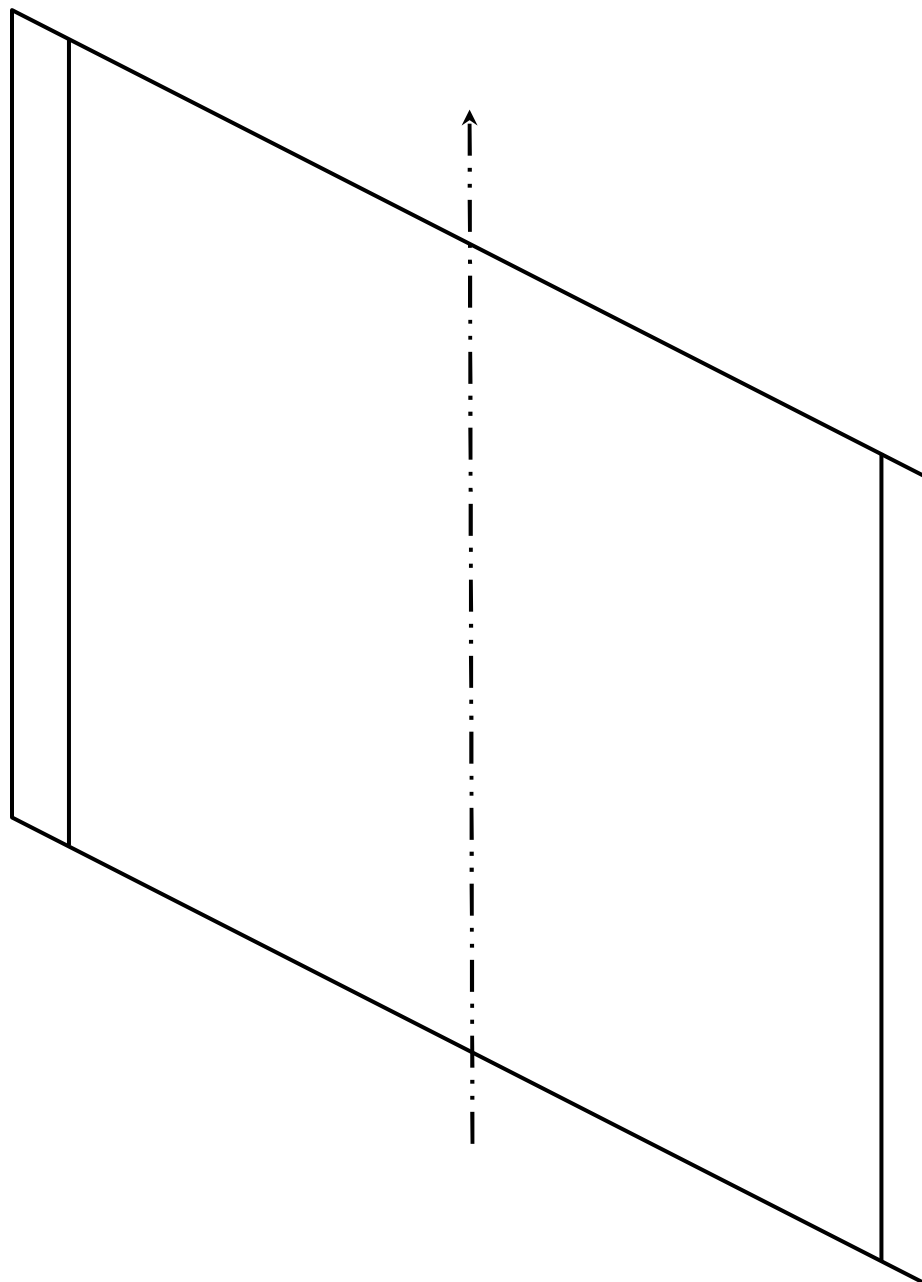
Overhangs up to 15% spalled with exposed rebar

8' x 2' delaminated area with 0.06" crack and 5" x 5" x 1" spall

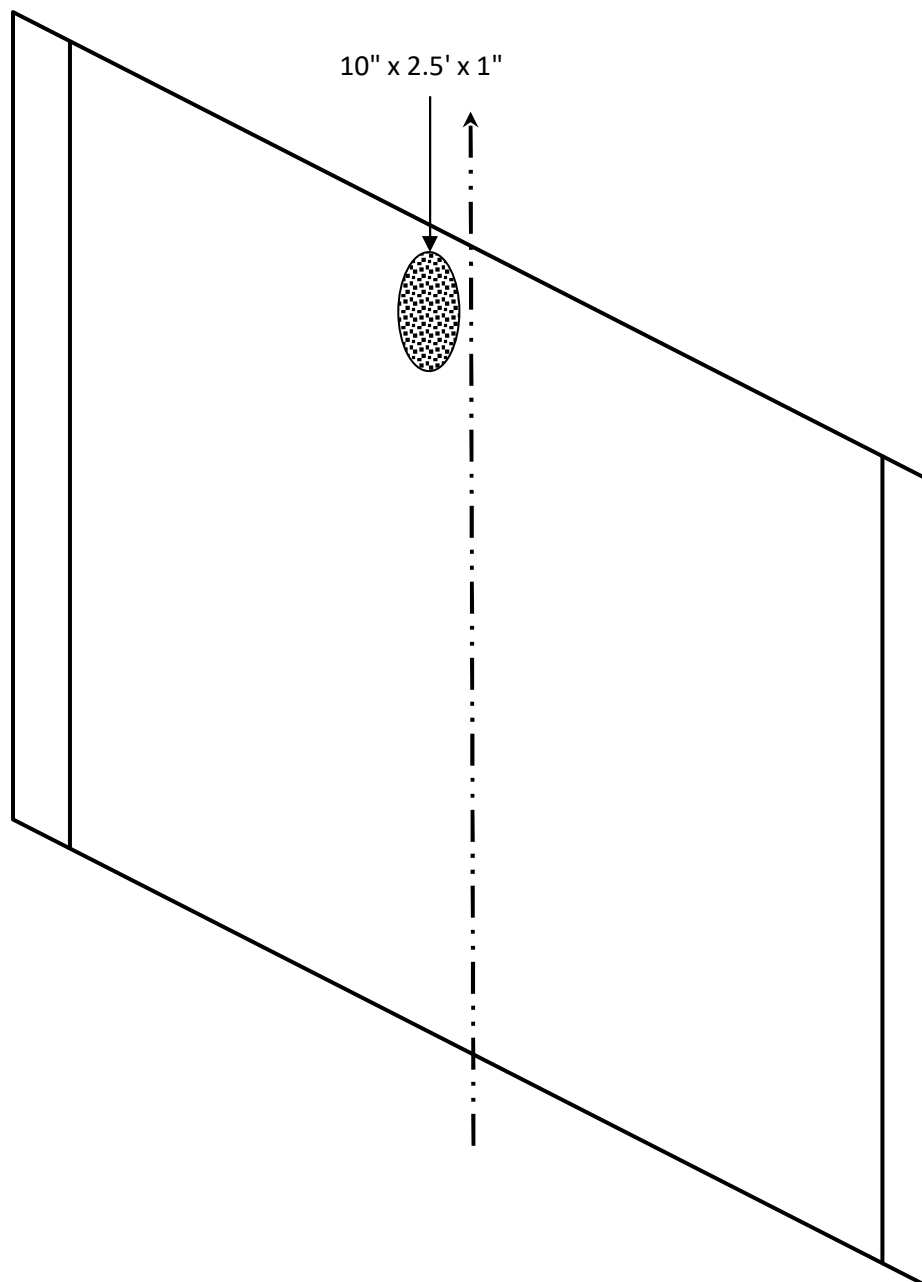
Top of Deck Span No. 2

Asphalt is rough and uneven with moderate cracking throughout

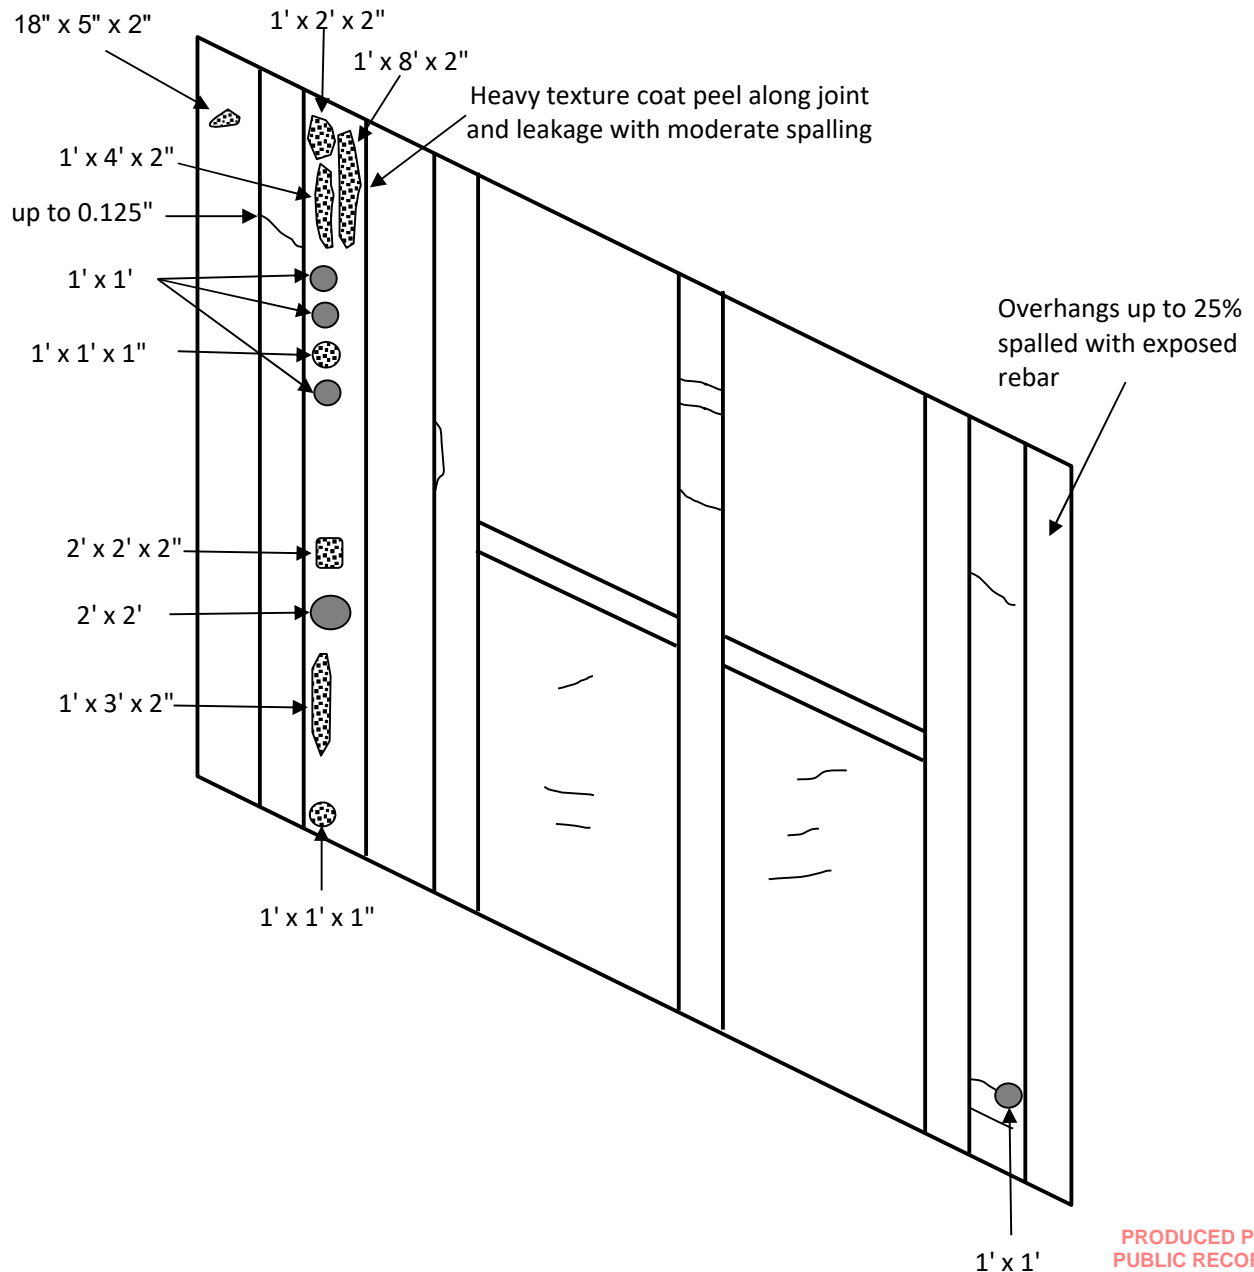
Bottom of Deck Span No. 2

Cracks are hairline with minor efflorescence
Spalls have exposed rebar
