MCMINNILLE HWY. Crossing I24

Routine Bridge Inspection Report

City of Manchester in Coffee County	
Federal ID	16I00240030
Location	16-SR055-14.77-L
Description	McMinnville Highway over I-24, I-24 Milepost 111.20
GPS Coordinates	35.489667, -86.074233
Date	10/25/2023
Overall Condition	Poor

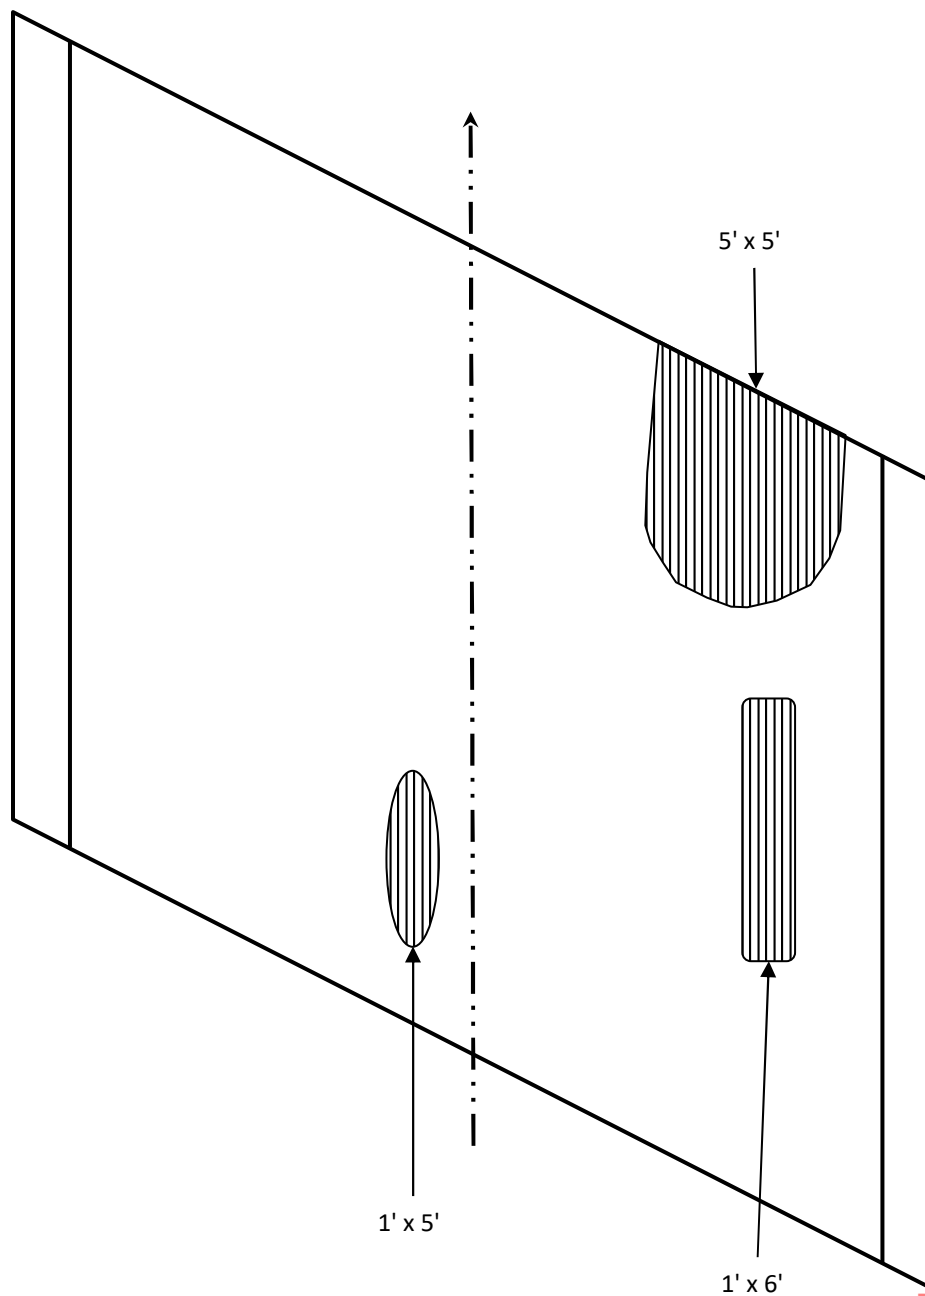
Top of Deck Span No. 3

Asphalt is rough and uneven with moderate cracking throughout

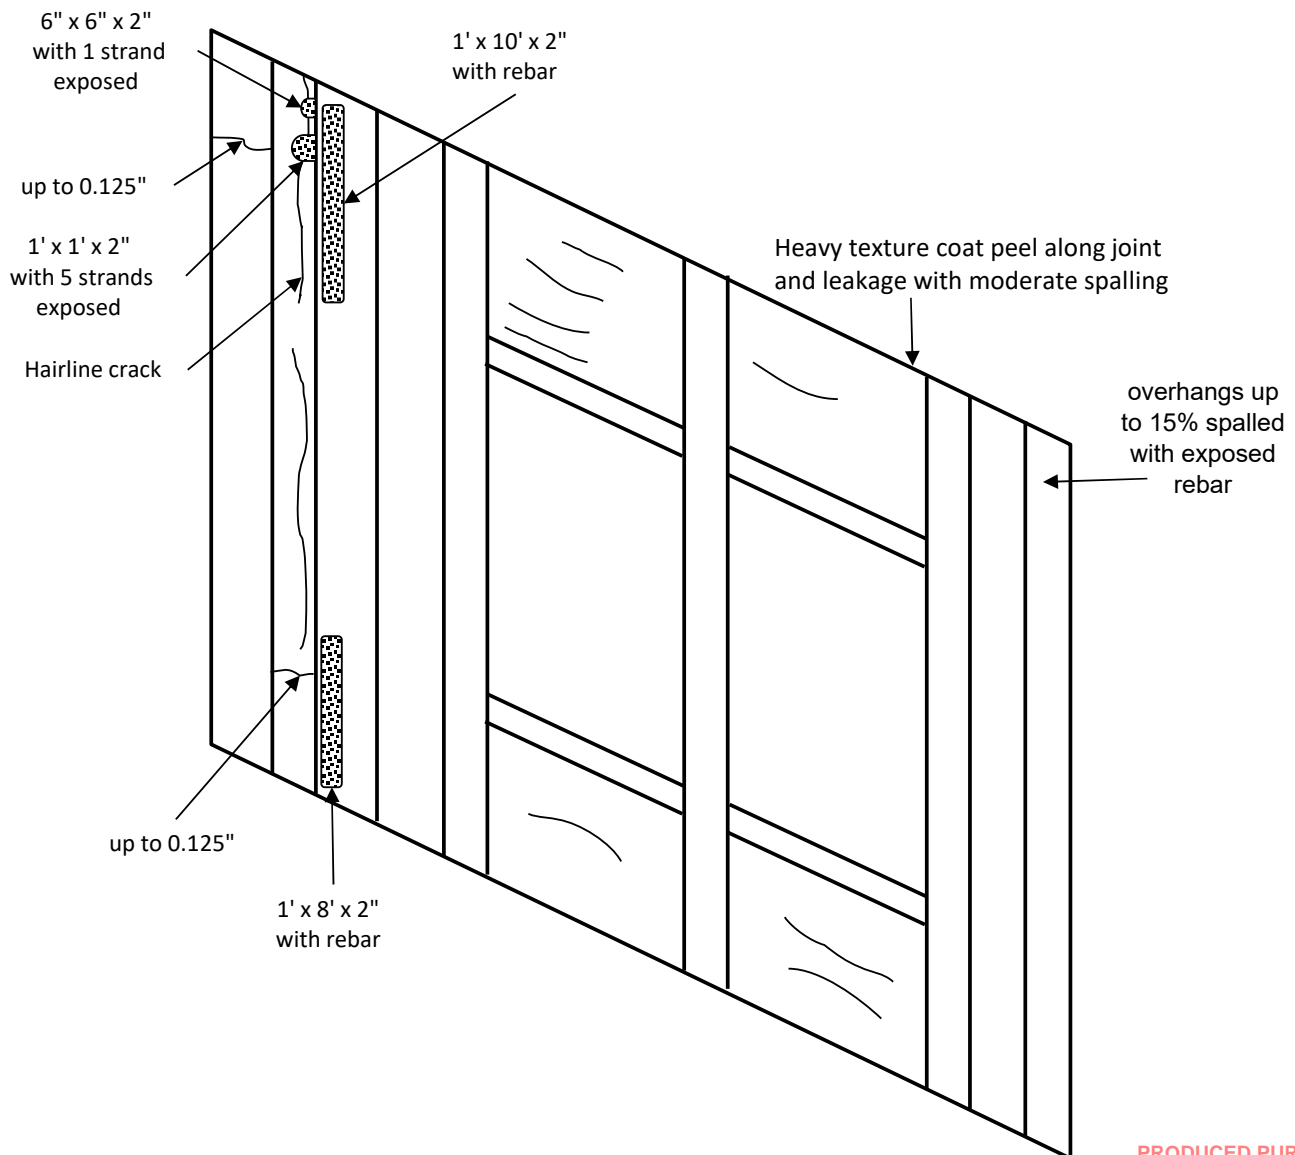
Bottom of Deck Span No. 3

Cracks are hairline with slight efflorescence

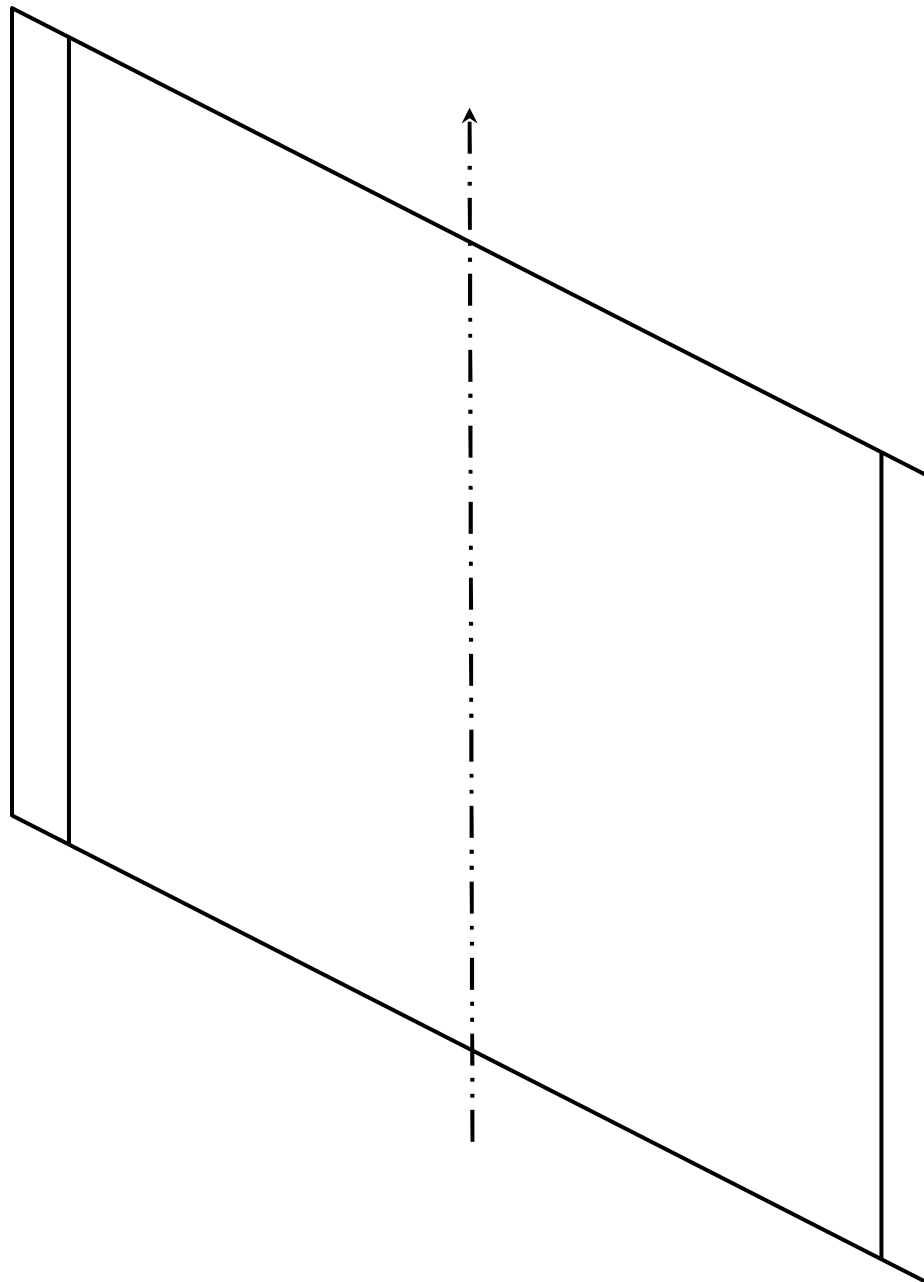
Top of Deck Span No. 4

Asphalt is rough and uneven with moderate cracking throughout

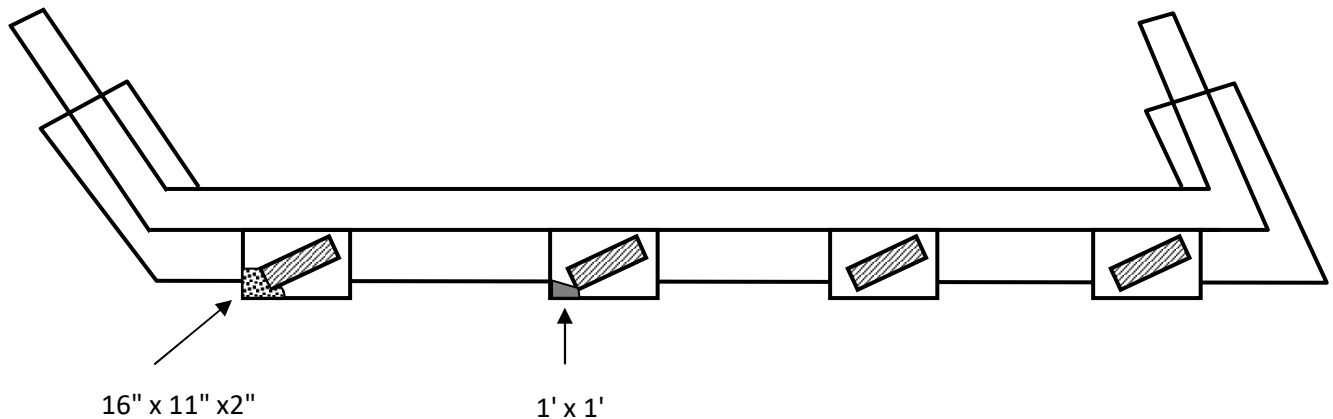
Abutment No. 1

cracks are hairline

Corroded bearings "A" and "C"
paint failed

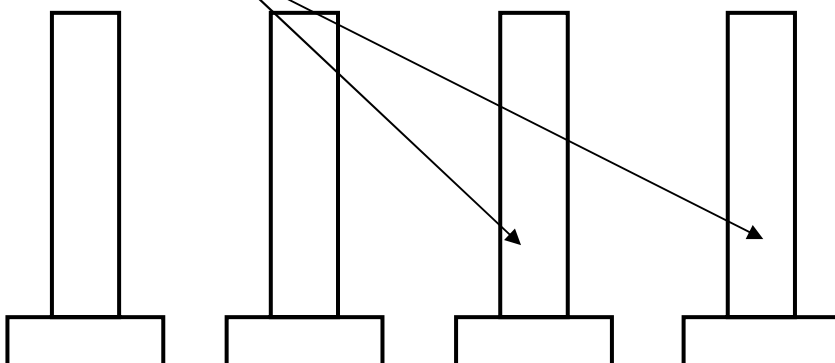
Vegetation growth

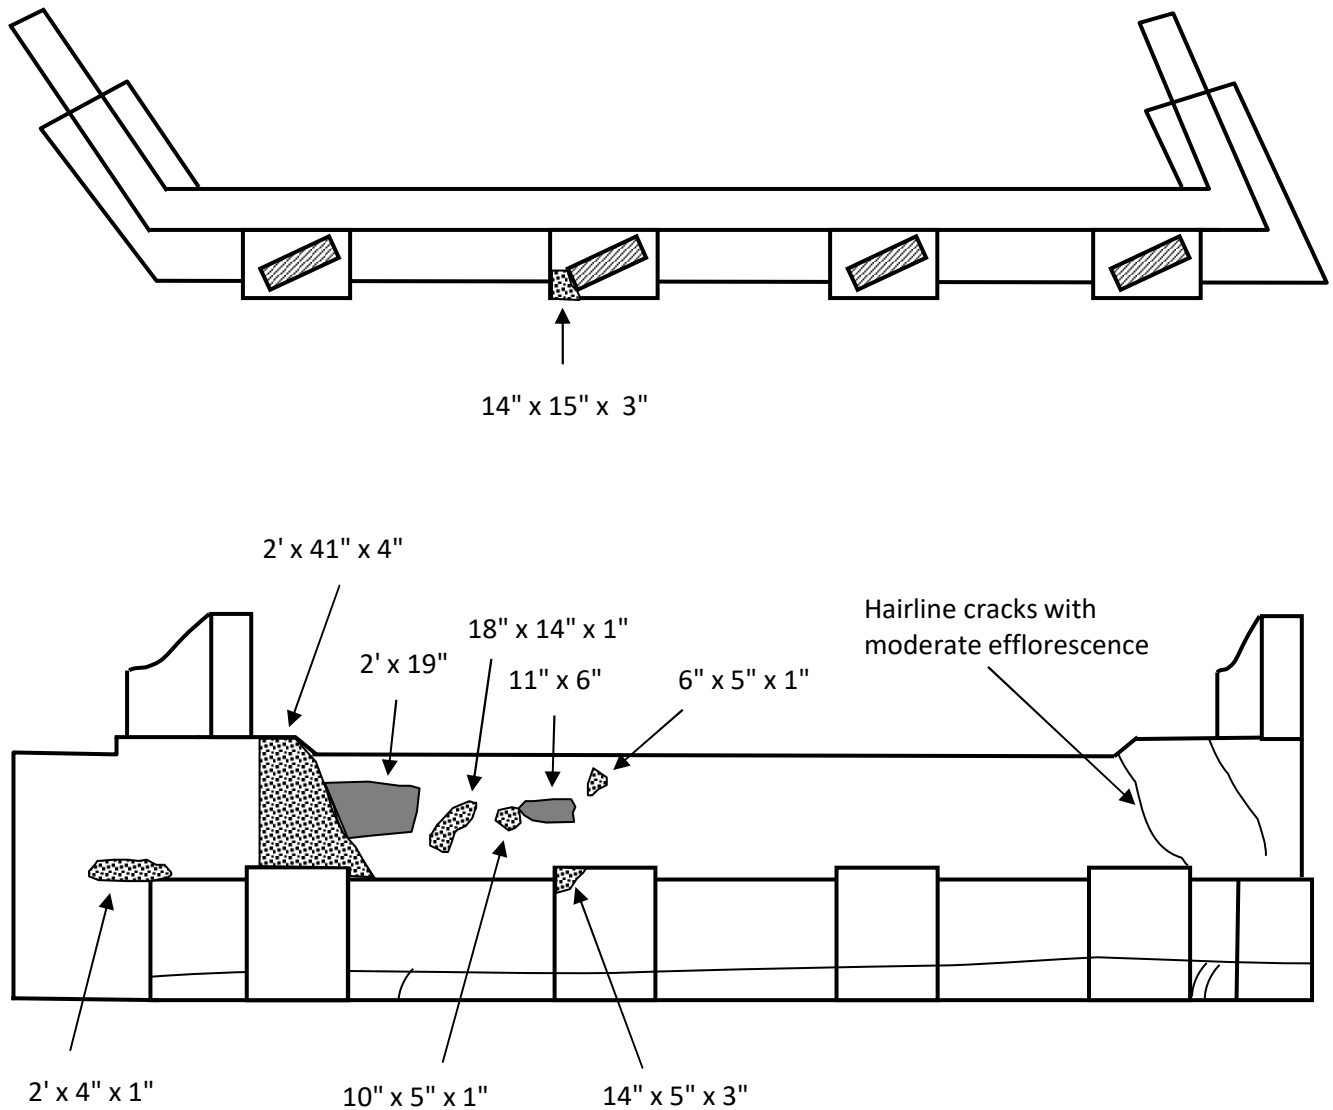
Abutment No. 2

cracks are small
