JAMES ROBERTSON PKWY. Crossing CUMBERLAND RIVER

Inspection Date(s): 05/15/2025 - 05/15/2025

IDENTIFICATION	
(1) State Names	47 - Tennessee
(8) Structure Number	19SR0060015
(5) Inventory Route	1
(2) Highway Agency District	Region 3
(3) County Code	19 - Davidson

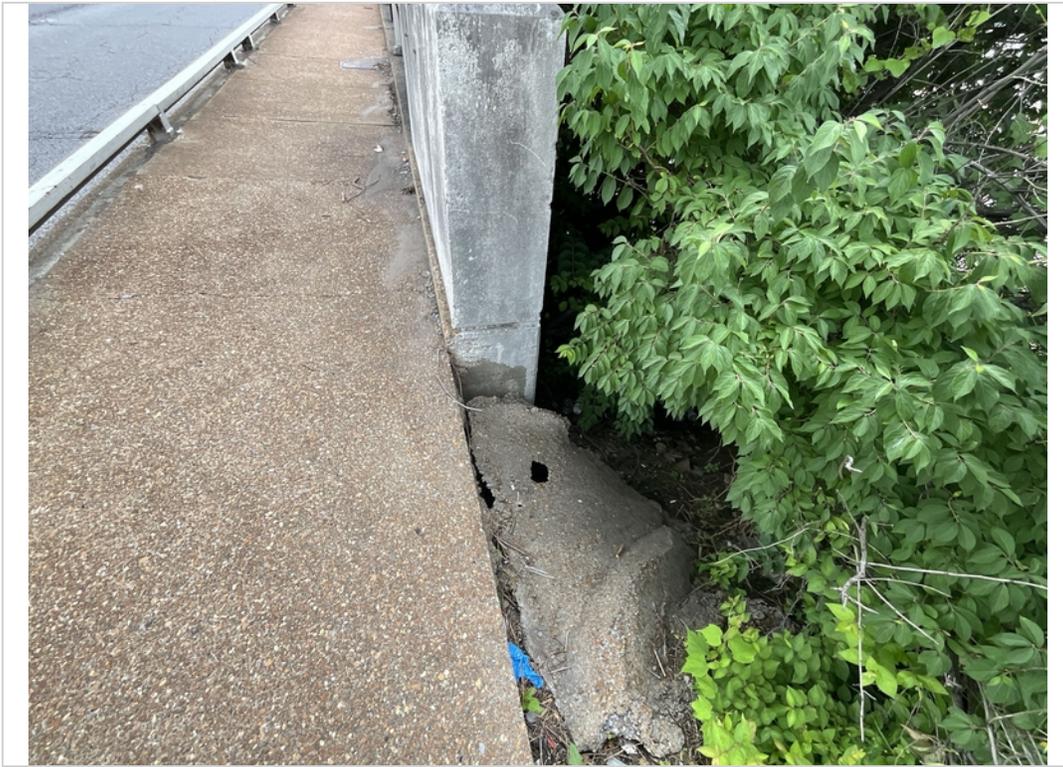
Typical Approach Drain at Approach 1 Right

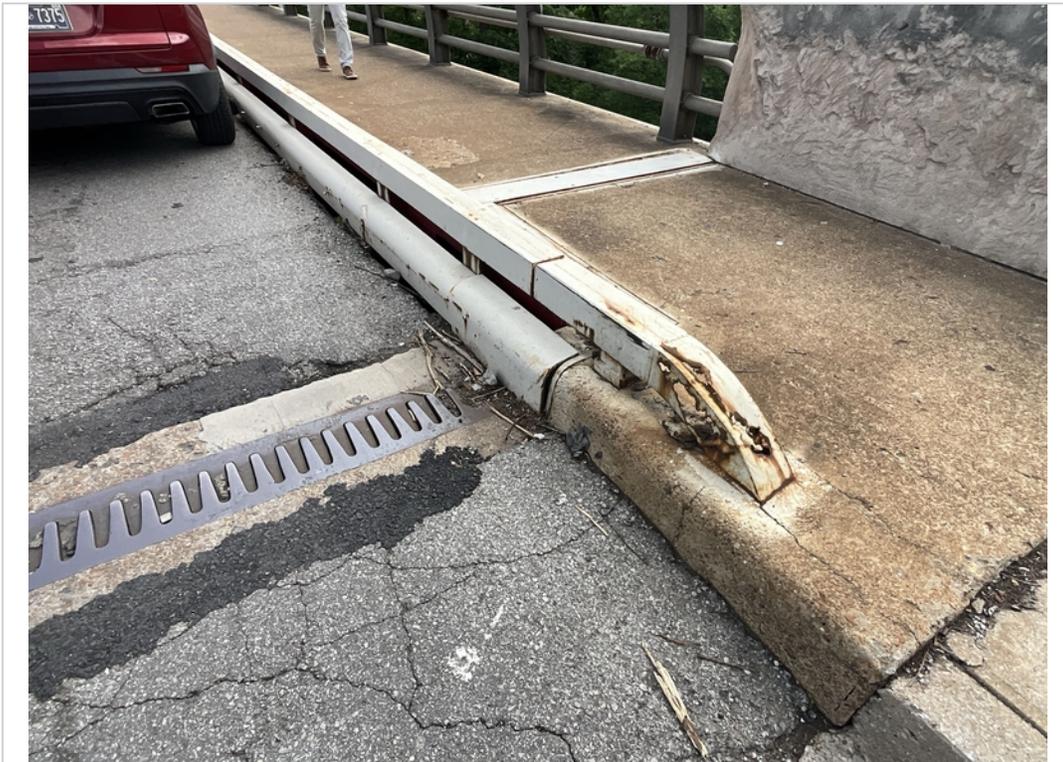
The bridge railing is in Good condition. There is an area of bridge rail separation directly over the abutment 2 joint on the right side. Other Traffic Safety Features do not exist for this structure.

Metal Bridge Rail Disconnected at Right Side above Abutment 2

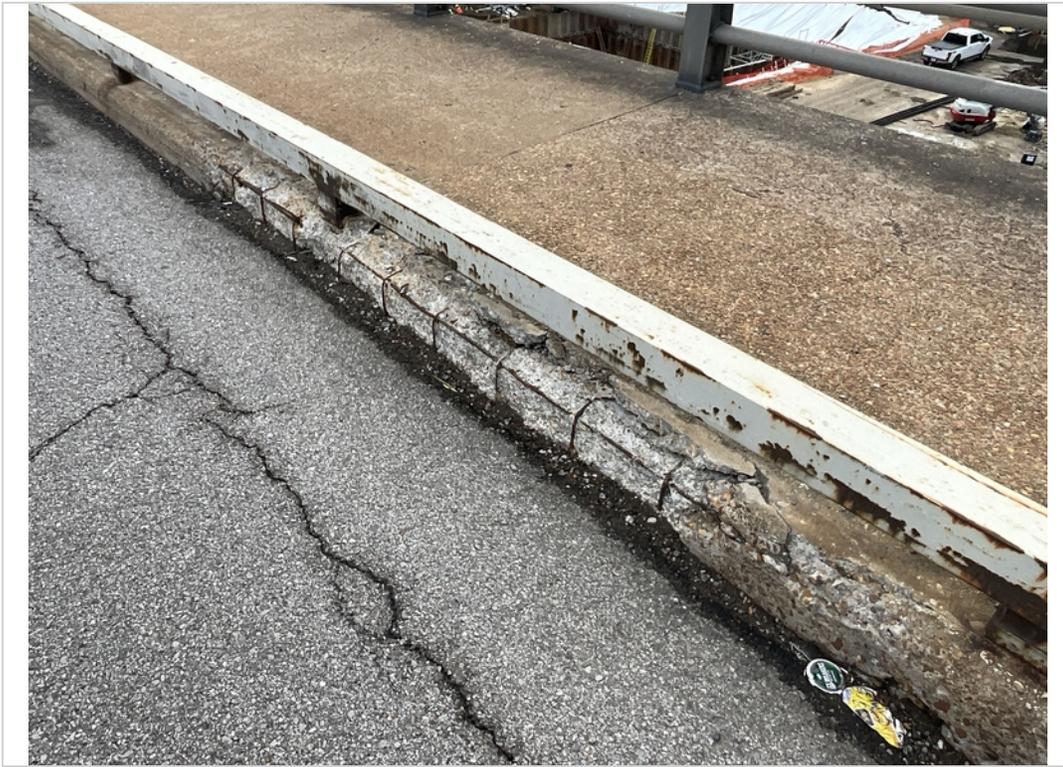
Right Side Rub-rail above Abutment 1 - Holed Through Section Loss and Active Corrosion. Typical of end of rail on both sides at both approaches

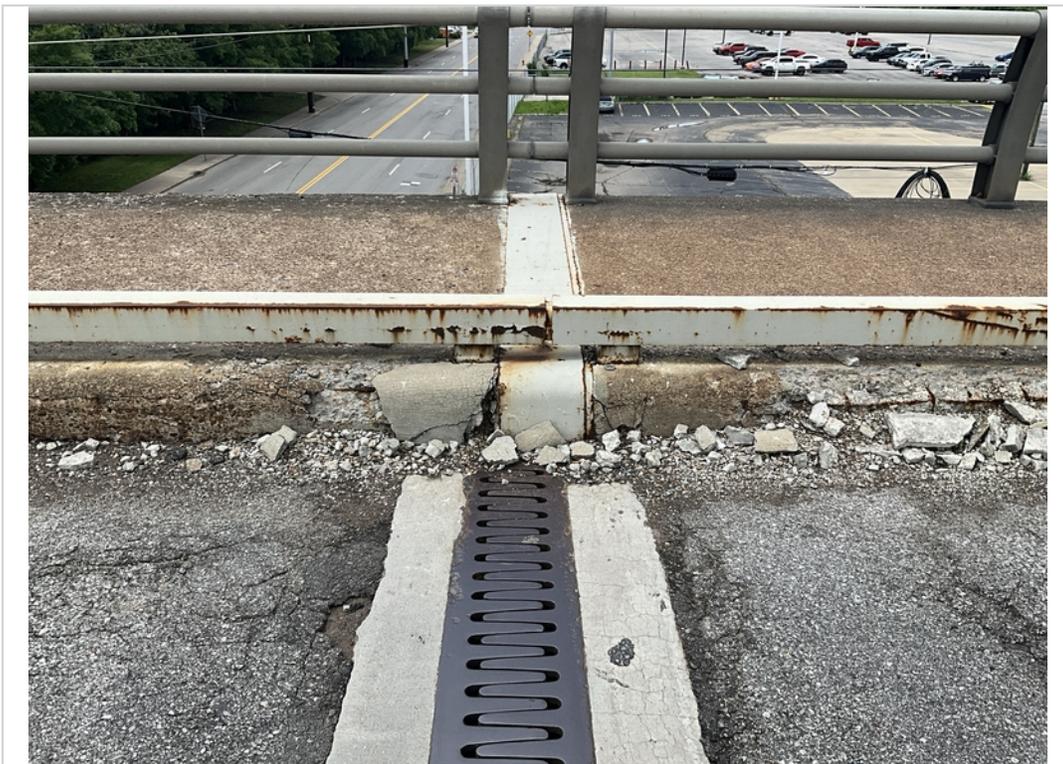
Typical curb spall with exposed rebar, showing right side

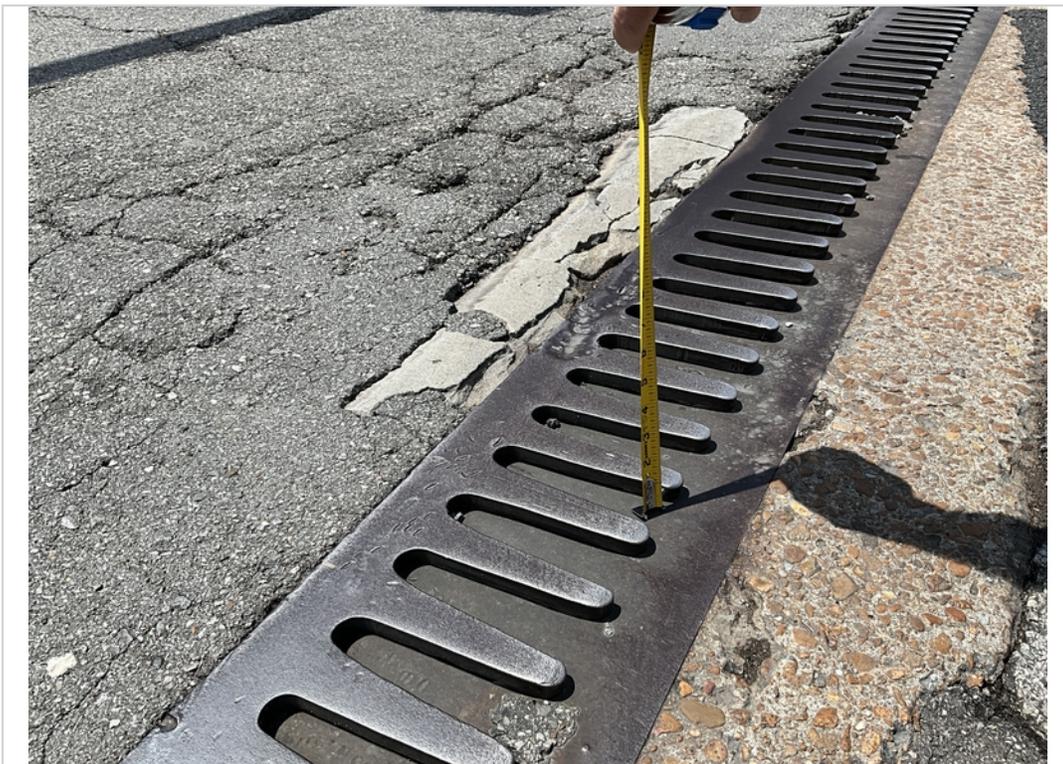
Abutment 1 Finger Joint, Looking Left - Note fresh Asphalt Repair Patching along the Deck Joint

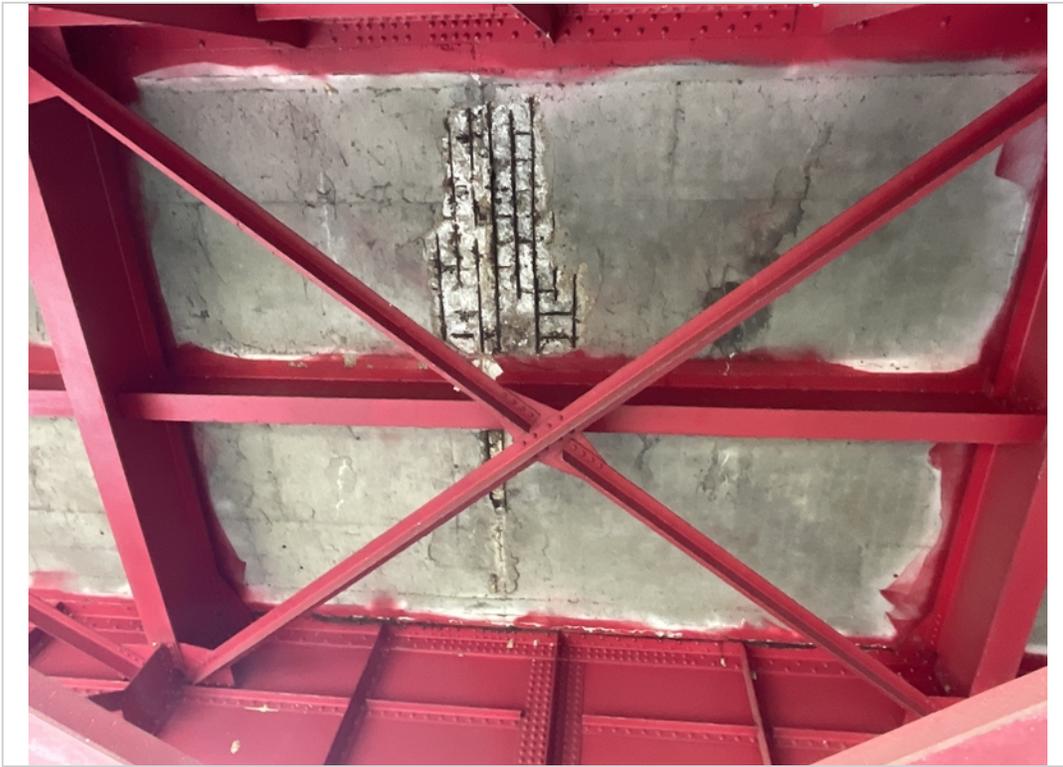
Span 2 in Panel 12, Bay C. Large Spall to Steel and adjacent Delamination

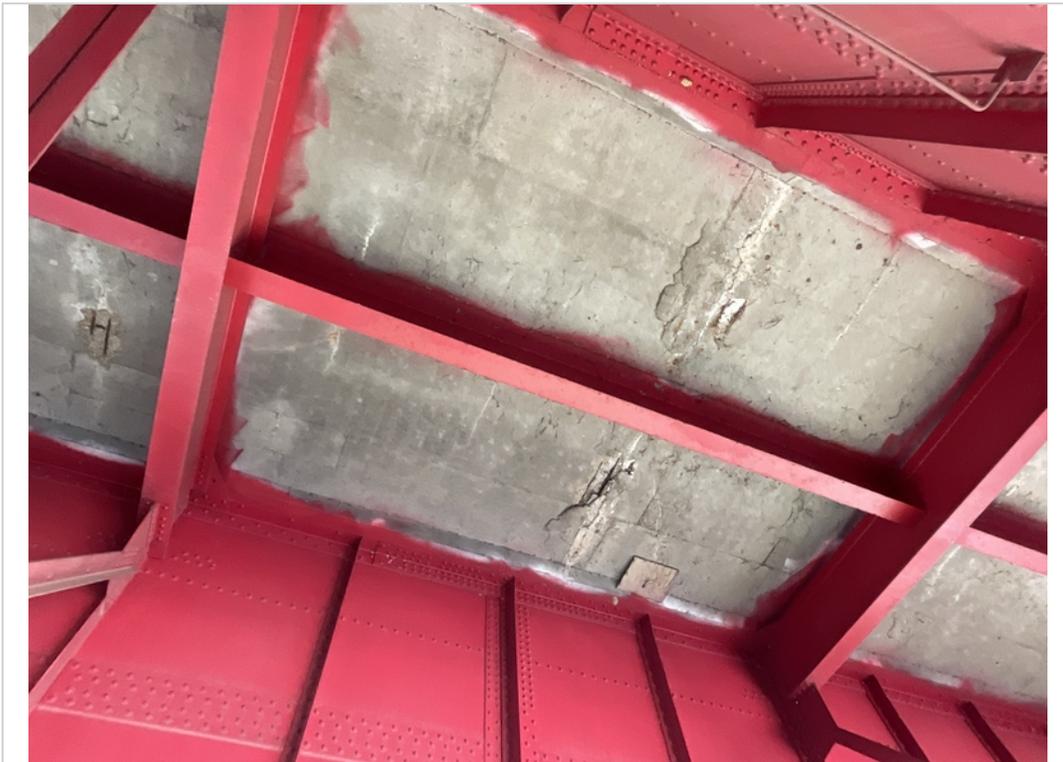
Span 3, Panel 4, Bay A - Large Spall to Steel with up to 50% Section Loss

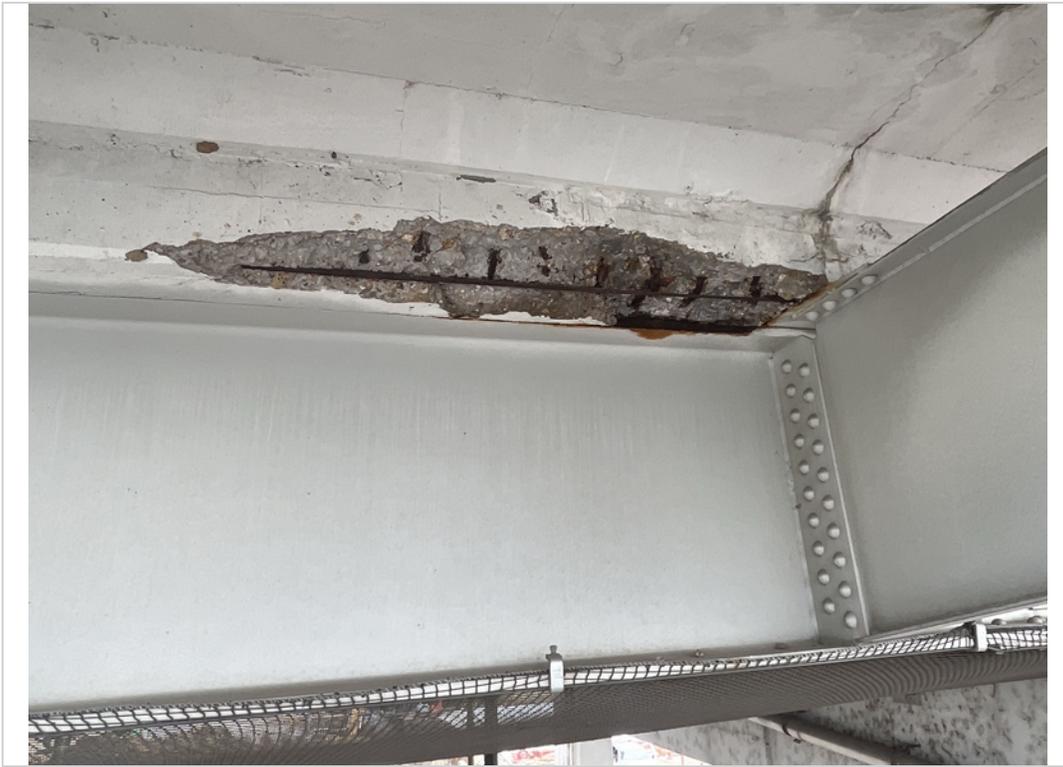
Span 3, Panel 4, Bay B - Spalls to Steel, Delamination and Formwork left in place

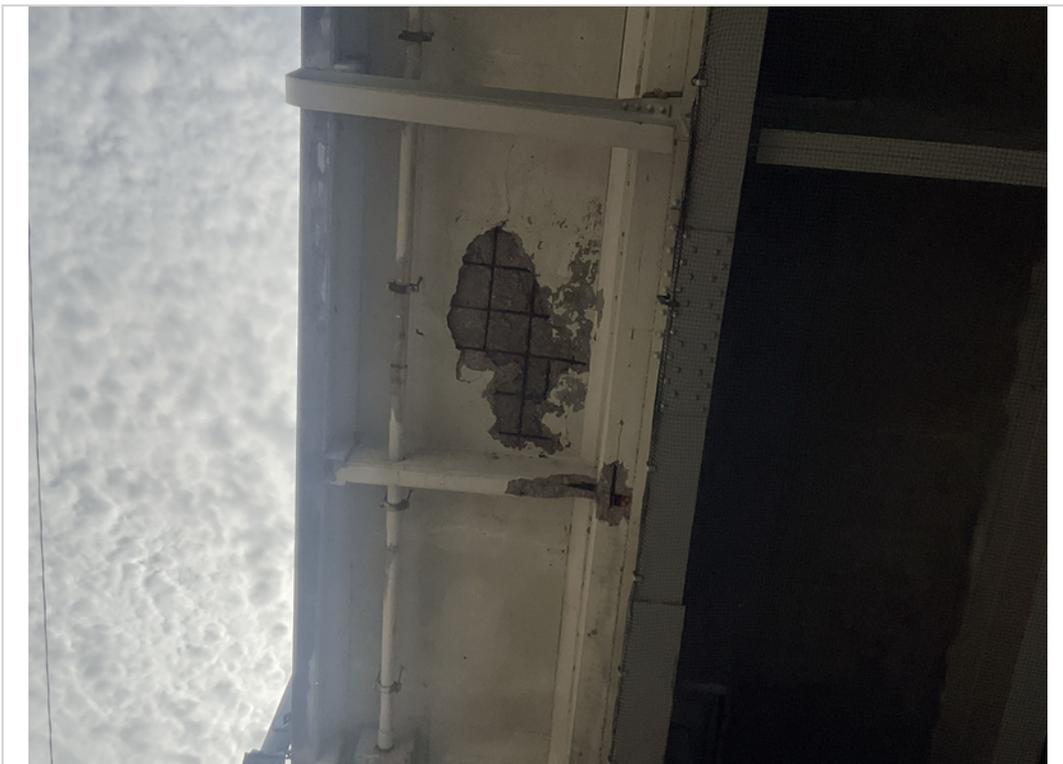
Span 9, Left Overhang near Bent 5 - Spalls to Steel

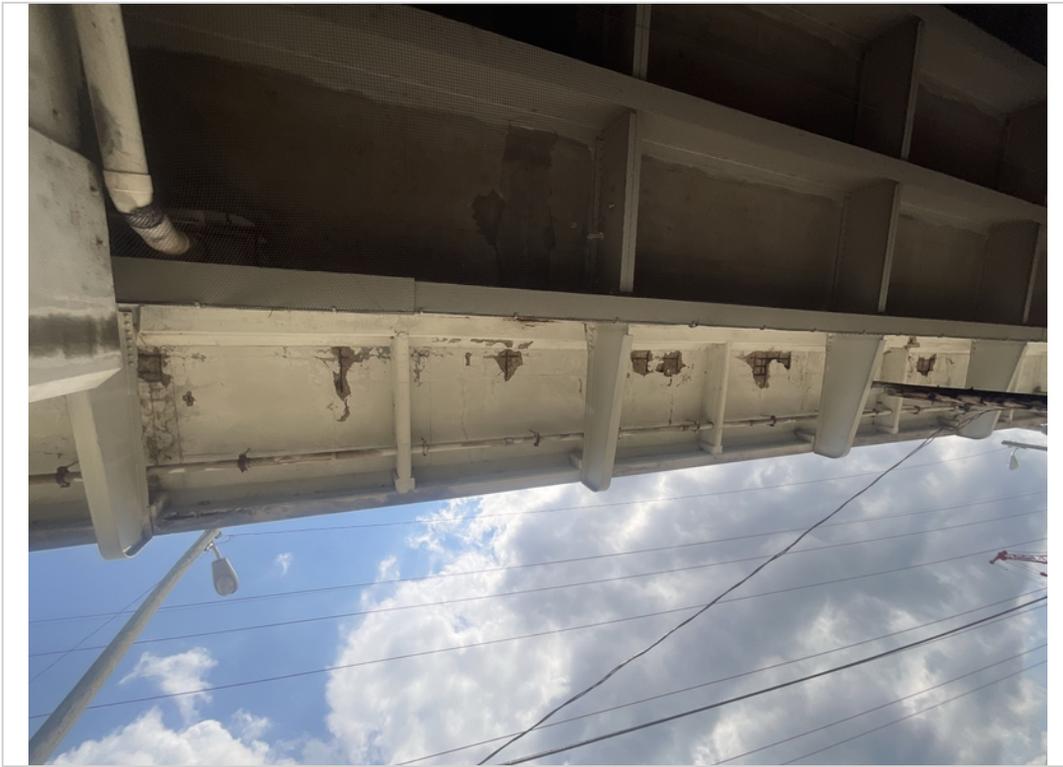
Span 9, Right Overhang near Bent 5 - Large Spall to Steel and Spall to Concrete Diaphragms

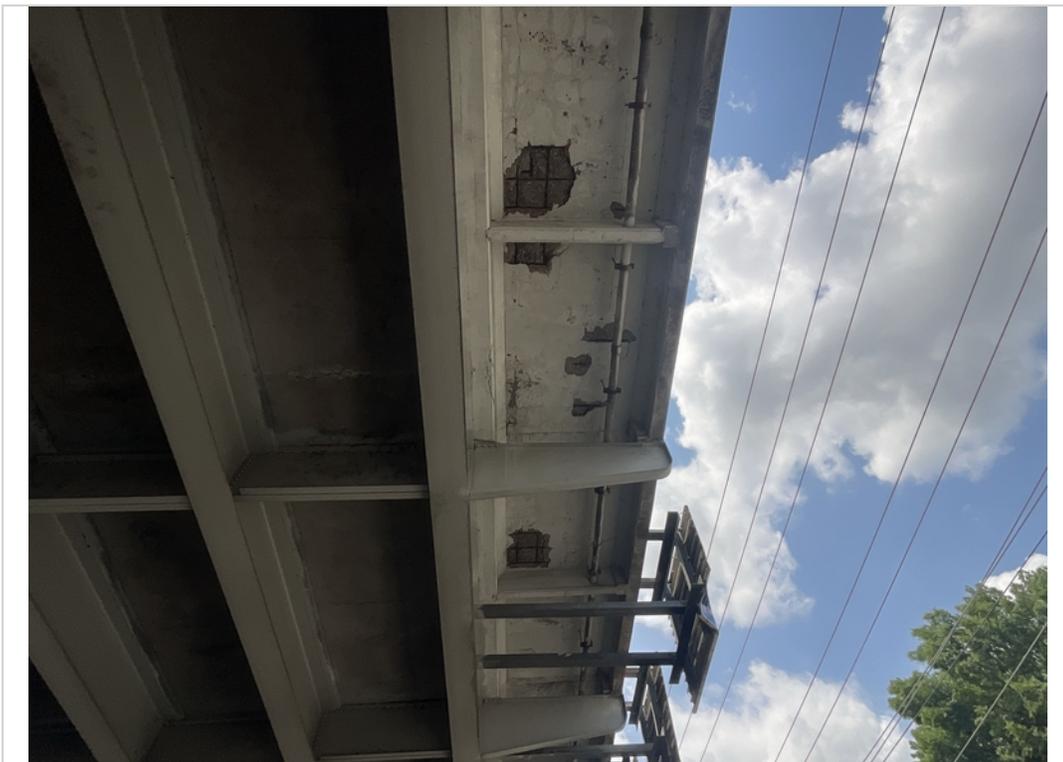
Span 13, Right Overhang - Typical Spalls to Steel, some with Section Loss

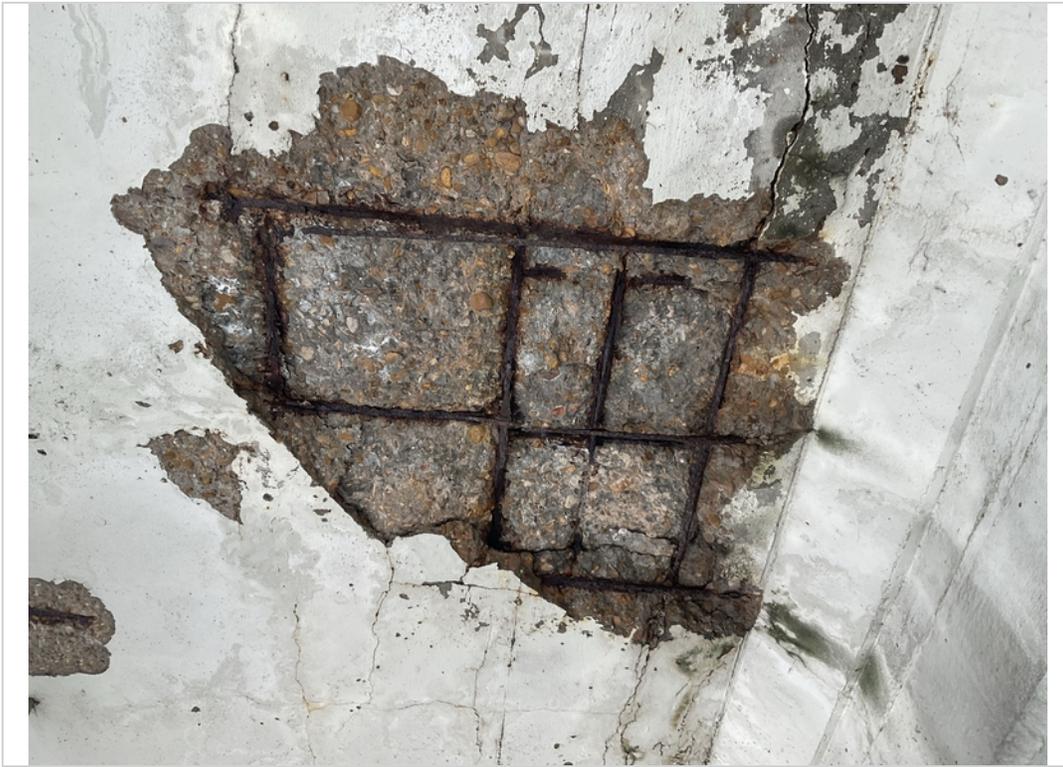
Span 15, Left Overhang - Spalls to steel

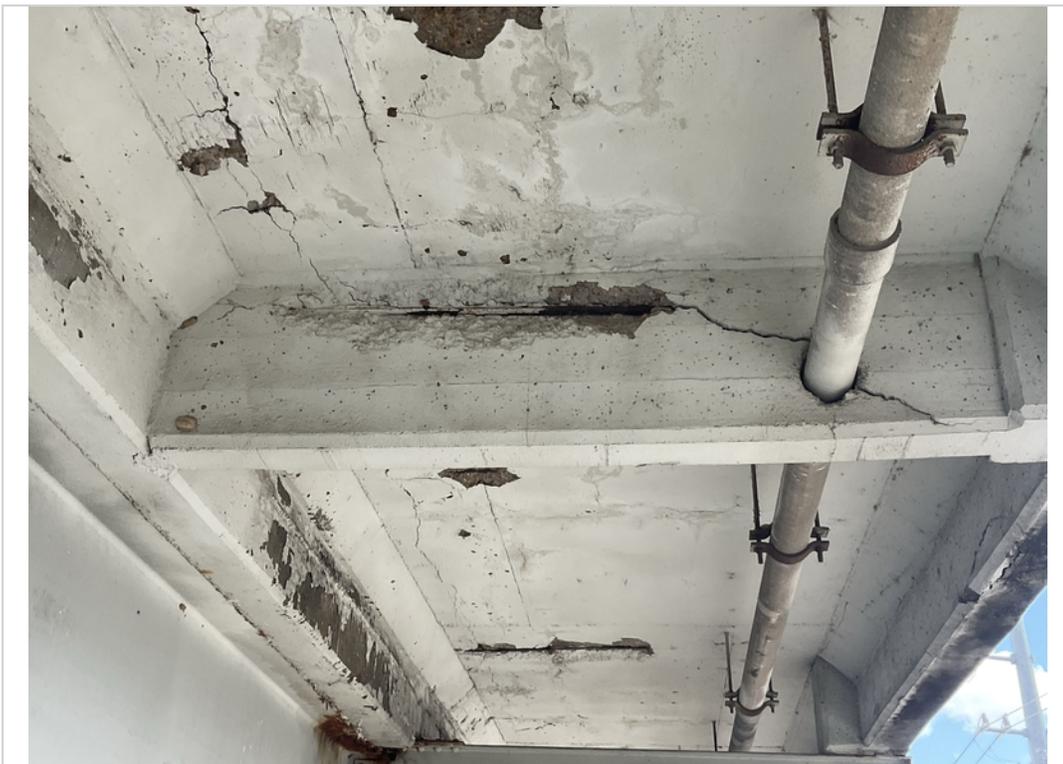
Span 19, Right Overhang - Spall to Steel with up to 100% Section Loss

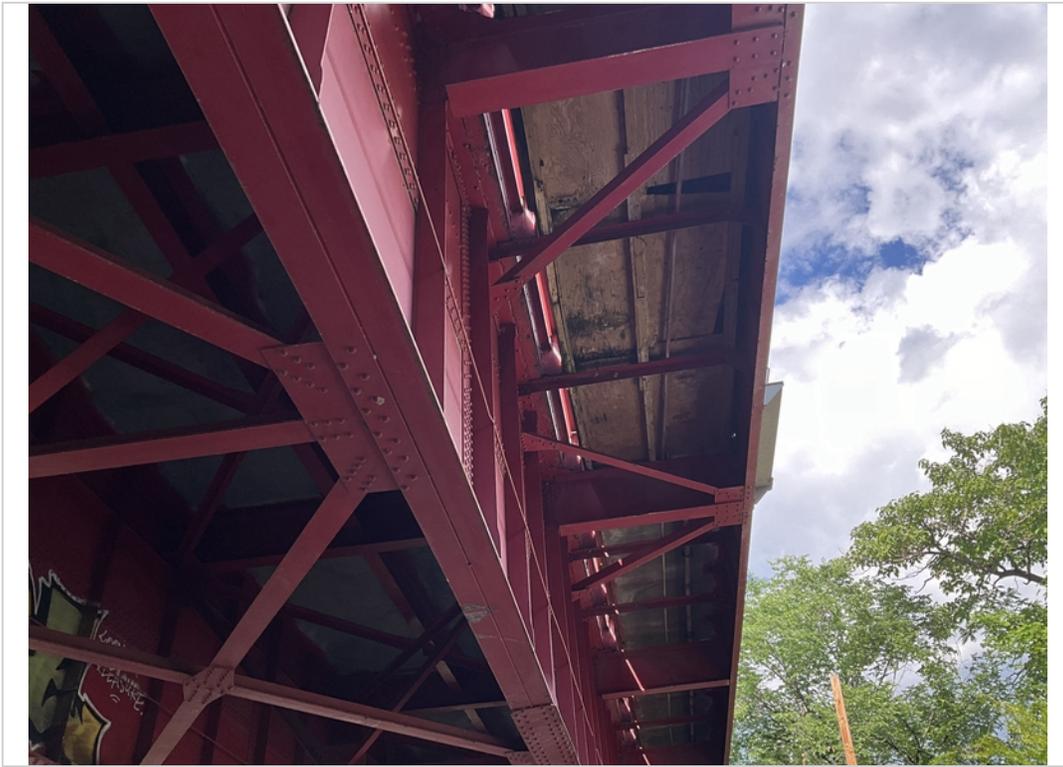
Span 19, Right Overhang - Concrete Diaphragm with Spalls to Steel and Cracking thru Full Section

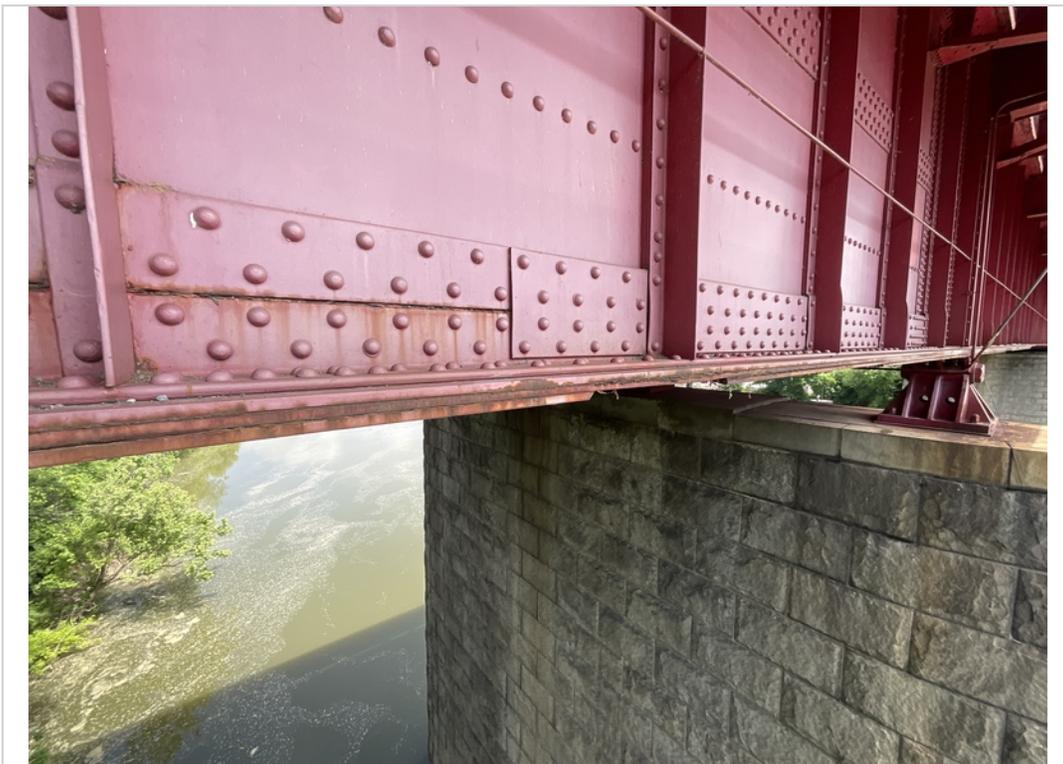
Span 1, Girder D over Gay Street - Minor Impact Damage to the Bottom Flange

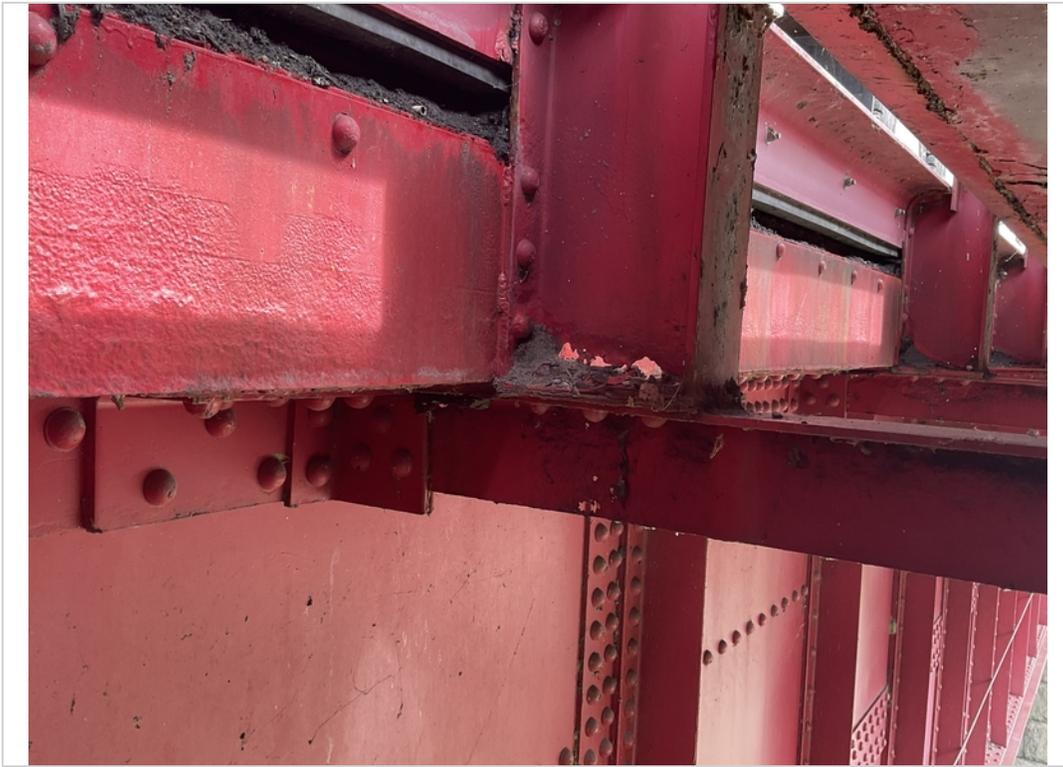
Span 1, Girder D near Pier 1 - Bottom Flange Pack Rust

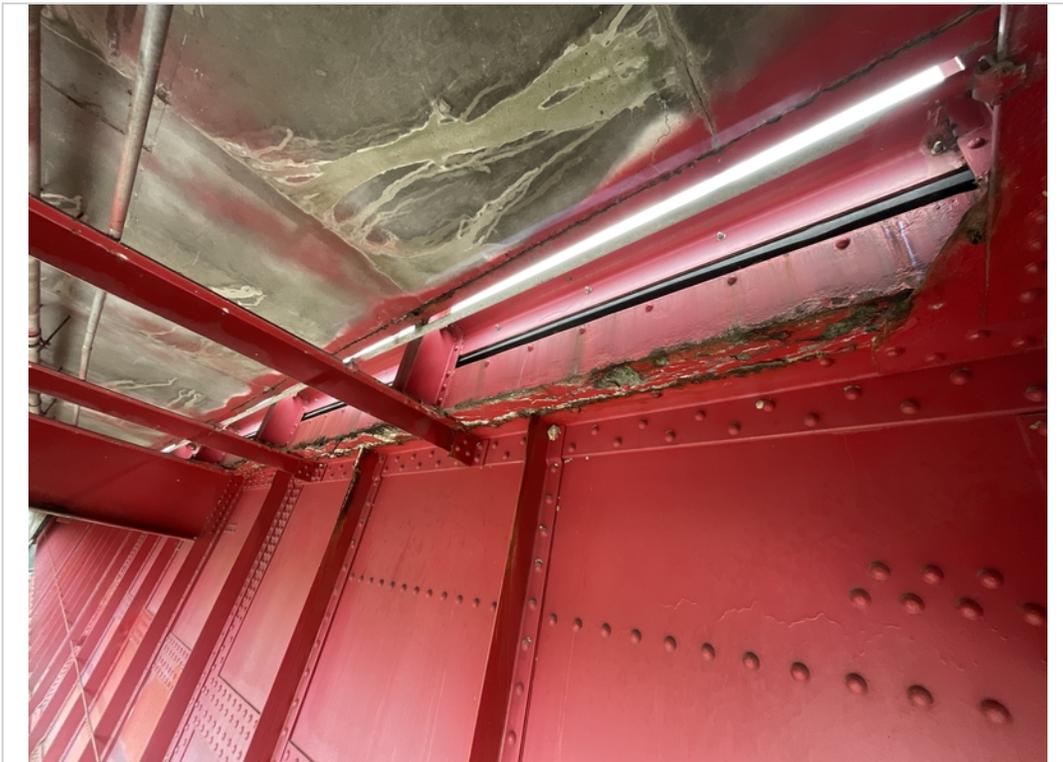
Span 1, Right Overhang at Panel 7 - Holed Through Section Loss to Rub-rail Post and Strut

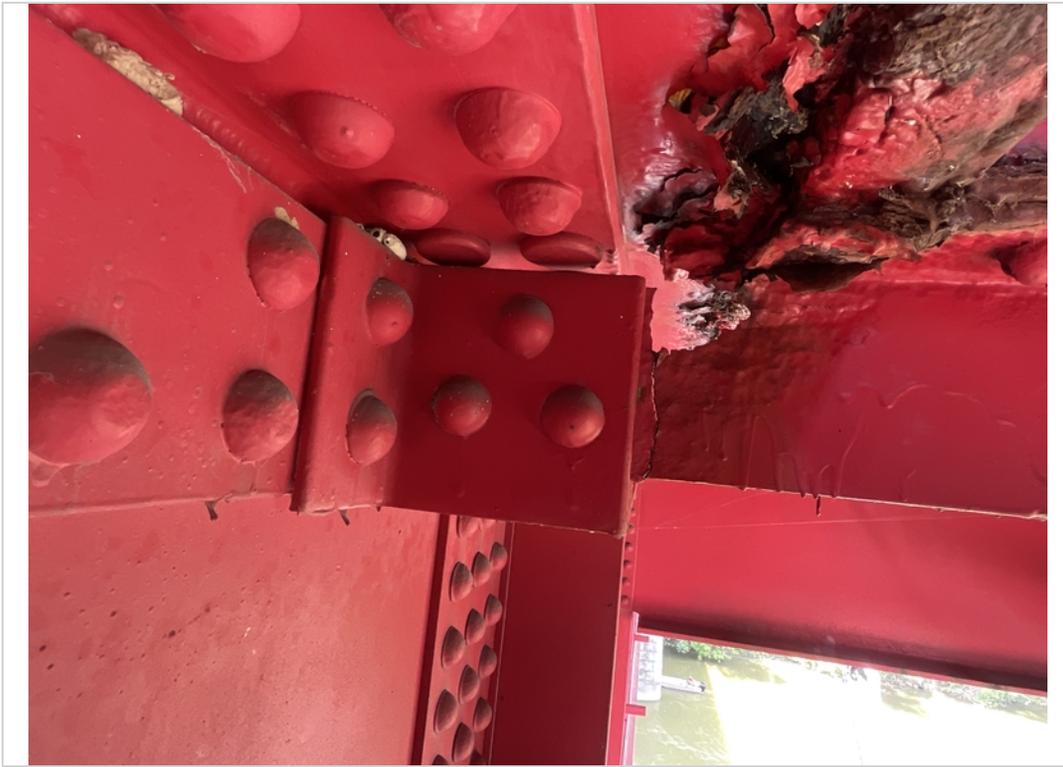
Span 2, Right Overhang in Panel 4 - Girder D Top Flange. Moderate corrosion for full length

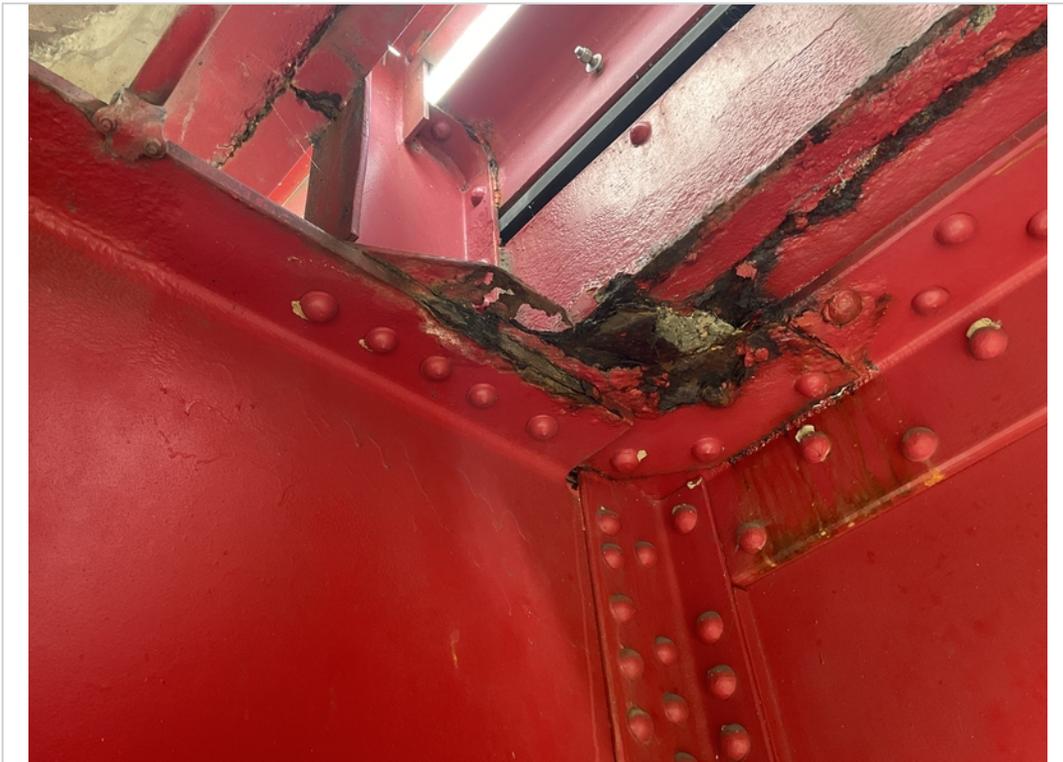
Span 2, Left Overhang in Panel 11 - 100% Section Loss and Crack in Strut Connection to Girder A

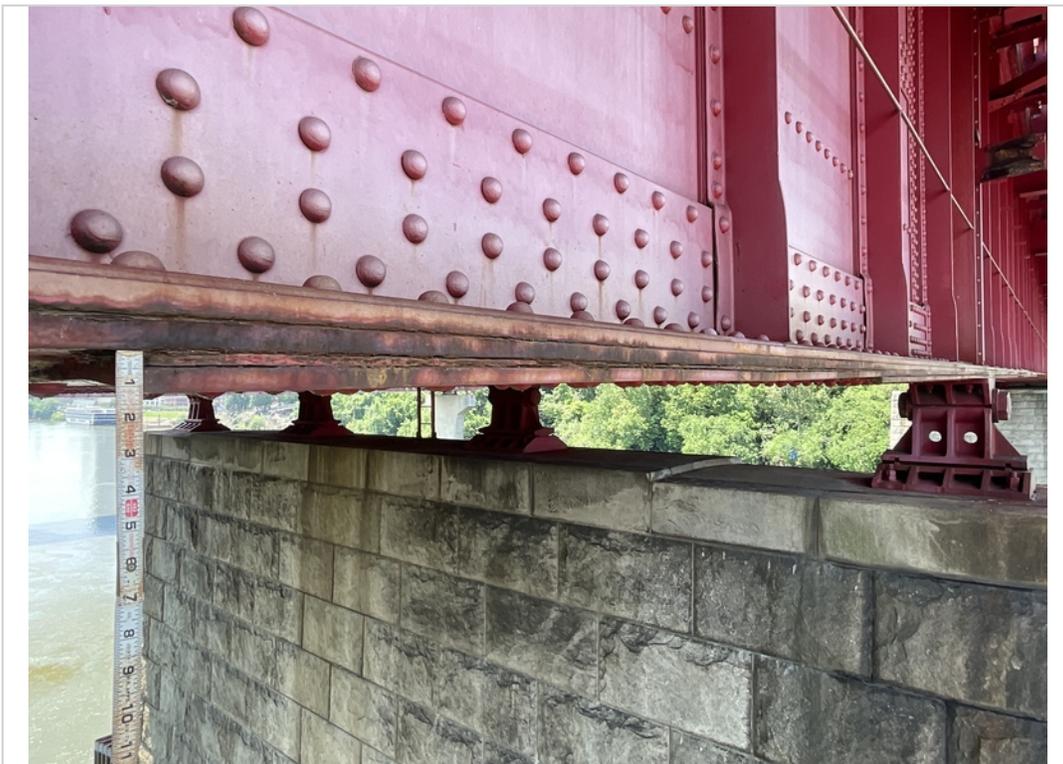
Span 2, Left Overhang in Panel 14 - 100% Section Loss of Strut Connection to Girder A

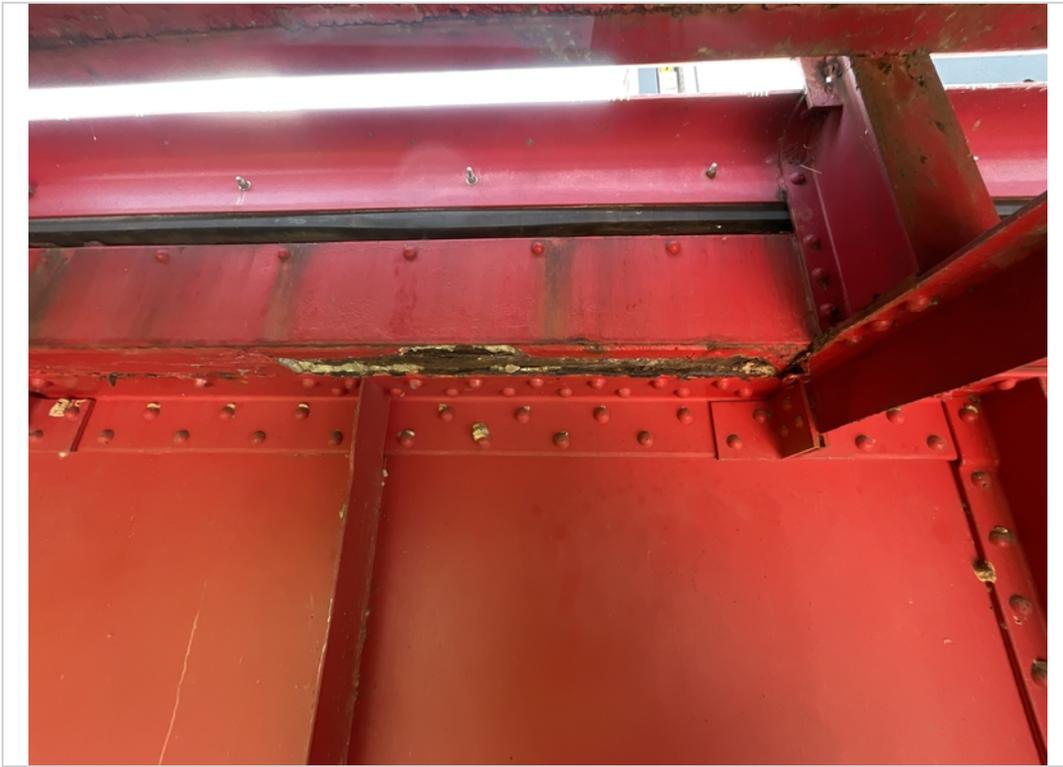
Span 3, Girder A Bottom Flange Below Panel 1 - Up to 1/2" thick Pack of Rust

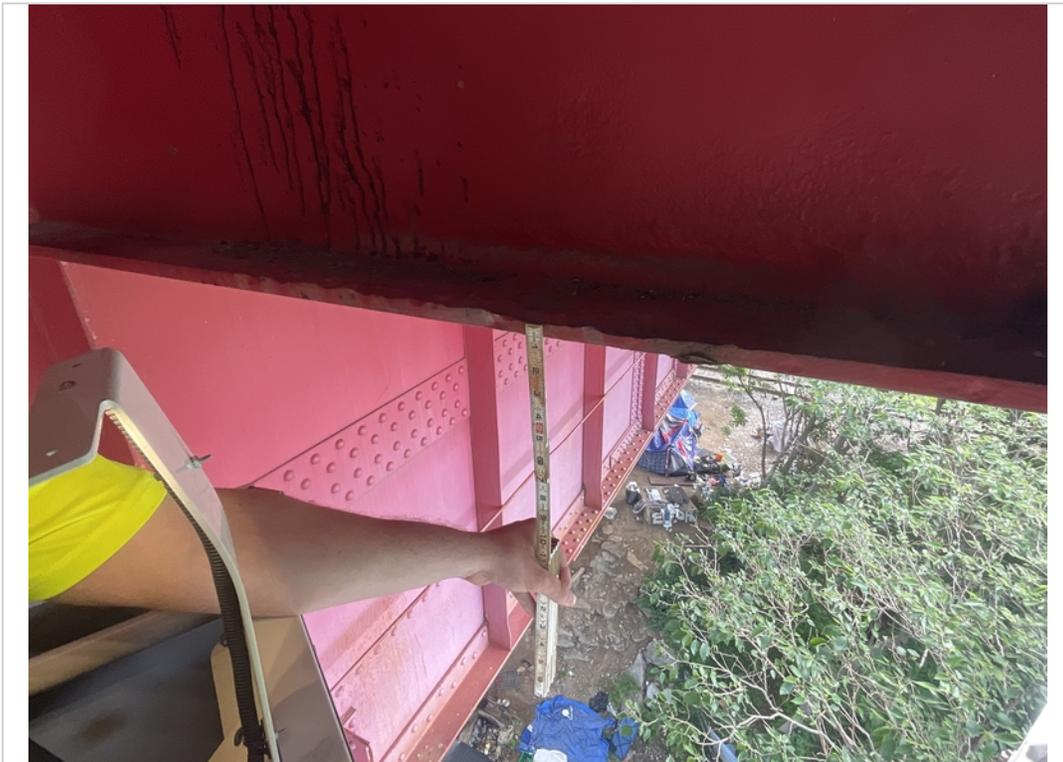
Span 3, Girder A Top Flange in Panel 3 - 4 LF of Heavy Corrosion / Exfoliation with up to 1/8" Section Loss

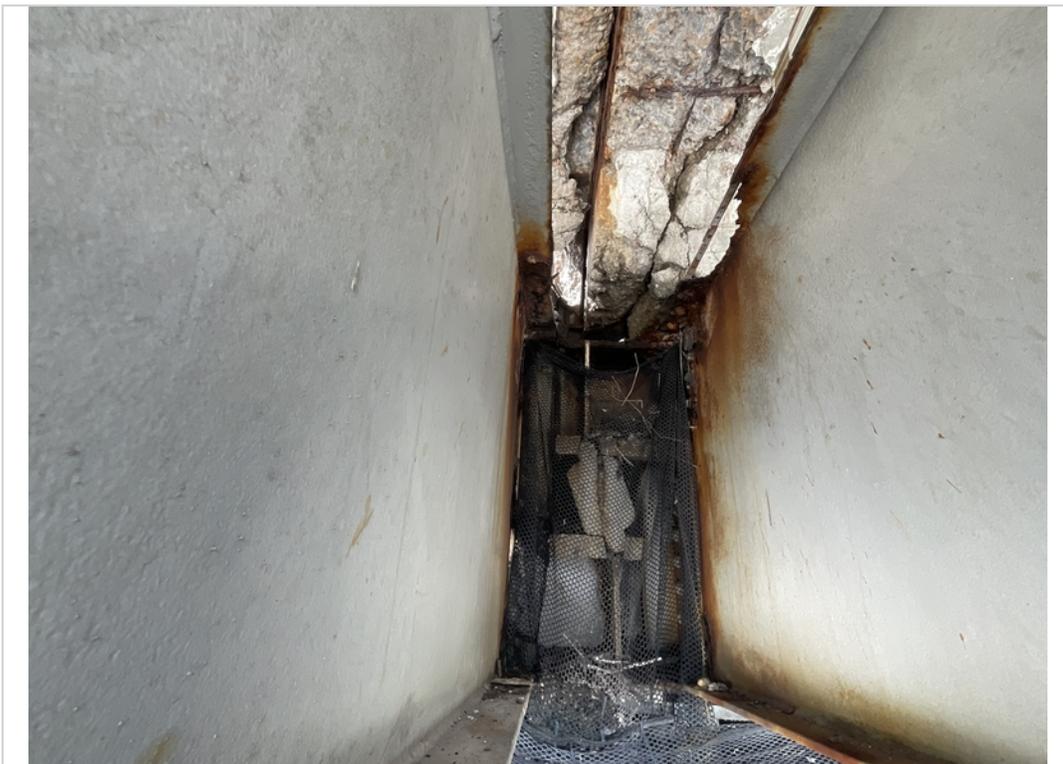
Span 3, Right side Overhang Bracket Tie-Plate for Panel 5/6. 100% Section Loss 9" L x 3" W

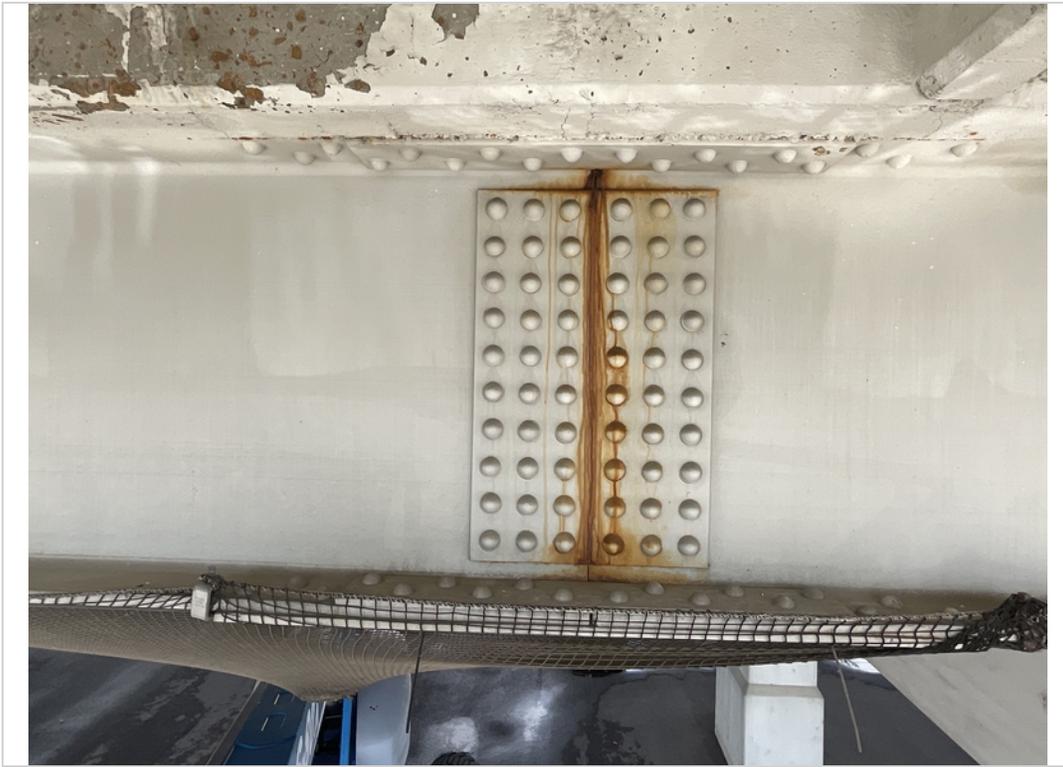
Span 17 - Damaged and Torn Netting

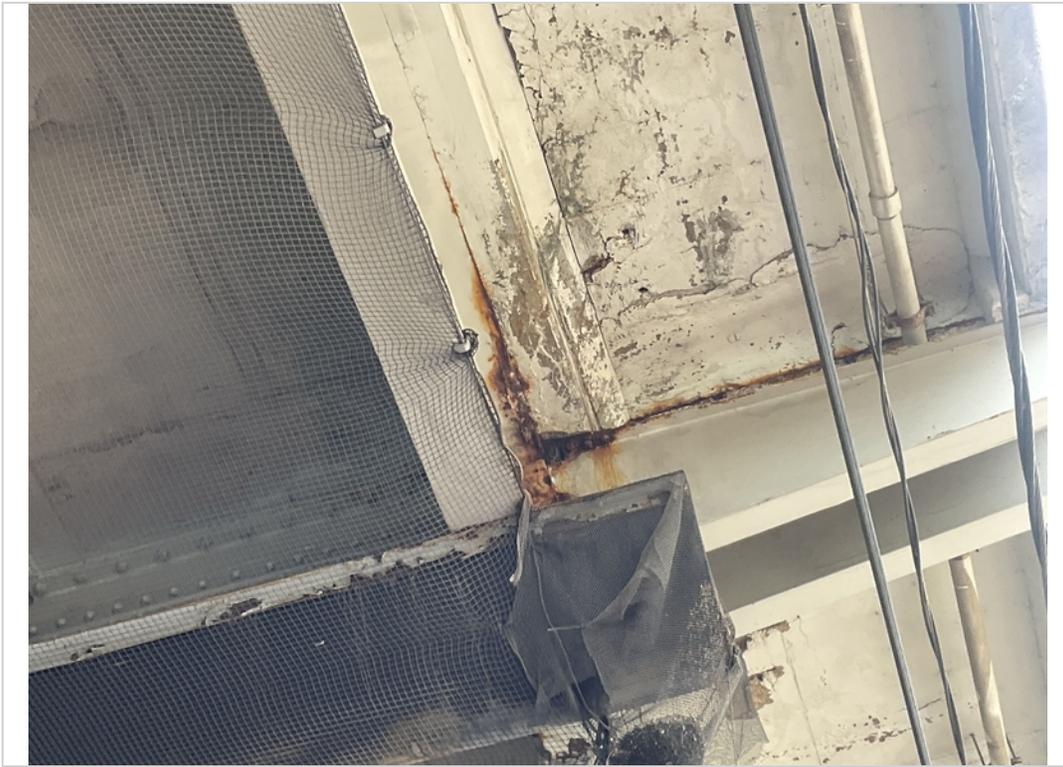
Typical Leakage with Efflorescence and Rust Stain at Top Flange of Beam in the Overhang (Showing Span 18 Right Side Beam H)

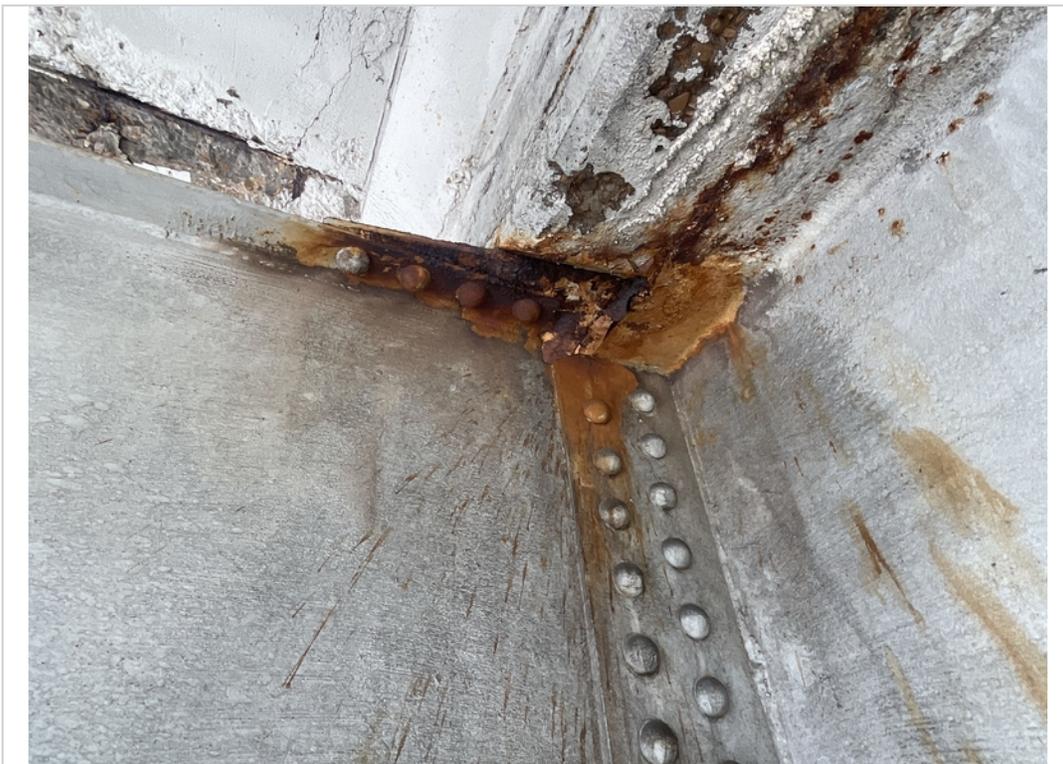
Severe Corrosion at the Steel Overhang Brackets and Tie Plates Under the Joint in Span 11 Right Side

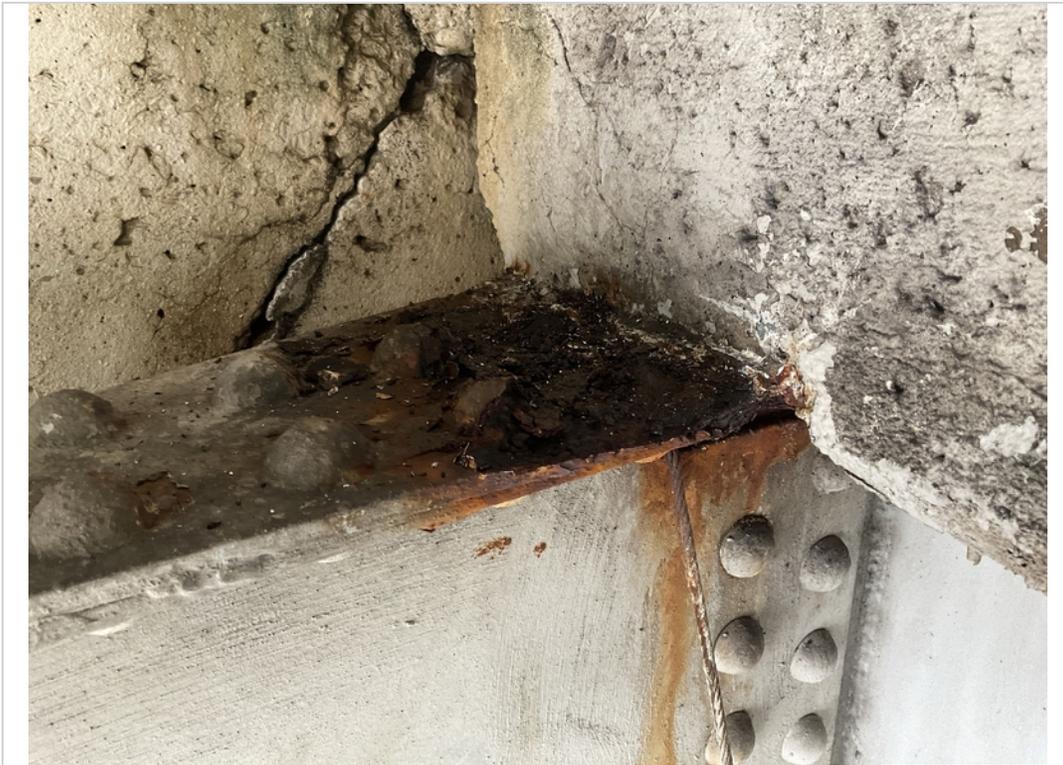
Typical Corrosion of the Riveted Connection from Steel Overhang Brackets to Top Flange of Beam (Showing Span 19 Right Side)
