JAMES ROBERTSON PKWY. Crossing CUMBERLAND RIVER

Inspection Date(s): 05/15/2025 - 05/15/2025

IDENTIFICATION	
(1) State Names	47 - Tennessee
(8) Structure Number	19SR0060015
(5) Inventory Route	1
(2) Highway Agency District	Region 3
(3) County Code	19 - Davidson

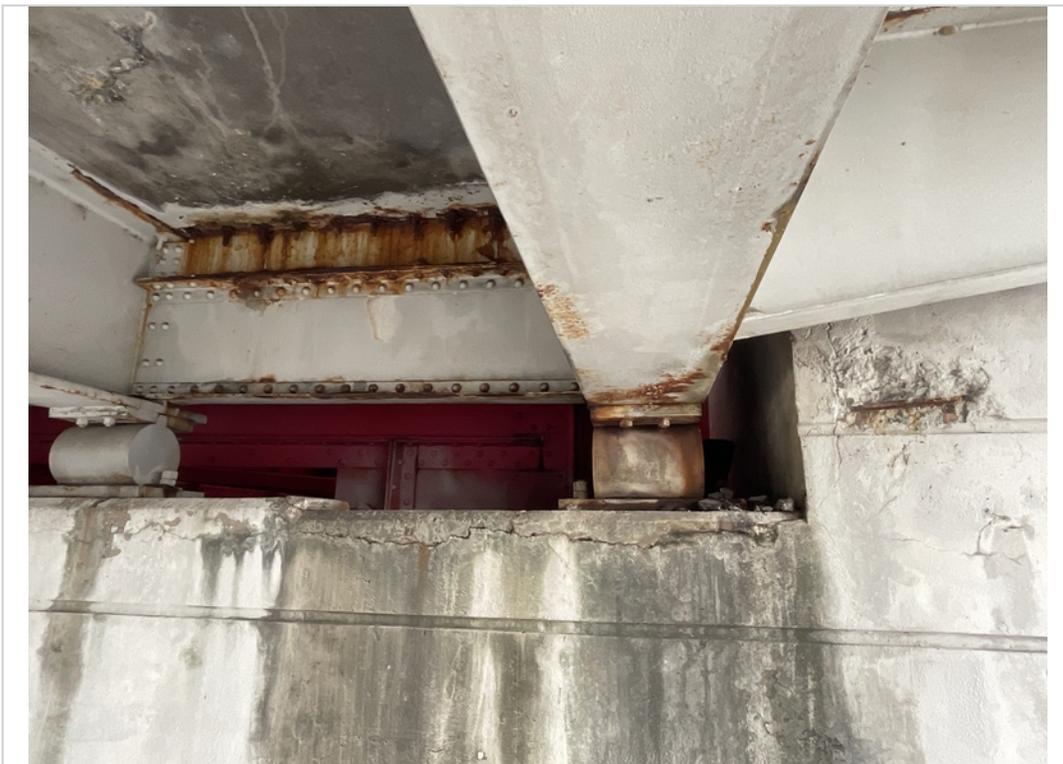
Typical Rivets to Steel Overhang Bracket have Severe Corrosion and "Rosebudding" at Rivets (Cleaned) Connection to Steel Beam, Showing Beam A at Abutment 2

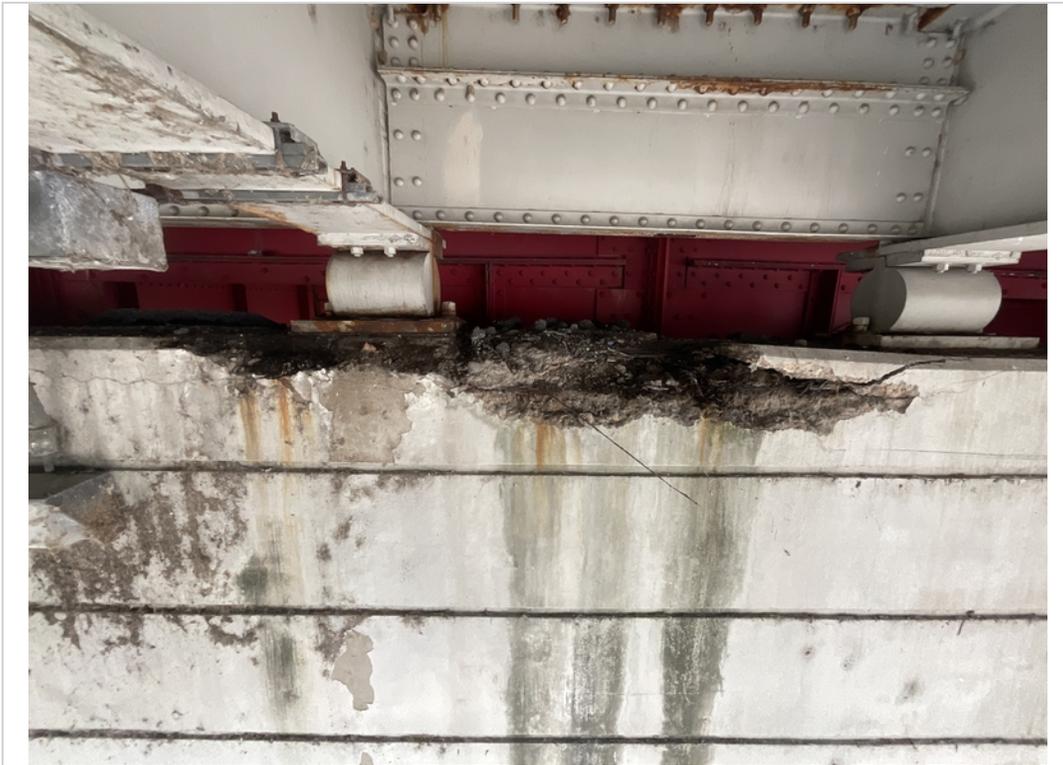
Pier 3 from Span 4, Looking Back under Girders A and B - Wide Horizontal Crack, Spall to Steel and Corrosion on End Diaphragm and Girder A Bearing

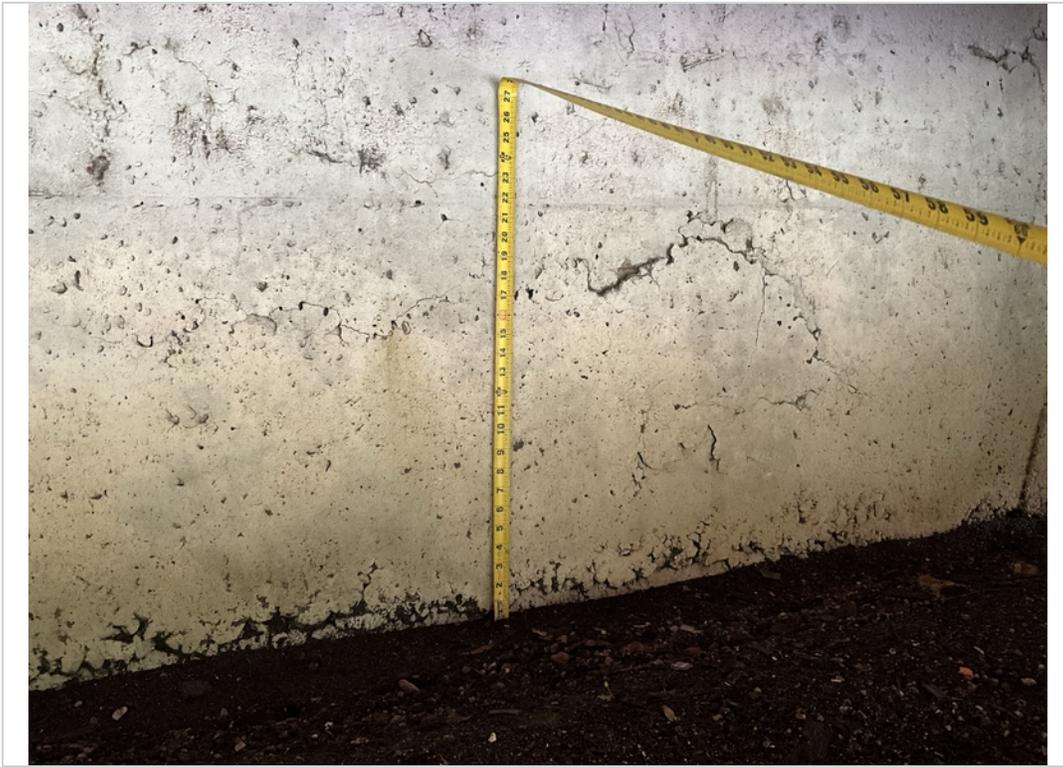
Abutment 1 Right Side - Typical Cracks

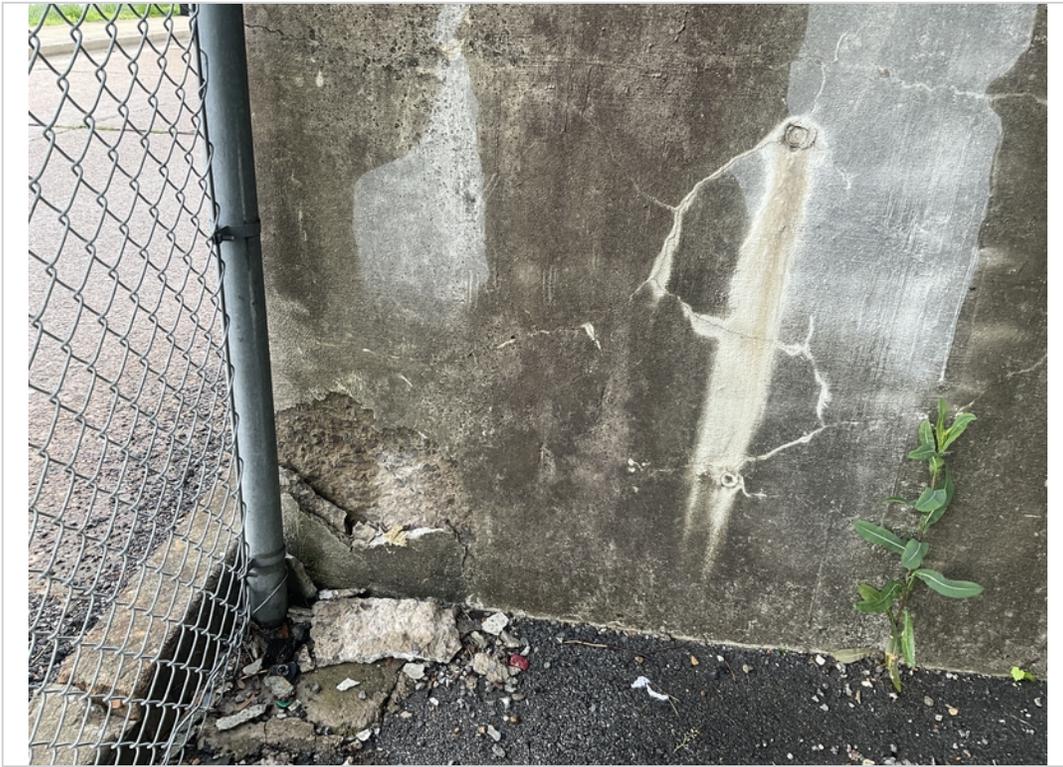
Abutment 2 Backwall - Impending Spall and Spall to Steel on either side of Girder C

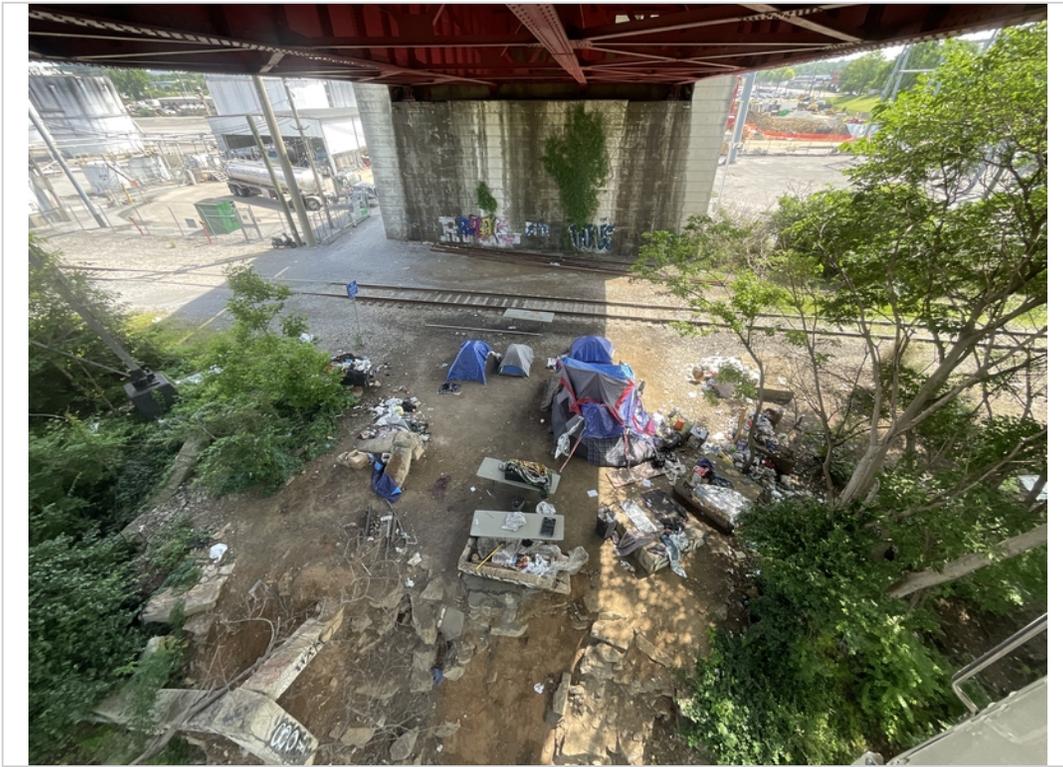
There are six (6) total navigation lights in Span 2. It was noted that 3 of the 6 were partially illuminated (1 of 2 lights not illuminating).

Span 2 Right Center Navigation Light. Bottom Light is not Illuminated. Similar condition to Center Light  
Left for Top and Top Light at Pier 1 Left

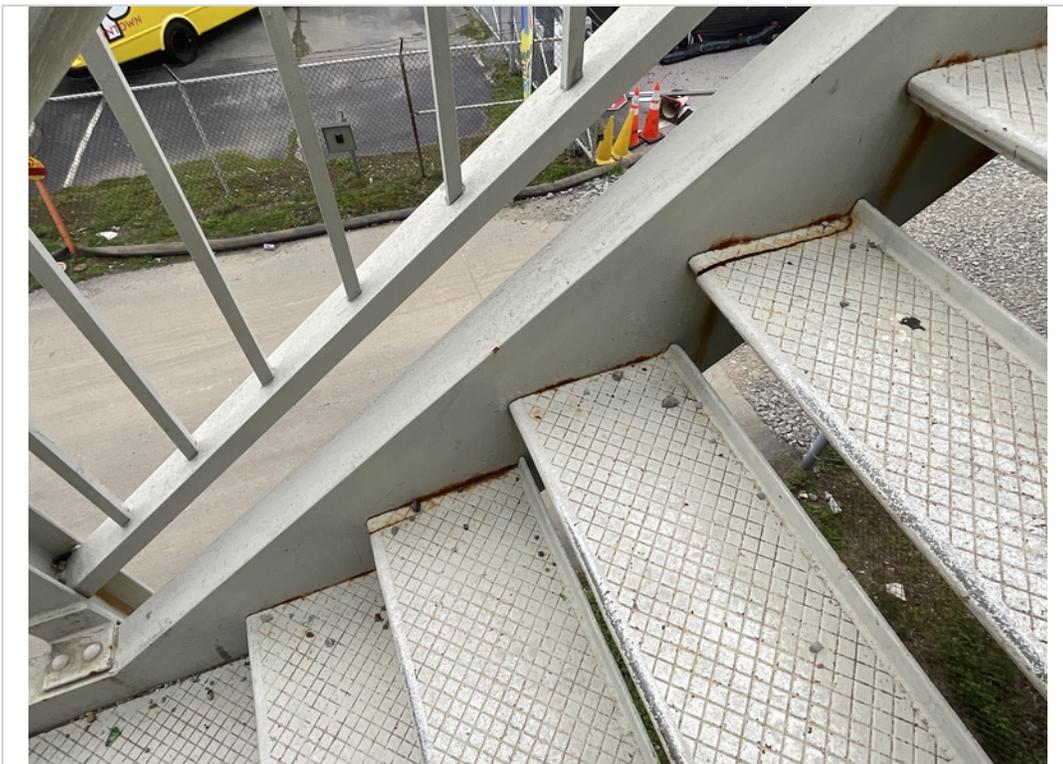
Right Side Tower of Overhead Traffic Light Structure - Unsecured Cover Plate Exposing Electrical Wires

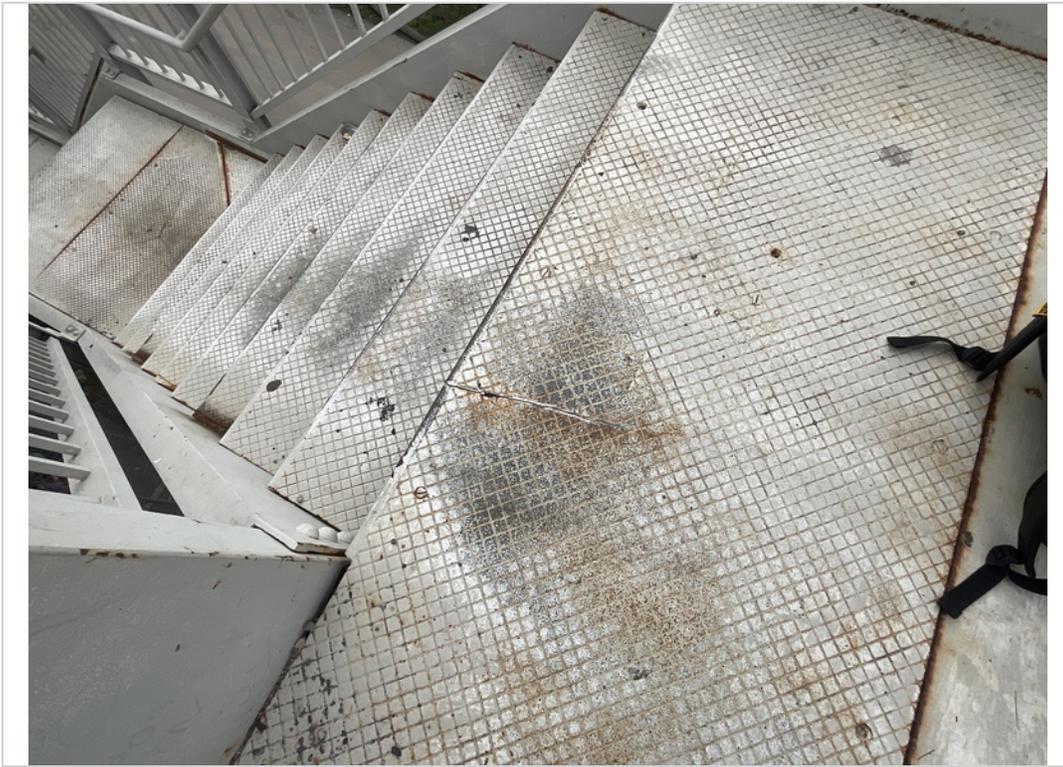
Steel Staircase at Right side of Span 14 - Cracks in steel steps between Landings 2 and 3

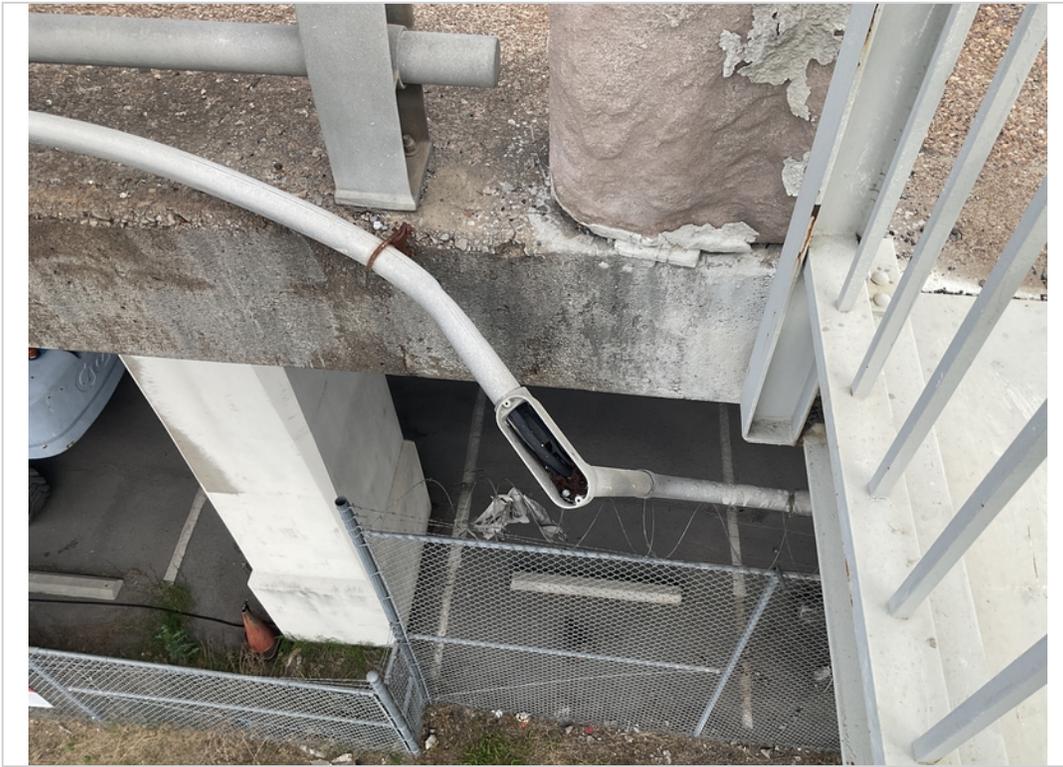
Anchor Bolt for Staircase Column - Moderate to Heavy Corrosion. Similar to opposite side Anchor Bolt

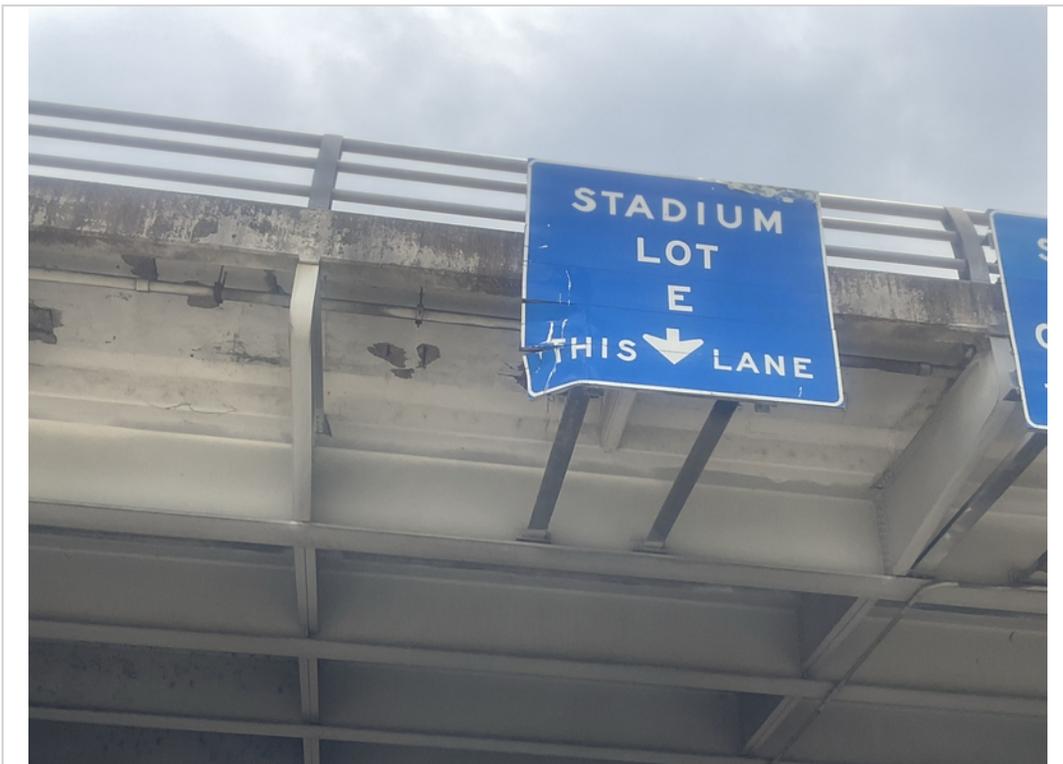
Span 14, Right Fascia adjacent to Staircase - Missing Cover for Electrical Junction Box
