SOILS AND GEOLOGY REPORT ADDENDUM
US-441/STATE ROUTE 71 FROM
US-411 (SR 35/ SR358) TO MACON LANE
SEVIER COUNTY
PROJECT NO. 78008-1244-14
PIN NO. 104959.01

Executive Summary

Introduction

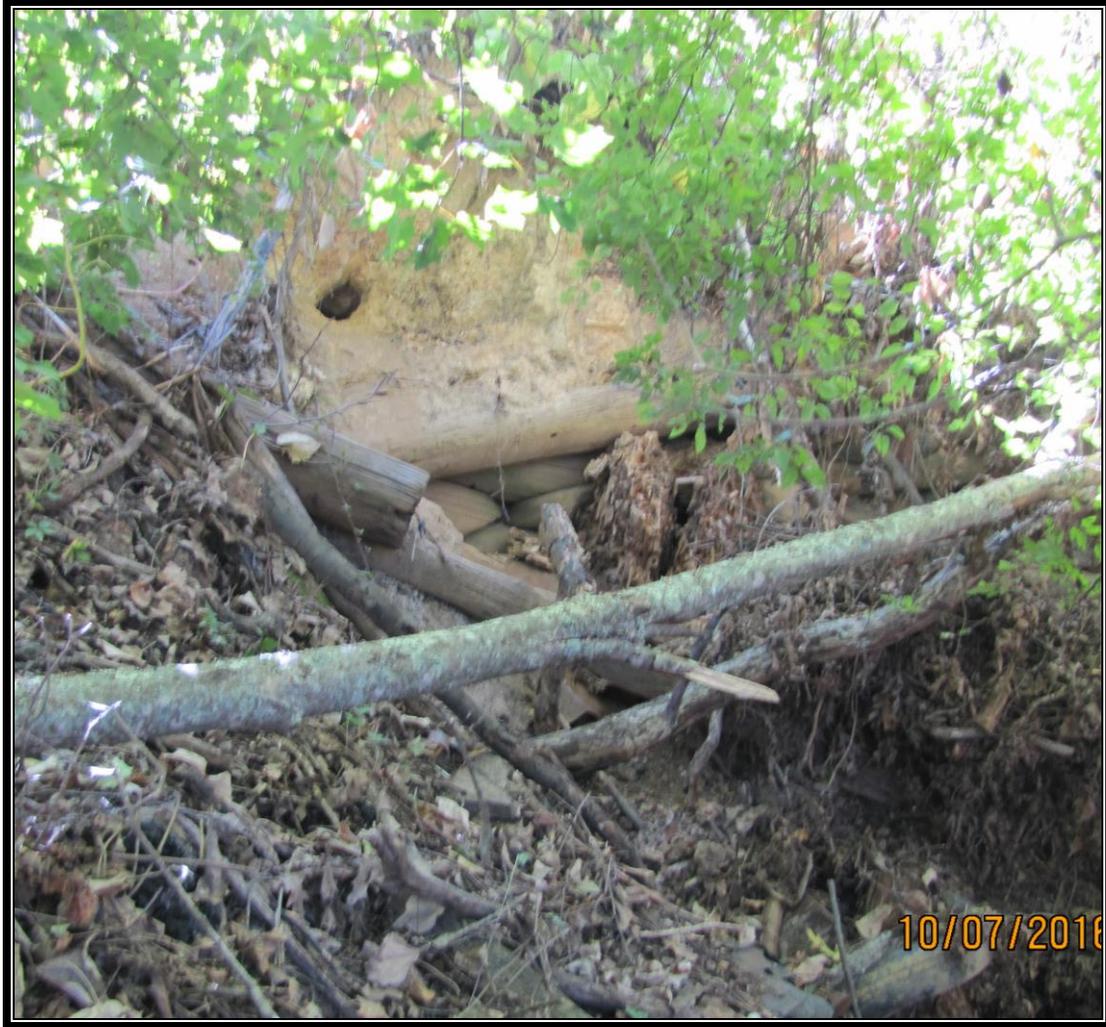
At Site 2, a slope/retaining feature (refer to Figure 3) made of old wooden utility poles, tires and concrete is located at the outlet end of the cross drain pipe from approximately Station 41+75 to Station 42+25 (refer to Figure 1) right of centerline of Valerie Way. It is recommended that all of this poor material (wood, concrete and tires) be removed and replaced with suitable borrow material.

Figure 3 Site 2 - Poor fill material to be removed.
