**STATE OF TENNESSEE
DEPARTMENT OF TRANSPORTATION
ENVIRONMENTAL DIVISION
SUITE 900 - JAMES K. POLK BUILDING
505 DEADERICK STREET
NASHVILLE, TENNESSEE 37243-0334**

MEMORANDUM

Subject: ENVIRONMENTAL BOUNDARIES REPORT FOR:
Davidson County; SR-112, From SR-12 to SR-155
P.E. 19046-1214-14 PIN 103764.00

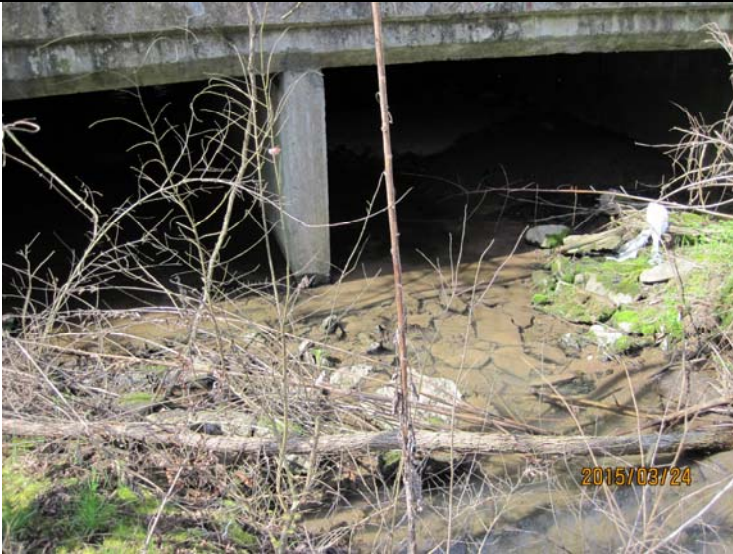
Photo 1: STR-3

Upstream of SR-112,
looking downstream
towards the entrance to
the box culvert.

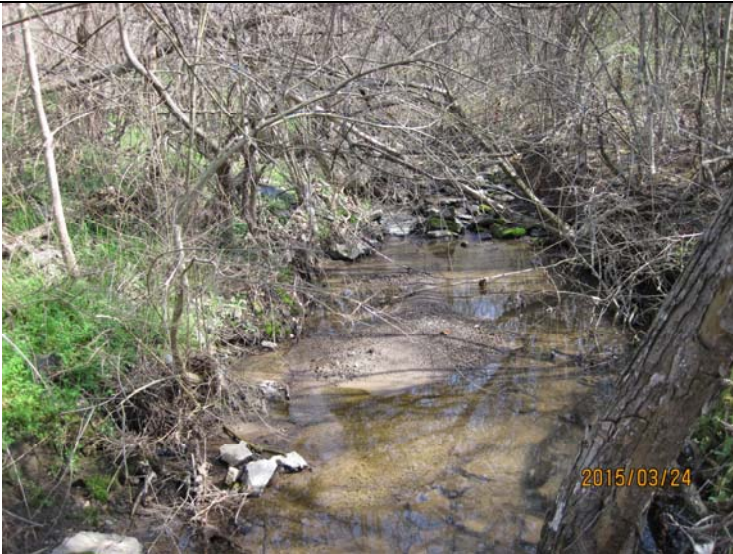
Photo 2: STR-3

Upstream of SR-112,
looking upstream from
entrance to box culvert.

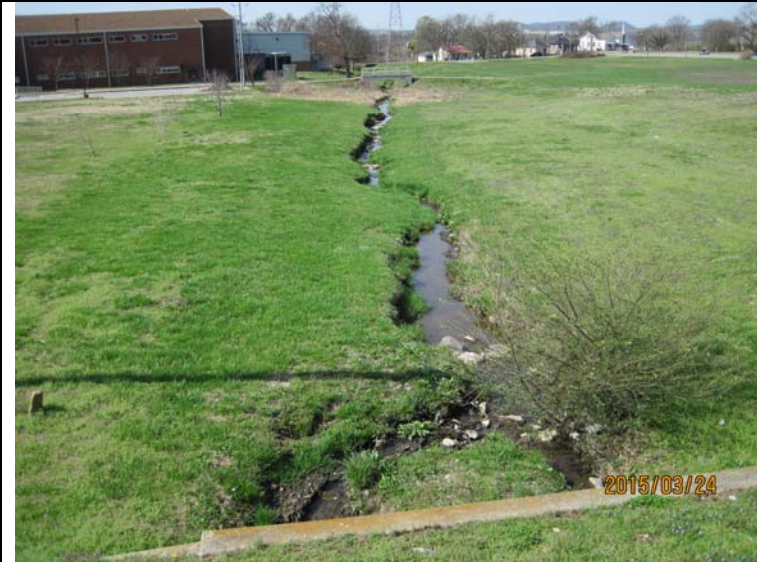
Photo 3: STR-3

Downstream of SR-112,
looking downstream
from box culvert outlet.

STR-3 will be unaffected
by the project.
Approx. Station #
99+45

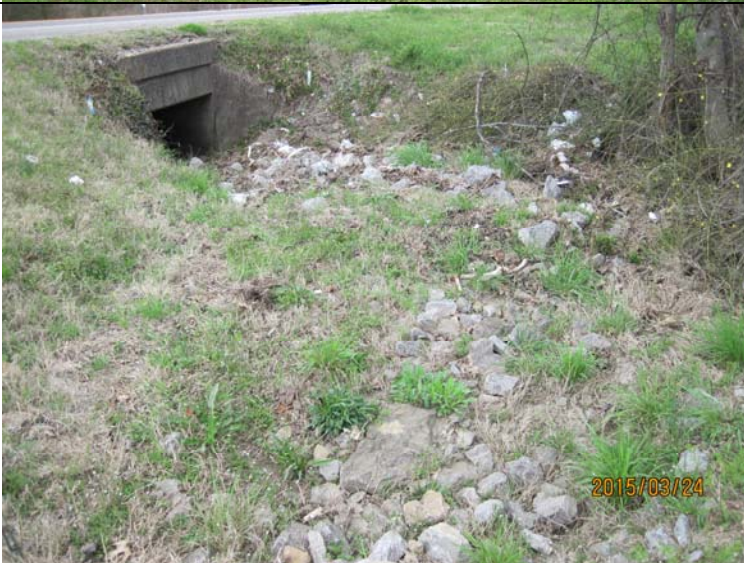
Photo 32:

WWC-2/EPH STR-2
View looking down-
channel at inlet to box
culvert under SR-112.

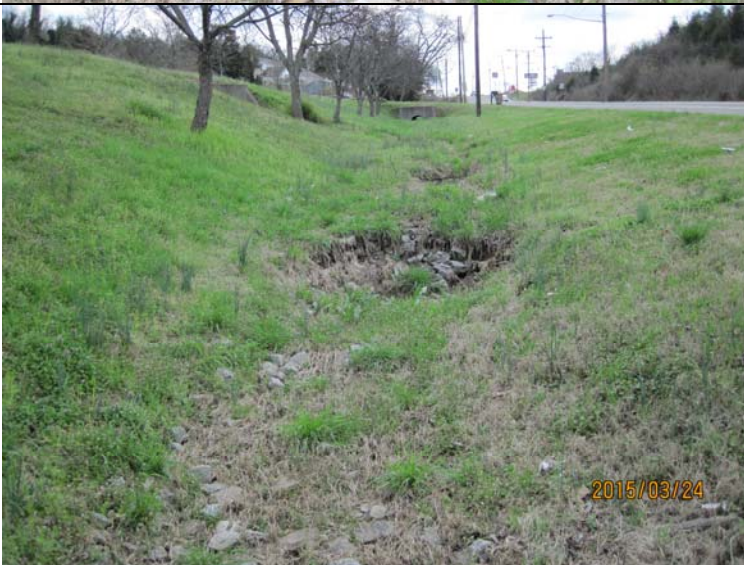
Photo 33:

WWC-2/EPH STR-2
View looking up-channel
from box culvert under
SR-112.

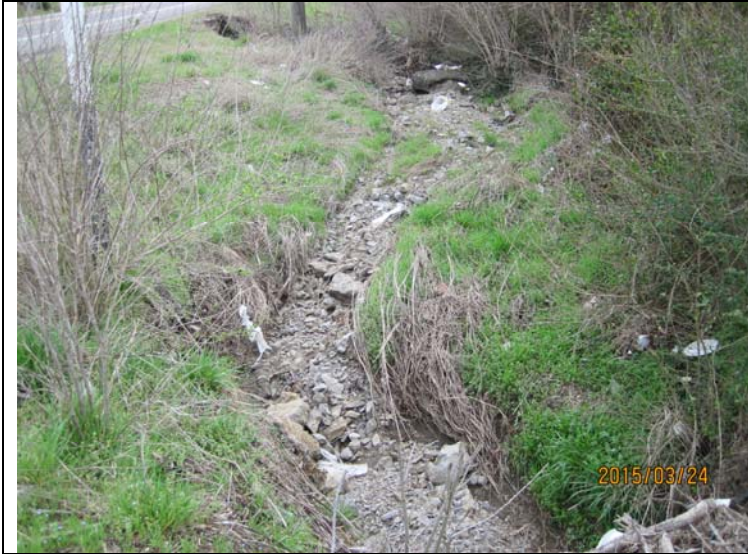
Photo 30:

WWC-3/EPH STR-3
View looking up channel
towards junction with
WWC-2/EPH STR-2.

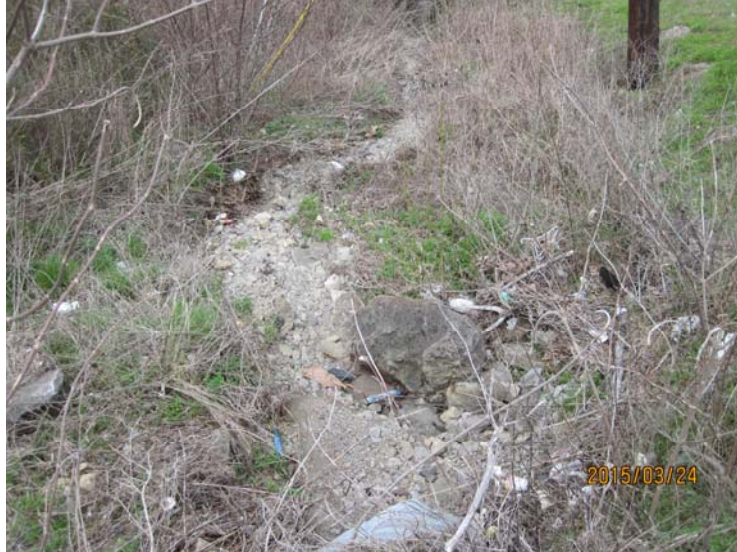
Photo 31:

WWC-3/EPH STR-3
View down-channel from
Driveway Crossing at
Station 122+25L

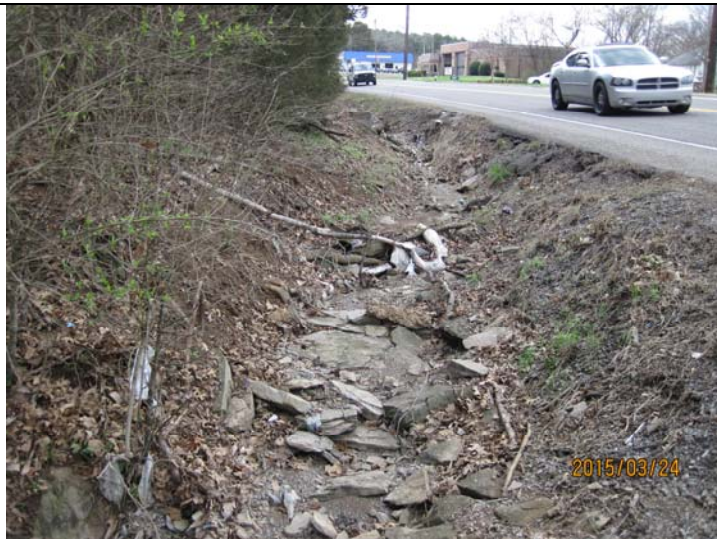
Photo 28:

WWC-1/EPH STR-1

View looking up-channel
at approximate Station #
130+30R

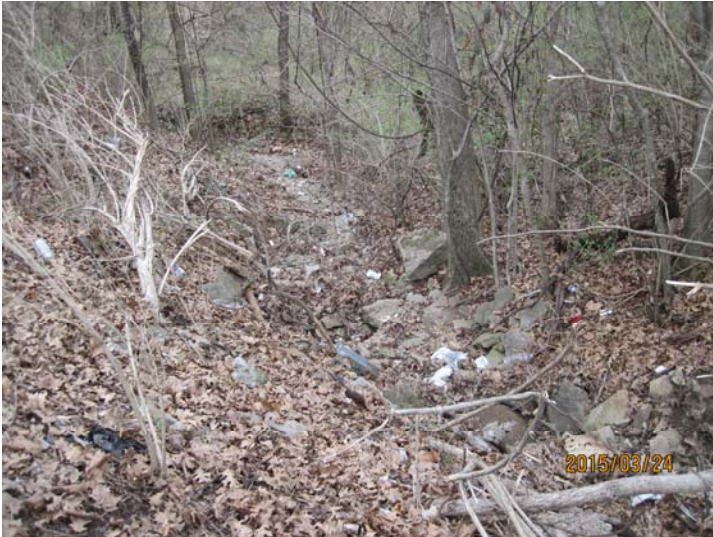
Photo 29:

WWC-1/EPH STR-1
View looking down
channel towards STR-1
(Whites Creek).

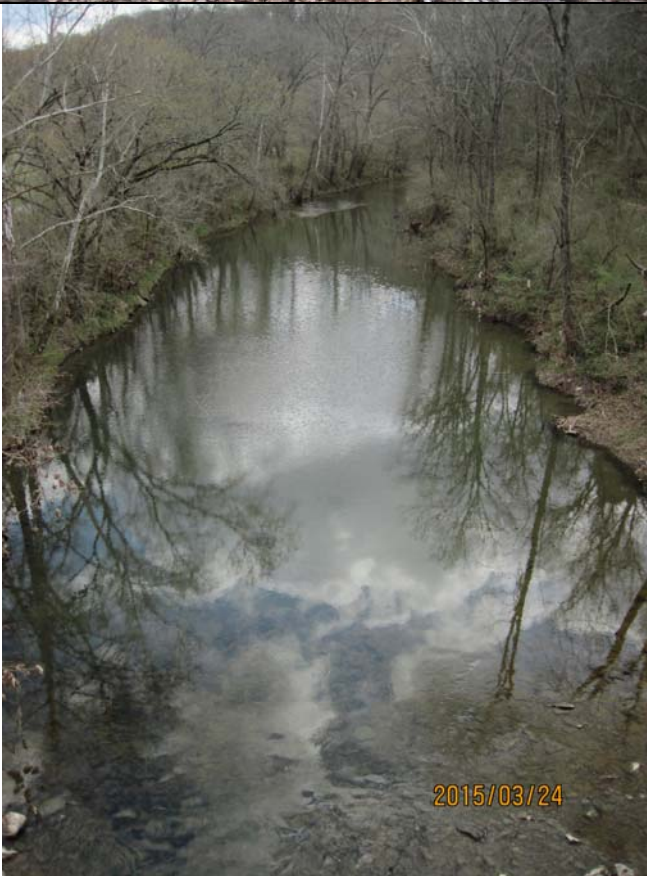
Photo 22:

STR-1 (Whites Creek)

View looking upstream
from the SR-112 bridge.

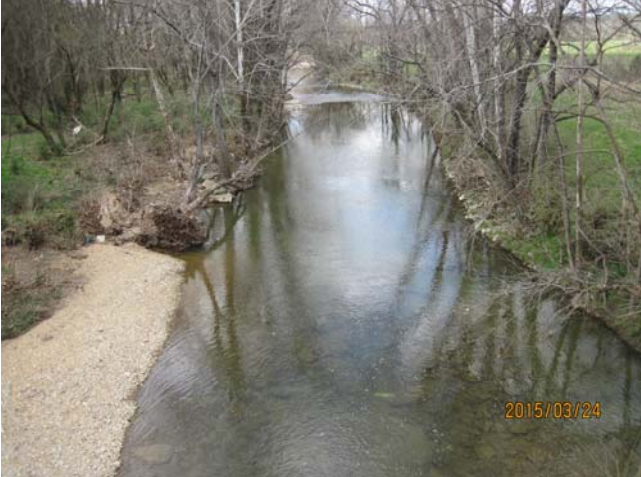
<p>Photo 23:</p> <p>STR-1 (Whites Creek)</p> <p>View looking downstream from the SR-112 bridge.</p> <p>Approx. Station # 132+50</p>

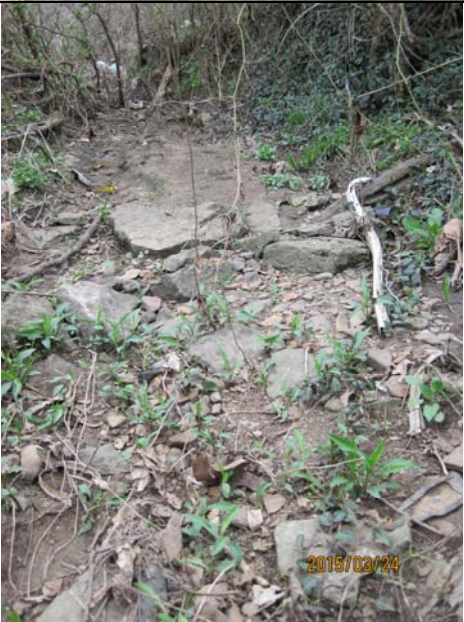
<p>Photo 36:</p> <p>WWC-4/EPH STR-4</p> <p>View looking up-channel, just up-channel from junction with Whites Creek.</p> <p>Approx. Station # 133+15R</p>

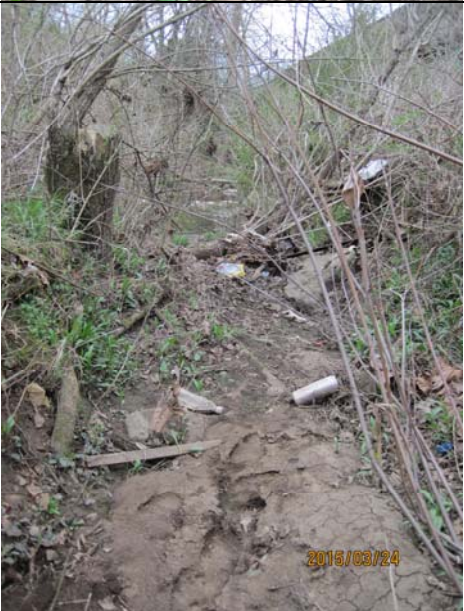
<p>Photo 37:</p> <p>WWC-4/EPH STR-4</p> <p>View looking down-channel towards Whites Creek.</p> <p>Approx. Station # 136+50R</p>

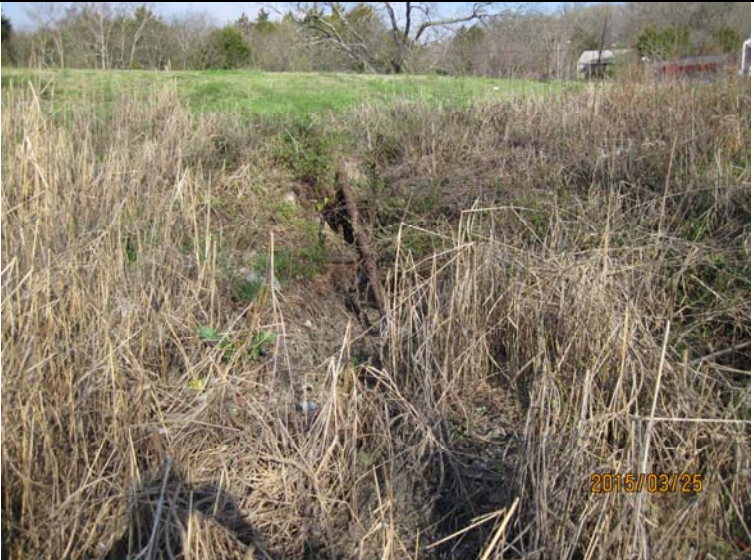
<p>Photo 40:</p> <p>WWC-5/EPH STR-5</p> <p>View down-gradient towards entrance to existing pipe under SR-112.</p> <p>Approx. Station # 179+90L</p>

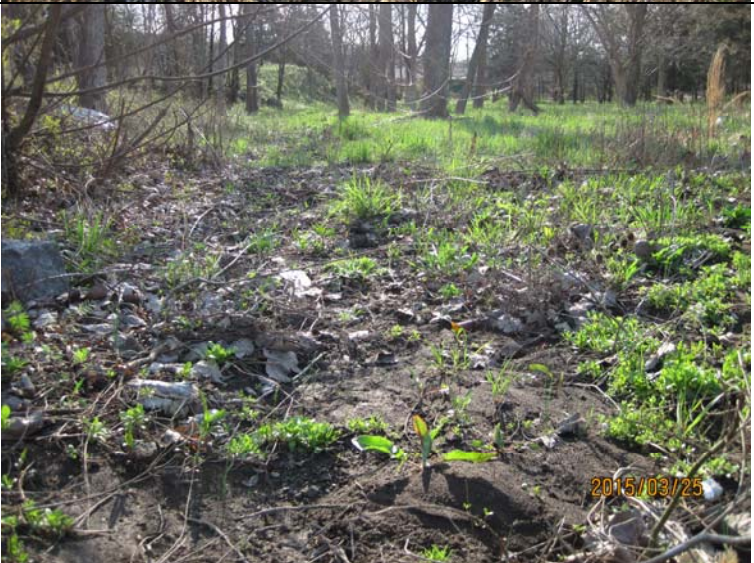
<p>Photo 41:</p> <p>WWC-5/EPH STR-5</p> <p>View down-gradient, from outlet of existing pipe under SR-112.</p> <p>Approx. Station # 179+90R</p>

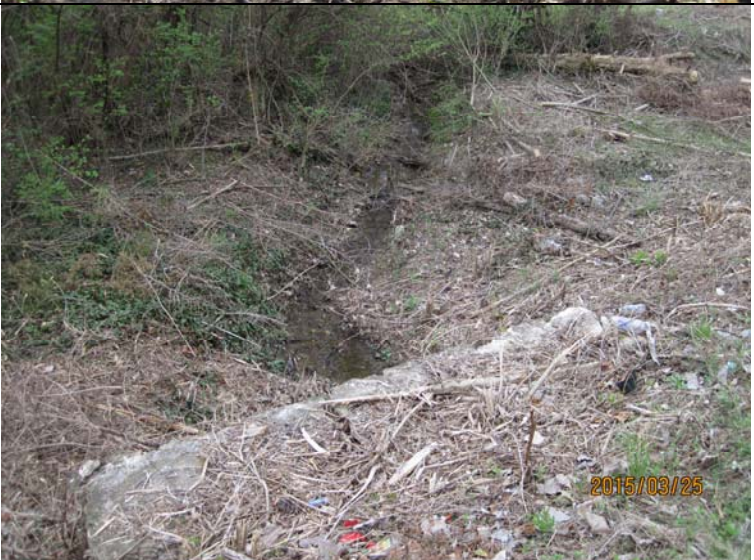
<p>Photo 48:</p> <p>STR-4</p> <p>View looking downstream from outlet of existing pipe underneath Fairmeade Drive.</p> <p>Approx. Station # 193+00R</p>

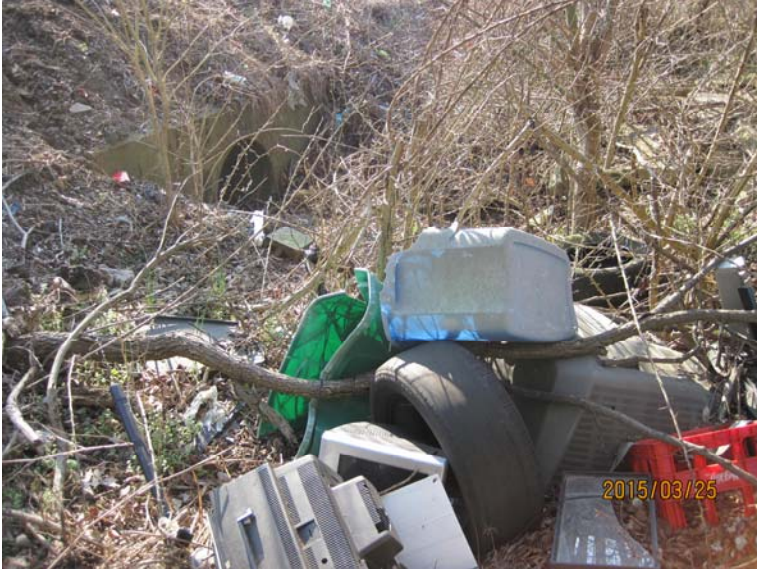
Photo 42

WWC-6/EPH STR-6

View down-gradient
towards inlet of existing
pipe under SR-112.

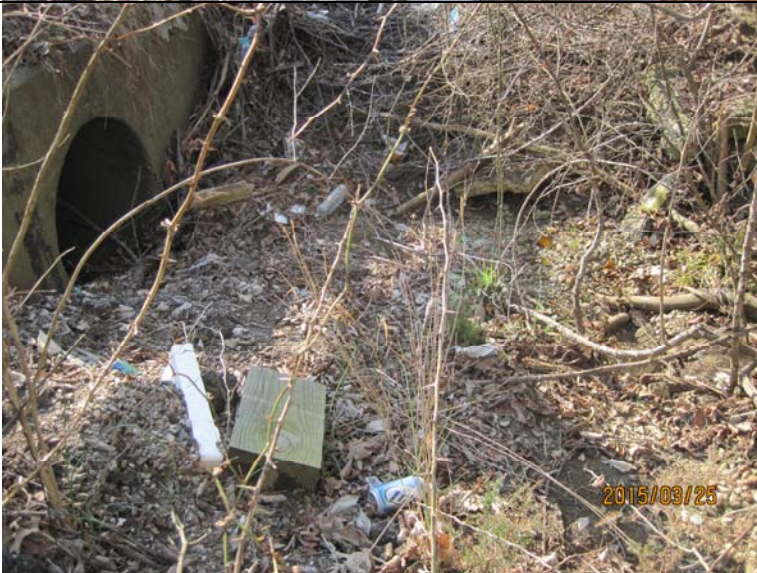
Photo 43

WWC-6/EPH STR-6

View at inlet of existing
pipe underneath SR-112

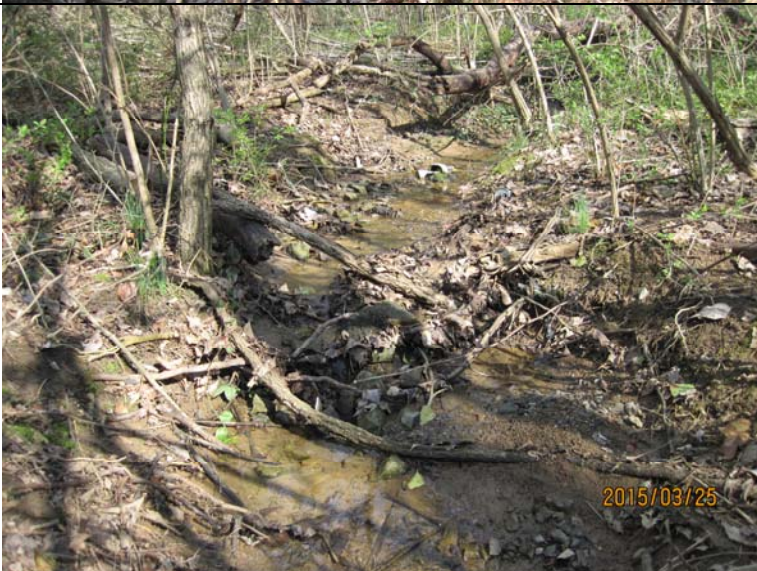
Photo 44

STR-4

View Upstream at
Approximate Station #
195+00R

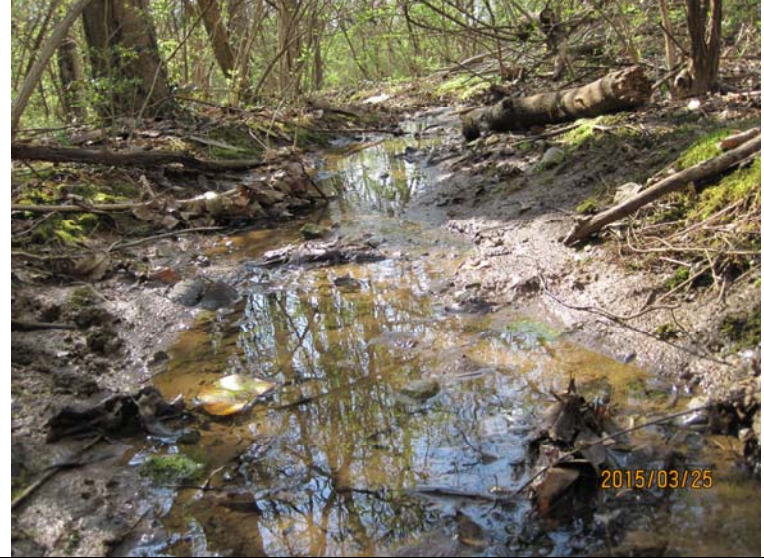
<p>Photo 45</p> <p>STR-4</p> <p>View Downstream at Approximate Station # 195+00</p>

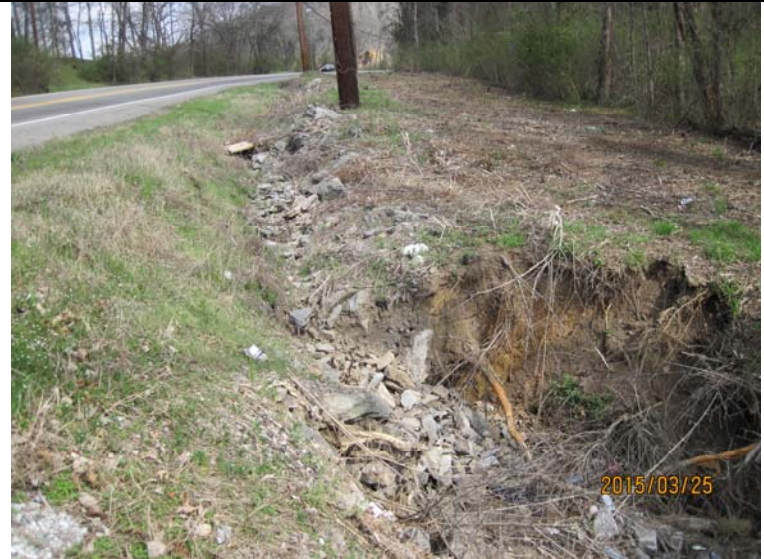
<p>Photo 46</p> <p>WWC-7/EPH STR-7</p> <p>View Up-channel at Approximate Station # 197+20R</p>

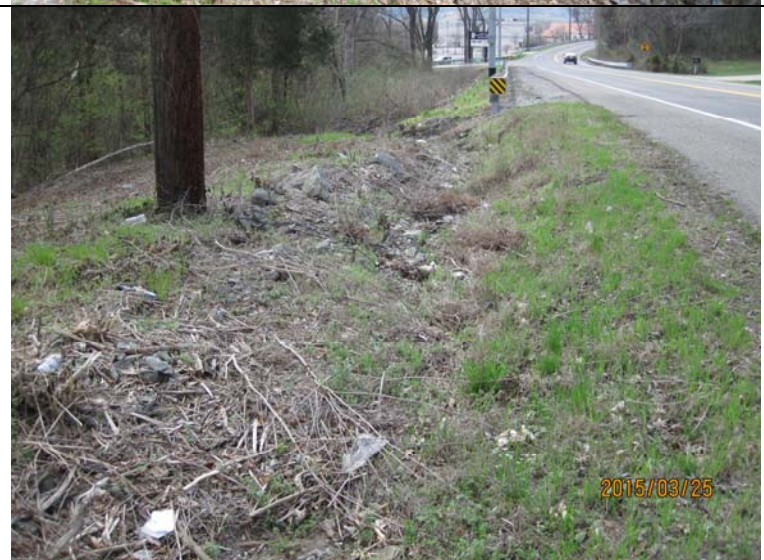
<p>Photo 47</p> <p>WWC-7/EPH STR-7</p> <p>View Down-channel at Approximate Station # 198+00R</p>
