TENNESSEE DEPARTMENT OF TRANSPORTATION  
ASBESTOS INSPECTION REPORT

Interstate 75 Over State Route 63  
07100750018  
Interstate 75  
Campbell County

June 23, 2014  
Terracon Project Number: 18147070

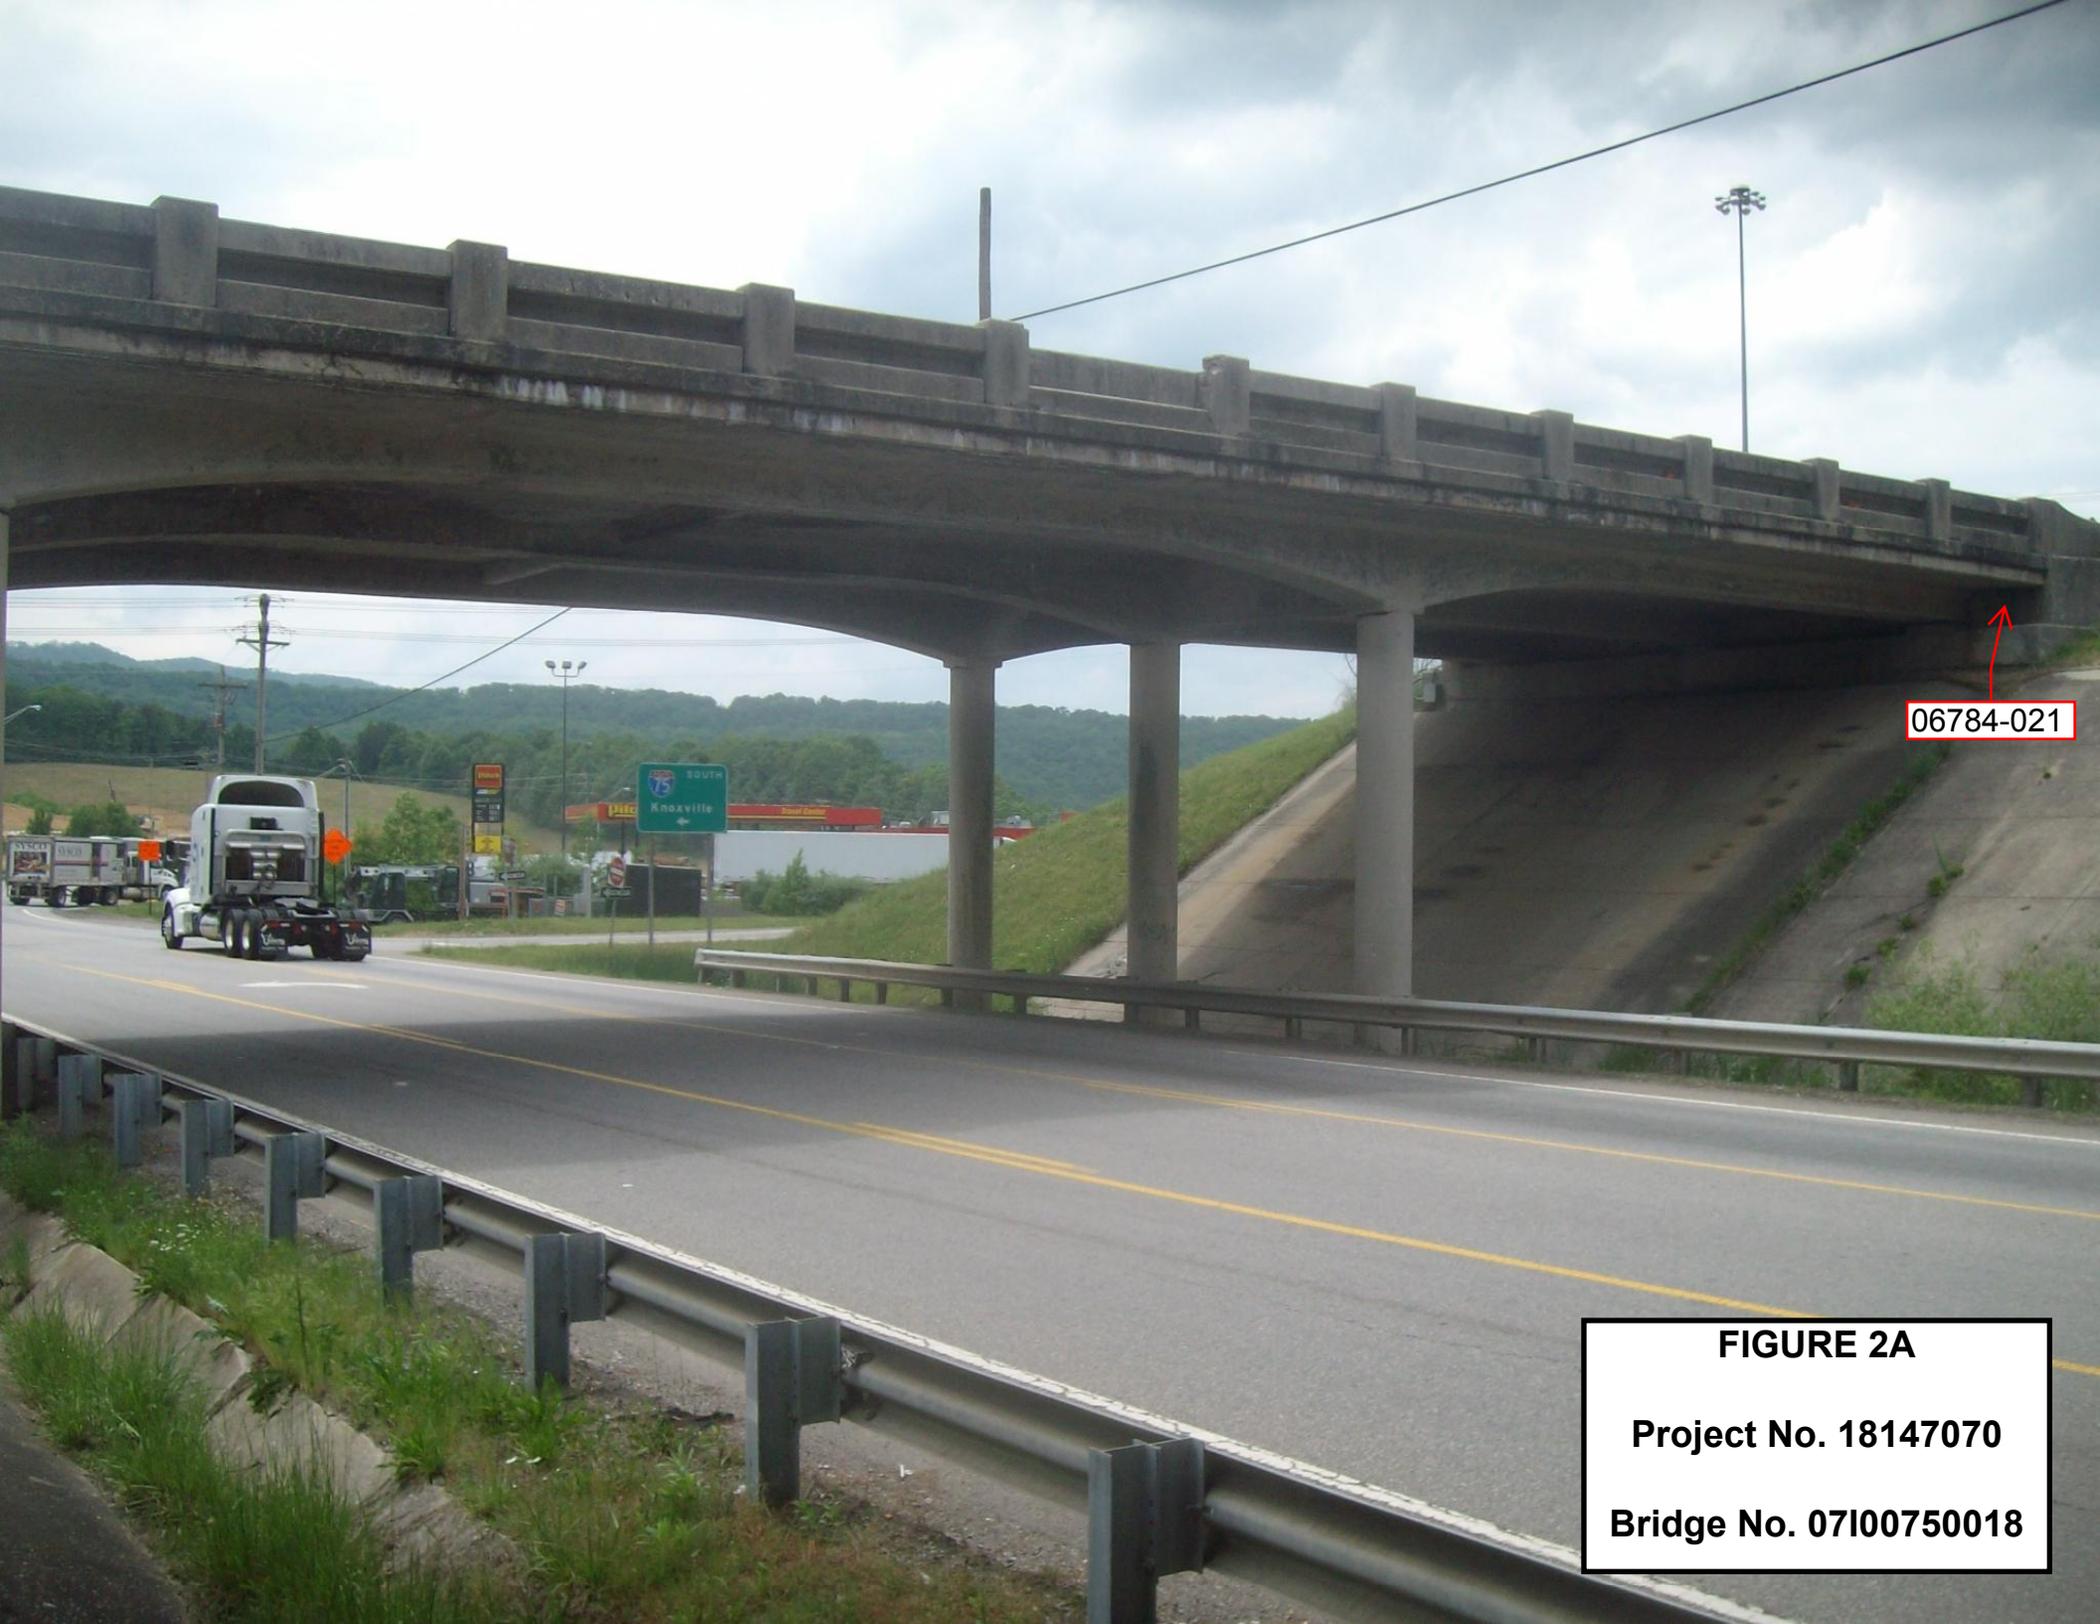
**FIGURE 2A**  
**Project No. 18147070**  
**Bridge No. 07I00750018**

06784-021

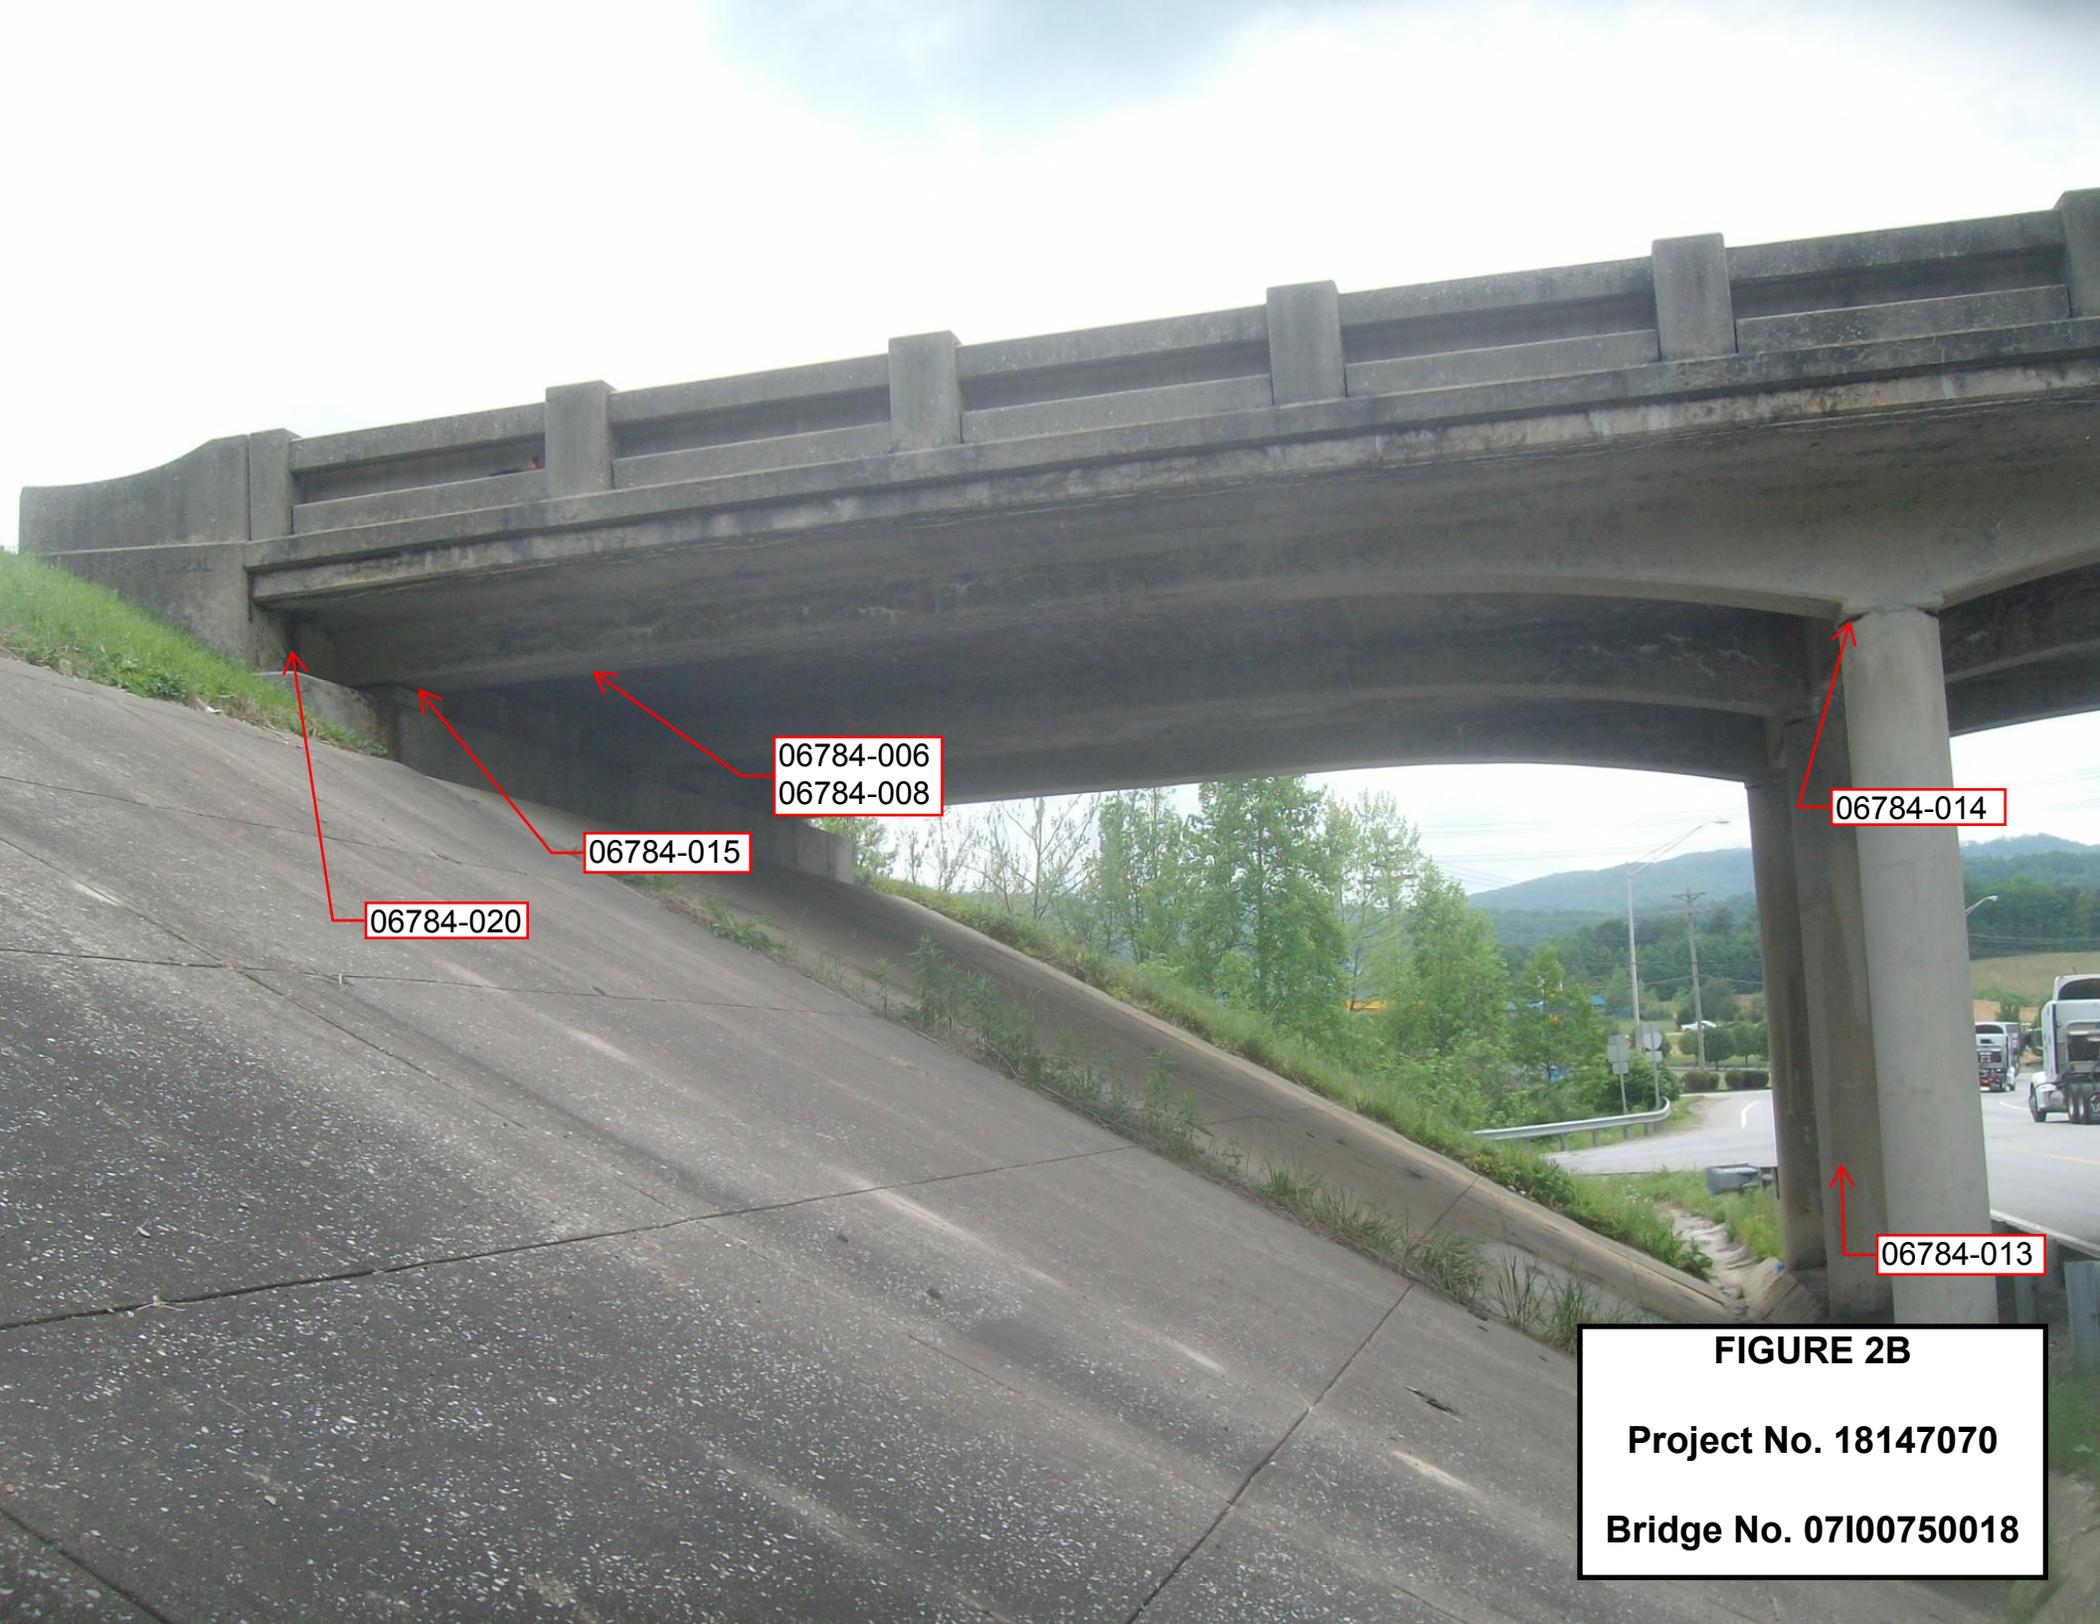
**FIGURE 2B**  
**Project No. 18147070**  
**Bridge No. 07I00750018**

06784-020

06784-015

06784-006  
06784-008

06784-014

06784-013

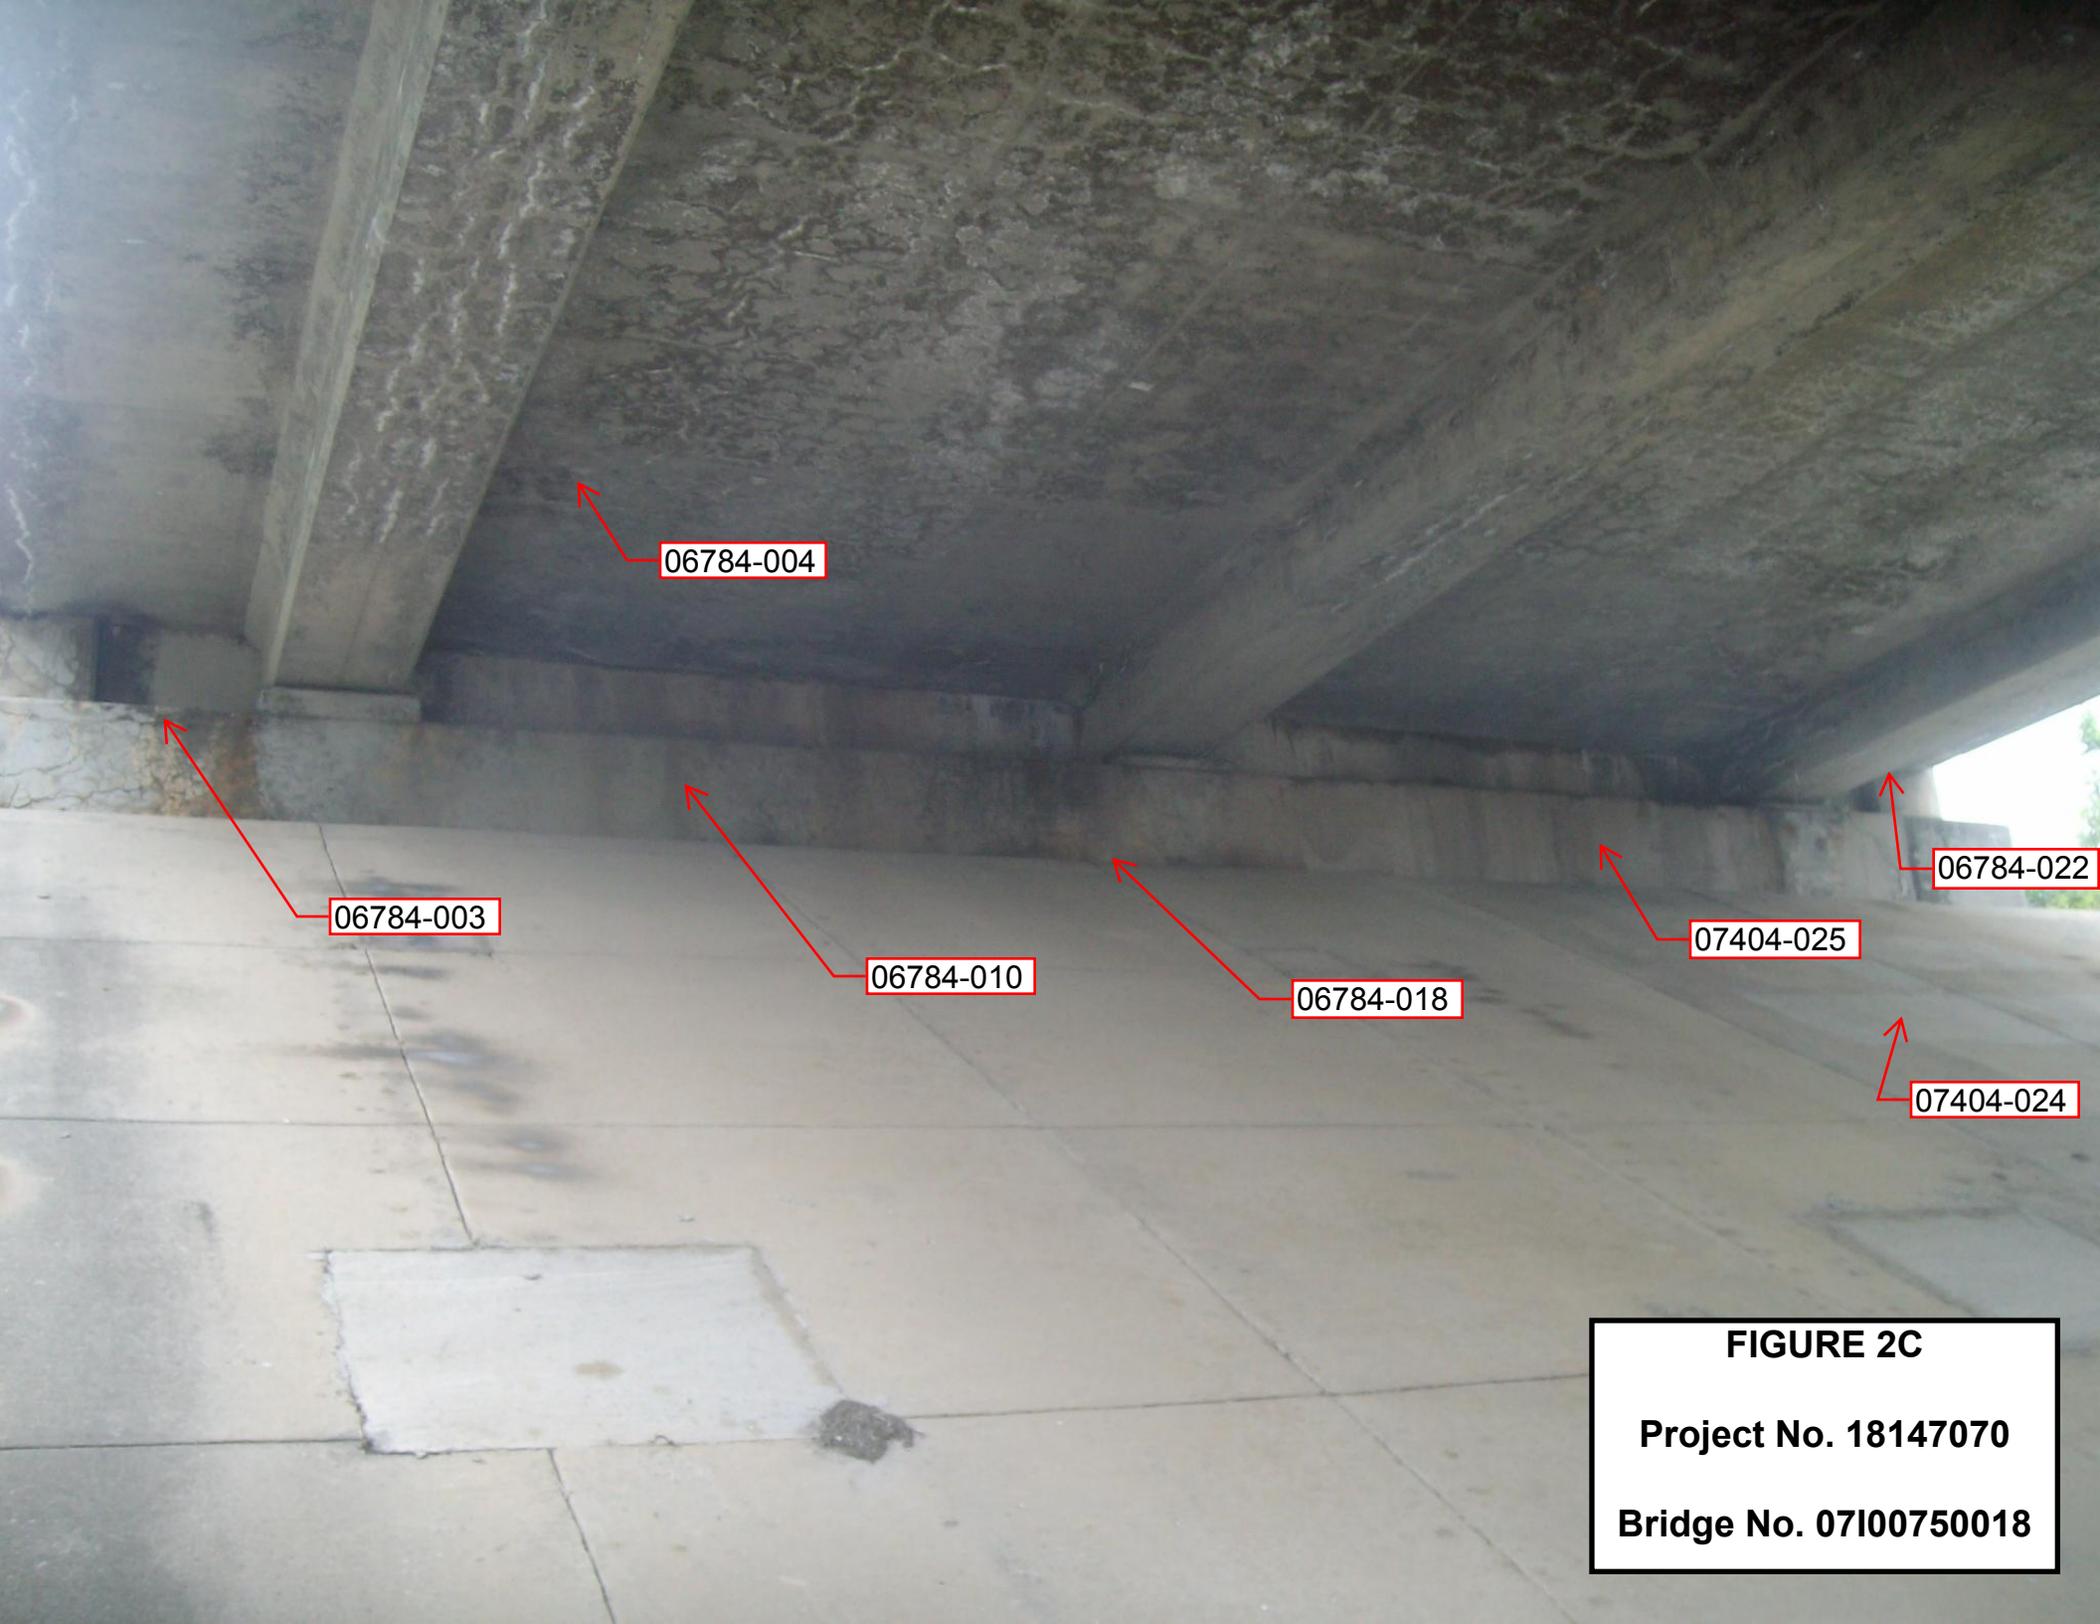
**FIGURE 2C**  
**Project No. 18147070**  
**Bridge No. 07100750018**

06784-004

06784-003

06784-010

06784-018

07404-025

06784-022

07404-024

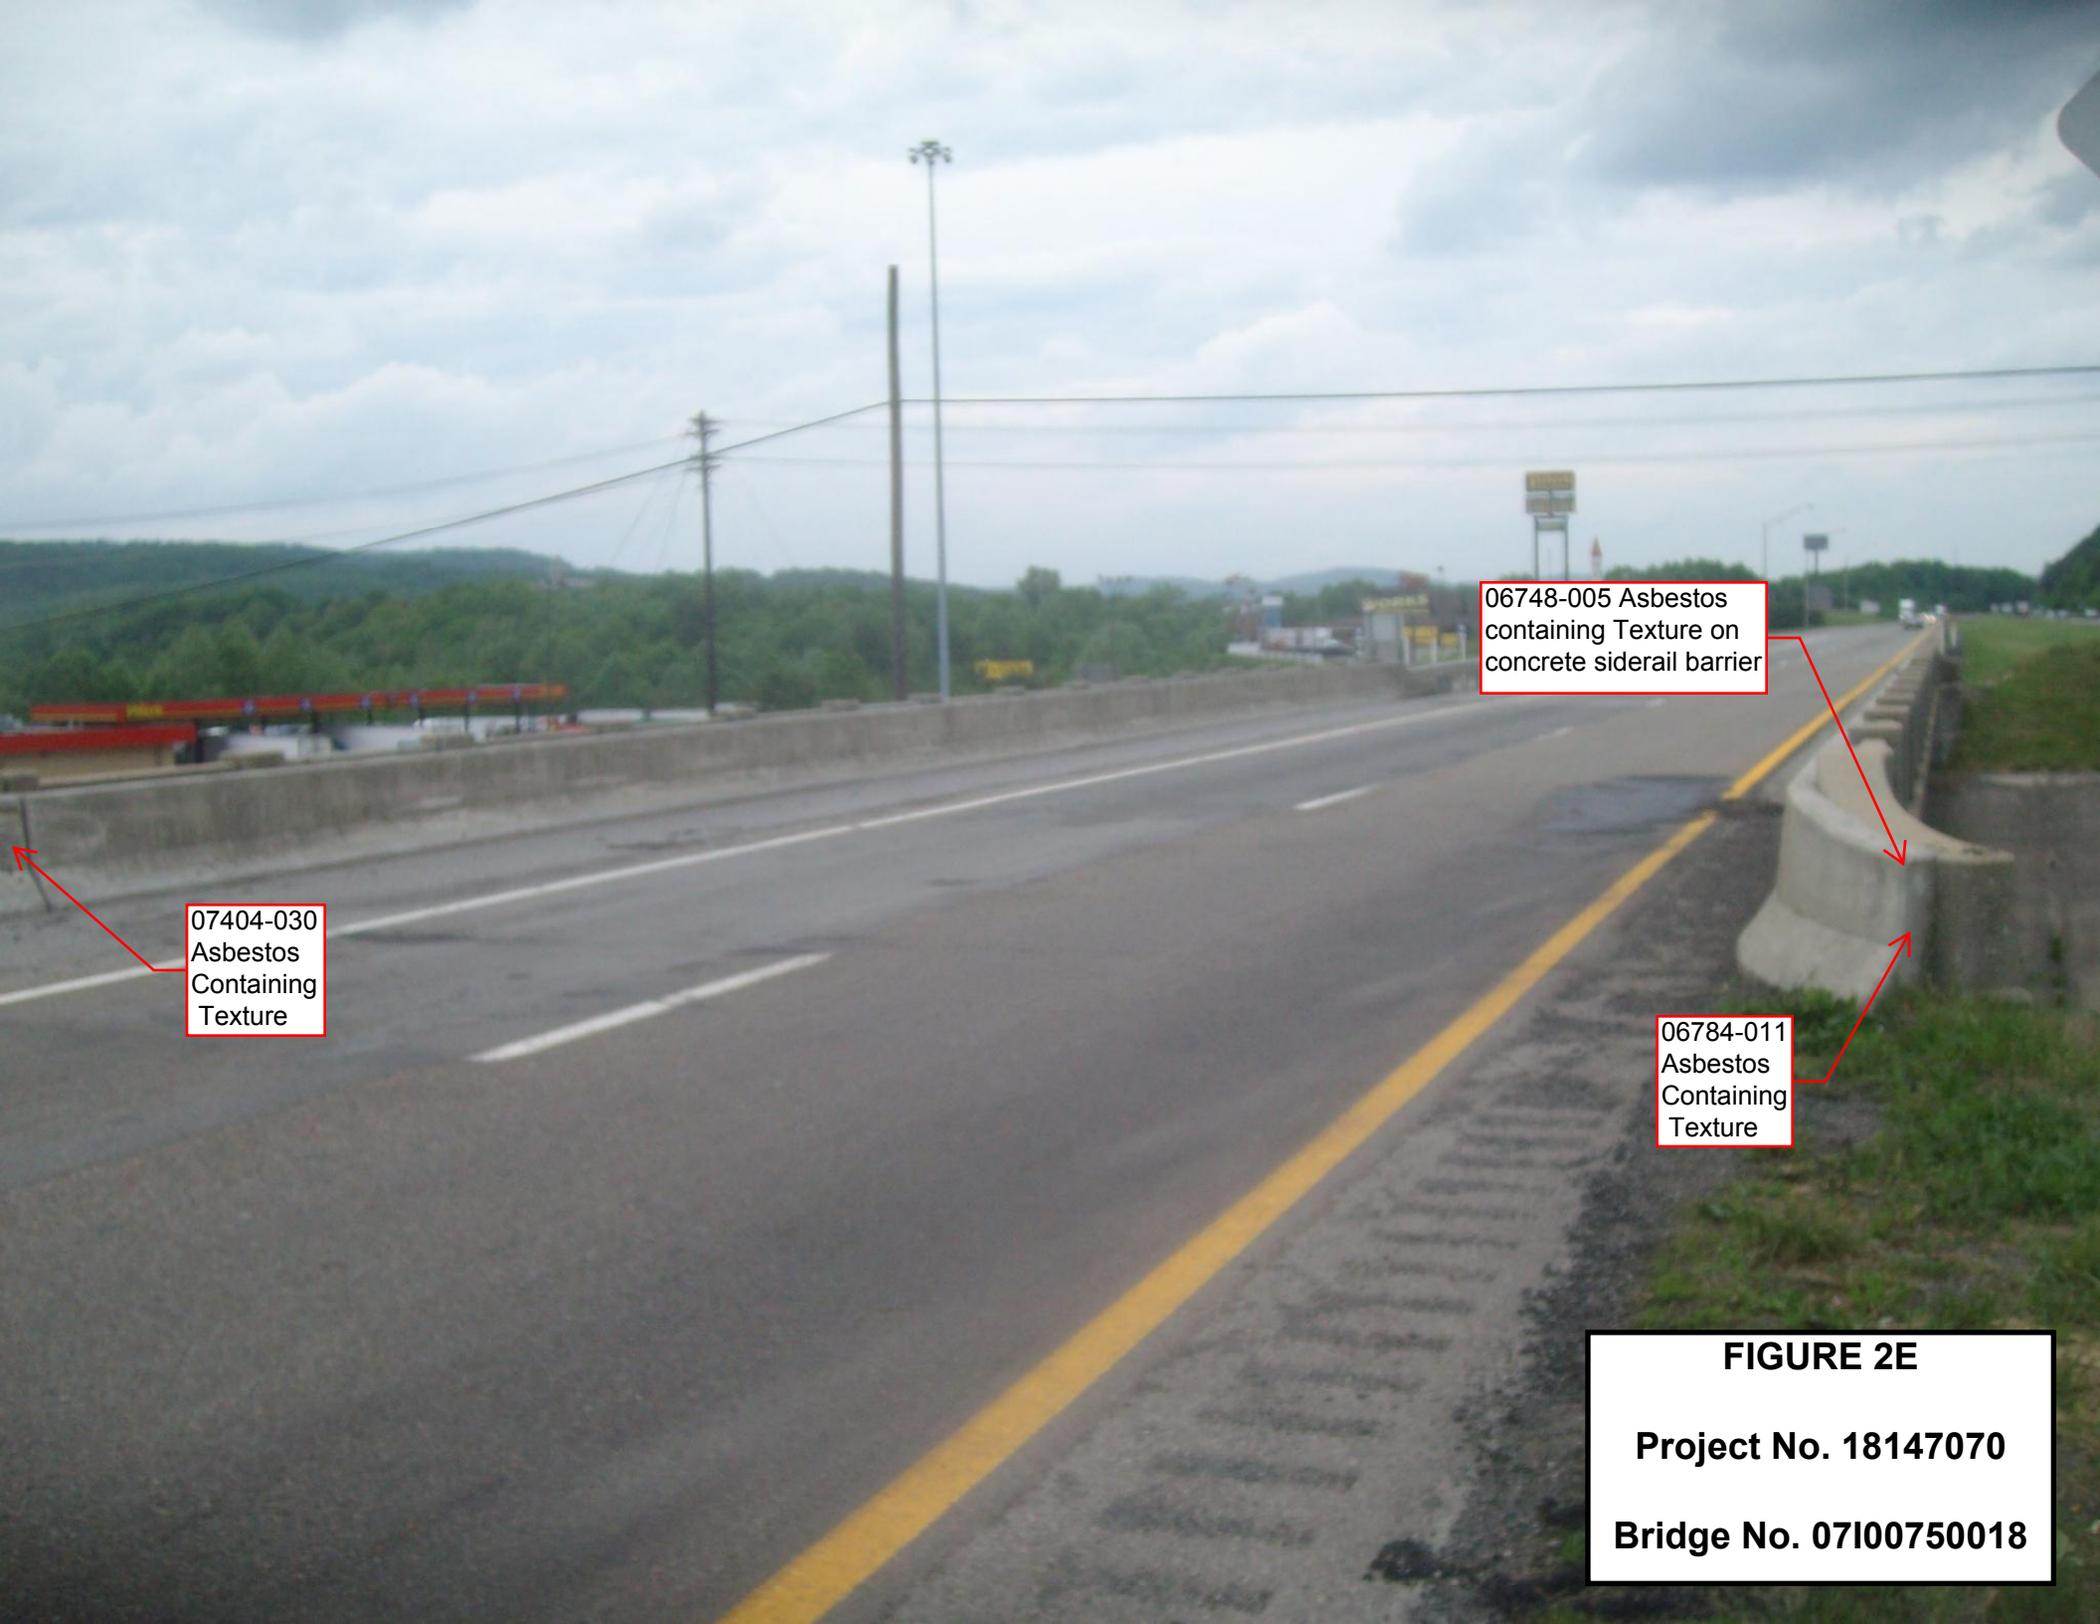
**FIGURE 2E**  
**Project No. 18147070**  
**Bridge No. 07I00750018**

07404-030  
Asbestos  
Containing  
Texture

06748-005 Asbestos  
containing Texture on  
concrete siderail barrier

06784-011  
Asbestos  
Containing  
Texture

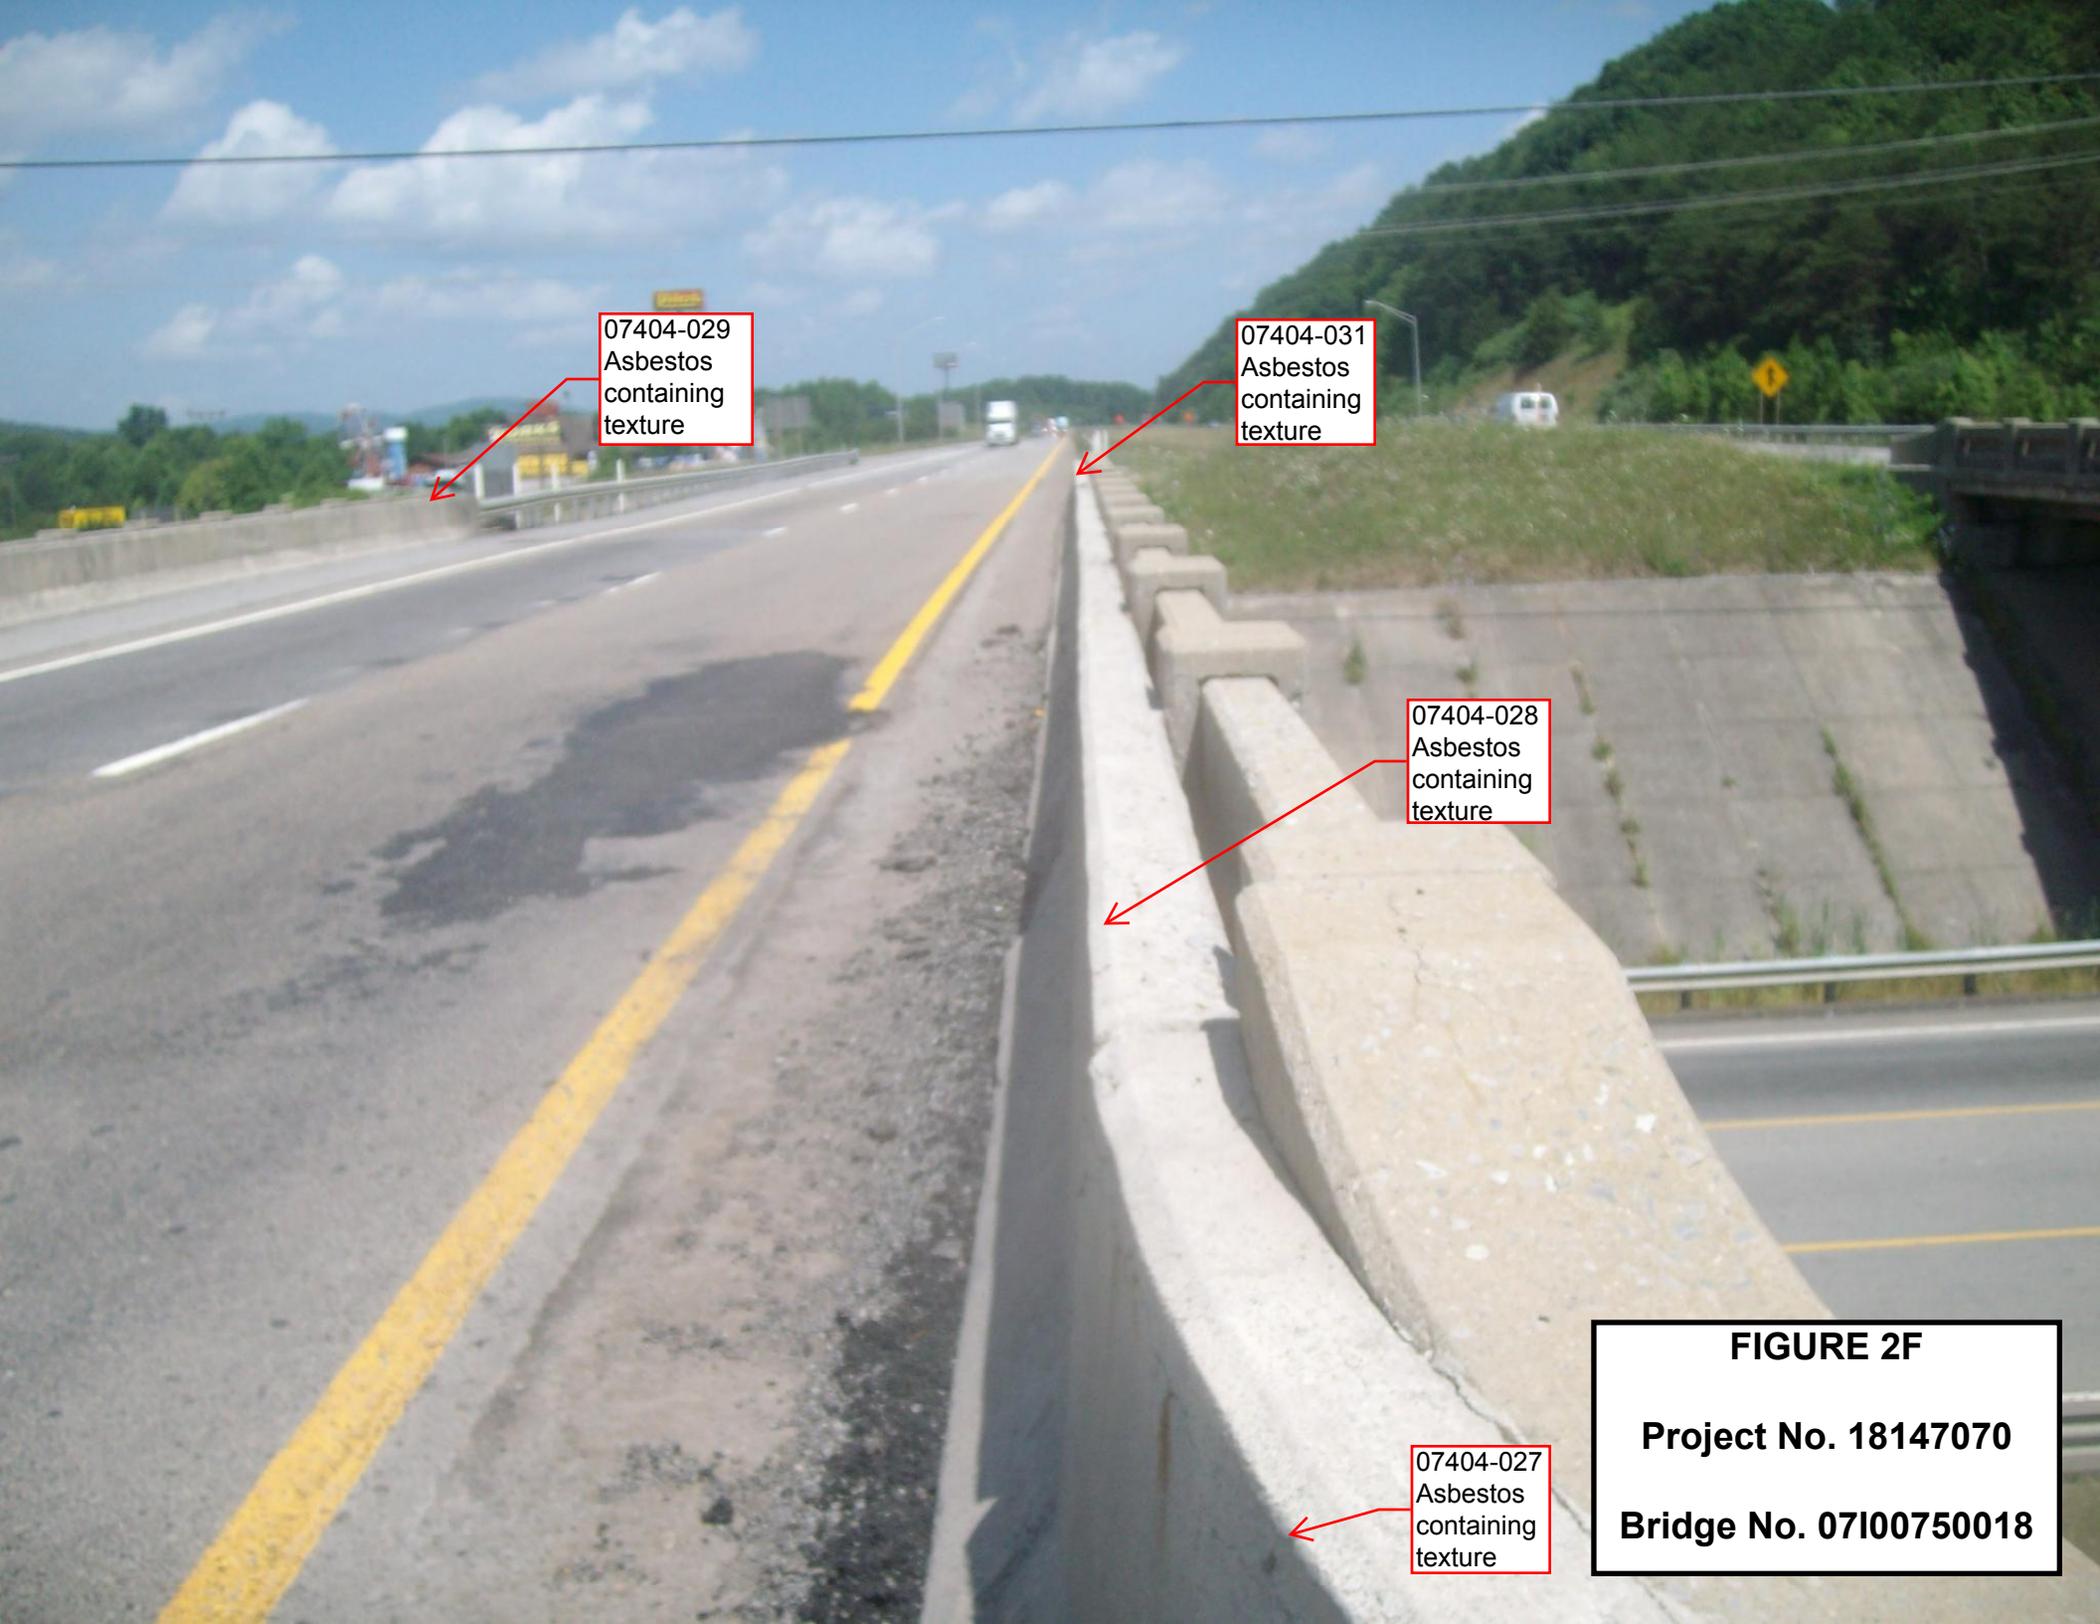
**FIGURE 2F**  
**Project No. 18147070**  
**Bridge No. 07I00750018**

07404-029  
Asbestos  
containing  
texture

07404-031  
Asbestos  
containing  
texture

07404-028  
Asbestos  
containing  
texture

07404-027  
Asbestos  
containing  
texture

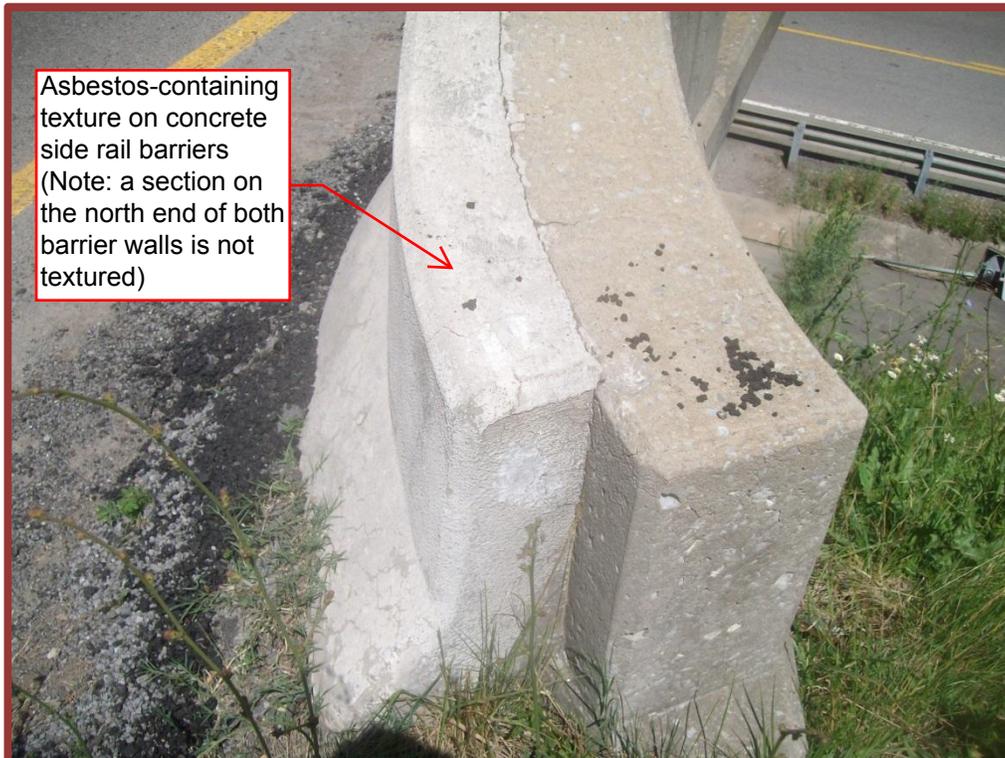
Photo 2: View of asbestos containing texture located on the concrete side rail barrier

Sample No.	HA/Material Description	Location (Bridge Component)	Approx Qty.	Friable (Y/N)	Type Asbestos and Content
06784-005	HA 06 – Texture (off-white)	Side rail barrier (barrier wall inside of original bridge side rail)	1,000 ft <sup>2</sup> per side rail barrier totaling 2,000 ft <sup>2</sup>	Y	No Asbestos - concrete 2% Chrysotile - filler
06784-011	HA 06 – Texture (off-white)	Side rail barrier (barrier wall inside of original bridge side rail)	1,000 ft <sup>2</sup> per side rail barrier totaling 2,000 ft <sup>2</sup>	Y	2% Chrysotile - texture
07404-027	HA 06 – Texture (off-white)	Side rail barrier (barrier wall inside of original bridge side rail)	1,000 ft <sup>2</sup> per side rail barrier totaling 2,000 ft <sup>2</sup>	Y	3% Chrysotile - texture
07404-028*	HA 06 – Texture (off-white)	Side rail barrier (barrier wall inside of original bridge side rail)	1,000 ft <sup>2</sup> per side rail barrier totaling 2,000 ft <sup>2</sup>	Y	Not analyzed

07404-029*	HA 06 – Texture (off-white)	Side rail barrier (barrier wall inside of original bridge side rail)	1,000 ft <sup>2</sup> per side rail barrier totaling 2,000 ft <sup>2</sup>	Y	Not analyzed
07404-030*	HA 06 – Texture (off-white)	Side rail barrier (barrier wall inside of original bridge side rail)	1,000 ft <sup>2</sup> per side rail barrier totaling 2,000 ft <sup>2</sup>	Y	Not analyzed
07404-031*	HA 06 – Texture (off-white)	Side rail barrier (barrier wall inside of original bridge side rail)	1,000 ft <sup>2</sup> per side rail barrier totaling 2,000 ft <sup>2</sup>	Y	Not analyzed
