TENNESSEE DEPARTMENT OF TRANSPORTATION ASBESTOS INSPECTION REPORT

SR-238 Bridge over Spring Creek
Bridge ID Number 63S63520005
Montgomery County, Tennessee

April 15, 2014

KSWA Project Number: 100-14-0019

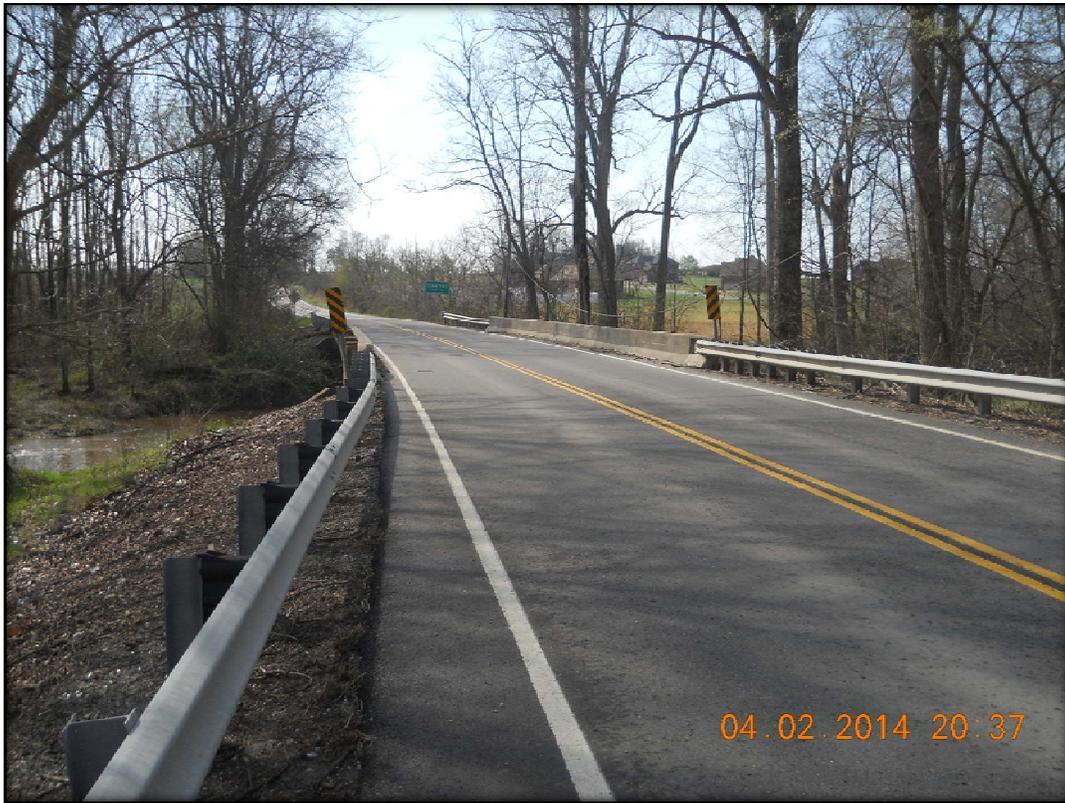
Photo 1: View of the SR-238 Bridge over Spring Creek in Montgomery County, Tennessee

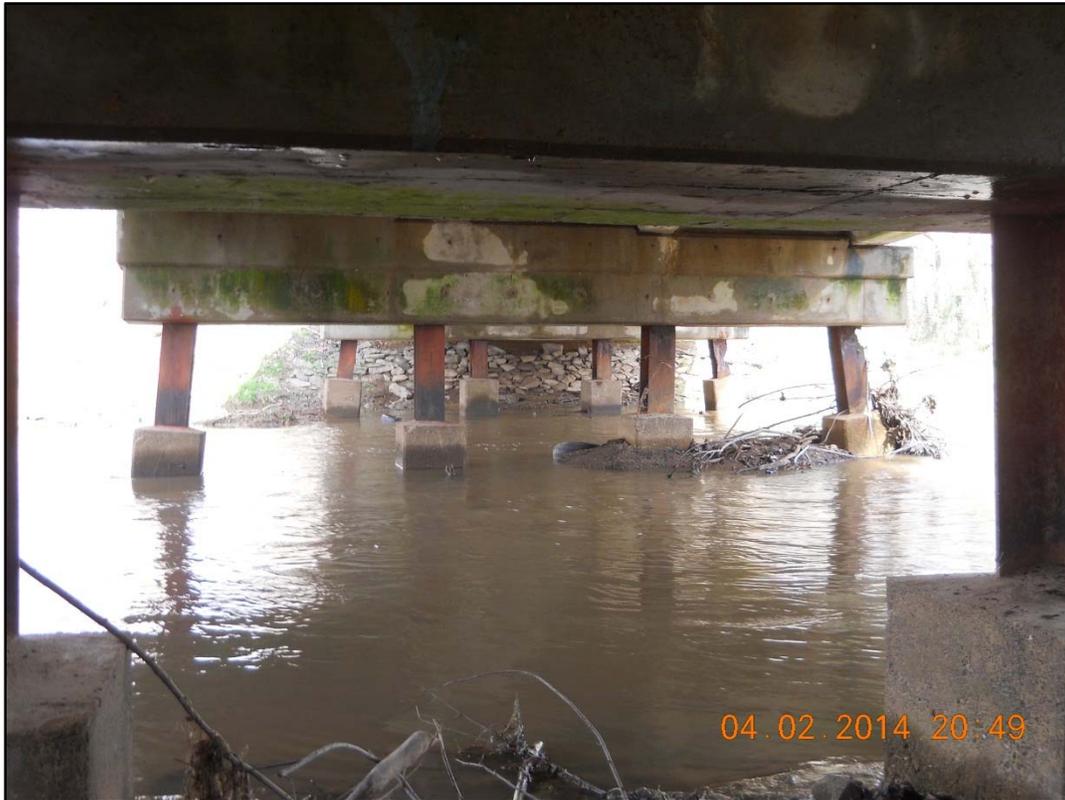
Photo 2: View of the SR-238 Bridge over Spring Creek in Montgomery County, Tennessee from below

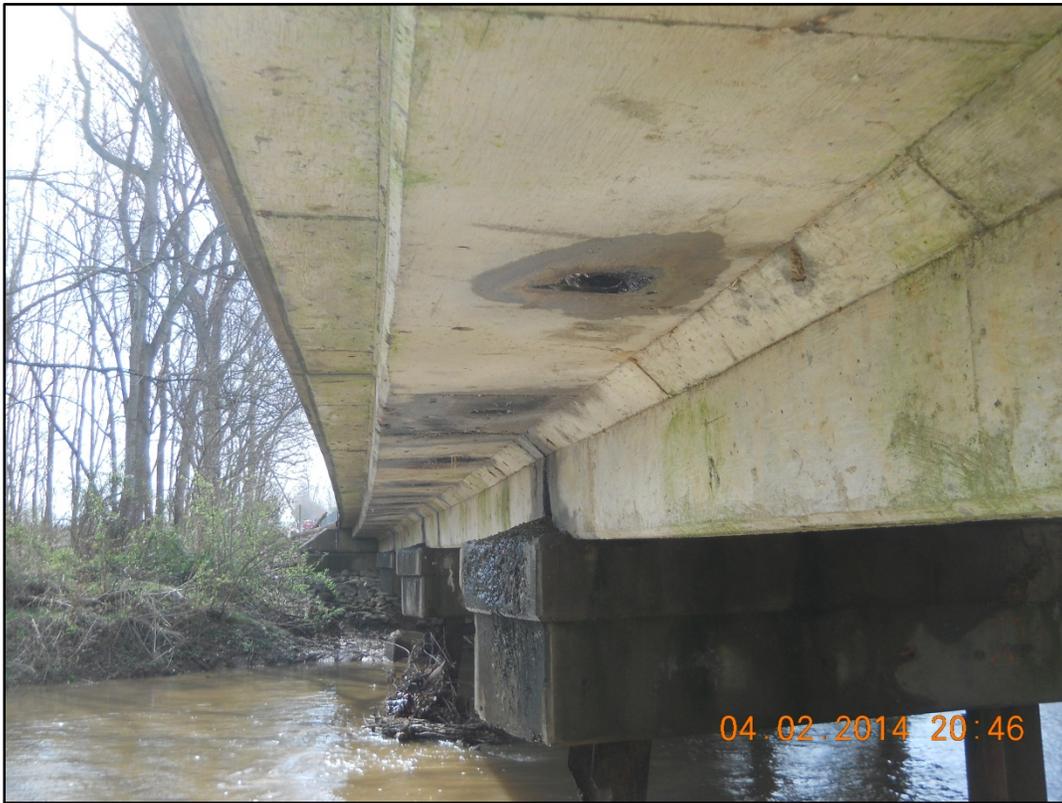
Of the various material sampled, the cementitious down drains was found to be asbestos-containing. **Table – 3** summarizes the various sampled materials which were found to contain asbestos. Photographs of the different homogeneous areas sampled that tested positive for containing asbestos are presented in **Appendix B**.

Sample No.	HA / Material Description	Location (Bridge Component)	Approx. Qty.	Friable (Y/N)	Type Asbestos and Content
238-28**	Cementitious Down Drains	North East	10 Total Pipes in 2 ft sections	No	3.25% Chrysotile 1.50% Crocidolite
238-29*	Cementitious Down Drains	Middle East	24 Total Pipes in 2 ft sections	No	First Positive Stop
238-30*	Cementitious Down Drains	South East	24 Total Pipes in 2 ft sections	No	First Positive Stop

Photo 3: View of the cementitious down drains on SR-238 Bridge over Spring Creek in Montgomery County, Tennessee from below

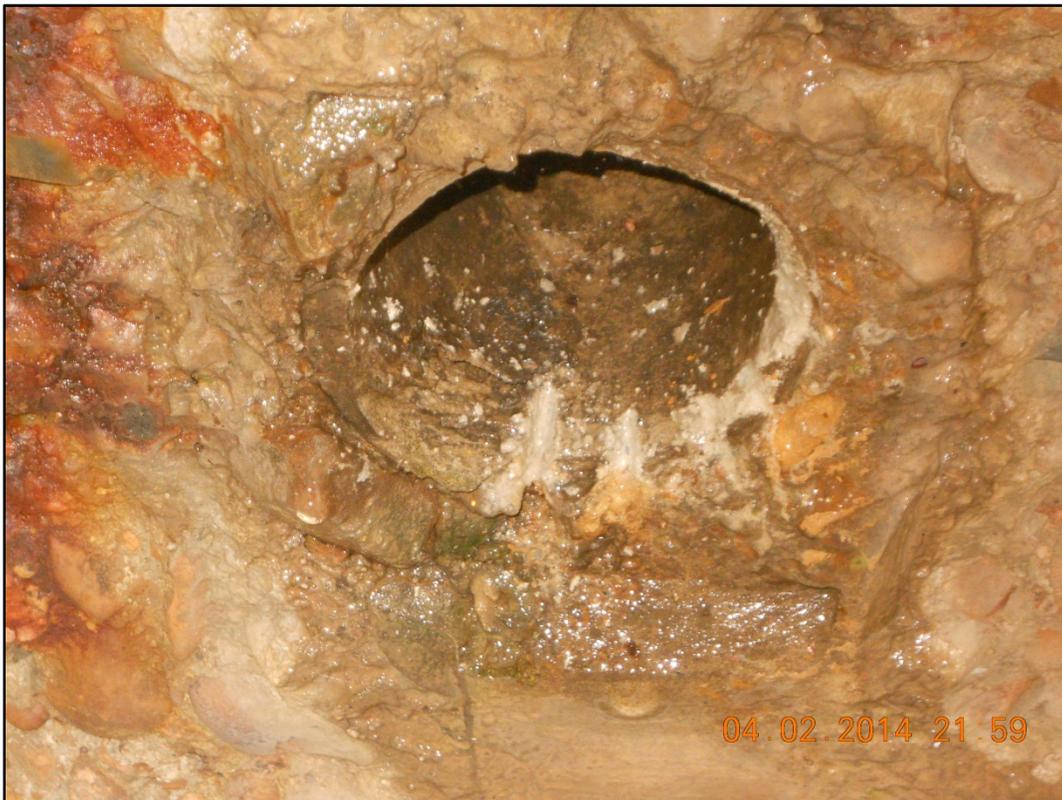
Photo 4: Close-up view of the SR-238 Bridge cementitious down drains from below

238-28 021401815-0028	Cementitious Down Drains	Gray/Beige Fibrous Homogeneous	<1% Cellulose	96% Non-fibrous (other)	3% Chrysotile 1% Crocidolite

Sample	Description	Appearance	Non-Asbestos		Asbestos
			% Fibrous	% Non-Fibrous	% Type
238-28 021401815-0028	Cementitious Down Drains	Gray/Beige Fibrous Homogeneous		95.25% Non-fibrous (other)	3.25% Chrysotile 1.50% Crocidolite
