Re: Asbestos Inspection Report  
Sumner County; SR-25 Bridge over Liberty Branch  
Bridge #: 83SR0250013 (LM 10.88)  
TDOT Project # 83005-4246-04, PIN 120026.00  
TDOT Contract: E1647; Work Order: 076

## TENNESSEE DEPARTMENT OF TRANSPORTATION ASBESTOS INSPECTION REPORT

Bridge over Liberty Branch  
Bridge No. 83SR0250013 (LM10.88)  
State Route 25  
Sumner County

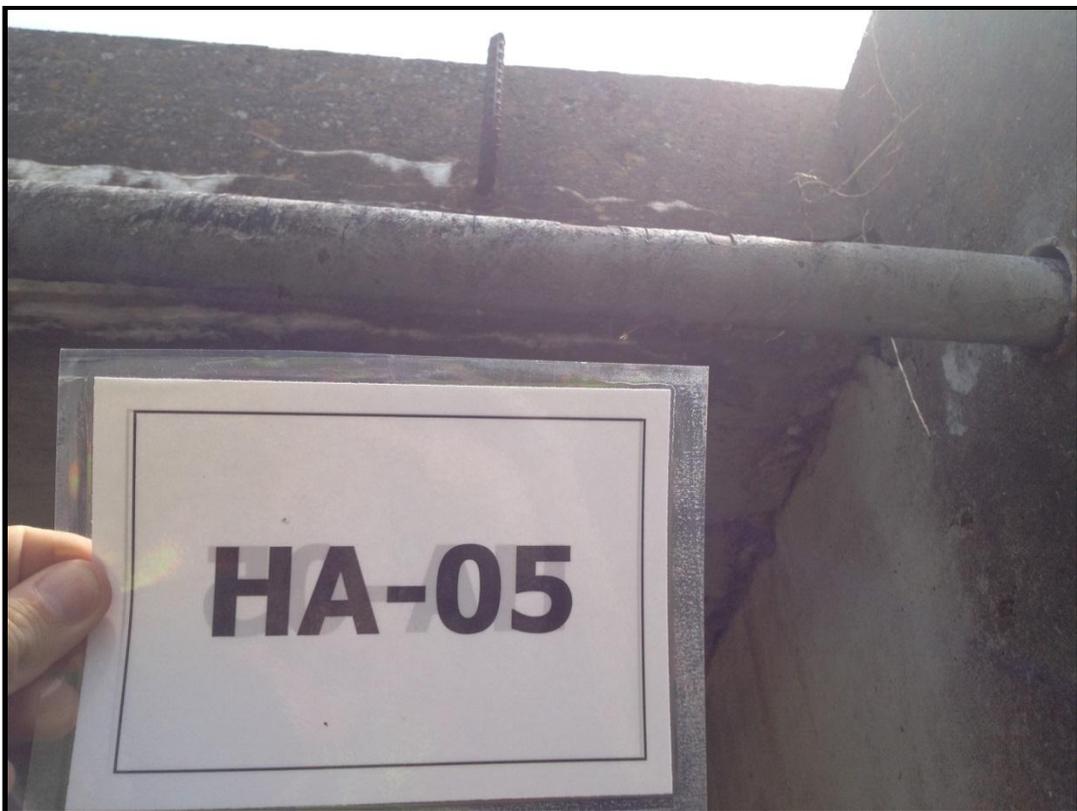
Enclosed is the asbestos inspection report for the above-referenced bridge. A total of 20 samples were obtained during the inspection. Asbestos was detected in the utility pipe wrap located on the western side of the bridge.

In its current condition, this asbestos containing material (ACM) was determined to be non-friable; that is, it could not be pulverized using hand pressure alone. Accordingly, it is classified under Environmental Protection Agency (EPA) National Emission Standards for Hazardous Air Pollutants (NESHAP) rules (40 Code of Federal Regulations [CFR] 61) as a Category II non-friable ACM, and it is not considered a "Regulated Asbestos-Containing Material" (RACM) in its current state. However, if it is expected that demolition or renovation methods used would render the material friable, this material should be removed by trained workers or segregated such that it cannot be rendered friable.

**Photo 2:** Asbestos-containing sample of the utility pipe wrap, located on the west side of the bridge.

The Occupational Safety and Health Administration (OSHA) would consider the abatement of this ACM to be a Class II activity, which would require trained workers and a competent person to oversee the work (an asbestos supervisor). Additionally, State of Tennessee asbestos accreditation requirements (Tennessee Code Annotated [TCA] 1200-01-20) mandate that such work be performed by an accredited firm (contractor) using accredited abatement workers and supervisors.

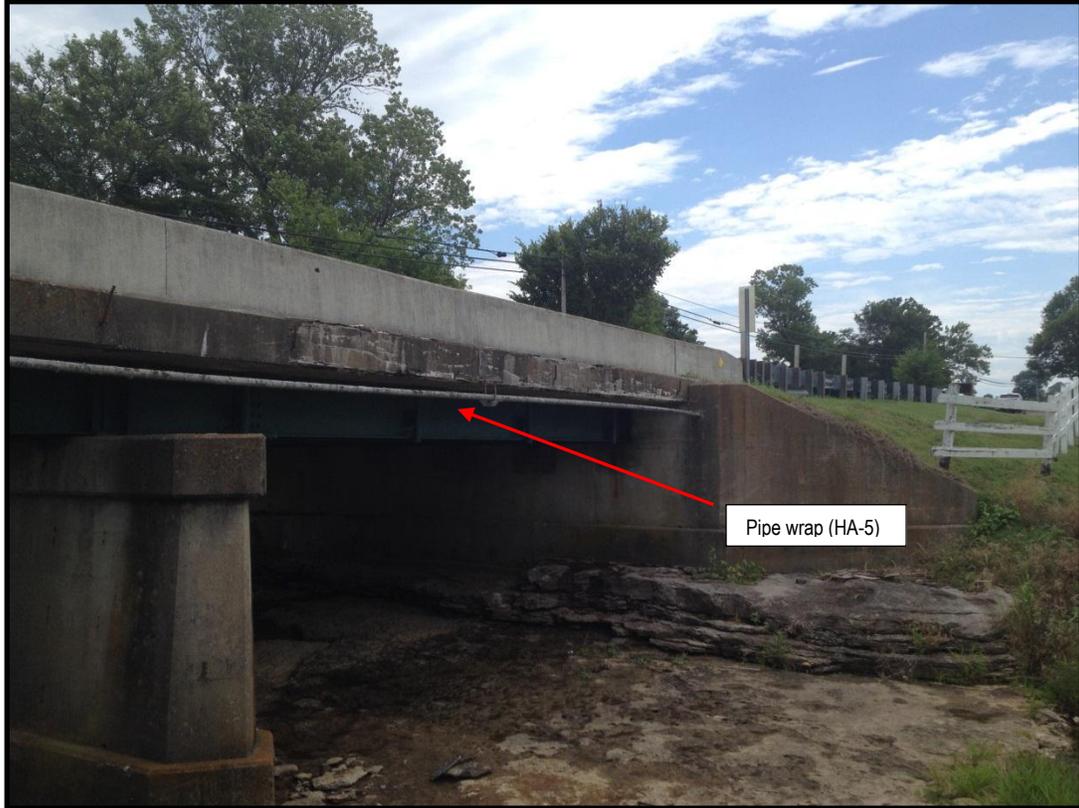
Sample No.	HA/Material Description	Location (Bridge Component)	Approx Qty.	Friable (Y/N)	Type Asbestos and Content
<b>14017786-013_25HA5A</b>	HA-5 Pipe Wrap	Utility pipe, west side of bridge	65 LF	N	35% Chrysotile
<b>14017786-014_25HA5B *</b>	HA-5 Pipe Wrap	Utility pipe, west side of bridge	65 LF	N	assumed 35% Chrysotile-Not analyzed

**Photo 3:** View of the asbestos-containing material: pipe wrap (HA-5).
