**TENNESSEE DEPARTMENT OF TRANSPORTATION  
ASBESTOS INSPECTION REPORT**

**SR-116 Bridge over Stockstill Creek  
Morgan County  
TDOT Project No. 65006-0217-94  
PIN 115689.00**

September 18, 2013  
AMEC Project No. 164613036

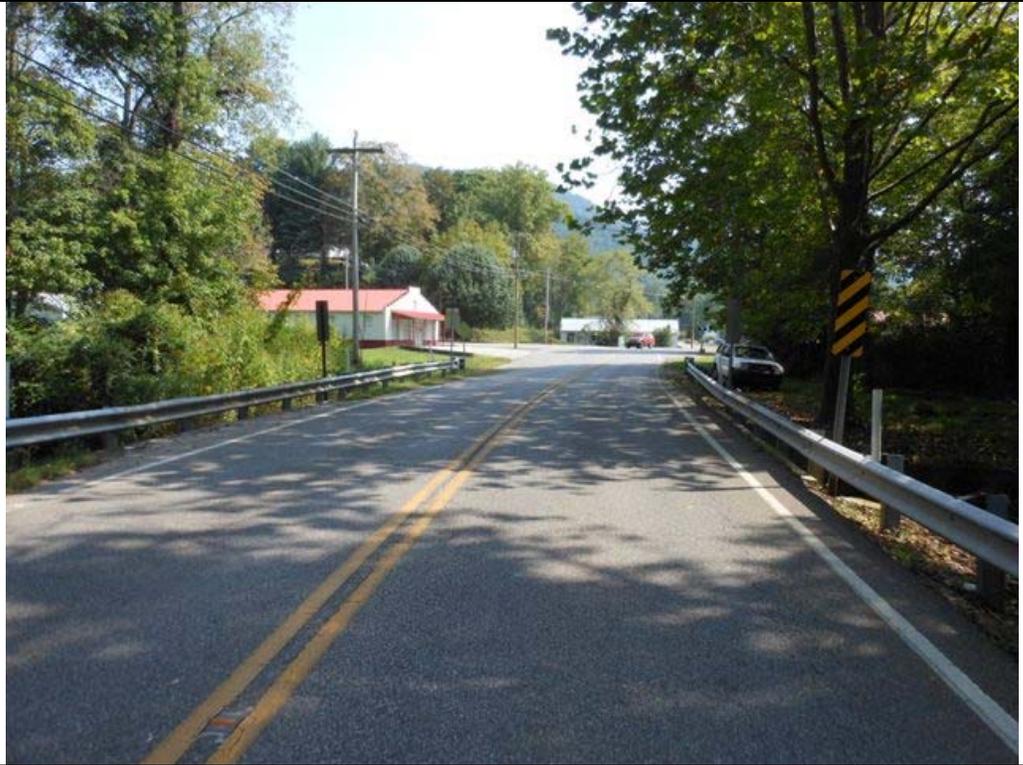
Comments:  
P-1 – Approach to  
Bridge from the West.  
Bridge defined by  
yellow & black  
warning signs.

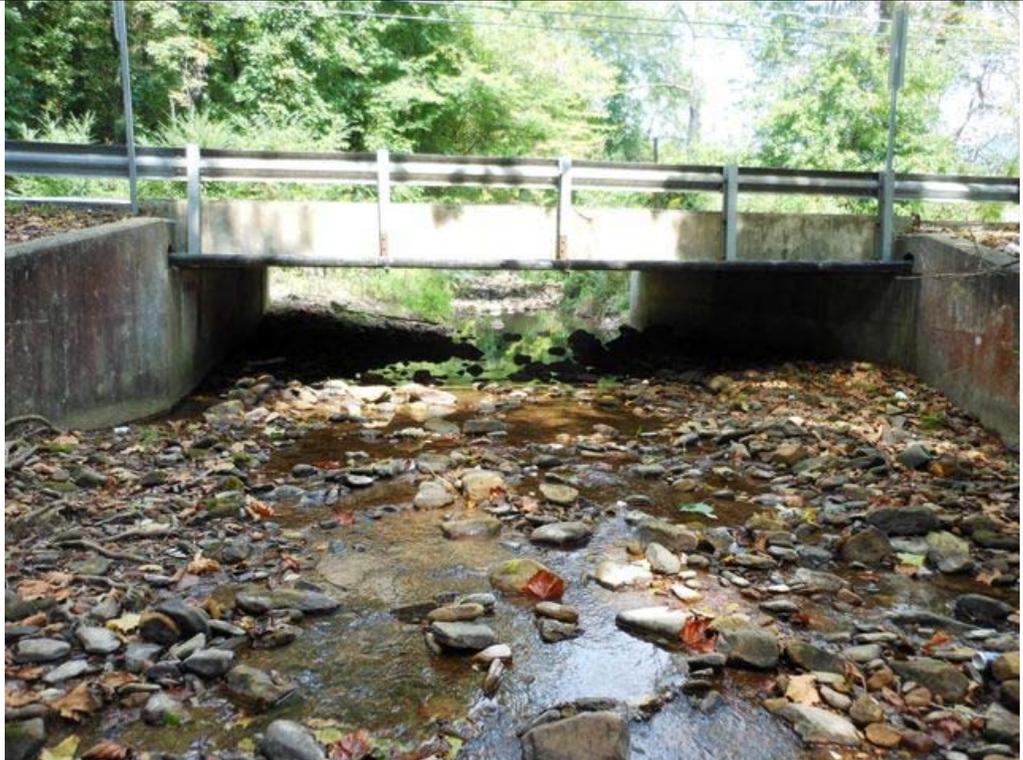
Comments:  
P-2 – Bridge is a  
simple span of 29  
feet from Abutment 1  
(left) to Abutment 2.  
Side guard rails are  
all metal.

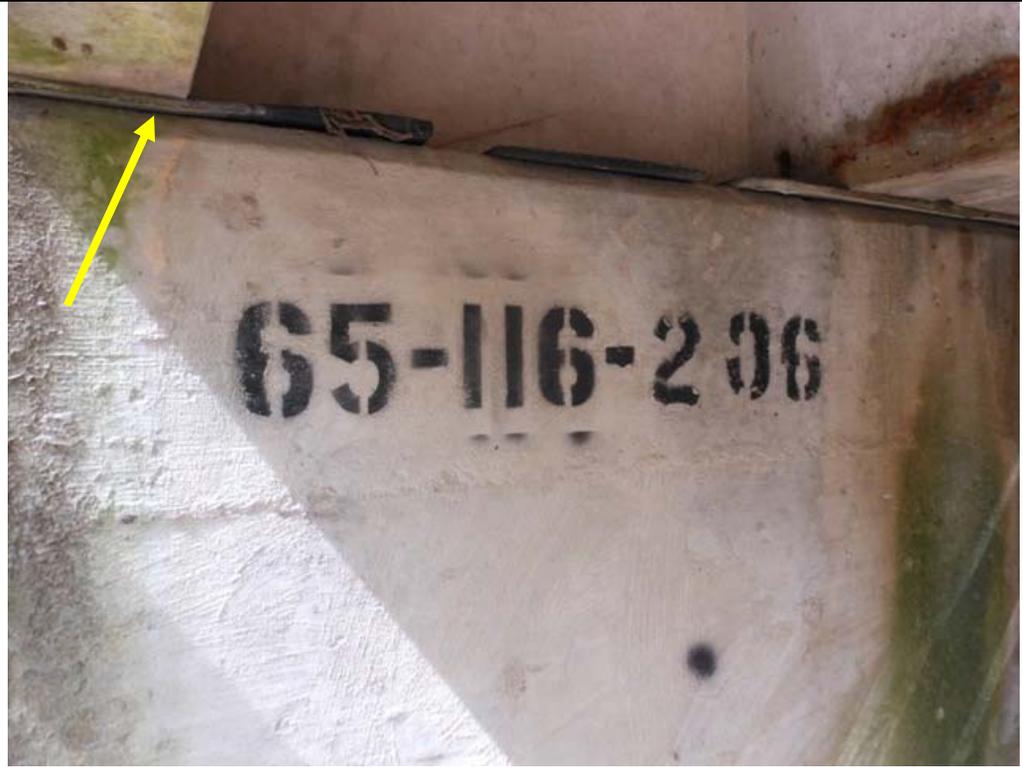
**Comments:**  
P-3 – Bridge Identification Number on Abutment 1. The thick expansion material (60%) on top of abutments under legs of Channel Beams (MO-06-01) is used as a bearing pad.

Chrysotile (40%) asbestos fibers were detected in the thin expansion material used to isolate the deck from the abutment (HA-04). Chrysotile (60%) asbestos was also identified in the thick expansion like material used as bearing pads atop the abutments under the beams and diaphragms (HA-06). Any materials similar in appearance are considered ACM. See **Appendix B** for pictures of the materials. As discussed above in Section 3.1, the remaining samples from the HAs were not analyzed. No asbestos was detected in the other analyzed samples.

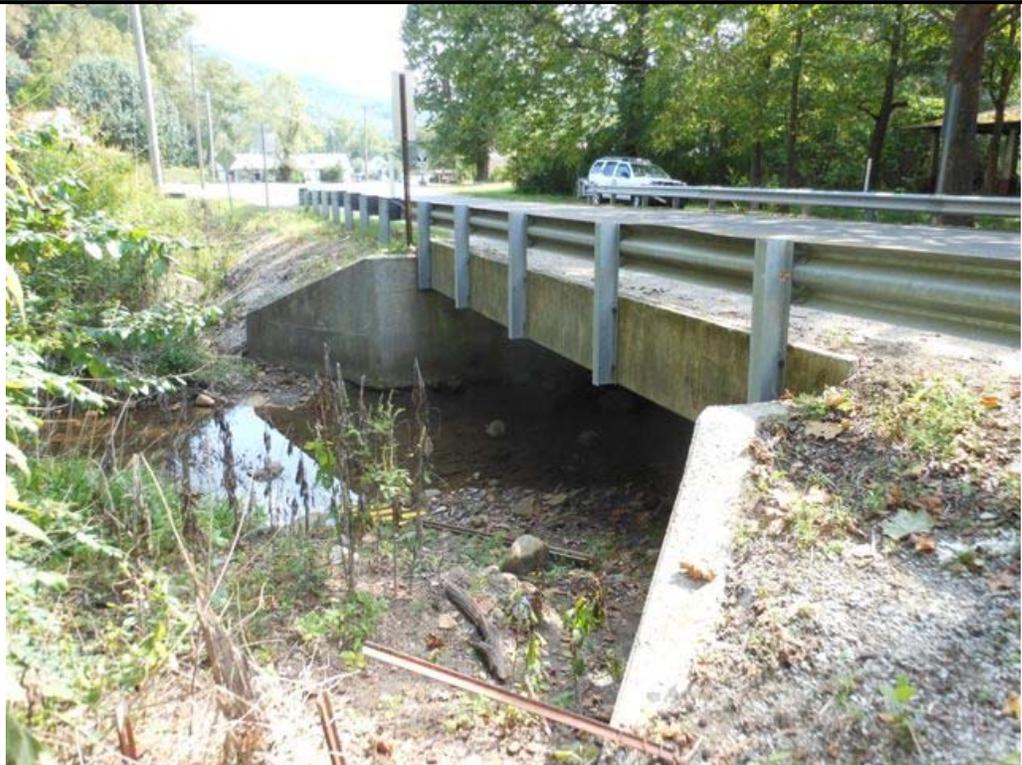
**Comments:**  
P-4 – Abutments are cast in place concrete with wingwalls. Side of bridge is also cast in place. Thin expansion material isolates the span from the abutment.

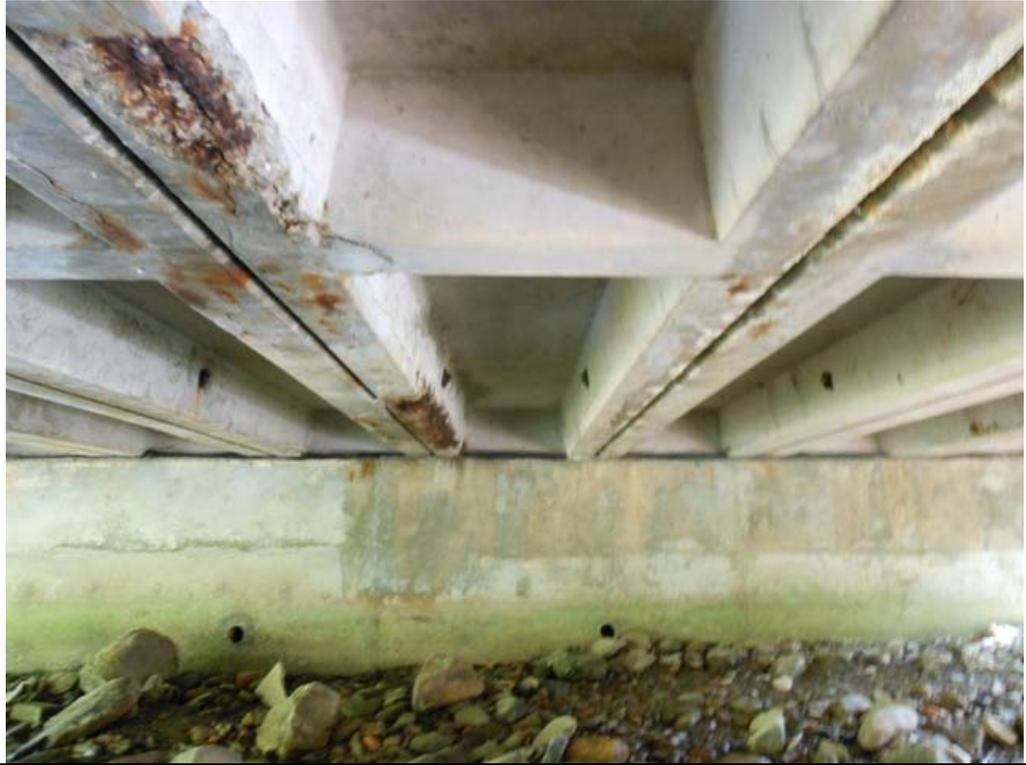
Comments:  
P-4- Bridge is constructed of precast concrete channels bolted together. Weep holes in abutment are steel pipes.

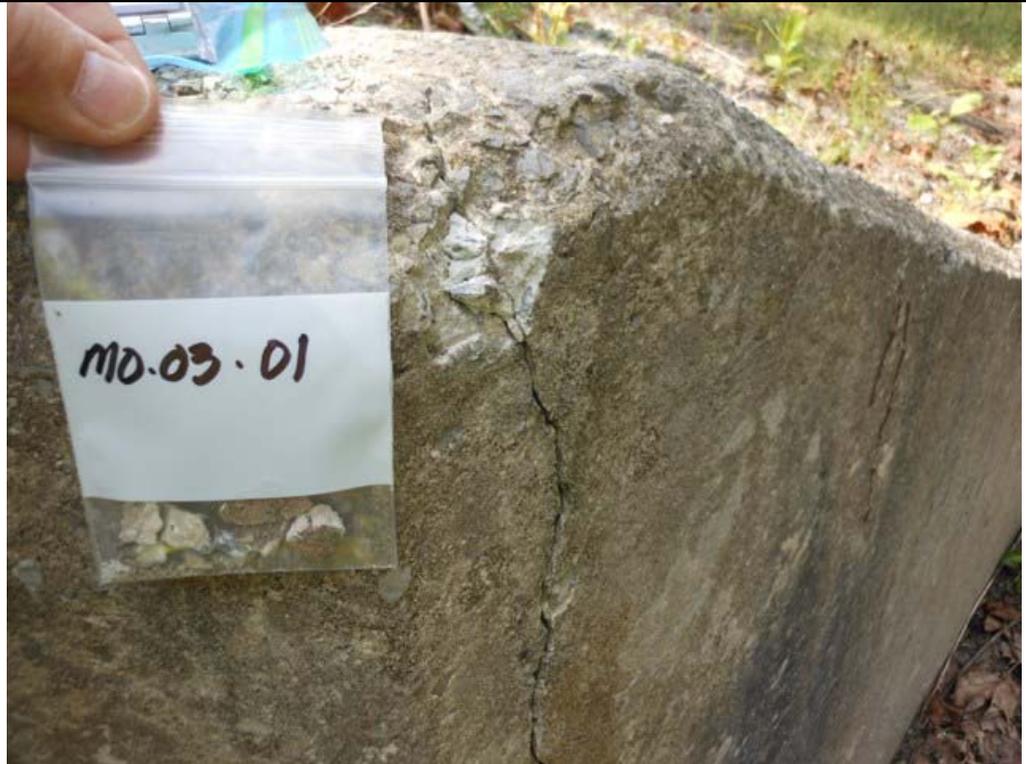
Comments:  
P-5 –Concrete sample of cast-in-place concrete collected from the wingwall. Cast in place concrete was not ACM.

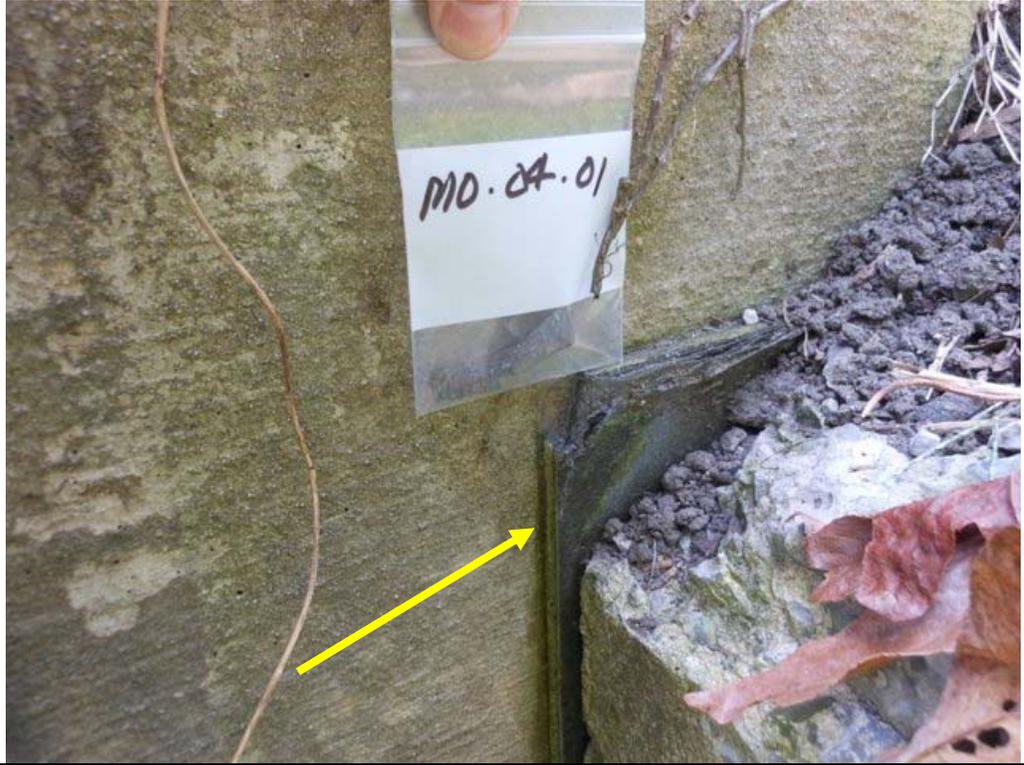
construction joint between the abutment/wing walls and the deck was a thin black layered expansion material (HA-04).

Comments:  
P-7 – Close-up of thin expansion material that isolates the side of the bridge from the wingwall. The thin material sample contained 40% asbestos.

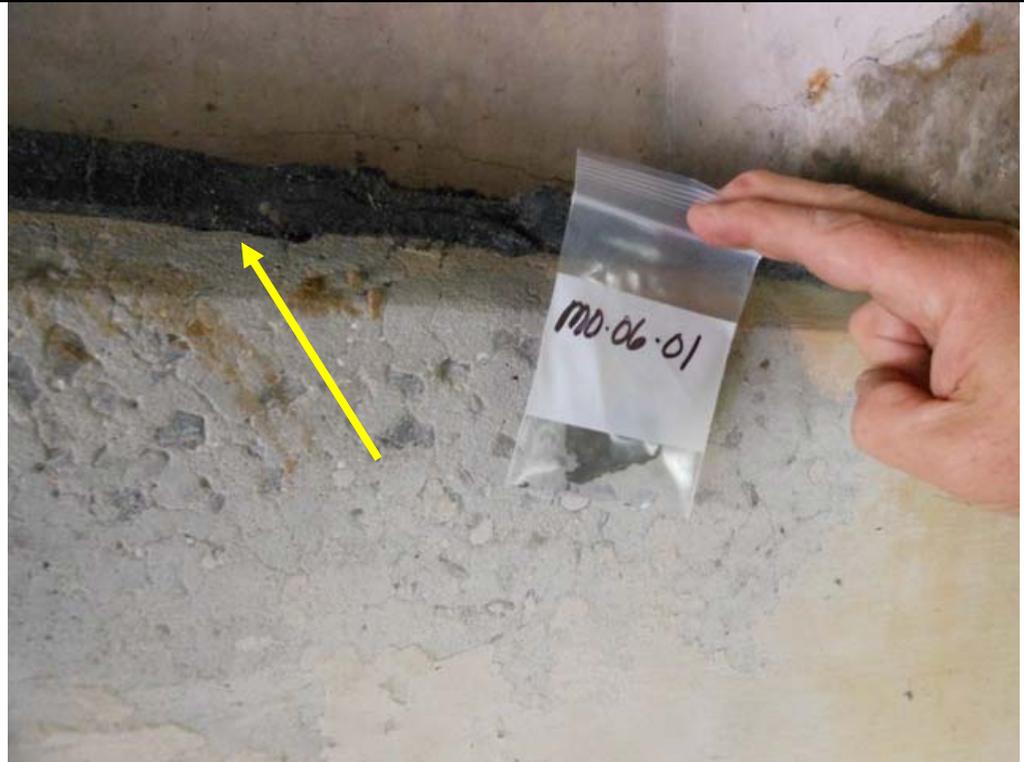
Comments:  
P-8 – Close up of Thick expansion material used as bearing pads under channel beams. Bearing pad material contained 60% asbestos

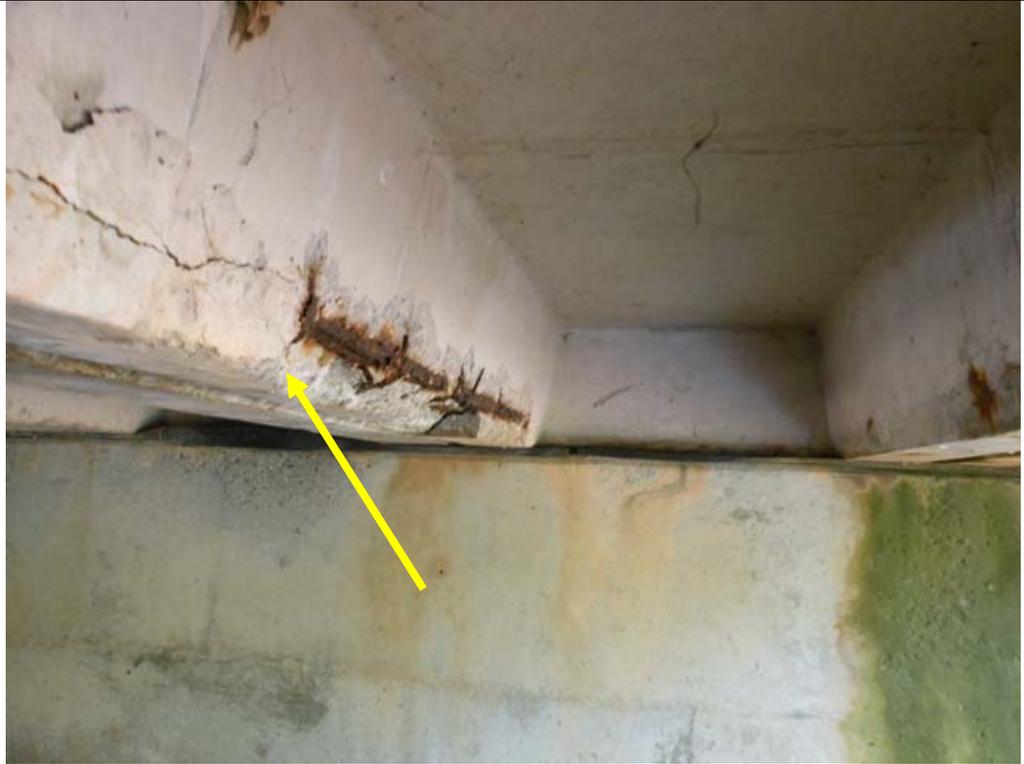
The precast concrete bridge channel beams were accessible by foot from below and samples were collected at locations of concrete damage (HA-05). The concrete beams extended from the abutment to abutment. The Channel beams spans rested on the legs of the channel and diaphragms on thick expansion material like bearing pads (HA-06). There was no evidence that repairs had been made to the bridge beams.

Comments:  
P-9 Precast concrete  
were collected from  
locations where  
concrete was spalling  
from beams.  
Concrete samples did  
not contain asbestos.

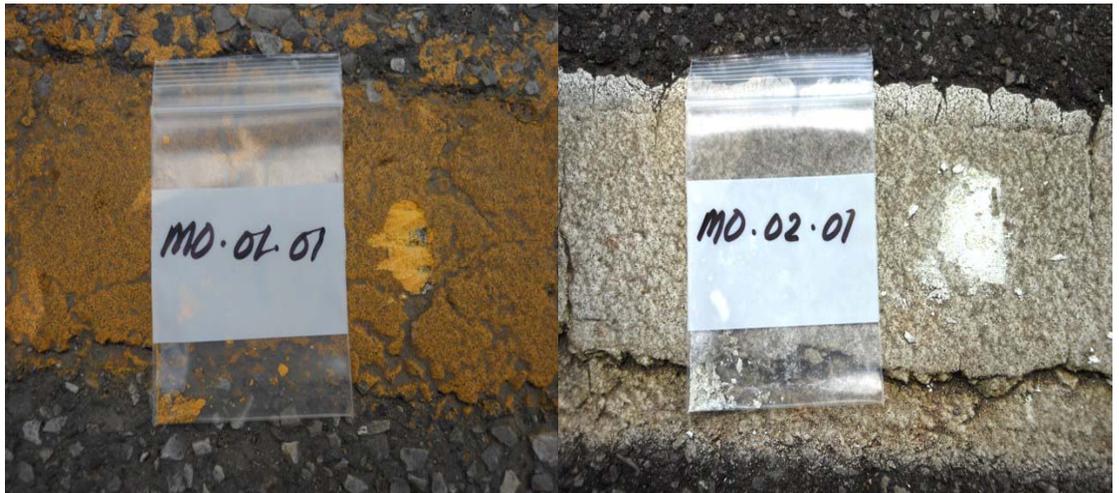
Comments:  
P-10 Yellow and  
white striping were  
the only suspect  
materials on the top  
of the bridge. Striping  
samples did not  
contain asbestos.
