**TENNESSEE DEPARTMENT OF TRANSPORTATION
ASBESTOS INSPECTION REPORT
SR-140 Bridge over Mill Creek, LM 23.03 (40S81720003)
Henry County
TDOT Project No. 40030-4208-04, PIN 117914.00**

September 5, 2014
AMEC Project No. 180914002

PROJECT: Asbestos Survey
 Bridge 40S81720003 (40-SR140-2303)
 SR-140 Bridge over Mill Creek, LM 23.03
 Henry County, Tennessee

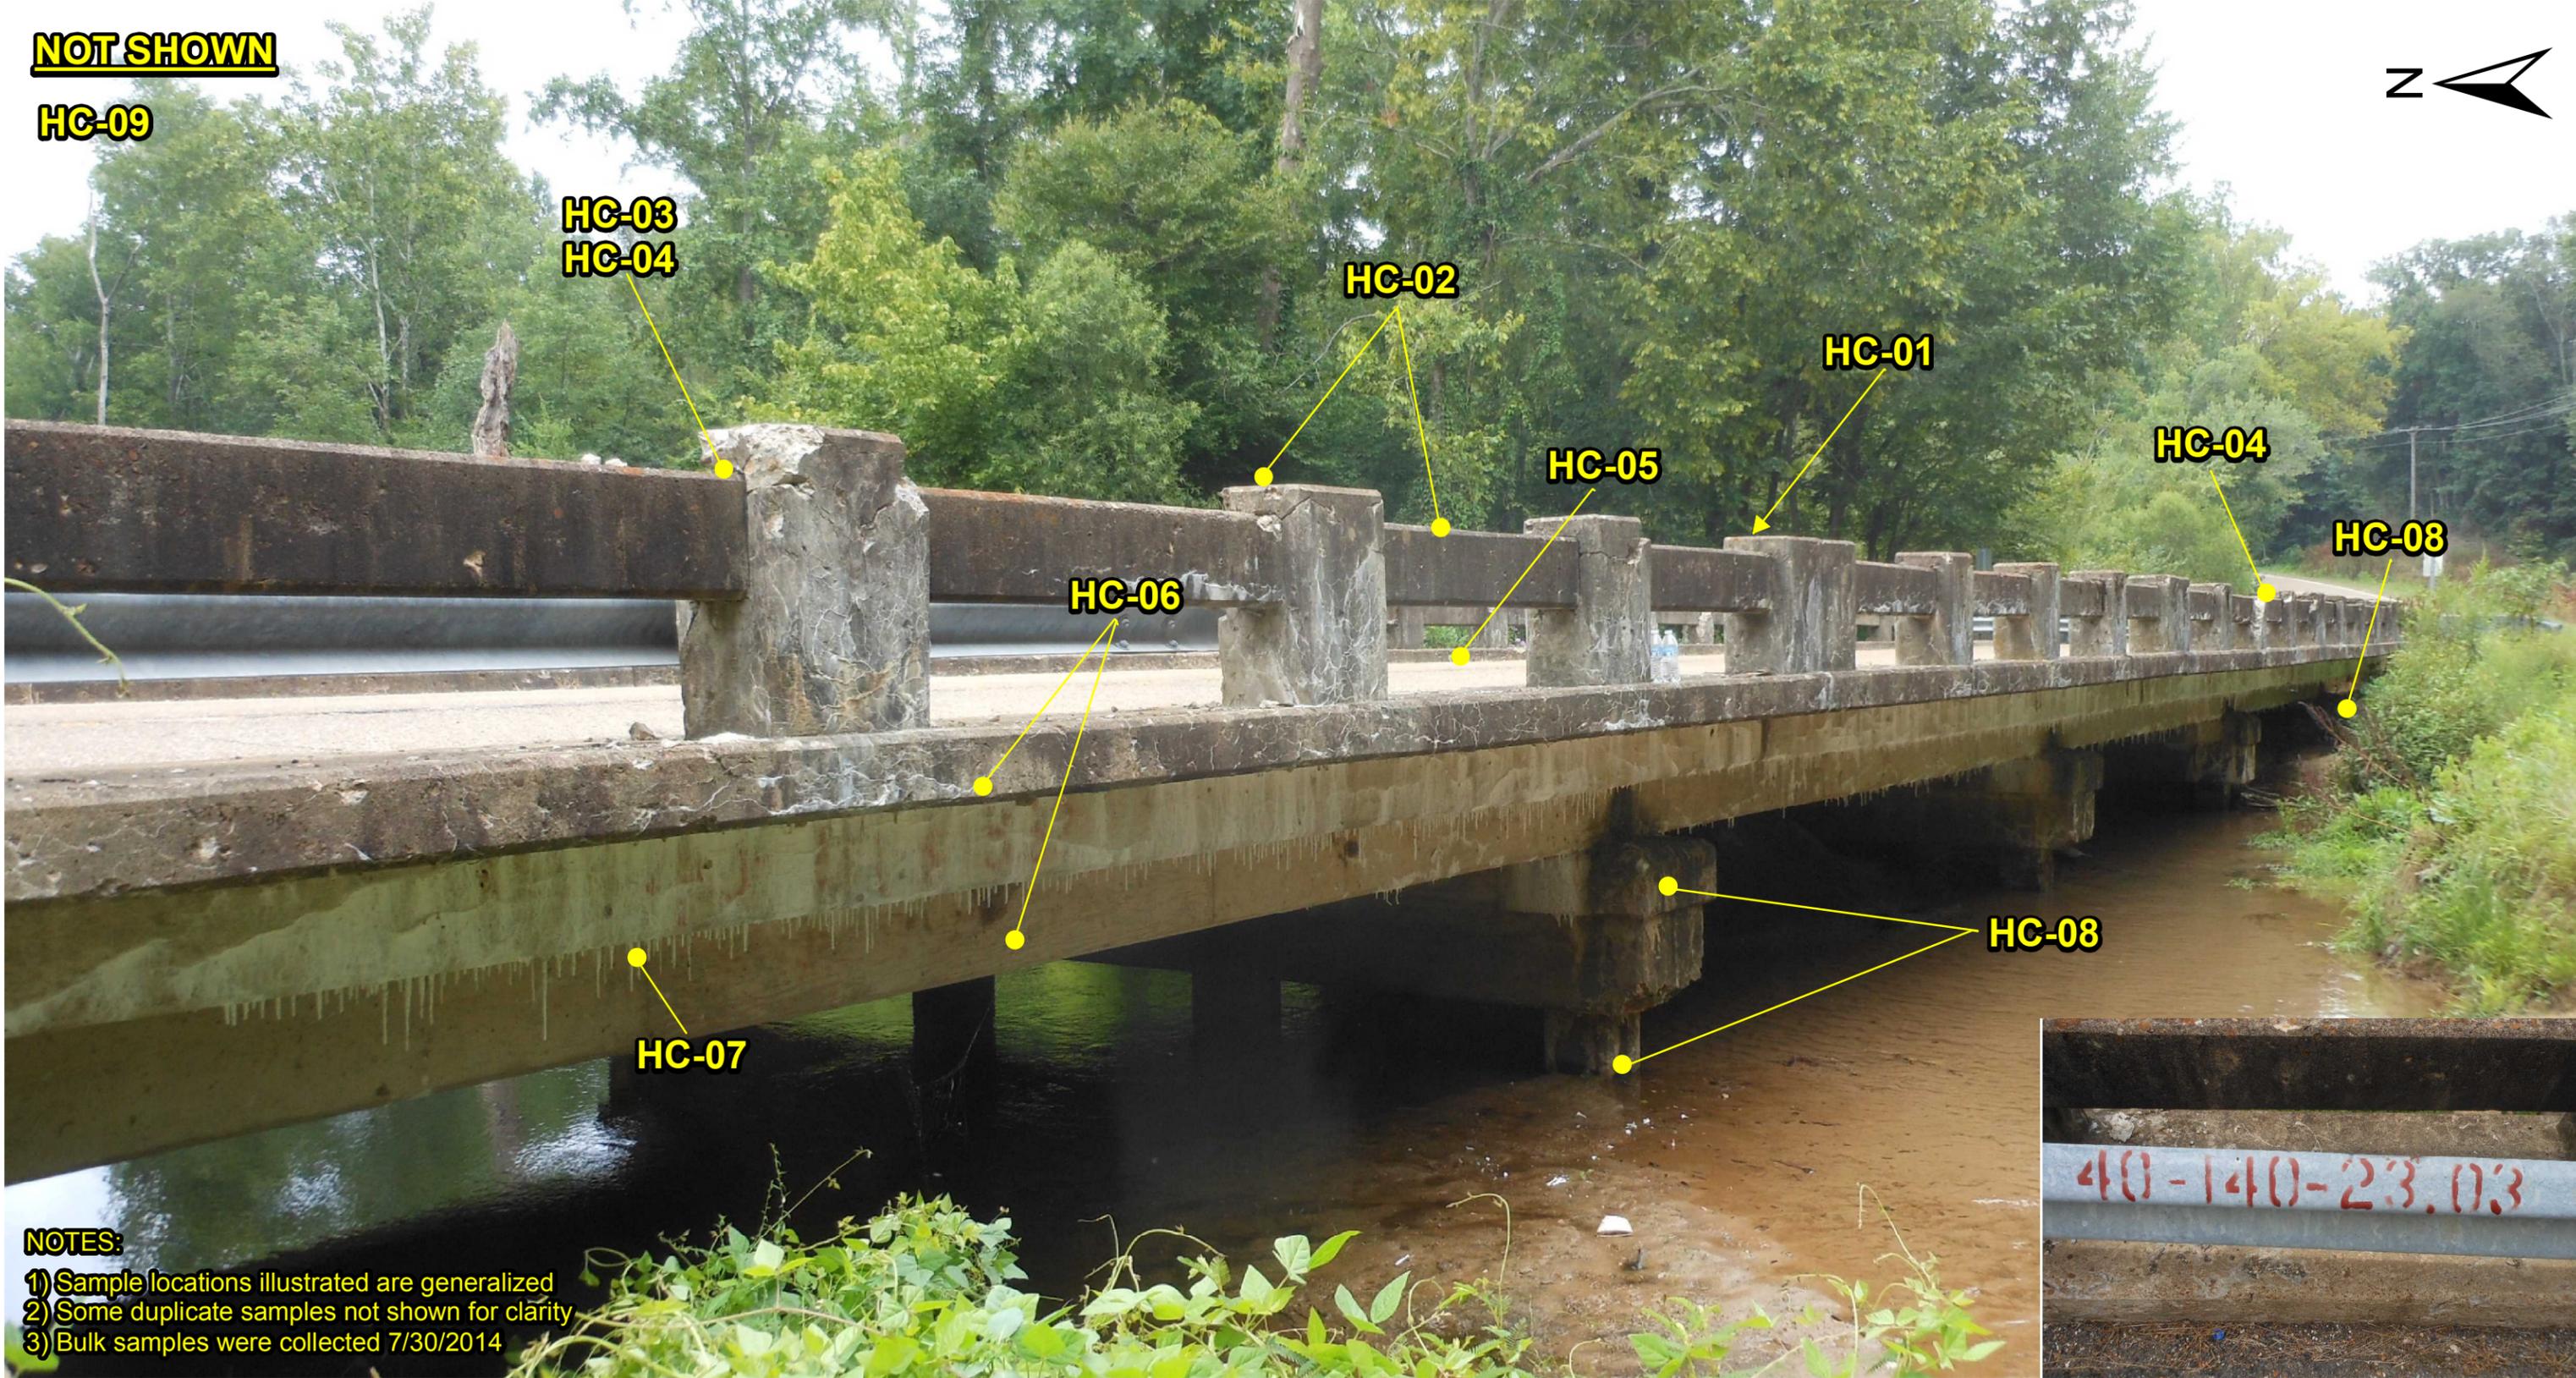
**Figure 1: Bridge Profile
(Depicting Sample Locations)**

A total of 30 samples, from nine (9) HAs, were collected on July 30, 2014 and submitted for laboratory analysis. **Figure 1** is a side view or profile of the bridge with representative sample locations noted. Typical photographs of the bridge and various sampling locations are presented in **Appendix B**, and Chain-of-Custody forms and laboratory analytical data sheets are included in **Appendix C**.

- 1) Sample locations illustrated are generalized
- 2) Some duplicate samples not shown for clarity
- 3) Bulk samples were collected 7/30/2014

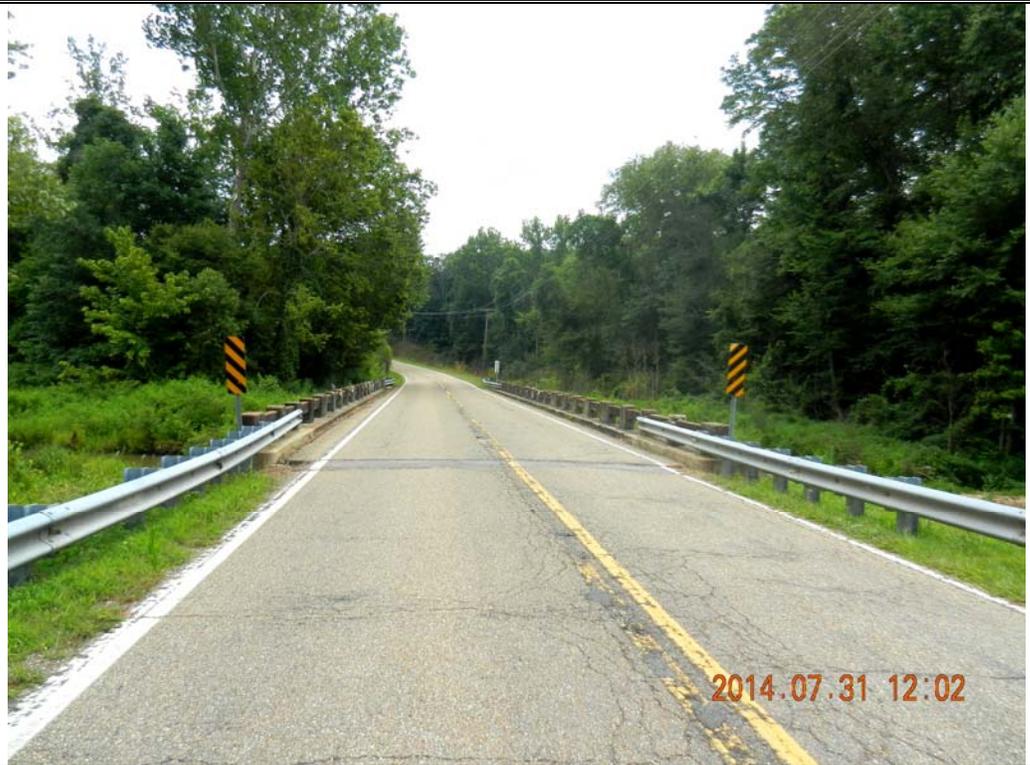
Comments:
P-1 – Bridge approach
from West

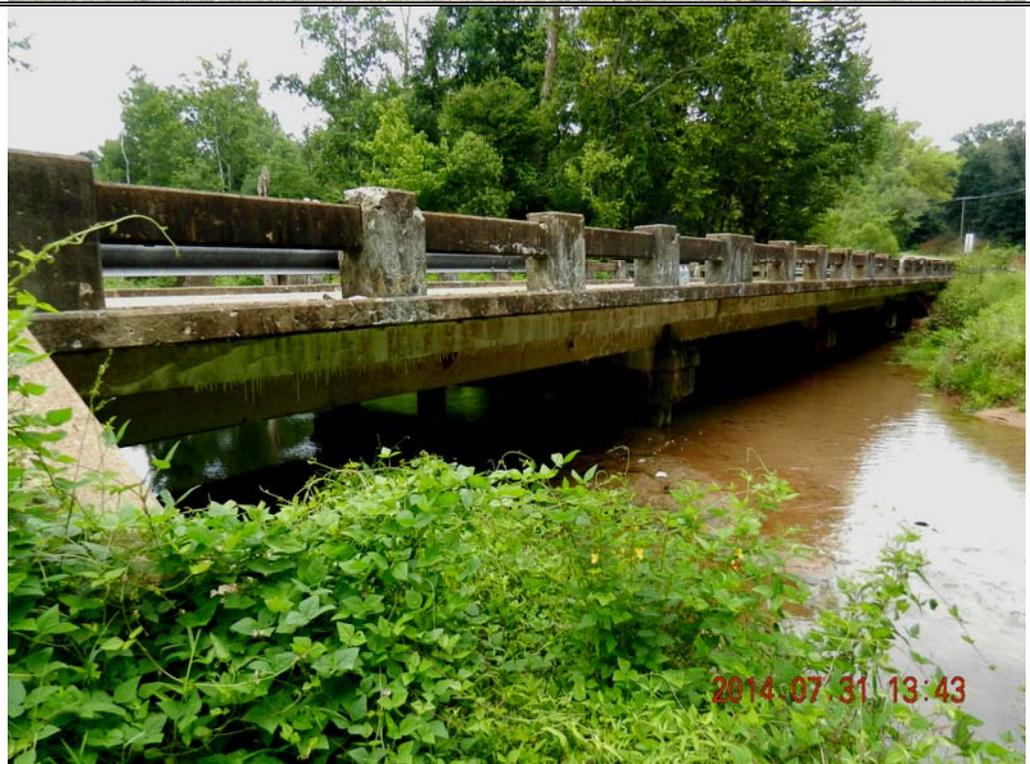
Comments:
P-2 Profile of bridge
from downstream.
Bridge is a five span
structure. Bridge was
constructed in 1957.

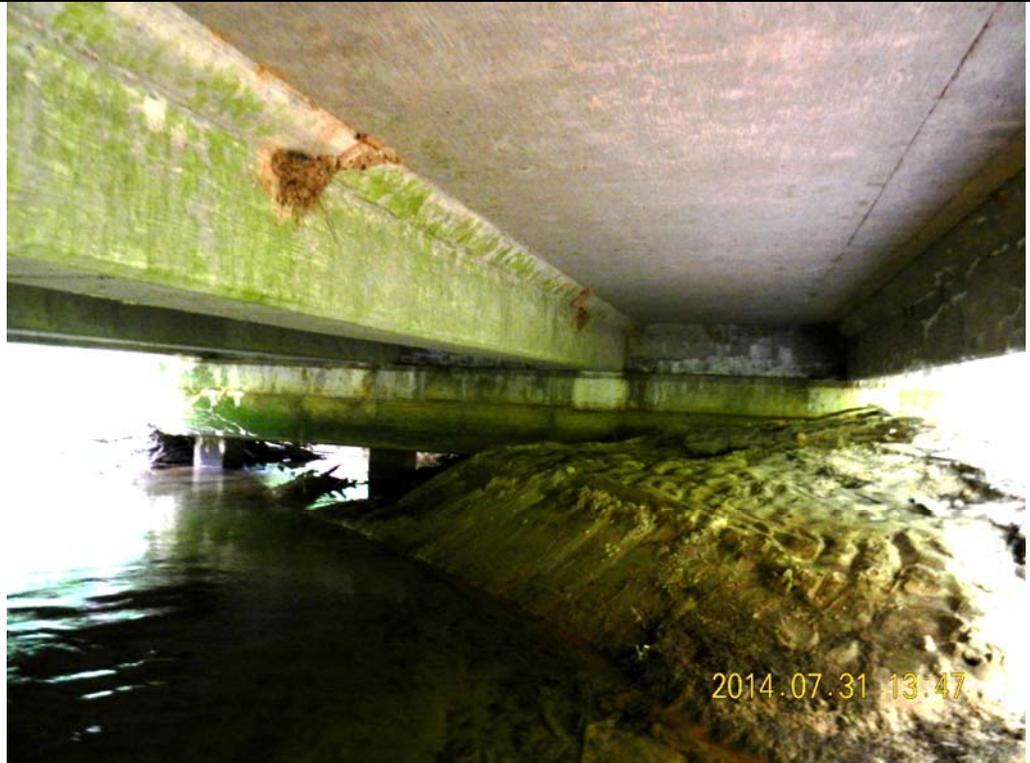
The concrete piles, bents (pile caps), and beams were accessible without assistance and appeared to be homogenous. Samples (HA-06 & HA-08) were collected from the piles, caps, and support beams. No bearing pads were observed.

Comments:
P-3 – Bridge is cast in place concrete structure with integral deck and beams. Beams are supported by pile caps at bents. No bearing pads were observed.

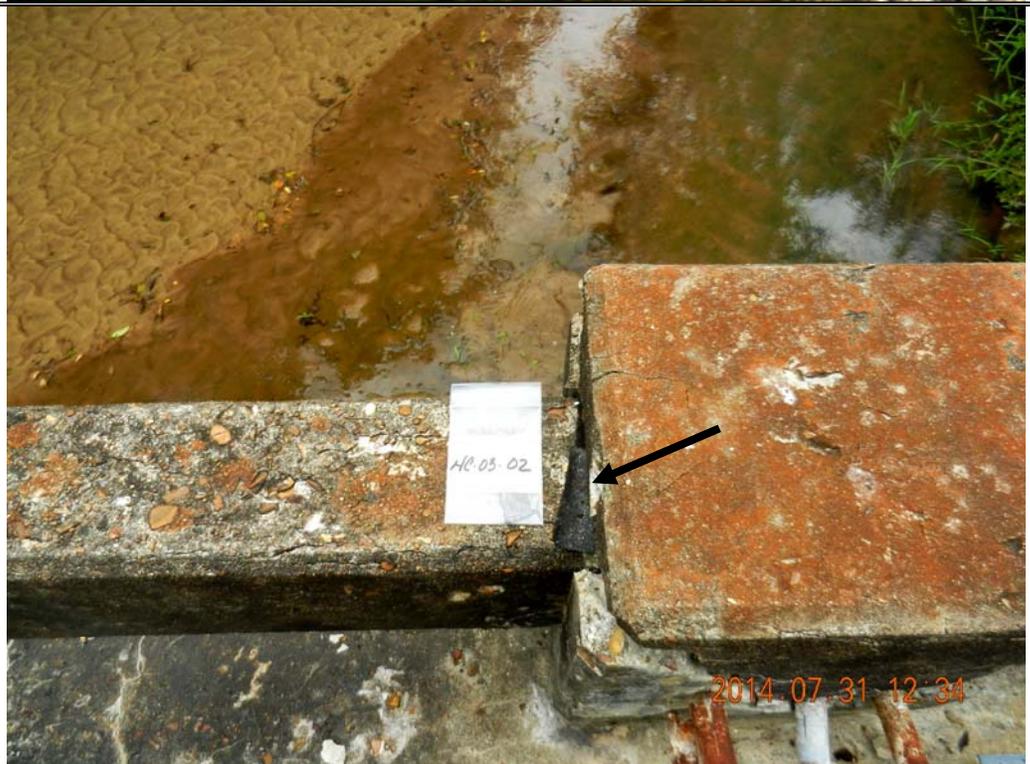
Comments:
P-4- View of bridge railing. Ends of rails are wrapped with builders felt (HA-03) to allow rails to slip in post. Felt was not asbestos. Bridge surface is not coated.

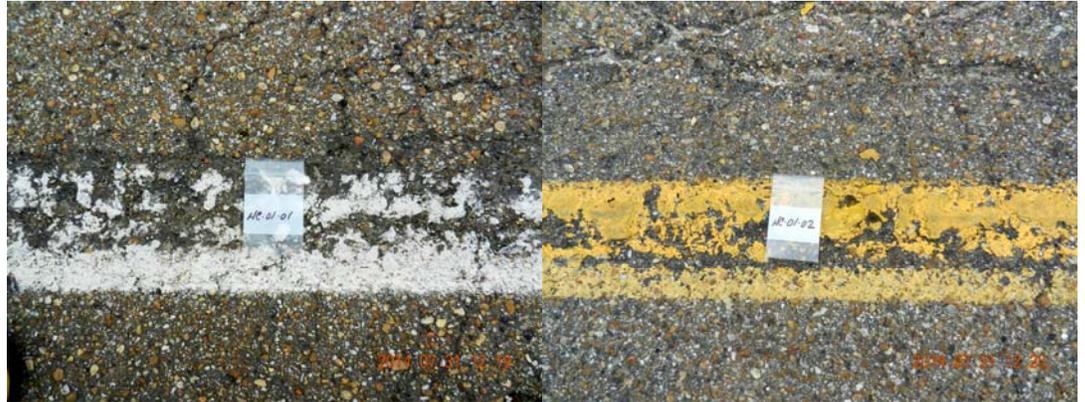
Comments:
P-5 – Deck has an asphalt wearing surface. Samples were collected of white and yellow pavement stripes (HA-01). Neither striping material was asbestos.

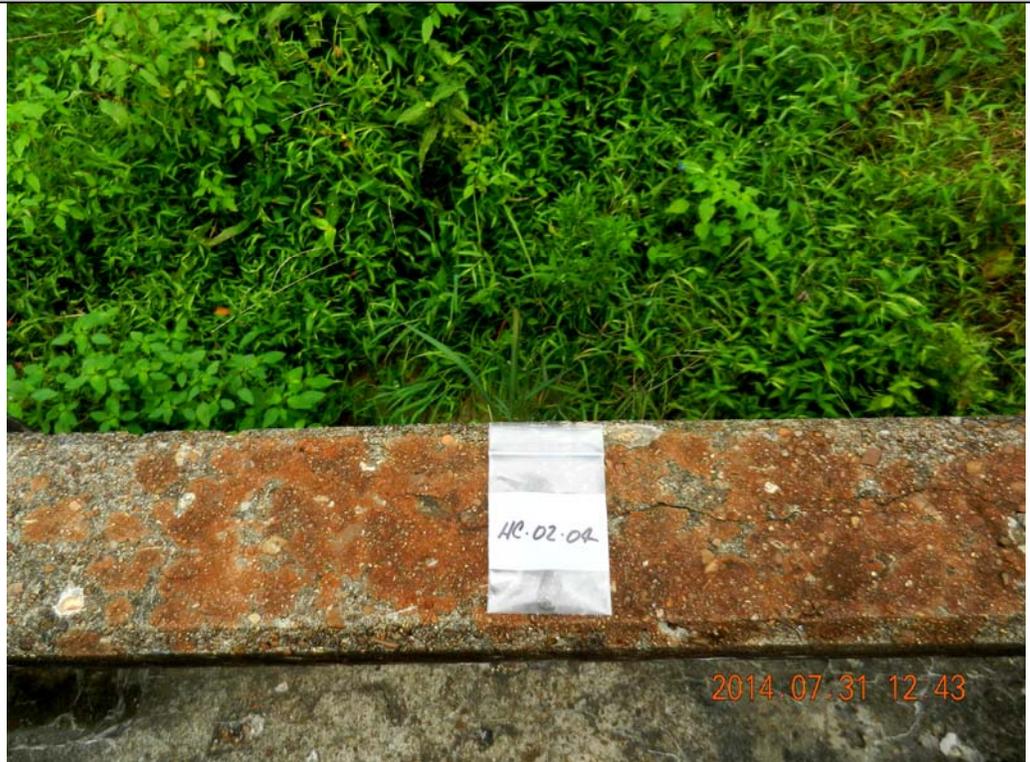
Comments:
P-6- Concrete above deck sampled from the railing and posts on top of the bridge (HA-02). Concrete did not test positive for asbestos.

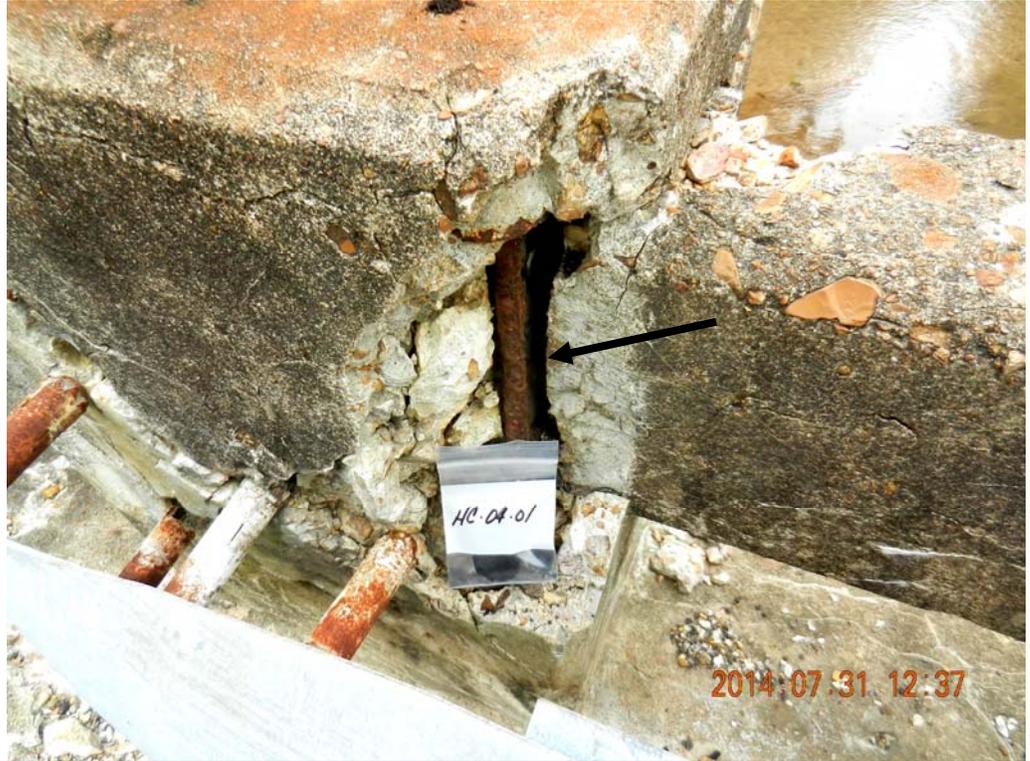
Comments:
P-7 – Black expansion board material (HA-04). This sample collected from void between post and end of rail. No expansion material tested positive for asbestos.

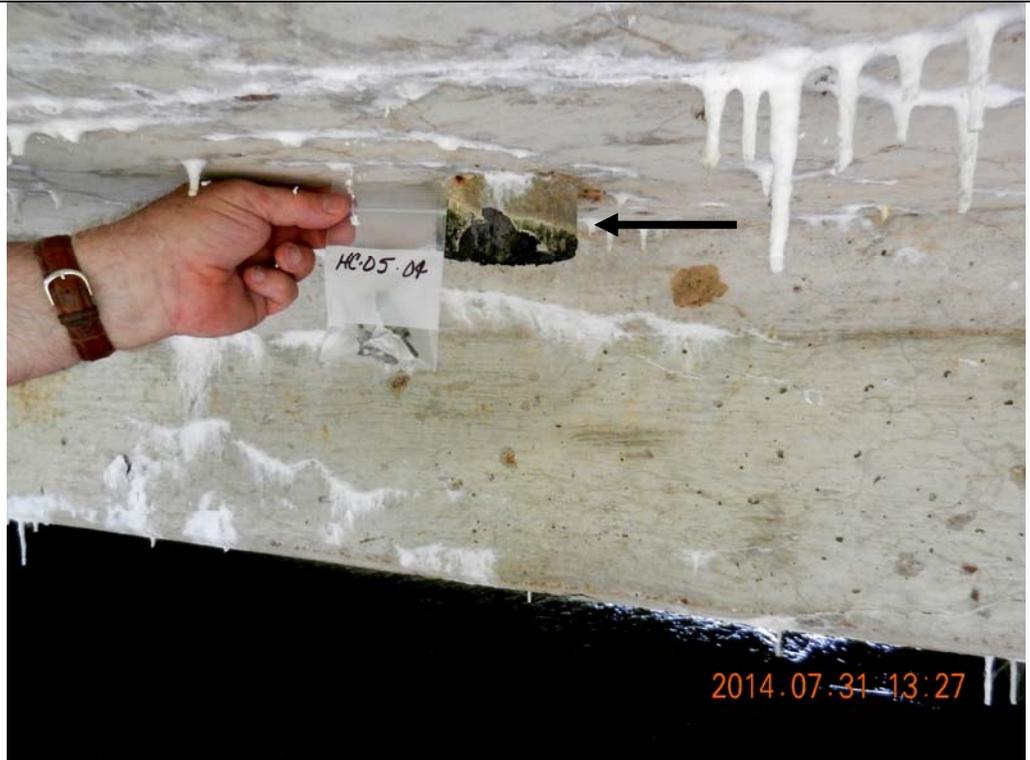
Sample Number	Description	Type	Sample Location	Percent Asbestos
HC-05-01	Transite Scupper Pipes	Misc/ NF	Through Deck Drains	30% Chrysotile 2% Crocidolite

Based on the sample results, the Transite scupper piping material was determined to be asbestos-containing material. The duplicate samples of this material were not analyzed per the “Positive Stop” protocol. The analytical results of all the samples collected from the property, along with the chain-of-custody records, are included in **Appendix C**.

Comments:
P-8 – Sample of asbestos Transite scuppers (HA-05). Scuppers are visible from both top and bottom of the deck. A row of 21 scuppers runs the length of the deck on both sides.

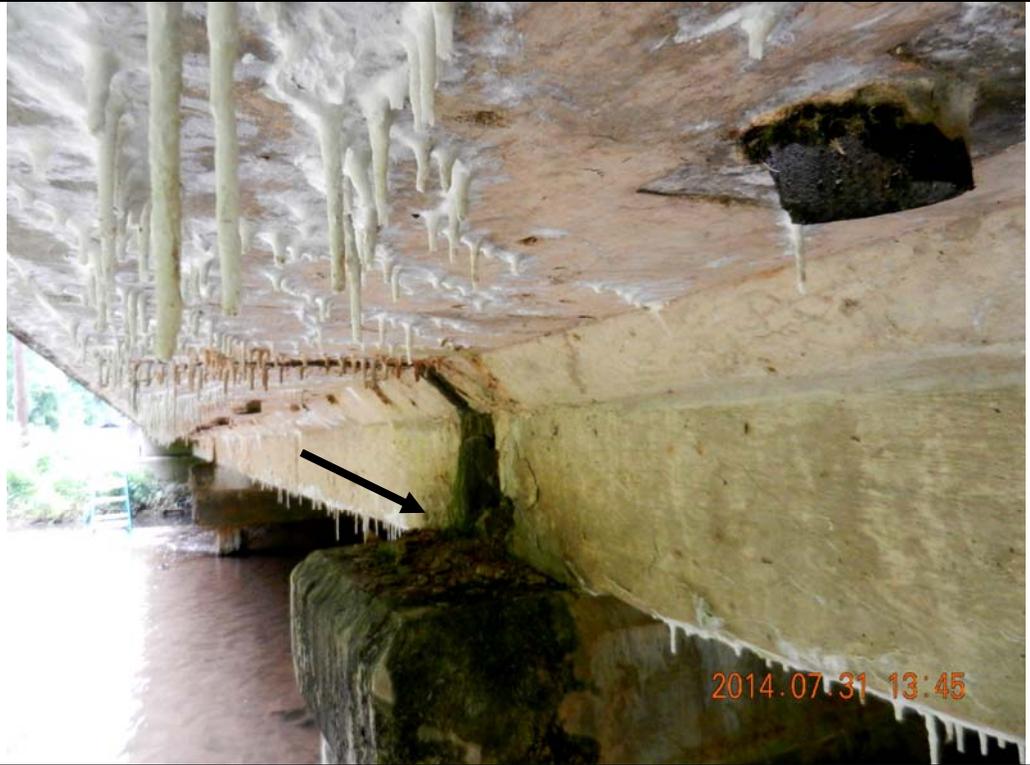
Comments:
P-9 No expansion material or bearing pads were under diaphragms or beams at piers. Concrete samples (HA-08) did not contain asbestos.

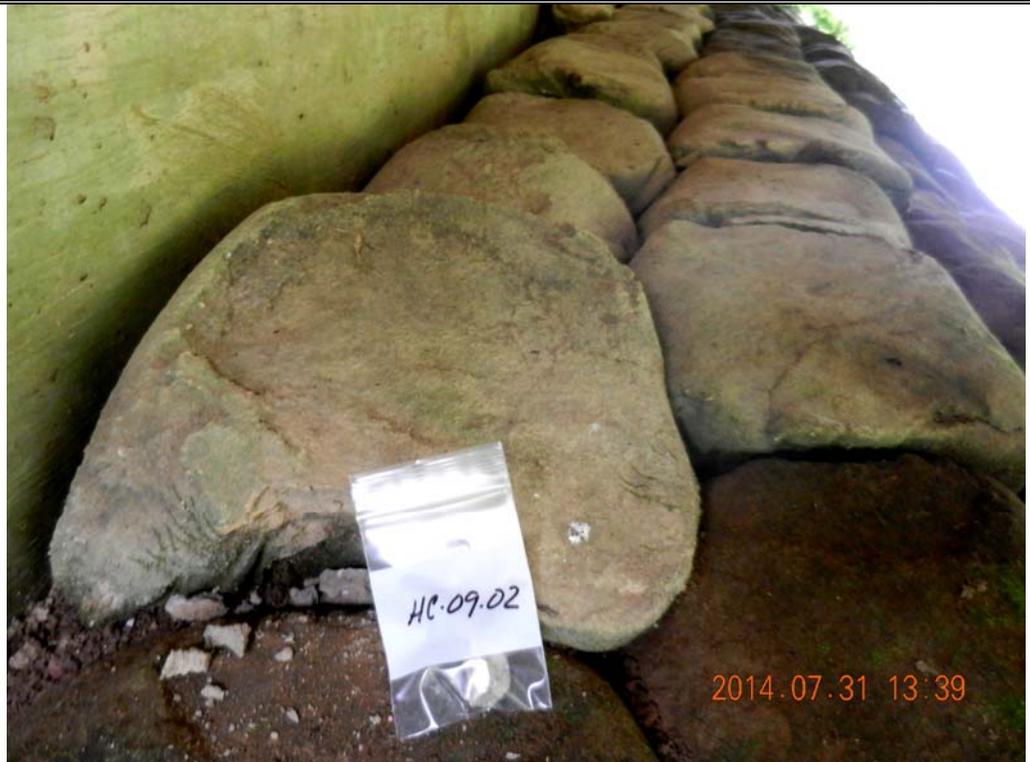
Comments:
P-10 – Sand/cement riprap (HA-09) at Abutment 1. Samples from sand/cement riprap did not contain asbestos.

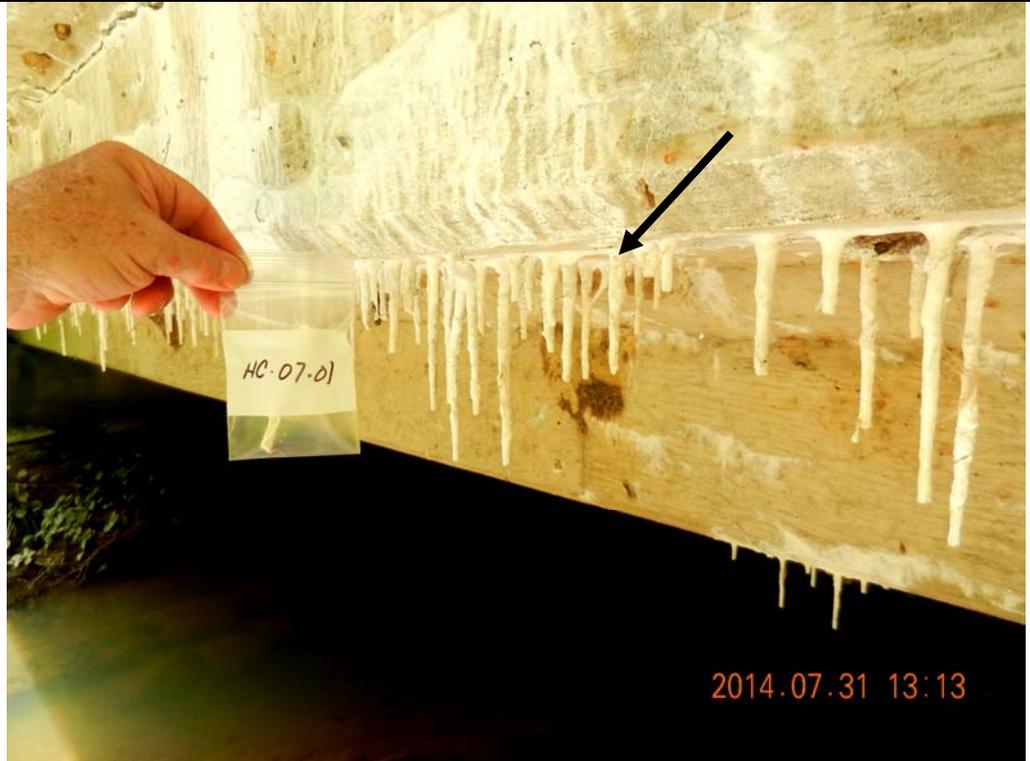
Comments:
P-11 View of
efflorescence along
bridge beam.
Efflorescence samples
(HA-07) did not contain
asbestos.

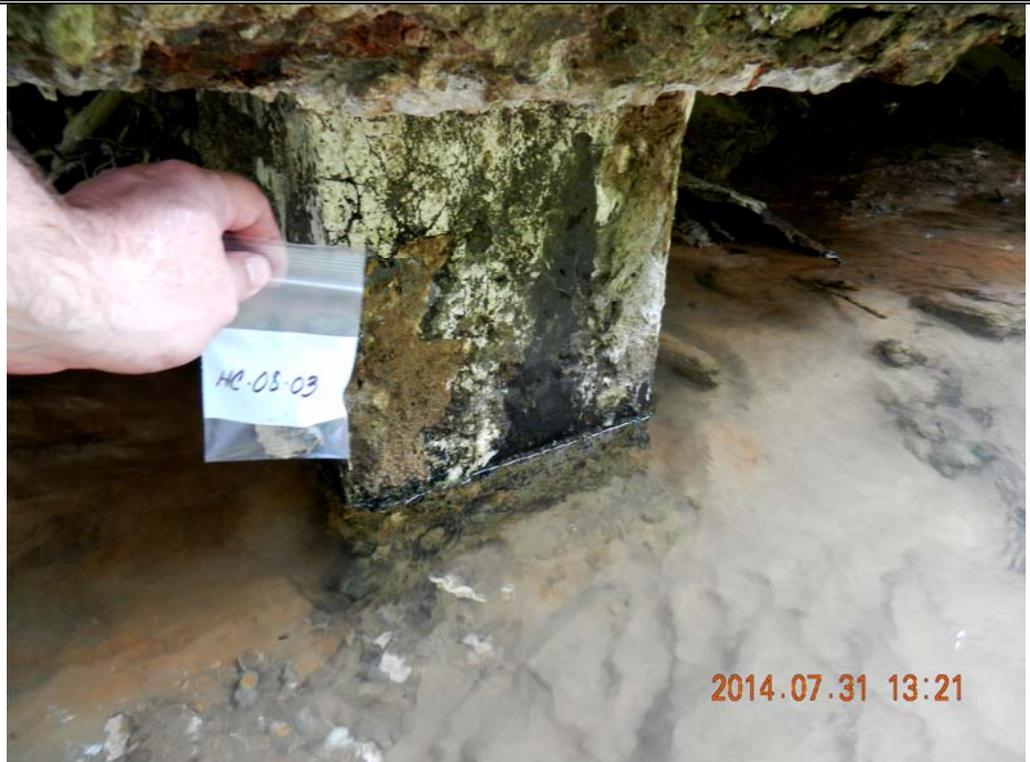
Comments:
P-12 – Concrete pile
supporting concrete
bent cap. Concrete
samples (HA-08) did
not contain asbestos.
