Re: Asbestos Inspection Report
Shelby County; SR-14 Overflow Bridge
Bridge #: 79SR0140033 (LM 26.58)
TDOT Project # 79024-4298-04, PIN 116134.00
TDOT Contract: E1647; Work Order: 06

TENNESSEE DEPARTMENT OF TRANSPORTATION ASBESTOS INSPECTION REPORT

Overflow Bridge
Bridge No. 79SR0140033 (LM 26.58)
State Route 14
Bartlett, Shelby County

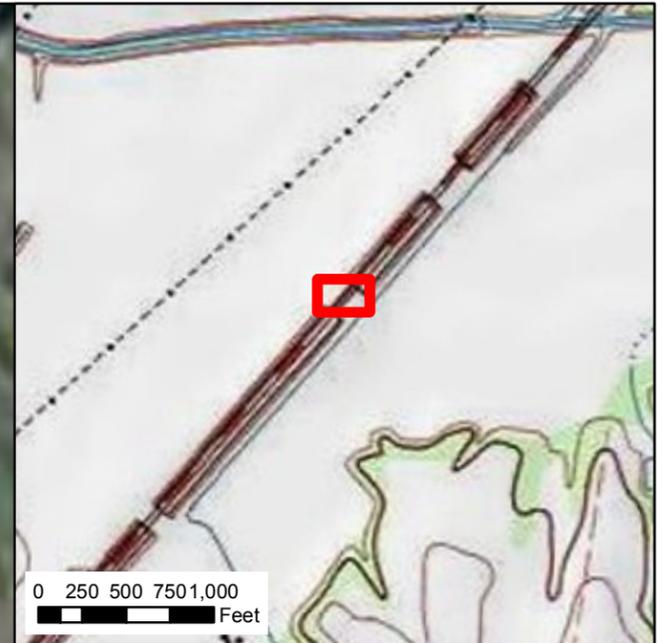
Figure – 2: Asbestos-Containing Pipe Wrap Sample Locations

● 33HA-12A

● 33HA-12B

● 33HA-12C

● Sampled Drain Pipe Wrap Location. Approximately twenty five 4-inch diameter drains total, with an estimated 25 linear feet of ACM for all 25 drains.

Table – 2 below summarizes the various sampled materials which were found to contain greater than 1% asbestos minerals. Figure – 2 delineates the locations of ACM-containing samples. Photographs of the different HAs sampled that were found to be asbestos-containing are presented in Appendix B, and the analytical result of all the samples collected from the property, along with the chain-of-custody records, are included in Appendix C.

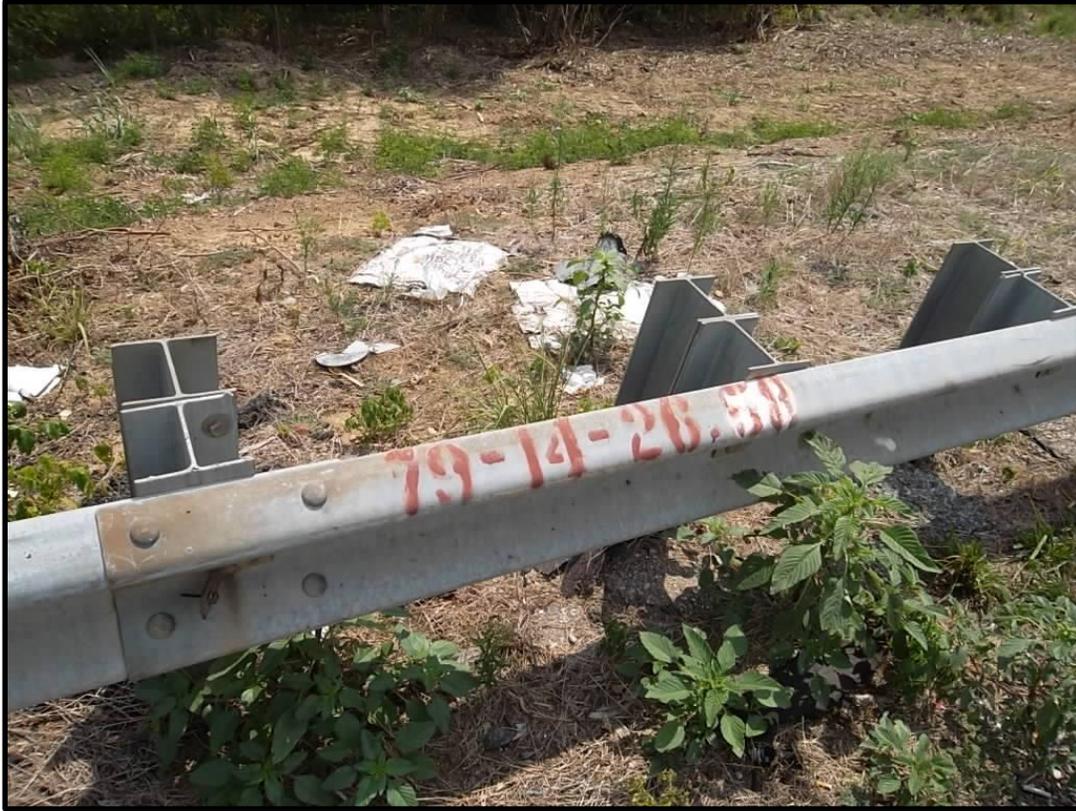
Photo 1: Bridge Identification photograph.

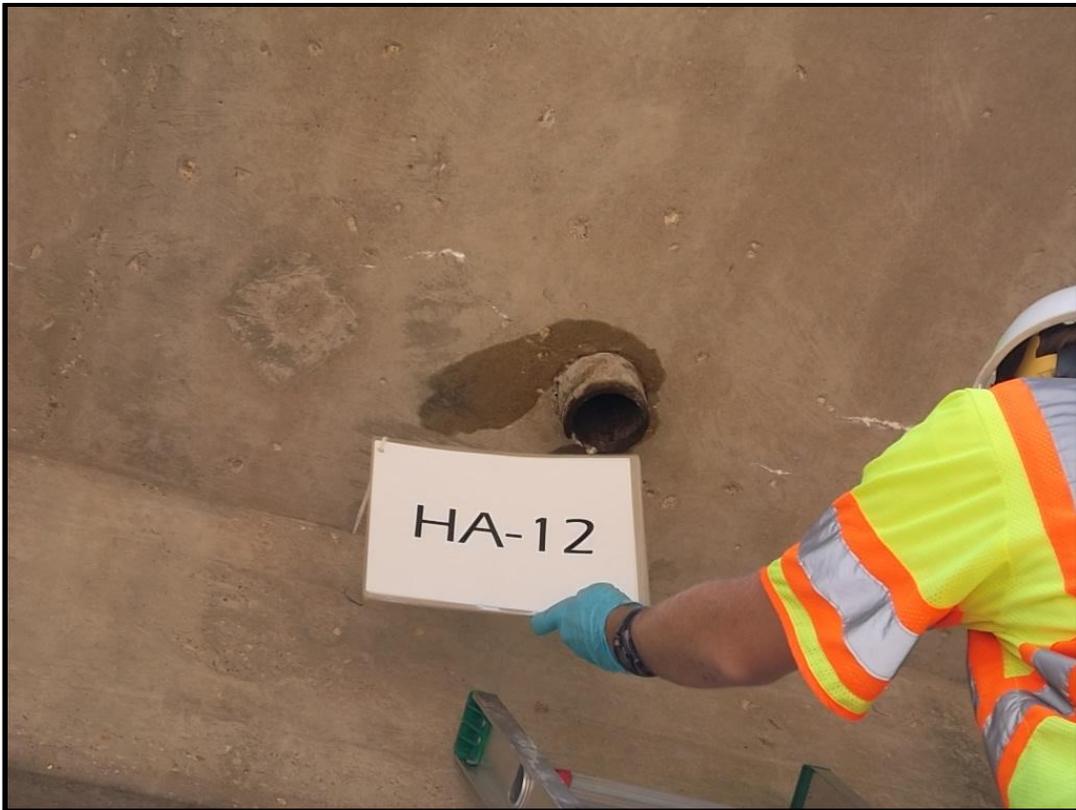
Enclosed is the asbestos inspection report for the above-referenced bridge. A total of 42 samples were obtained during the inspection. Asbestos was detected in the wrap around the drain pipes that penetrate the decking. There were 25 drains located, but based on the condition of the drains, it was not possible to determine if the entire drain pipe is wrapped in this material or if it is only the portions that extend below the bridge deck. Most likely it is the entire drain.

In its current condition this ACM was determined to be non-friable, that is, it could not be pulverized using hand pressure alone. Accordingly, it is classified under EPA NESHAP rules (40 CFR 61) as a Category II non-friable ACM in its current condition. Depending upon the type of bridge maintenance required, there could be potential for the material to become pulverized and thereby become friable, at that time it would be considered a "Regulated Asbestos-Containing Material" (RACM).

Drainage from the bridge is through piping cored through the bridge deck on the northwest side of the bridge. The piping appeared to be metal and was coated with a hard wrapping. The pipe wrap was sampled as 33HA-12A through 33HA-12C.

Photo 2: Asbestos-containing sample of wrapping located around the drain pipes.

OSHA would consider the abatement of RACM to be a Class II activity, which would require trained workers and a competent person to oversee the work (an asbestos supervisor). Additionally, State of Tennessee asbestos accreditation requirements (TCA 1200-01-20) mandate that such work be performed by an accredited firm (contractor) using accredited abatement workers and supervisors.
