MEMORANDUM

Subject: ENVIRONMENTAL BOUNDARIES AND MITIGATION DESIGN FOR:
Fayette County, Interstate 40 Interchange at State Route 222
P.E. 24001-0147-44 PIN 114219.00

Fayette County I-40 Interchange at SR-222

Project: Fayette County, I-40 at SR-222

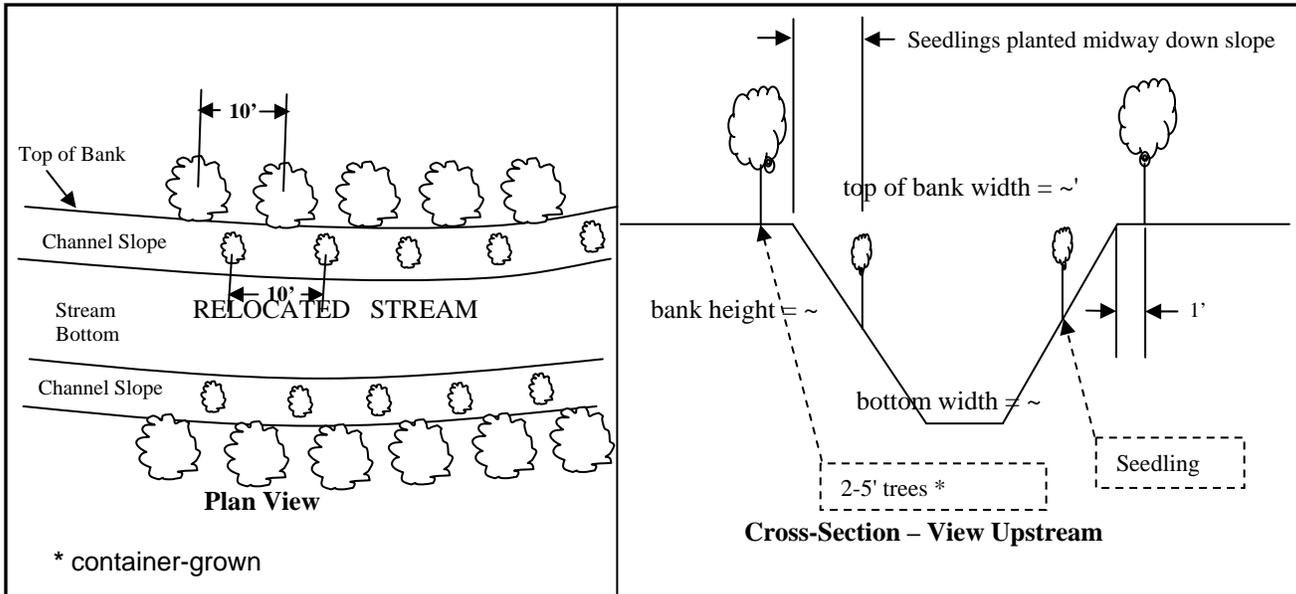
SPACING FOR PLANTING ALONG RELOCATED STREAM

Plant two alternating rows of tree or shrub species on both sides of the new channels; the first row shall be bare root seedlings that are planted on the channel slope, centered on the midpoint of the slope. Along top of bank, two- to five-foot (2-5 ft) container grown trees are to be planted within one foot of the top of bank. If needed, black willow (*Salix nigra*) stakes will be installed along the edge of water in the new channel. The stakes will be fresh material cut in approximately foot lengths. The stakes will be installed on approximately five foot centers at the edge of water in the new channel. The stakes are to be driven in such that approximately six inches of the stake are left above ground. The bare root seedlings will be the same species as the trees, unless otherwise indicated.

Rip-rap, if required, should be limited to ends of culverts. All relocated channels and their accompanying mitigation features, including trees, are to be placed in right-of-way rather than easements; this may require acquisition of additional right-of-way. Use the following specifications for planted species.

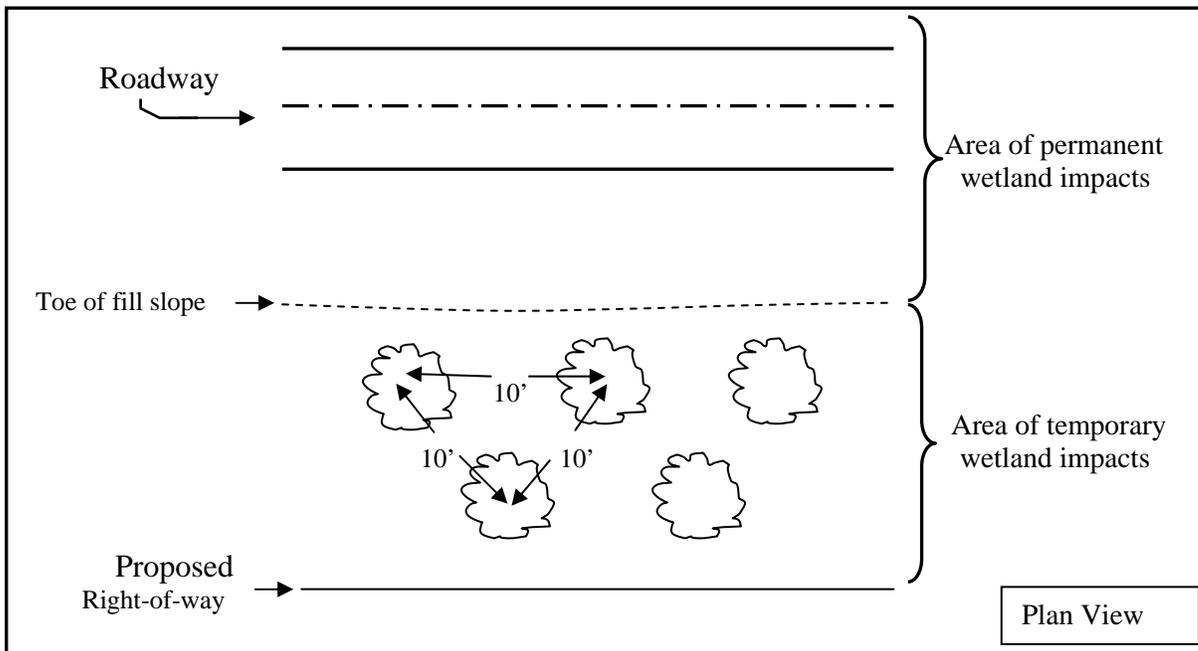
Tree planting scheme for temporary wetland impact areas

Apply these measures to all applicable temporary wetland impact areas listed in Form J. For temporary wetland impact areas, remove the top 12" of topsoil and stockpile it until construction is complete. Once construction activities are completed, restore all temporary wetland impact areas to pre-construction conditions. This includes removing haul roads (if applicable), restoring the site to the original (pre-construction) elevation and spreading stockpiled topsoil back over the wetland site. The area of temporary impacts will be stabilized according to standard practices. Planting will be based on notes provided by Ecology. Wetland areas located outside of proposed right-of-way and construction easements are to be clearly marked and not disturbed.

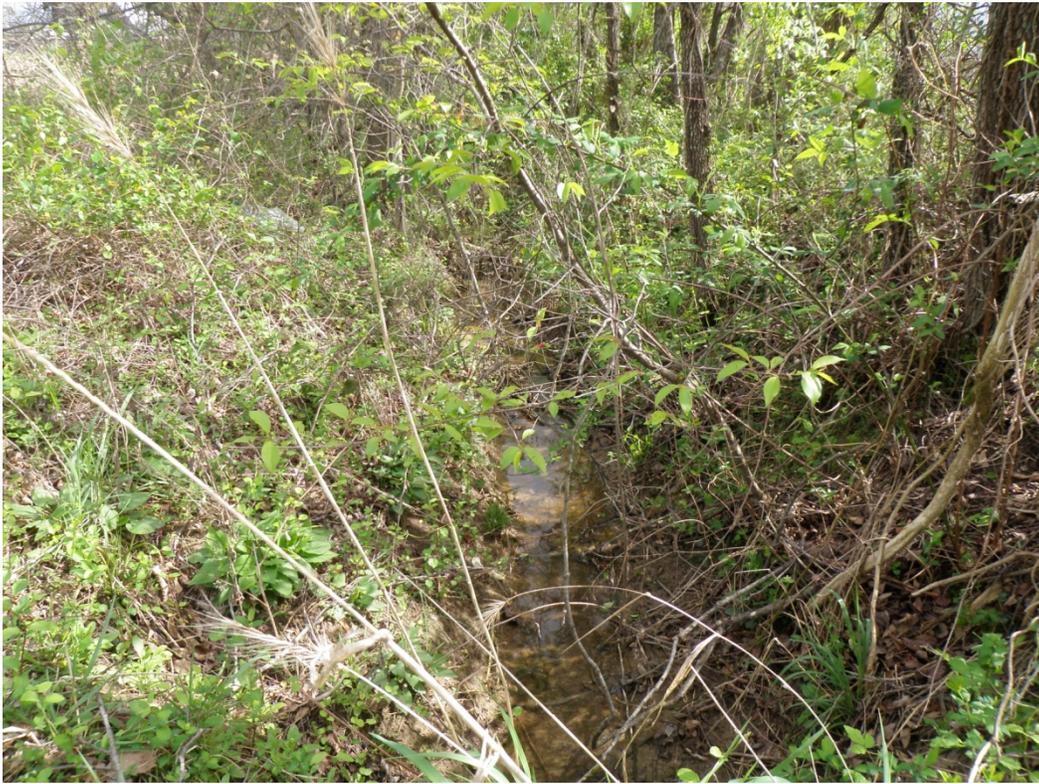
1-Station: from plans	None provided
2-Map label and name	STR-1
3-Latitude/Longitude	89 24'41.27"W 35 23'40.18"N
4-Potential impact	Crossing
5-Feature description:	
what is it	Intermittent stream
blue-line on topo? (y/n)	No
defined channel (y/n)	Yes
straight or meandering	Straight
channel bottom width	1'
top of bank width	6'
bank height and slope ratio	3'
avg. gradient of stream (%)	
substratum	Soil, leaves
riffle/run/pool	20/0/80
width of buffer zone	LB: 7' RB: 7'
water flow	Slight
water depth	2"-1'
water width	1'
general water quality	Clear, flowing
OHWI indicators	Bed and bank, vegetation absent, deposition
groundwater connection	Yes
bank stability: LB, RB	Eroding
dominant species: LB, RB	Black willow, box elder, honeysuckle
overhead canopy (%)	85%
benthos	No
fish	No
algae or other aquatic life	Algae
habitat assessment score	
photo number (s)	1 Looking D/S from farm road crossing; 2 looking U/S from farm road crossing

STR-1 looking downstream from farm road crossing

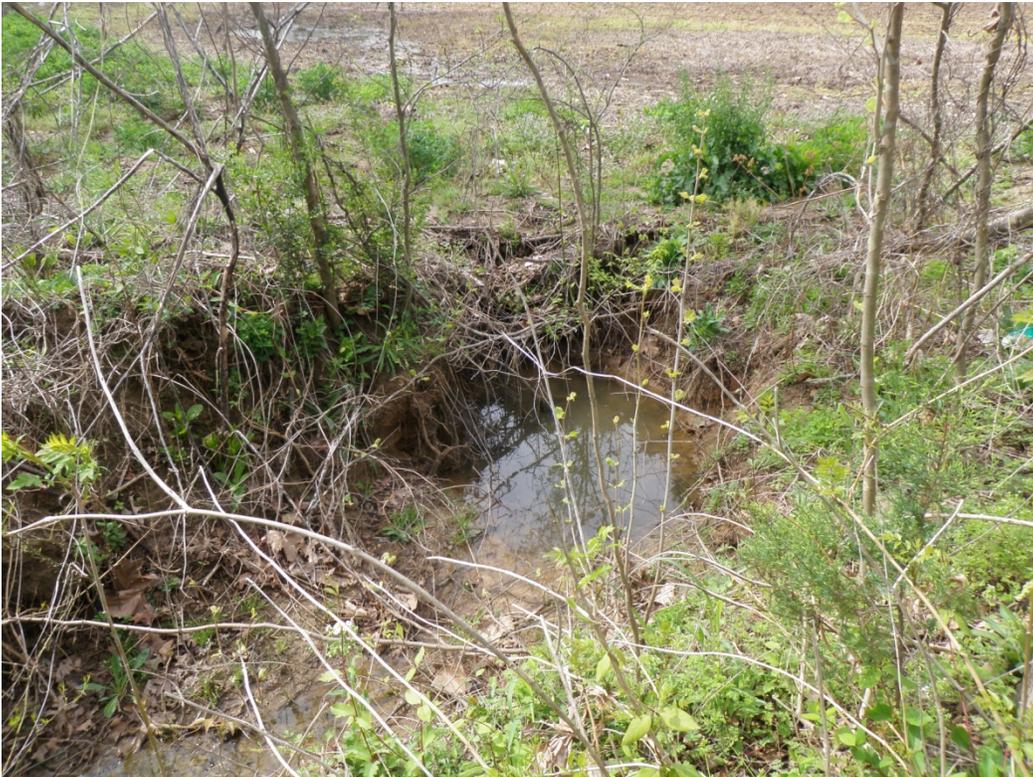
Remarks:
 SPG-1 to west is hydrology source for WTL-1 and STR-1

SPG-1 looking west

Station	Map label	Attachments: Marked-up plans sheet (A); notes (B); mitigation plan (C) attached	Calculate permanent & temporary wetland impacts & provide to (name of regional biologist) and John Hewitt ("X")	Apply "standard" stream relocation configuration & instructions ("X")	Survey boundaries as flagged in field ("X")	General notes and/or specific changes requested
None Provided	STR-1	A, B, C		X		Unknown if STR-1 will require relocation or culvert extension. In-lieu fee payment required if culvert exceeds 200'. Standard stream relocation (attached) applies if a required relocation exceeds 50' in length.
None Provided	WTL-1	A, B, C	X		X	Unknown if WTL-1 will be impacted. If permanent project wetland impacts exceed 0.10 acres, mitigation will be required at 2:1 ratio in the Hatchie Mitigation Bank. Temporary wetland impact instructions are attached if necessary.
None Provided	SPG-1	A				Unknown if SPG-1 will be impacted. A spring box will be required to maintain flow to STR-1 if fill will cover SPG-1.

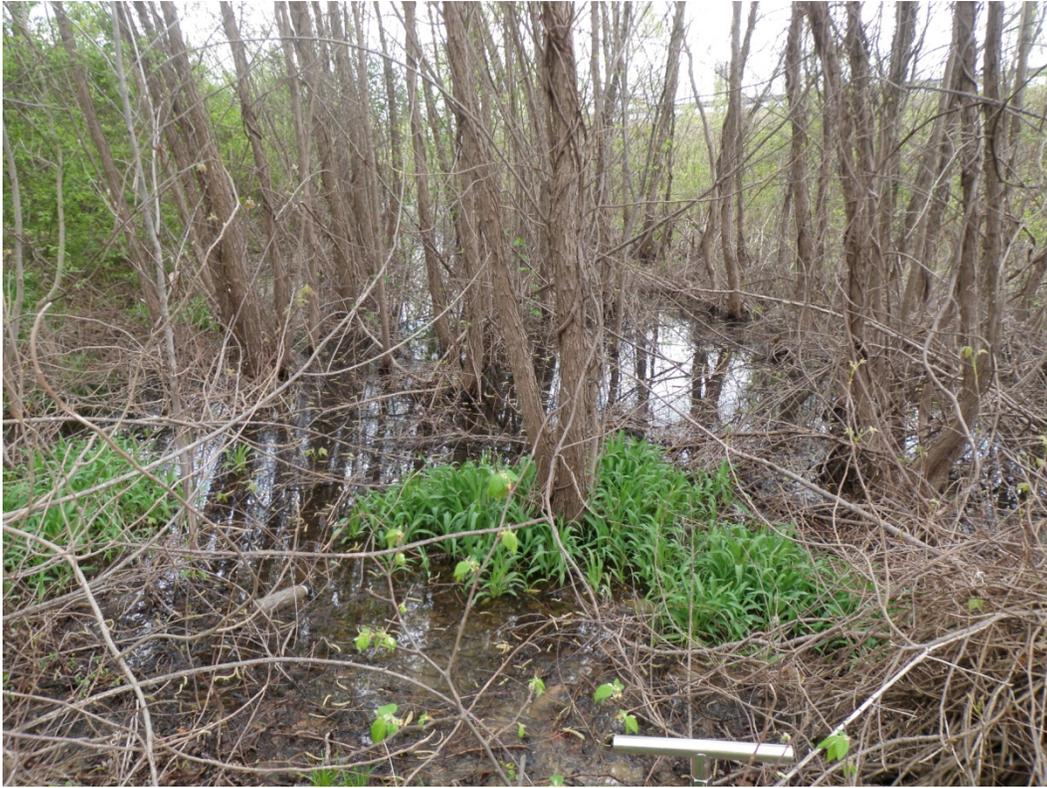
Hydrophytic Vegetation Present? Yes _____ No _____ Hydric Soil Present? Yes _____ No _____ Wetland Hydrology Present? Yes _____ No _____	Is the Sampled Area within a Wetland? Yes _____ No _____
Remarks: Photo 5 looking east

Remarks:
 Water held between I-40 ramp and berm to north.

WTL-2 looking east

None Provided	WTL-2	A B, C	X		X	Unknown if WTL-1 will be impacted. If permanent project wetland impacts exceed 0.10 acres, mitigation will be required at 2:1 ratio in the Hatchie Mitigation Bank. Temporary wetland impact instructions are attached if necessary.
None Provided	WTL-3	A, B, C	X		X	Unknown if WTL-1 will be impacted. If permanent project wetland impacts exceed 0.10 acres, mitigation will be required at 2:1 ratio in the Hatchie Mitigation Bank. Temporary wetland impact instructions are attached if necessary.

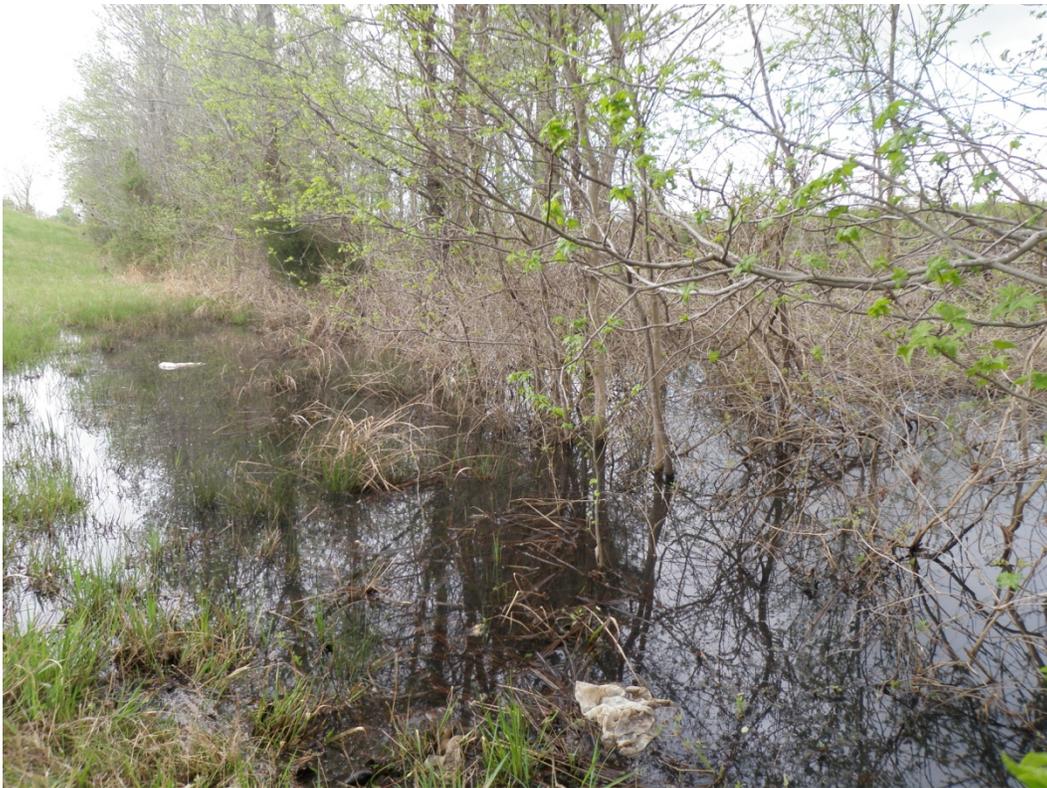
Hydrophytic Vegetation Present? Yes <input checked="" type="checkbox"/> No _____ Hydric Soil Present? Yes <input checked="" type="checkbox"/> No _____ Wetland Hydrology Present? Yes <input checked="" type="checkbox"/> No _____	Is the Sampled Area within a Wetland? Yes <input checked="" type="checkbox"/> No _____
Remarks: Photo 6 looking west

Remarks:
 Water held between I-40 ramp and field road to the north.

WTL-3 looking west
