**TENNESSEE DEPARTMENT OF TRANSPORTATION  
ASBESTOS INSPECTION REPORT**

**I-40 Bridges (EB & WB) over SR-29, LM 9.96  
Roane County  
TDOT Project No. 73100-4116-04  
PIN 118499.00**

August 16, 2013  
AMEC Project No. 164613031

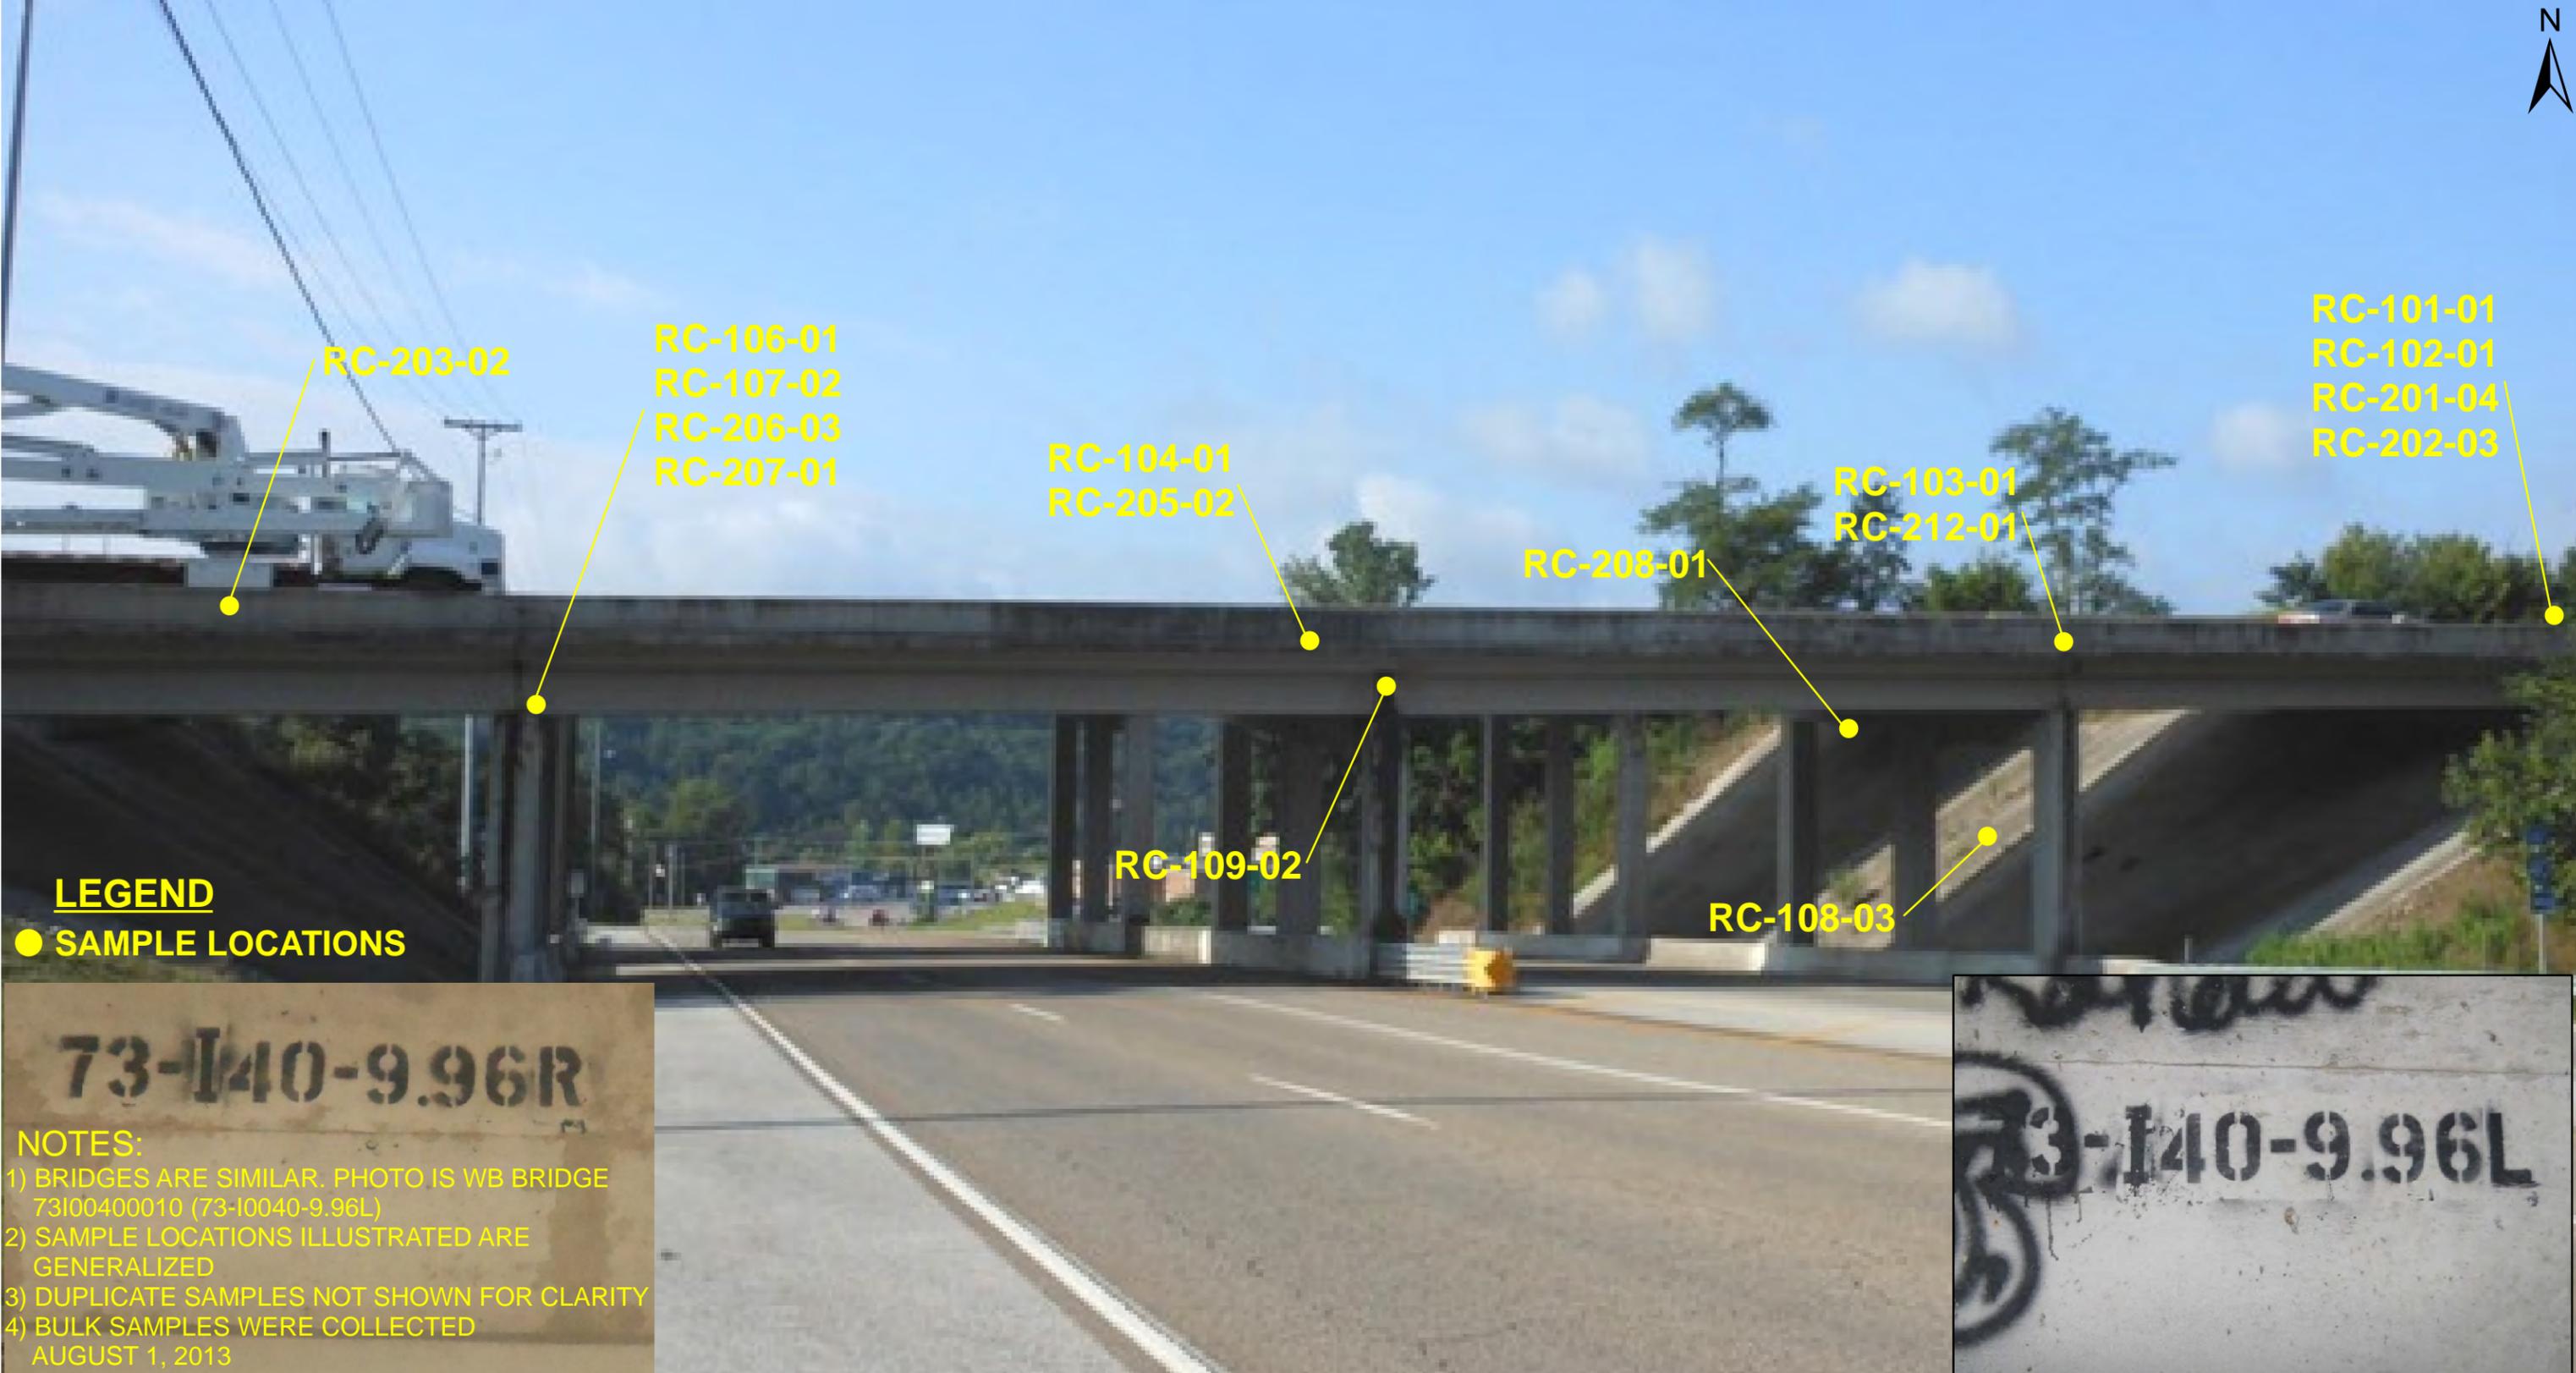
**Figures**  
**Bridge Profiles**  
**(Depicting Sample Locations)**

A total of 41 samples from 13 HAs from the Westbound Bridge and 39 samples from 12 HAs from the Eastbound Bridge were collected and submitted for laboratory analysis. **Figure 1** is a side view or profile of the bridge with the representative sample locations noted. Photographs of the bridges and various sampling locations are presented in **Appendix B**, and laboratory analytical data sheets are included in **Appendix C**.

- 1) BRIDGES ARE SIMILAR. PHOTO IS WB BRIDGE 73I00400010 (73-I0040-9.96L)
- 2) SAMPLE LOCATIONS ILLUSTRATED ARE GENERALIZED
- 3) DUPLICATE SAMPLES NOT SHOWN FOR CLARITY
- 4) BULK SAMPLES WERE COLLECTED AUGUST 1, 2013

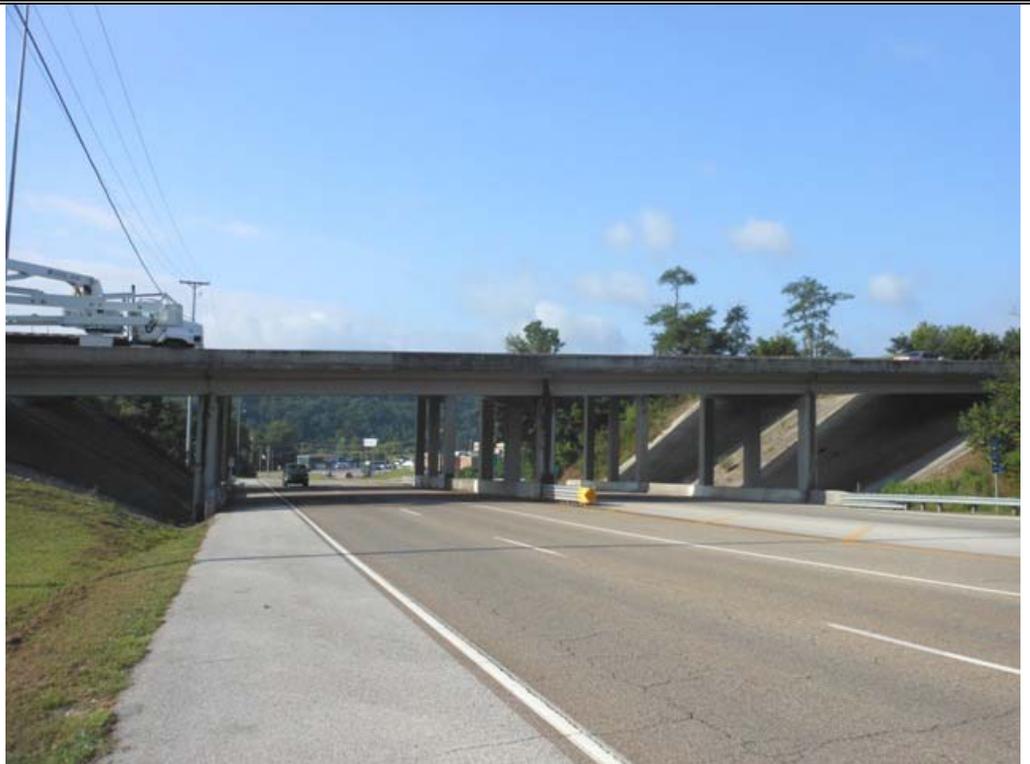
Comments:  
P-2 – Profile of west bound  
lane in foreground of  
Photograph. Construction of  
Bridges is typical in both  
directions. Second bridge  
columns (east bound bridge)  
are visible.

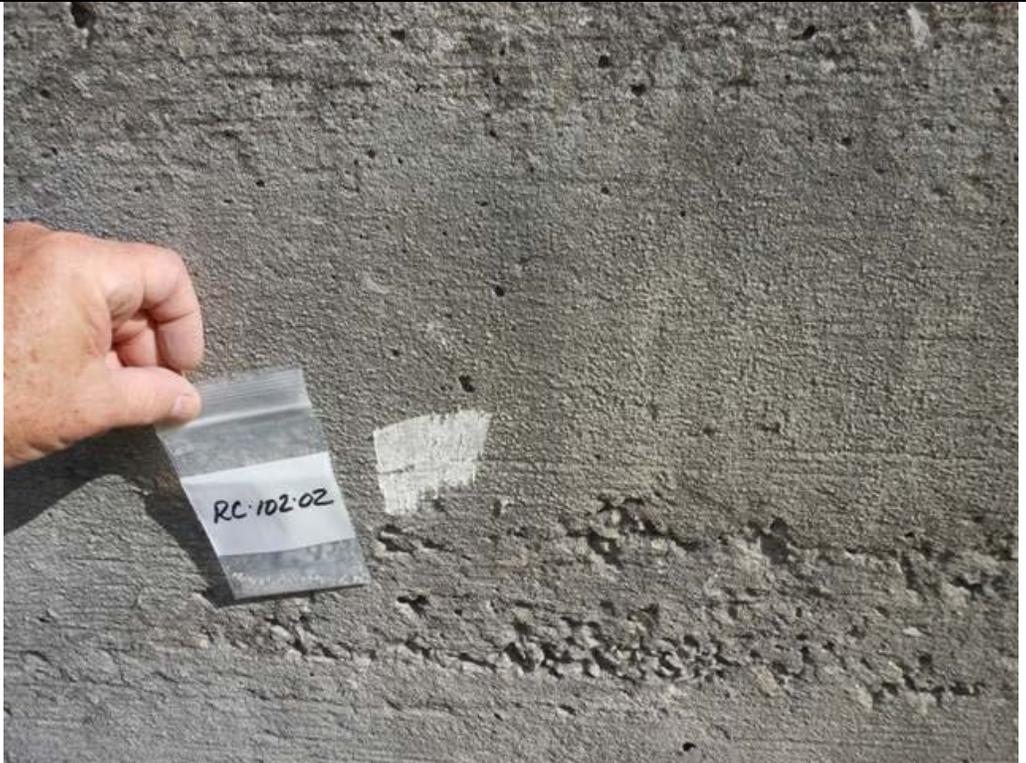
**Comments:**  
P-3 – Barrier walls are coated with a concrete coating or surfacing. Surfacing on this bridge was not an asbestos-containing material.

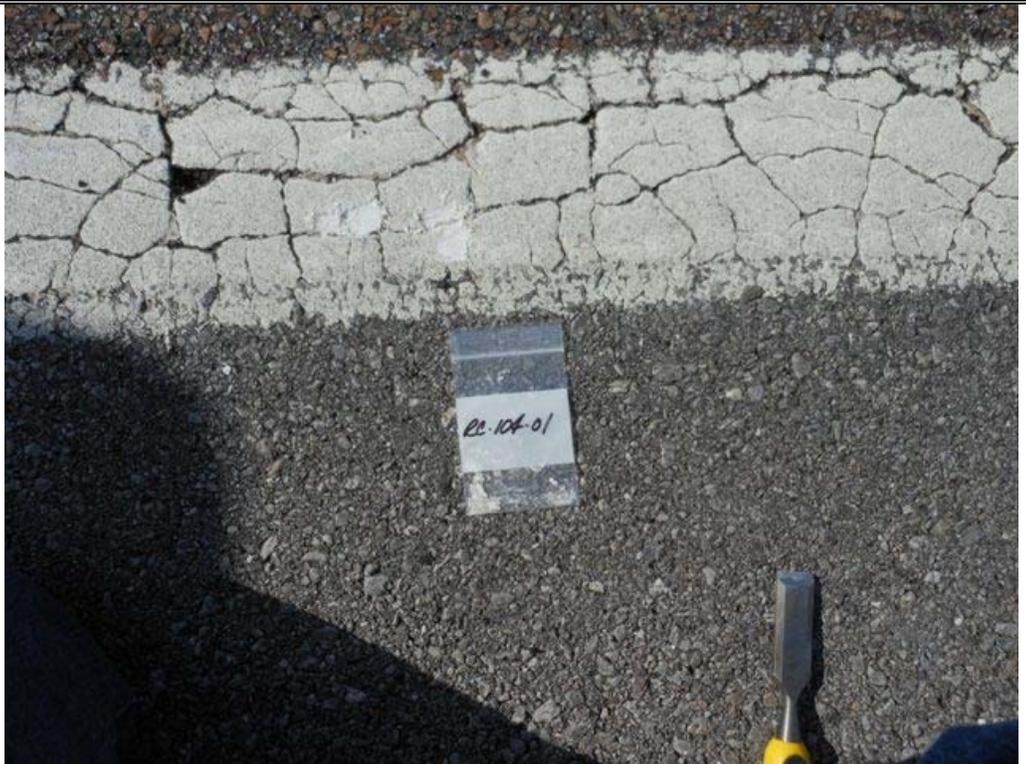
**Comments:**  
P-4- Samples white striping materials were collected for analysis. Striping material samples did not contain asbestos.

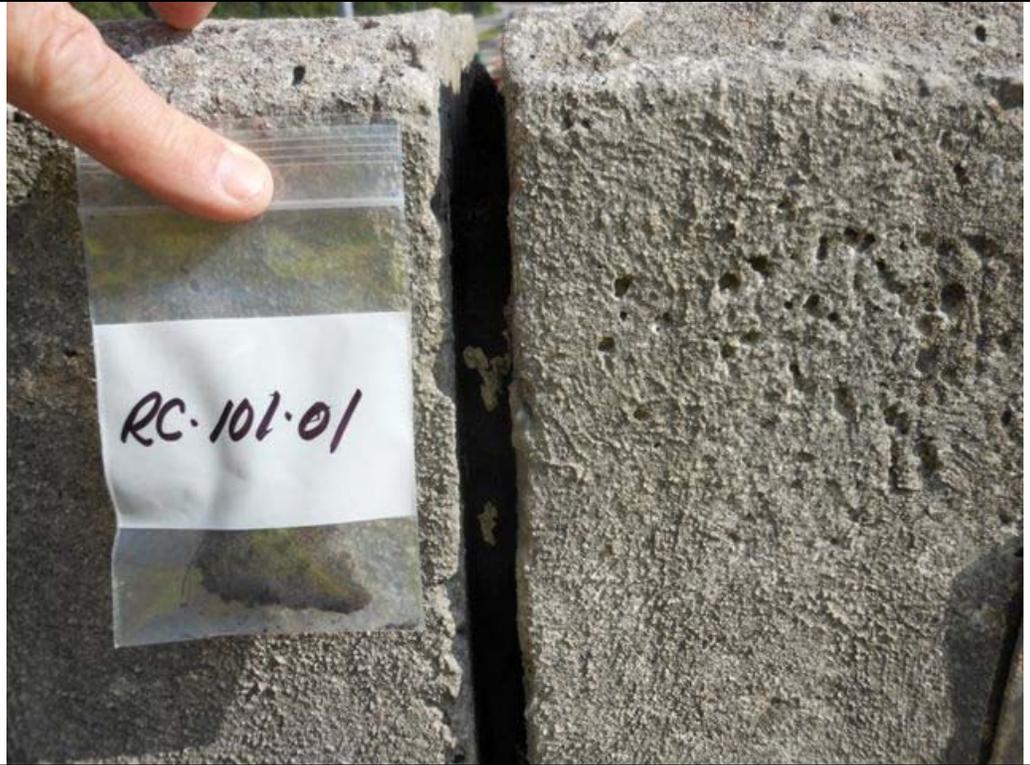
Comments:  
P-5 – Black Expansion Board material was sampled from the barrier walls, and was determined not to contain asbestos by analysis.

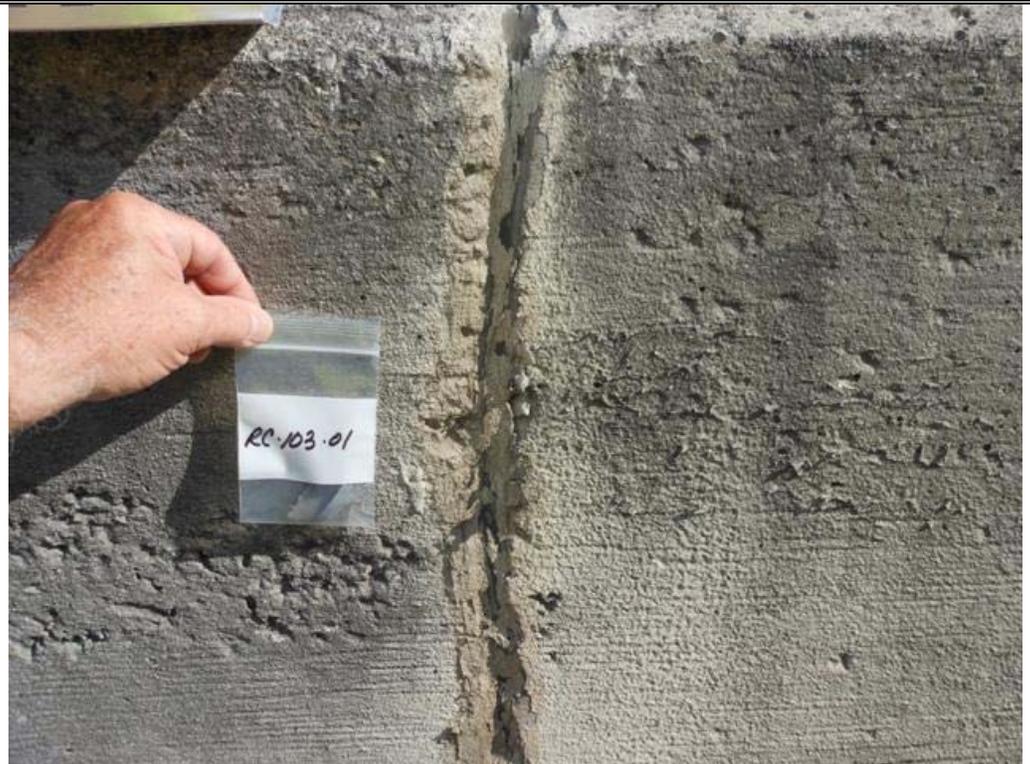
Only one material was determined to be asbestos-containing material based on the analytical results. Samples of a black asphalt based sealant were collected at the tapered barrier end walls at the abutments of the Eastbound Bridge. This material was not observed on the other bridge, but if a similar material is observed it should either be sampled or assumed asbestos-containing material. The analytical results of all the samples collected from the property, along with the chain-of-custody records, are included in **Appendix C**.

Comments:  
P-6 – Joints in the barrier walls were filled with either a gray rubbery caulk or a black asphalt joint sealant. Black sealer was observed and sampled on the east bound bridge. Samples of the black sealant contained 2% Chrysotile Asbestos

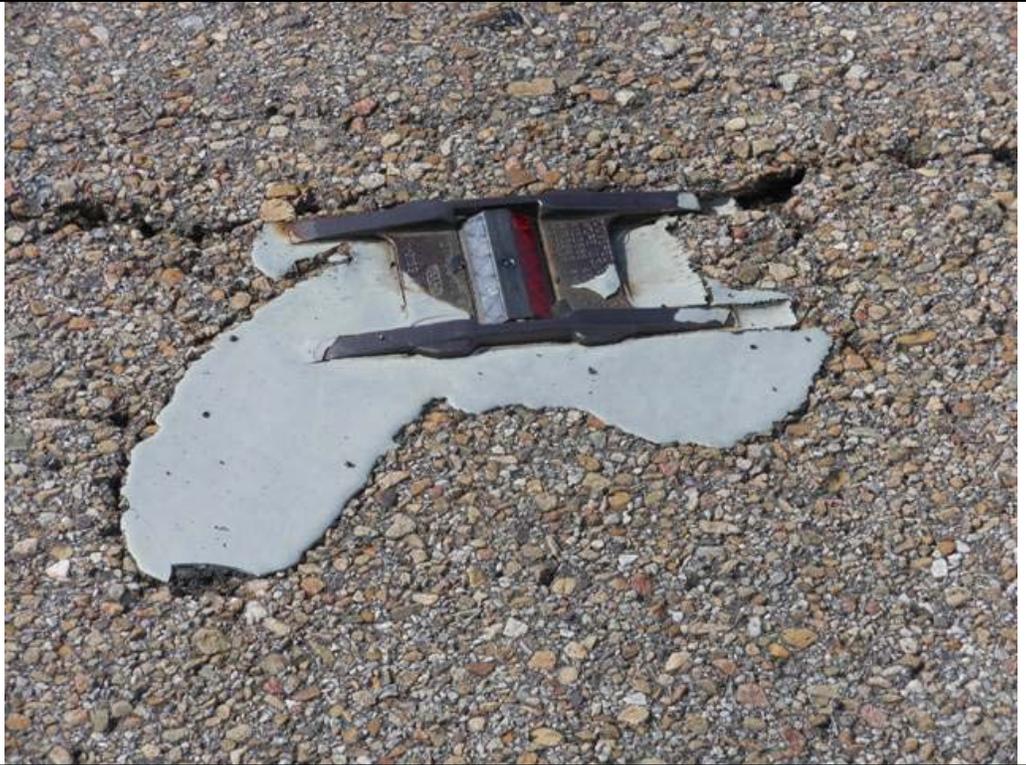
Comments:  
P-7 – Gray epoxy glues were used to secure reflectors to the deck. Samples of the epoxy were analyzed at the laboratory and determined not to contain asbestos.

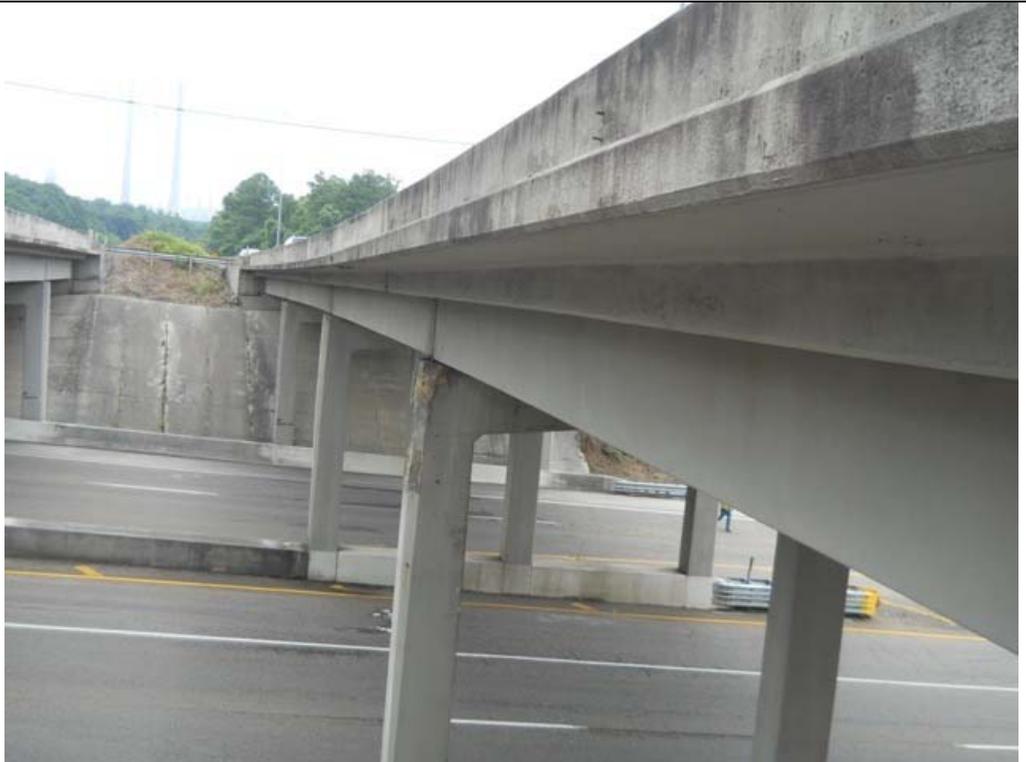
Comments:  
P-8 – The structures are concrete box beams, bents, parapets, abutments, and paved slopes.

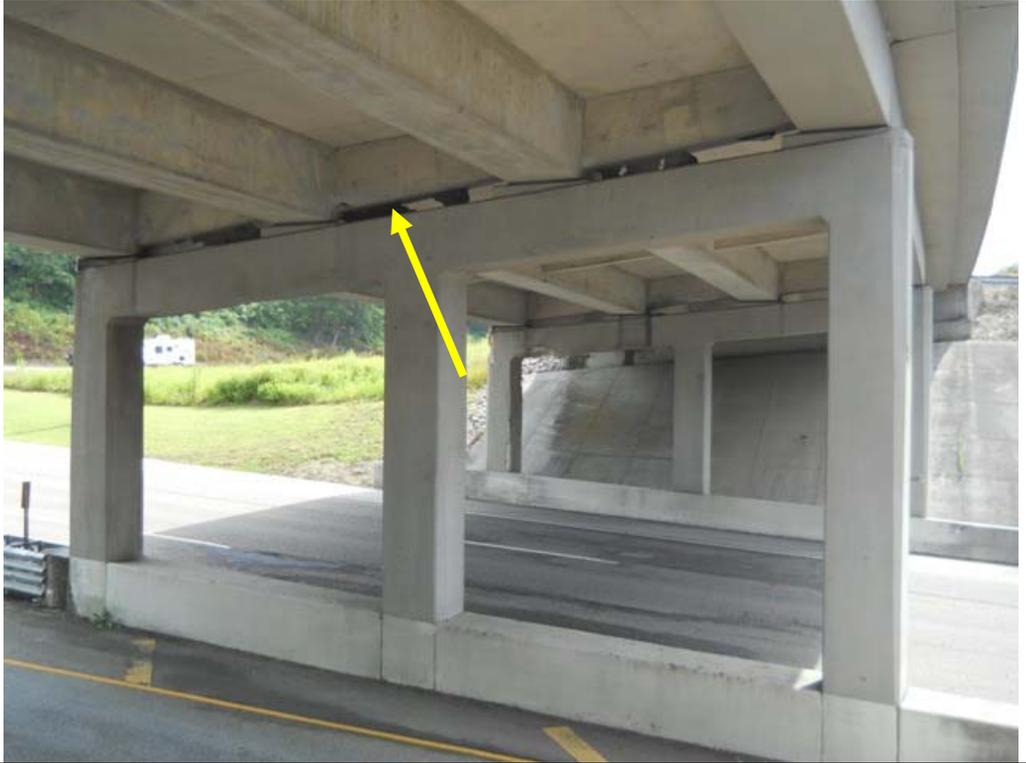
Comments:  
P-9 – View of box beams and bents. Expansion material hanging down from diaphragms was sampled and determined to be similar to the expansion board identified above (arrow)

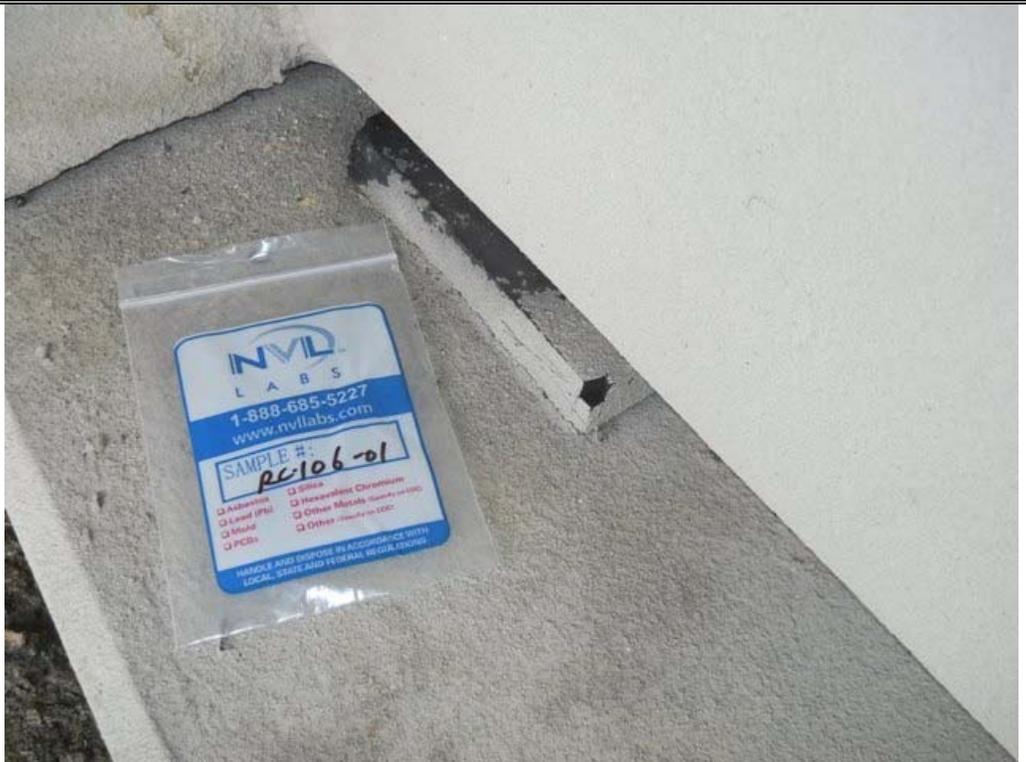
Comments:  
P-10 – Close-up of bearing pad under beam on abutment was typical. Bearing pads were non-asbestos material.

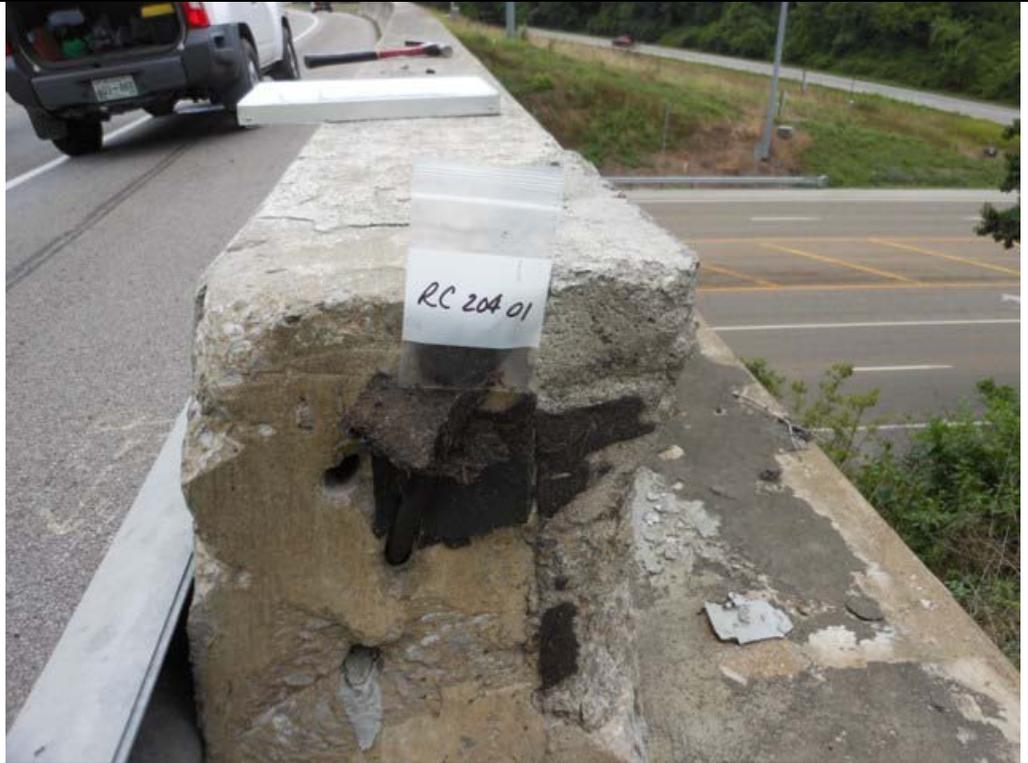
Comments:  
P-11 – End of EB wingwall  
was knocked over exposing  
expansion material, concrete  
and surfacing. All three  
samples were non-asbestos

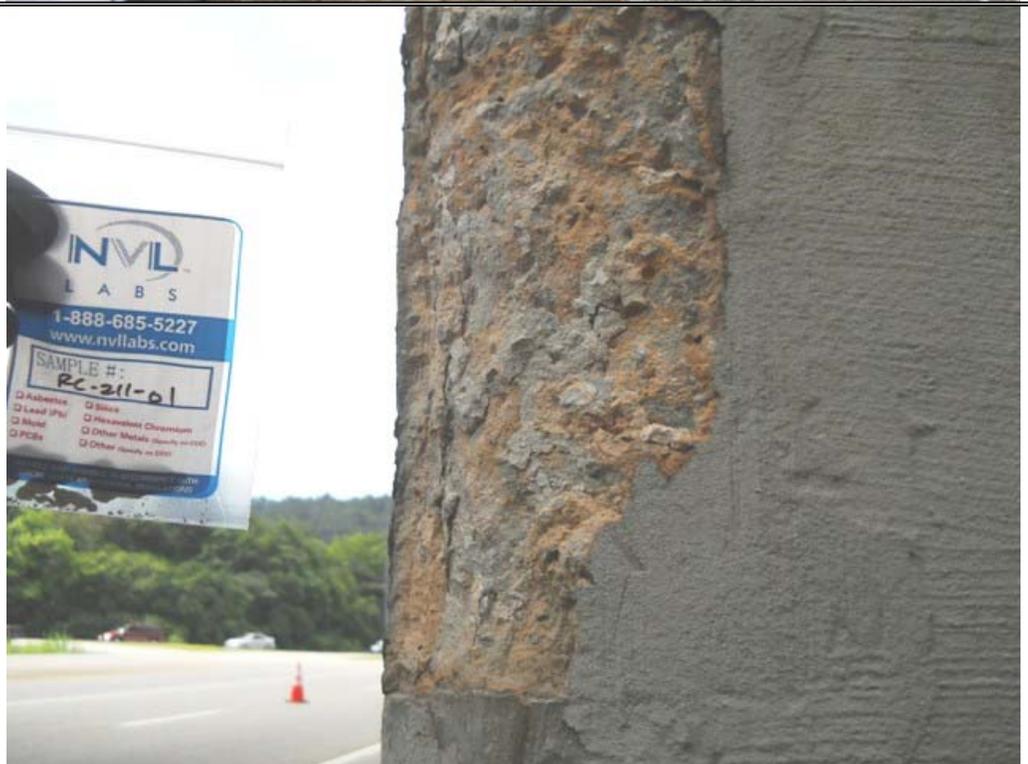
Comments:  
P-12 – Concrete columns  
were sampled at damaged  
areas. No concrete tested  
positive for asbestos.
