### Special Inspection Report

Location: 33-I0024-12.08

4 Span Bridge

I-24

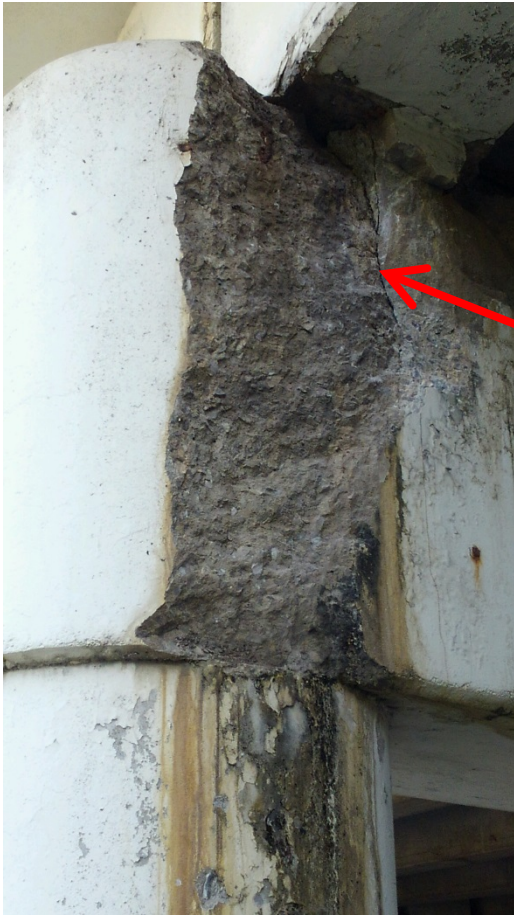
Photograph 1

Bent 3 - Right side  
Delam removed  
Crack under bearing area revealed

Crack

- Span 4 - Repair concrete test bore hole and patch pothole in wearing surface
- Bent 3 – Right – Provide supportive bearing area for right outside beam

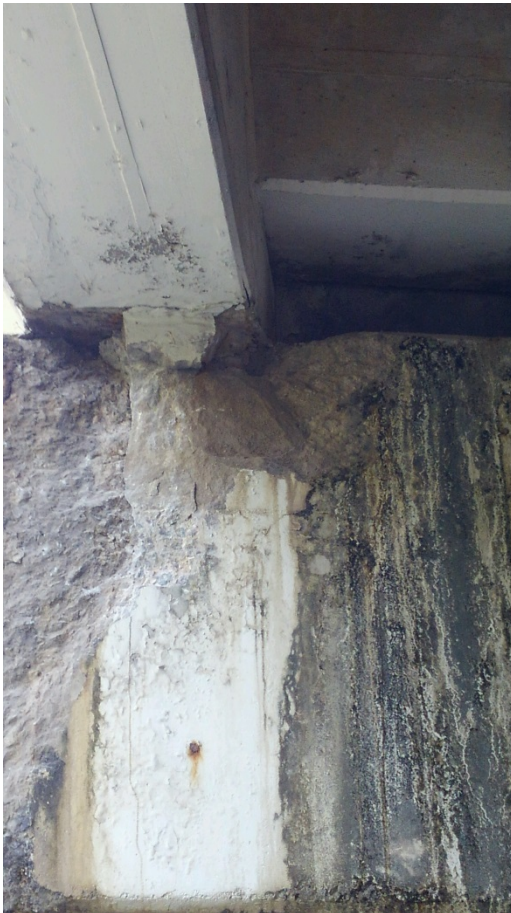
Photograph 2

Bent 3 - Right side  
Delam removed  
Loss of bearing area

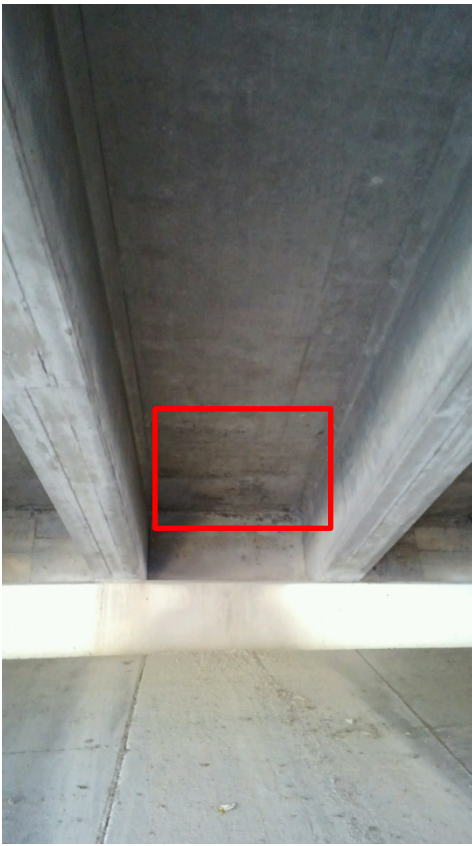
### Photograph 3

Span 4 – Bay D

Honeycomb section surrounding, what appears to be, a test bore hole. Area is receiving direct traffic impact due to a pothole in the wearing surface at this location above.
