TENNESSEE DEPARTMENT OF TRANSPORTATION ASBESTOS SURVEY REPORT

Federal Bridge Number: 45I00400019
I-40 Bridge over French Broad River and
Roundhouse Road (0A983), LM 14.68
PIN: 106301.03, Project Number: 55022-4213-04,
Jefferson County, Tennessee

PREPARED BY
ENSAFE

30 JANUARY 2024

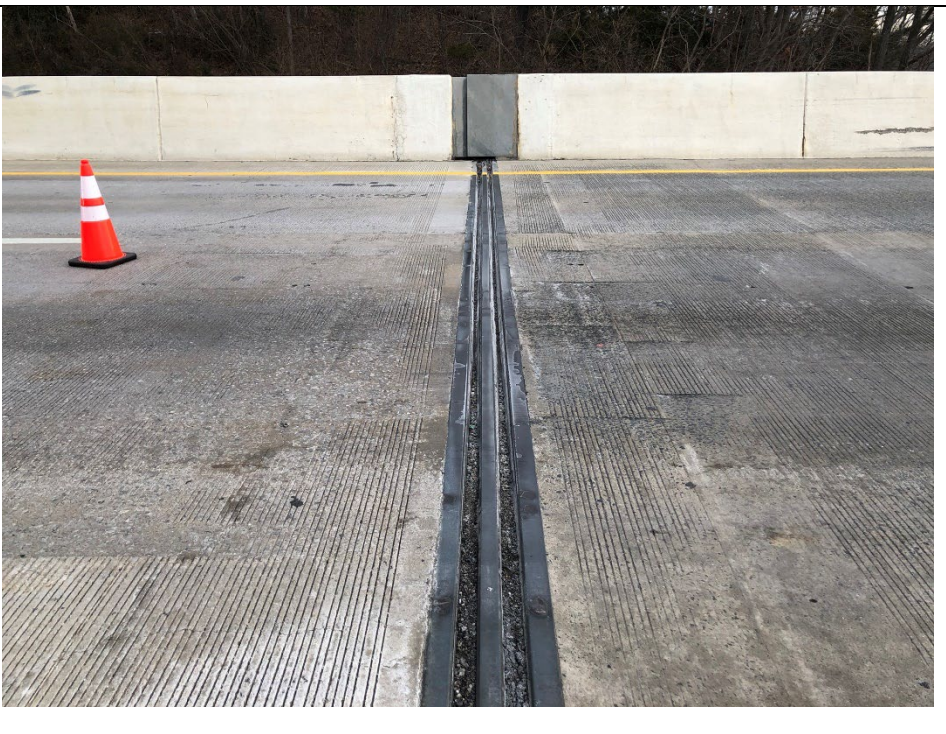
Date: 1/23/2024	
Description: Photograph 4 – View of Expansion Joint

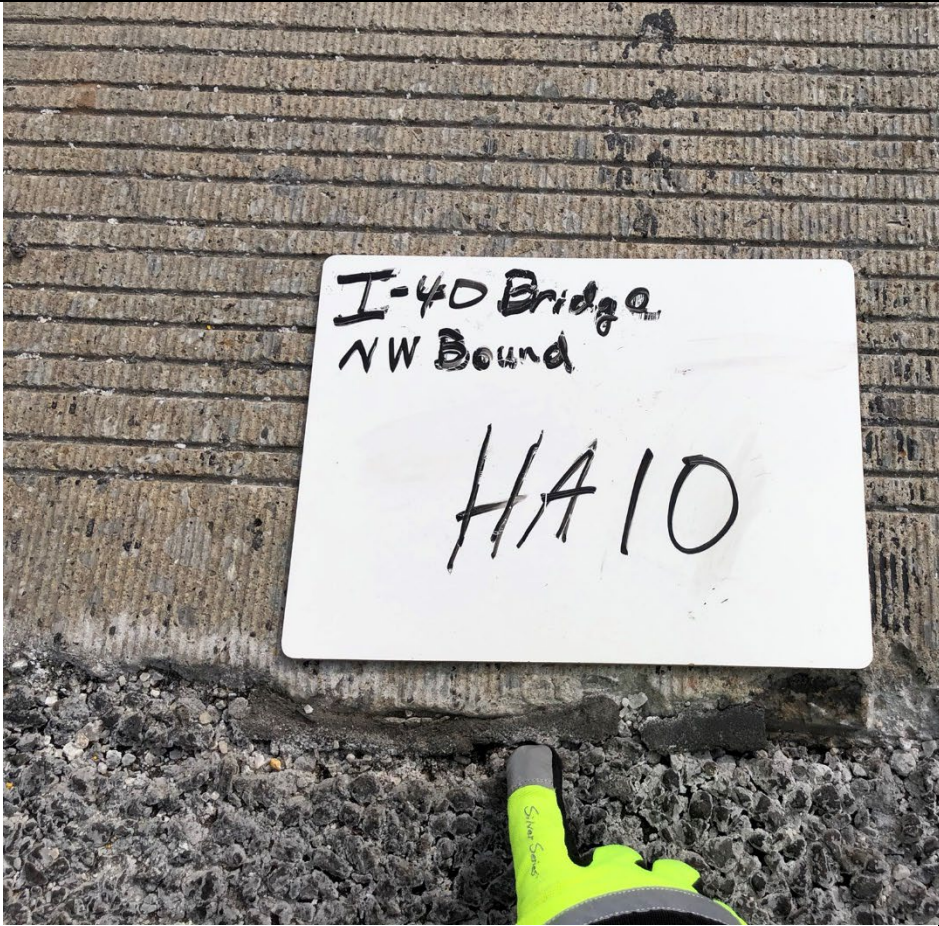
Date: 1/23/2024	
Description: Photograph 17 – Homogeneous Area 10 Black / Gray Pliable Expansion Joint Material Sample Locations HA10-1, -2
