**STATE OF TENNESSEE
DEPARTMENT OF TRANSPORTATION**

Subject: **Environmental Boundaries For:** Jefferson County, I-40 over French Broad River @ L.M. 14.70.

PE: 45002-1135-94

PIN: 106301.00

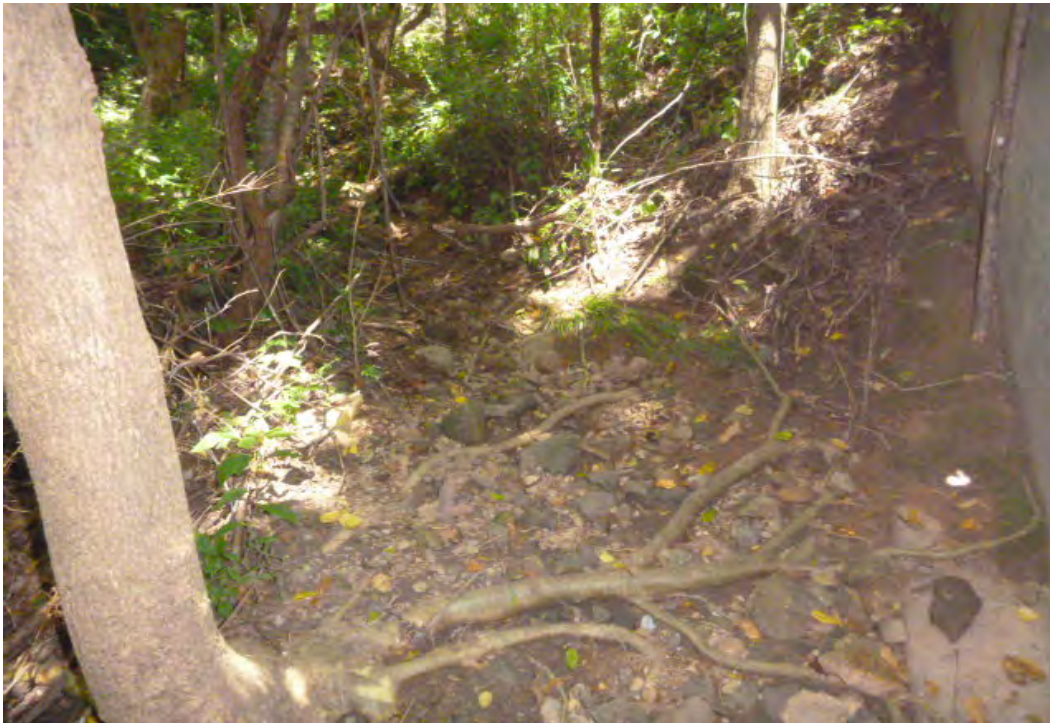
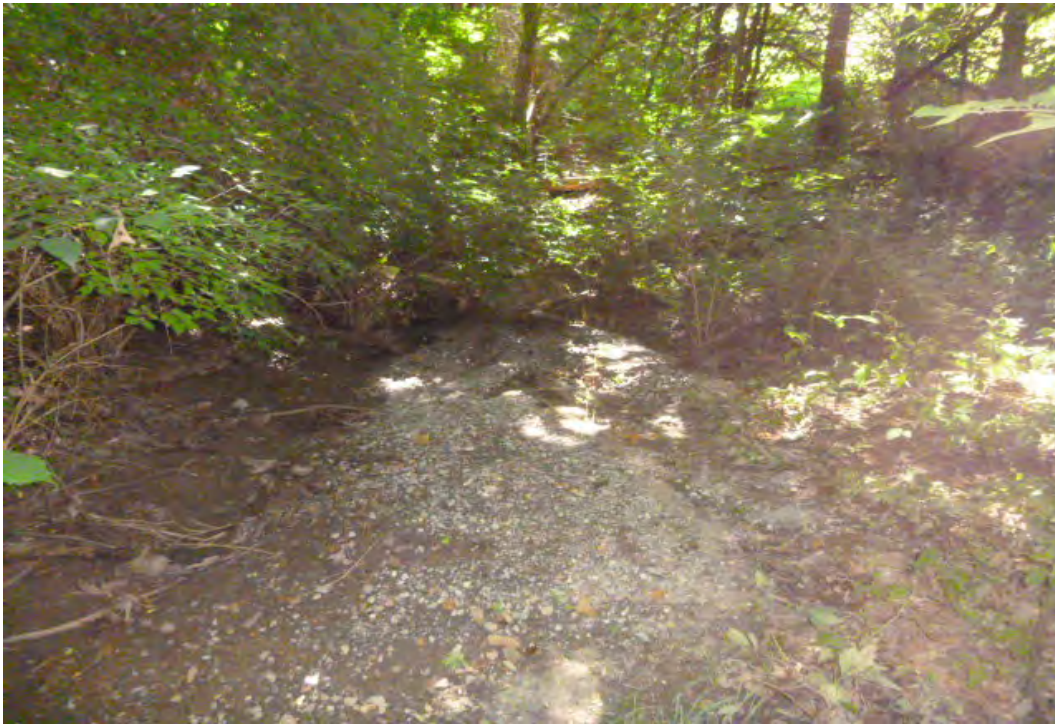
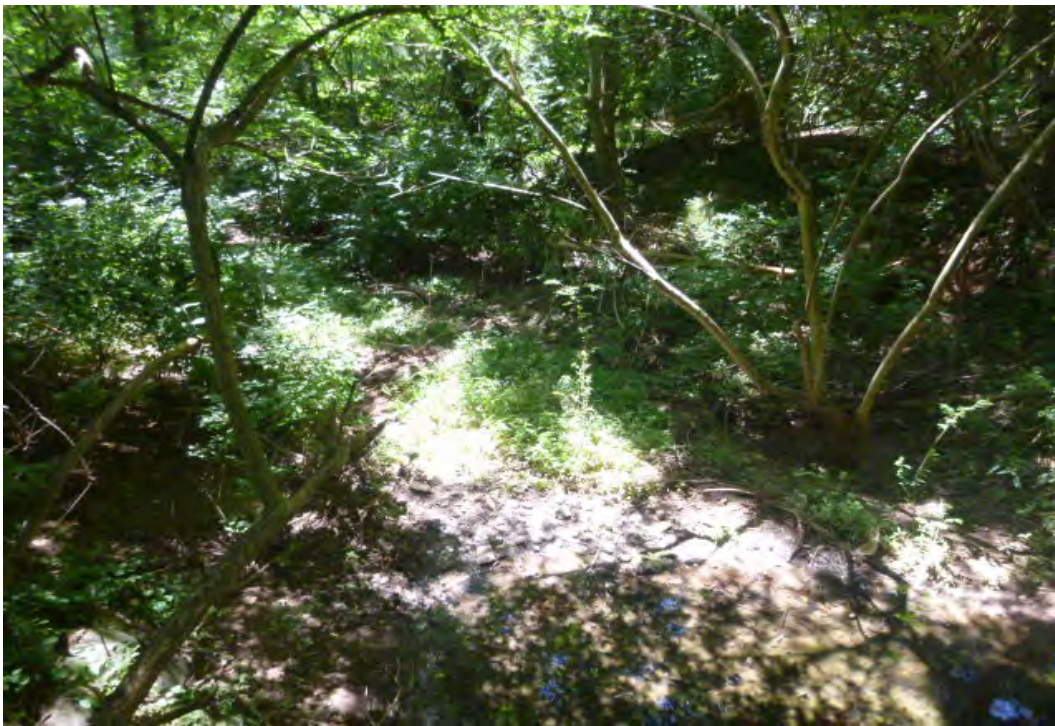
Photo 4: STA 106+50 LT.
View of WWC-1/EPH-1
facing north.

Photo 5: STA 106+50 LT.
View of WWC-1/EPH-1
facing north.

Photo 6. STA 106+50 RT.
View of WWC-1/EPH-1
facing south.

1-Station: from plans	STA 106+50 CL
2-Map label and name	WWC-1/EPH-1
3-Latitude/Longitude	36.048180 -83.346565
4-Potential impact	encapsulation / runoff
5-Feature description:	
what is it	wet weather conveyance/ephemeral stream
blue-line on topo? (y/n)	yes
defined channel (y/n)	yes
straight or meandering	straight
channel bottom width	3'
top of bank width	5'
bank height and slope ratio	1' 1:1
avg. gradient of stream (%)	>5%
substratum	soil/gravel/cobble
riffle-pool complex (y/n)	no
width of buffer zone	20'
water flow	n/a
water depth	n/a
water width	n/a
general water quality	n/a
OHWM indicators	wrack lines
groundwater connection	none observed
bank stability: LB, RB	LB-good RB-good
dominant species: LB, RB	LB- green ash RB- green ash
overhead canopy (%)	80%
benthos	none observed
fish	none observed
algae or other aquatic life	none observed
habitat assessment score	68
photo number (s)	4, 5, & 6
rainfall information	no significant rainfall previous 7 days (TVA-Douglas Dam)

Overall Hydrologic Determination = WWC / Ephemeral Stream

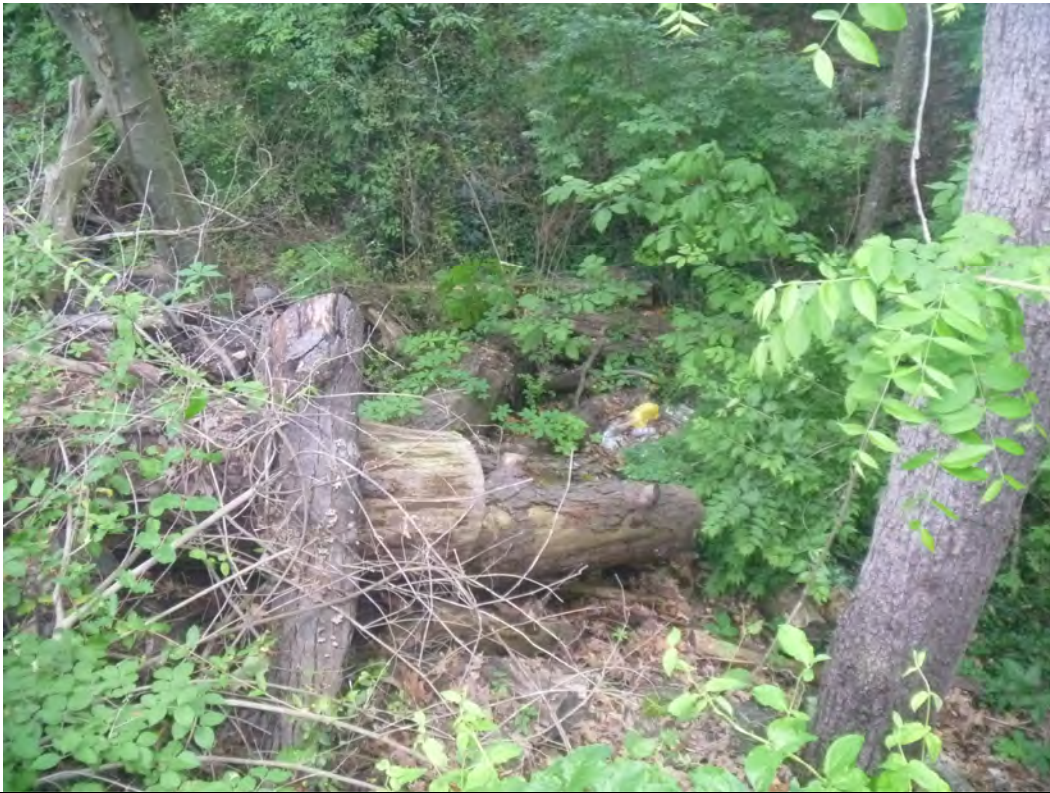
Photo 7: SR-115STA
13+00 CL. View of SNK-1
facing northeast.

1-Station: from plans	SR-113 STA 313+00 RT	
2-Map label	SNK-1	
3- Lat/Long	36.045367 -83.341106	
4-Potential impact	runoff/fill	
5-Feature name		
6-Feature description:		
what is it	sinkhole	
portion affected		
approximate size	50' x 50'	
photo number	7	
other		
7- HUC code & name (8 & 12-digit)	06010107 0103 Douglas Lake-Middle	
8-Determination: TDOT/ consultant	TDOT	
9-Determination: Confirmed? By?	Not necessary, obvious	
10-Mitigation: to be included in design		
11-Notes	no visible open throat: accumulation of yard waste in bottom.

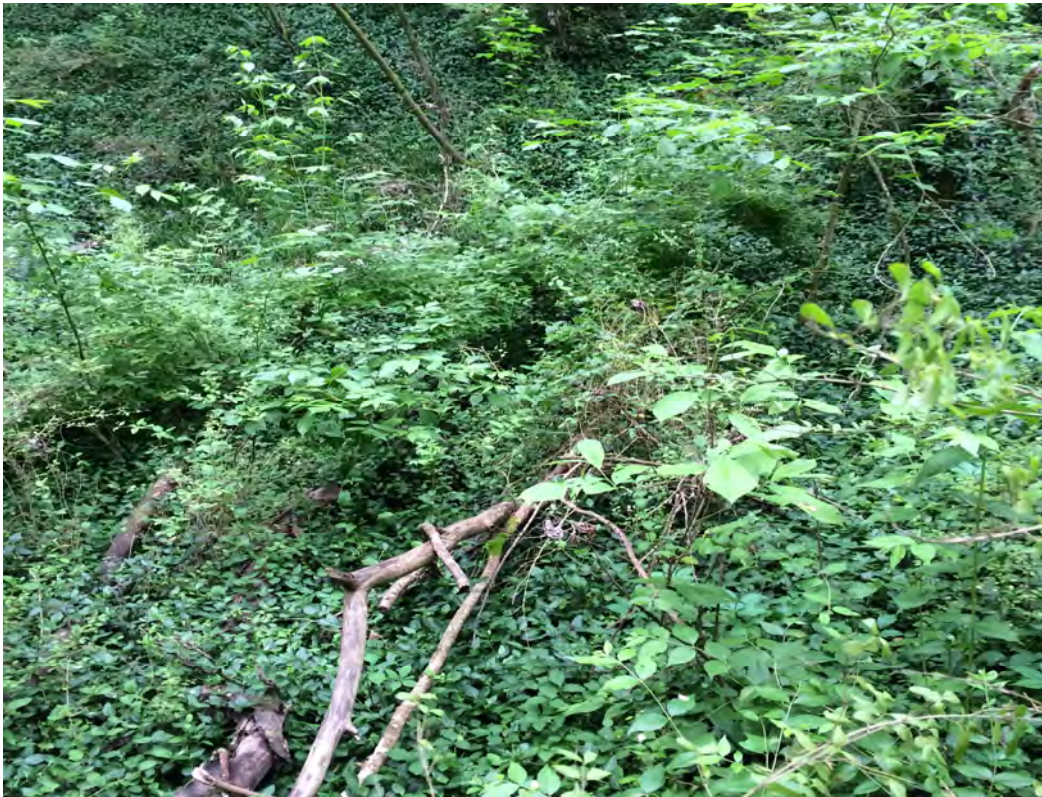
Photo 8. STA 13+00 CL.
View of SNK-2 facing
southwest.

1-Station: from plans	SR-113 STA 316+00 RT	
2-Map label	SNK-2	
3- Lat/Long	36.045689 -83.340538	
4-Potential impact	runoff/fill	
5-Feature name		
6-Feature description:		
what is it	sinkhole	
portion affected		
approximate size	50' x 50'	
photo number	8	
other		
7- HUC code & name (8 & 12-digit)	06010107 0103 Douglas Lake-Middle	
8-Determination: TDOT/ consultant	TDOT	
9-Determination: Confirmed? By?	Not necessary, obvious	
10-Mitigation: to be included in design		
11-Notes	no visible open throat.

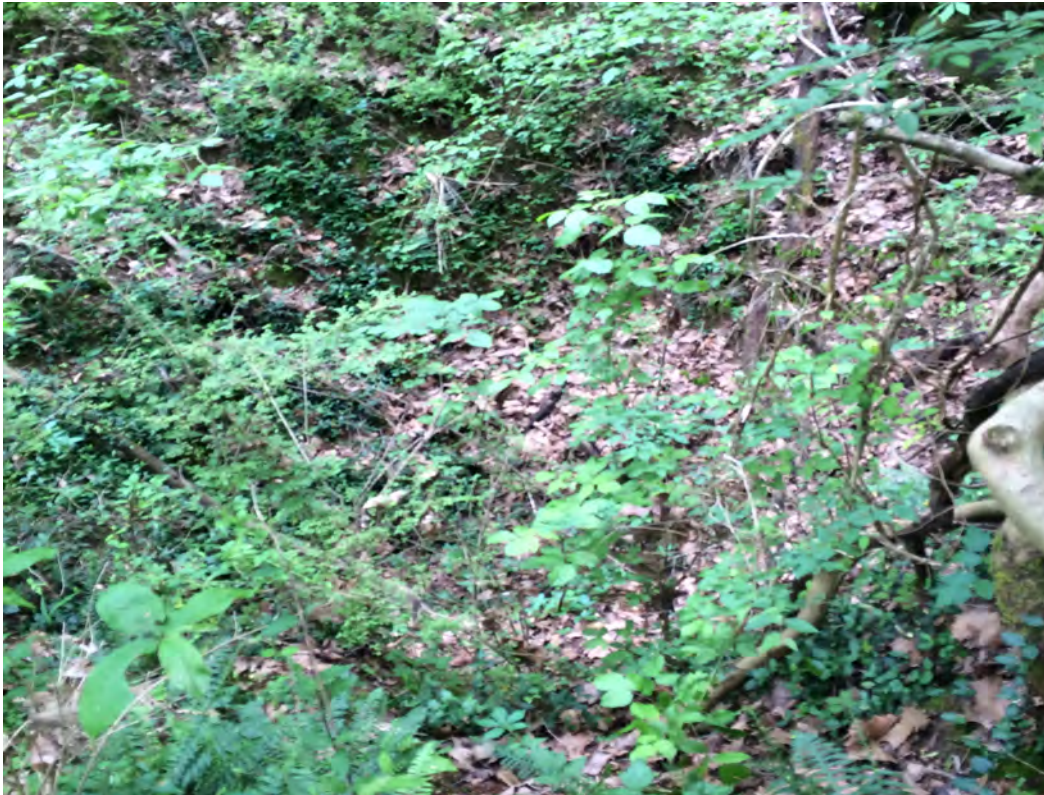
Photo 9: STA 13+00 CL.
View of SNK-3 facing
southeast.

1-Station: from plans	SR-113 STA 317+50 RT	
2-Map label	SNK-3	
3- Lat/Long	36.045964 -83.340058	
4-Potential impact	runoff/fill	
5-Feature name		
6-Feature description:		
what is it	sinkhole	
portion affected		
approximate size	20' x 20'	
photo number	9	
other		
7- HUC code & name (8 & 12-digit)	06010107 0103 Douglas Lake-Middle	
8-Determination: TDOT/ consultant	TDOT	
9-Determination: Confirmed? By?	Not necessary, obvious	
10-Mitigation: to be included in design		
11-Notes	no visible open throat

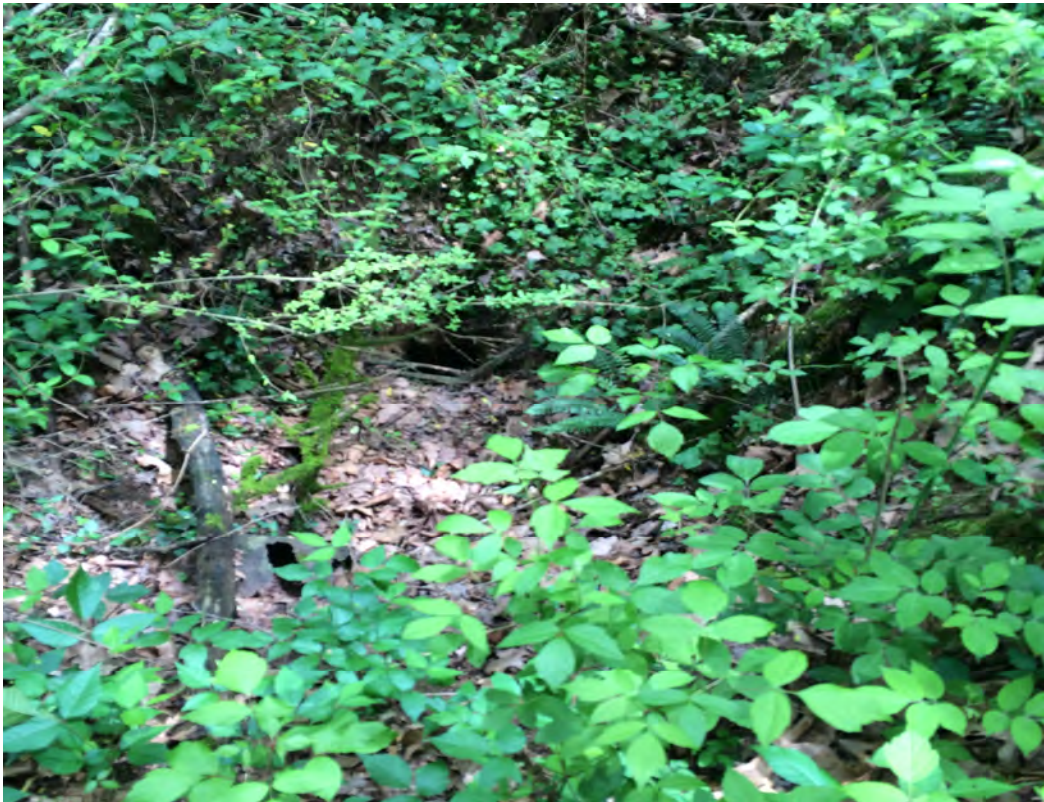
Photo 10. STA 13+00 CL.
View of SNK-4 facing
southeast.

1-Station: from plans	SR-113 STA 317+60 RT	
2-Map label	SNK-4	
3- Lat/Long		
4-Potential impact	runoff/fill	
5-Feature name		
6-Feature description:	36.046078 -83.339820	
what is it	sinkhole	
portion affected		
approximate size	10' x 10'	
photo number	10	
other		
7- HUC code & name (8 & 12-digit)	06010107 0103 Douglas Lake-Middle	
8-Determination: TDOT/ consultant	TDOT	
9-Determination: Confirmed? By?	Not necessary, obvious	
10-Mitigation: to be included in design		
11-Notes	Open throat

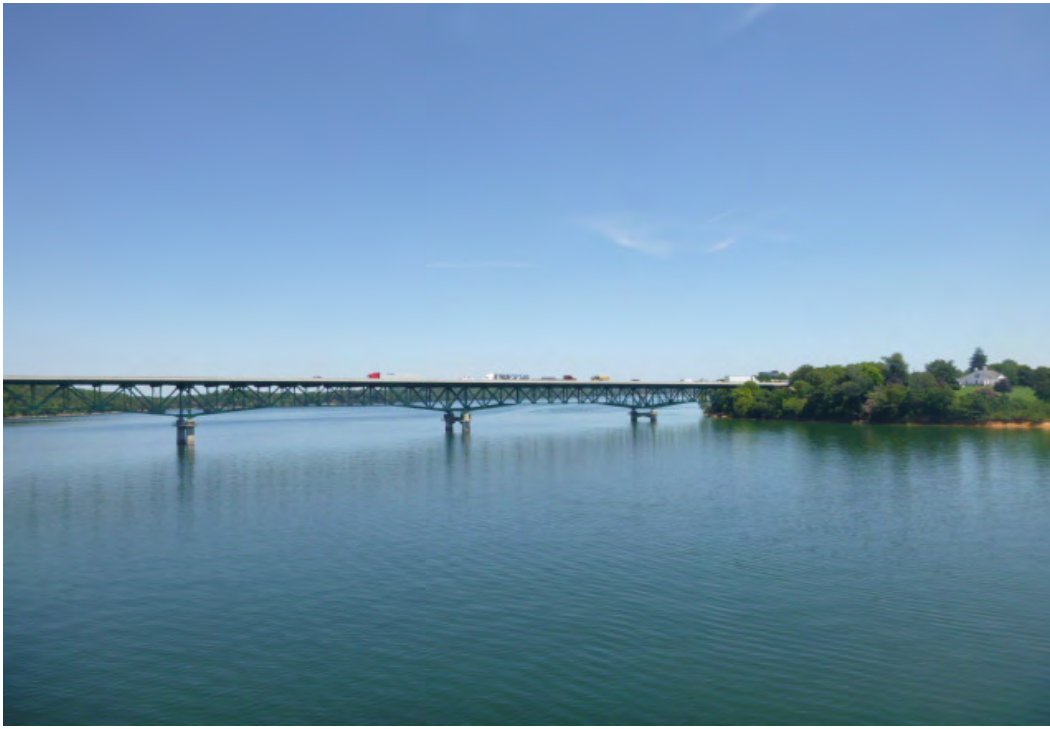
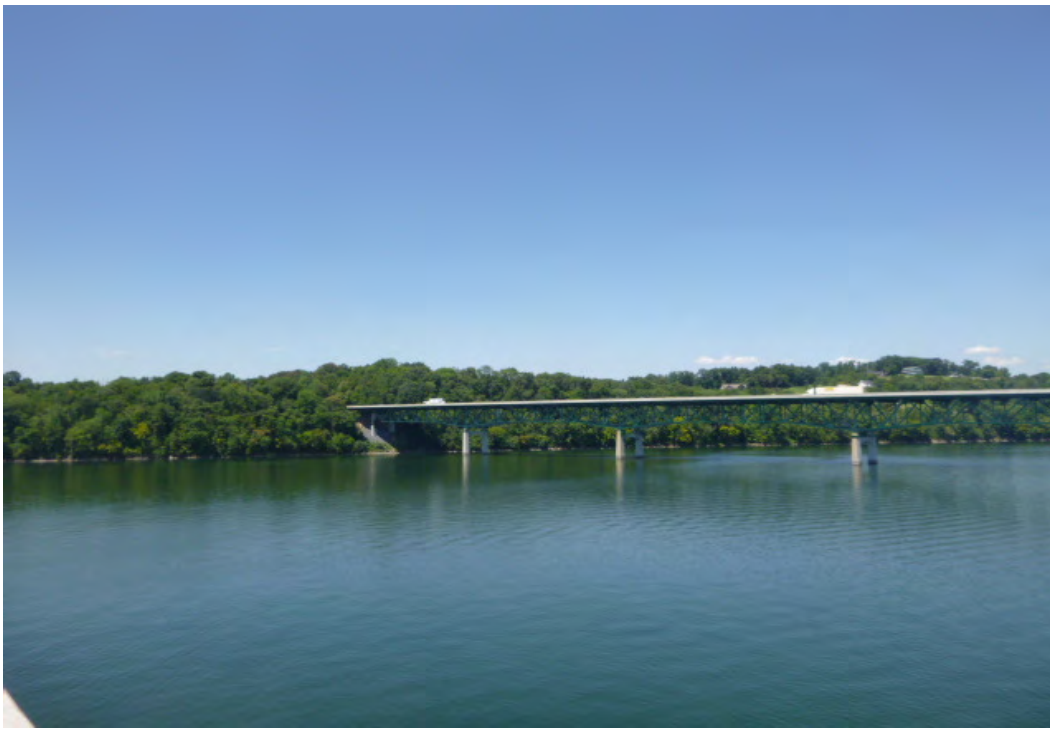
Photo 11: View of I-40 bridge over French Broad River (STR-1) from US-25W bridge facing east.

Photo 12: View of I-40 bridge over French Broad River (STR-1) from US-25W bridge facing northeast.

1-Station: from plans	from STA 135+00 CL to STA 156+00 CL
2-Map label and name	STR-1 French Broad River-Douglas Lake
3-Latitude/Longitude	36.045696 -83.339803
4-Potential impact	runoff/fill
5-Feature description:	
what is it	perennial stream/reservoir
blue-line on topo? (y/n)	yes
defined channel (y/n)	yes
straight or meandering	straight
channel bottom width	unknown-impounded
top of bank width	2000'
bank height and slope ratio	unknown-impounded
avg. gradient of stream (%)	>5%
substratum	unknown-impounded
riffle-pool complex (y/n)	no
width of buffer zone	100'
water flow	yes
water depth	unknown-impounded
water width	2000'
general water quality	good
OHWM indicators	bed and bank
groundwater connection	yes
bank stability: LB, RB	unknown-impounded
dominant species: LB, RB	LB-mixed hardwoods RB-mixed hardwoods
overhead canopy (%)	0%
benthos	none observed
fish	none observed
algae or other aquatic life	none observed
habitat assessment score	31

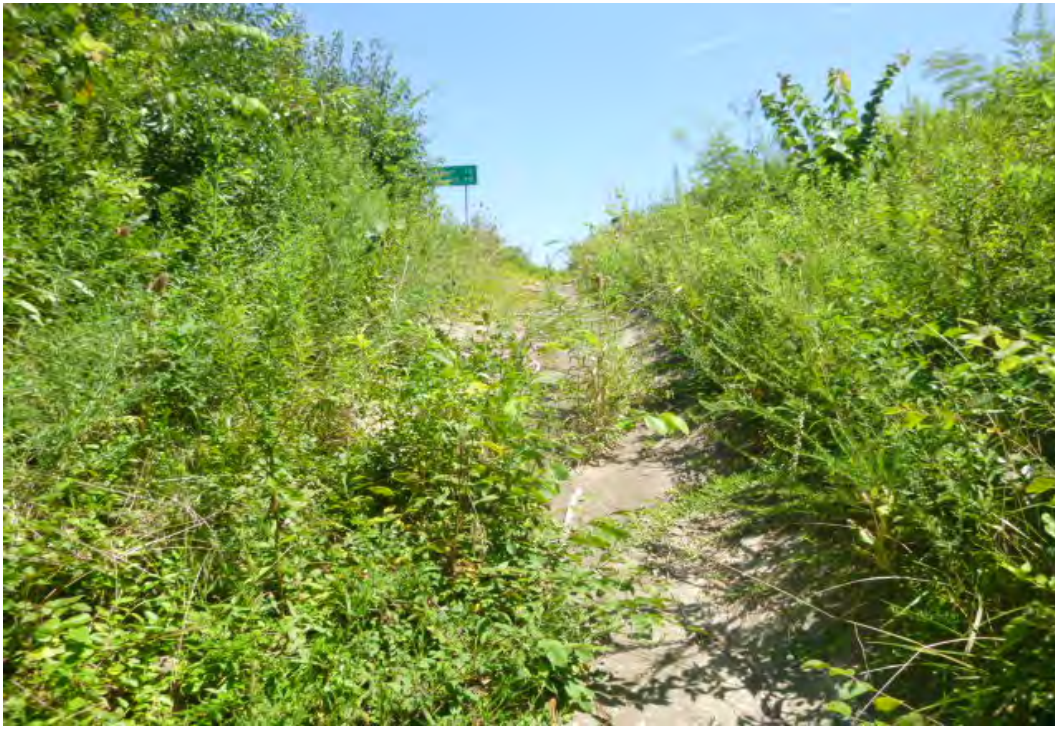
Photo 15: STA 182+00 RT.
View of concrete ditches
facing east.

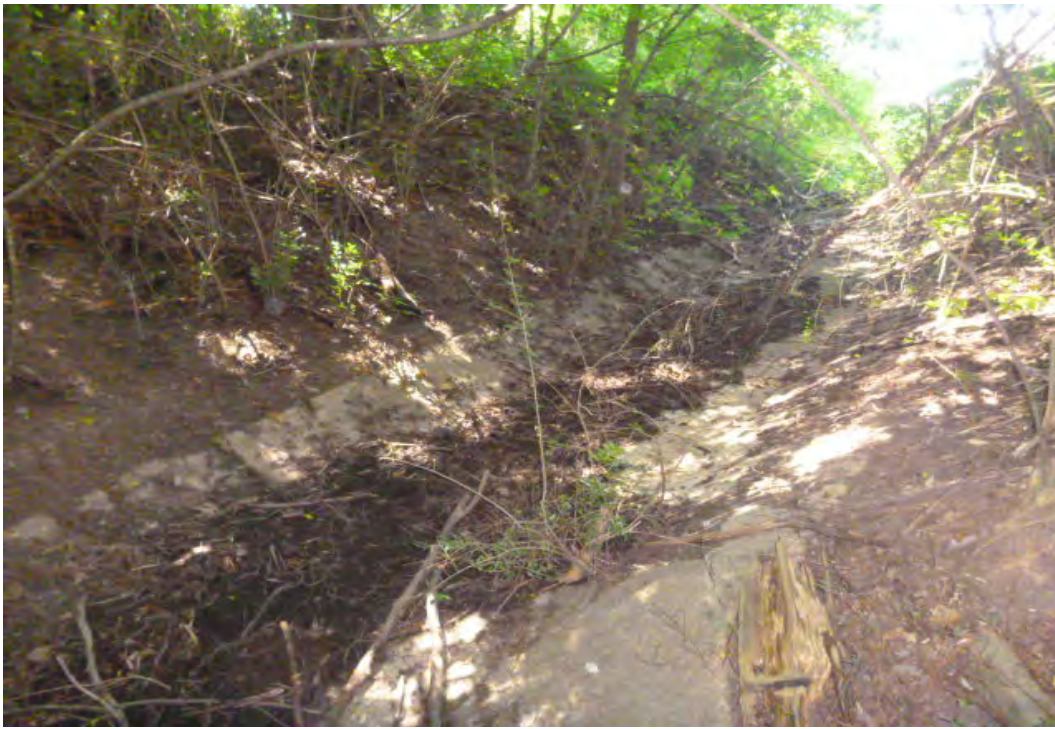
Photo 16: STA 189+00 RT.
View of concrete ditches
facing east.

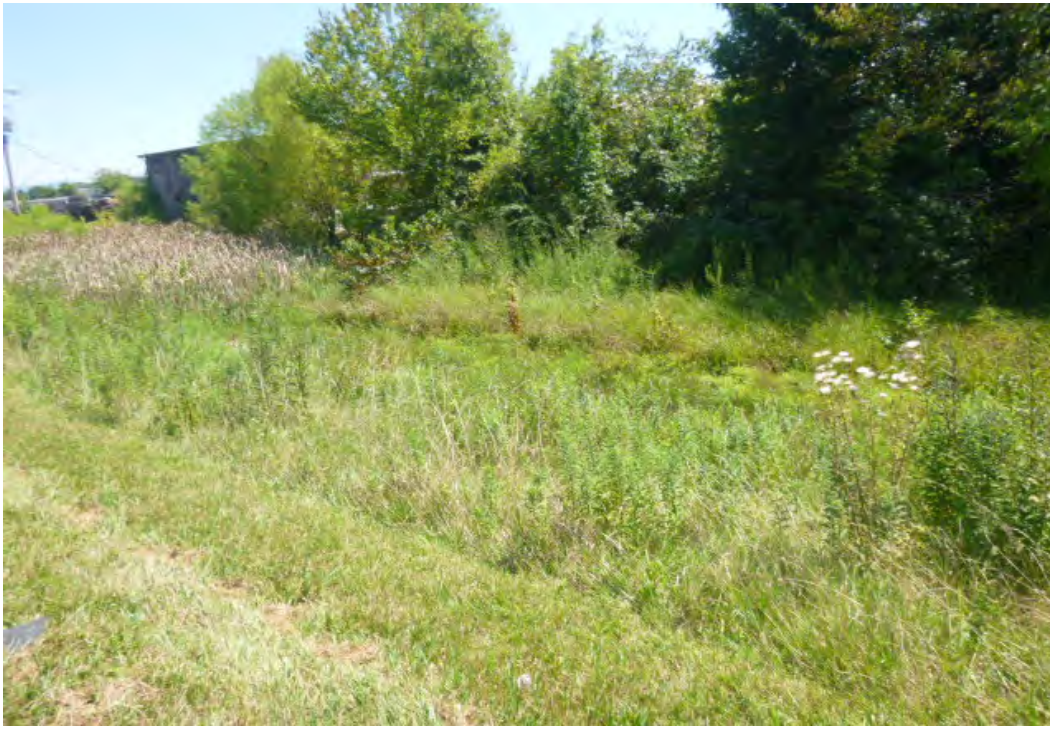
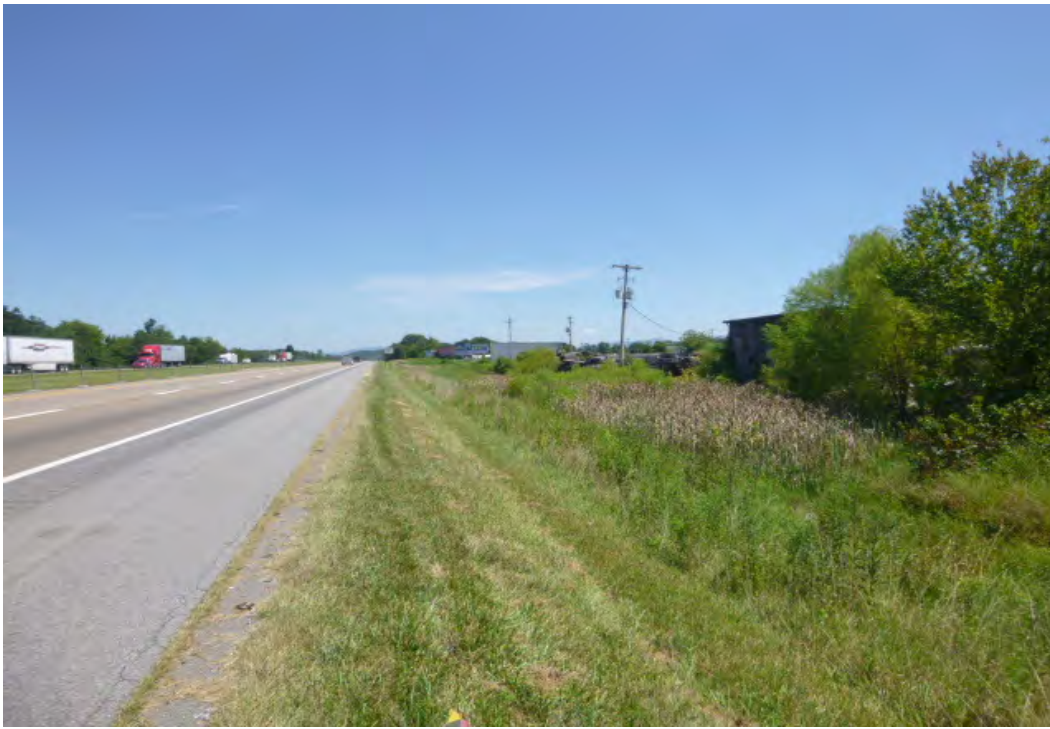
Photo 17: STA 198+50 RT.
View of WTL-1 facing south.

Photo 18: STA 199+00 RT.
View of WTL-1 facing
southeast.

WTL-1 is an emergent type wetland with a primary function of wildlife habitat. The size of WTL-1 is approximately 0.32 acres. Based on the available plan sheets, there will be no permanent or temporary impacts to WTL-1.
