# TENNESSEE DEPARTMENT OF TRANSPORTATION

## ASBESTOS INSPECTION REPORT

I-440 From I-40 to I-24, Davidson County  
PE-D Number 19014-1169-04  
PIN Number 125325.00  
Bridge ID Number 19I04400054

November 28, 2017

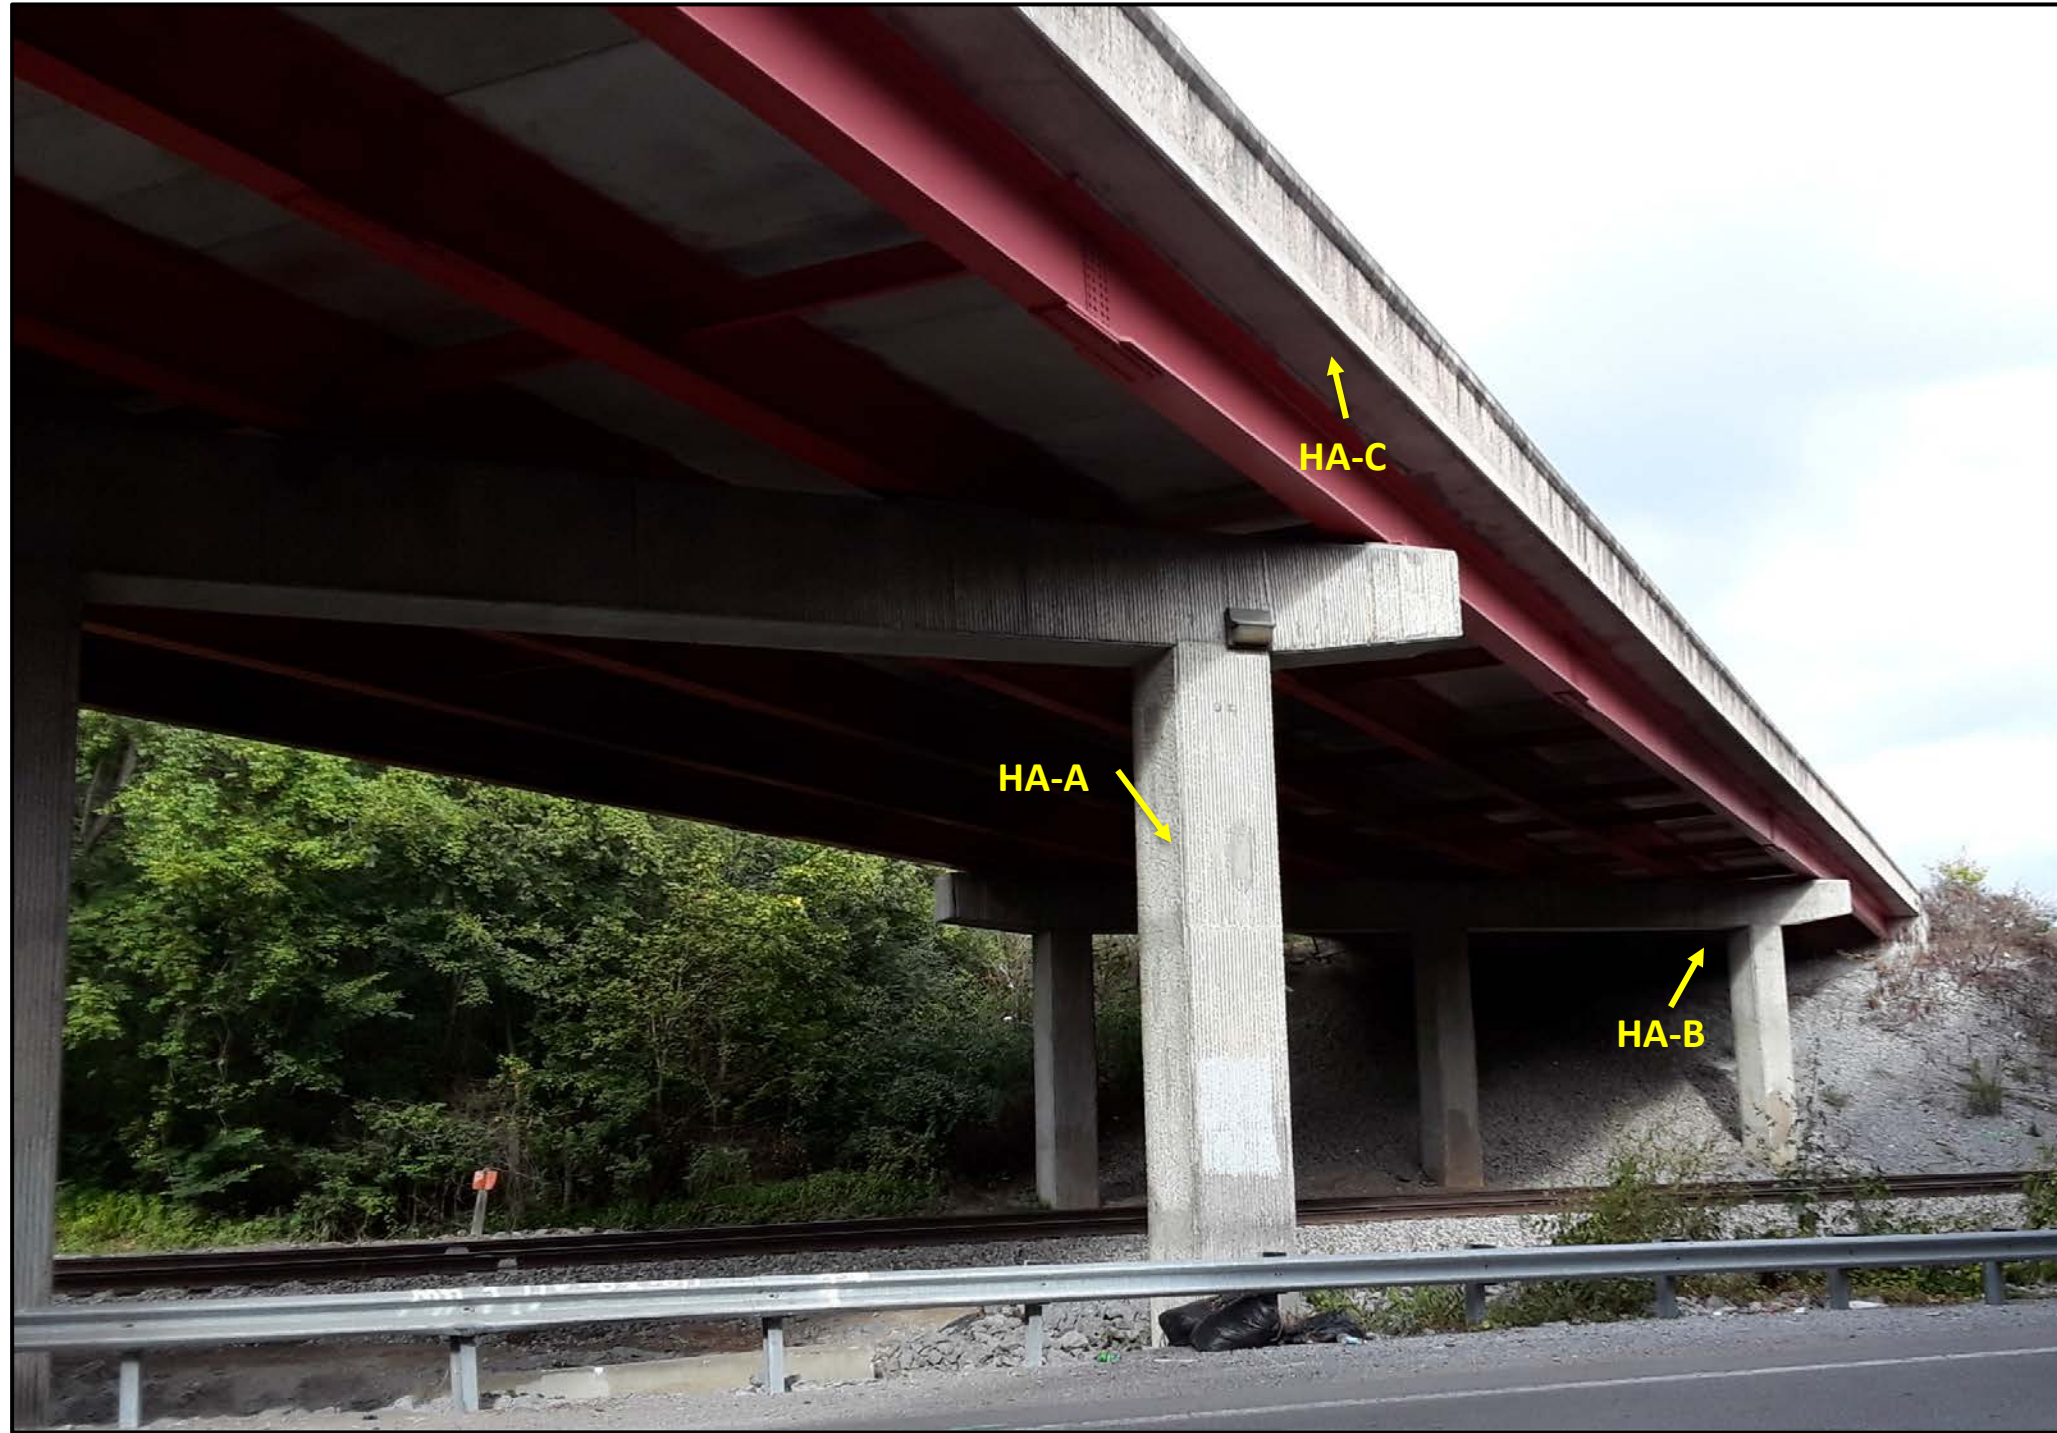
**19104400054**  
**19-10440-7.04 LT**  
**10440 LL/GLENROSE AVE. & CSX RR**

## Homogeneous Areas:

- A- Concrete Bent with Coating
- B- Concrete Abutment
- C- Concrete Decking with Coating

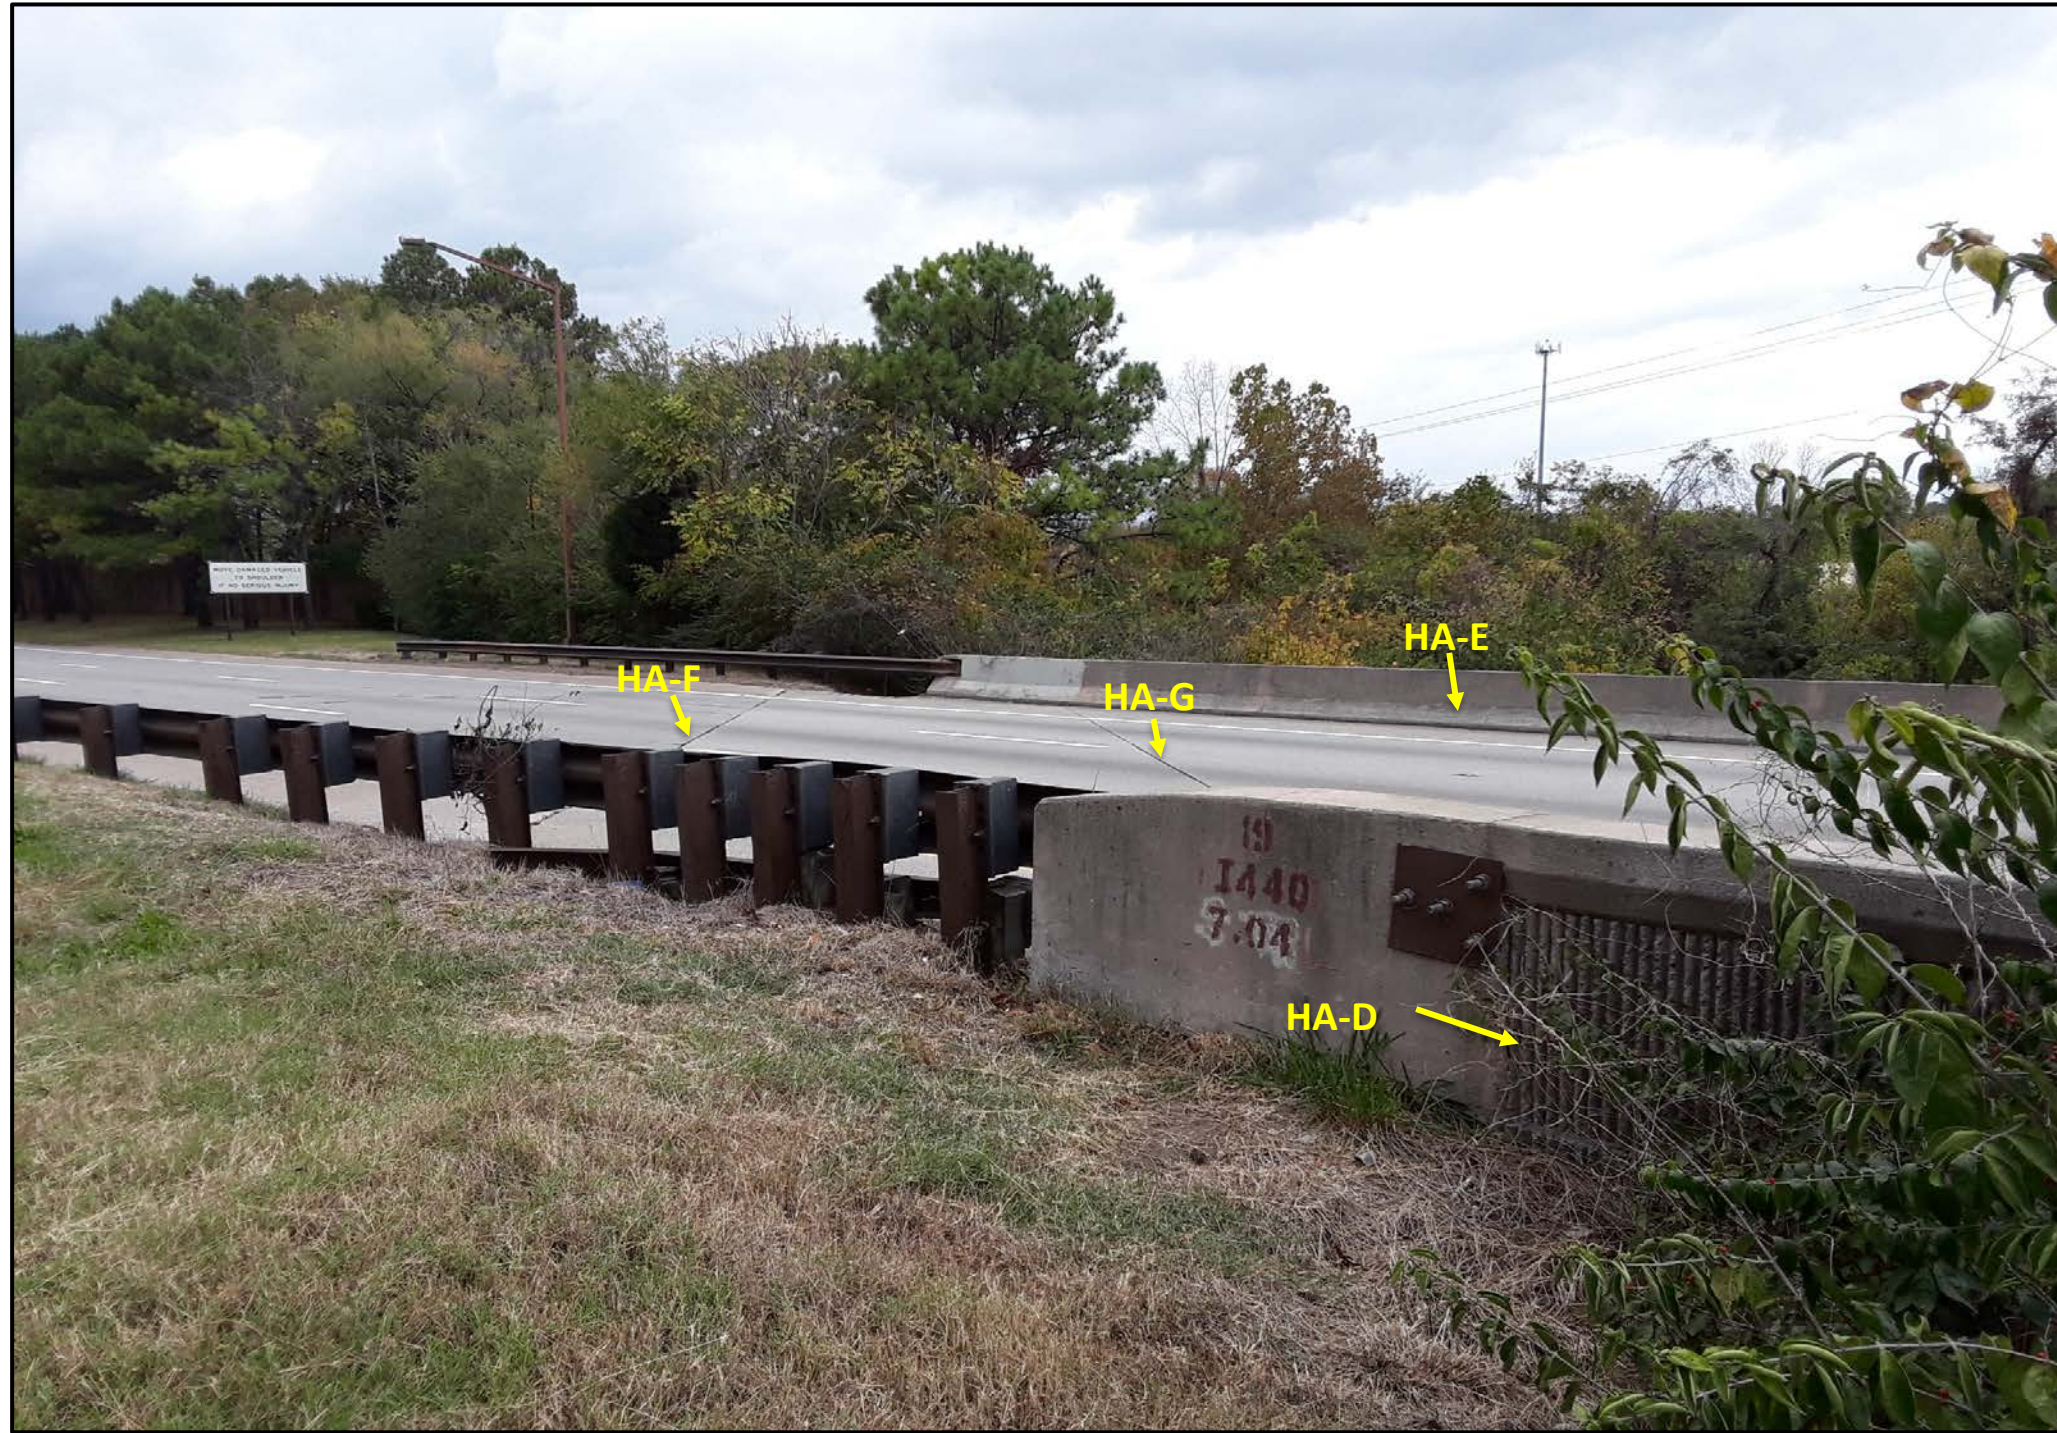
## Homogeneous Areas:

- D- Outside Concrete Guardrail with Coating
- E- Inside Concrete Guardrails
- F- Grey Joint Compound
- G- Black Joint Compound

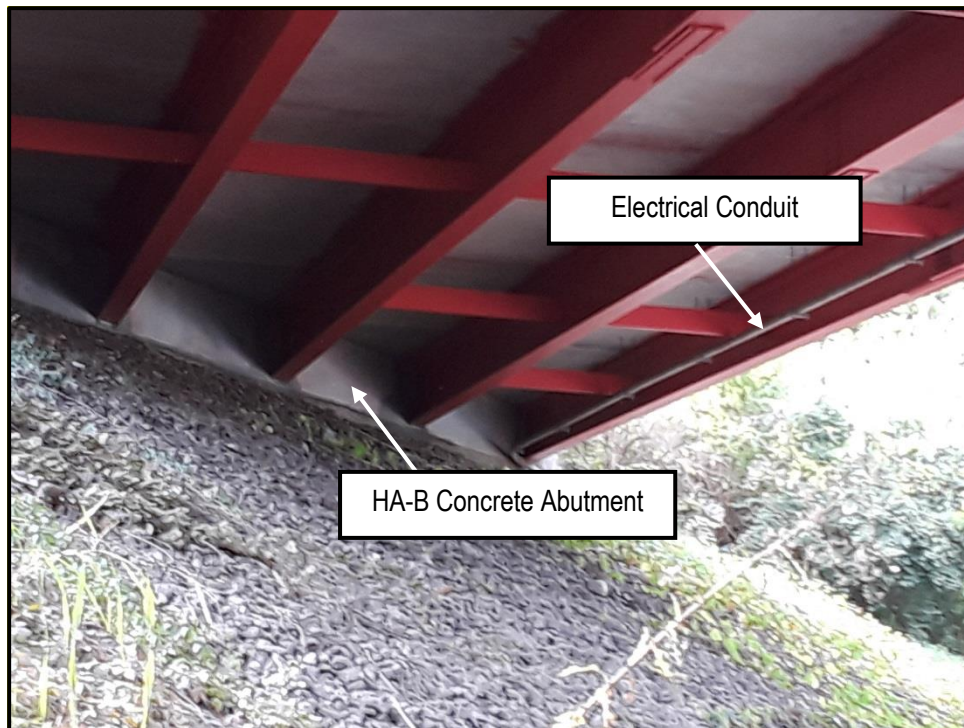
**Photo 2:** View of HA-B on the westbound I-440 bridge over Glenrose Avenue and CSX RR

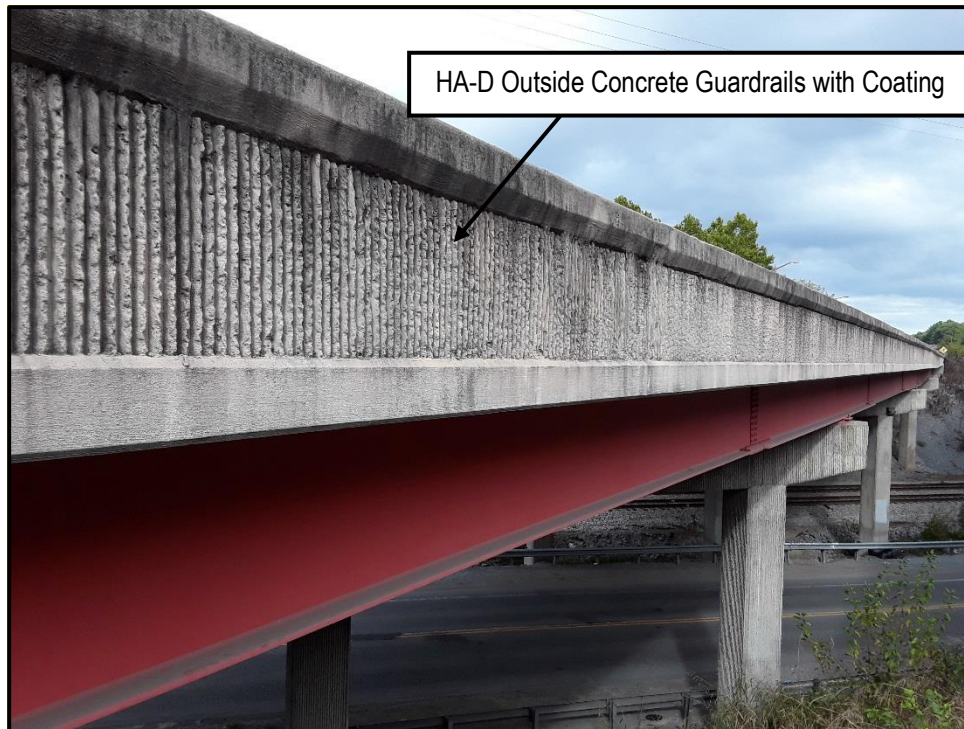
HA-D Outside Concrete Guardrails with Coating

**Photo 4:** View of HA-D on the westbound I-440 bridge over Glenrose Avenue and CSX RR

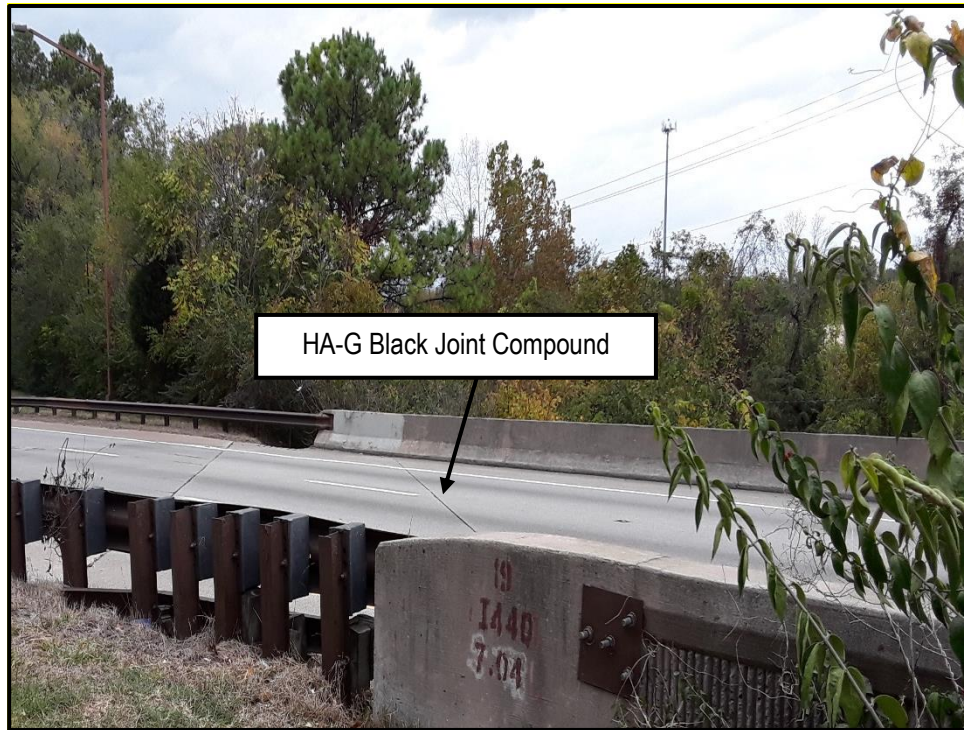
**Photo 7:** View of HA-G on the westbound I-440 bridge over Glenrose Avenue and CSX RR

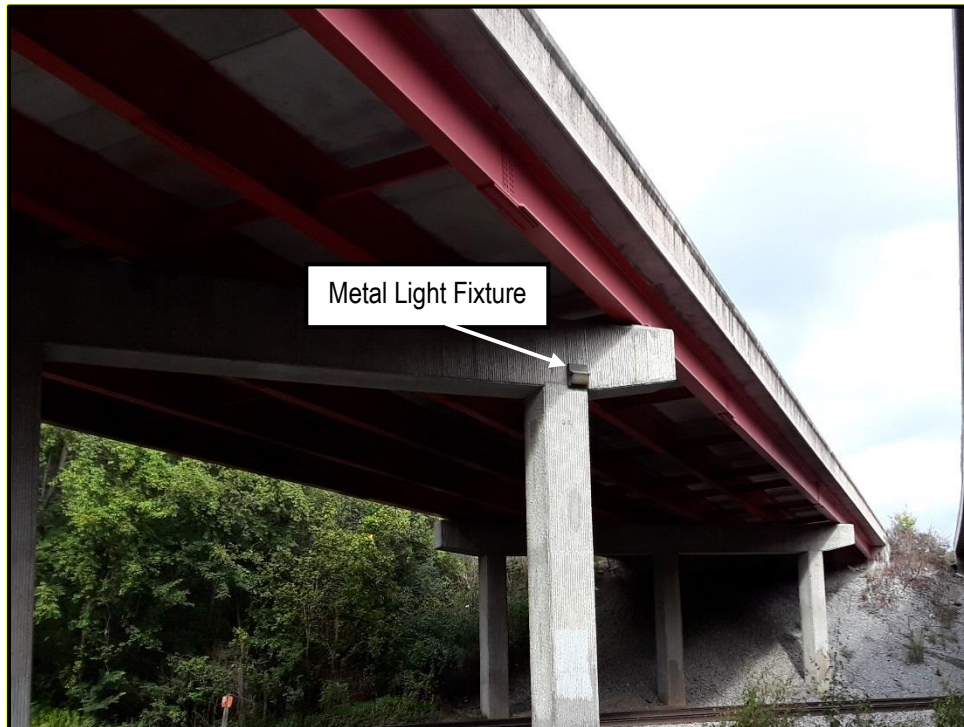
The KSWA field crew observed an electrical conduit attached to the underside of the northern decking. This electrical conduit was apparently connected to nearby street lighting. The field crew assumed that the electrical conduit was live, and did not disturb it. The electrical conduit was not obviously made of metal or plastic material, and would be a potentially suspect material that was not sampled during this survey. Metal light fixtures were also observed attached to the concrete bents of the bridge. These fixtures were obviously made of a metal material and would not be a potentially suspect material that would have been sampled during this survey.

**Photo 8:** View of metal light fixture on the westbound I-440 bridge over Glenrose Avenue and CSX RR

No asbestos was found to be present in any of the materials sampled from the westbound I-440 bridge over Glenrose Avenue and CSX RR at LM 7.04. Please note that the electrical conduit on the underside of the northern decking of the bridge was a potentially suspect material that could not be sampled during this survey due to safety concerns.
