I-440 Concrete Ramps

Report: Miller Bernhardt, Julie Hartman

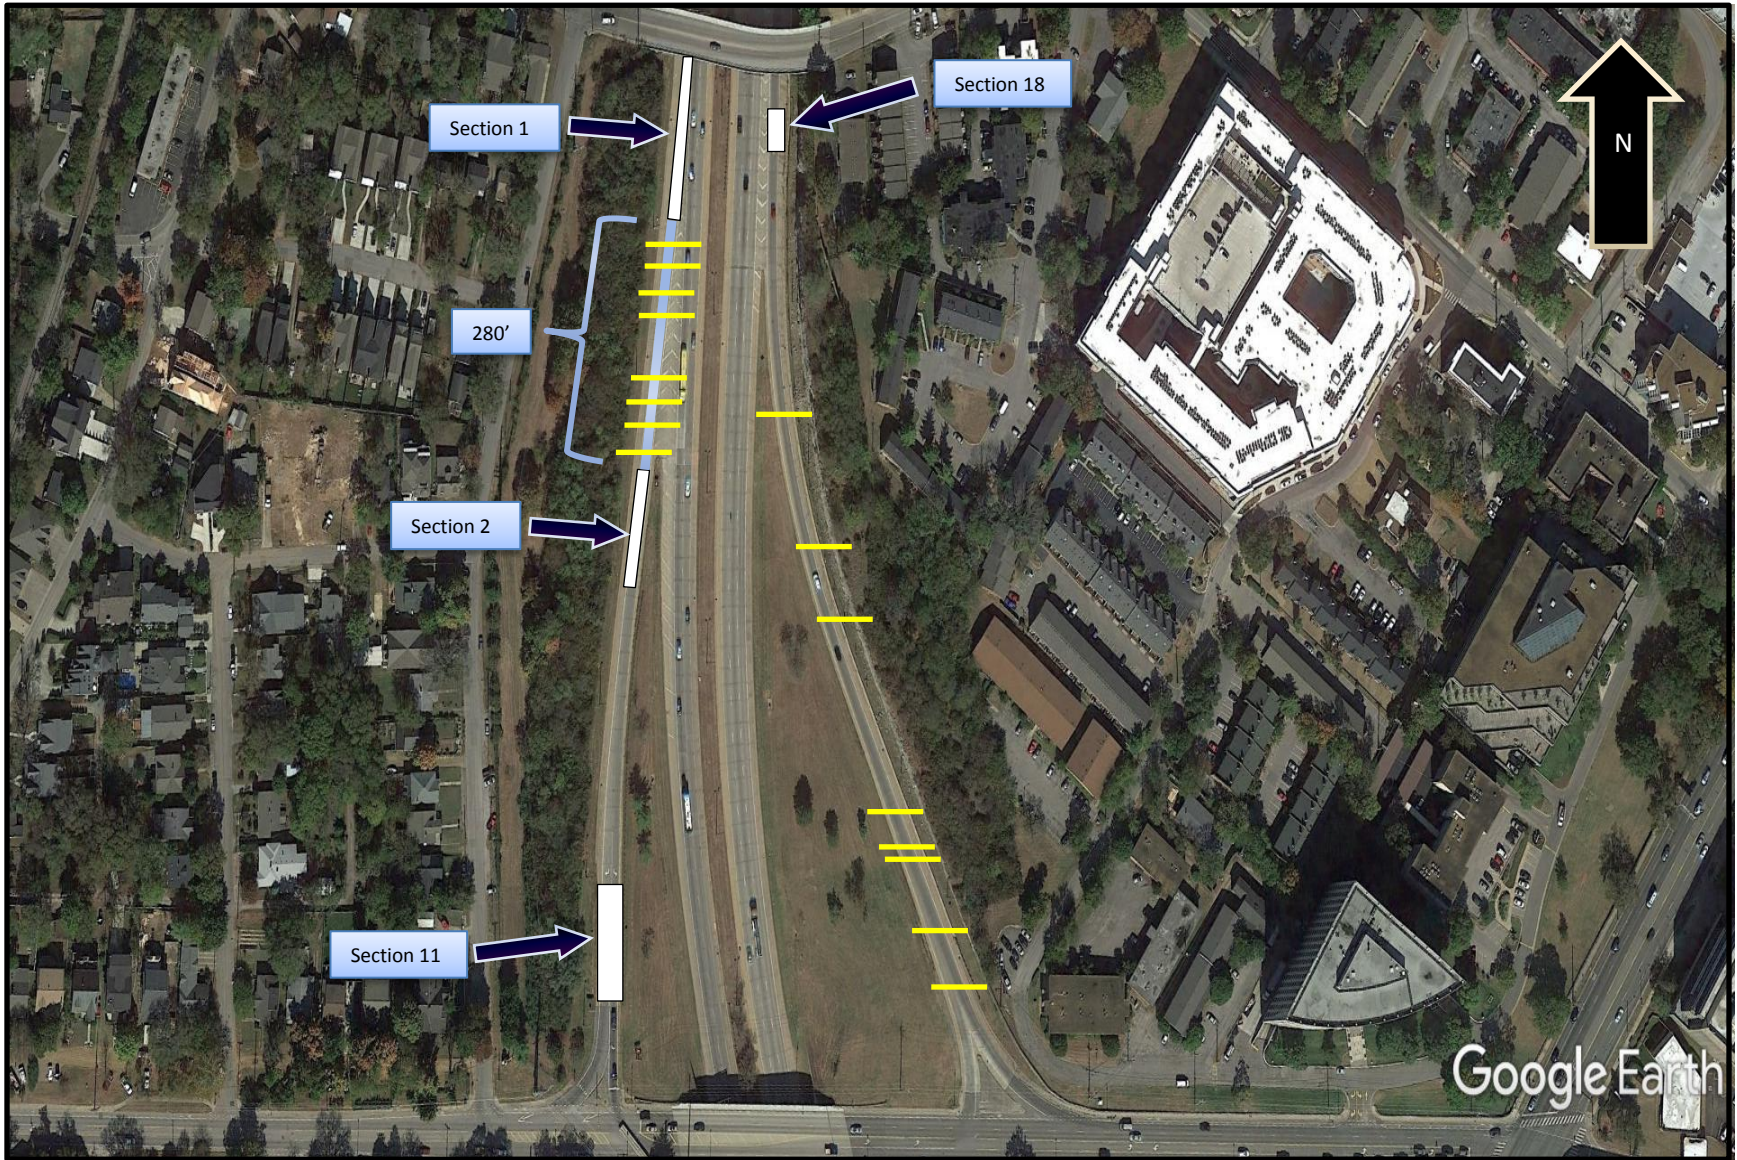
Figure 1: Murphy Road

- RP-J-23, RP-J-24, RP-J-25 Standard drawings were used to determine which areas needed to be repaired.
- These yellow bars represent a standard 6' X 16" section of full depth repair.

- The 6' X 16" areas shown in the photos below are a general representation of what is out there. Not all areas were photographed.

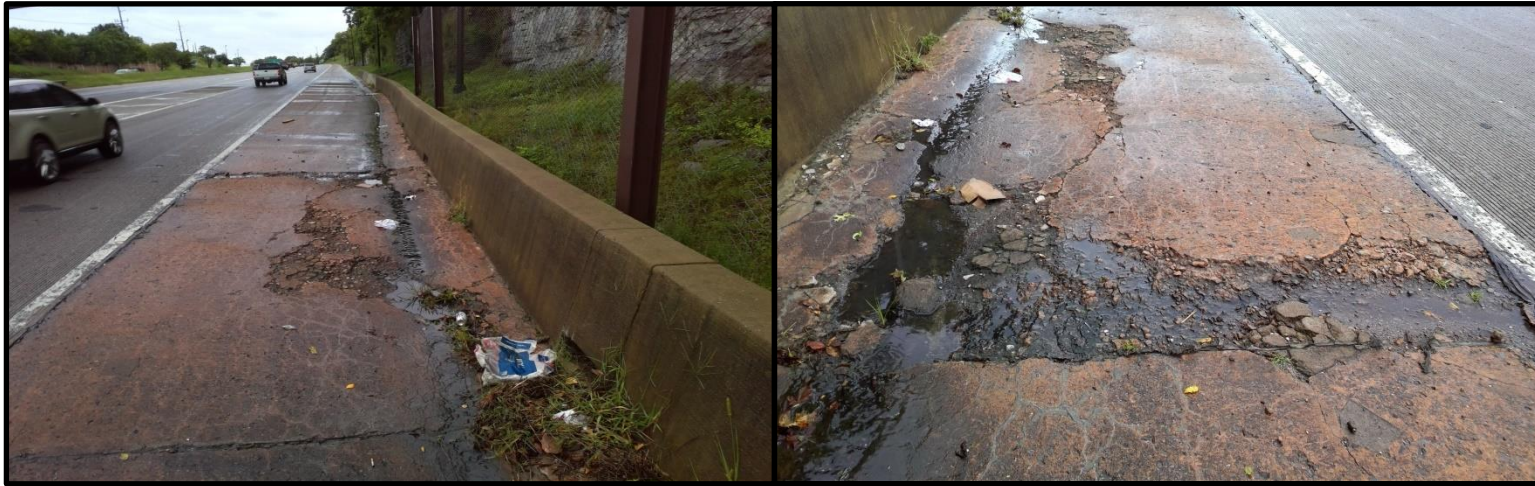
Section 19

Possible faulting and subgrade issues

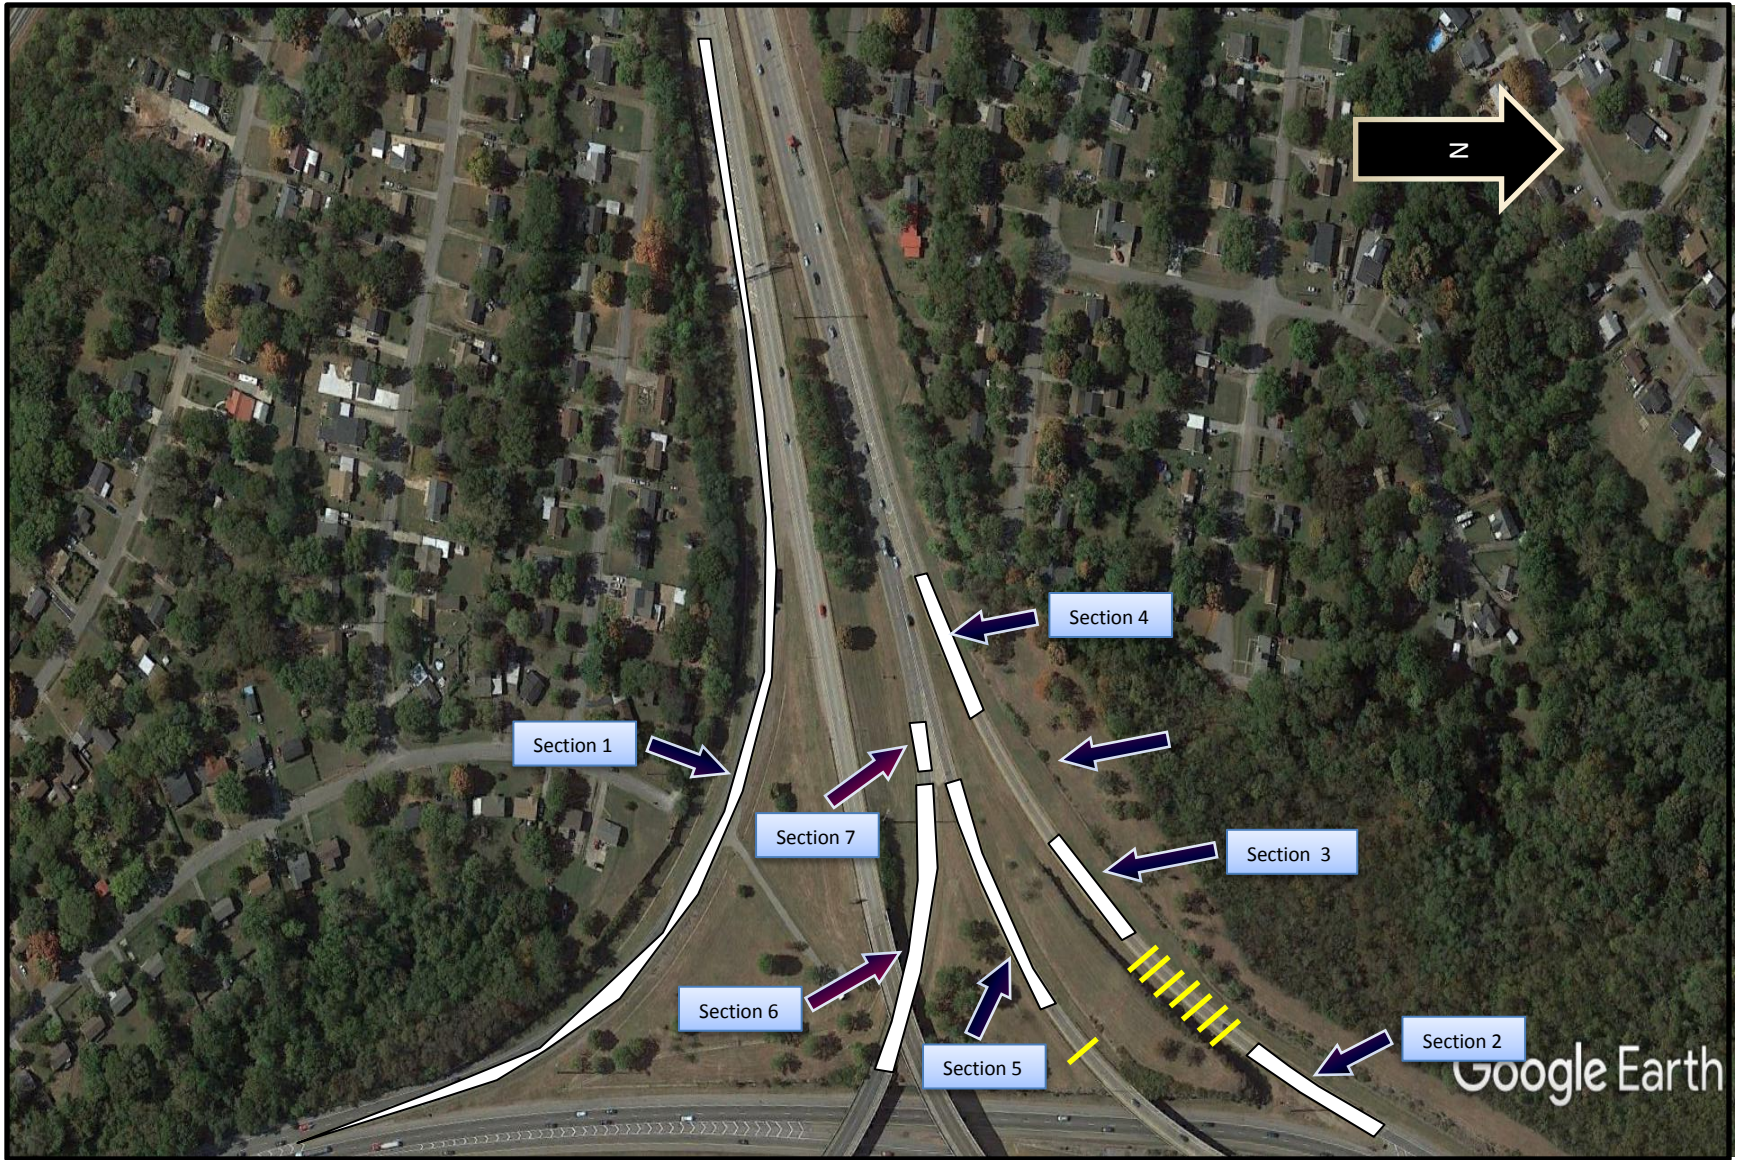
Figure 10: I24 and I40 Interchange

- Murphy Road and Hillsboro Road intersection improvement areas were included in this ramp research. With our right of way review plans we were unable to tell if the existing ramp area would be replaced or repaired.
- There is cracking, faulting, spalling, and may have some subgrade issues.
- The interchange at I24 and I40 has multiple overlays and the concrete is deteriorating underneath.
- There are centerline cracks throughout.
- Several areas at the intersections near the tops of the ramps have loop wires and handicap ramps.
- Most ramps are polished and have friction issues.
- Shoulders are in very good condition except about 4-5 locations (shown above).

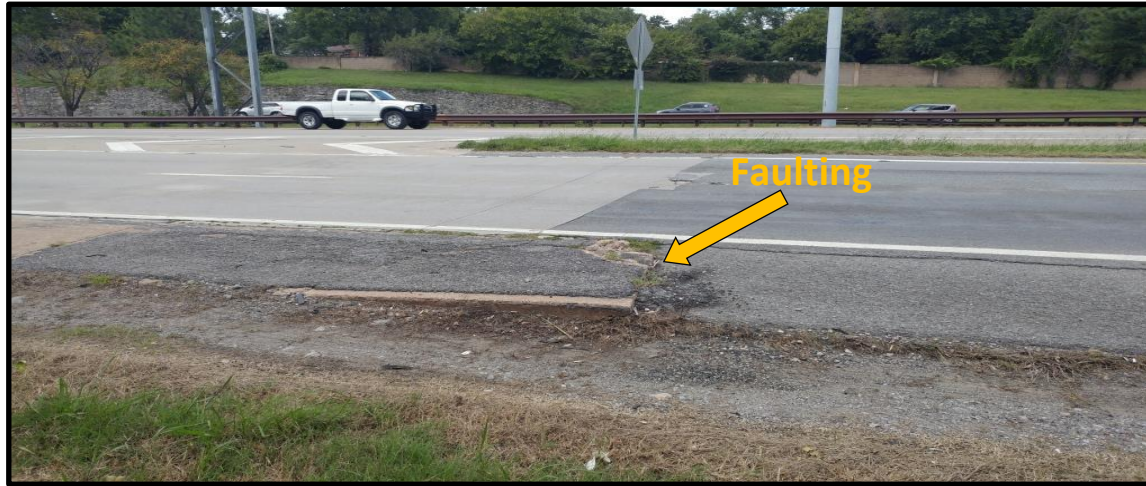
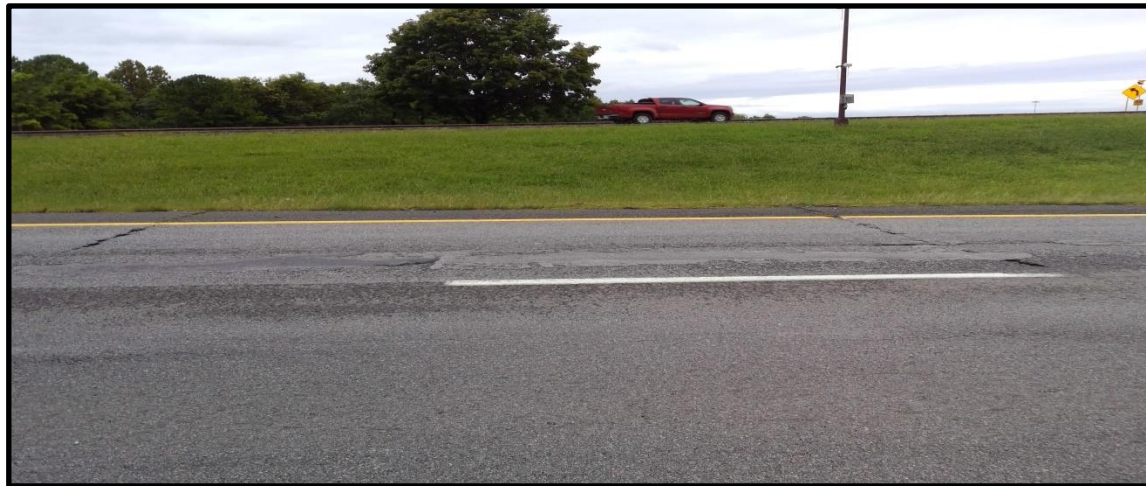
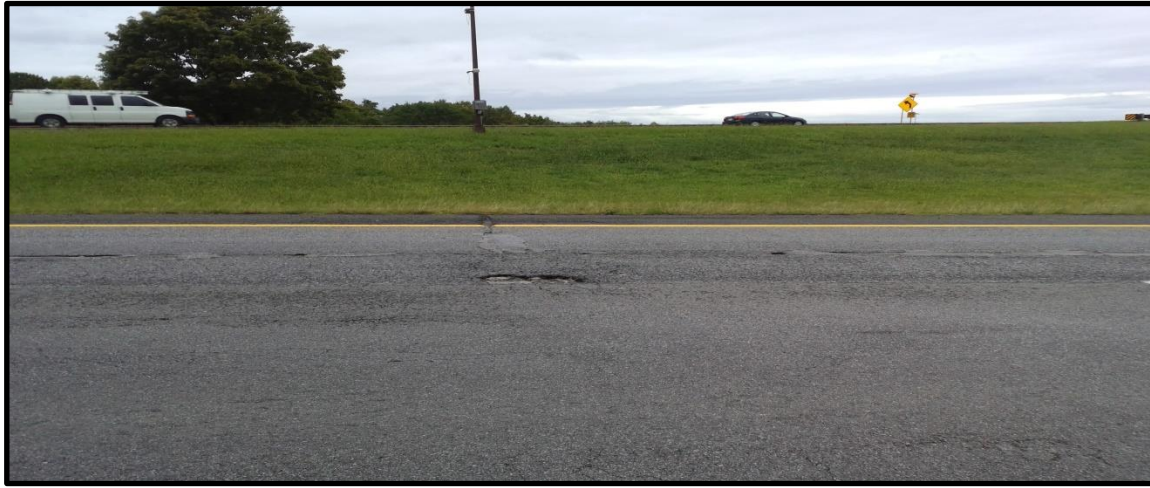
Section 1

Asphalt overlay on concrete deteriorating

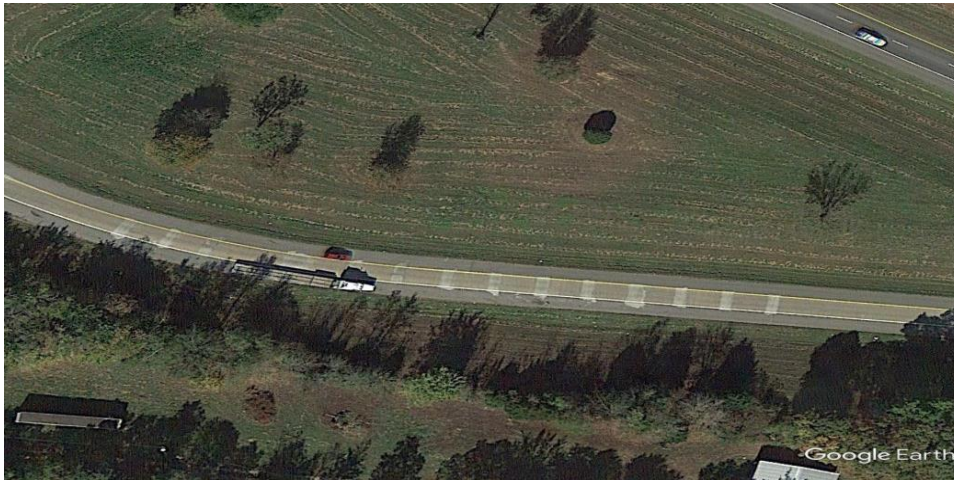
- Add random crack sealing.
- West End ramps on the eastside are in the best condition and should be considered for repair only.
- Multiple 6' X 16' repair areas in a row will look like the image below: Rides smooth but not aesthetically pleasing.
