STATE OF TENNESSEE
DEPARTMENT OF TRANSPORTATION

Bridge Condition Coding Form

Bridge Number: 09S823300011
(Includes Item 5A)

Feature Intersected: REEDY CREEK

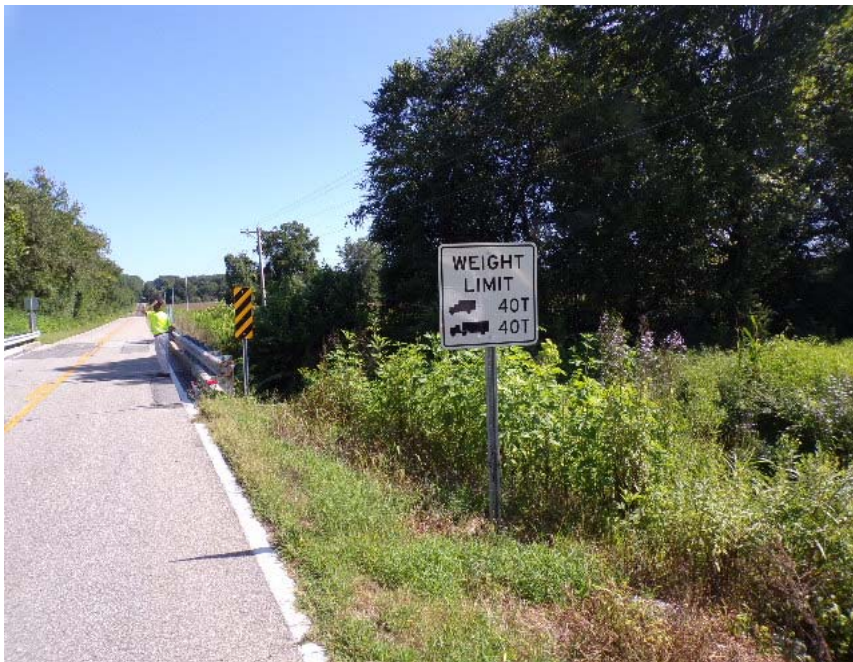
APPROACH # 1 WEIGHT LIMIT SIGN

YES	NO	NEEDED	Weight Limit Posted
Paddleboards	(X)	()	()	YES (X) NO ()
Vertical Clearance (<14'-6")	()	(X)	()	Gross..... <u>40</u> Tons
NARROW ()	()	(X)	()	2 Axle..... <u>40</u> Tons
ONE LANE BRIDGE ()	()	(X)	()	3 or more Axles.. _____ Tons

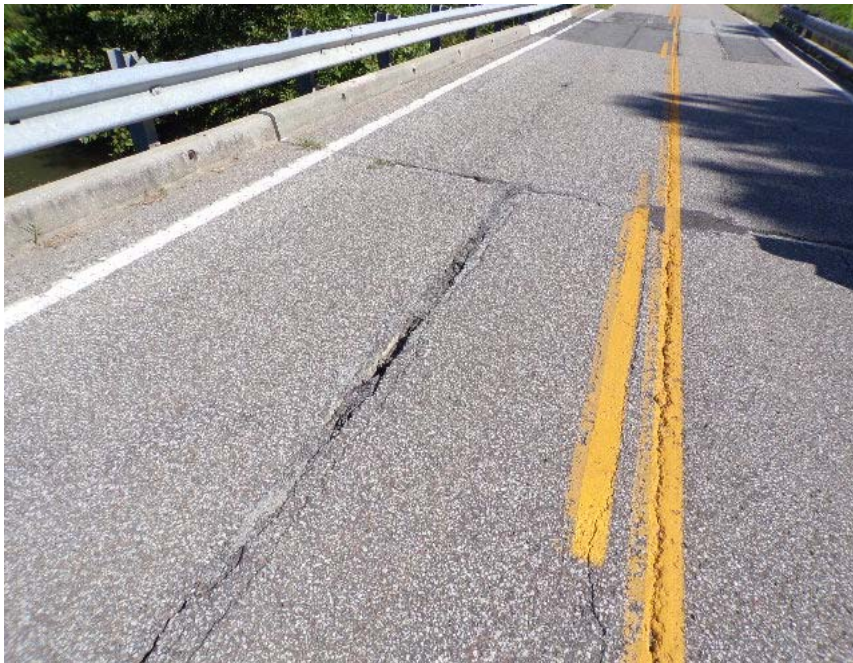
SPAN # 1 SETTLING

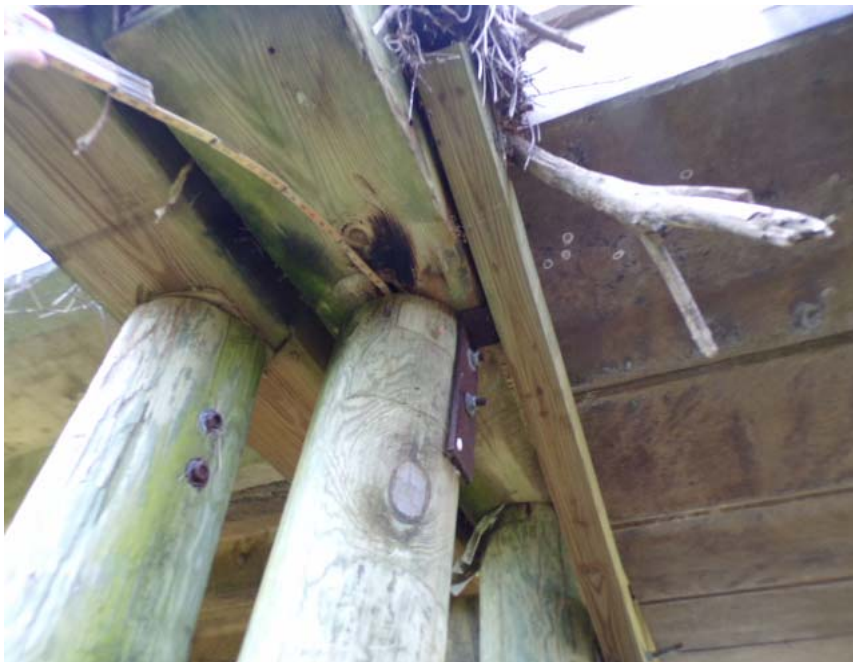
BENT # 1 "B" CAP DECAYED

PILE(S)	BENT
Caps	G F <u>P</u> C	Bent #1 'B' Decayed		(135)
Columns Rip Rap	<u>G</u> F P C			
Plumb	<u>G</u> F P C			
Footings conc casing	<u>G</u> F P C			
Piles	G <u>F</u> P C			
Bearing	G F P C			
Bracing	G <u>F</u> P C			
Earthquake Devices	G F P C

ELEMENT	RATING	COMMENT
CAP 12"x14" L	G F <u>P</u> C	① Decay 8" Wx 2' Lx 3" D
PILES A 11"	G <u>F</u> P C	med. weathering
B 11"	G <u>F</u> P C	
C 12	G <u>F</u> P C	
D 10"	G <u>F</u> P C	
E 12"	G <u>F</u> P C	
F 10"	G <u>F</u> P C	
RIP - RAP	<u>G</u> F P C	
BRACING	G <u>F</u> P C	light weathering
Conc casing	<u>G</u>

REPAIR CAPBEAM AT BENT NO.1B

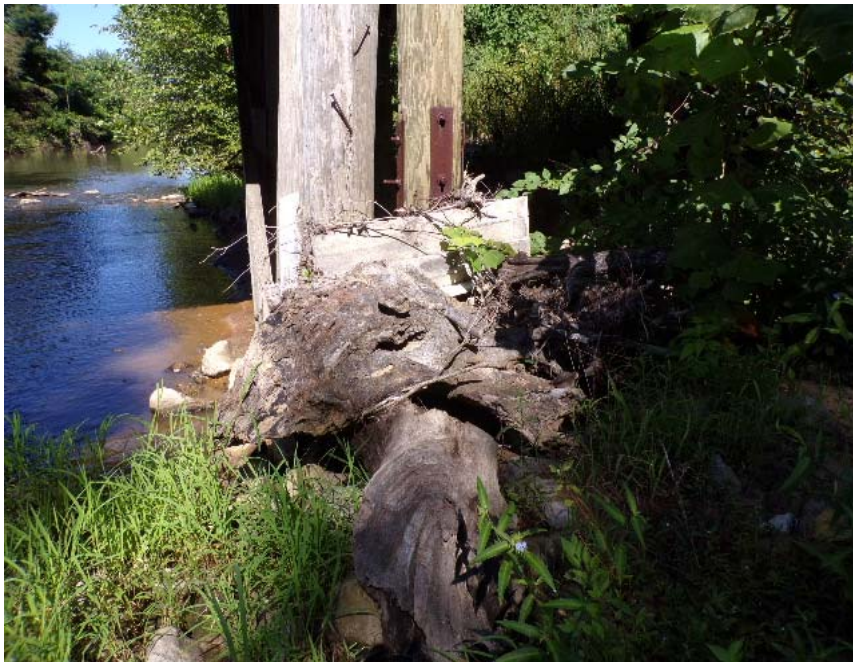
BENT # 2 DRIFT

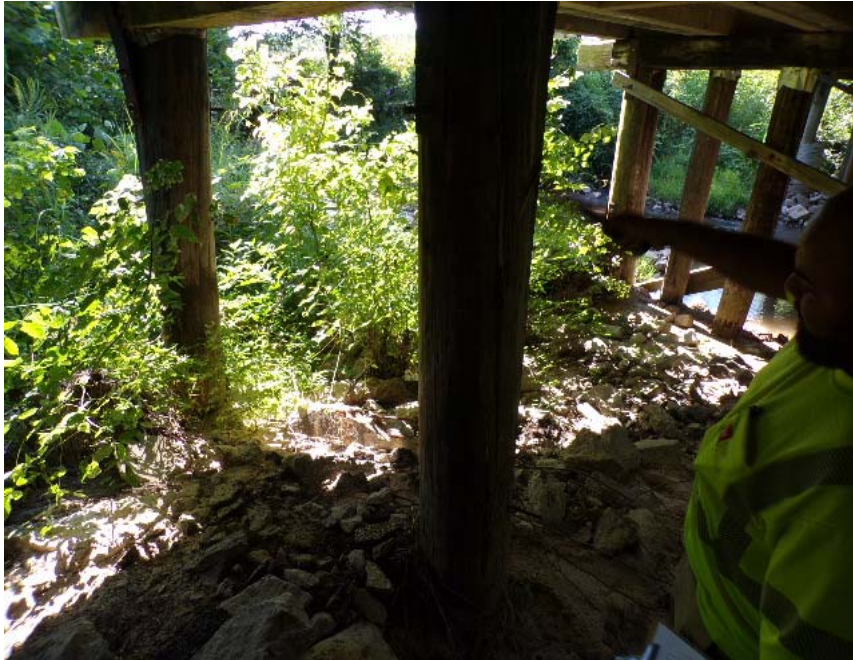
BENT # 3 PILE "C" SPLIT

THIS IS A 4 SPAN CONCRETE BOX BEAM & P.C.C.S. BRIDGE IN FAIR
CONDITION
SUBSTRUCTURE IS TIMBER
TRAFFIC SAFETY FEATURES CONSIST OF METAL BRIGE RAILS, 4 PADDLE
BOARDS & 40 TON WEIGHT LIMIT POSTED @ APPROACH # 1 & 2
APPROACH A/C HAS FINE CRACKS & LIGHT SETTLING
A/C WEARING SURFACE HAS SPALLING, FINE CRACKS & IS SETTLED
BETWEEN SLABS
P.C.C.S. HAVE FINE CRACKS WITH EFFLORESCENCE STAINS & SPALLING
TO STEEL AREAS
CONCRETE BOX BEAMS HAVE SURFACE STEEL
BNET # 1 "B" CAP IS DECAYED
SUBSTRUCTURE HAS LIGHT TO MEDIUM WEATHERING
BENT # 3 PILE "C" HAS A SPLIT AREA
