Programmatic Categorical Exclusion

State Route (SR) 1

Bridge over Muddy Creek, Log Mile (LM) 2.13

PIN 124505.00

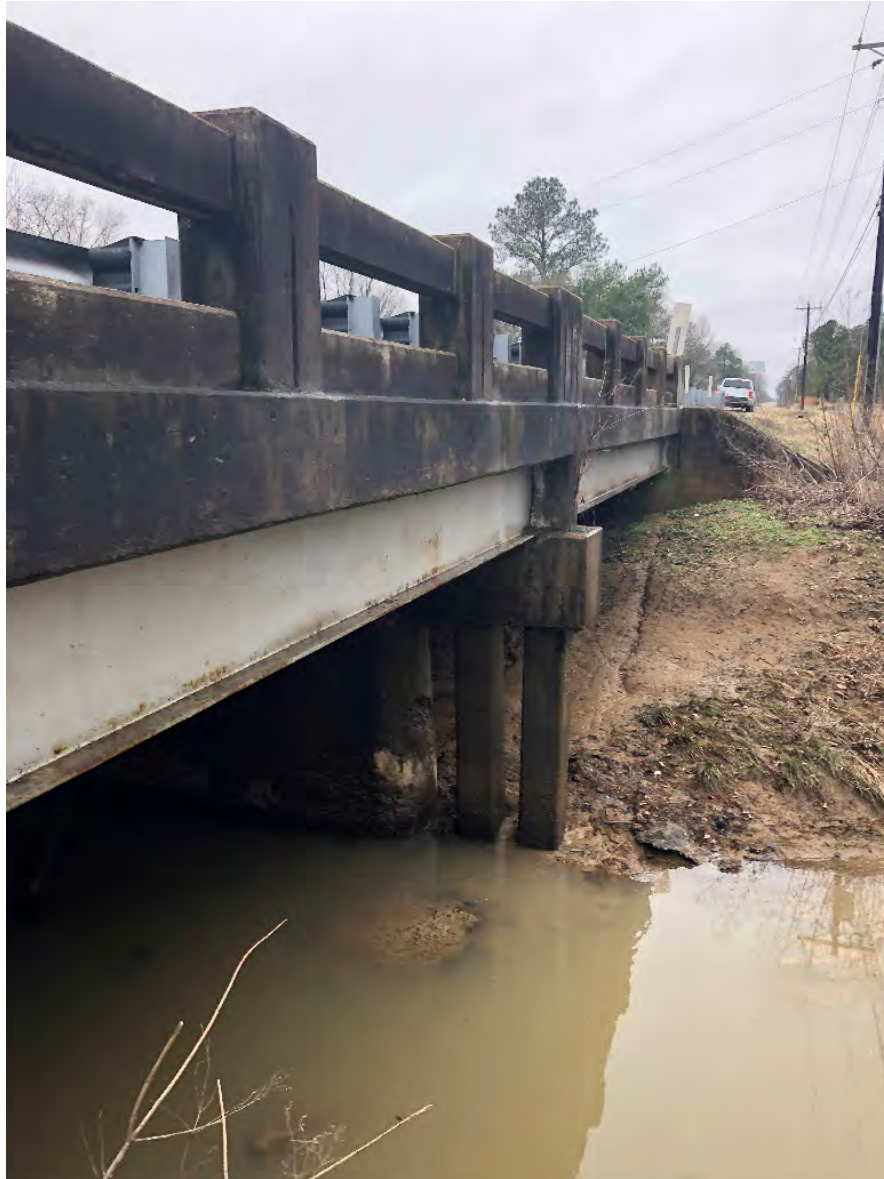
Corrosion on Girder at Outlet

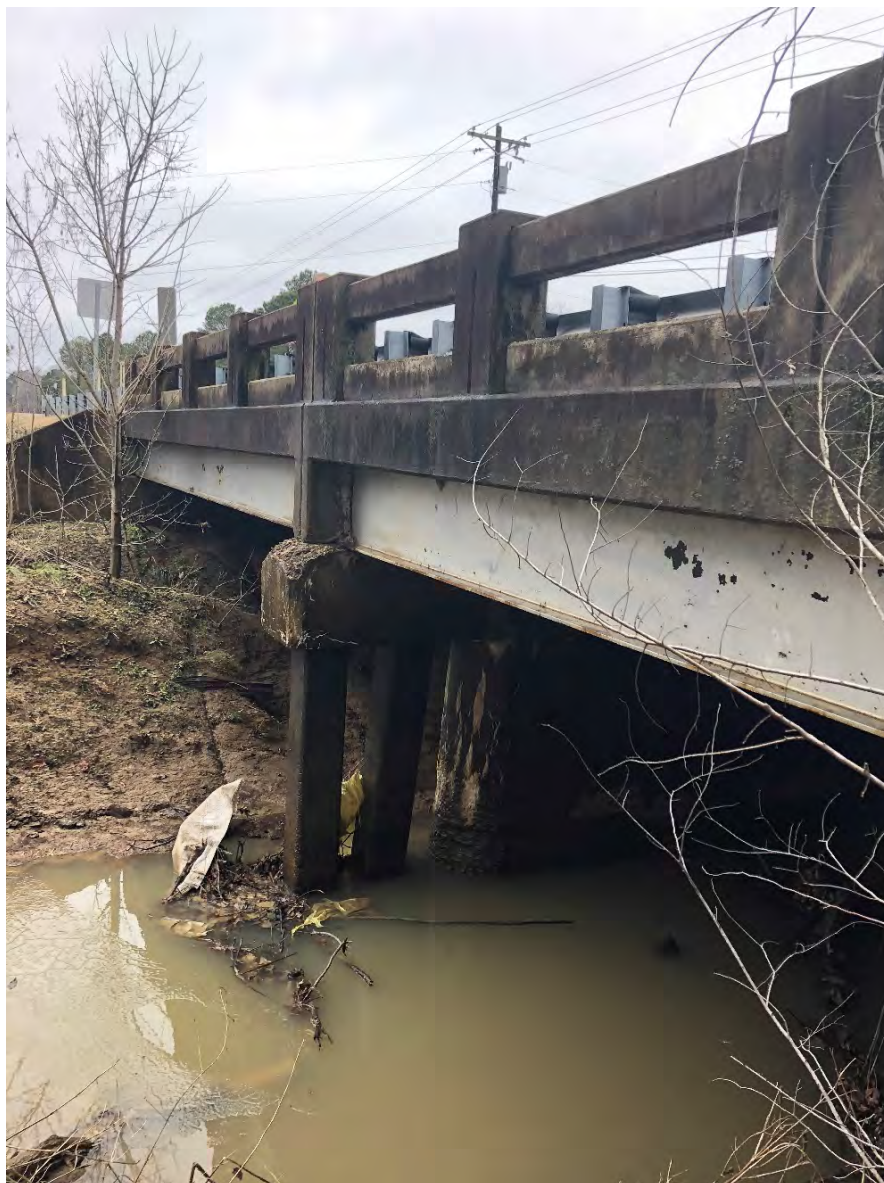
Extensive Decay of Pier near Girder and Foundation at Inlet

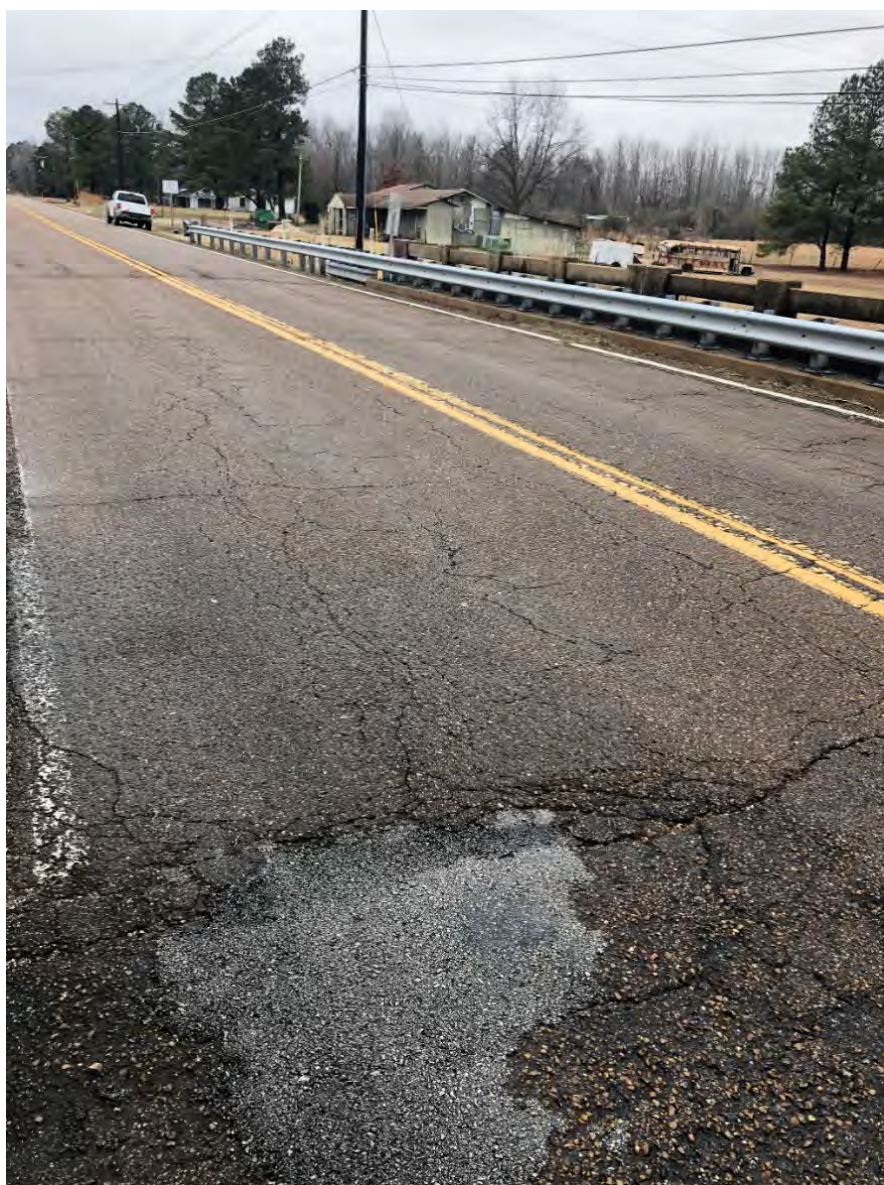
Extensive Pavement Cracking and Rutting on Bridge

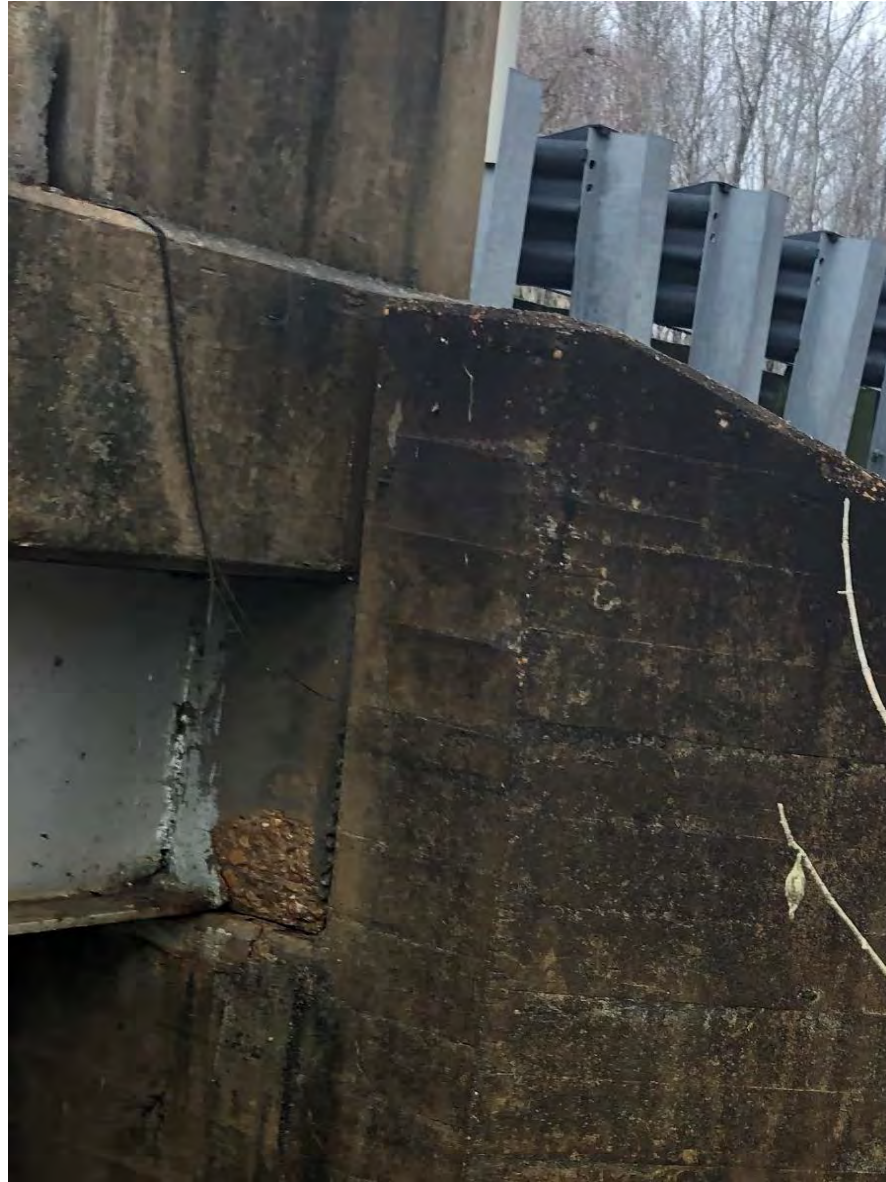
Corrosion and Decay at Girder Connection to East Abutment on Inlet Side

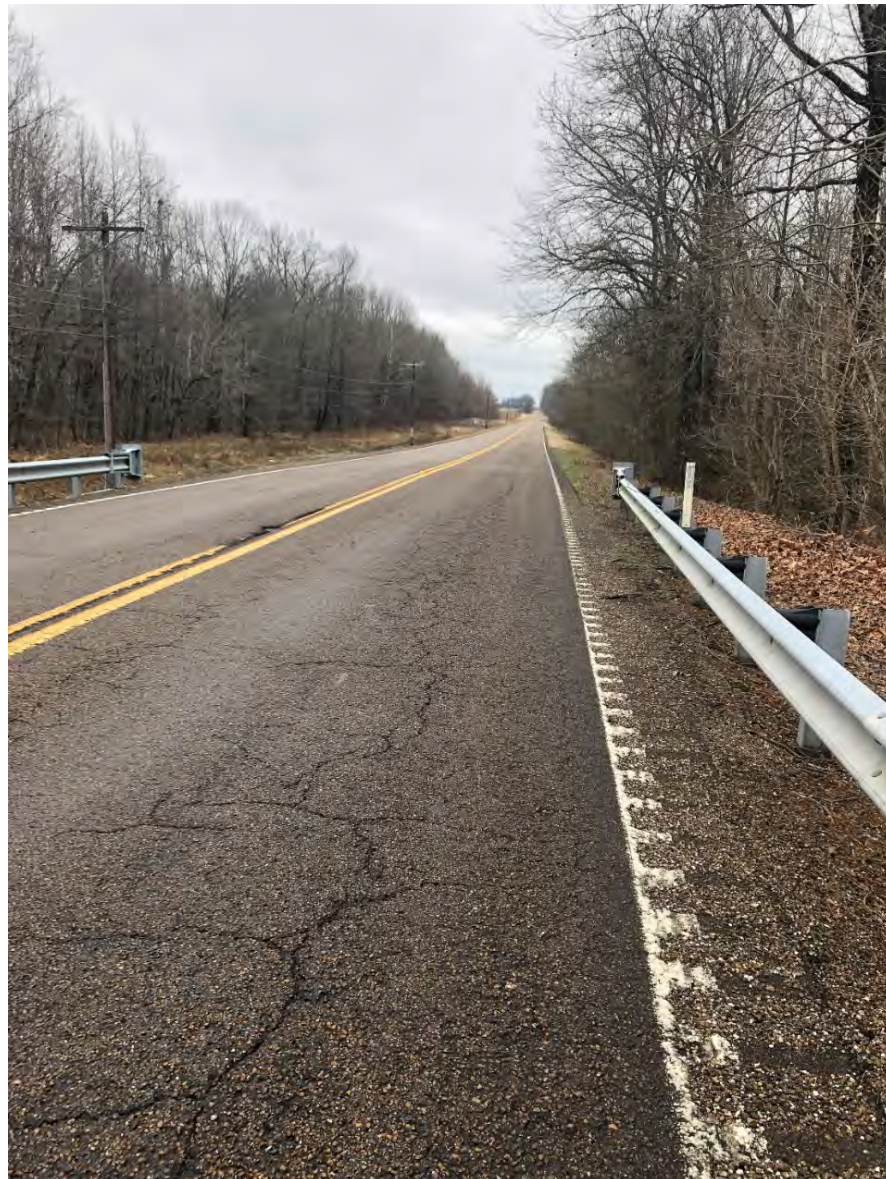
Extensive Pavement Cracking and Rutting Leaving Bridge Eastbound

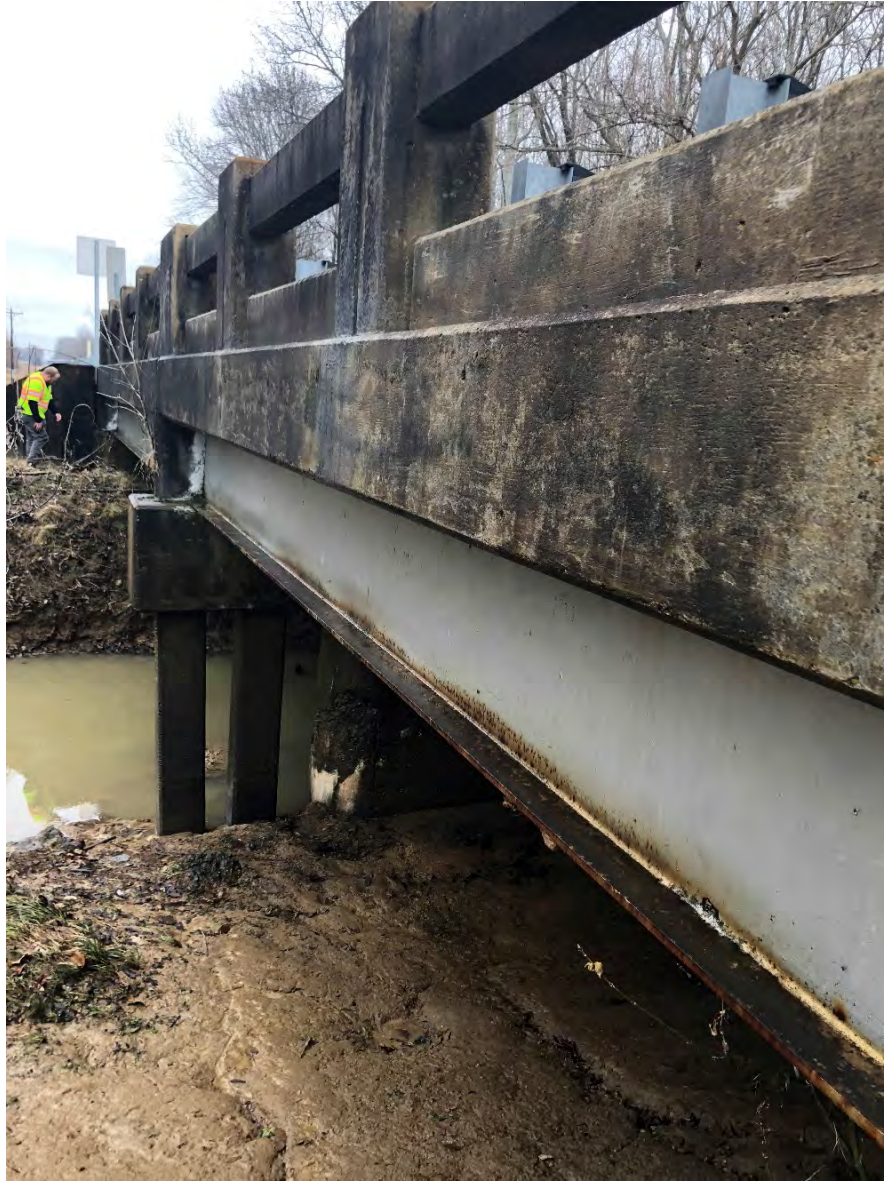
Corrosion of Outlet Girder between West Abutment and Pier

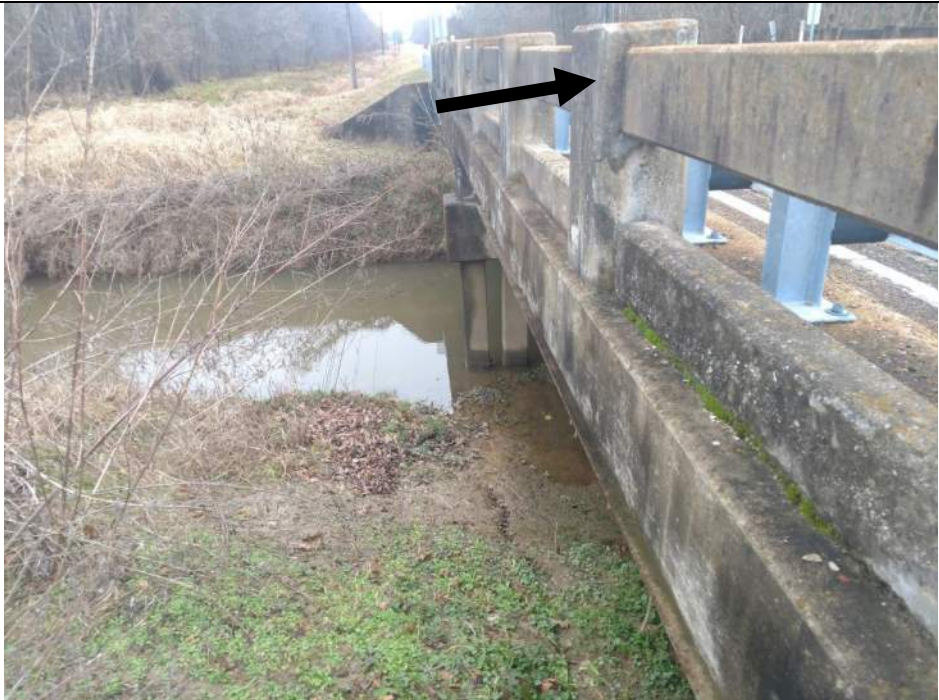
Subject: Haywood County; SR-1, HWY 70 E. Bridge over Branch at LM 2.89; P.E. 38002-0217-94, PIN 124505.00
Haywood County; SR-1, HWY 70 E. Bridge over Branch at LM 2.89; P.E. 38002-0217-94, PIN 124503.00
Mr. Tim Nehus,

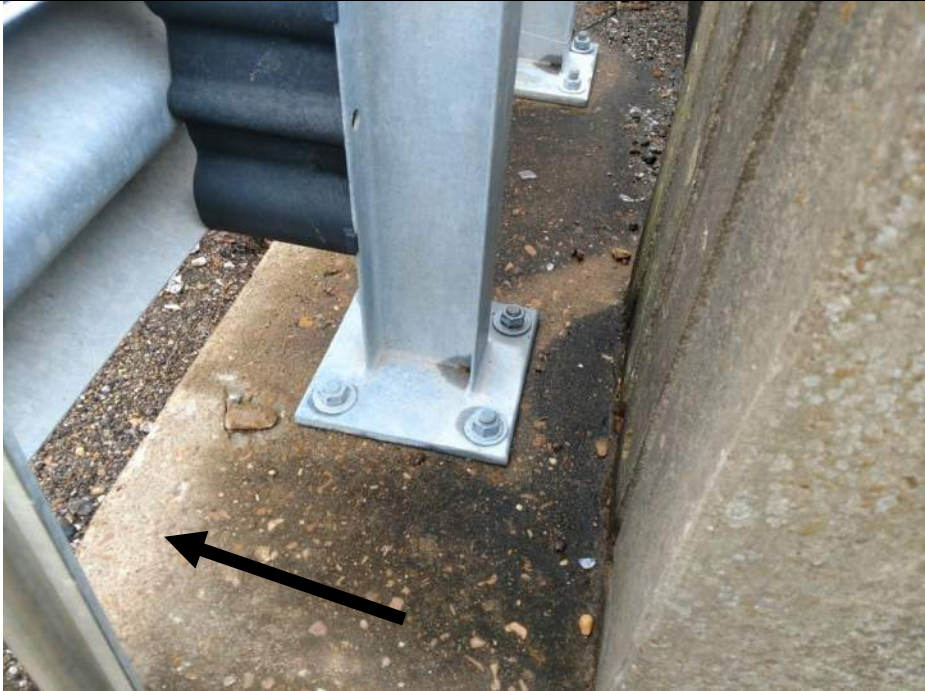
Date: 12/18/2017	
Description: Photograph 3 – Homogeneous Area 2 Curb Sample Locations MC-02-04 MC-02-05 MC-02-06

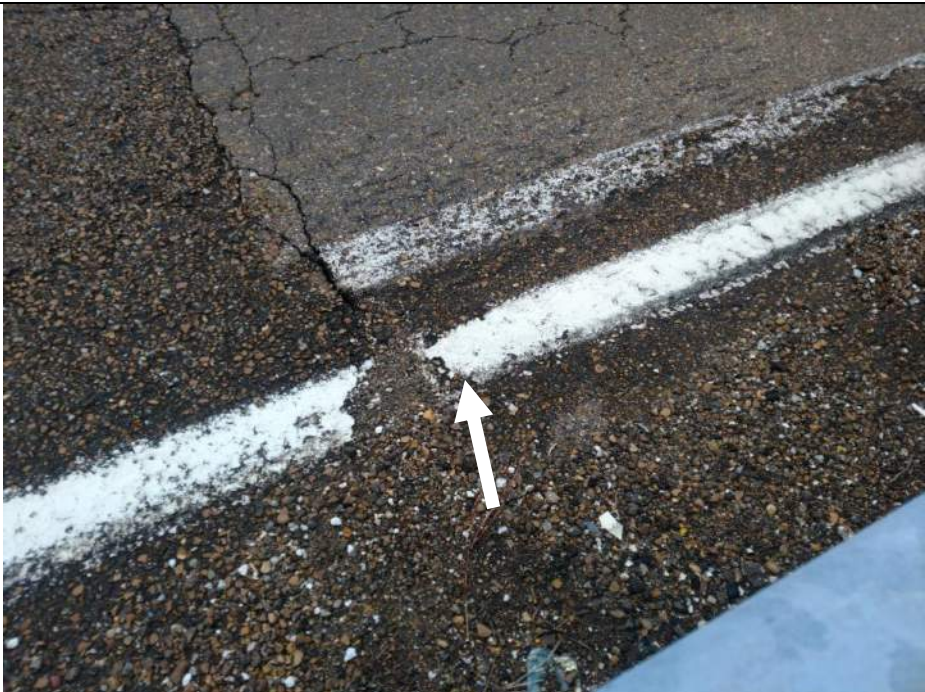
Date: 12/18/2017	
Description: Photograph 4 – Homogeneous Area 3 Road Stripe Sample Locations MC-03-07 MC-03-08 MC-03-09

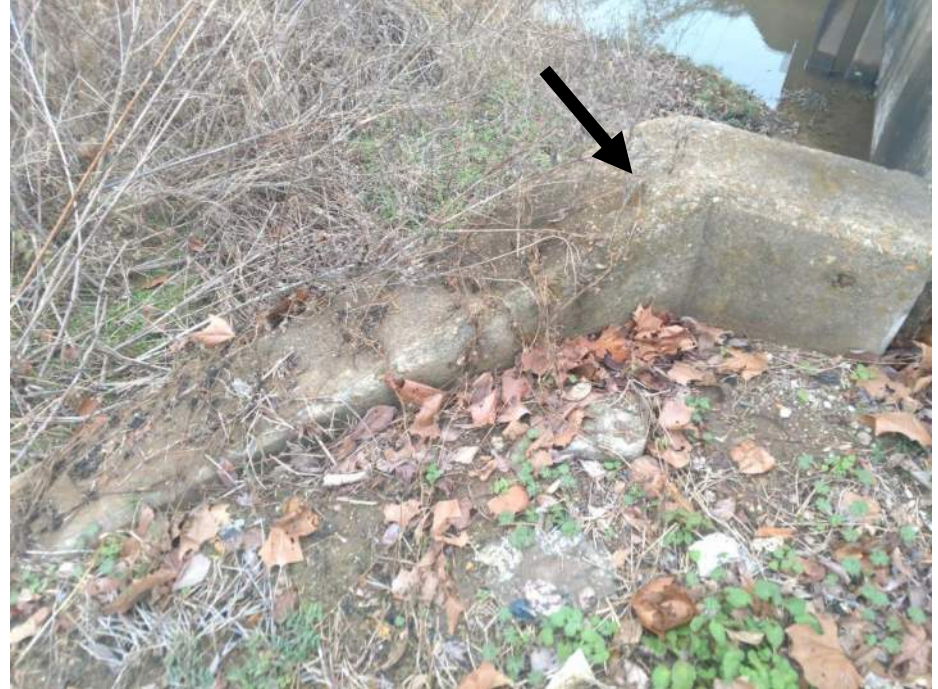
<p>Date: 12/18/2017</p>	
<p>Description: Photograph 5 – Homogeneous Area 4 Wing Wall Sample Locations MC-04-10 MC-04-11 MC-04-12</p>

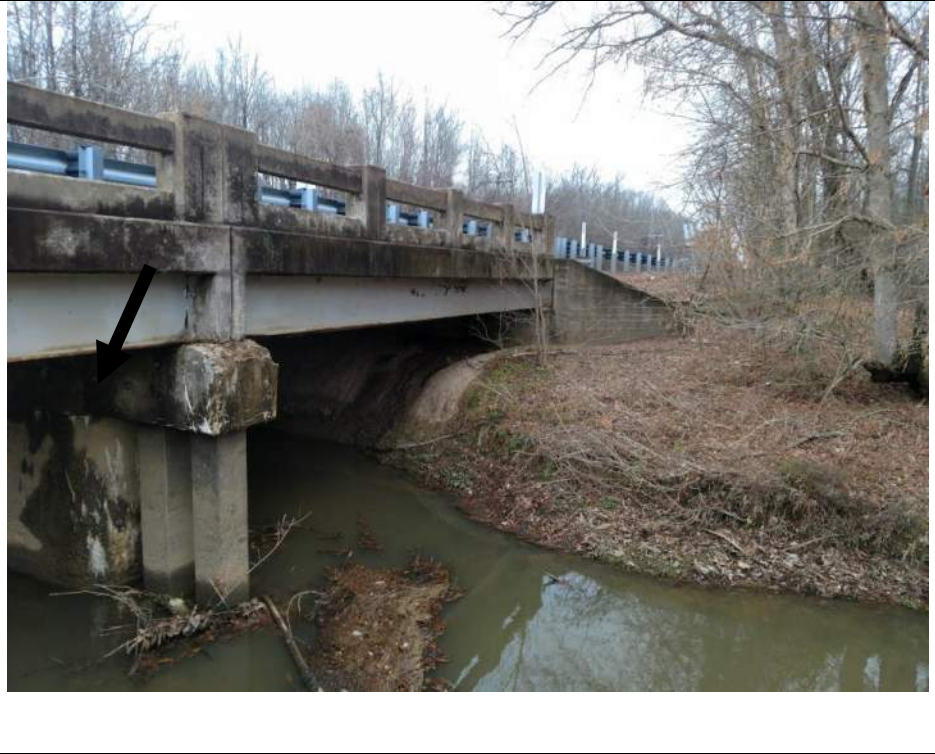
<p>Date: 12/18/2017</p>	
<p>Description: Photograph 11 – Homogeneous Area 10 Old Pier Cap Sample Locations MC-10-28 MC-10-29 MC-10-30</p>	
<p>Photographer: Chelsea Sachs</p>

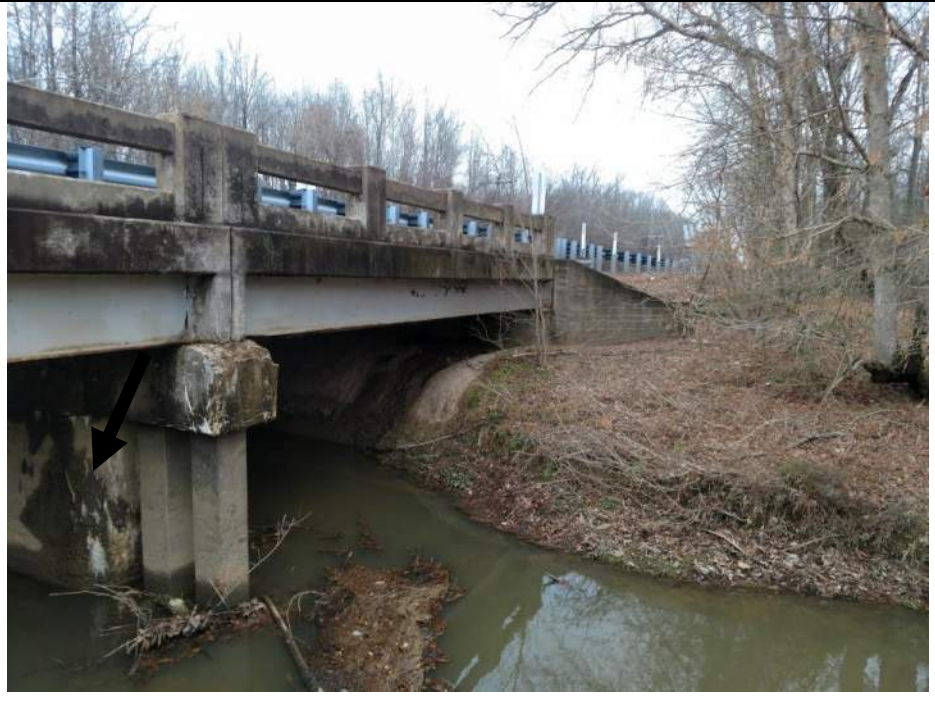
<p>Date: 12/18/2017</p>	
<p>Description: Photograph 12 – Homogeneous Area 11 Old Pier Sample Locations MC-11-31 MC-11-32 MC-11-33</p>
