Quality Assurance Review

Programmatic Categorical Exclusion

State Route (SR) 87

Bridge over Overflow, Log Mile (LM) 3.88 (IA)

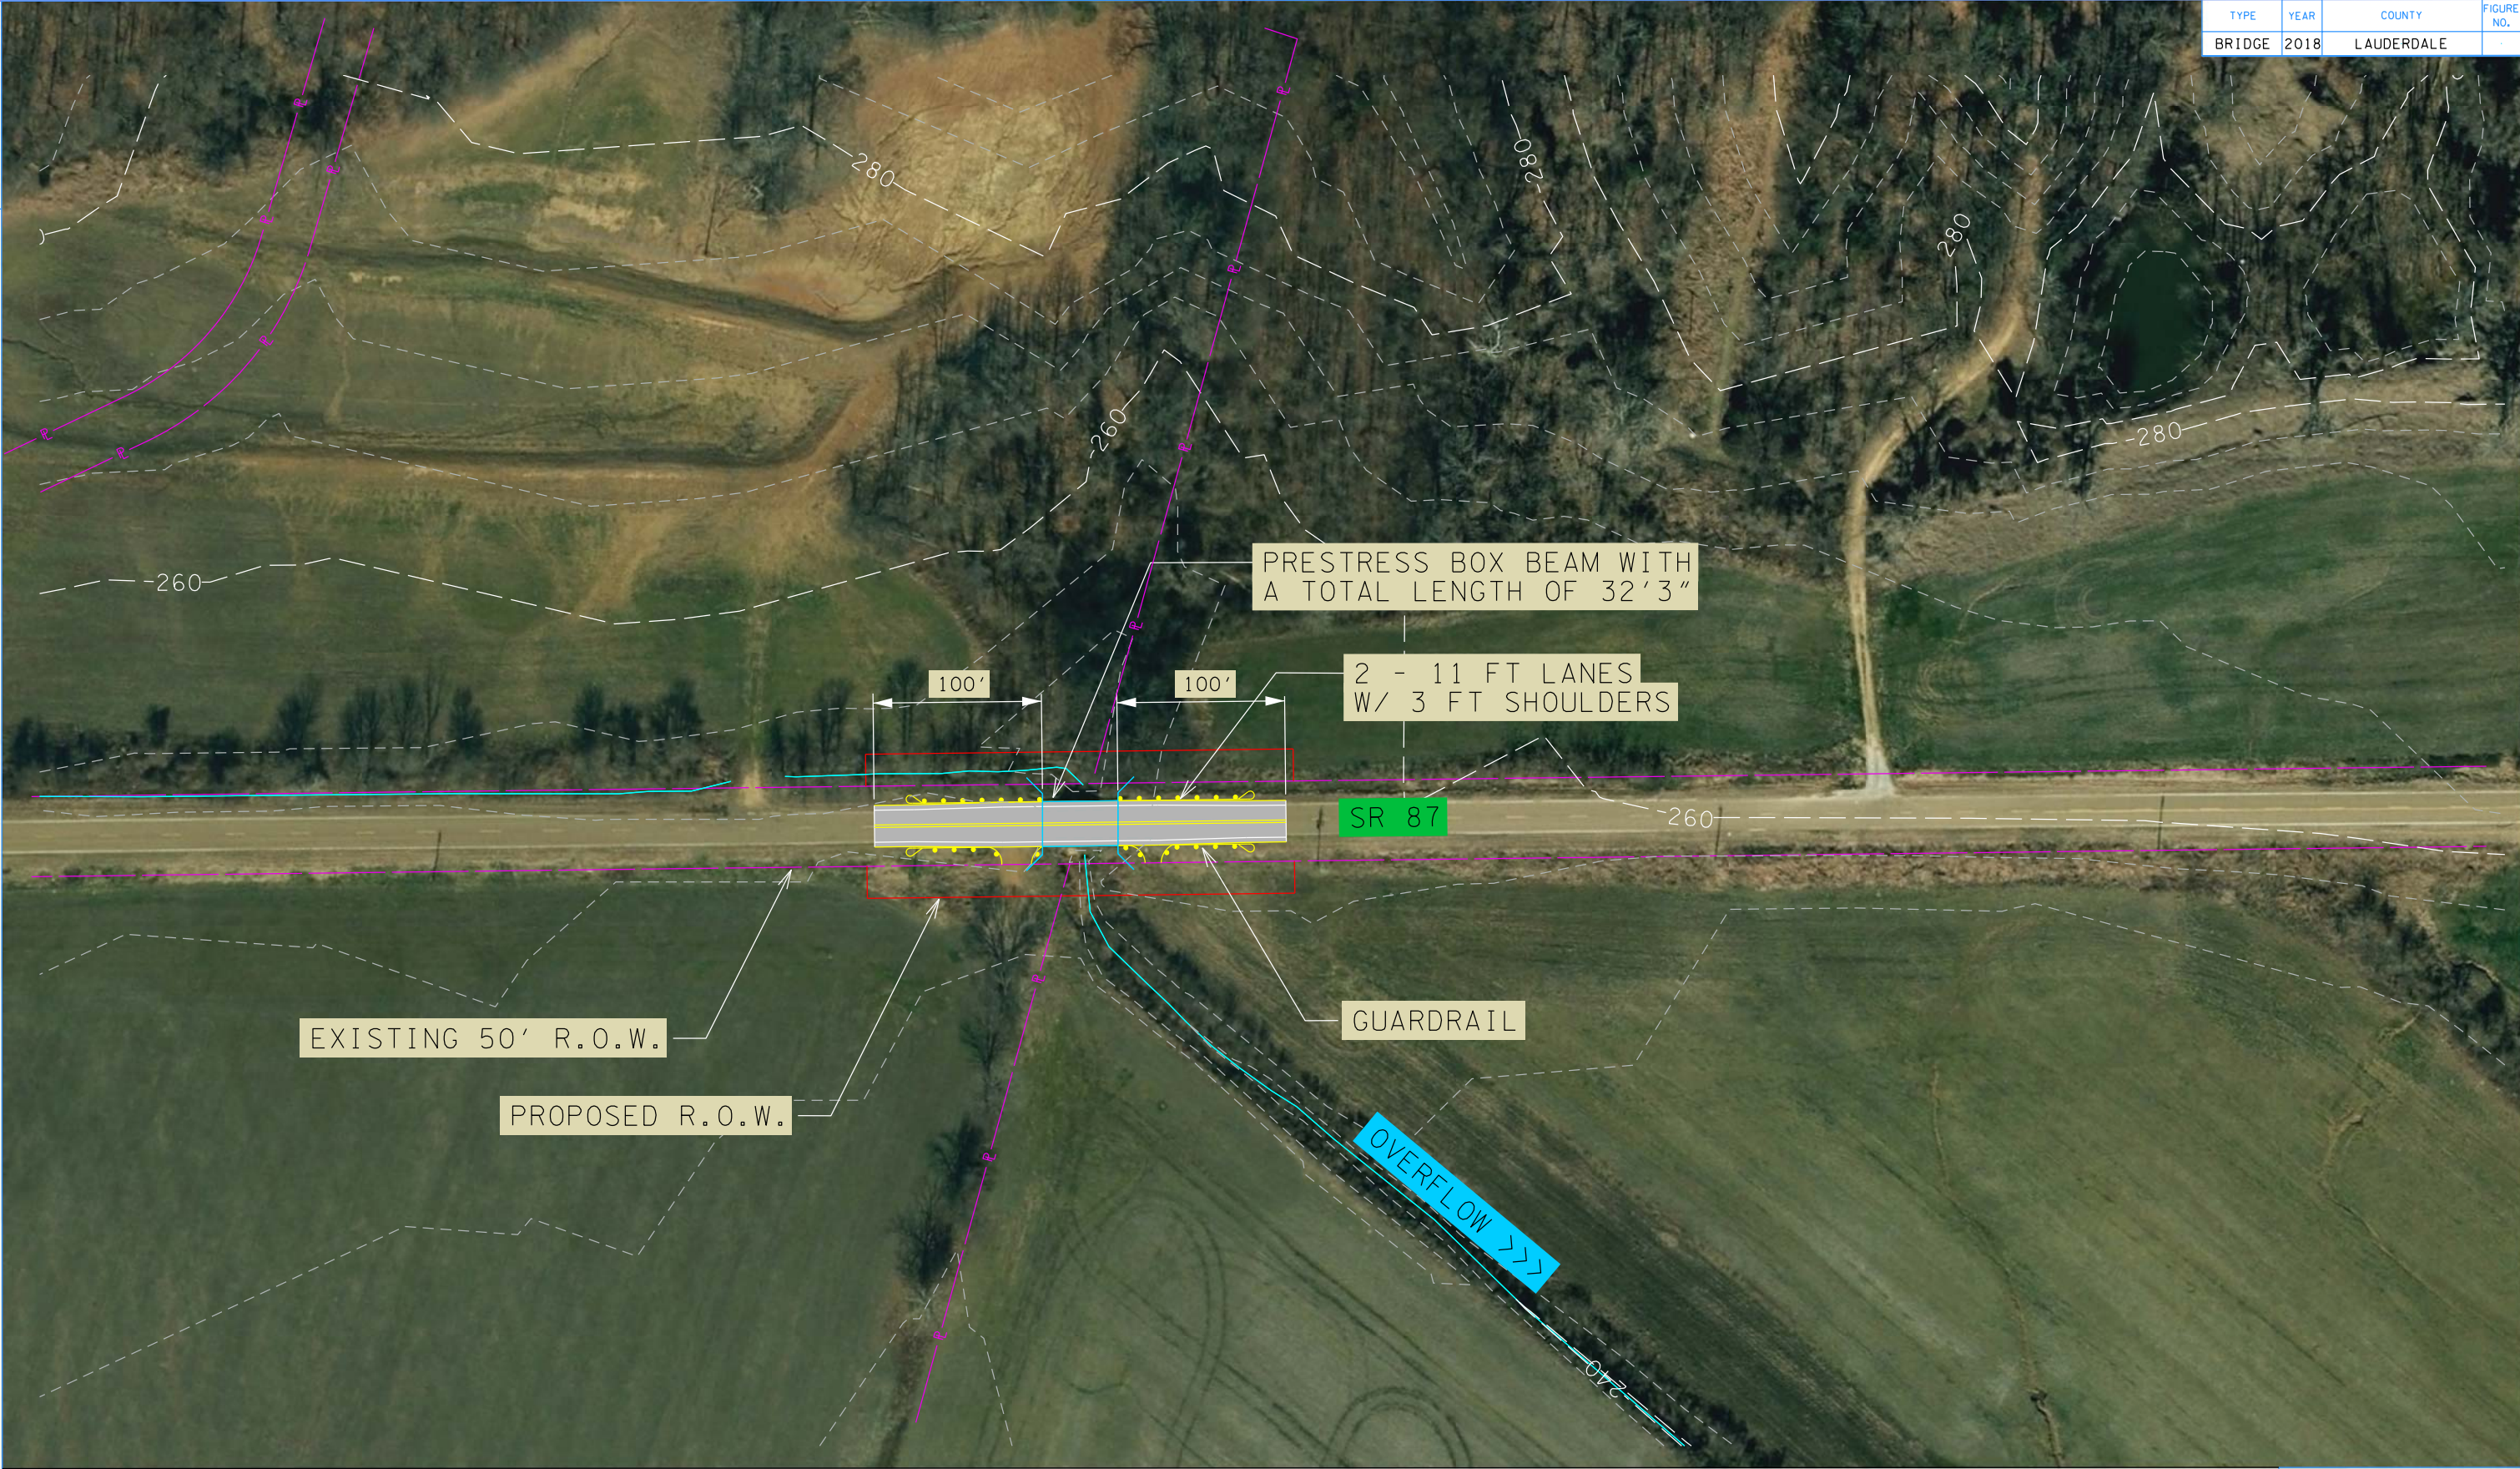
BRIDGE TIR

STATE ROUTE 87 (SR087)
BRIDGE OVER OVERFLOW @ L.M. 3.88
LAUDERDALE COUNTY

55 MPH DESIGN SPEED

The proposed alignment and grade for the replacement structure will remain the same as the existing structure including the 90-degree skew with the river channel. There is a 55 mph posted speed limit on State Route 87, which will also be the design speed based on the tangent

alignment. The TDOT Hydraulics Section has recommended that the proposed structure be a reinforced concrete box bridge with two (2) barrels with a length of 16 feet and a total clearance of 9 feet (2 @ 16' x 9') giving a total structure length of 34 feet per TDOT structures standard STD-17-83. However, this bridge will likely not pass TWRA permitting standards due to the proximity of the project area to the Lower Hatchie National Wildlife Refuge and the design standards of a box culvert could have a negative impact on the stream. Based on the TDOT recommendations after TWRA input it was determined that the proposed structure be a single span pre-stressed box beam structure with a total length of 32 feet 3 inches. The new pre-stressed box beam bridge will also require the grade of the roadway to be raised 2.5 inches. An additional option that may be considered at the time of design is to lower the vertical clearance of the proposed bridge by 2.5 inches. TDOT Hydraulics would need to determine if lowering the vertical clearance is feasible due to the drainage area being 0.04 square miles. Lowering of the vertical clearance will keep the roadway on grade and lessen the potential impacts to TWRA land. It is estimated that four (4) tracts of land will be affected resulting in approximately 0.14 acres of right-of-way (ROW) acquisition. It is also estimated that overhead utilities will need to be relocated. It is recommended that this bridge be stage constructed since no viable detour route is available.

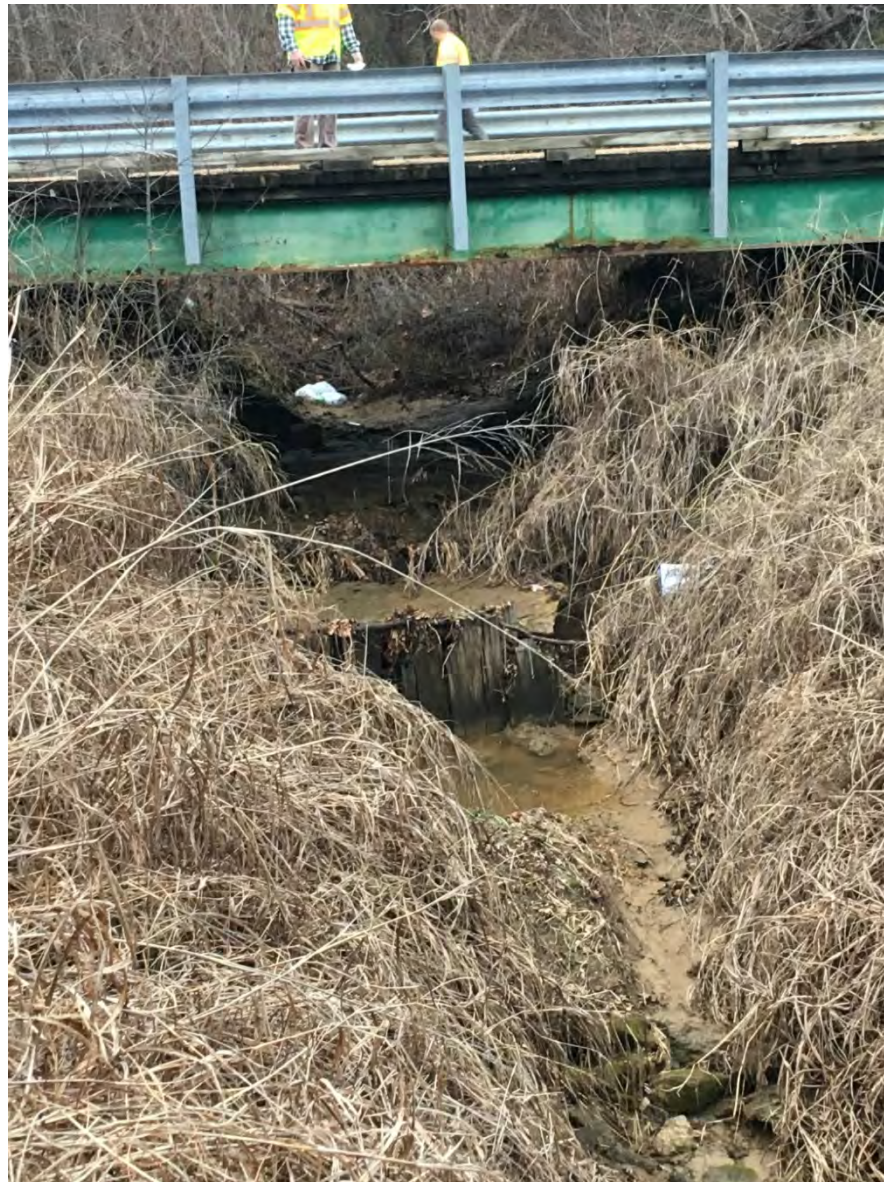
Corrosion of Girders at Outlet

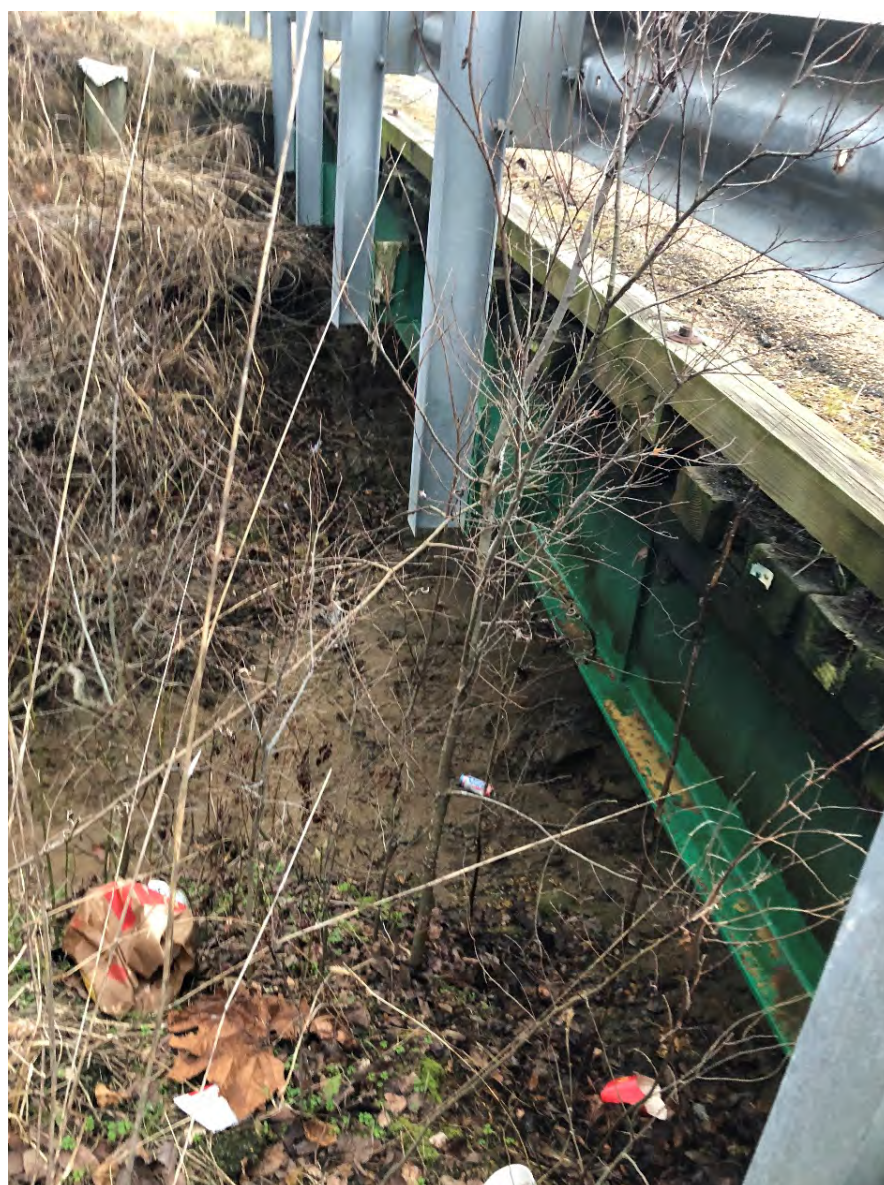
Corrosion and Vegetation of Girders at Inlet

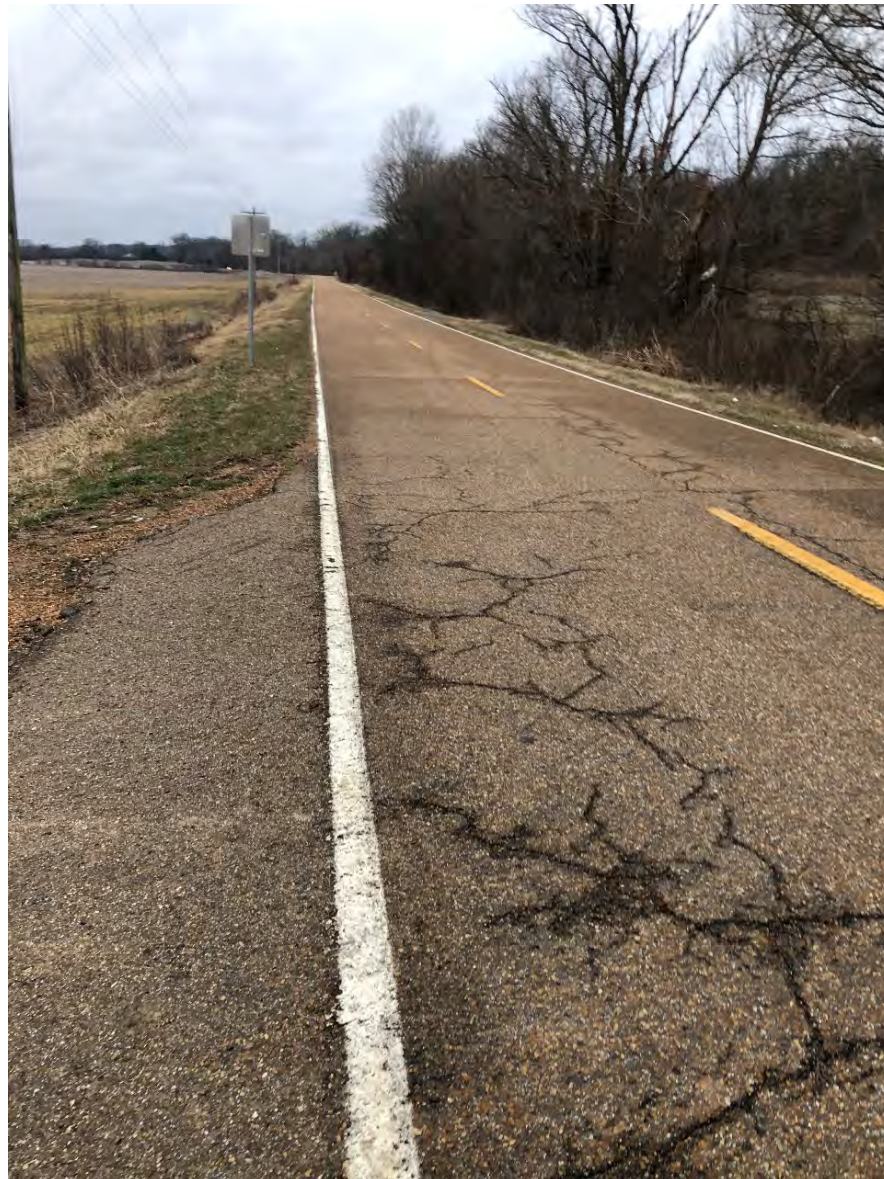
Cracking and Spalling of Pavement at West Approach

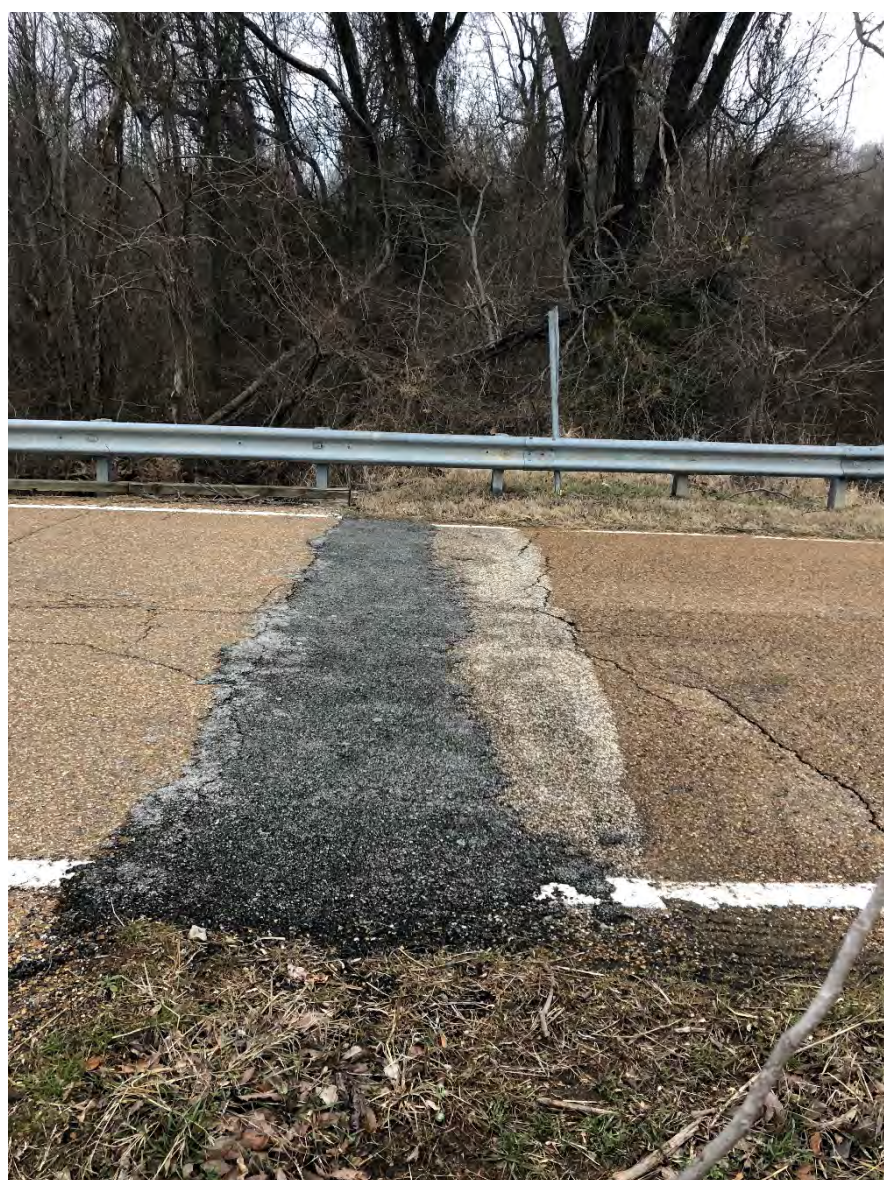
Cracking and Poor pavement patching conditions at East approach

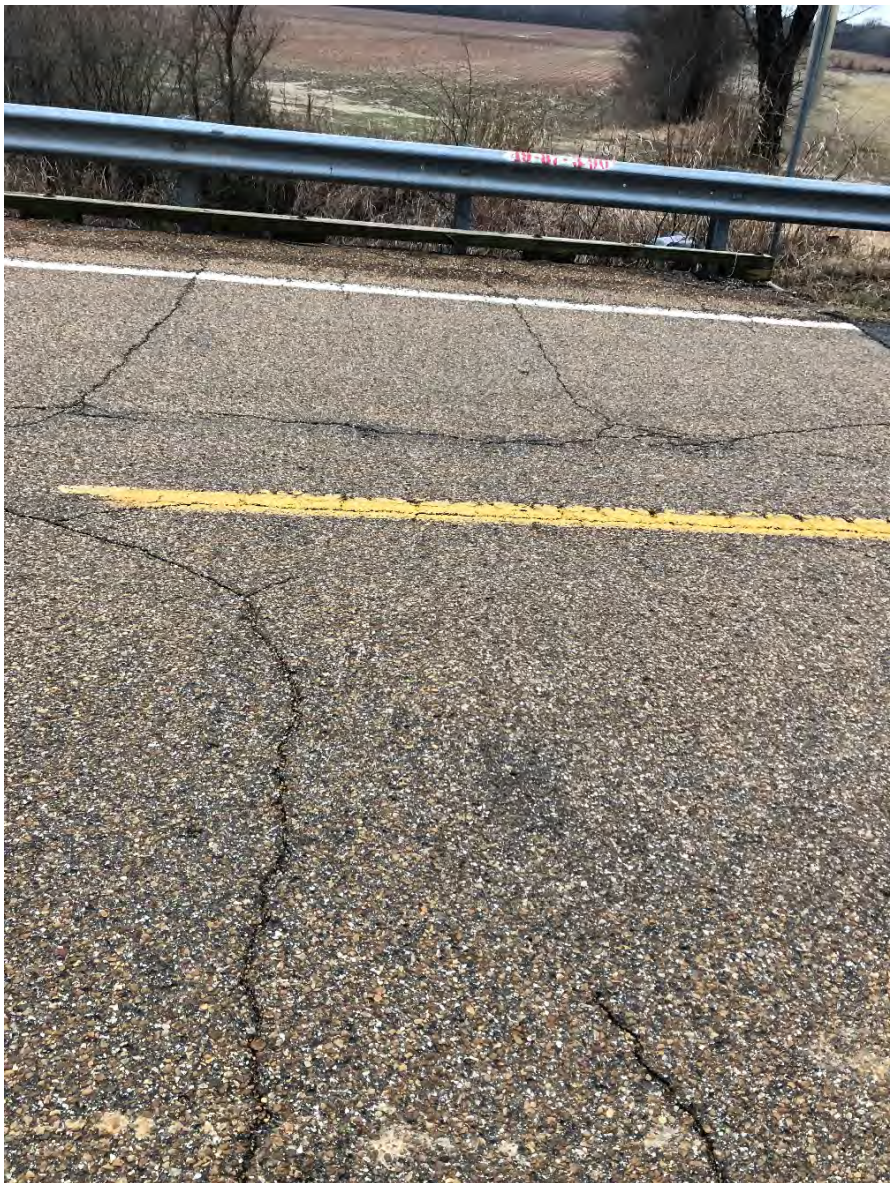
Severe Cracking on Bridge Surface

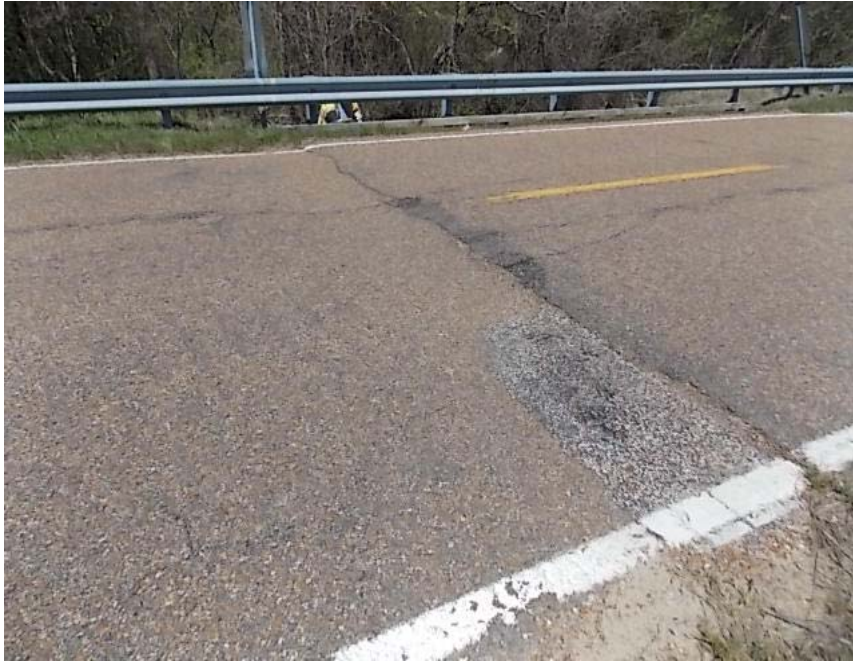
APPROACH # 1 A/C SETTLED & CRACKED

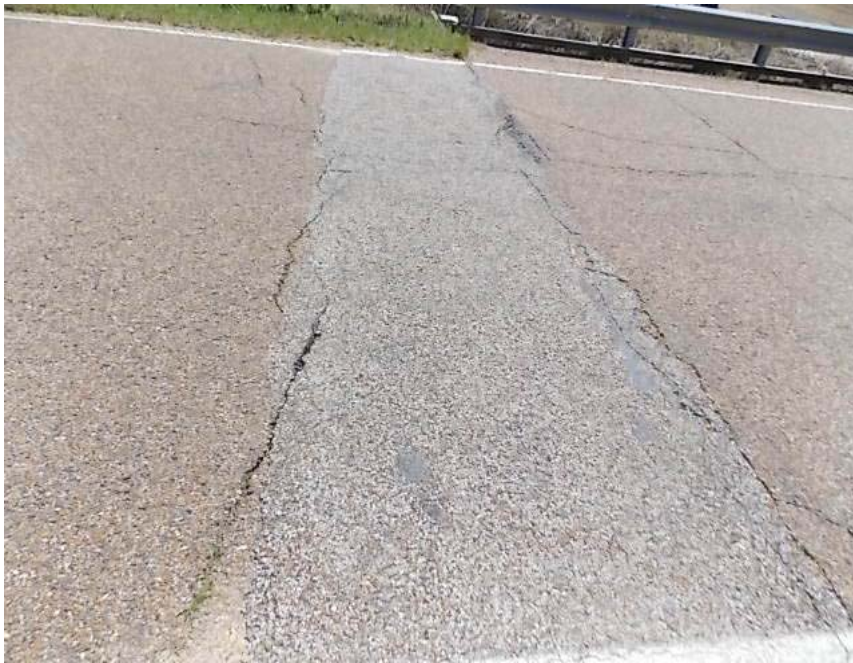
APPROACH # 2 A/C CRACKS

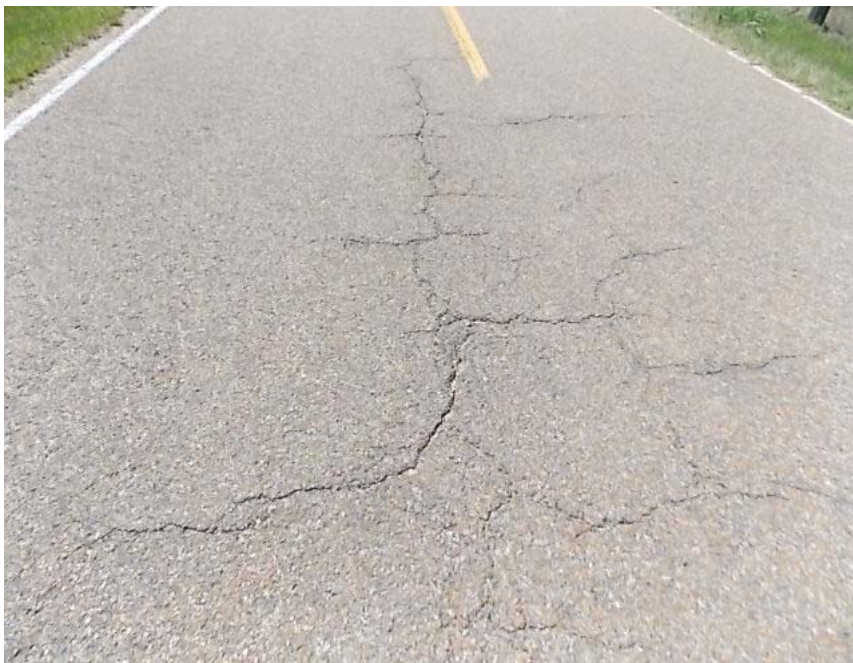
APPROACH # 2 A/C CRACKS

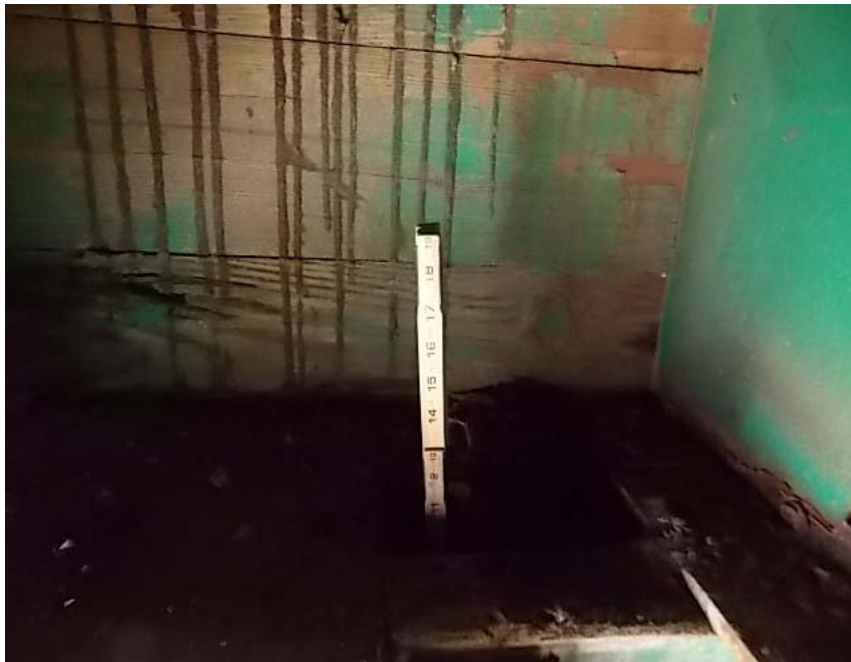
ABUTMENT # 1 CAP DECAYED OVER PILE "F"

200	REPAIR OR REPLACE _TIMBER_ CAP AT ABUTMENT NO. _1 & 2
-----	---

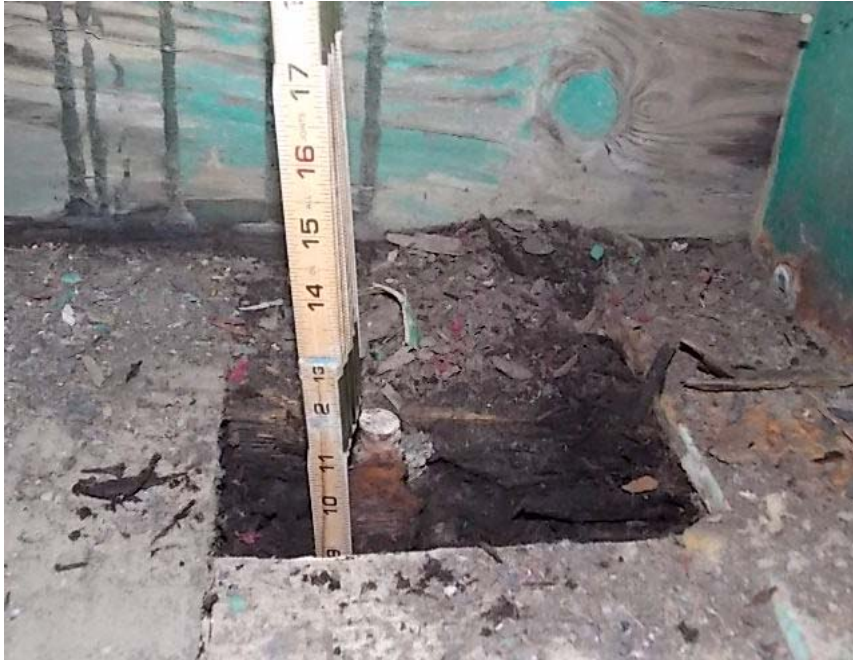
ABUTMENT # 1 CAP DECAYED OVER PILE "F"

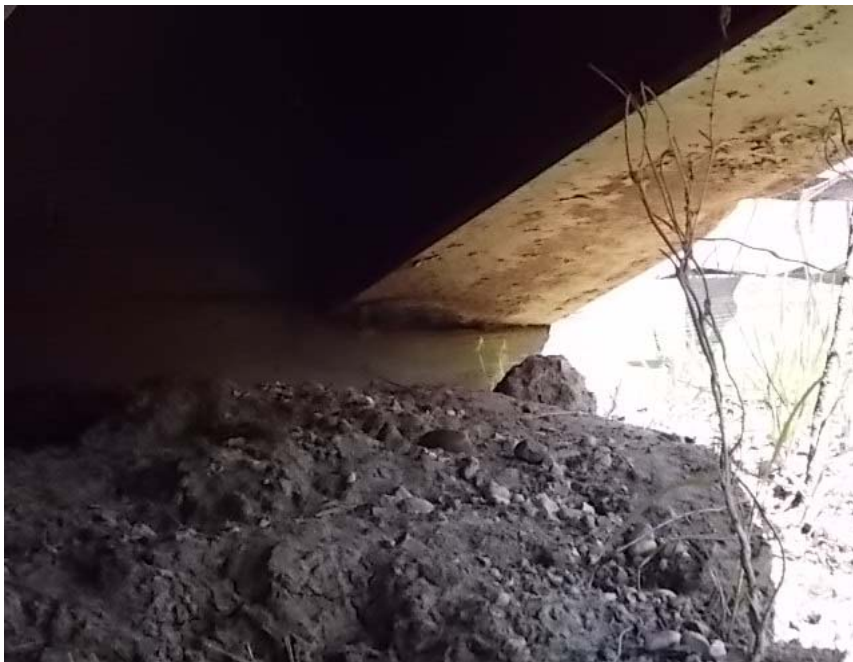
STEEL I BEAM "N" SETTLED TO ABUTMENT # 2 CAP

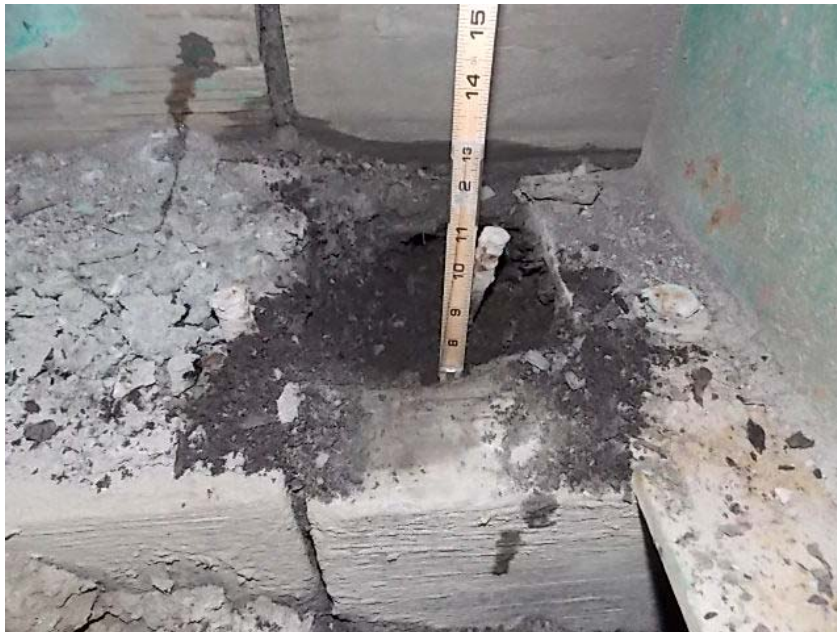
ABUTMENT # 2 TOP OF CAP DECAYED

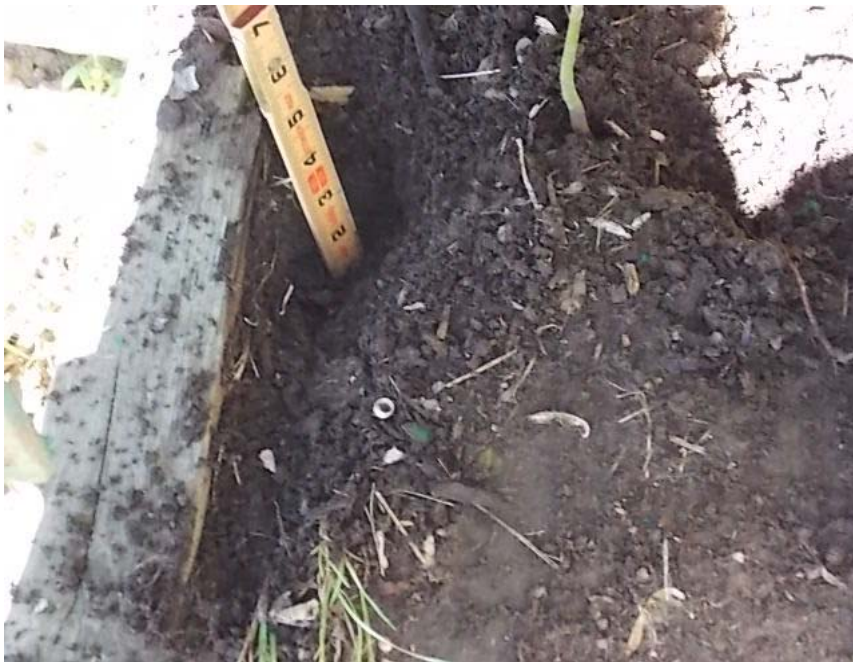
ABUTMENT # 2 RIGHT TOP OF CAP DECAYED

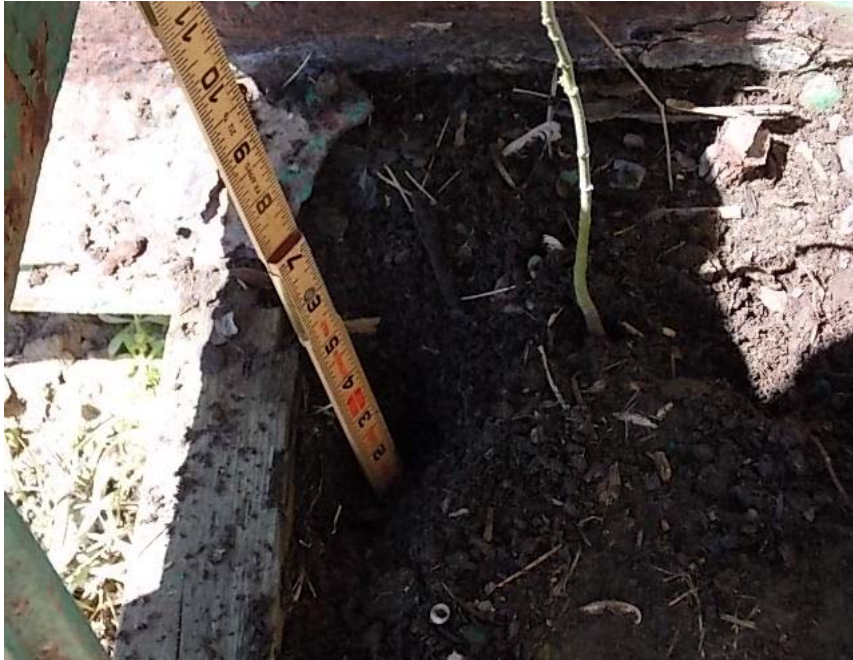
ABUTMENT # 2 RIGHT TOP OF CAP DECAYED

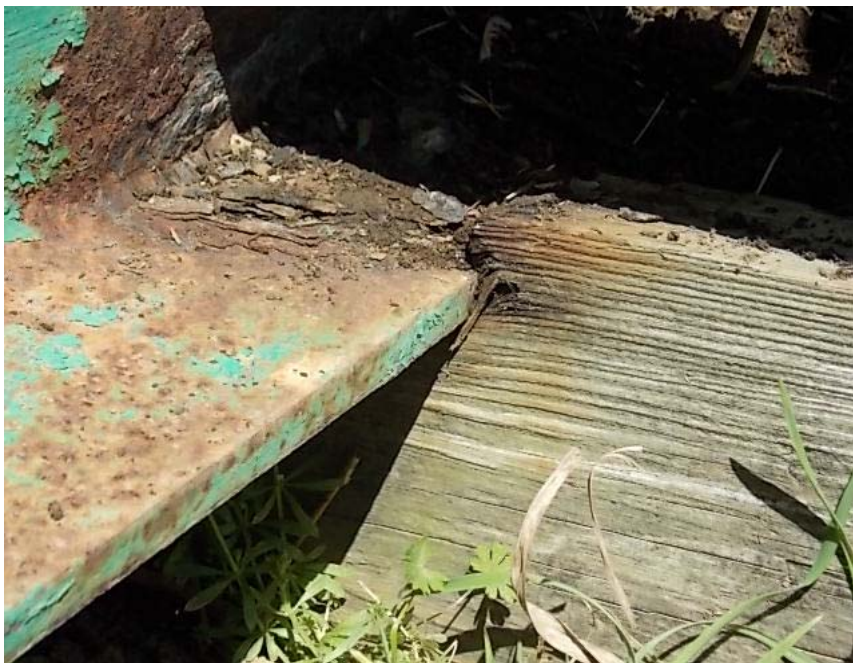
ABUTMENT # 2 RIGHT TOP OF CAP DECAYED

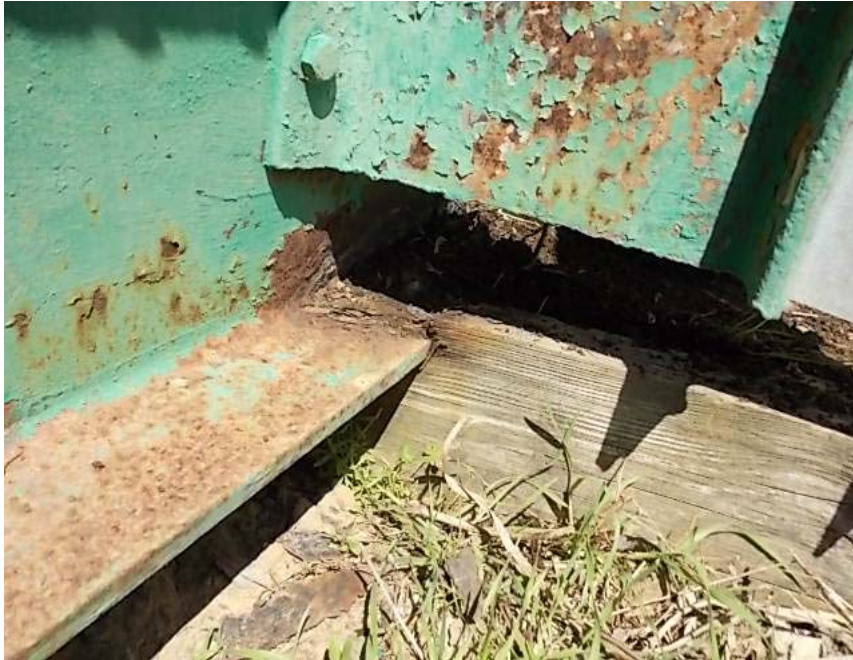
ABUTMENT # 2 RIGHT TOP OF CAP DECAYED

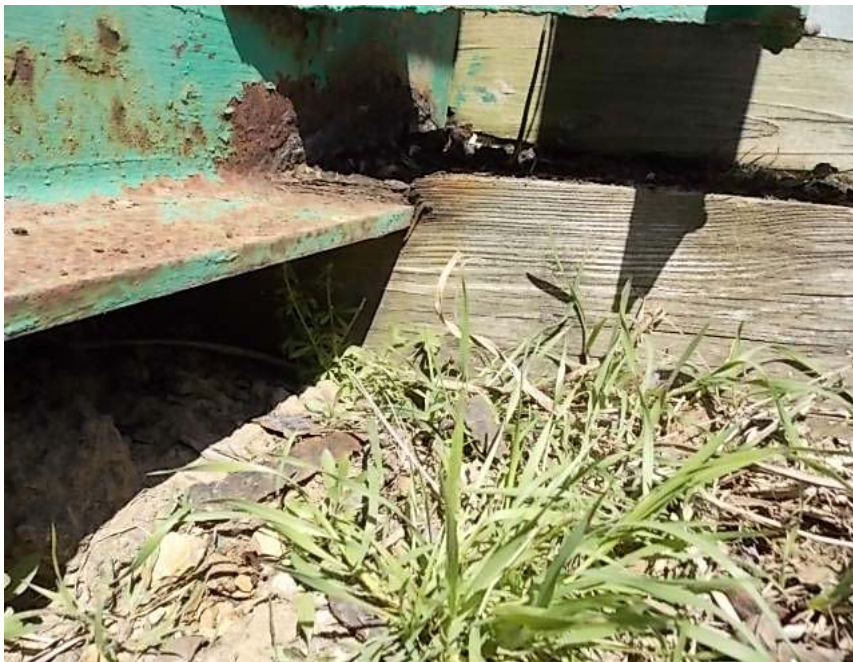
ABUTMENT # 2 RIGHT TOP OF CAP DECAYED
