# Technical Appendices

Reevaluation

State Route (SR) 436

Reedy Creek Road Bridge over Reedy Creek, Log Mile (LM) 0.68

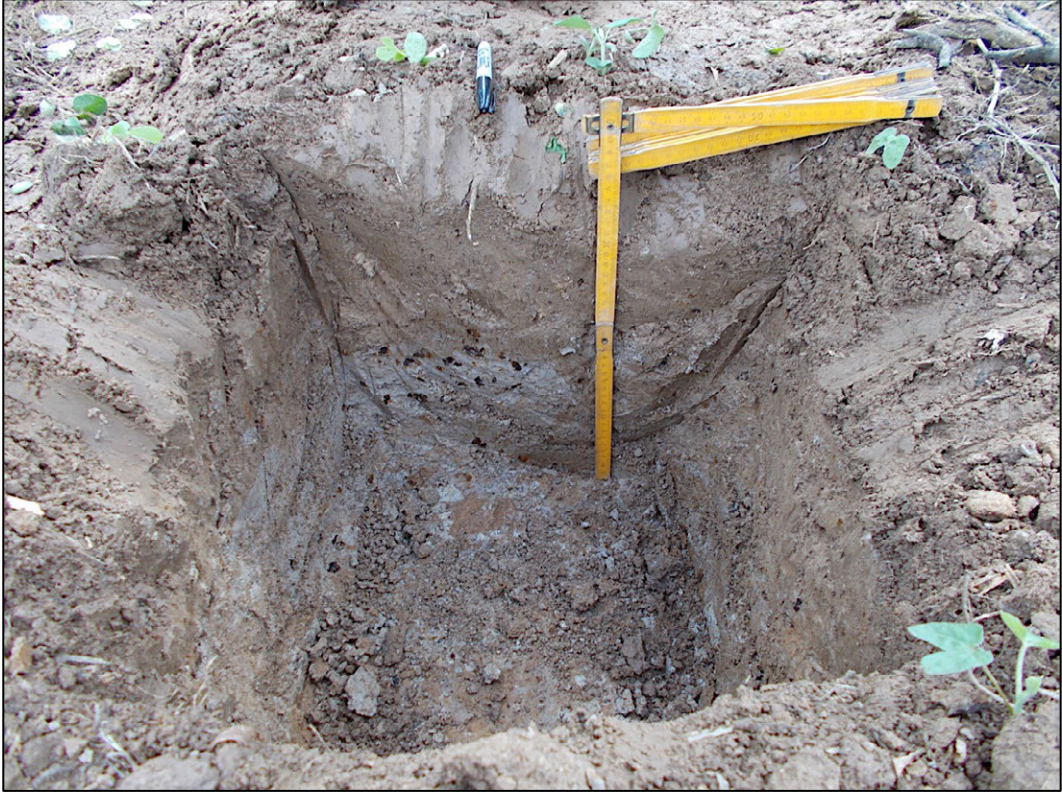
Figure 5-05. Typical soil profile, southwestern quadrant Shovel Test 3; view south (DSCN0692).

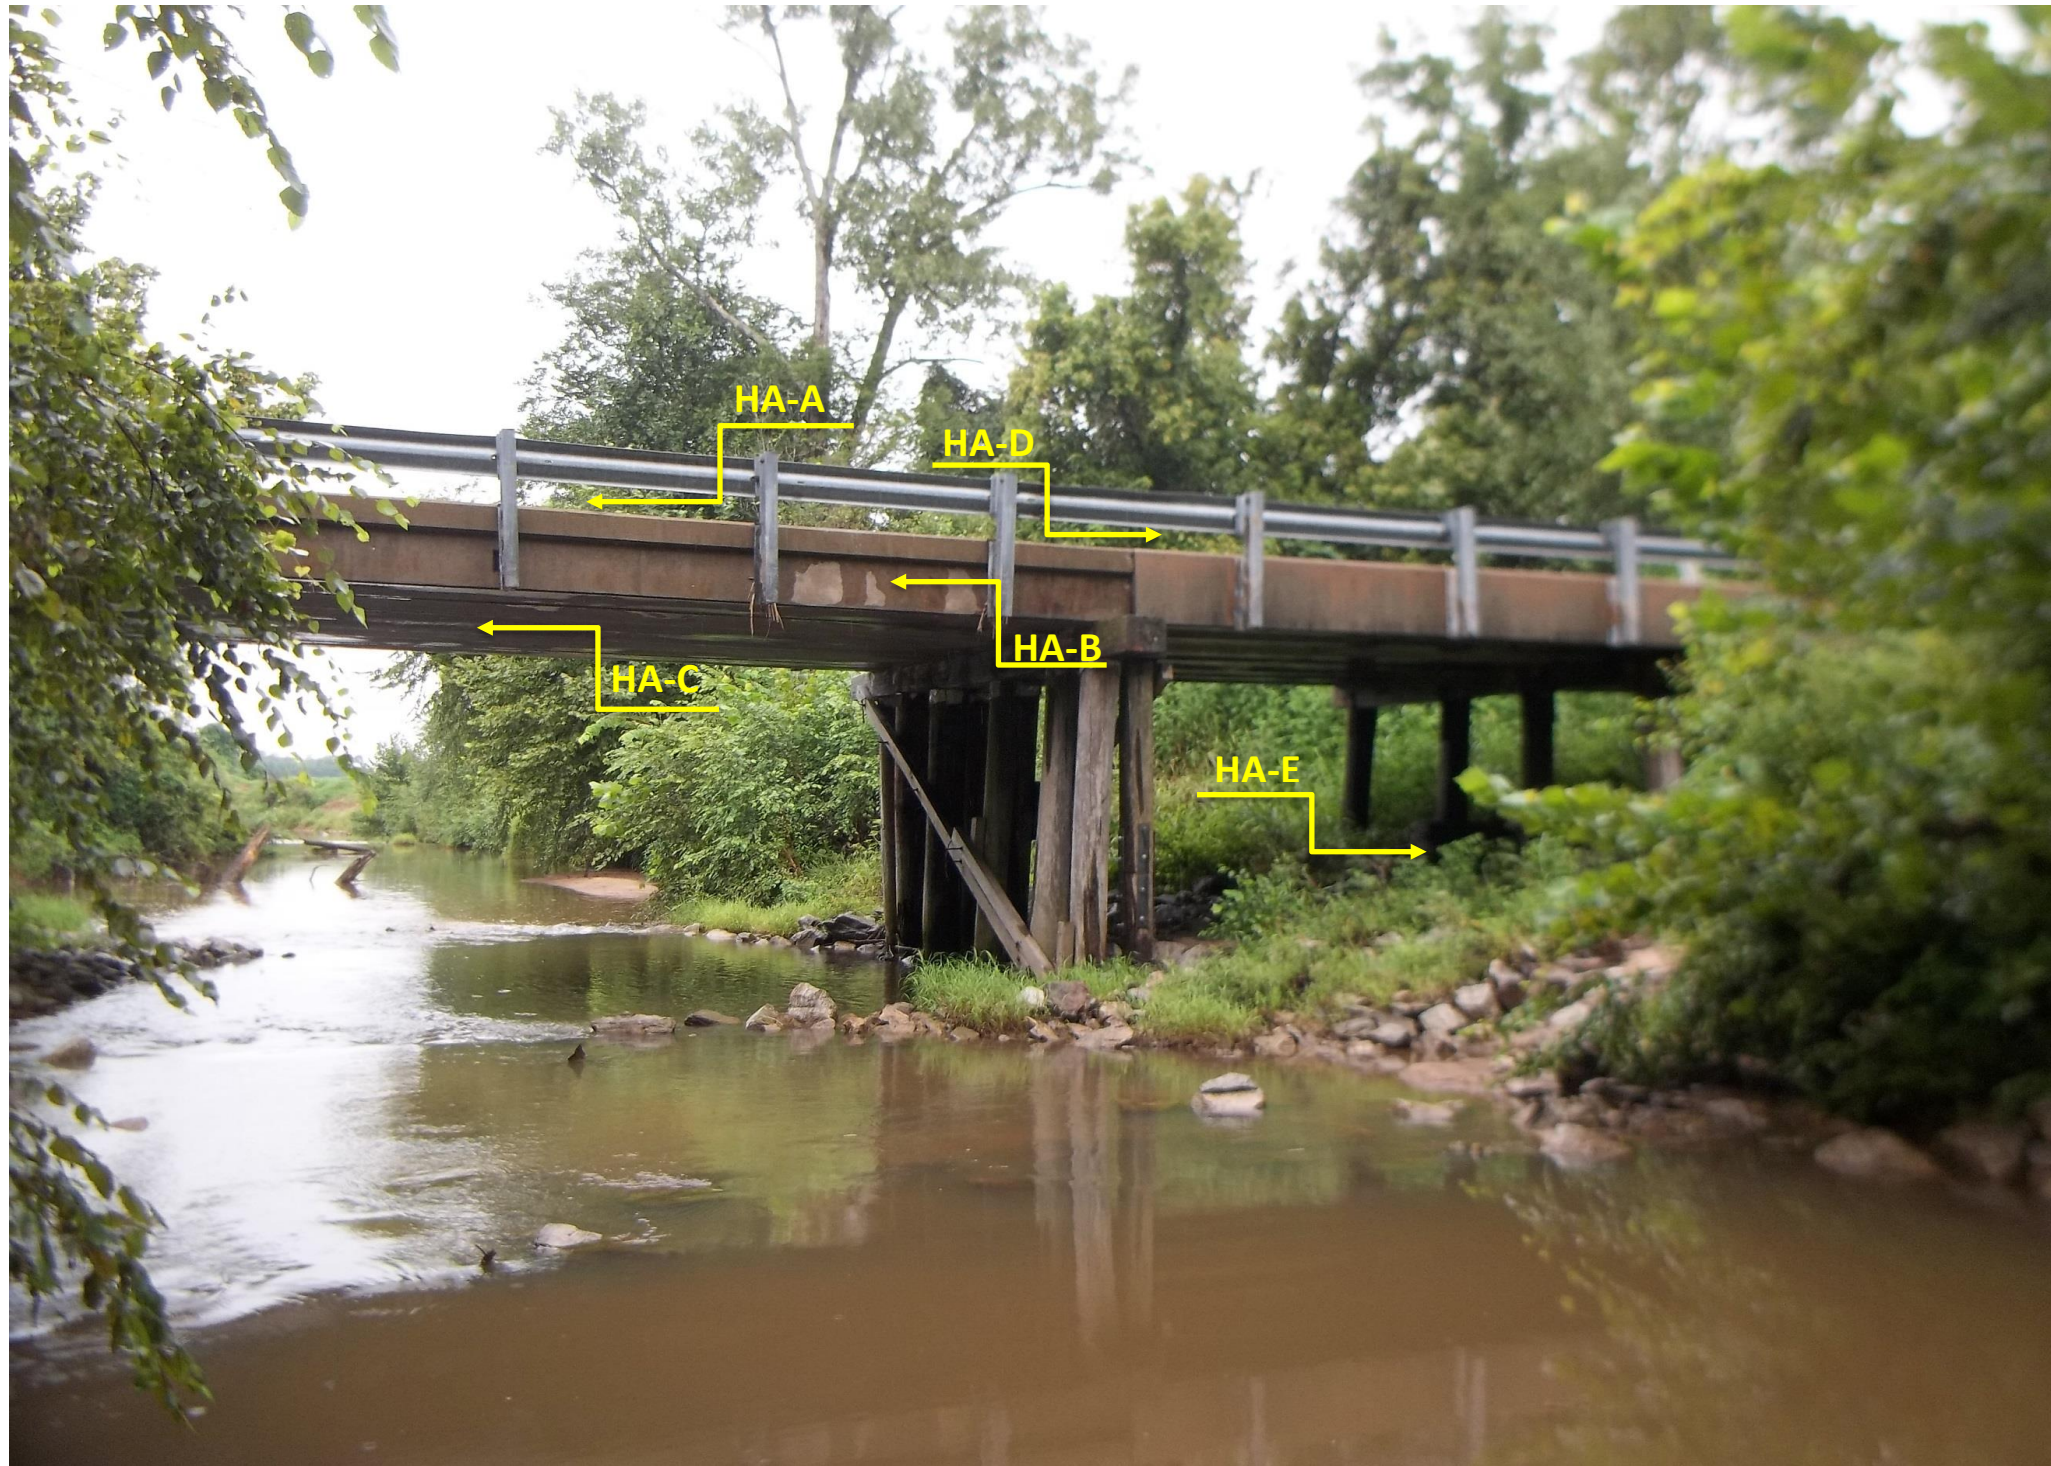
Homogeneous Areas:  
 A - Asphalt Overlay  
 B - Concrete Deck/Curb  
 C - Concrete Beams  
 D - Asphalt Patching  
 E - Concrete Footing
