Programmatic Categorical Exclusion Reevaluation

State Route 1

Bridge over Muddy Creek, LM 2.13 (IA)

PIN 128113.03

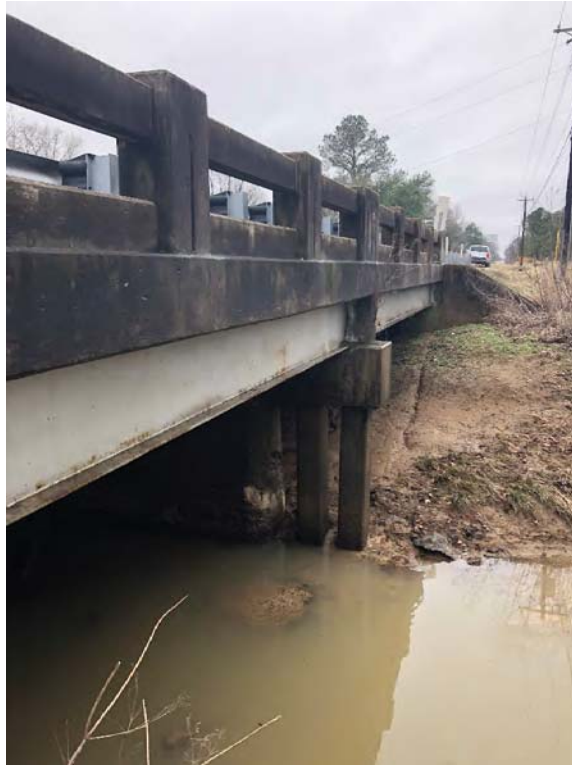
Corrosion on Girder at Outlet

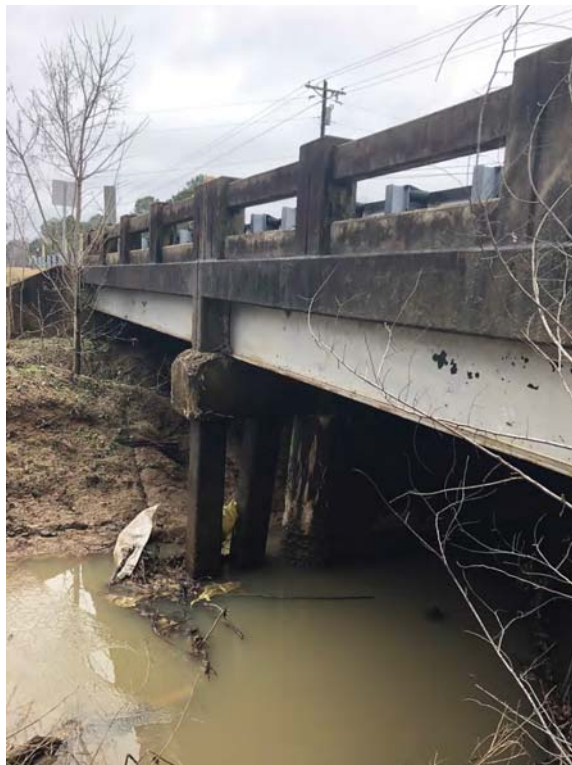
Extensive Decay of Pier near Girder and Foundation at Inlet

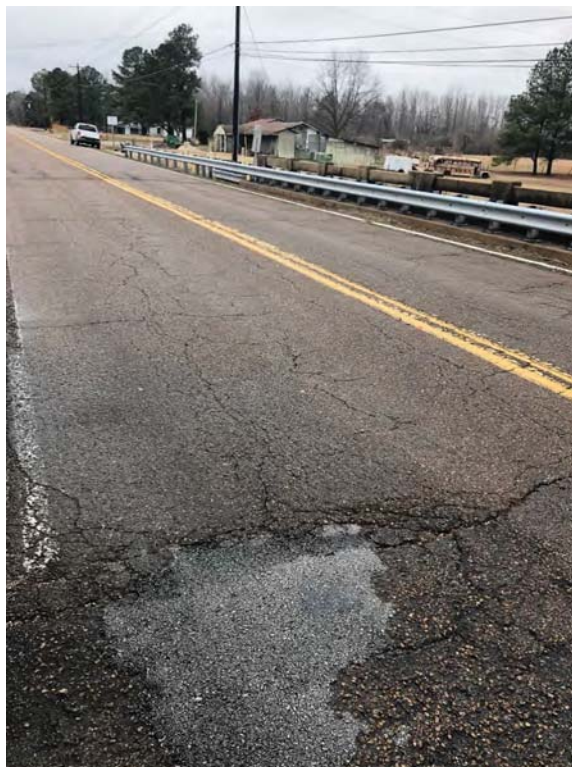
Extensive Pavement Cracking and Rutting on Bridge

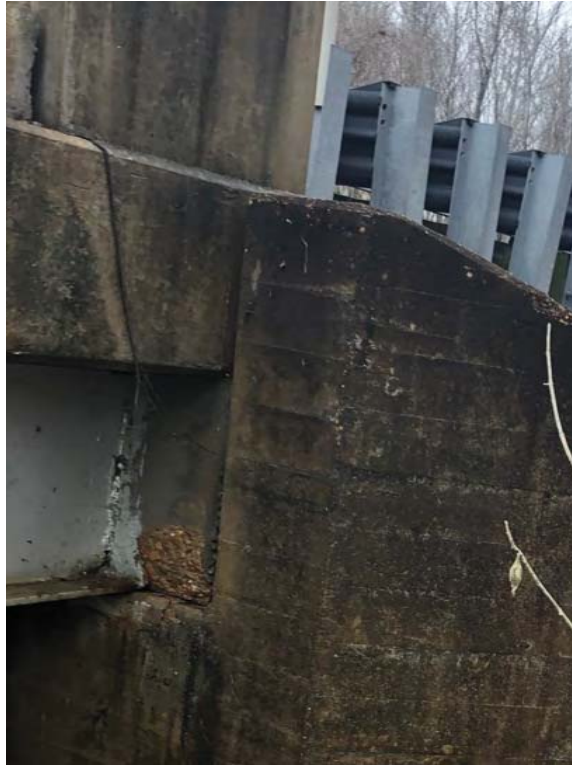
Corrosion and Decay at Girder Connection to East Abutment on Inlet Side

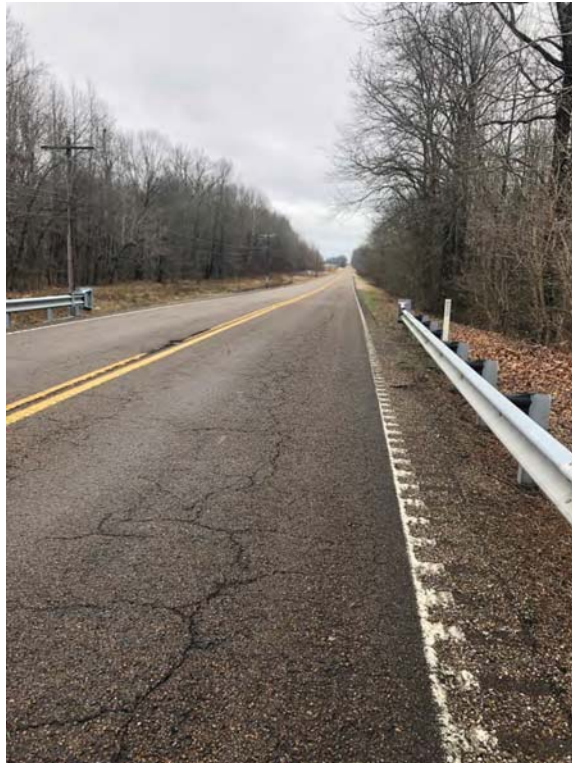
Extensive Pavement Cracking and Rutting Leaving Bridge Eastbound

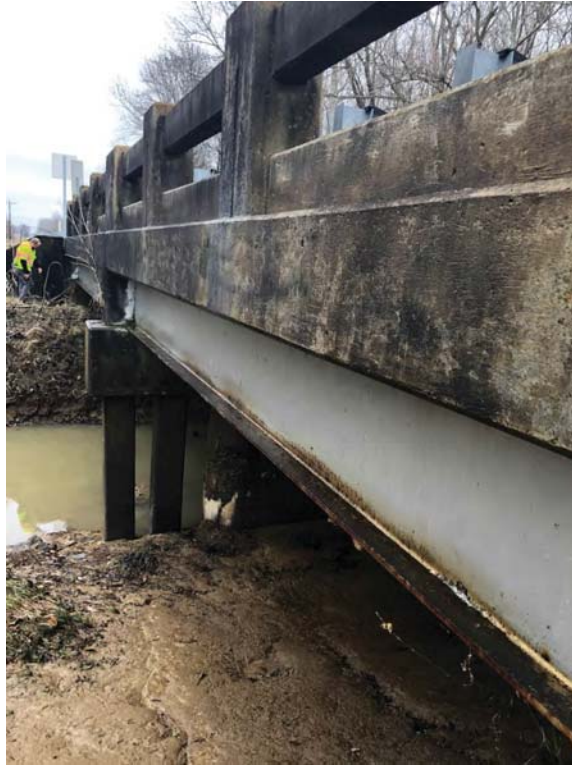
Corrosion of Outlet Girder between West Abutment and Pier

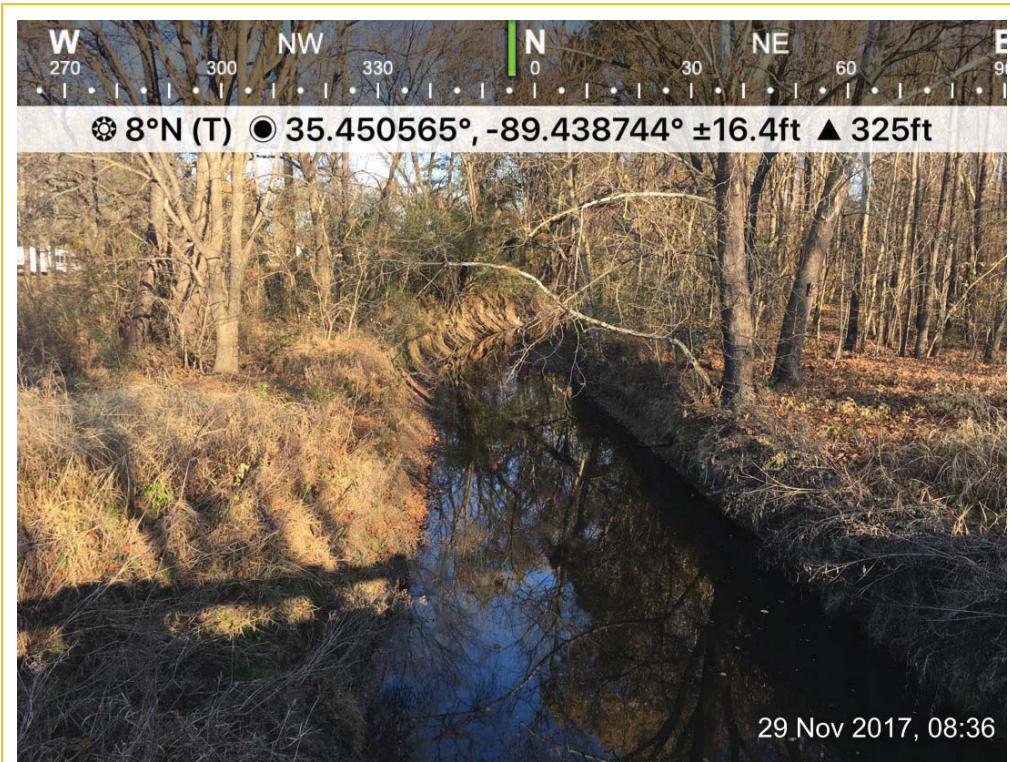
Photo 1. Downstream view of Little Muddy Cr. (STR-1)

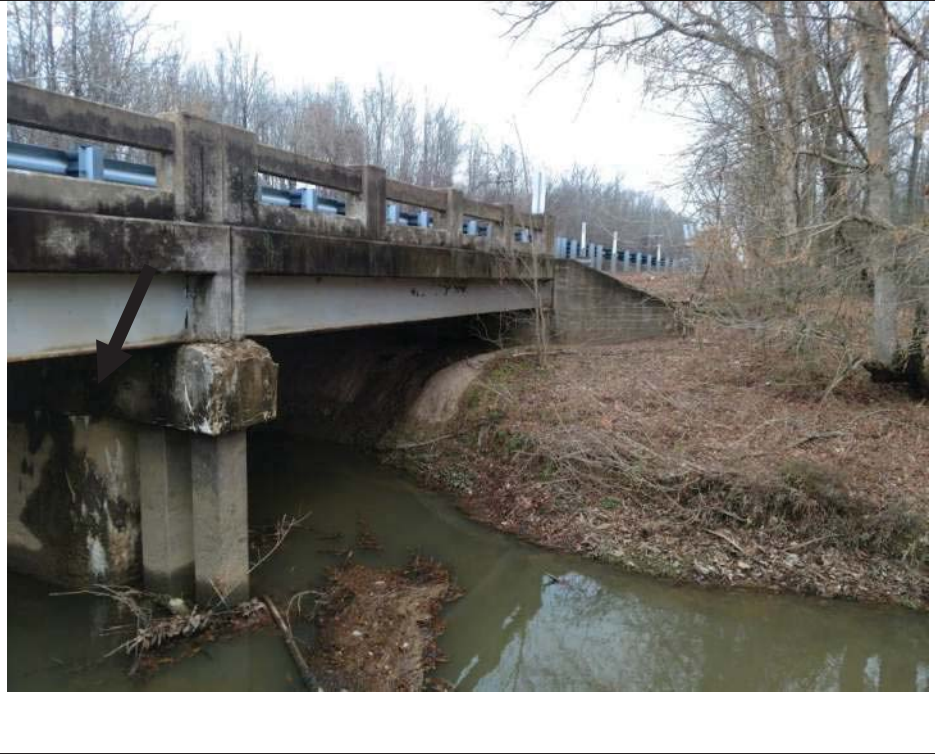
| <p>Description: Photograph 11 – Homogeneous Area 10 Old Pier Cap Sample Locations MC-10-28 MC-10-29 MC-10-30</p> | |

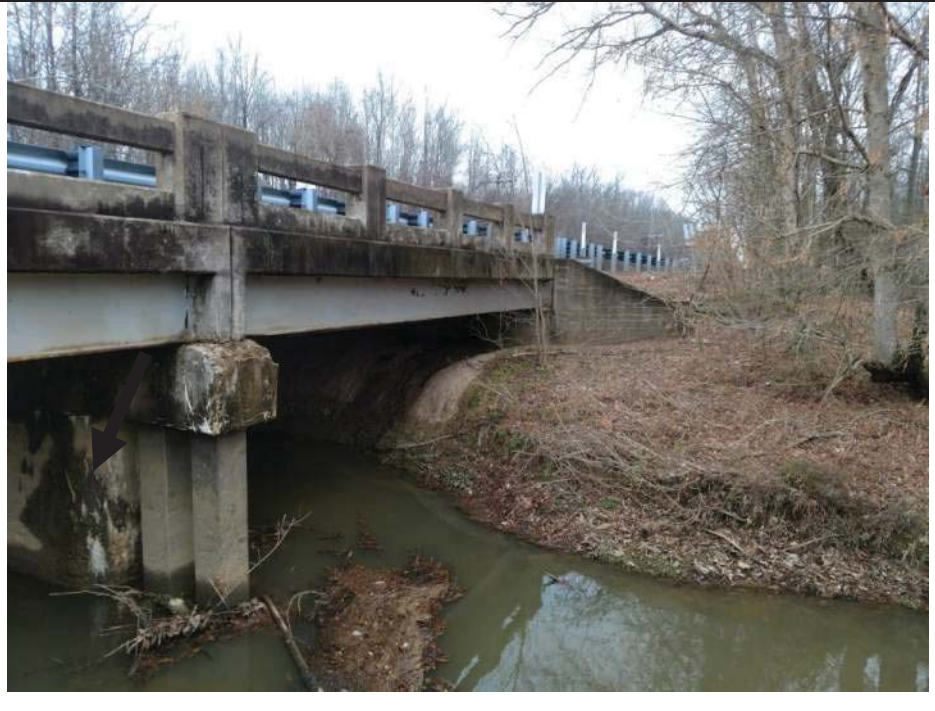
| <p>Description: Photograph 12 – Homogeneous Area 11 Old Pier Sample Locations MC-11-31 MC-11-32 MC-11-33</p> | |
