Reevaluation

State Route 1

Bridge over Branch at Log Mile (LM) 2.89

PIN 128113.04

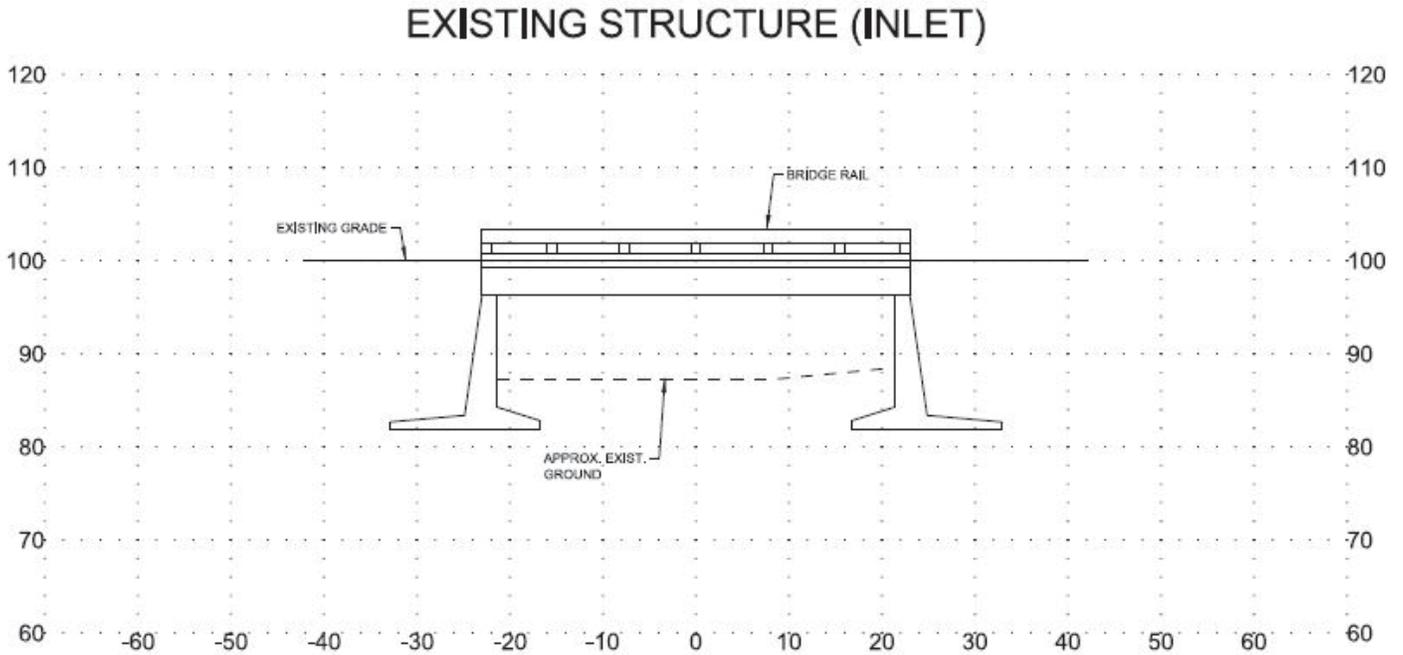
Based on the TIR dated 04/02/2018, located in the Technical Appendices, the project bridge is classified as a Rural Arterial Road carrying two 12-foot lanes, one in either direction, and consists of a single span precast concrete slab. The structure has an out-to-out width of 34 feet-five inches and an overall structure length of 46 feet (Figure 1 below). The project bridge was constructed in 1926 and was rehabilitated in 1959.

Figure 1. Existing structure from TIR (04/02/2018).

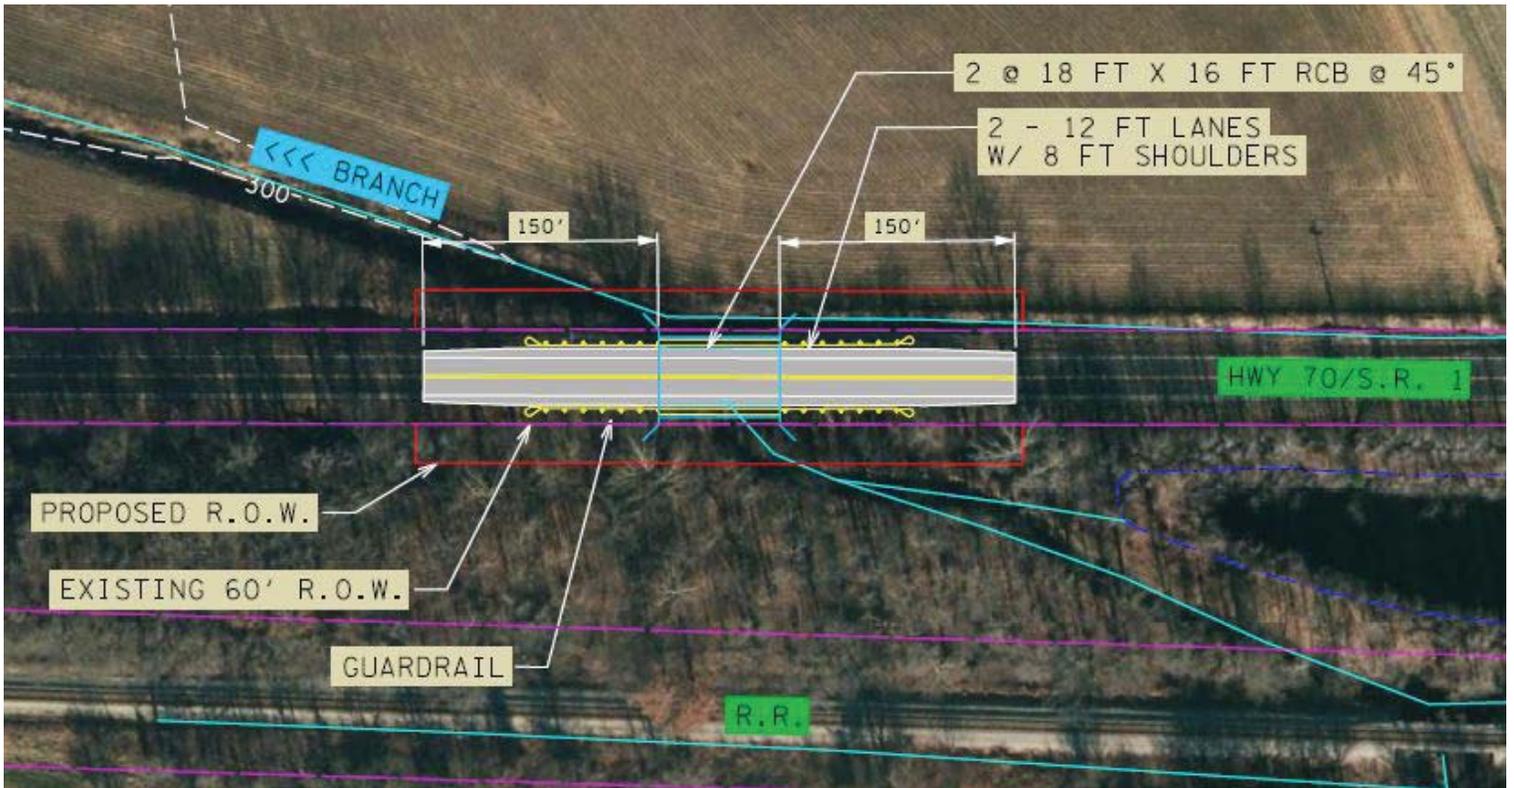
According to the TIR dated 04/02/2018, the proposed alignment and grade for the replacement structure will remain the same as the existing structure including the 45-degree skew with the river channel and speed limit of 55 miles per hour (mph). The proposed structure consist of two 12-foot travel lanes with eight-foot shoulders and guardrail, giving the structure an out-to-out width of 45 feet-six inches. The project will extend 150 feet from the structure to the east and to the west to install guardrail and to taper the paved shoulders back to the existing roadway (Figure 2 on the following page).

Figure 2. Proposed Bridge Aerial from TIR 04/02/2018.

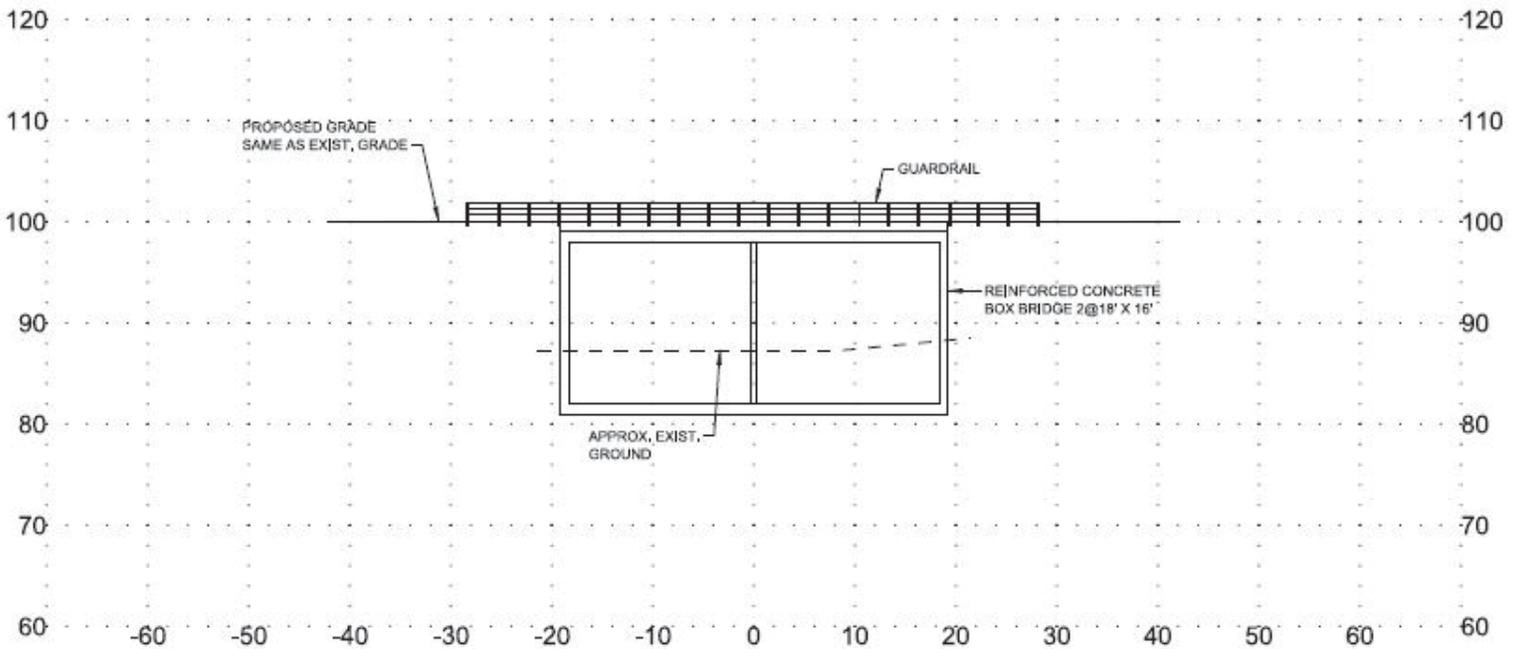
PROPOSED STRUCTURE (INLET)

Based on the TIR dated 04/02/2018, the proposed typical section would consist of a reinforced concrete box bridge with two barrels with a length of 18 feet and a total clearance of 16 feet giving a total structure length of 38 feet-four inches (Figure 3 on the following page).

Figure 3. Proposed Structure from TIR 04/02/2018.

The TDOT Hydraulics Section has recommended that the proposed structure be a reinforced concrete box bridge with two (2) barrels with a length of 18 feet and a total clearance of 16 feet (2 @ 18' x 16') giving a total structure length of 38 feet 4 inches per TDOT structures standard STD-17-88. It is estimated that two (2) tracts of land will be affected resulting in approximately 0.34 acres of right-of-way (ROW) acquisition. It is also estimated that underground and overhead utilities will need to be relocated. Construction phasing for both bridges on State Route 1 (Bridge over Muddy Creek at LM 2.13 and Bridge over Branch at LM 2.89) need to accommodate access to the property located in between the two (2) bridges in Haywood County. Detour routes are provided in report. The official detour will be the only detour route that is signed.

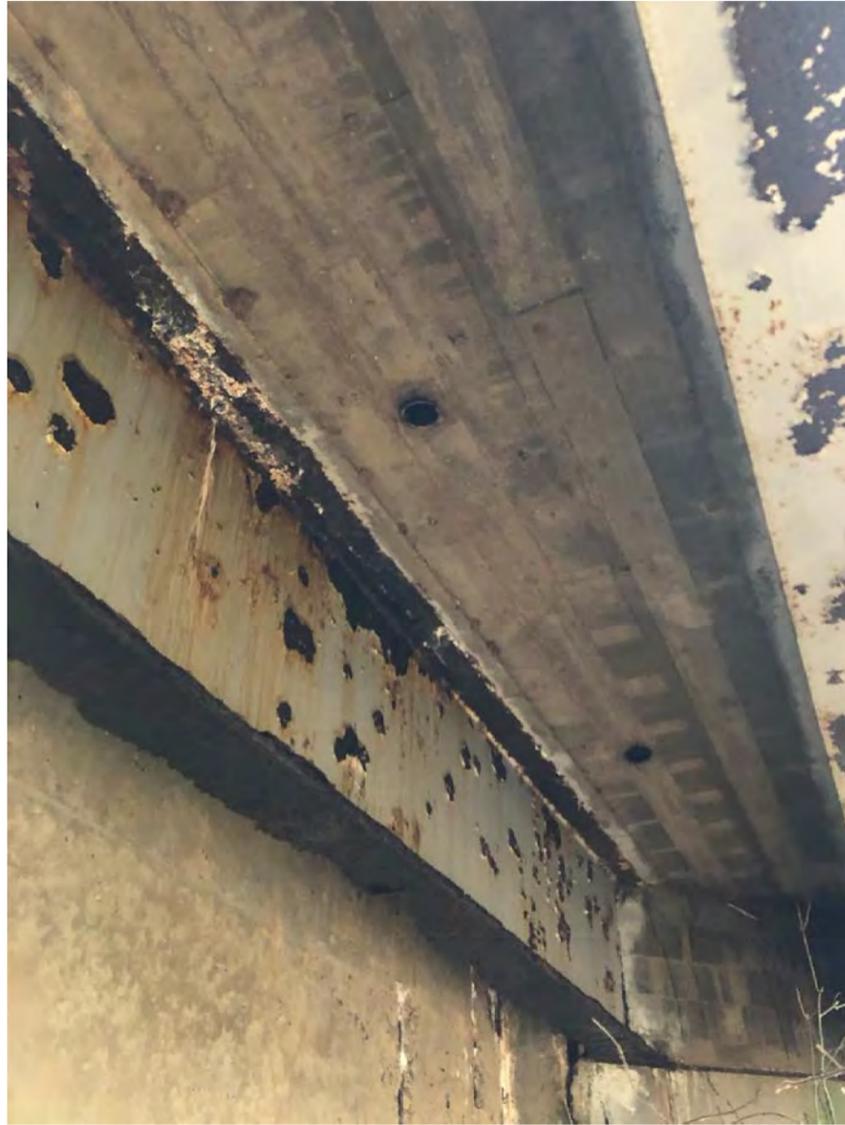
Extensive Corrosion on I-Beams at Inlet

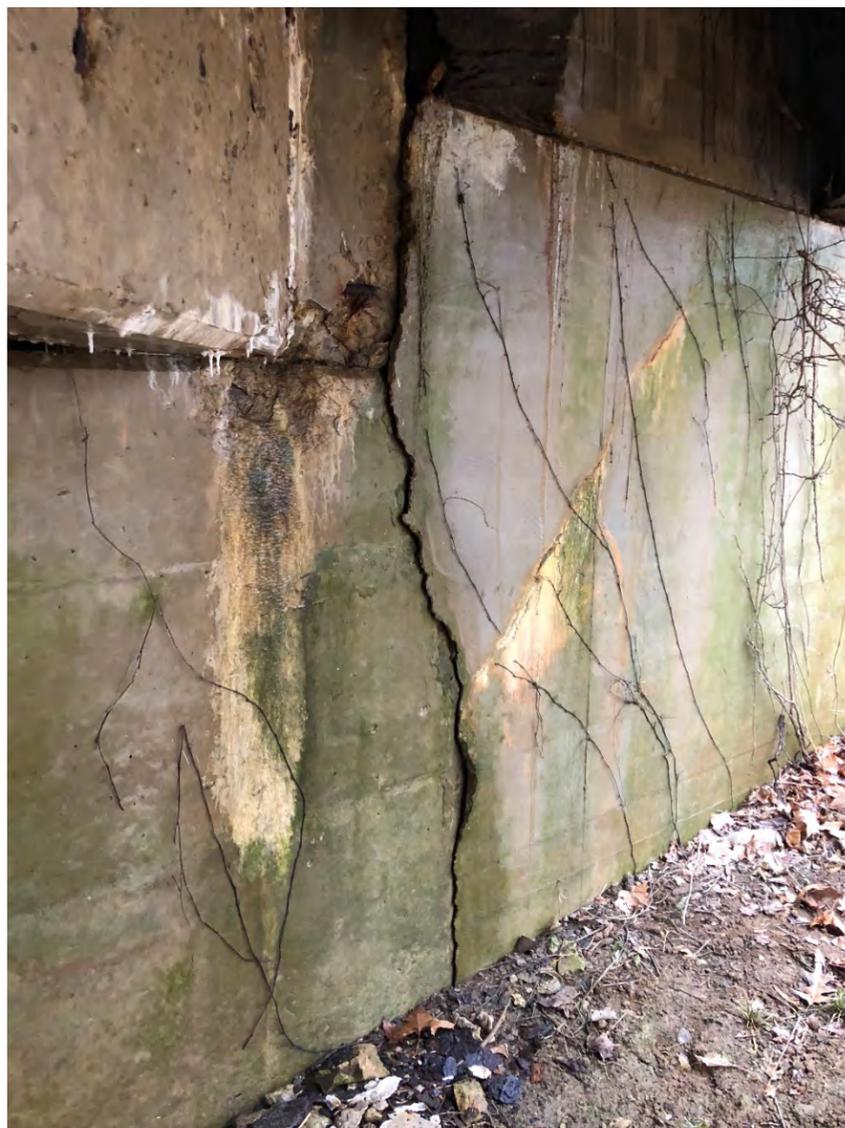
West Abutment Decay and Cracking

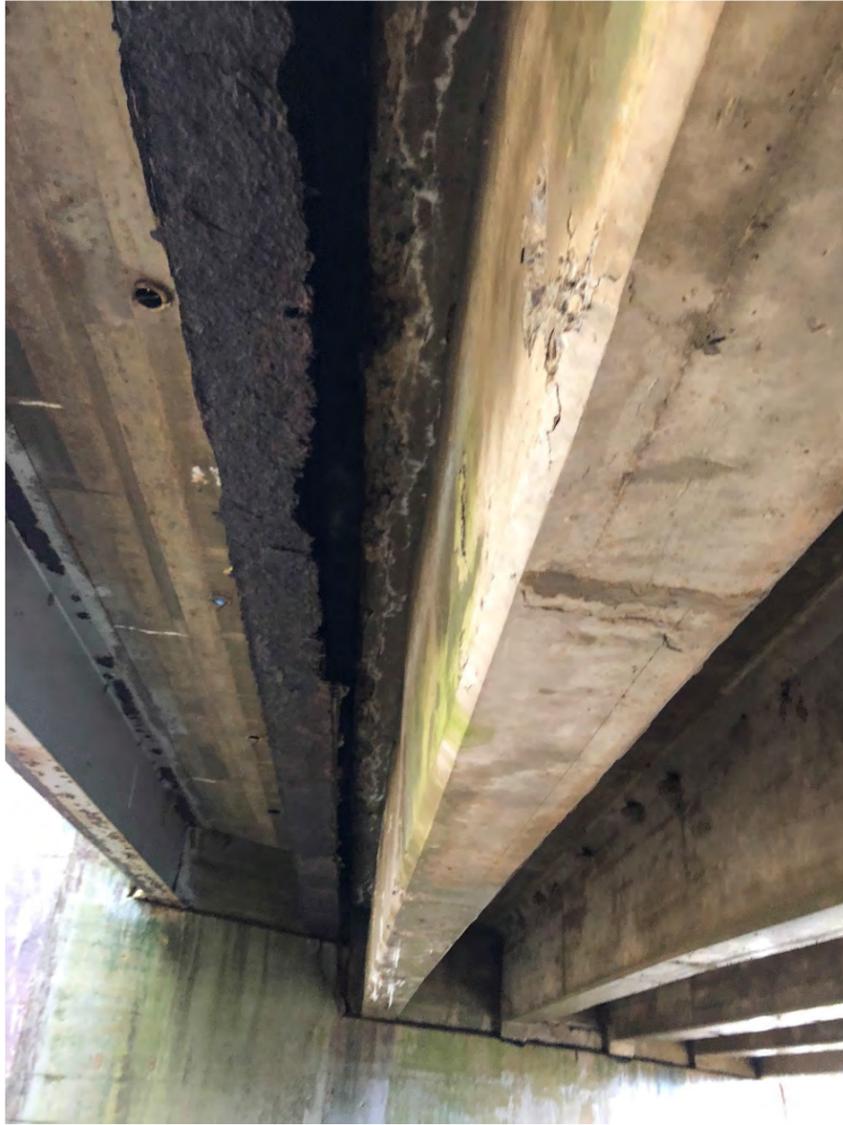
Extensive Corrosion of inner I-Beam at Inlet

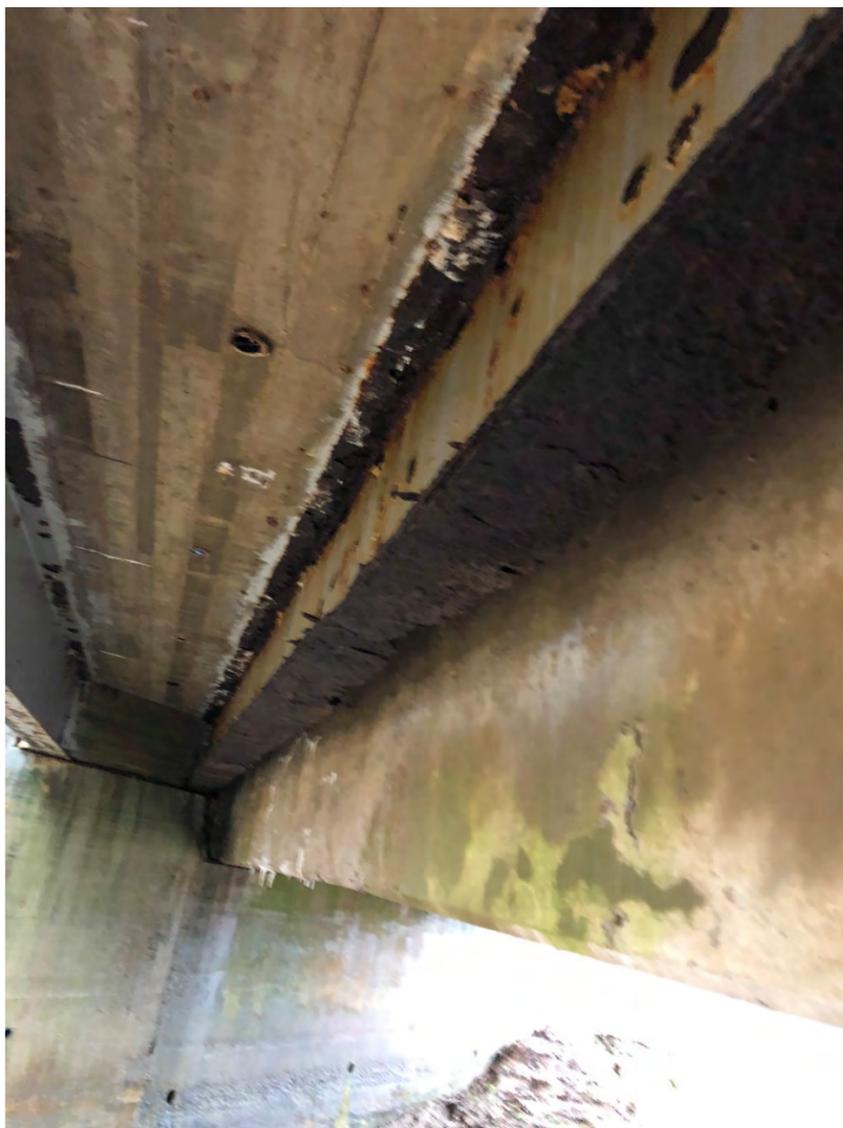
Extensive Corrosion of inner I-Beam at Inlet

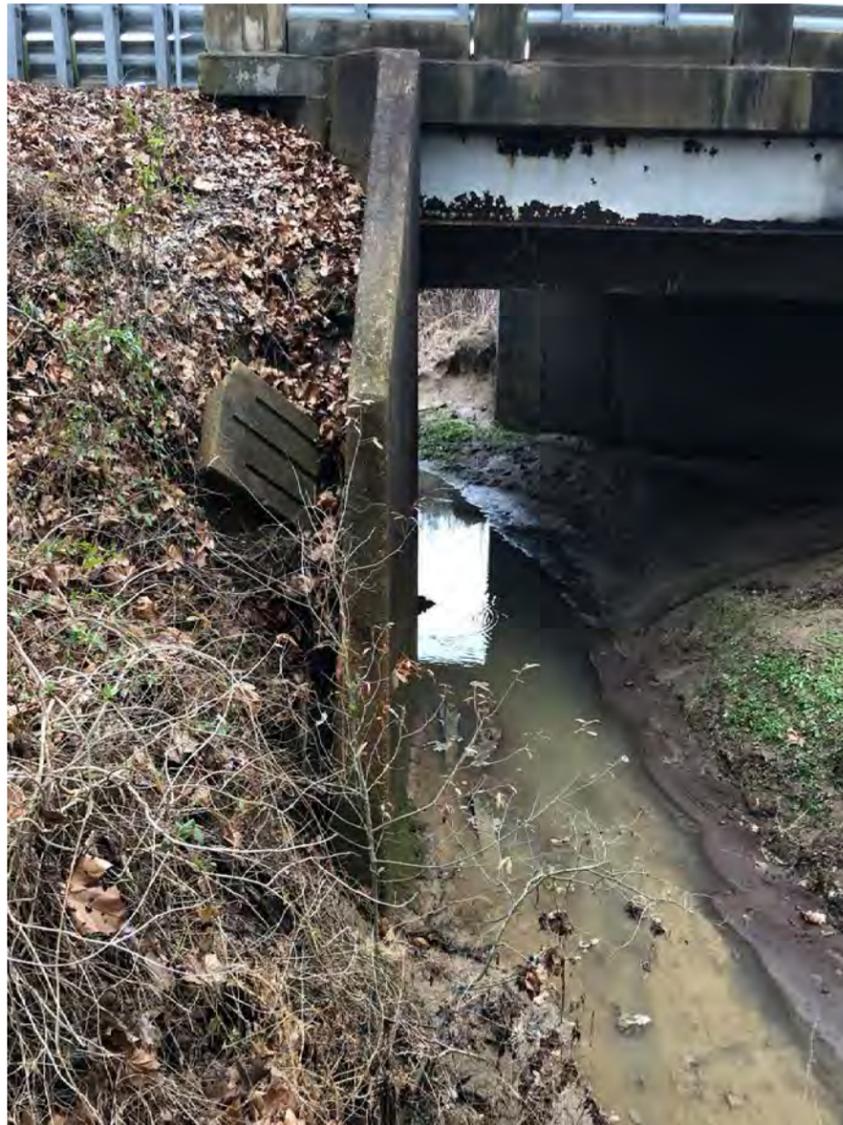
Washout and Vegetation on West Abutment at Inlet

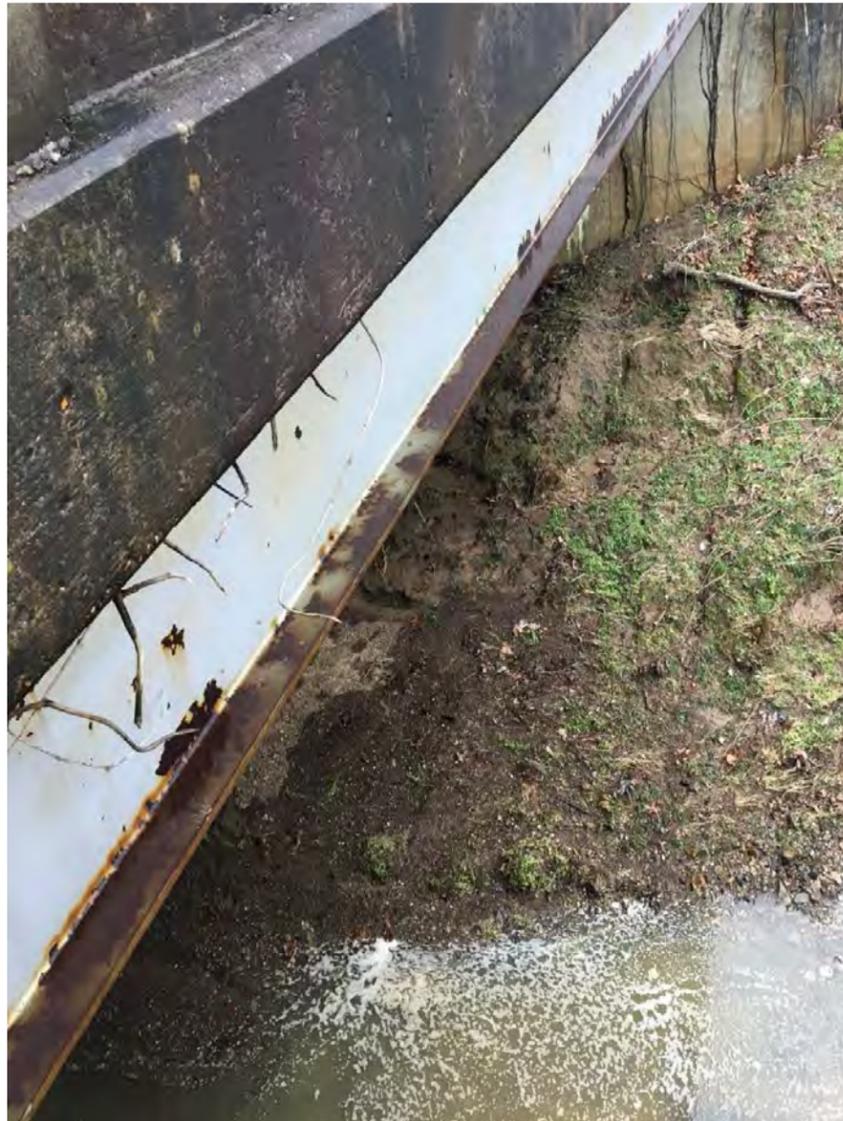
Severe Corrosion of Flange in Outer I-Beam at Outlet

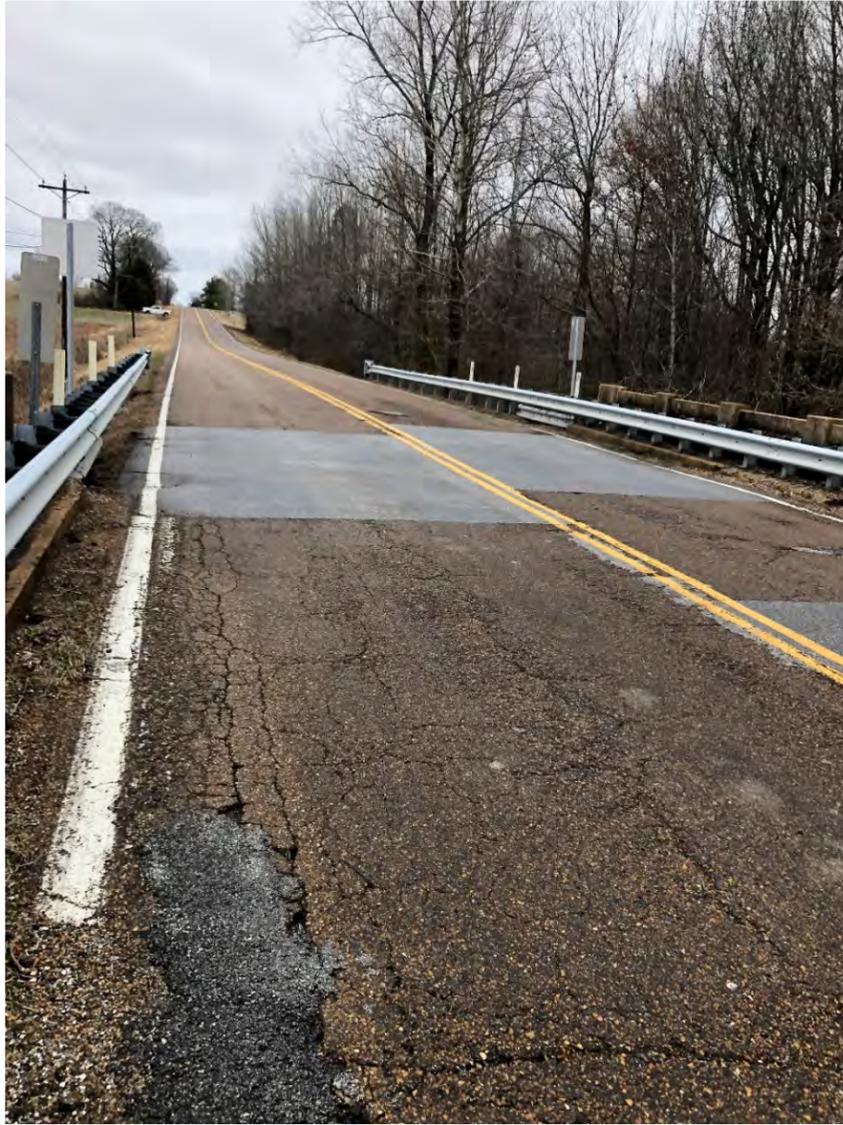
Pavement Cracking and Spalling along Surface from West Abutment

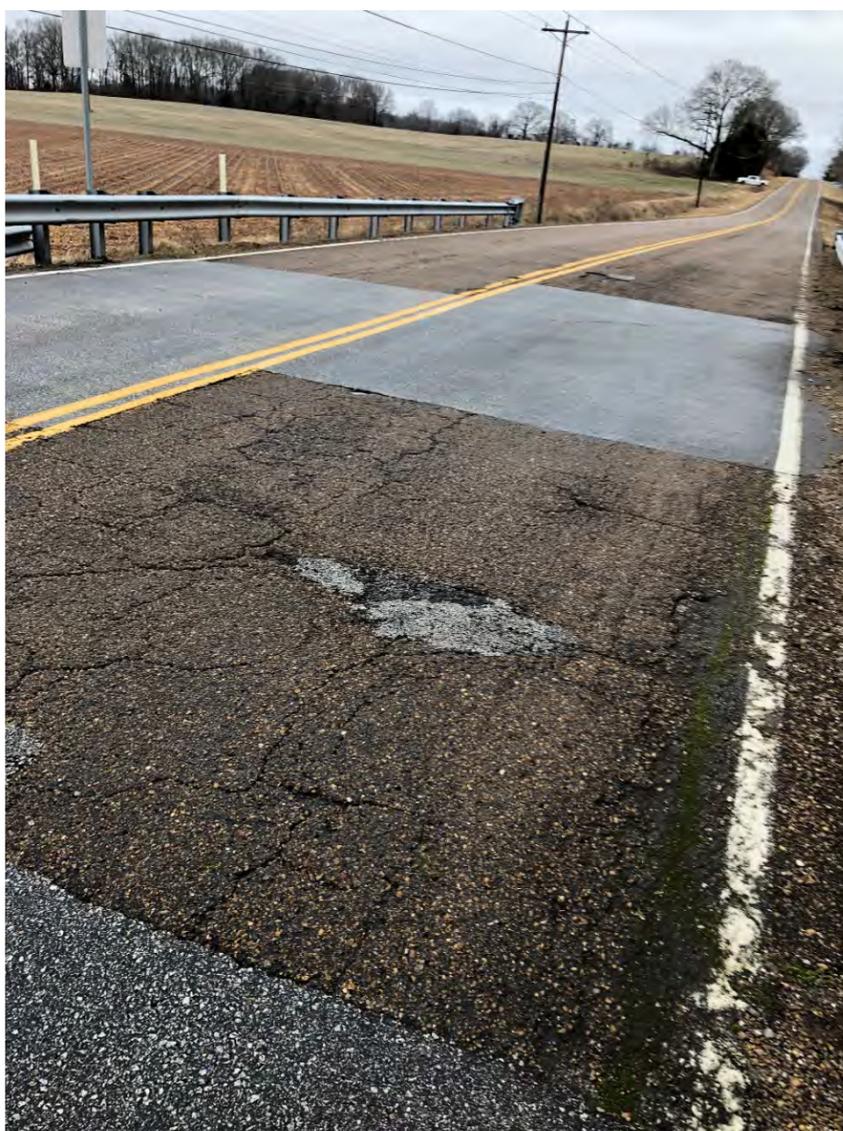
Spalling and Cracking along Surface

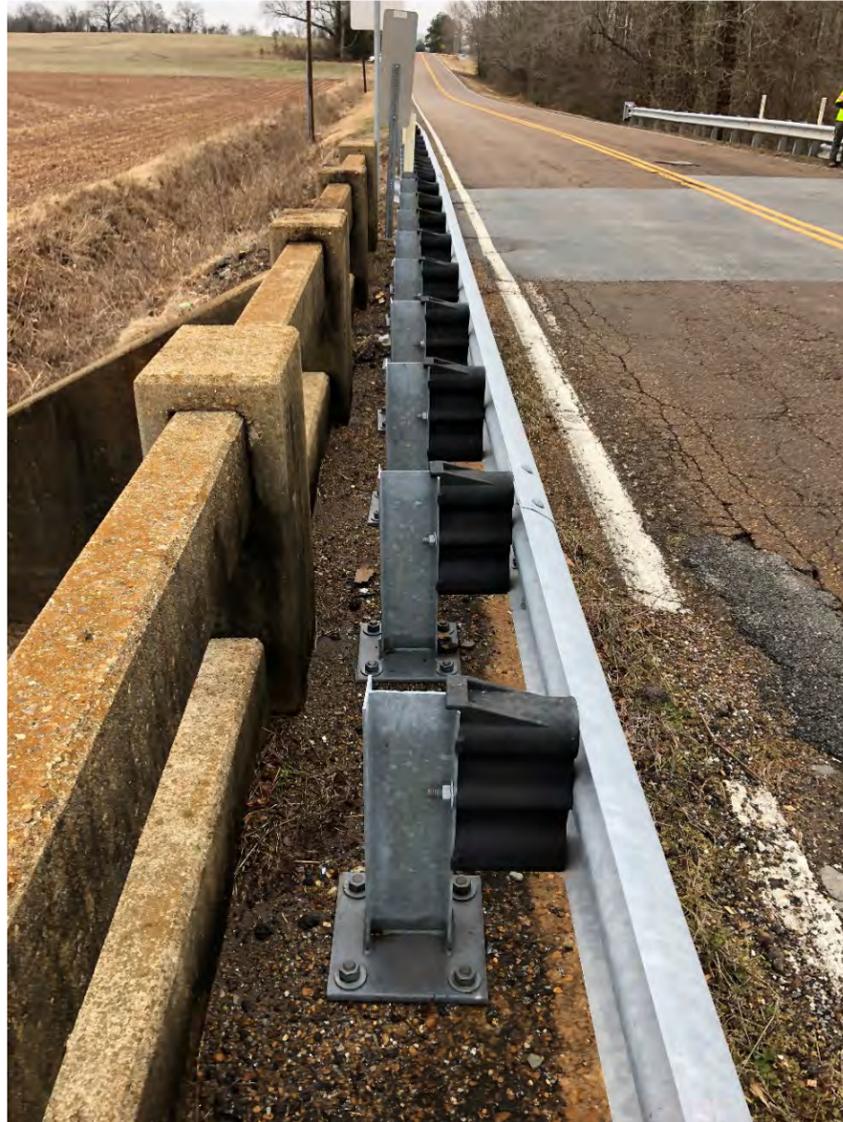
Poor conditions of Railing and Shoulder (Vegetation and Decay)

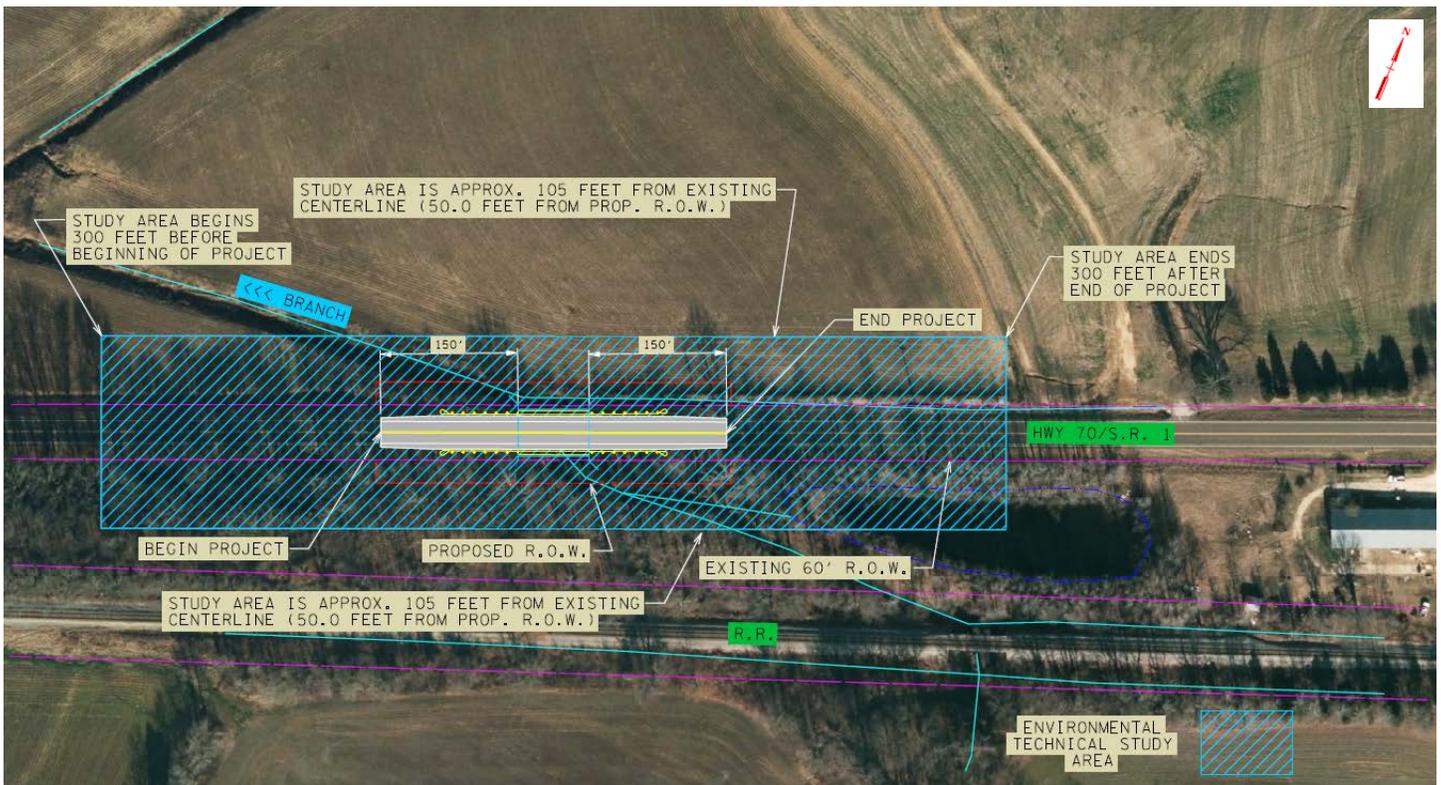
Figure 2: Functional layout for proposed bridge replacement, aerial view. Proposed ROW lines are for planning purposes.

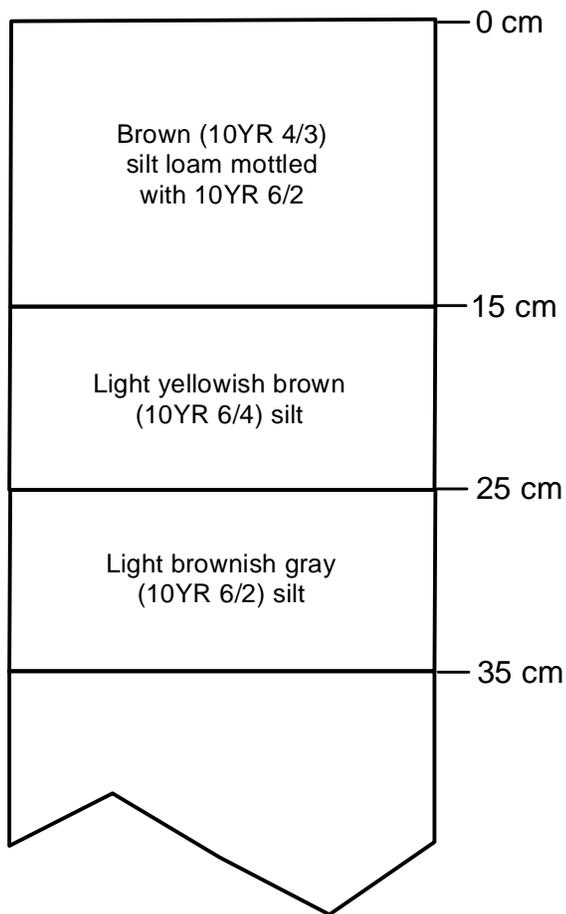
Redox features were noted in throughout the profile.

Figure 14. Representative shovel test profile.

Shovel test profiles were relatively consistent throughout the project area. Transect B Shovel Test 2 provides a representative profile for the project area (Figure 14). Three zones were defined in this shovel test. Zone I was a brown (10YR 4/3) silt loam that was mottled with 10YR 6/2. Zone I extended from the ground surface to approximately 15 cm below ground surface. Zone II was a light yellowish brown (10YR 6/4) silt that extended from 15 cm to approximately 25 cm below ground surface. Zone III was a light brownish gray (10YR 6/2) silt that extended from 25 cm to the base of the test at approximately 35 cm below ground surface. Redox features were noted throughout the profile. Zone III was not encountered in some of the shovel tests (Figure 15).

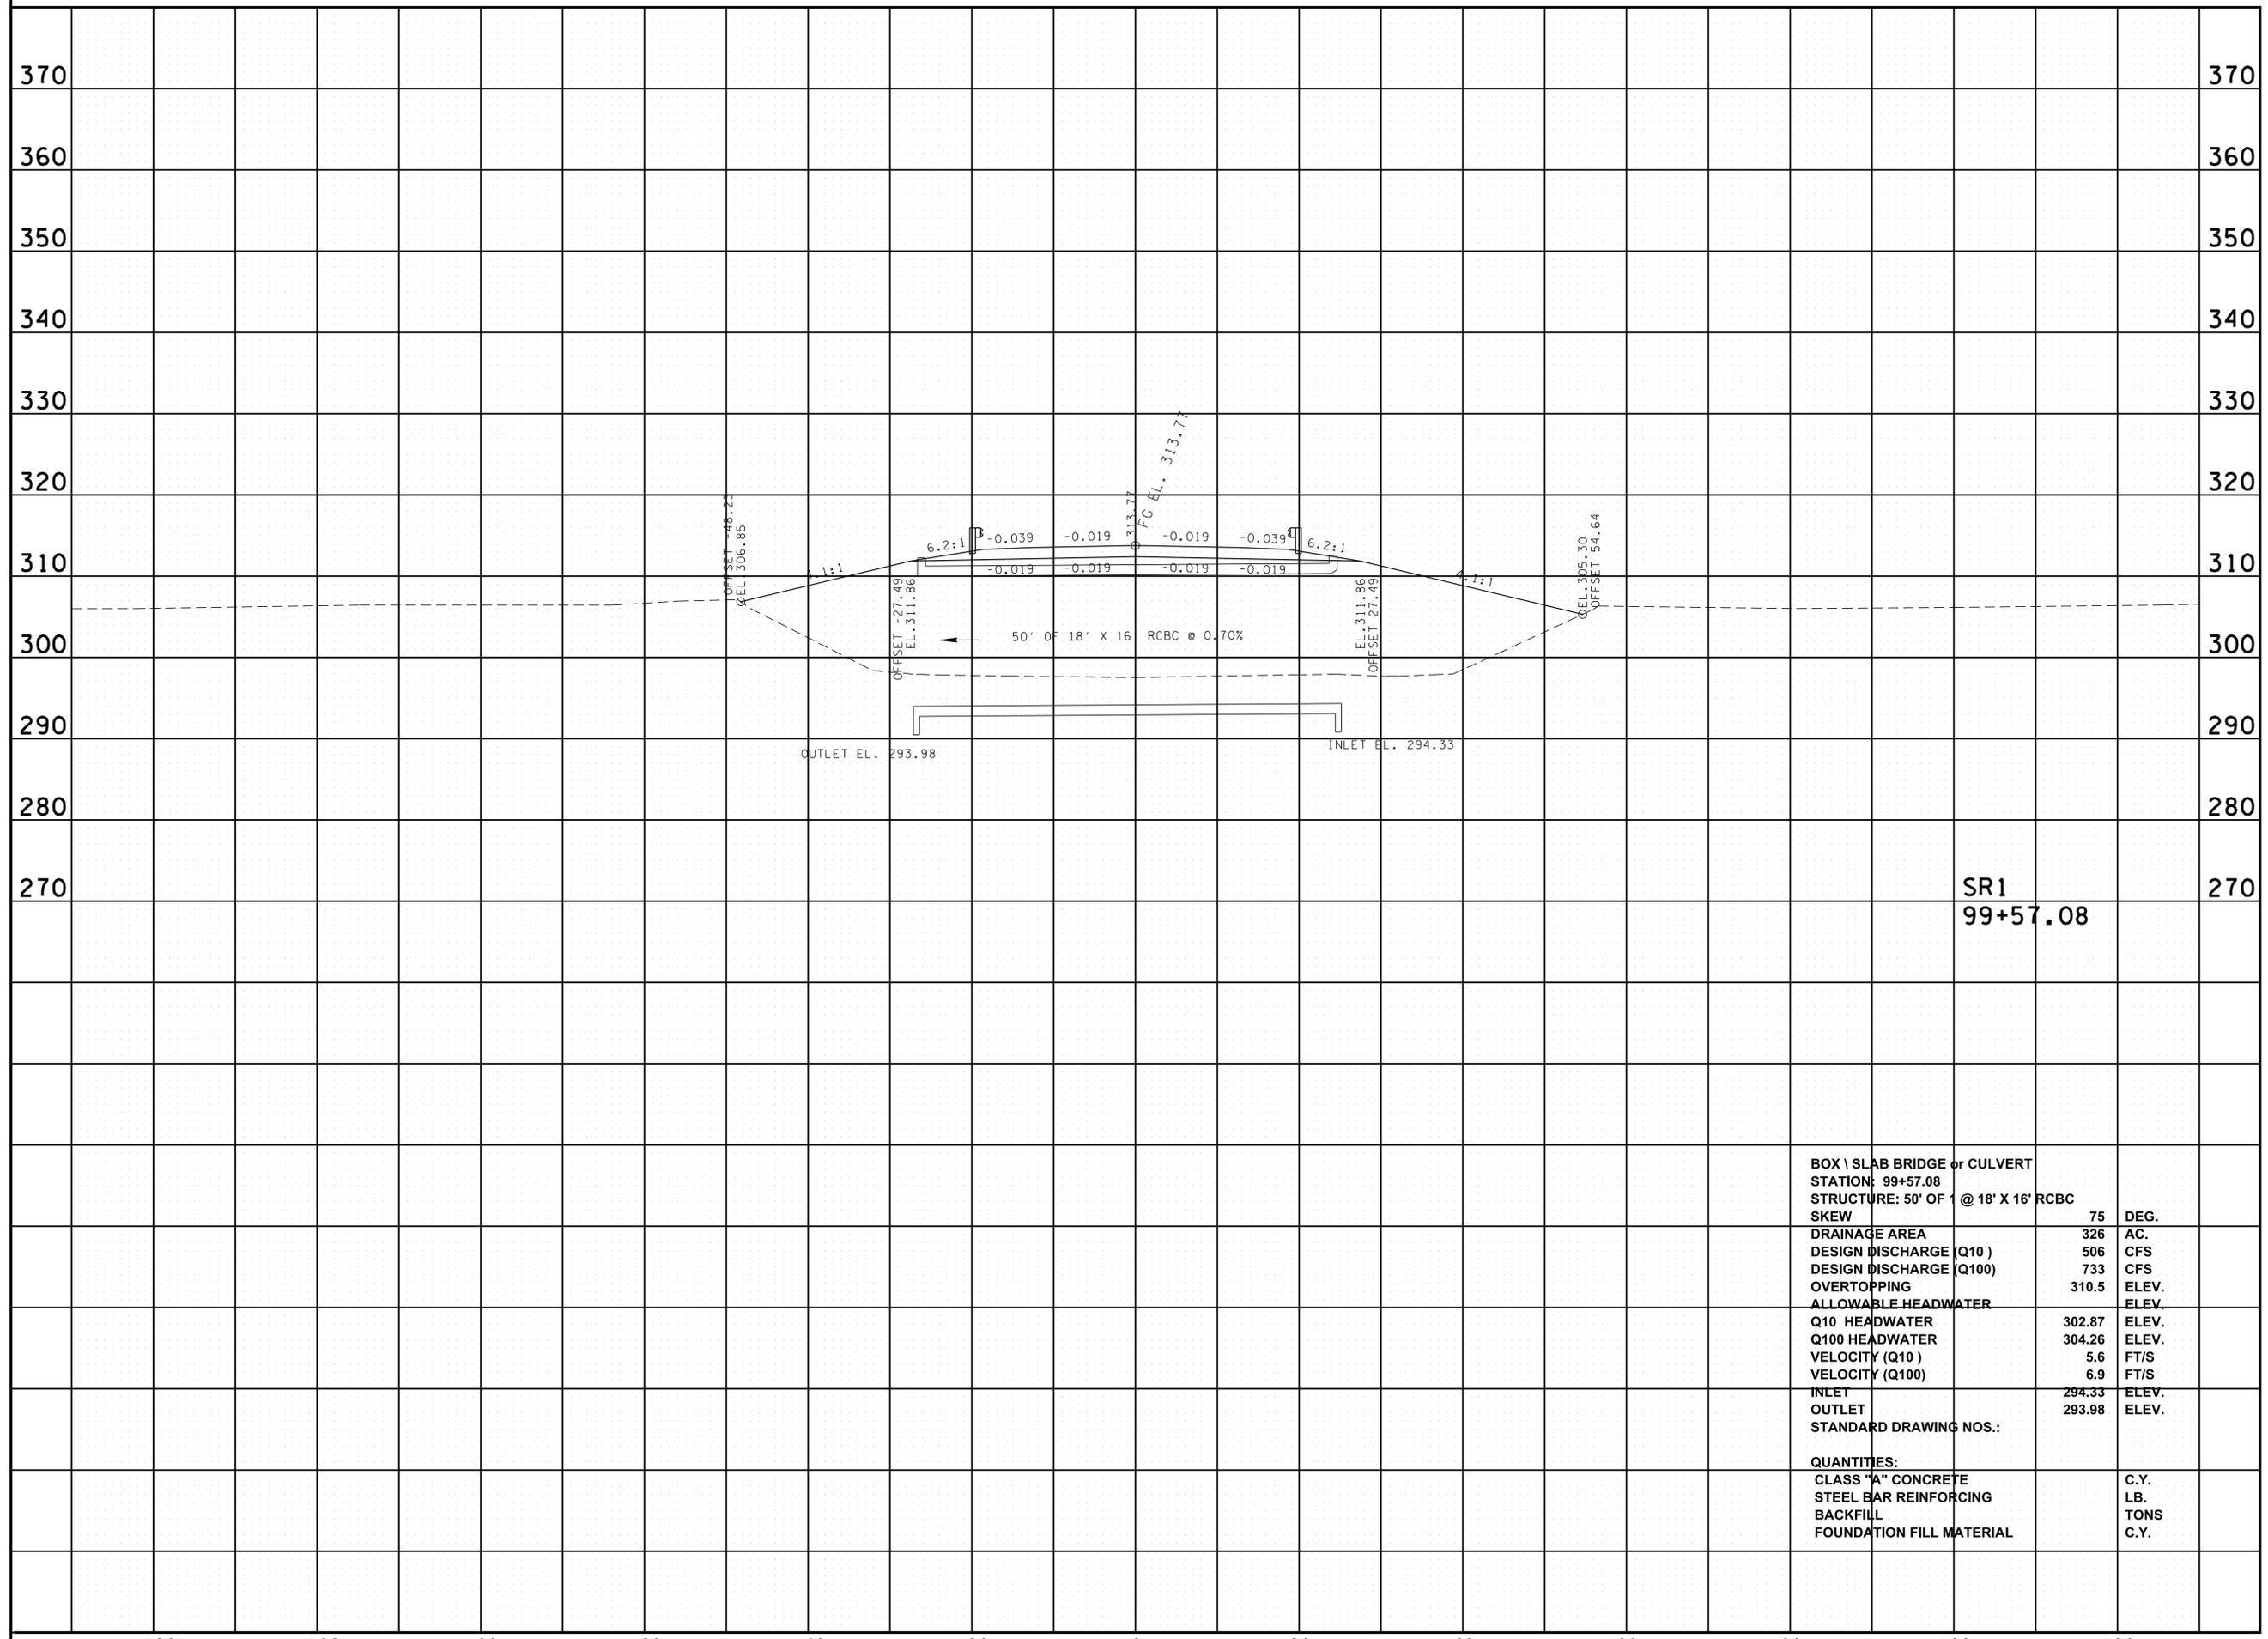
TYPE	YEAR	PROJECT NO.	SHEET NO.
PRELIM	2019	BR-NH-1(382)	6

BOX \ SLAB BRIDGE or CULVERT		
STATION: 99+57.08		
STRUCTURE: 50' OF 1 @ 18' X 16' RCBC		
SKEW	75	DEG.
DRAINAGE AREA	326	AC.
DESIGN DISCHARGE (Q10)	506	CFS
DESIGN DISCHARGE (Q100)	733	CFS
OVERTOPPING	310.5	ELEV.
ALLOWABLE HEADWATER		ELEV.
Q10 HEADWATER	302.87	ELEV.
Q100 HEADWATER	304.26	ELEV.
VELOCITY (Q10)	5.6	FT/S
VELOCITY (Q100)	6.9	FT/S
INLET	294.33	ELEV.
OUTLET	293.98	ELEV.
STANDARD DRAWING NOS.:		
QUANTITIES:		
CLASS "A" CONCRETE		C.Y.
STEEL BAR REINFORCING		LB.
BACKFILL		TONS
FOUNDATION FILL MATERIAL		C.Y.
